**To:**            Distribution- - see below  
**From:**        H. F. McAlpine  
**Date:**         October 22 1999  
**Subject:**     Dam Safety Assessment of the Mt. Nansen Tailings Dam

**BYG Tailings Dam, Mount Nansen, YT - Site Visit Report**

INDIAN AND NORTHERN AFFAIRS  
WATER RESOURCES DIVISION  
BYG Tailings Dam, Mount Nansen, YT - Site Visit Report

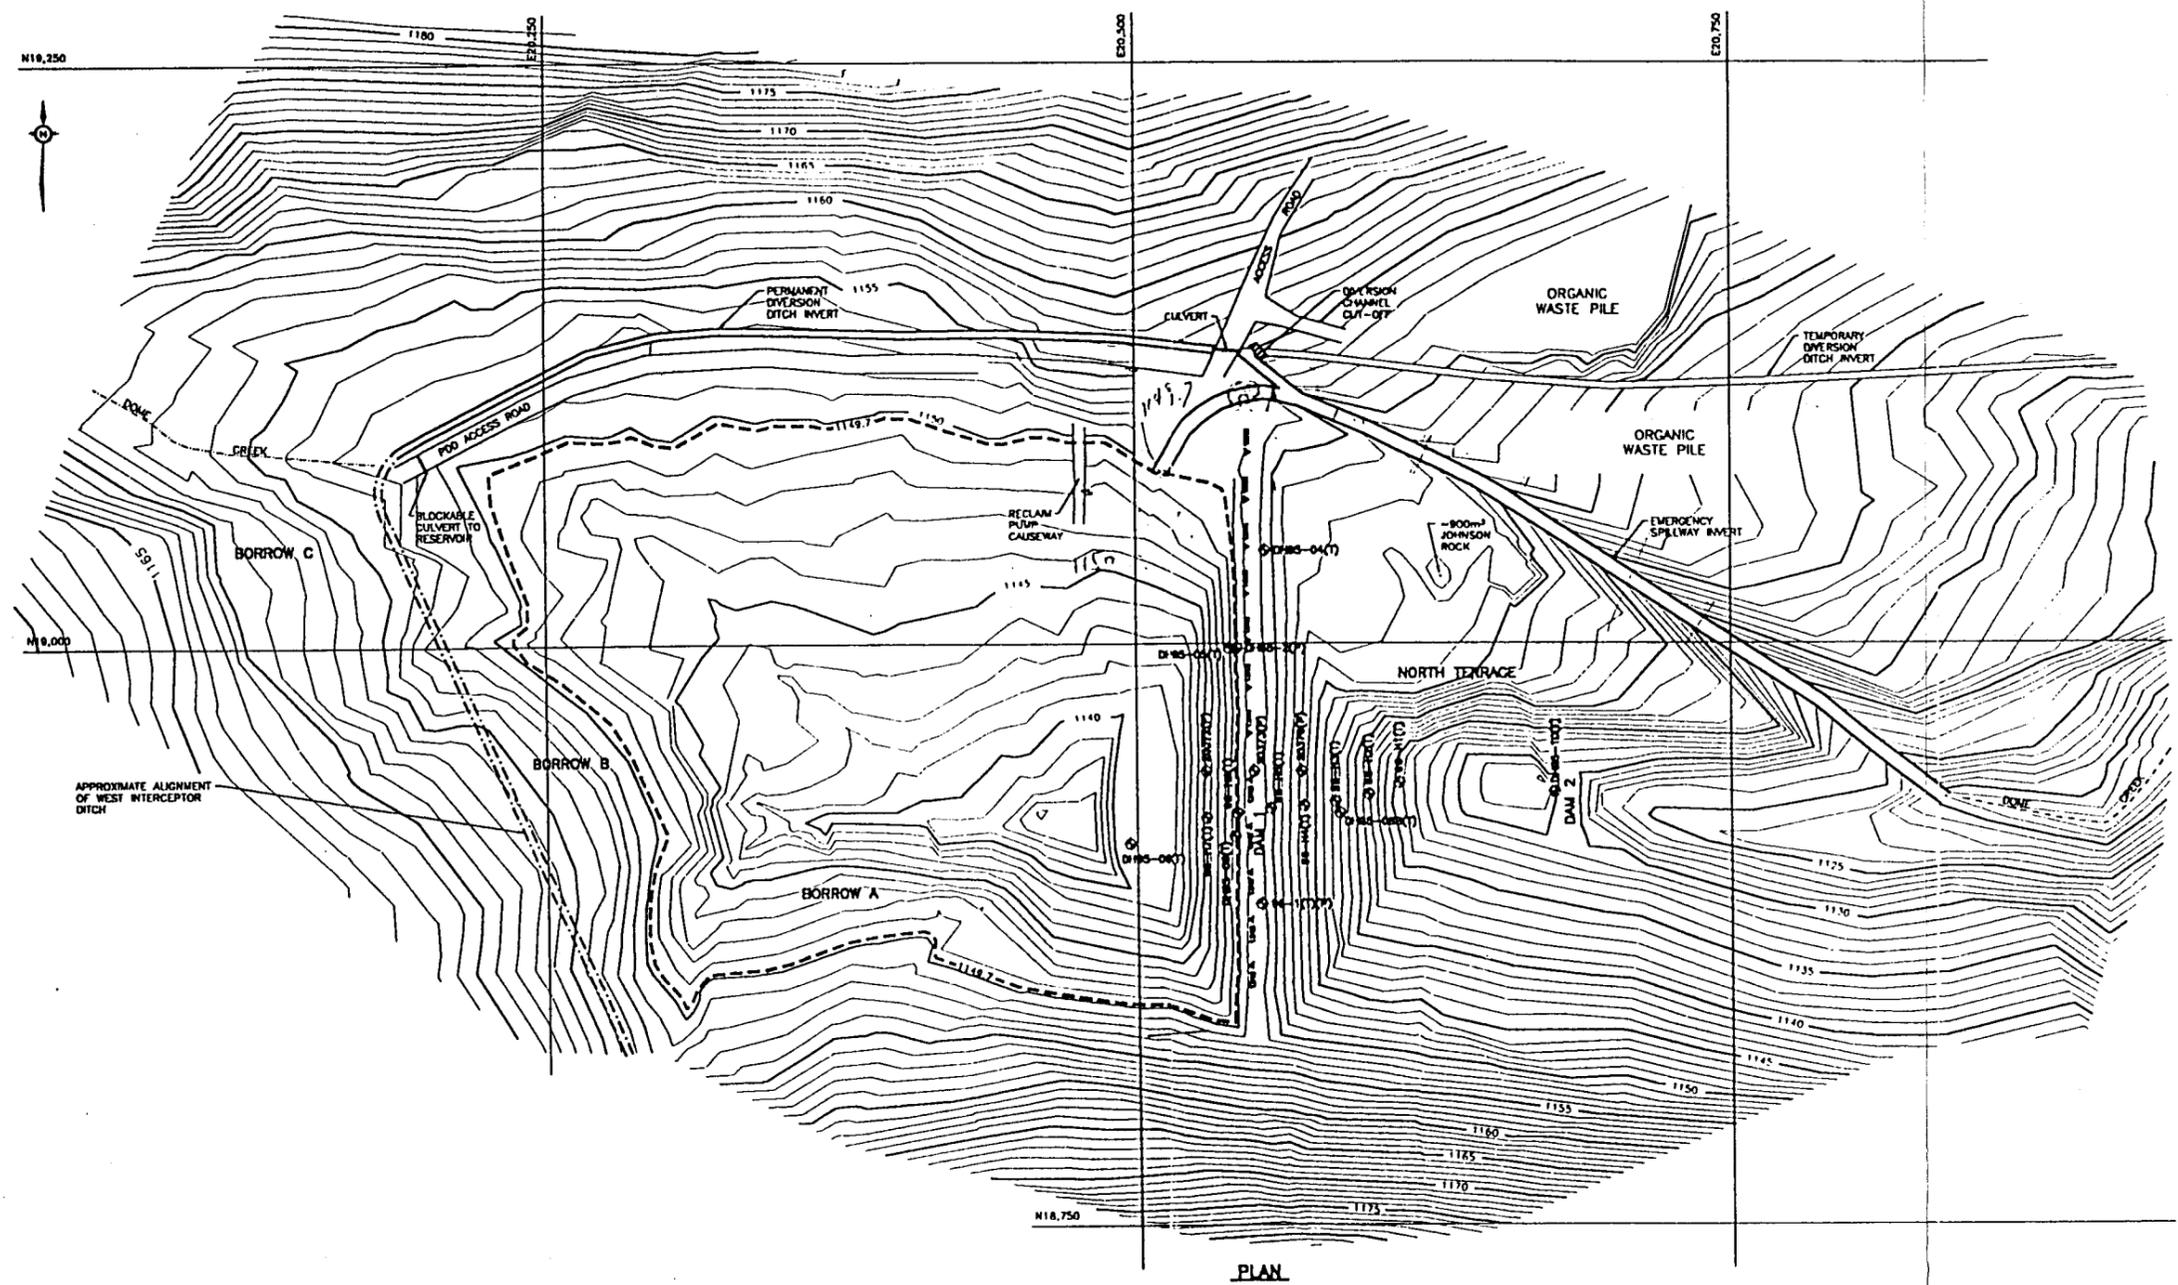
The purpose of this letter is to provide a general impression of the current condition of the BYG Tailings Impoundment (see Photo 1 and Figure 1 for site plan) as well as to identify some issues related to the safety and integrity of the dam that require immediate attention. On September 16, 1999 our Robert Lo visited the site together with yourself, Mr. Cord Hamilton of EBA and Mr. Milos Stepanek of Geo-engineering. This report is based mainly on our observations and discussions on site together with a preliminary review of some recent site monitoring data provided to us through EBA. The letter was prepared in consultation with Mr. Cord Hamilton of EBA. We will carry out a more thorough review as stipulated earlier, but this must not delay initiation of improvement measures given in this letter.

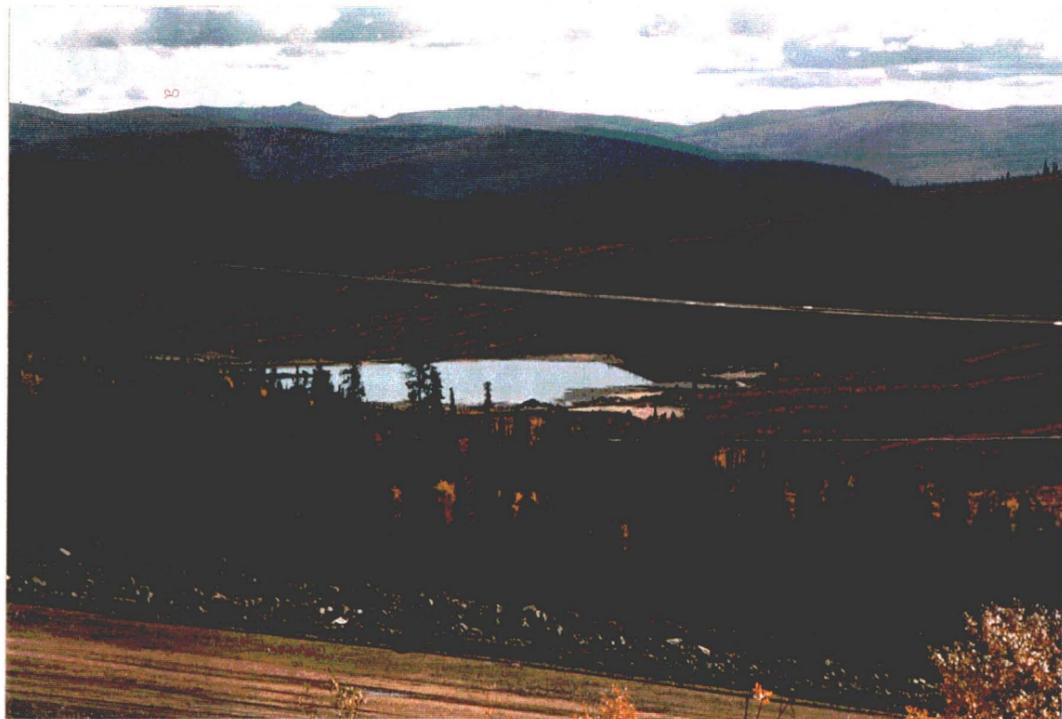
Photograph 1 Bird's eye view of Tailings Impoundment - looking southeast.
