Date: January 14, 2000
Subject: QZ99-043 Part A Section 10: Dam Safety Assessment of the Mt. Nansen Tailings Dam

BYG Tailings Dam, Mount Nansen, YT - Project Data Review Report

INDIAN AND NORTHERN AFFAIRS
WATER RESOURCES DIVISION
BYG Tailings Dam, Mount Nansen YT - Project Data Review Report

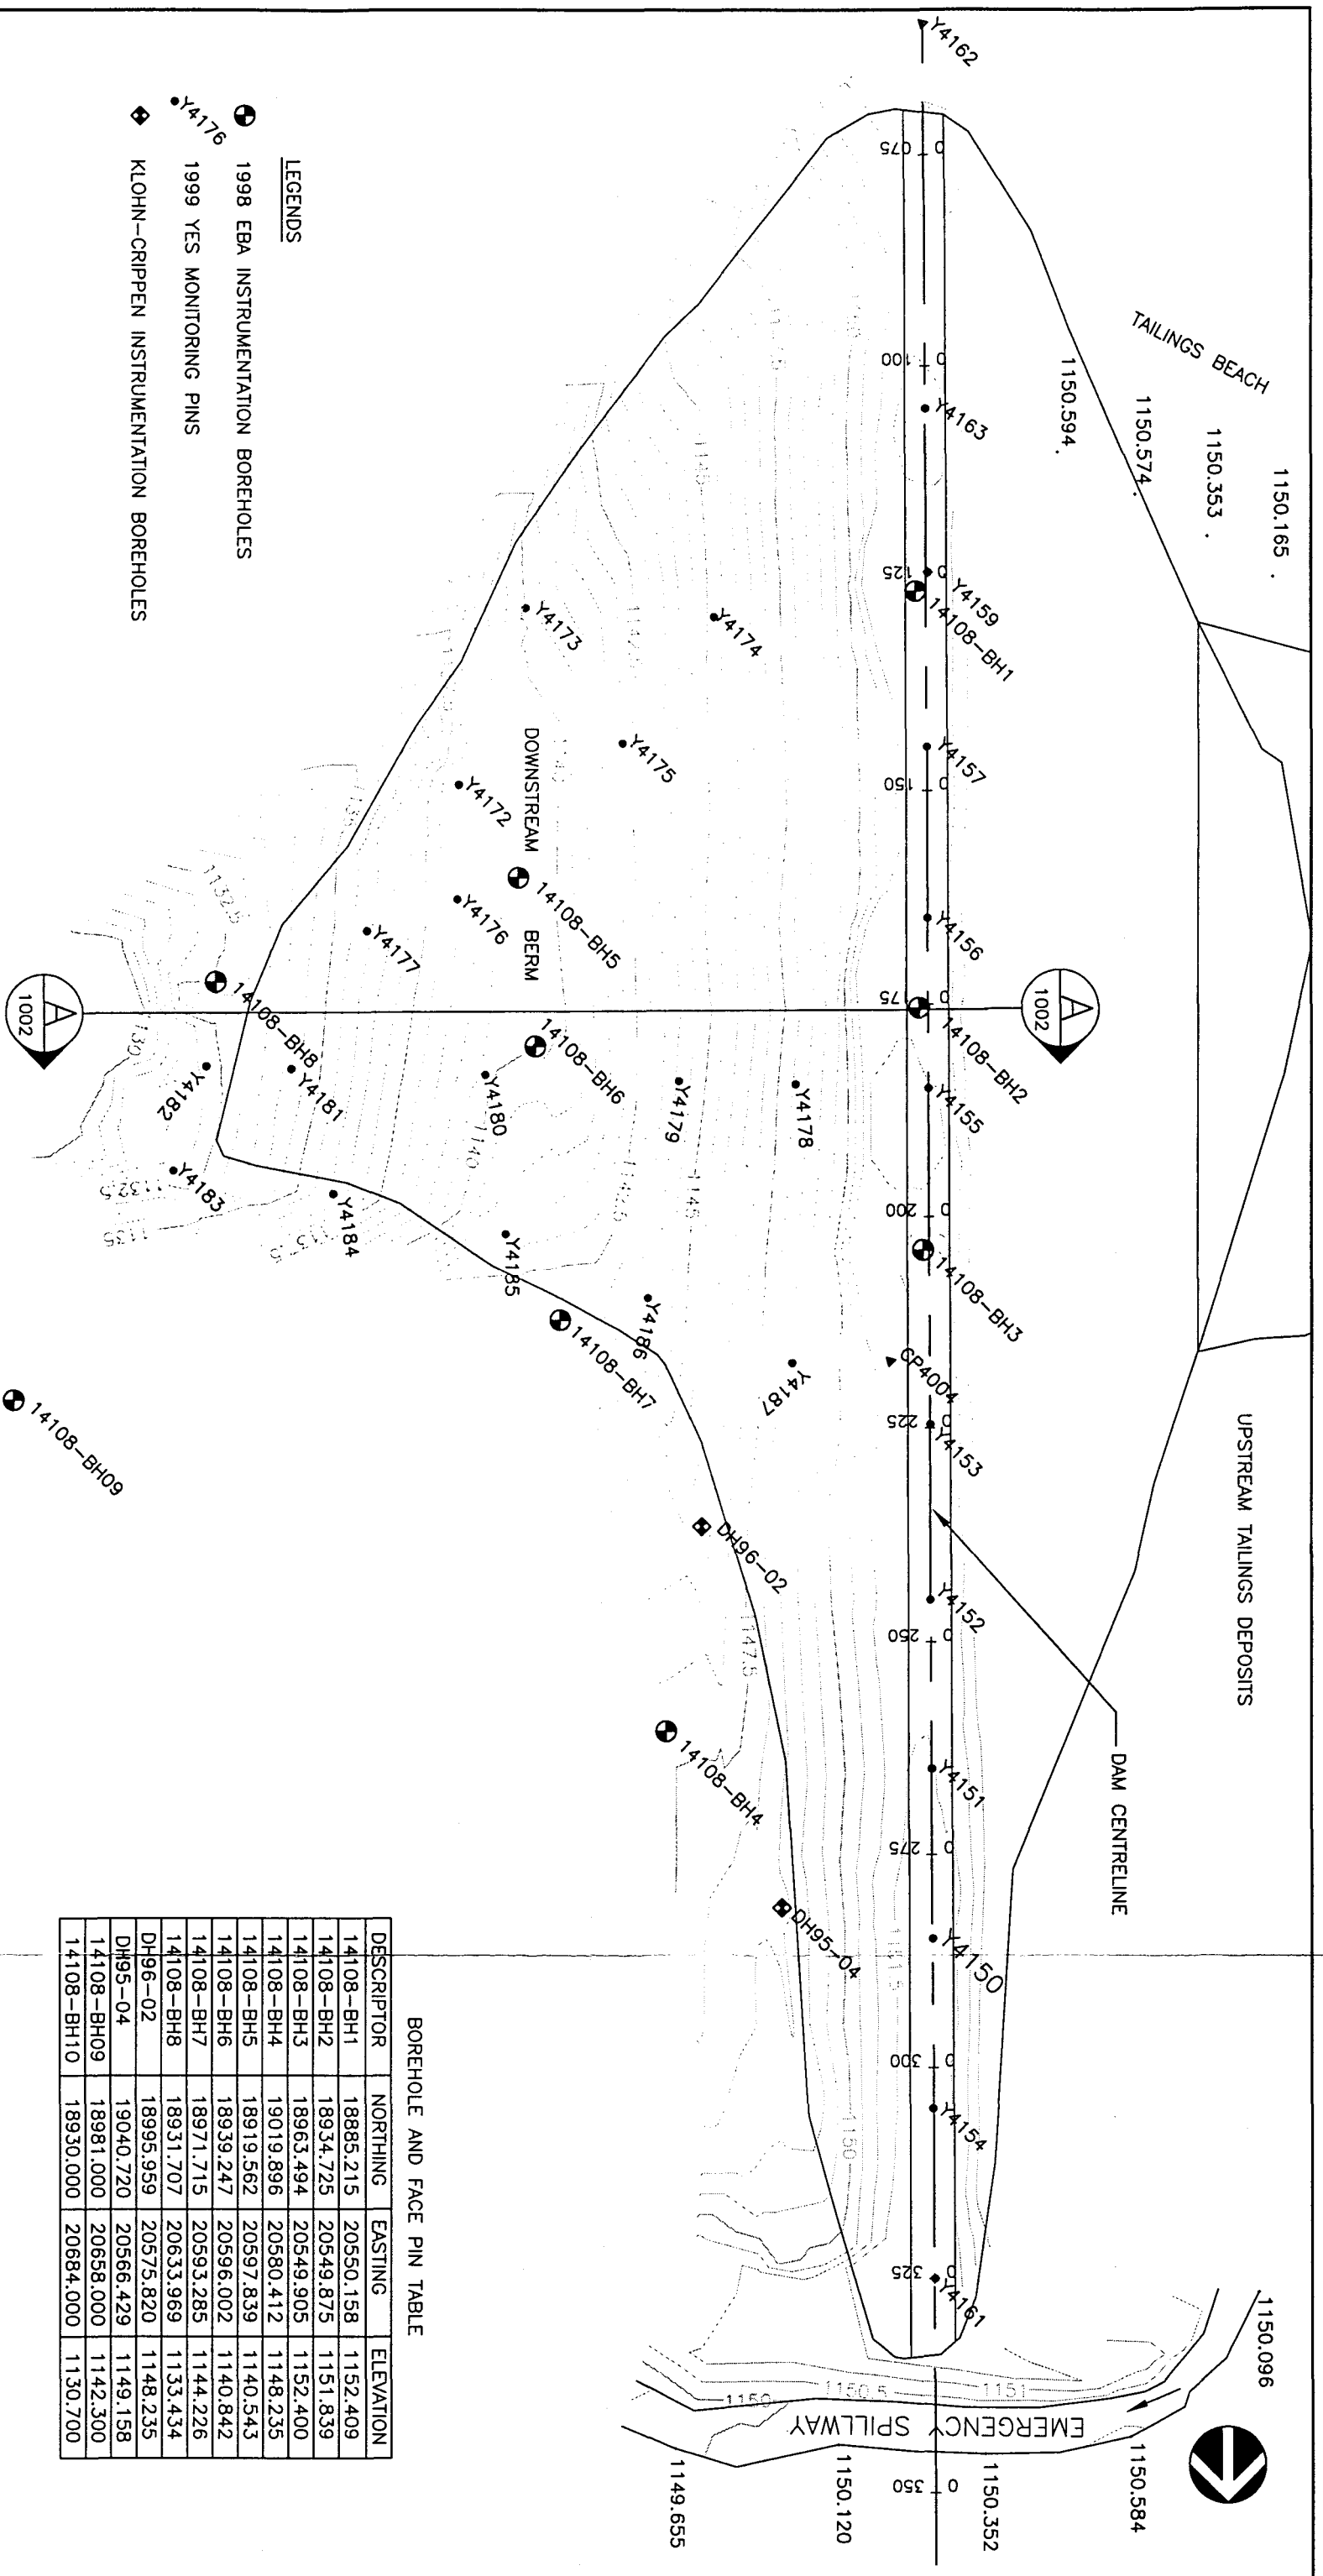
TAILINGS DAM - PLAN VIEW
Figure 1

- The downstream slope of the buttress berm near the right (south) abutment has local depressions and extensive cracks. Two survey pins were installed in the area to serve as reference points for facilitating future comparisons. In reviewing the circumstances of the 1997 berm construction, EBA considers that the surficial signs of fill adjustment may

EBA reviewed records of those thermistors installed in 1998 at 10 boreholes (see Figure 1 for their locations), and reported in their data review (Table 2 in EBA 1999a) that the foundation thaw depth within the dam proper (Boreholes BH #1 to #3, #5, #6 and #8) ranges from about 0.75 m at Borehole BH #1 to a maximum depth of 3.6 m to 4.9 m at Borehole BH #3. The concerns of permafrost degradation of the dam foundation are elaborated in Section 5.1.

Limit-equilibrium stability analyses were carried out for the downstream slope of the maximum dam section based on the geometry of the dam and its downstream berm as shown on Figure 1. Salient features of the stability analyses including the soil properties (also summarized in Table 1), piezometric levels, failure surfaces and static safety factors are summarized in Figure 7. As shown in Table 1, two sets of strength parameters were used: (1) design strength set used in the design report (Klohn-Crippen 1995); and (2) reduced strength set, used to investigate the possible effect of reduced strength.

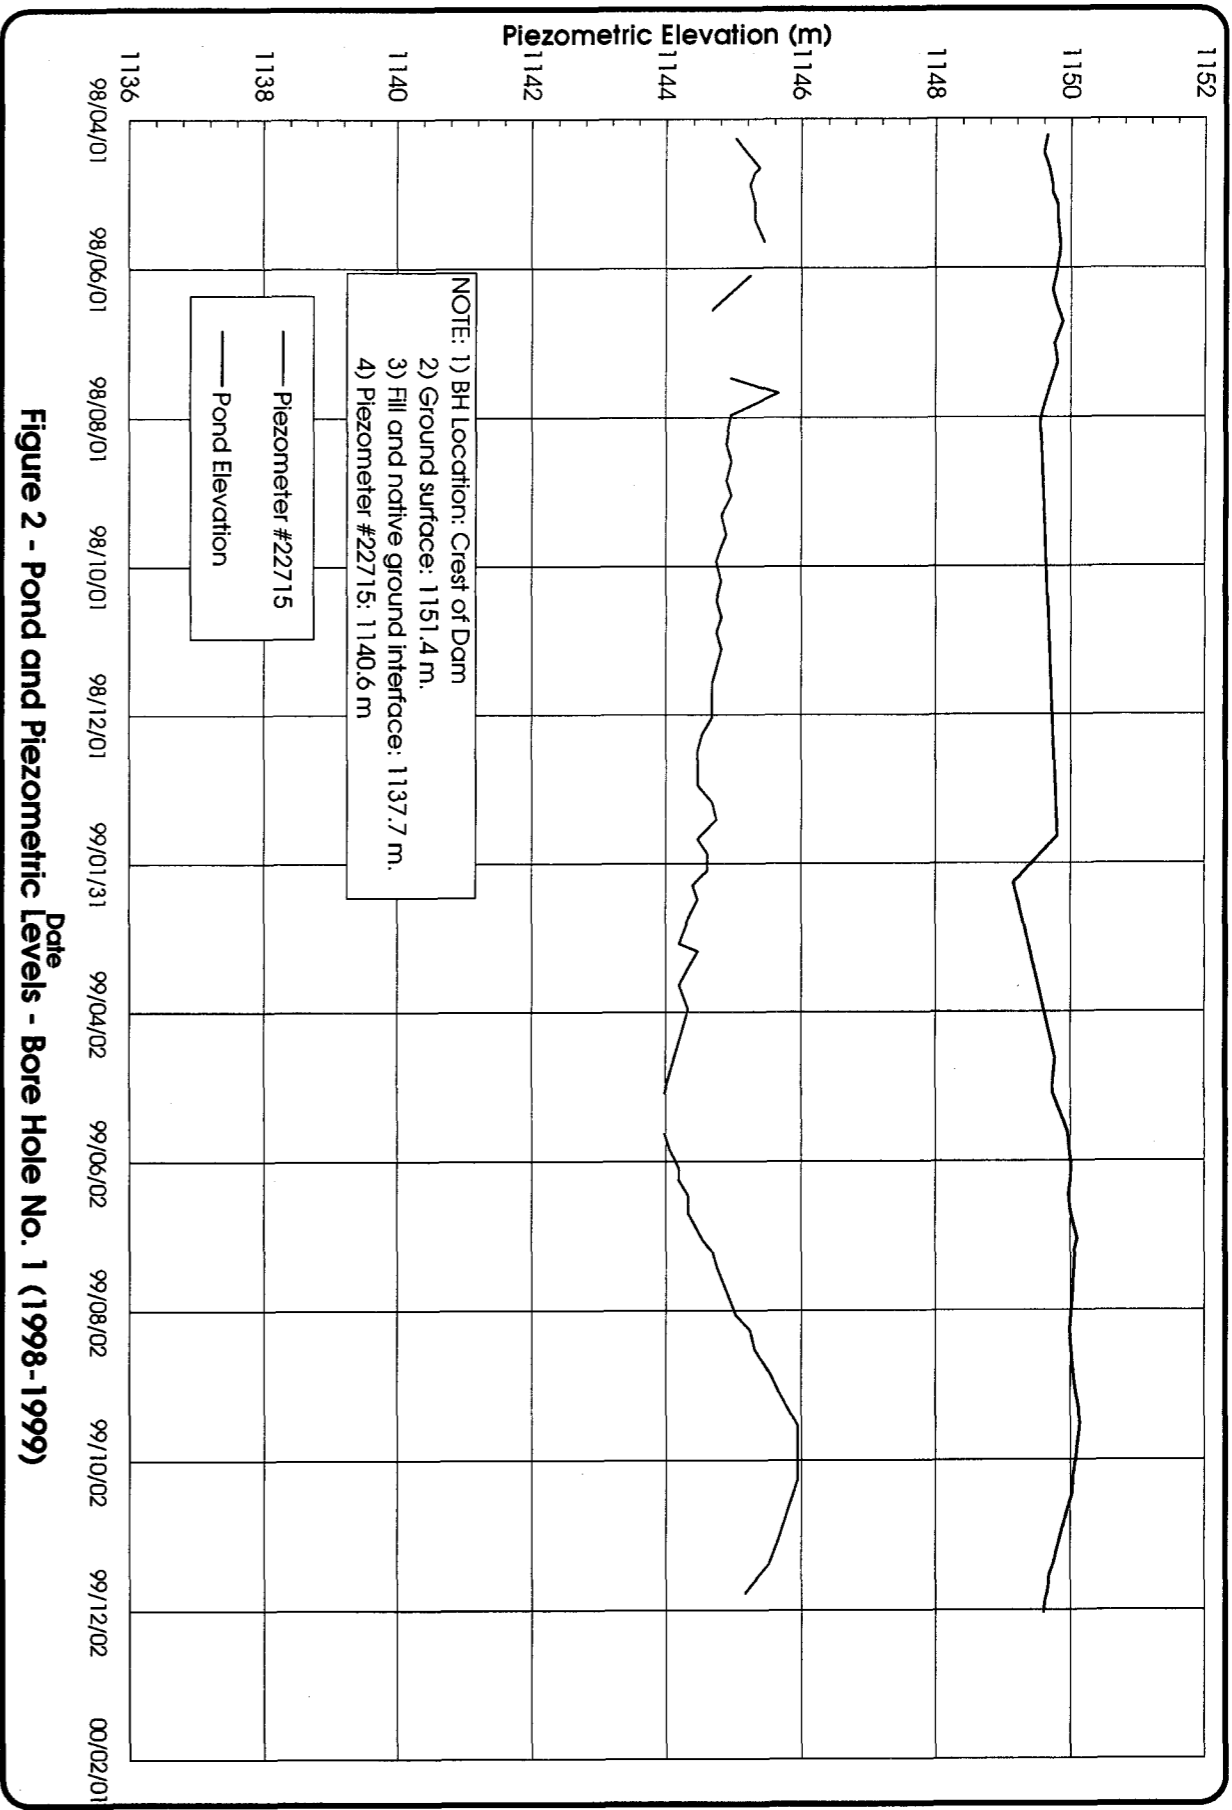
Figure 2 - Pond and Piezometric Levels - Bore Hole No. 1 (1998-1999)

Piezometric levels for five boreholes (Boreholes BH #1 to #3, #5 and #7) were plotted together with the pond level by EBA (1999a). These data are presented in Figures 2 to 6, using the same scale for both the piezometric and pond levels.

During foundation preparation for dam construction, the surficial organic layer was not removed due to its frozen condition and the limitation of construction equipment (Klohn-Crippen 1996). EBA (1998) instrumentation installation record confirms the presence of the organic layer, with a thickness in the range of 0.5 m to 2.8 m, beneath the dam base at the borehole locations. The review by EBA (1999a) of the thermistor data indicates that the organic layer at Boreholes BH #2 and #5 has already thawed out, while that at Boreholes BH #1, #6 and #8 still has a frozen zone with a thickness in the range of 0.5 m to 2 m. Thus, during the period of potentially ongoing thawing of the frozen organic subsoil, relative higher foundation pore pressure may exist locally prior to its dissipation due to consolidation. This could influence the local stability in the area, where the pore pressure is temporarily elevated. In our analyses, the highest recorded pore pressures at the existing piezometers were used. No additional allowance was made for even higher pore pressures due to thawing than those recorded to date.

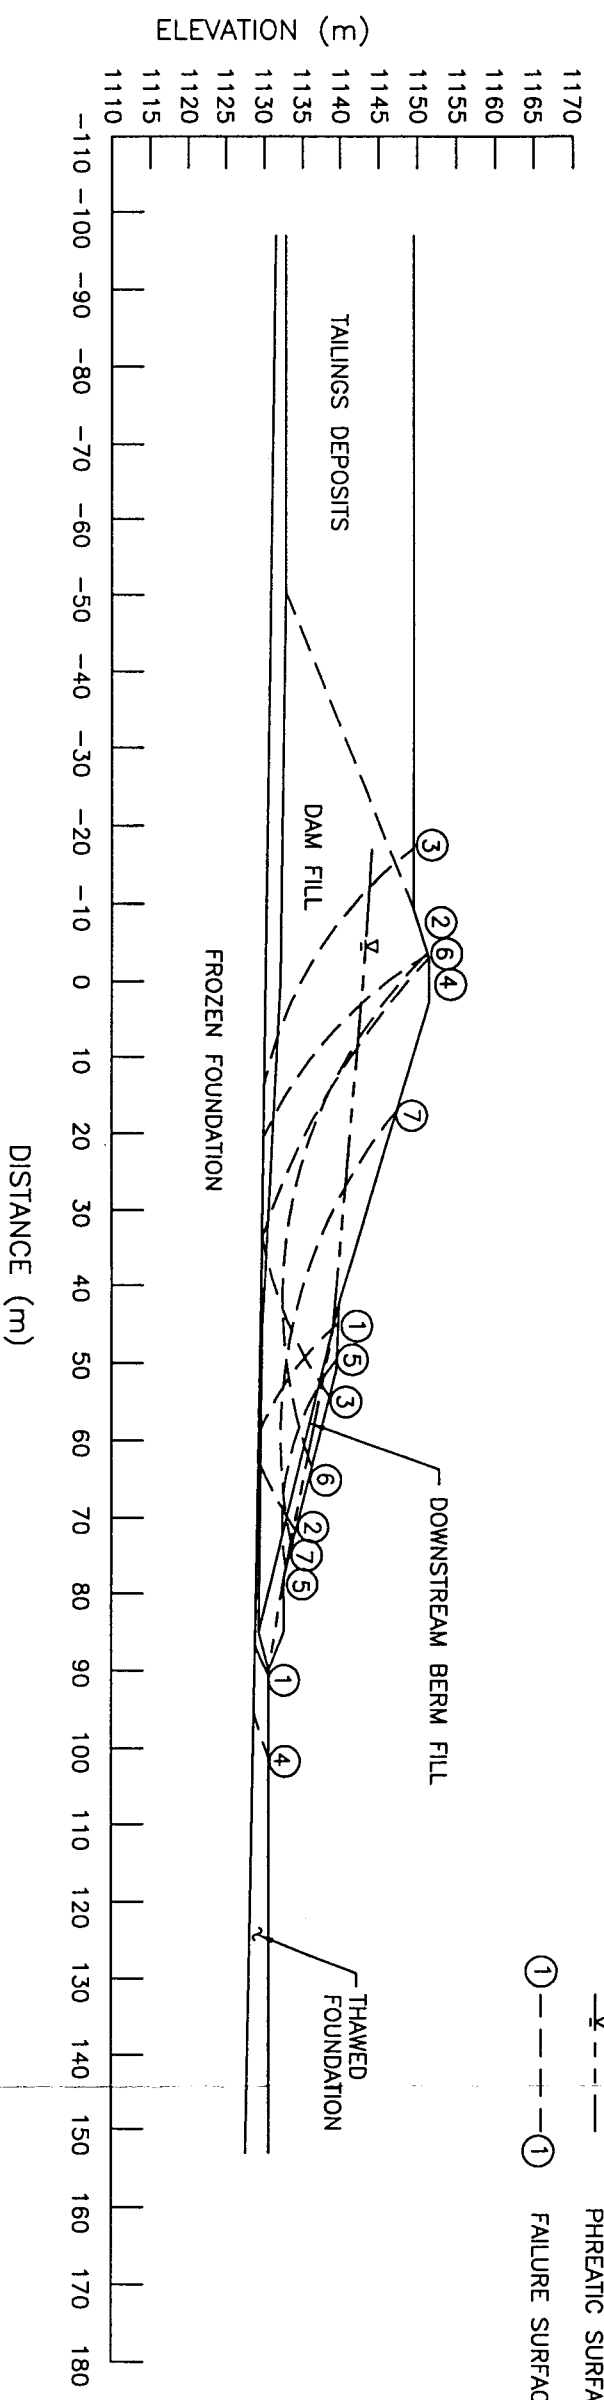
BYG TAILINGS DAM
 DAM SAFETY ASSESSMENT
 TAILINGS DAM -
 STABILITY ANALYSES
 Figure 7

Table 2 summarizes the static safety factors against downstream slope instability. As shown in the table, the static safety factors of the downstream slope are in a range of 1.5 to 3.0 (with design strength), with a minimum value of about 1.5 near the surface of the downstream berm slope. With the reduced strength, the corresponding static safety factors are in a range of 1.3 to 2.5, with a minimum value of about 1.3 near the surface of the downstream berm slope. These preliminary results indicate that the general downstream slope appears to be stable. However, potential seasonal and local conditions could influence the actual static safety factors, and should be further examined closely in order to ensure the dam stability in the long-term condition.

The downstream slope stability under the seismic condition was not analyzed at this time. Two important factors need to be evaluated first before the seismic stability could be confidently assessed. These factors are: the seismic resistance of the dam foundation and dam fill and seismic hazard as outlined in Sections 4.1 and 4.2.

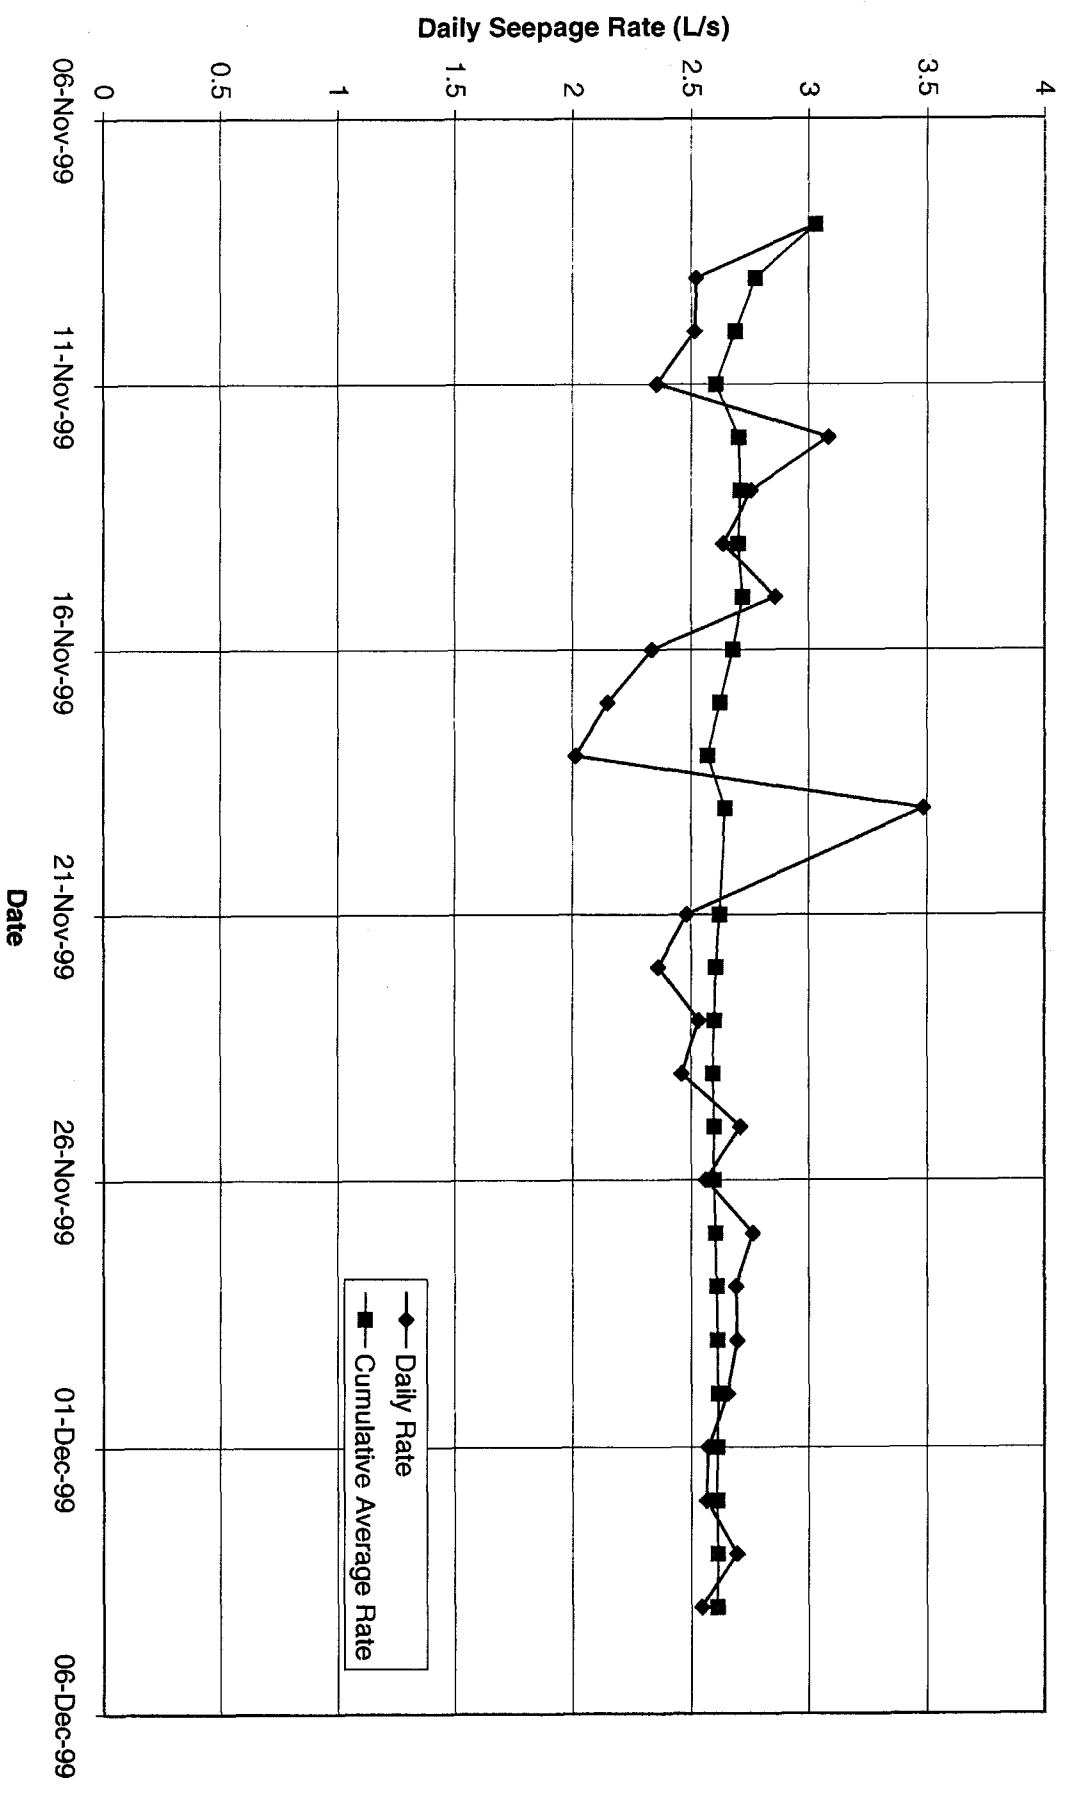
Figure 8 - Tailings Dam - Seepage Pump-back Rate Monitored by Flow Meter

A flow meter was installed in November 1999 to measure the seepage returning from the Seepage Recovery Pond to the tailings pond near the discharge end of the pump-back line (EBA 1999c). The flow rates calculated from both the daily and cumulative records from November 3 1999 to December 4, 1999 are plotted on Figure 8. The former represents the measured daily pumping rate, while the latter reflects the average pumping rate up to a specific date. EBA (1999c) also reviewed BYG's seepage records from March 29, 1999 to November 2, 1999 and concluded that a seepage pump-back rate in the range of 2.6 l/s to 2.9 l/s probably reflects the seepage condition not significantly affected by snowmelt or precipitation. This monitored seepage rate is about one order of magnitude higher than the value of 0.2 l/s estimated in the design report (Klohn-Crippen 1995). The potential reason for this difference is the fact that throughout the life of the tailings impoundment high pond levels have been maintained. Thus, the tailings beach is of insufficient width to act as the main seepage barrier as envisaged in the original design.
