INDIAN AND NORTHERN AFFAIRS CANADA

CLINTON CREEK CHANNEL STABILIZATION (STAGE 1) CONSTRUCTION REPORT

**Prepared by:
UMA Engineering Ltd.
1479 Buffalo Place
Winnipeg, Manitoba, R3T 1L7**

April 2003

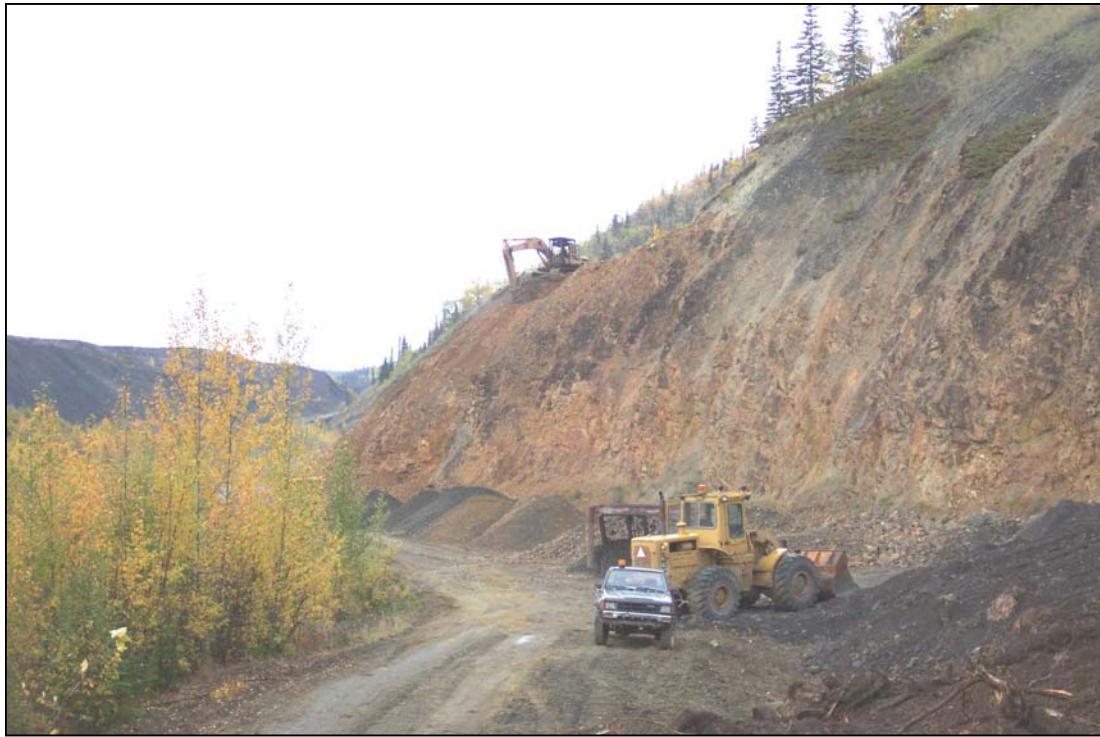
Photograph 3-1) Quarry site at Wolverine Creek.

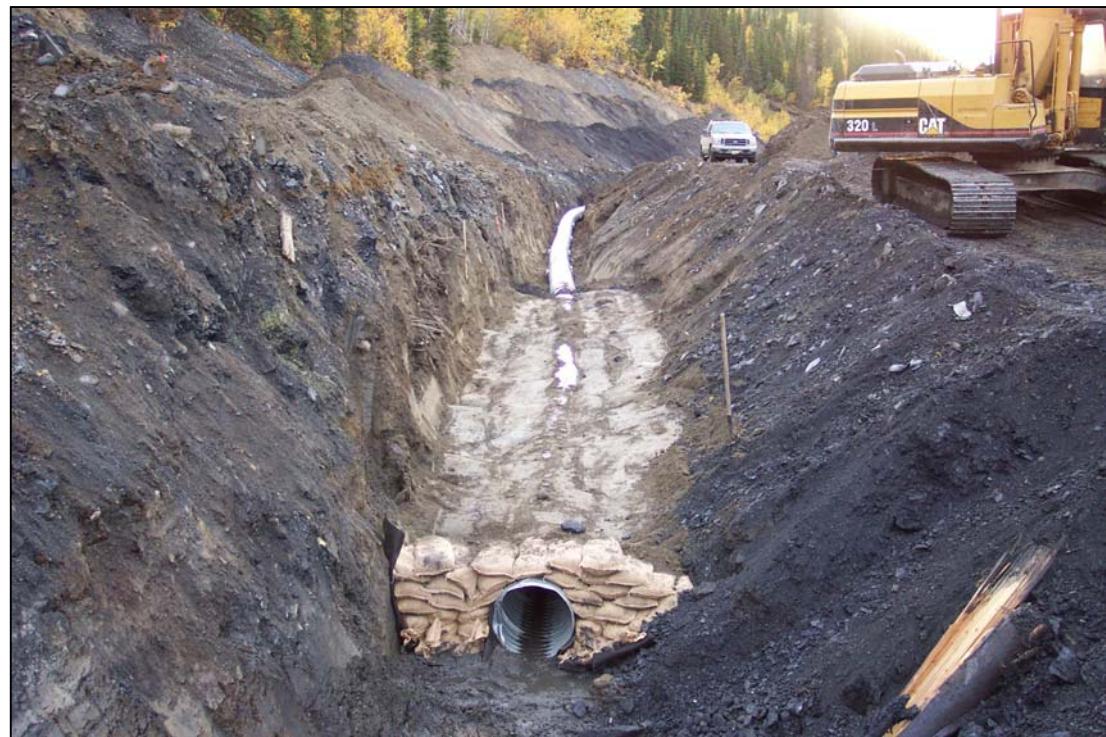
Photograph 3-2) Inlet of 600mm diameter CMP diversion pipe.

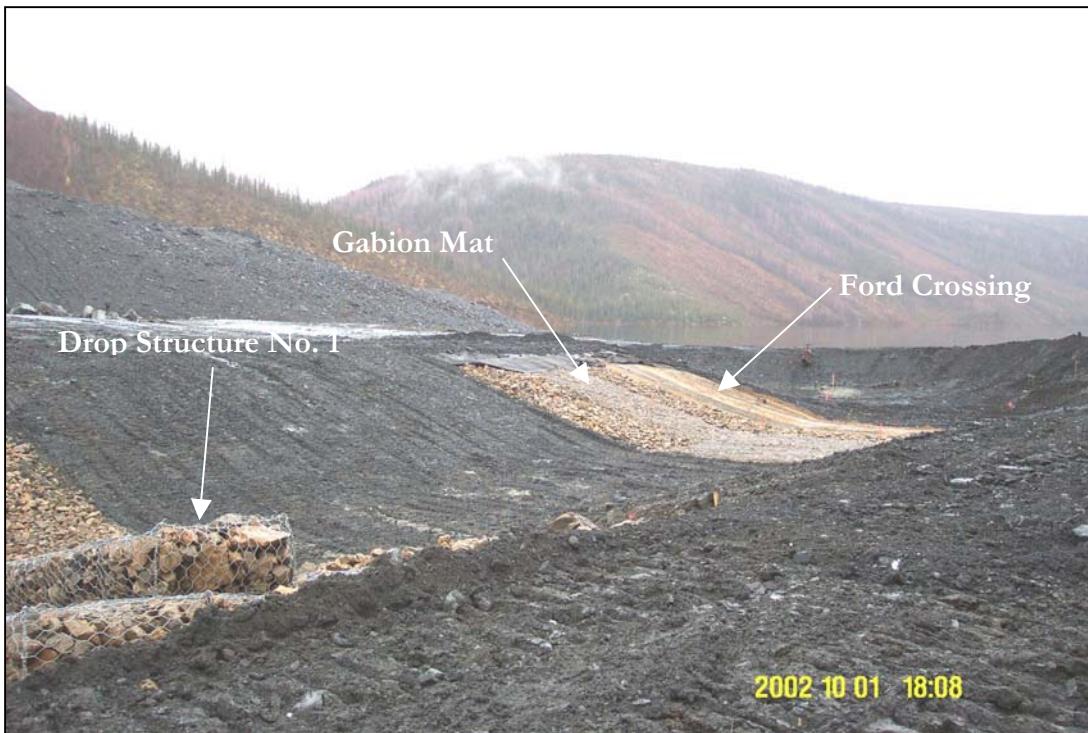
Photograph 3-8) Re-graded outlet from Hudgeon Lake.

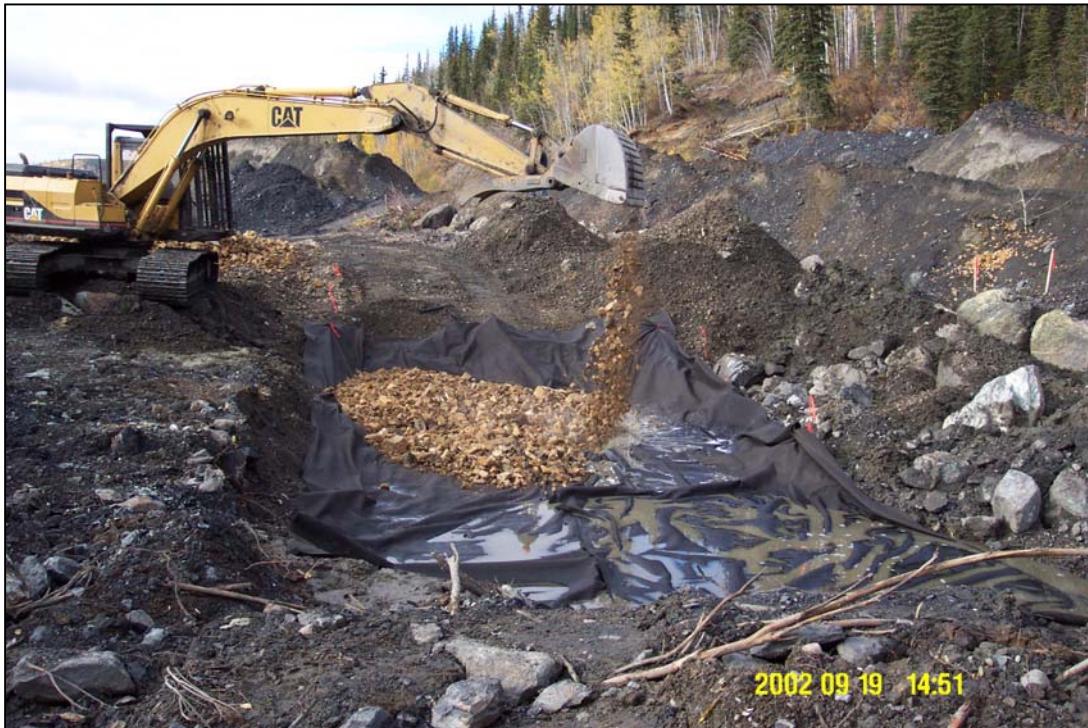
Photograph 3-11) Constructing a blanket drain below the lower level of the drop structure.

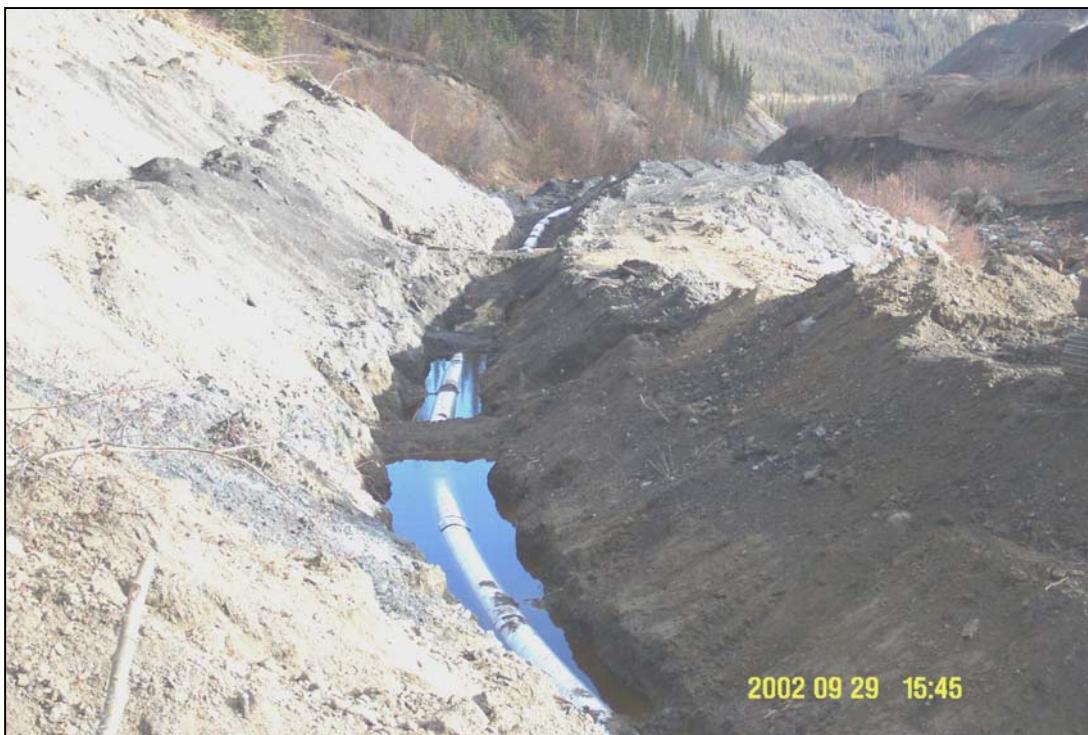
Photograph 3-12) Check dams installed in diversion pipe trench.
