**CLINTON CREEK CHANNEL**

**STABILIZATION (STAGE 3)**

**CONSTRUCTION REPORT**

**February 2005**

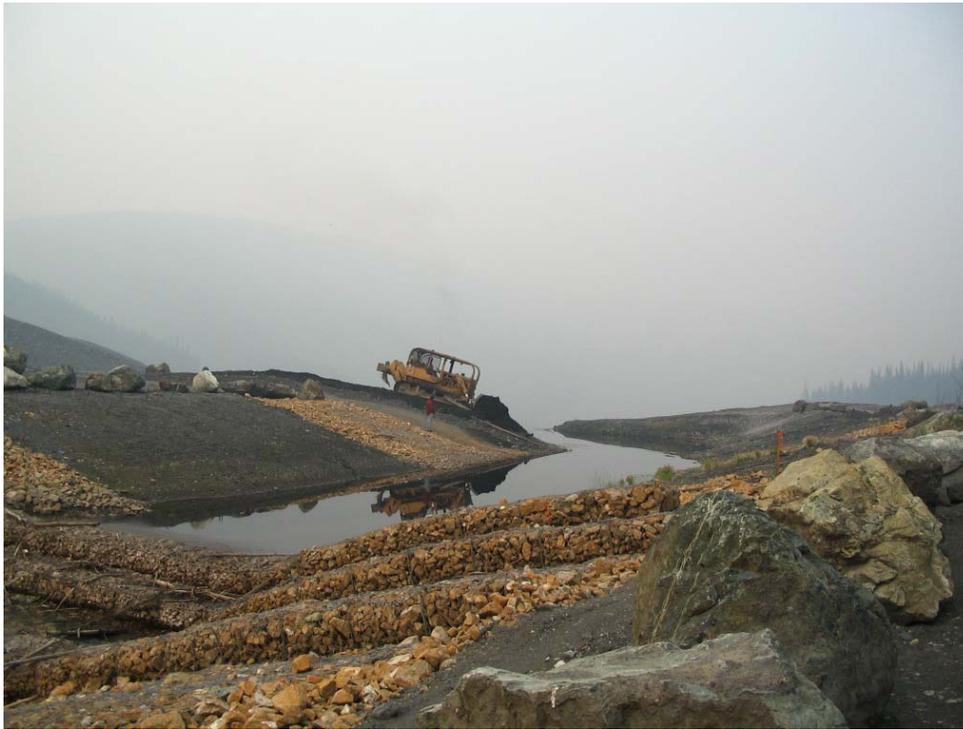
Photograph 3-1) Installing the cofferdam.

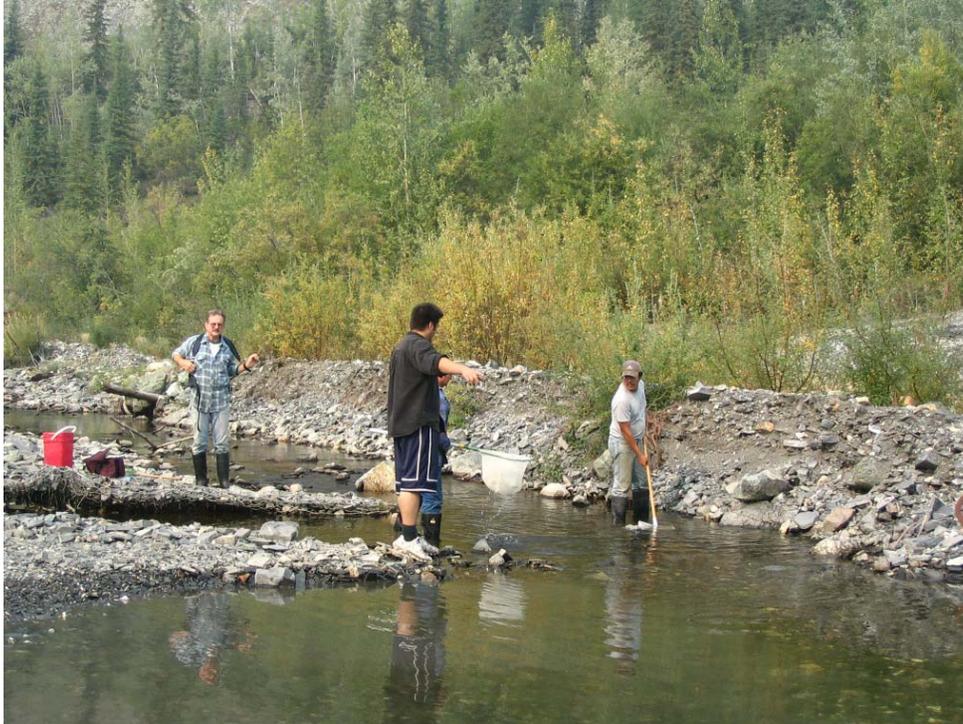
Photograph 3-2) Fish salvage operation.

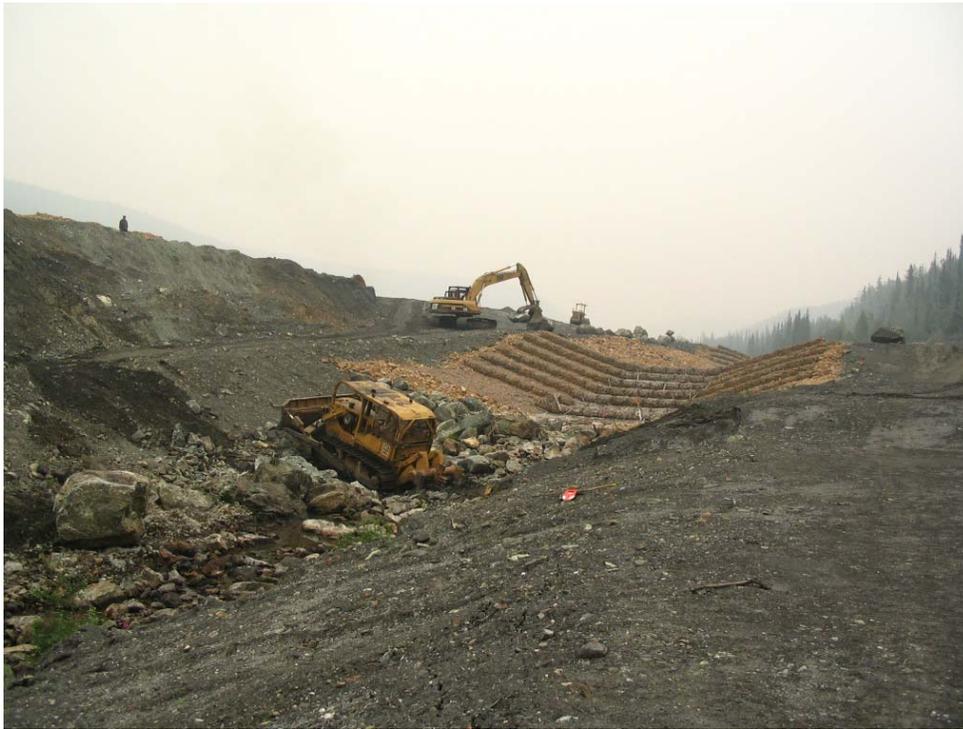
Photograph 3-3) Preparing sub-grade for Drop Structure 3.

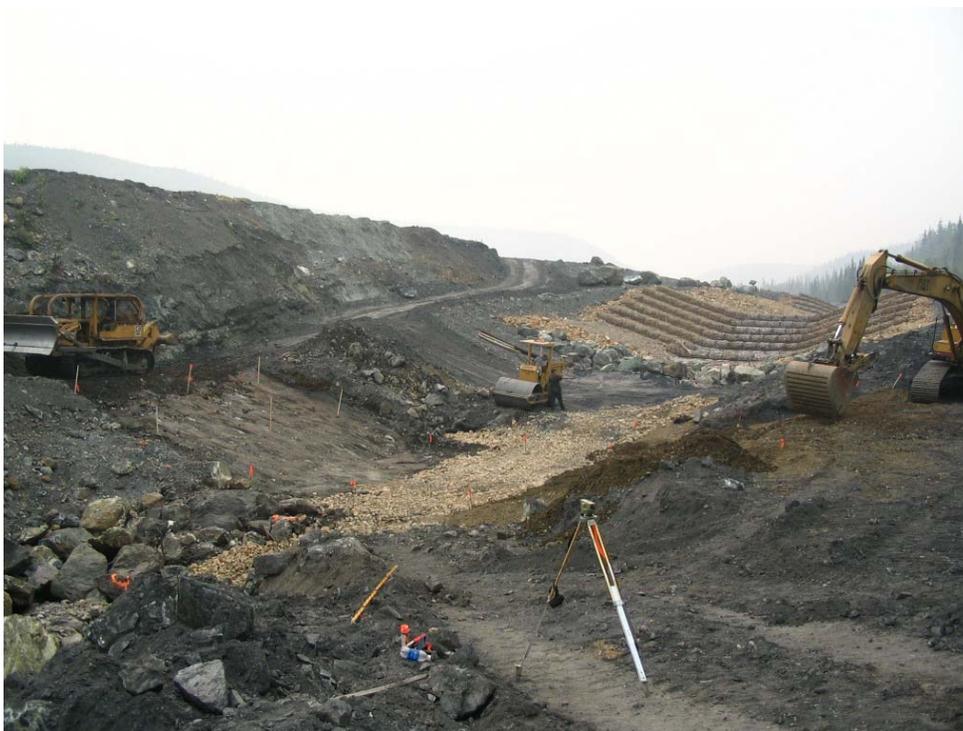
Photograph 3-4) Sub-grade prepared for Tier 1 of Drop Structure 3.

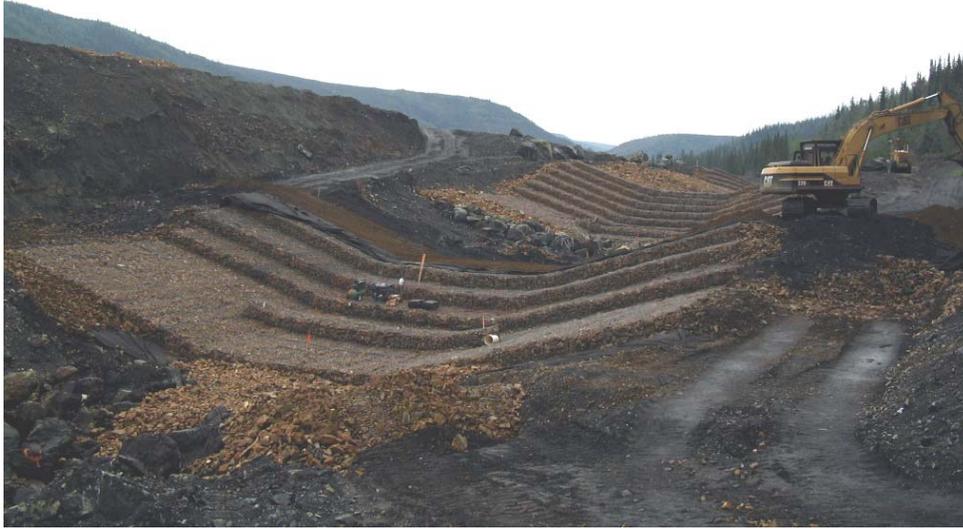
Photograph 3-5) Drop Structure 3: Tiers 1 to 4 installed.

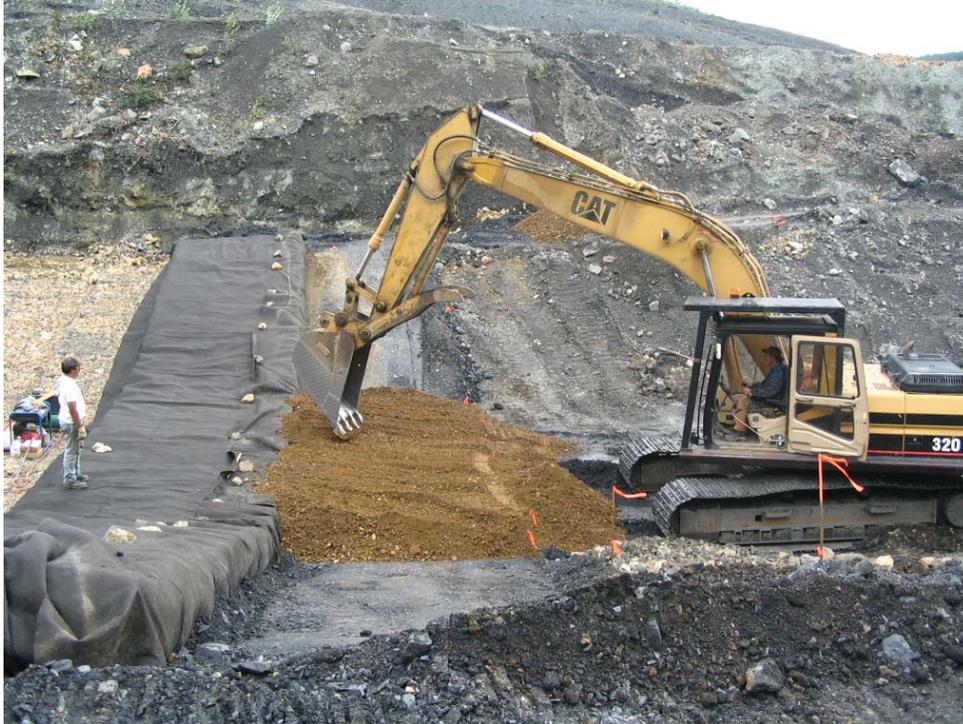
Photograph 3-6) Placing gravel base for the last tier of baskets in Drop Structure 3.

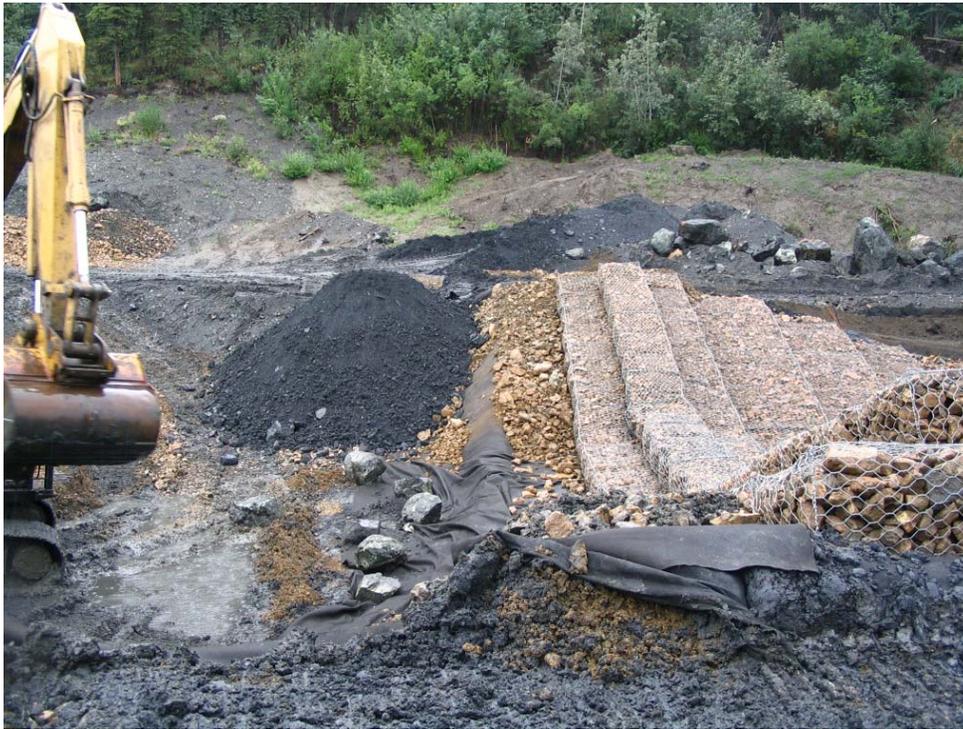
Photograph 3-7) Backfilling channel upstream of Drop Structure 3.

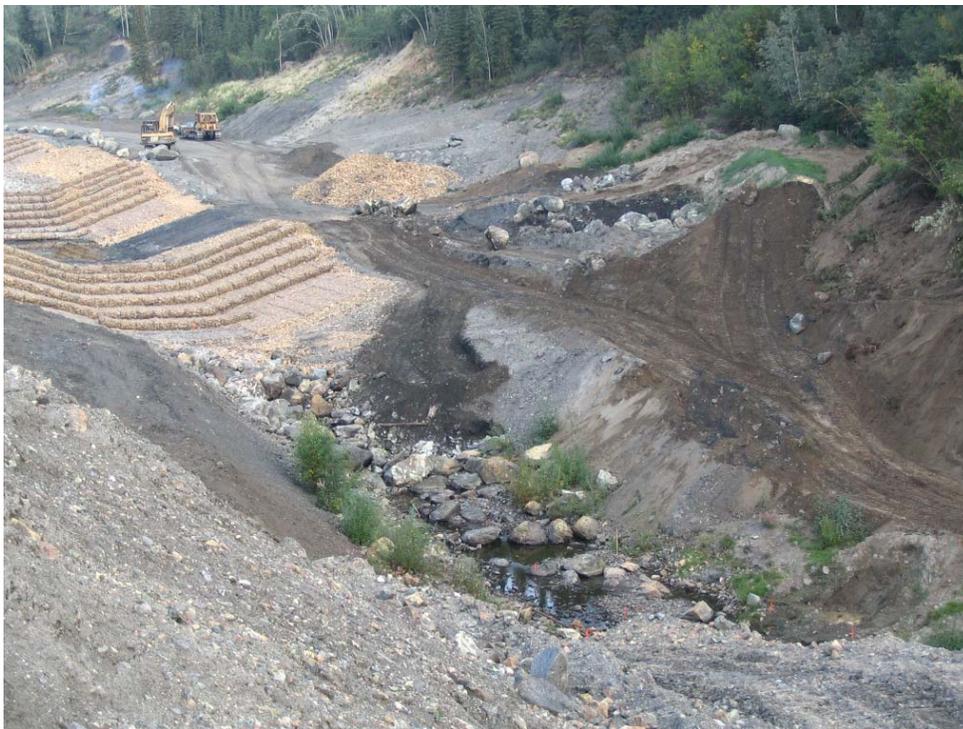
Photograph 3-8) Access to Drop Structure 4 prepared.

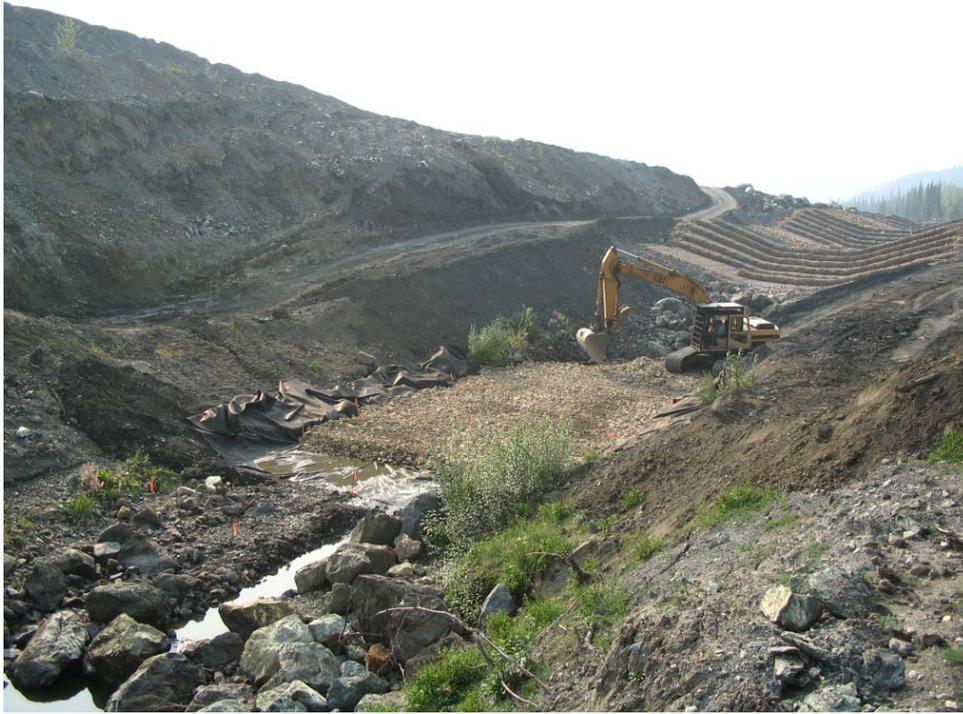
Photograph 3-9) Blanket drain and base for Drop Structure 4 installed.

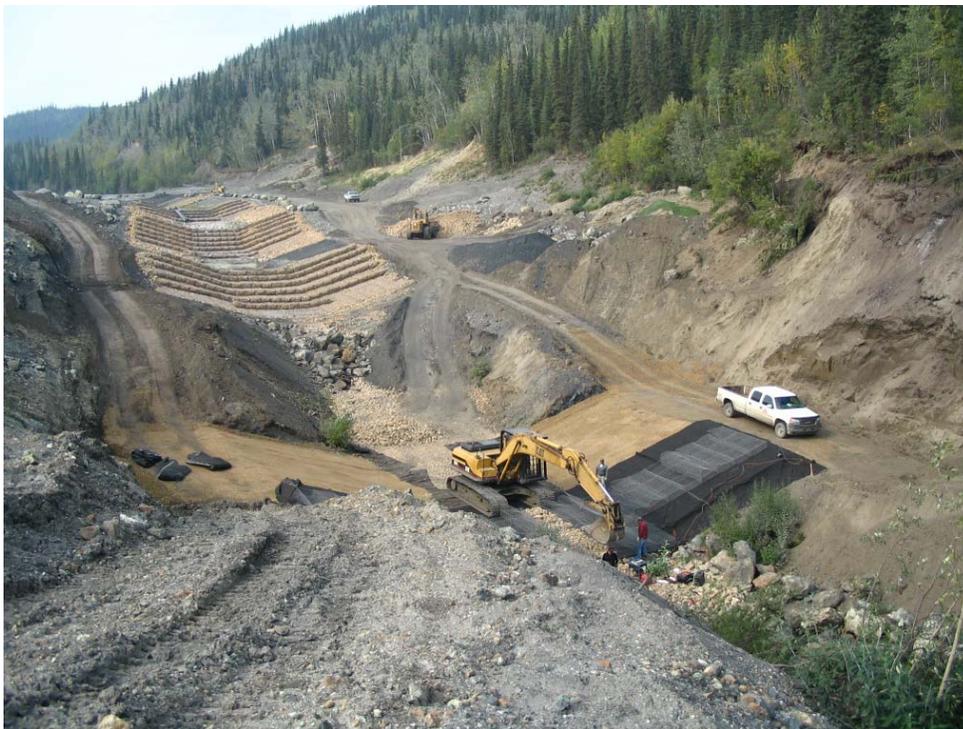
Photograph 3-10) Installing Tier 1 baskets for Drop Structure 4.

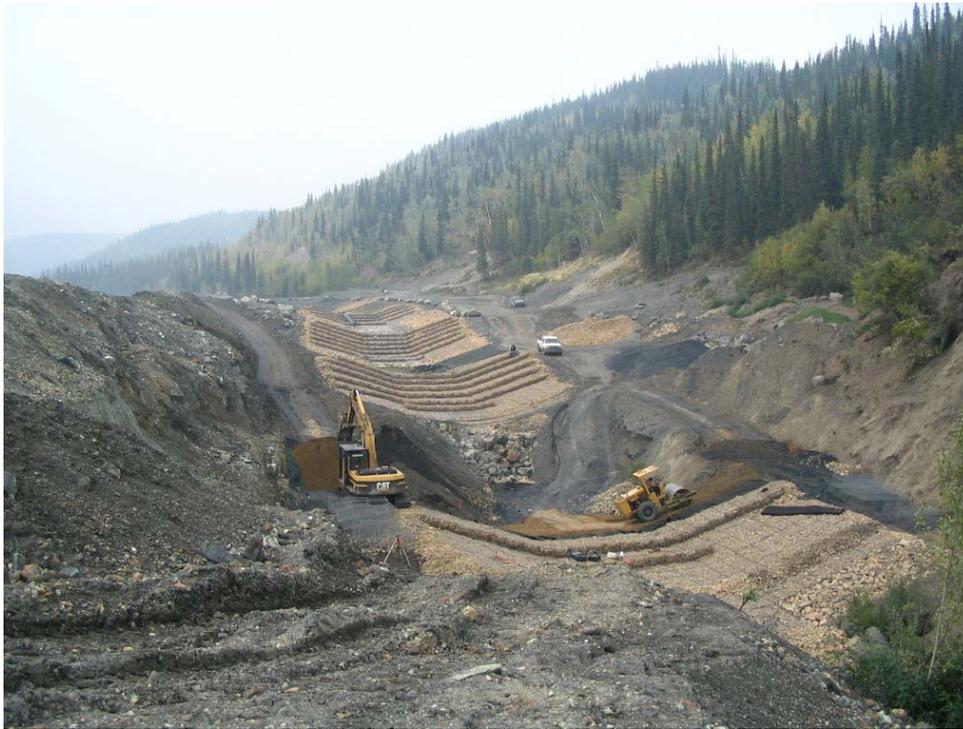
Photograph 3-11) Preparing base for Tier 3 baskets of Drop Structure 4.

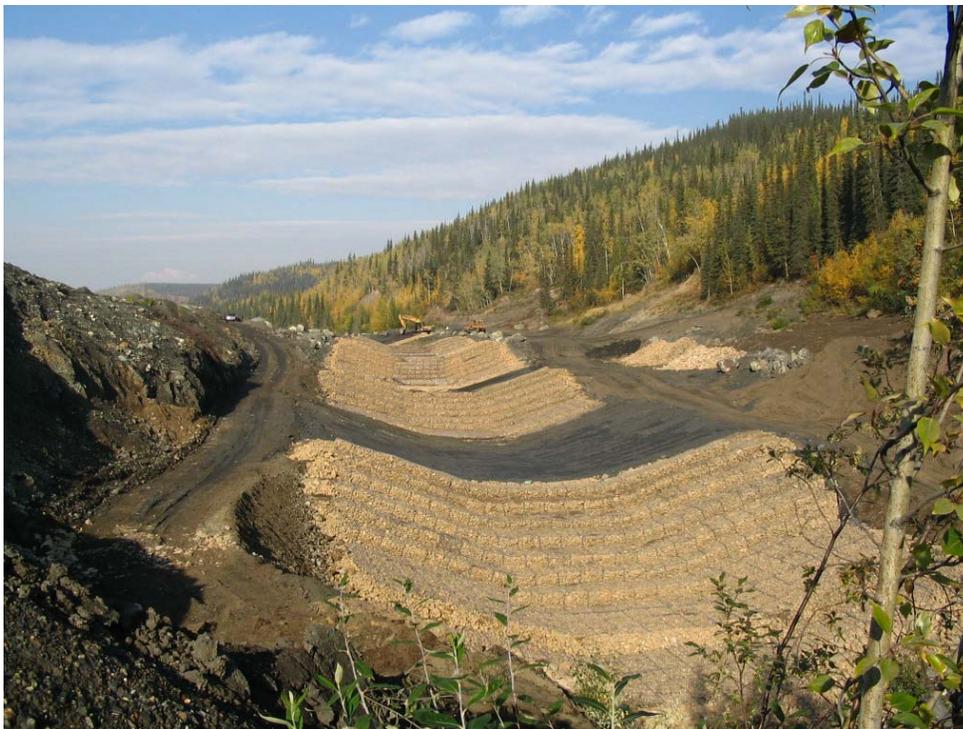
Photograph 3-12) Drop Structure 3 and 4 completed.

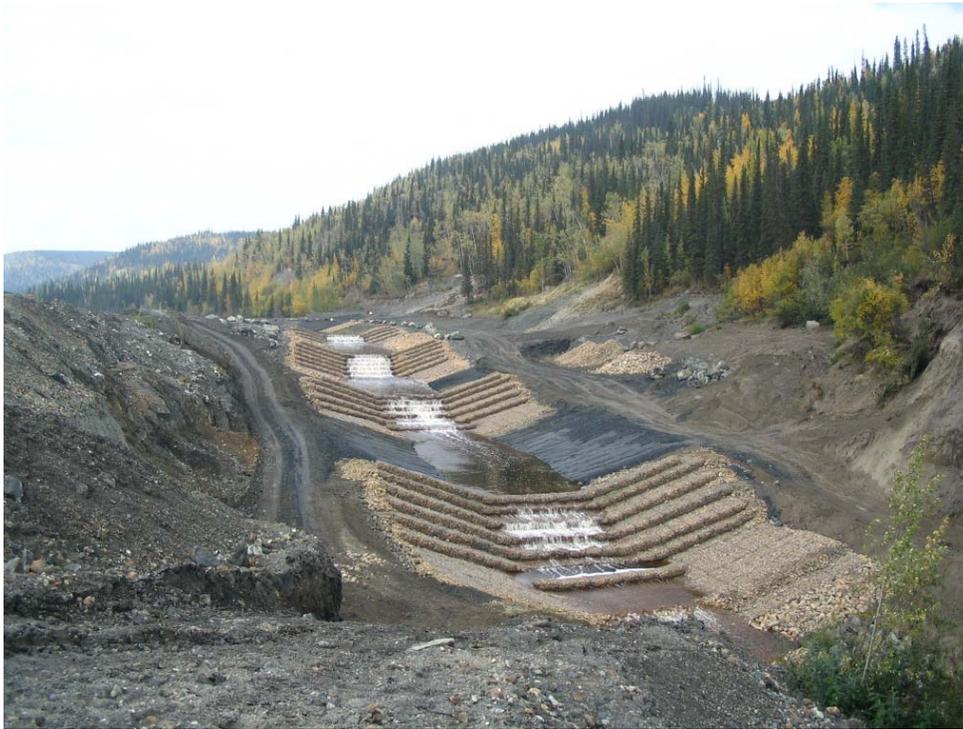
Photograph 3-13) Channel flow re-instated following completion of Drop Structure 4.

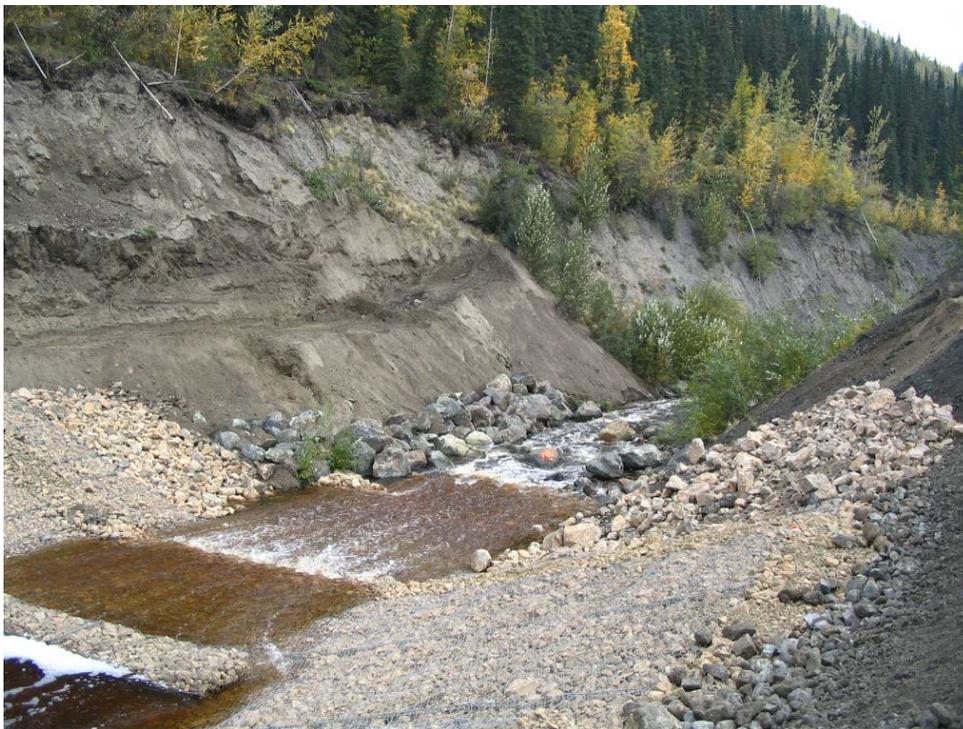
Photograph 3-14) Downstream end of Drop Structure 4.

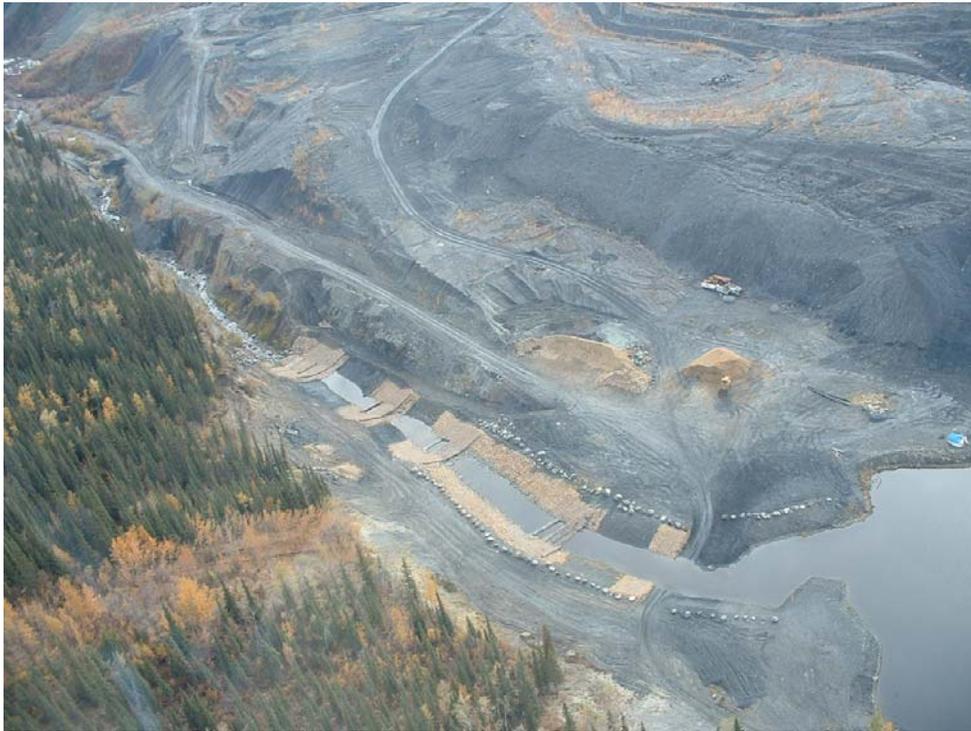
Photograph 3-15) Aerial view of completed channel stabilization works.
