# Clinton Creek Mine Risk Review 2009

***Government of Yukon***

*Project Reference Number  
SRK 1CY001.037*

***February 2010***

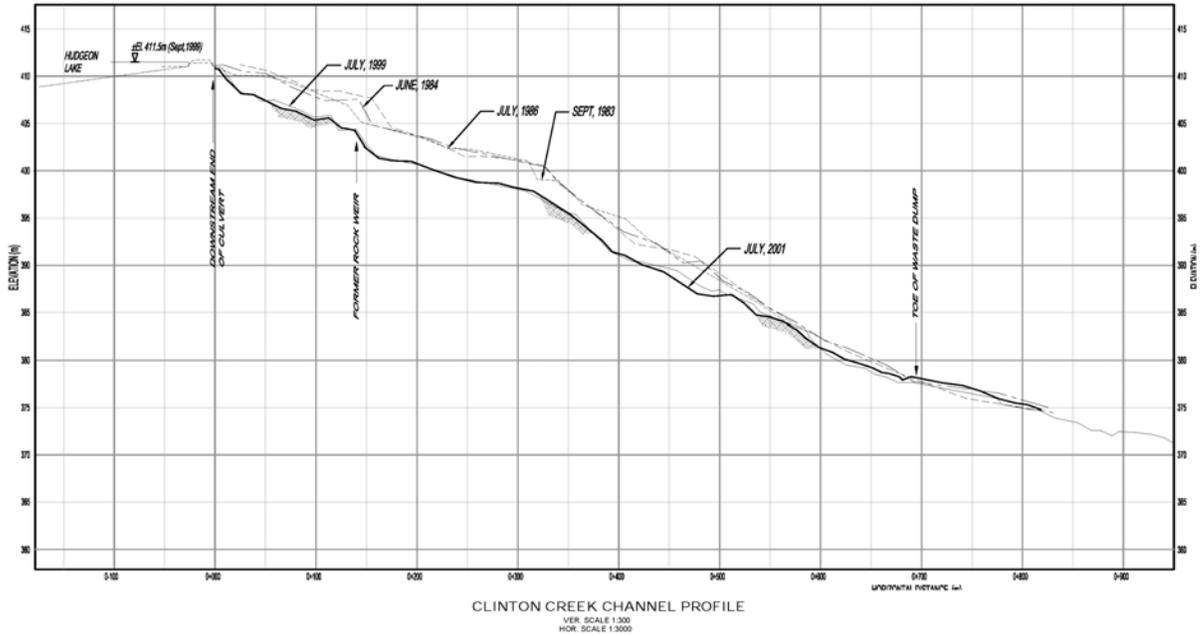
**Figure 5: Clinton Creek Channel Profiles (UMA, 2003)**

The data in Figure 5 shows that about 50m (in horizontal direction) of material was removed from the waste rock plug above elevation 405m between 1984 and 1999, while about 100m of material was removed at elevation 400m. This is a significant amount of material and led to fears “that the retrogressive incising would rapidly continue and a full breach of the lake outlet could be triggered”, AECOM (2009).

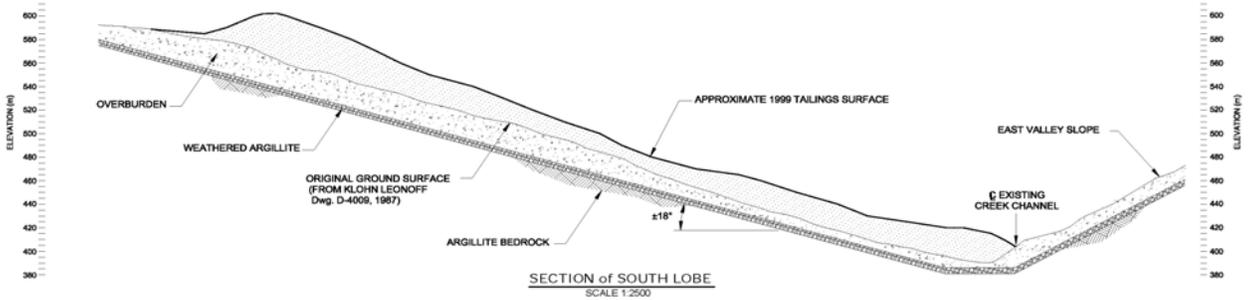
**Figure 6: Section through Tailings South Lobe UMA (2002)**

UMA (2002) indicates that the alignment and elevation of Wolverine Creek was about 25m further to the east and about 13m higher than it was before the South Lobe failed. The section of the South Lobe shown in Figure 6 also indicates that the slope of the foundation is about 18 degrees.

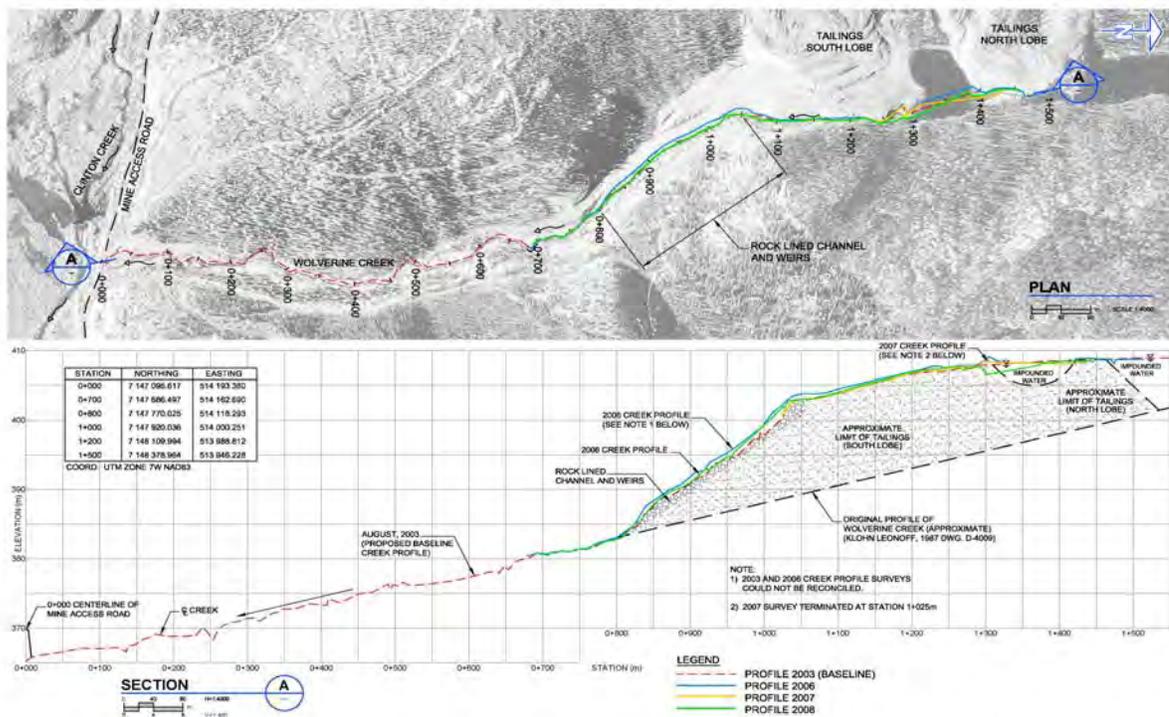
**Figure 7: Plan and Section of Rock-lined Channel Downstream of Tailings South Lobe (UMA, 2008)**

Partial re-grading of the north and south tailings lobes was done in 1978 and 1979 in an attempt to stabilize the tailings, this was unsuccessful. In 1978, a rock-lined channel with a series of rock weirs was constructed in Wolverine Creek across the tailings immediately downstream of the South Lobe. The slope of this system is 8 percent. Figure 7 below shows a plan of the rock-lined channel.

In 1981 Hardy found that the outfall immediately downstream of the last weir in the rock-lined channel was unprotected and that retrogressive erosion was occurring such that the structural integrity of the last three weirs was poor. A recommendation was made to install a rip-rap apron downstream of the last weir and to rehabilitate the damaged weirs. Over time the rock weirs have become flattened and brush has established along the channel banks and in the channel, which make the rock weirs barely recognizable in the field. These measures have performed well to date although some deterioration was noted during recent site visits. In 2007 recommendations were made to remove the trees and brush growing within the channel and this was done (AECOM, 2008 Performance Monitoring).
