CLINTON CREEK ASBESTOS MINE

REPORT  
ON  
1988 SITE INSPECTION

Prepared for:  
NORTHERN AFFAIRS PROGRAM  
Whitehorse, Y.T.

November 1988  
G052

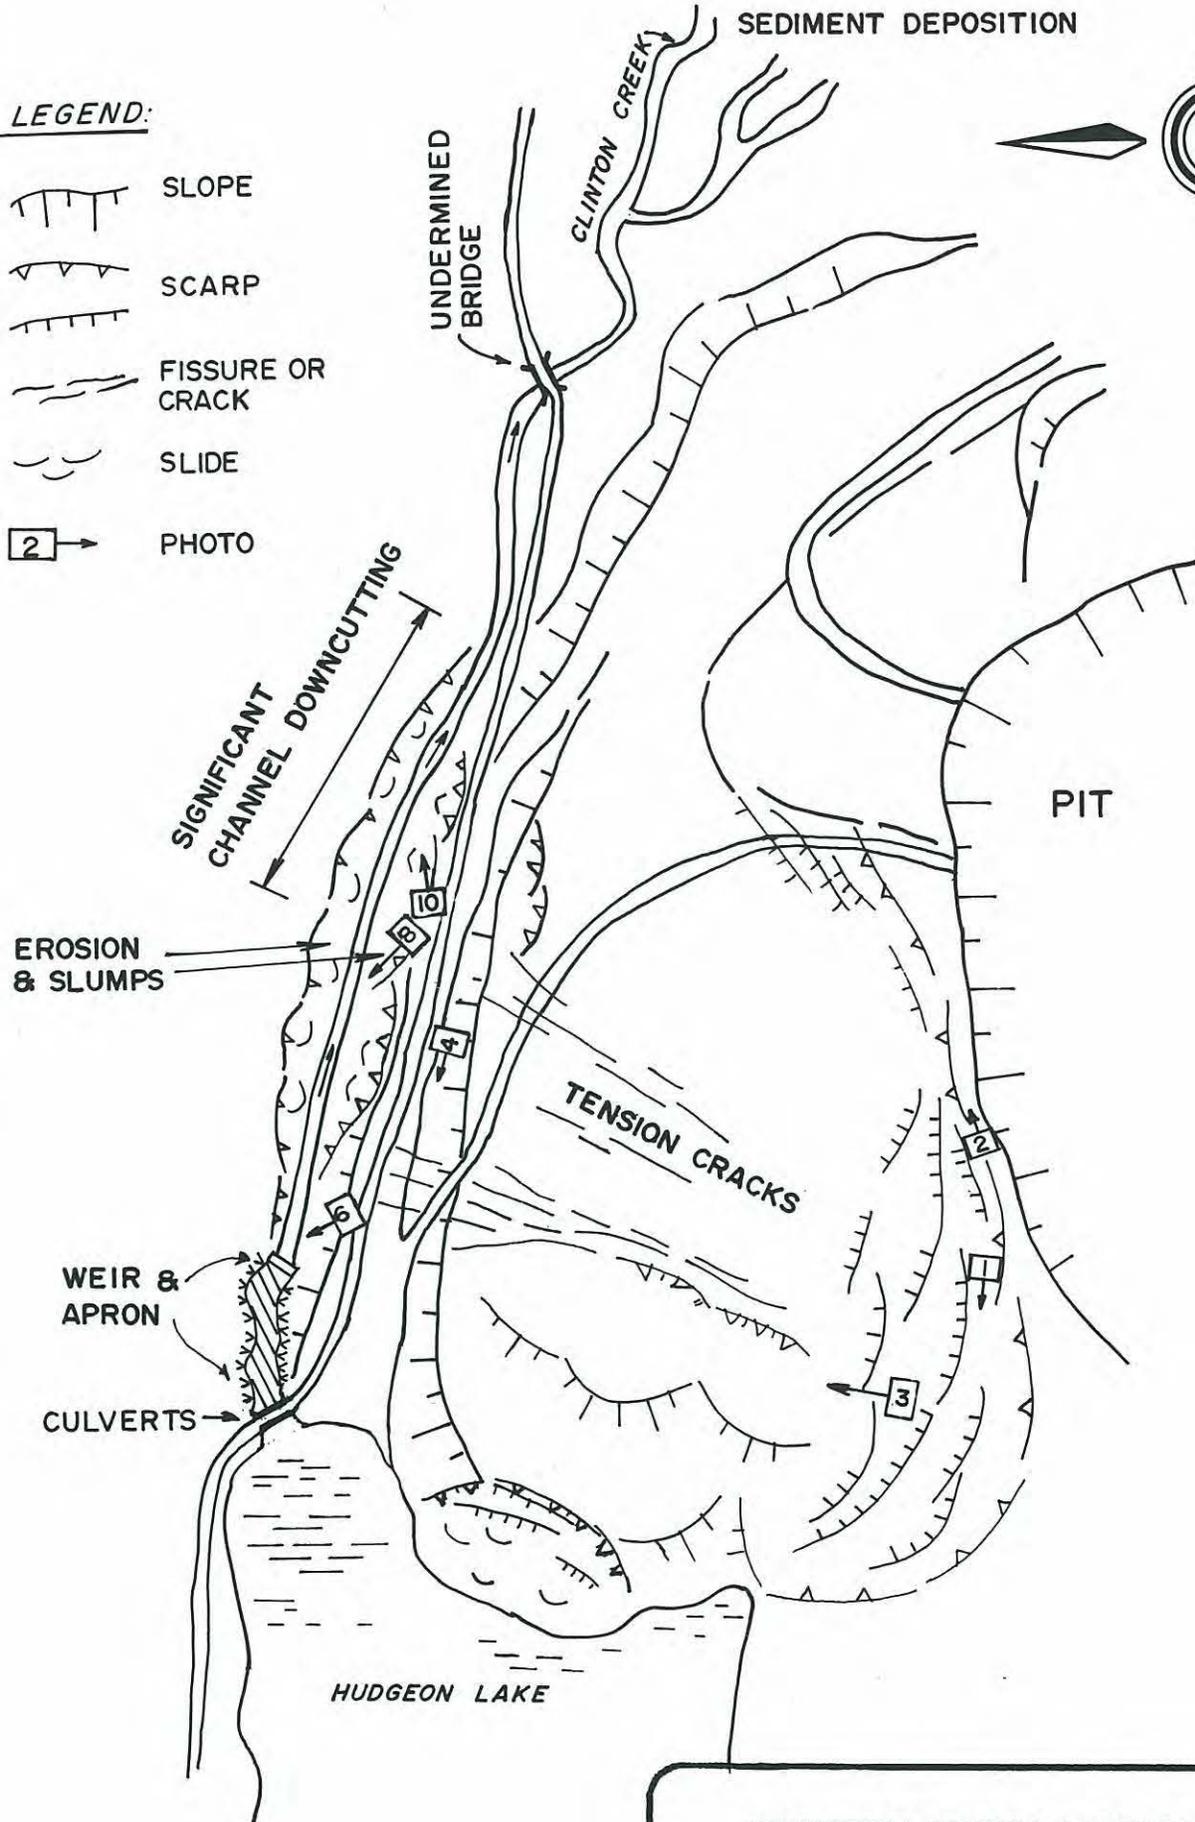
FIGURE 1.

Our review of the main slide features schematically outlined on Figure 1 indicates that the dump movements recorded during the last two years are pervasive and that their rate remains approximately the same. The major areas of activity are listed below:

- a) the uppermost dump sector moving into the valley,
- b) the west toe of the dump moving into the lake, and

- c) erosion of the north toe of the dump forming the south bank of the Clinton Creek channel.

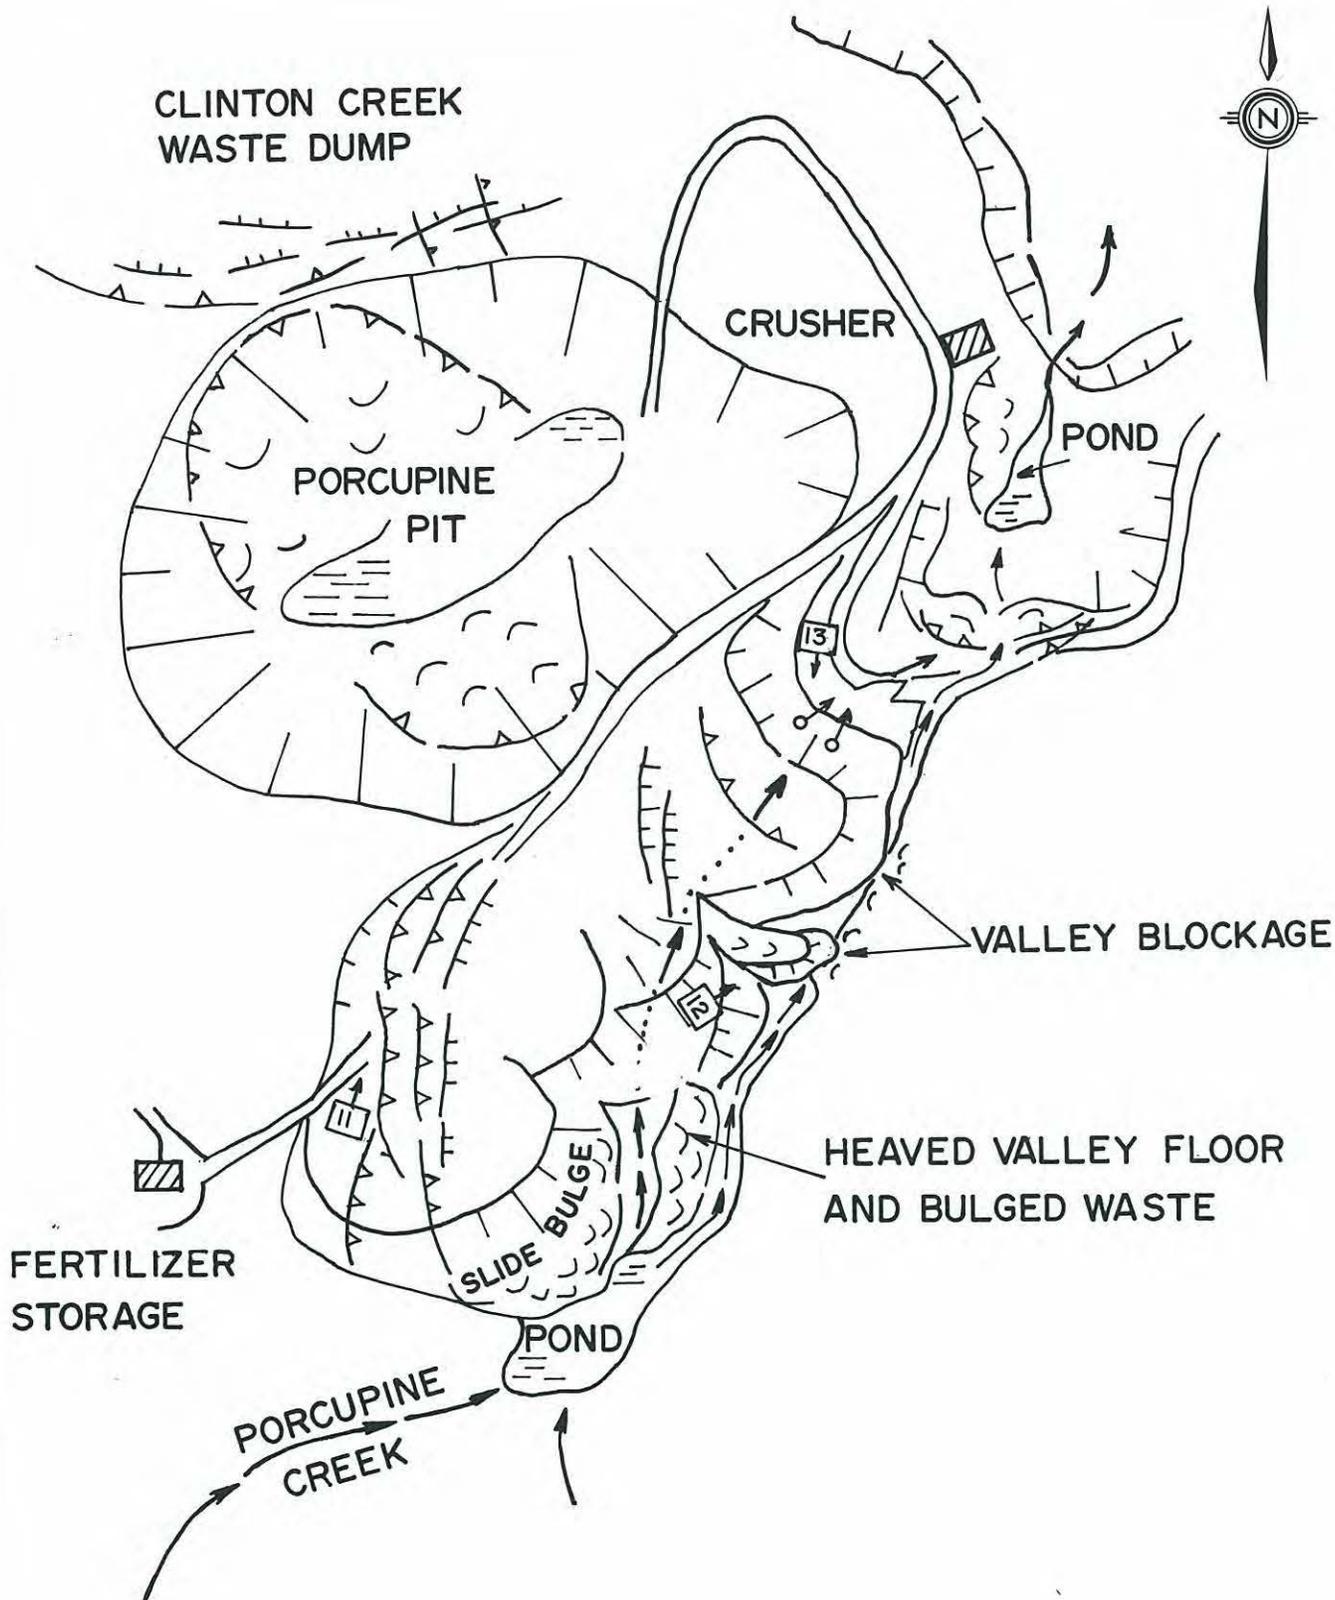
N.T.S. FIGURE 2.

The displacement of the mine waste deposited into the Porcupine Creek valley continues. The main instability features and drainage conditions are schematically shown on Figure 2.

Steep, fresh-looking scarps outlining the upper limit of the slide area encompass the entire waste dump (Photo 11). The toe area also exhibits fresh cracks confirming the overall instability of this dump.

The valley blockage caused by a relatively narrow slump, combined with ground heave, did not significantly change since last year (Photo 12). However, the outflow from this pond is now mainly underground since more heaving occurred on the east side of the blockage.

The outlet from the lake has been abandoned because of ground heave. This notwithstanding, a significant amount of seepage occurs at the north end of the dump. The seepage is dispersed over a relatively wide zone and does not have any adverse impact on this dump sector (Photo 13).

The flow from the dump and surface drainage paralleling the east side of the dump traverses a small dump and descends into the valley bottom. This dump is progressively failing.

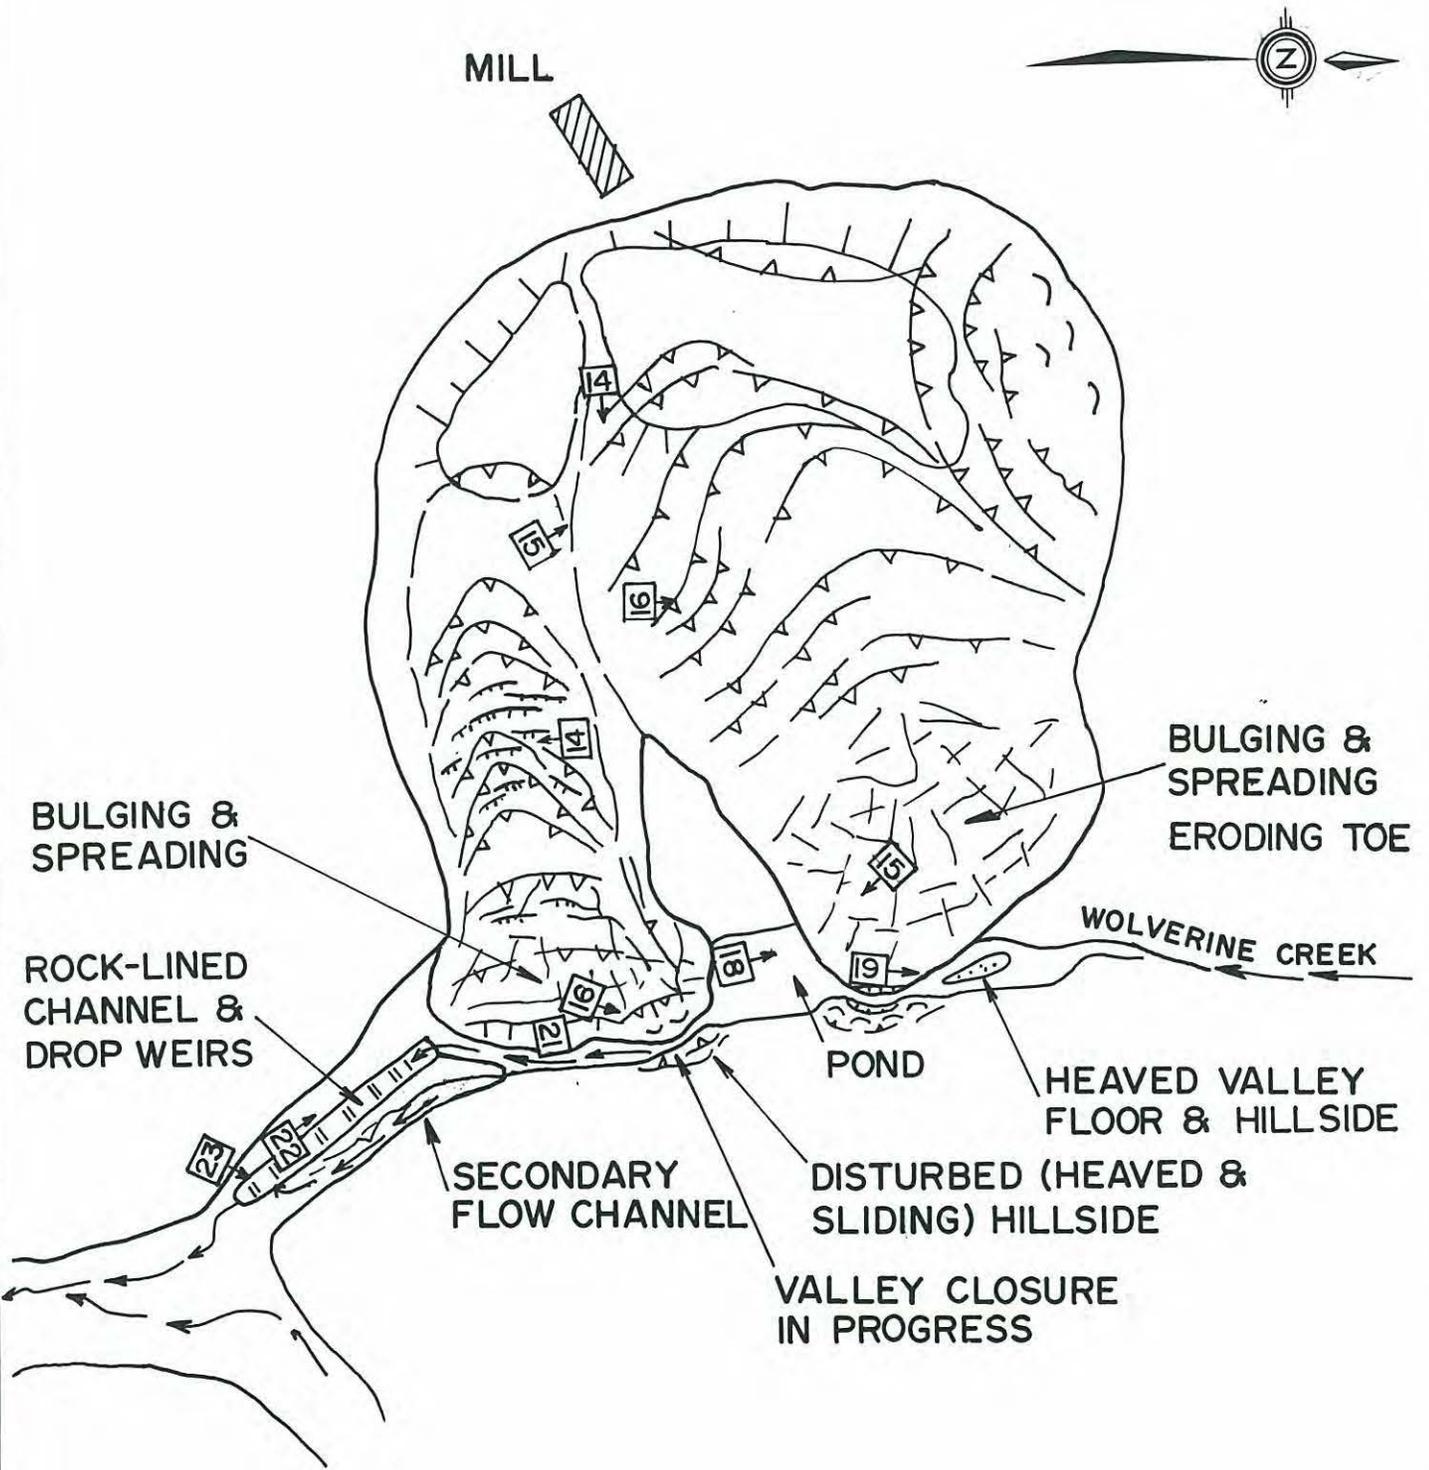
N.T.S. FIGURE 3.

The general appearance of both south and north lobes of the tailings pile is quite similar to that observed last year (Figure 3). The displacement of material continues, possibly at a somewhat slower rate.

The most active areas are presently along the toe of the south pile and the valley bottom in front of the north pile. The rate of horizontal movement of the south lobe is estimated to be in the range of 5 to 10 m per year. There are no major changes in the slide headscarps of both piles since last year (Photo 14).

The toe area of the south lobe is traversed by two main sets of cracks - parallel and perpendicular to the stream. The cracks are fresh and wide. Their appearance indicates recent movements. The toe area is spreading into the lake.

On the upstream side of the south pile, the heaving of the original valley floor continues. The opposite hillside shows less extensive sliding than in 1987.

The displacement rate of the toe area has decreased because of the support provided by the east valley wall. The toe bulge has approximately the same slope gradient as in 1987. The heaving of the valley bottom in front of this toe continues.

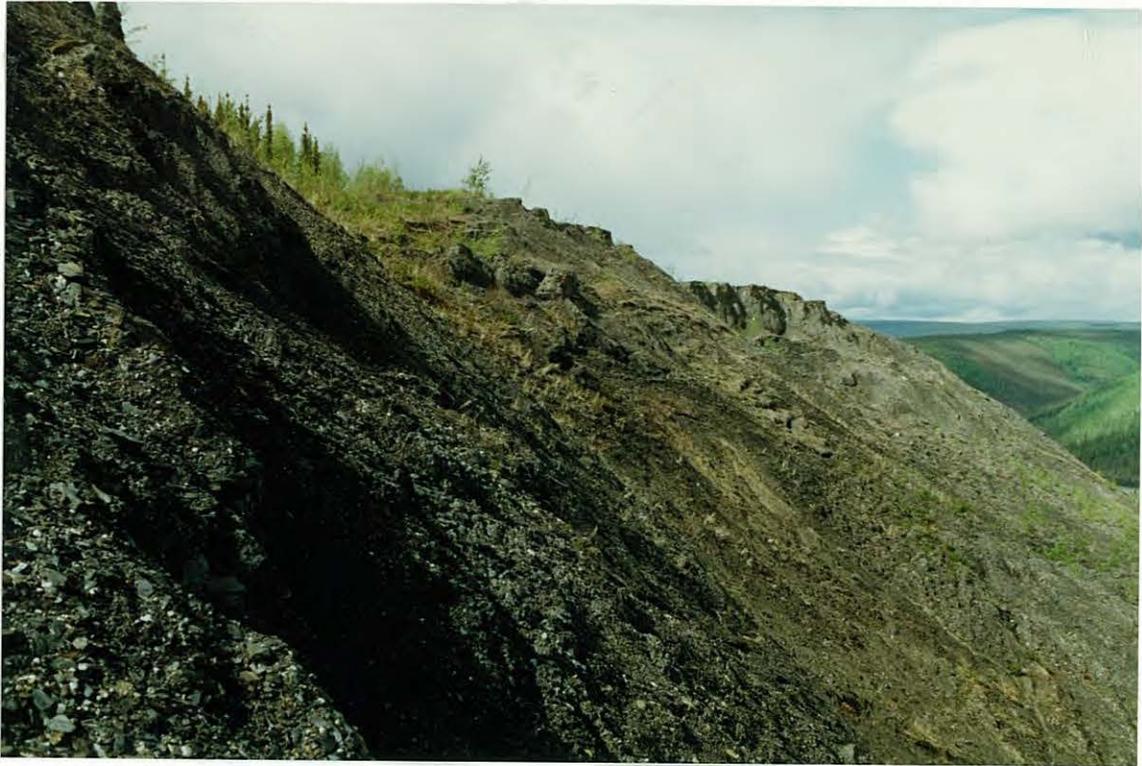
- The uppermost section of the dump (Photo 1) exhibits a series of steep and fresh-looking scarps which appear to be very similar to those observed in 1987. The retrogressive character of the movement is indicated by ongoing vertical displacement and cracks beyond the dump boundary.

Photo 1: The uppermost segment of the Clinton Creek waste dump is traversed with fresh scarps. The failure is retrogressive.

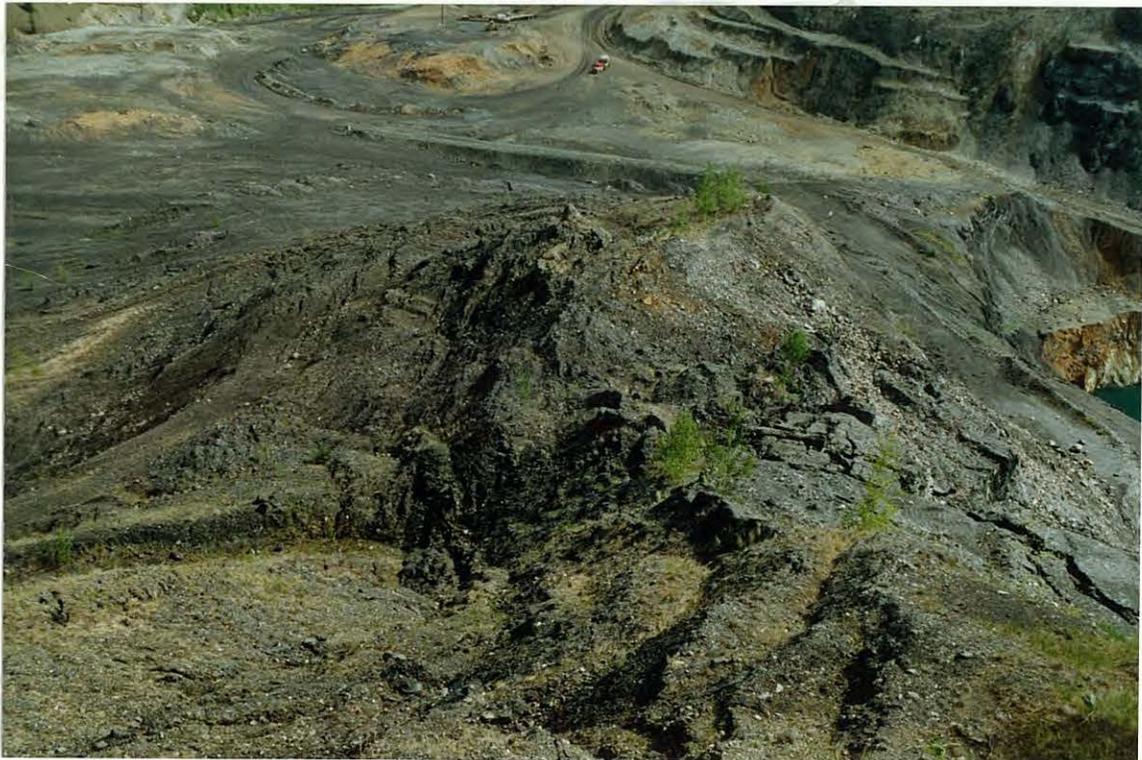
- Fissures caused by the sliding of the Porcupine pit north wall and the waste dump scarps are intersecting one another in the northeast sector of the dump (Photo 2).

Photo 2: The sliding waste dump and unstable north wall of the pit are in contact in the NE sector of the dump.

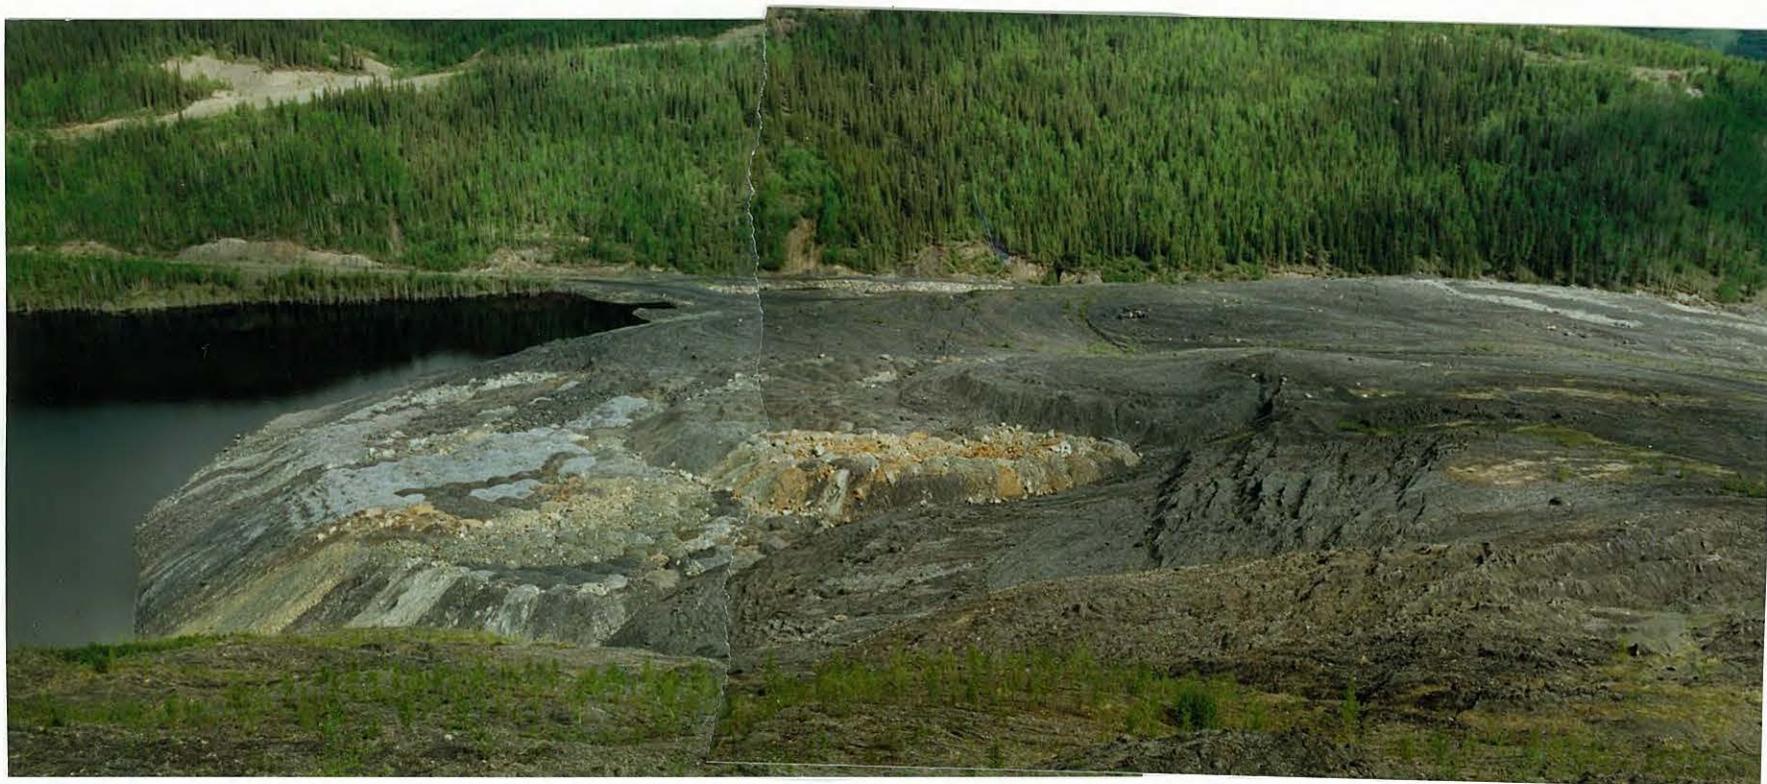
- A section of the dump forming the shore of Hudgeon Lake continues to move into the lake (Photo 3). The ground changes are discernible along the shore line. There is very little evidence suggesting significant displacement further upslope from the shore.

Photo 3: View of the N.W. sector of the Clinton Creek waste dump and Hudgeon Lake outlet. This dump segment continues to move into the lake and the surface expressions of the movement remain very similiar to those observed in 1987.

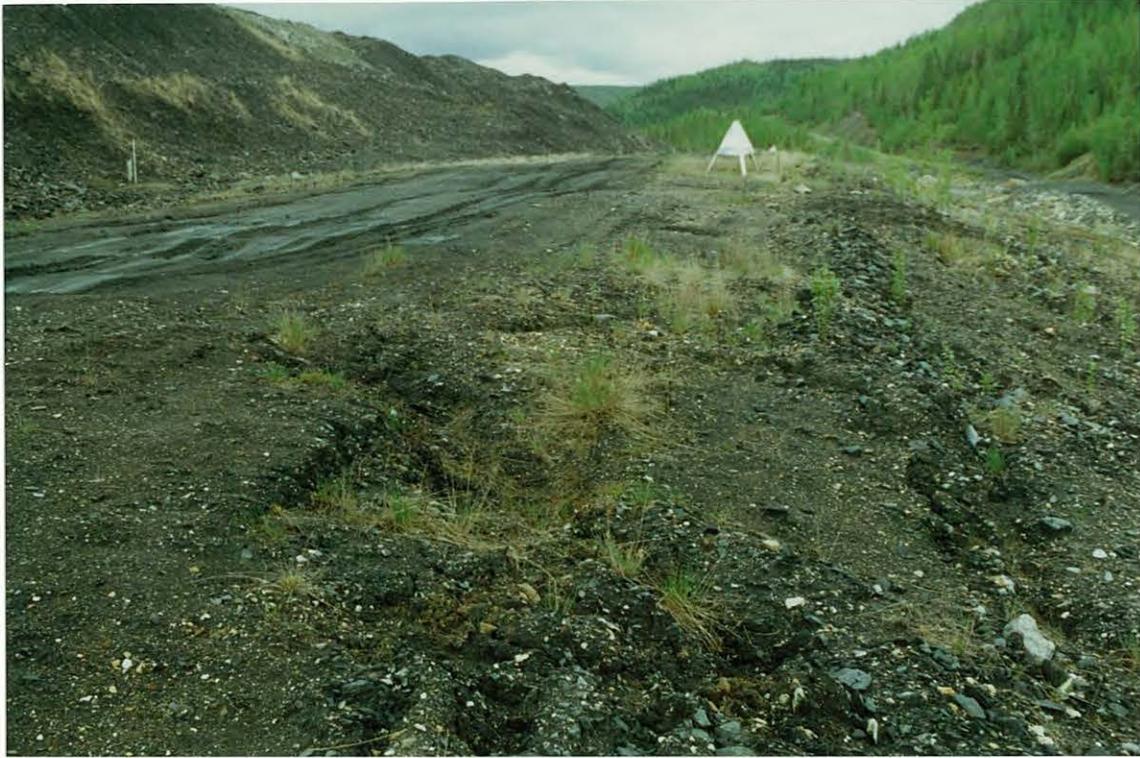
- Tension cracks running perpendicular to the Clinton Creek channel are fresh and indicative of recent movements.
- The south bank of the Clinton Creek channel, formed by the waste, is eroding downstream from the armoured channel section.

Photo 4: Access road paralleling the Clinton Creek channel is traversed by tension cracks. Cracks along the crest of the channel bank are fresh, but about the same locations as last year (refer to Photo 3 in the 1987 report).

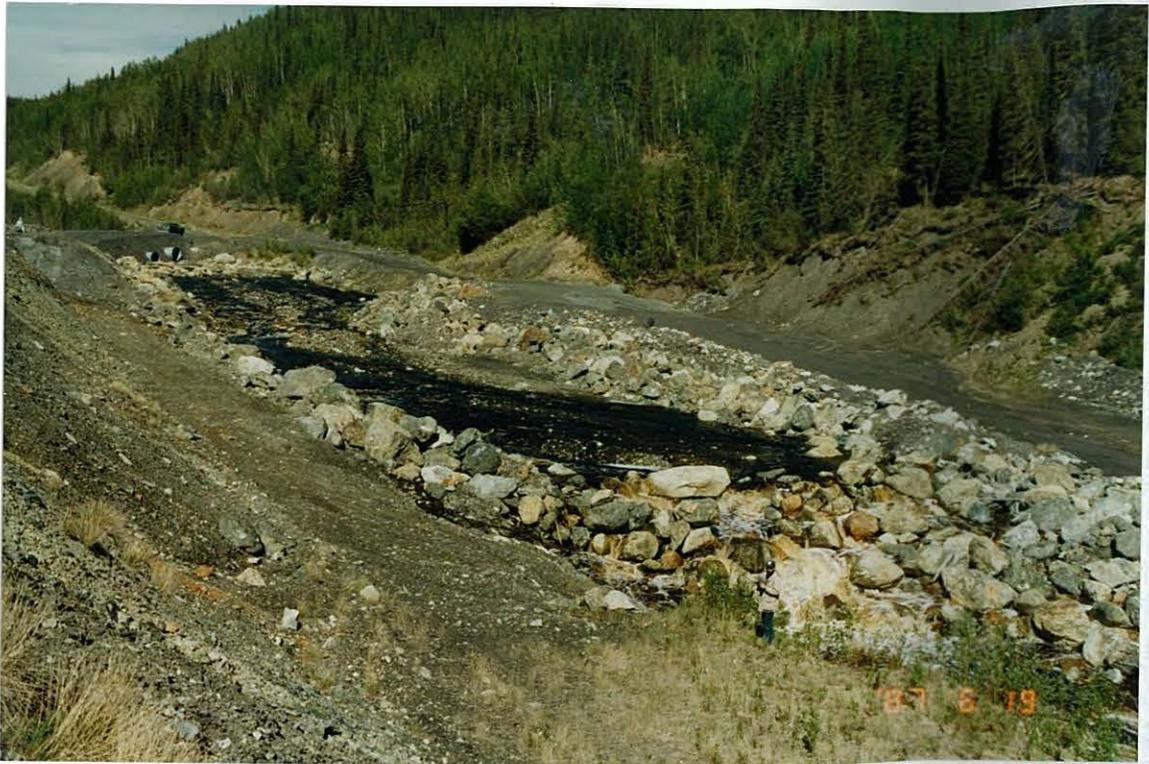
Photo 5: Basin between the lake outlet and drop weir; photo taken in June 1987.

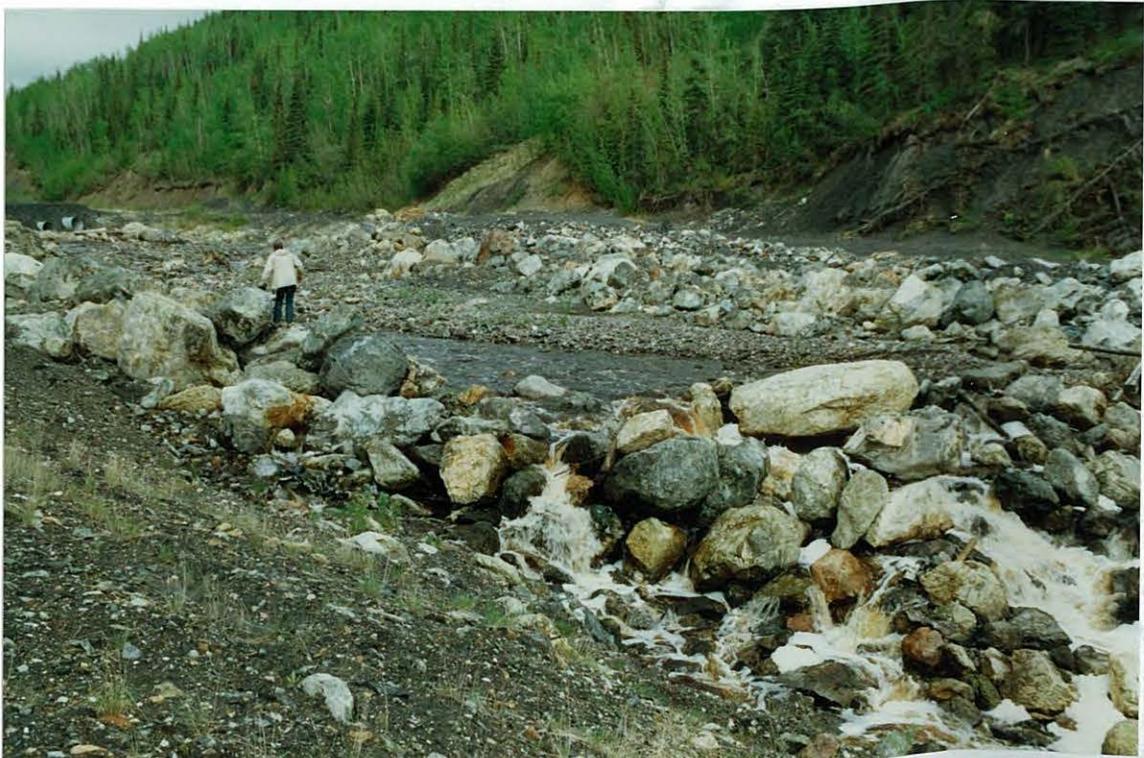
The armoured section of the creek channel between the lake outlet and the drop weir (Photo Nos. 5 and 6) exhibits only minor changes since the 1987 site visit. The downcutting of an incised channel upstream from the weir continues. A gravel bar is being developed along the north bank (Photo 6). Erosion of the south abutment at the drop weir continues without major impact on the weir.

Photo 6: Channelization and localized downcutting of the basin bottom continues.

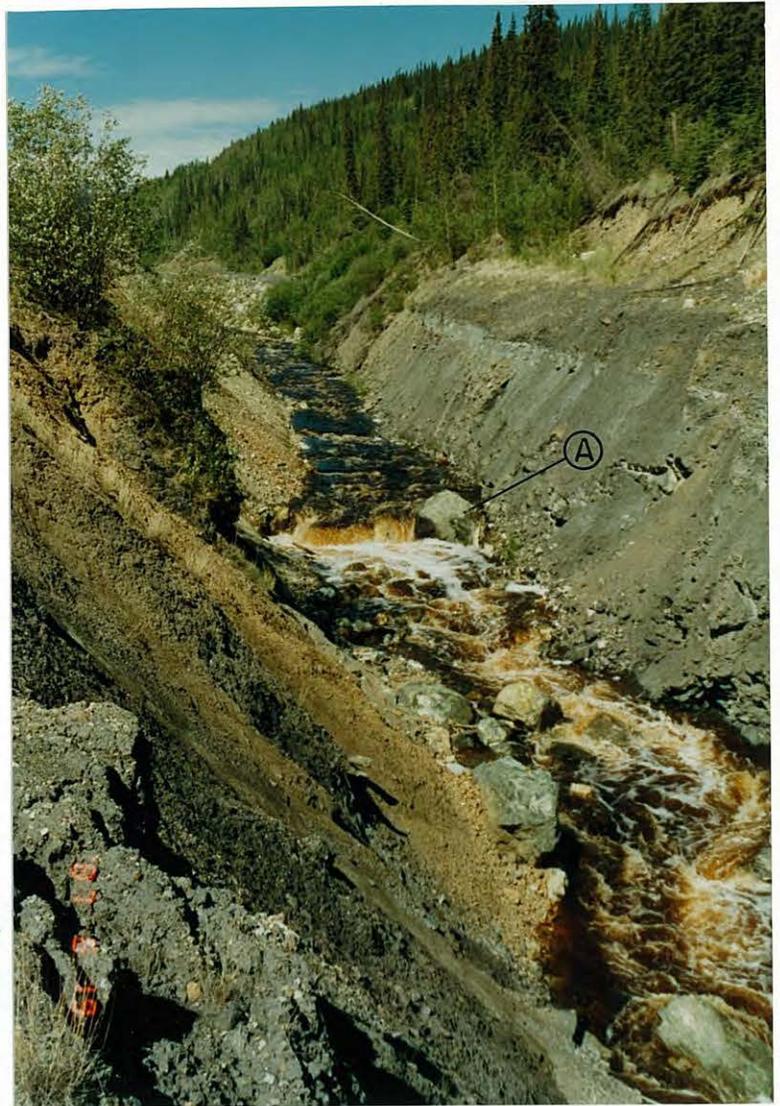
Relatively significant changes have taken place in the channel downstream from point A. The north bank is eroding, exposing thinly to medium-bedded, jointed shale and calcareous sandstone (Photo 8). While these strata will slow the erosion process, they are not competent enough to retard it entirely.

Photo 8: The same segment of the channel in June 1988. Note eroding banks and bedrock exposures in the channel bottom.

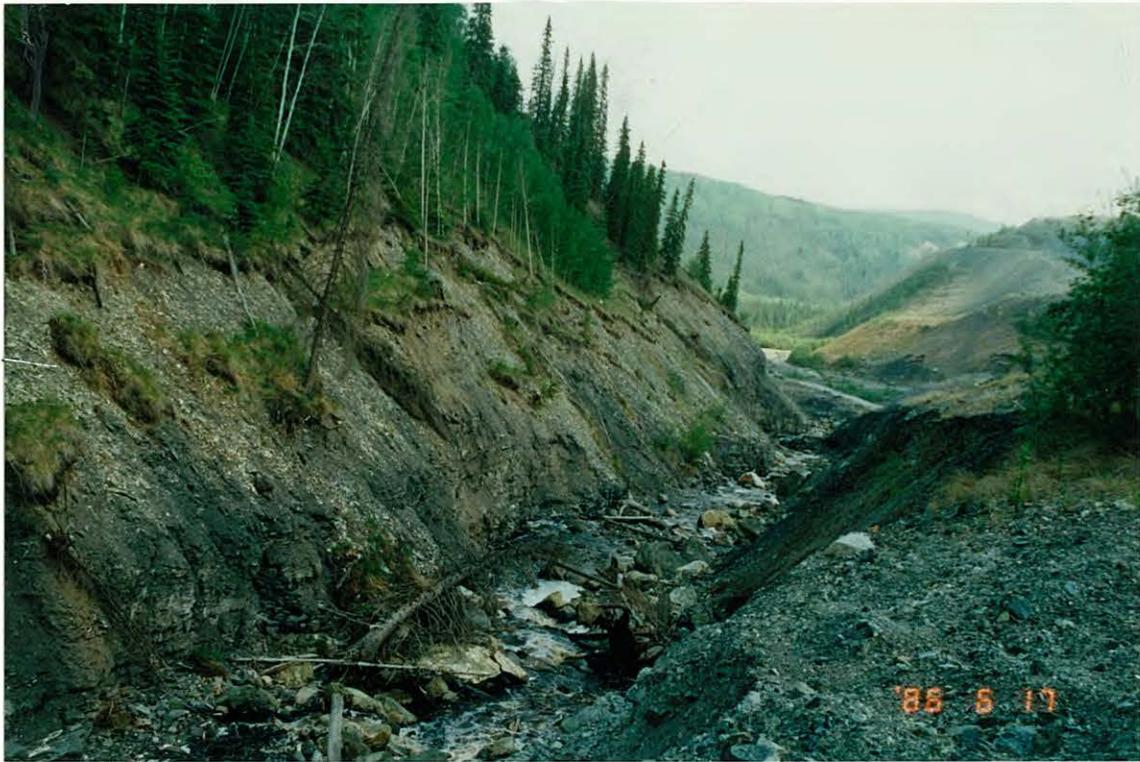
Photo 9: Downstream segment of the Clinton Creek channel in June 1986.

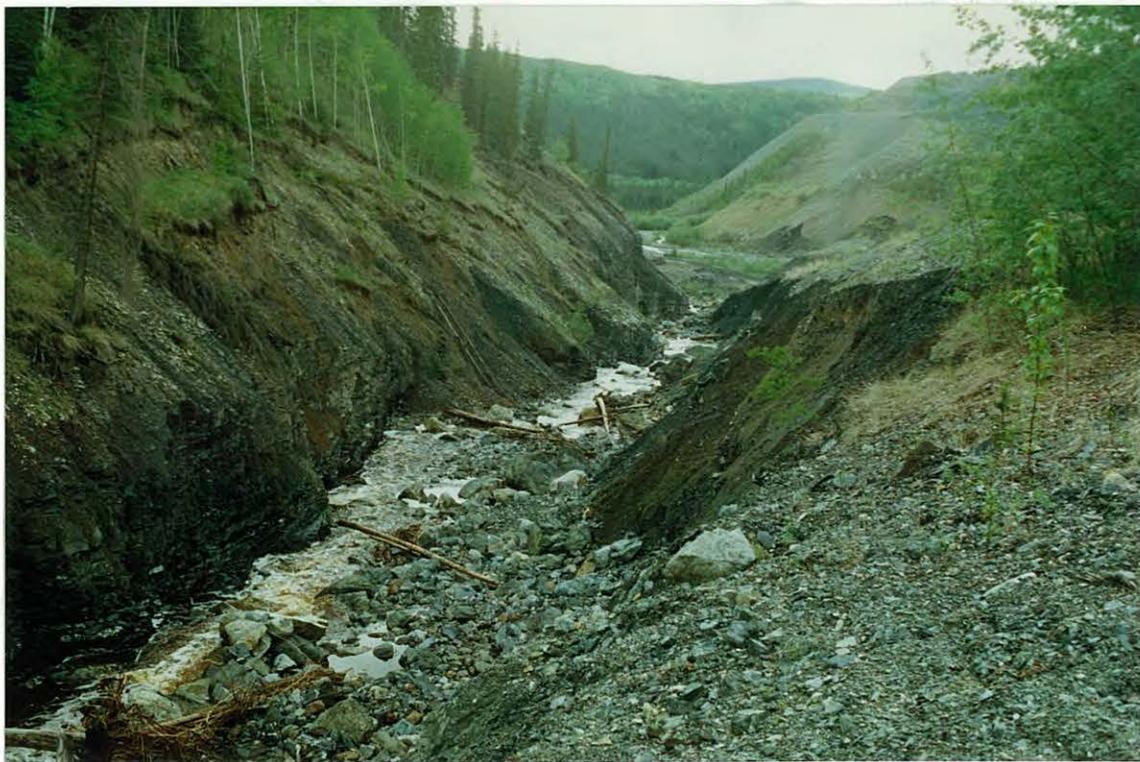
The downstream channel segment is downcutting and both banks are eroding. The changes which occurred since 1986 are apparent (Photo Nos. 9 and 10). The channel has shifted towards the north bank and material covering the channel bottom has been redistributed. Boulder pavement of the channel bottom is more consistent in this sector than further upstream.

Photo 10: The same creek segment in June 1988. There is evidence of creek downcutting and bank erosion despite bedrock exposures.

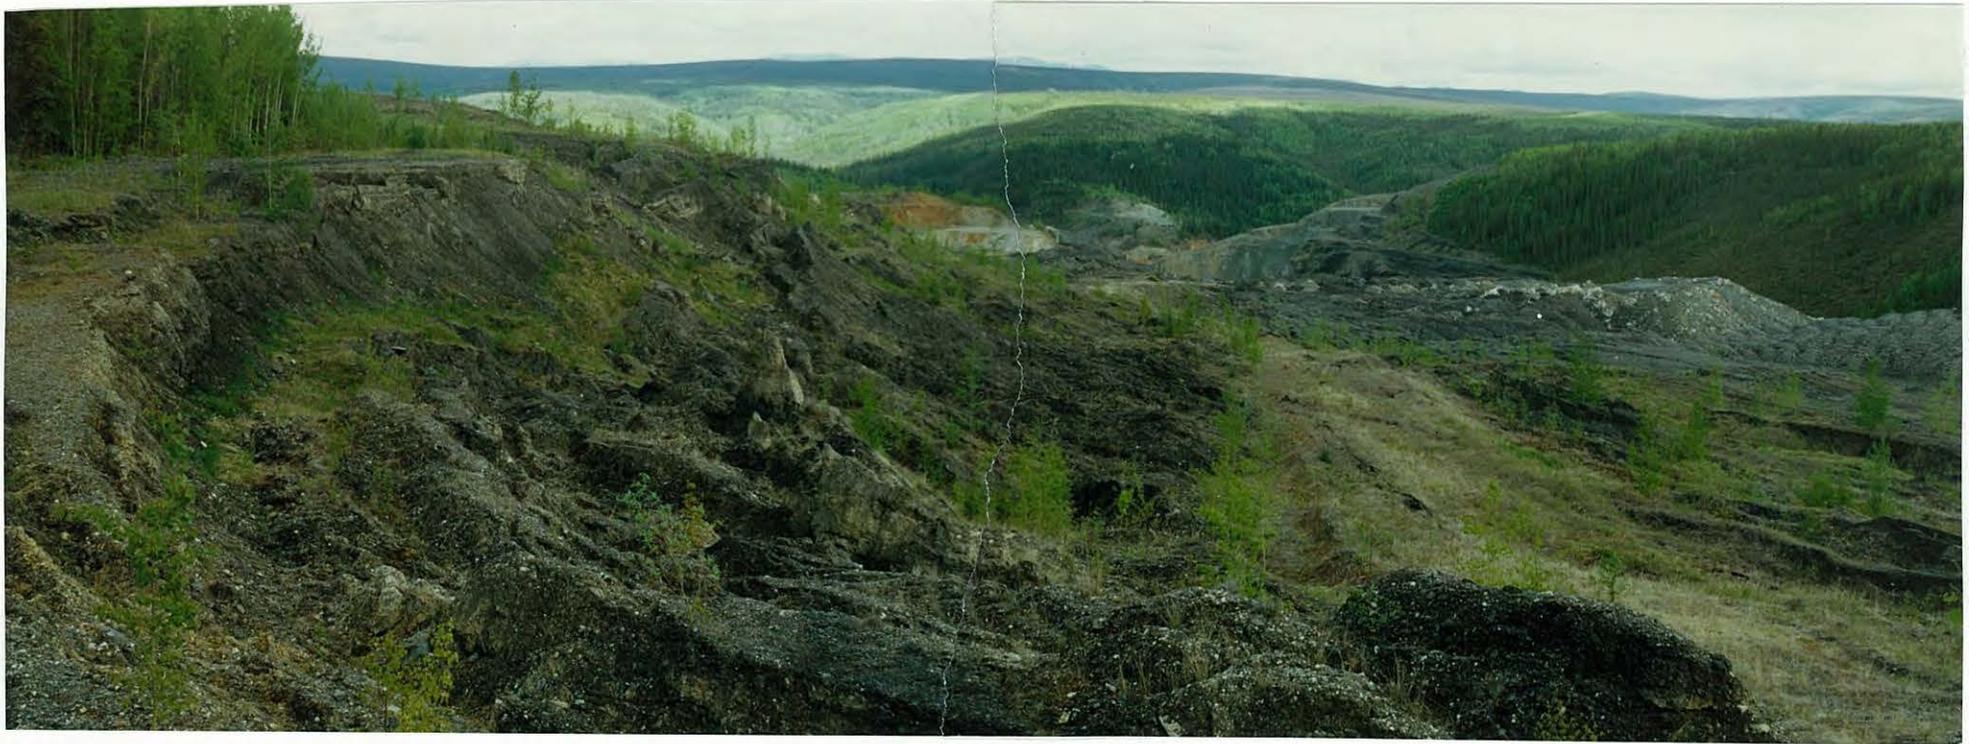
Photo 11: Oblique view of the Porcupine Creek dump looking north. Note fresh-looking cracks in the slide headscarp area and continuing bulging of the toe.

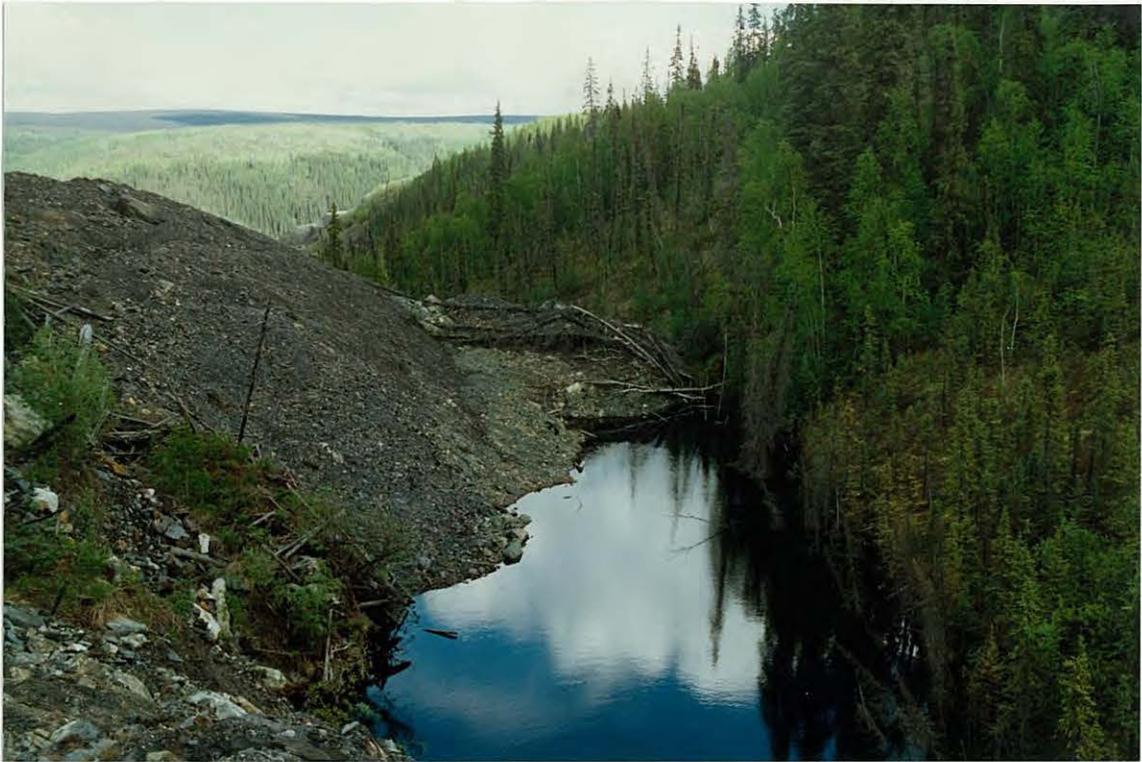
Photo 12: Surface appearance of the Porcupine Creek valley blockage did not change significantly since 1987 (Refer to Photo 8 in the 1987 report).

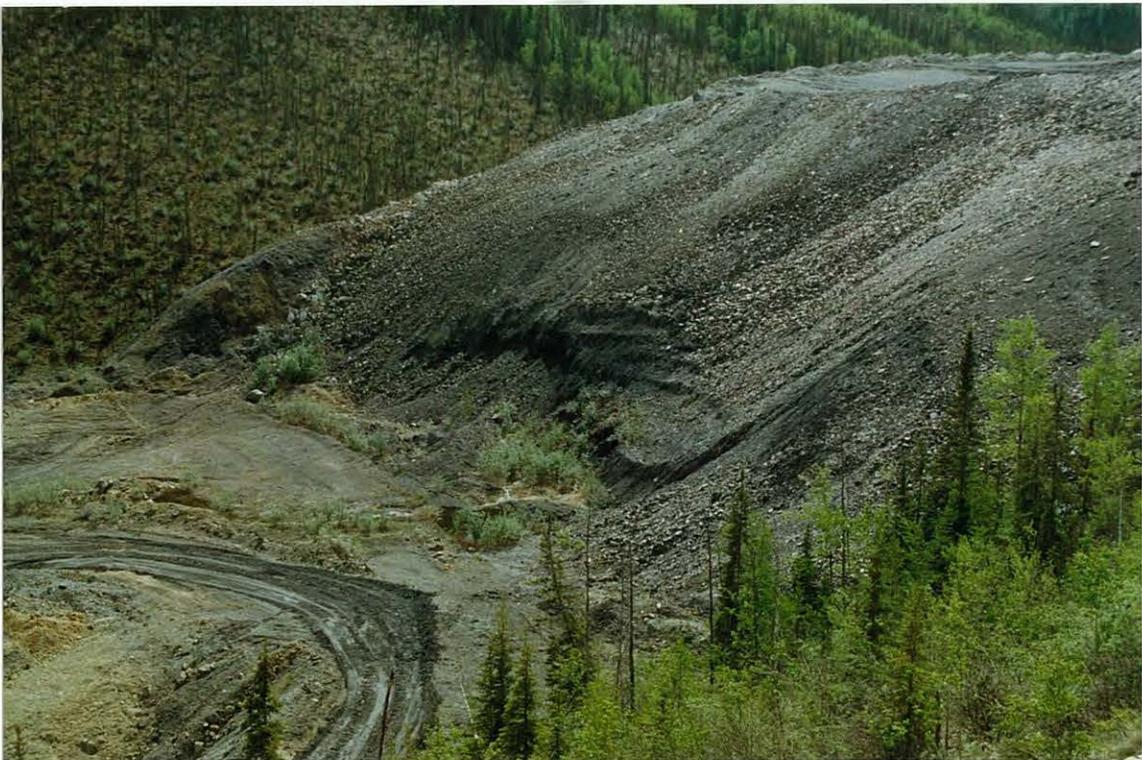
Photo 13: The north toe of the Porcupine Creek dump and the discharge of the underflow (Compare with Photo 10 of the 1987 report).

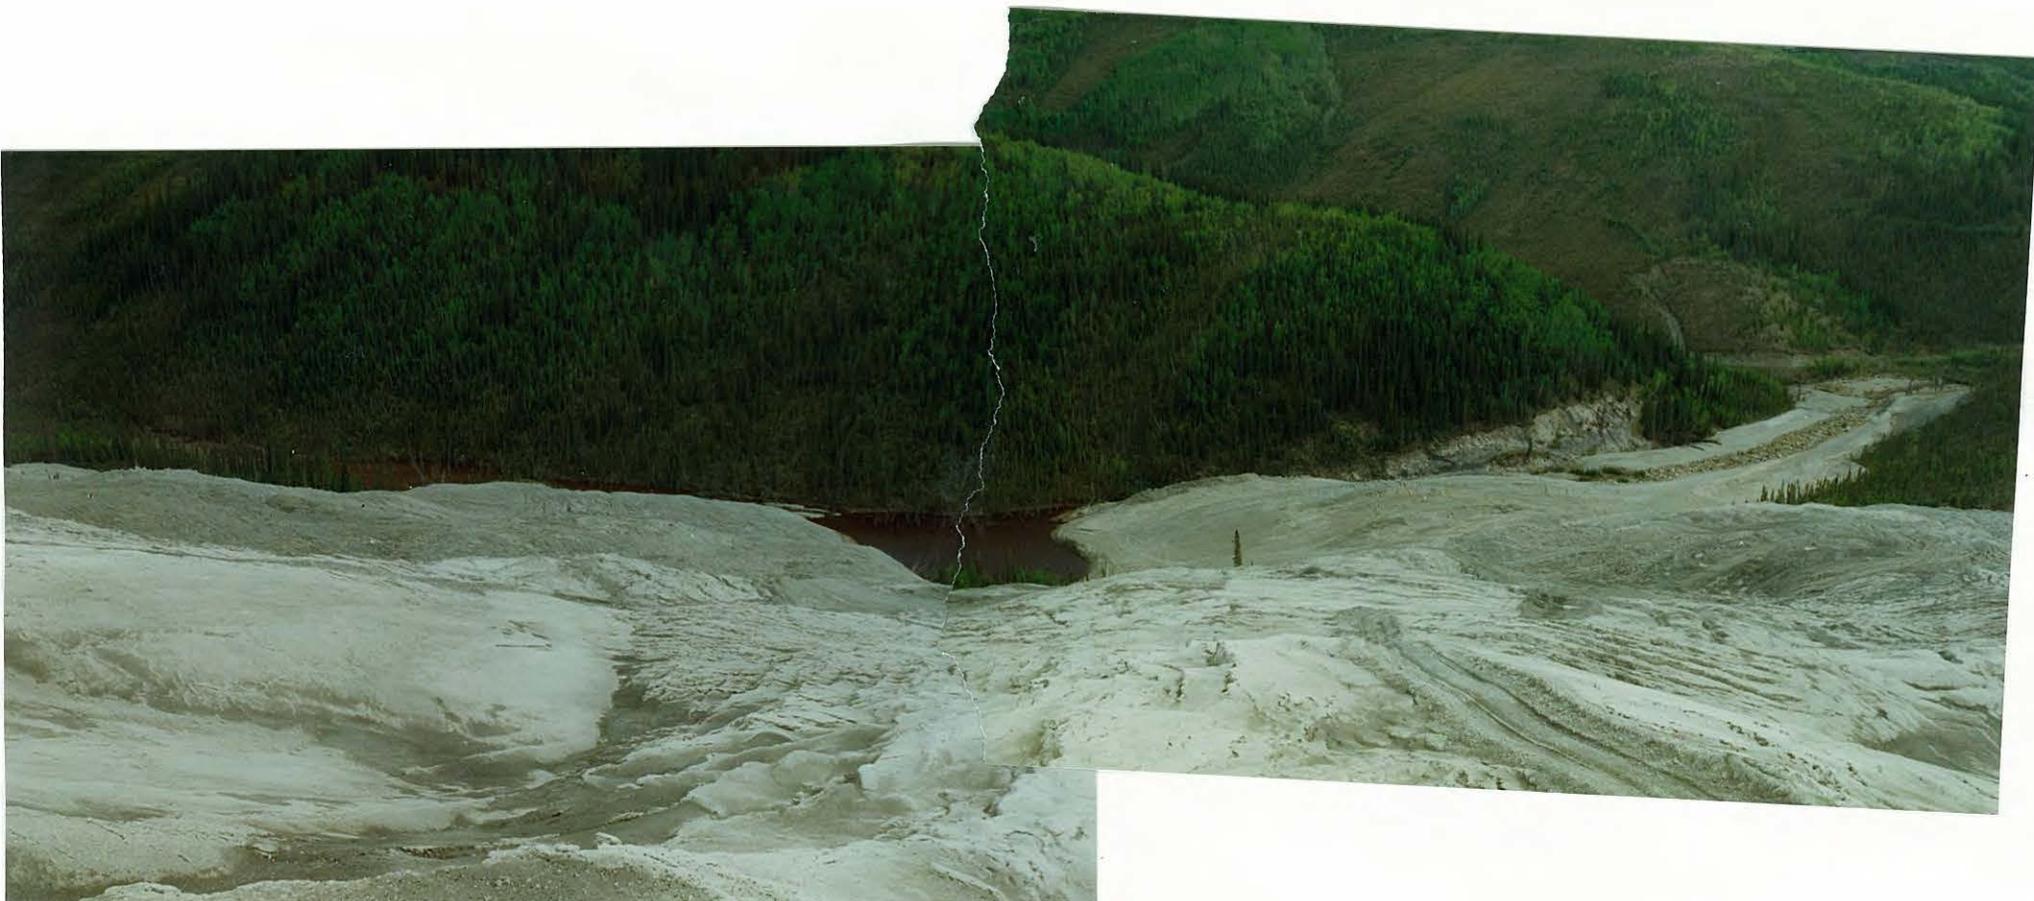
Photo 14: View of the north and south lobes (left and right, respectively) of the Wolverine valley tailings piles. there is a small elevation difference between the impoundment upstream of the north lobe and the pond upstream from the south lobe.

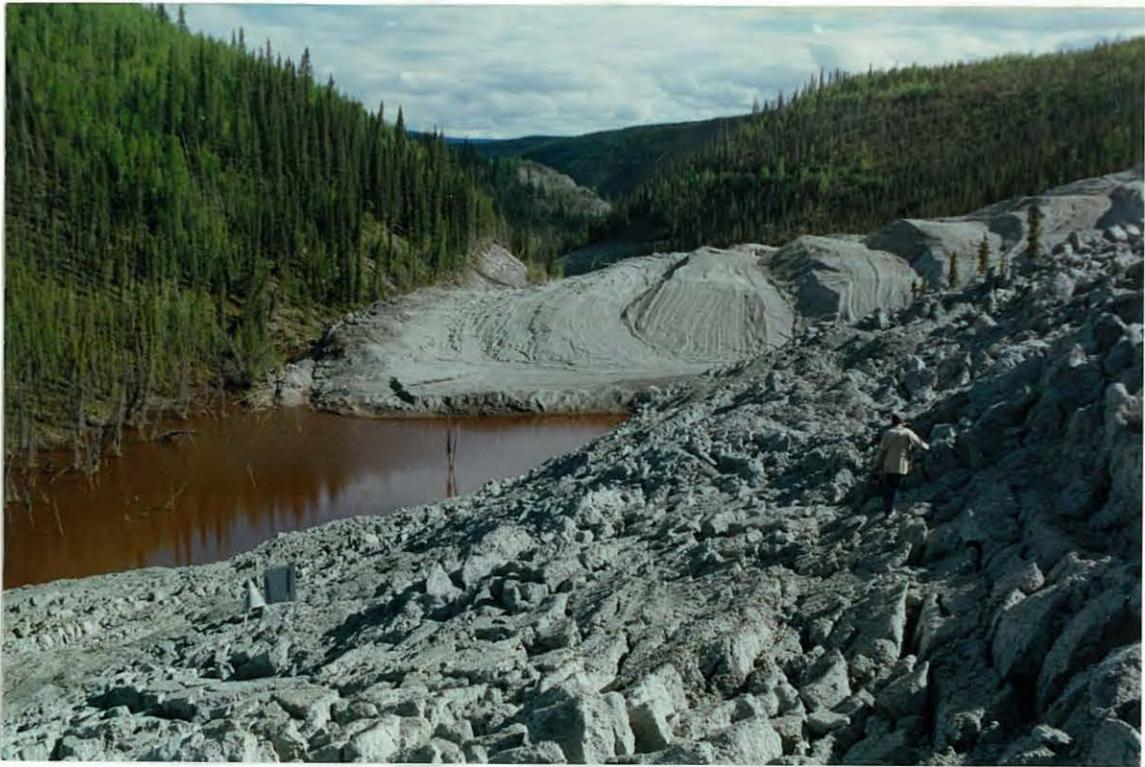
The south lobe (Photo 15) temporarily blocked the outlet channel which resulted in an approximate 0.5 m rise of the lake level. This blockage has been breached and the flow continues through the previously established channel (Photo 16).

Photo 15: View of the lower slope segment of the north lobe and toe of the south lobe.
