CLINTON CREEK ASBESTOS MINE

REPORT  
ON  
1988 SITE INSPECTION

Prepared for:  
NORTHERN AFFAIRS PROGRAM  
Whitehorse, Y.T.

November 1988  
G052

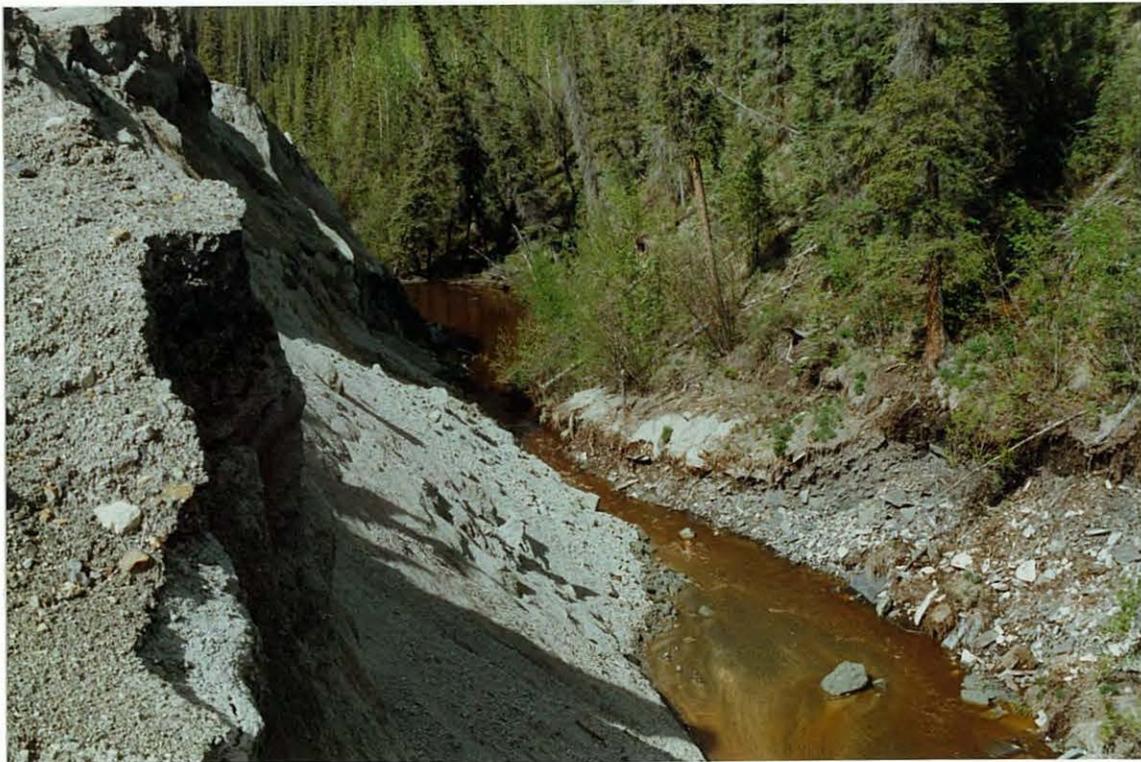
Photo 16: Breached blockage at the upstream side of the south lobe. Note tailings on the east side of the channel.

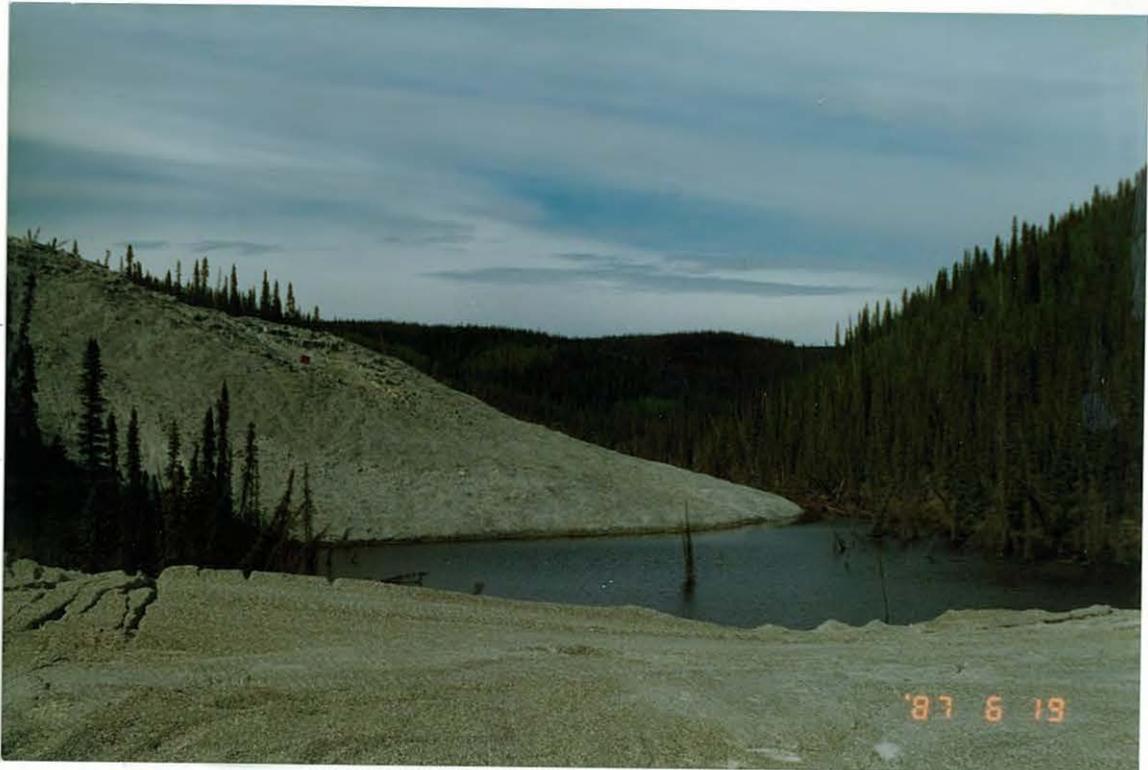
Photo 17: The toe of the north lobe in 1987.

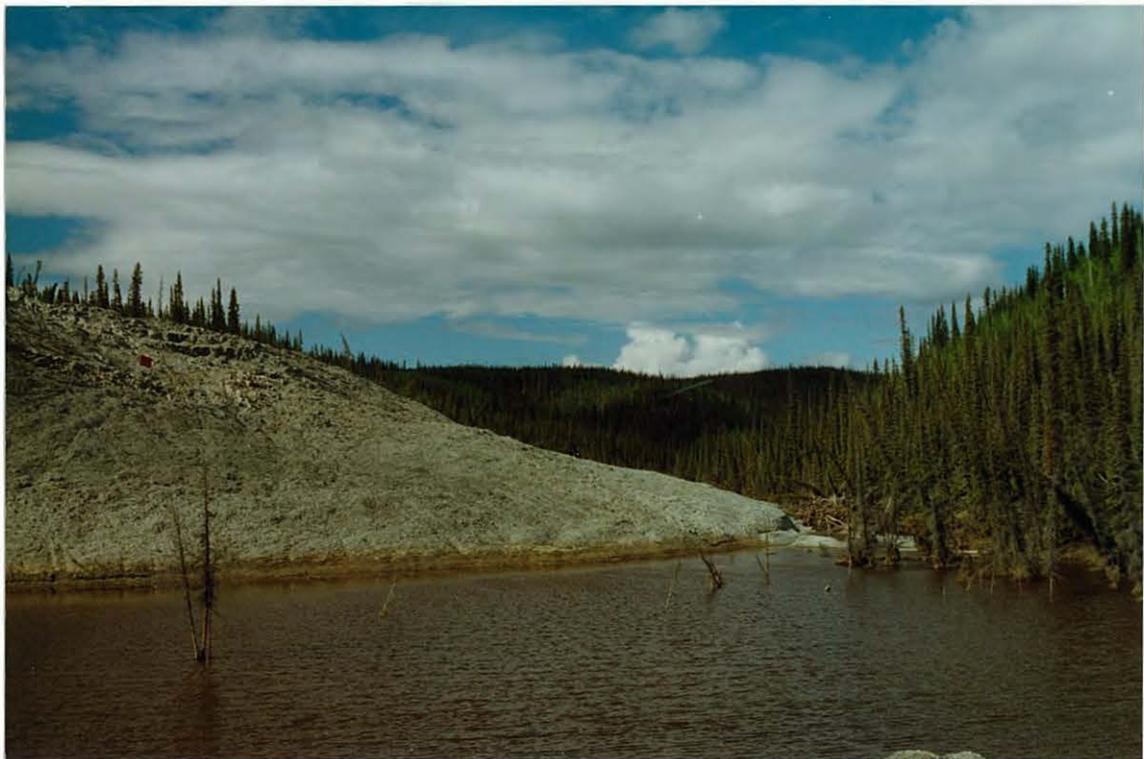
The downslope sector of the north pile is badly disturbed (Photo 16) and it is very difficult to evaluate the relative rate of movement. The toe area did not change significantly since 1987 (Photo Nos. 17 and 18), except that the toe at sometime this spring had completely blocked the valley. The blockage was breached and a channel cut through the tailings (Photo 19).

Photo 18: The same area in June 1988. Note breached blockage of the valley.

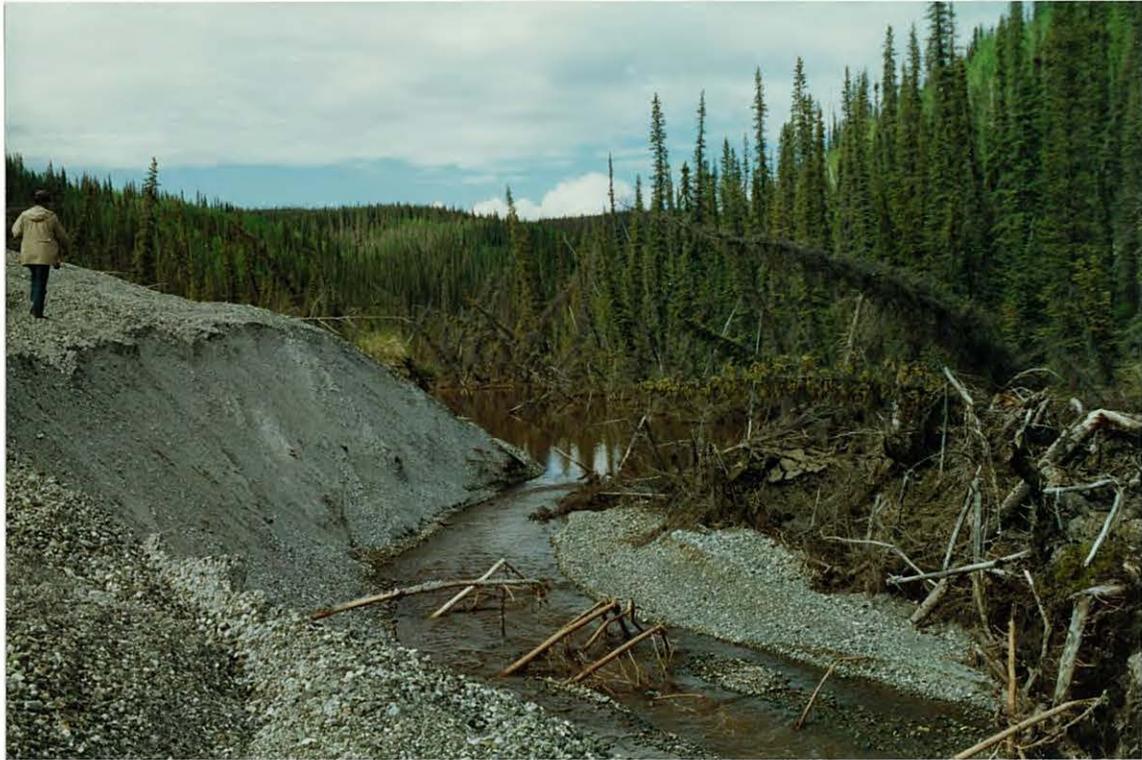
Photo 19: Detailed view of the eroding toe of the north lobe. Tailings temporarily blocked this valley segment and the valley which bottom has been bulged due to the pile movement.

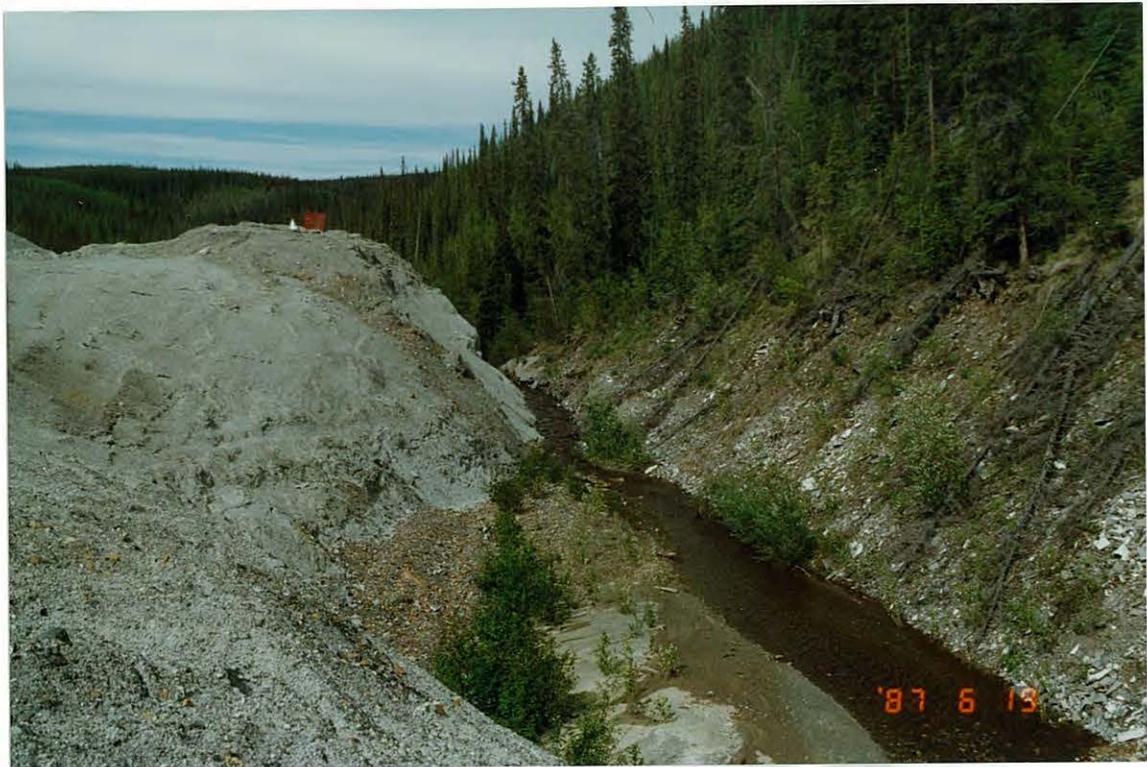
Photo 20: Channel through the south lobe in June 1987. Note the marker on the top of the west bank.

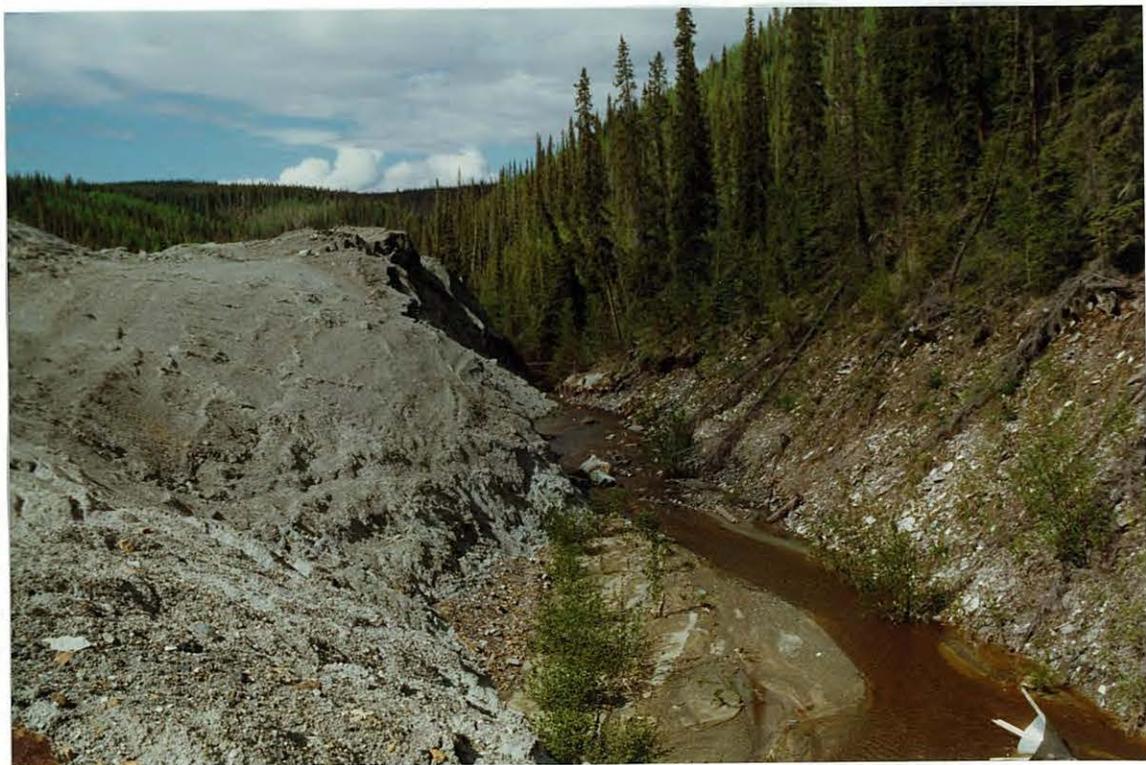
The channel blockage which probably occurred prior to the freshet at the upstream end of the south pile has been breached and the channel restored. However, significant erosion of the west bank (comprised of tailings) has occurred at this location, as documented on Photo Nos. 20 and 21. While this bank appears to be approximately at the same location, the failed marker indicates the horizontal movement of the bank to be in excess of 5 m since June 1987.

Photo 21: The same channel in June 1988. The bank advance is indicated by the failed marker now resting in the channel bottom.

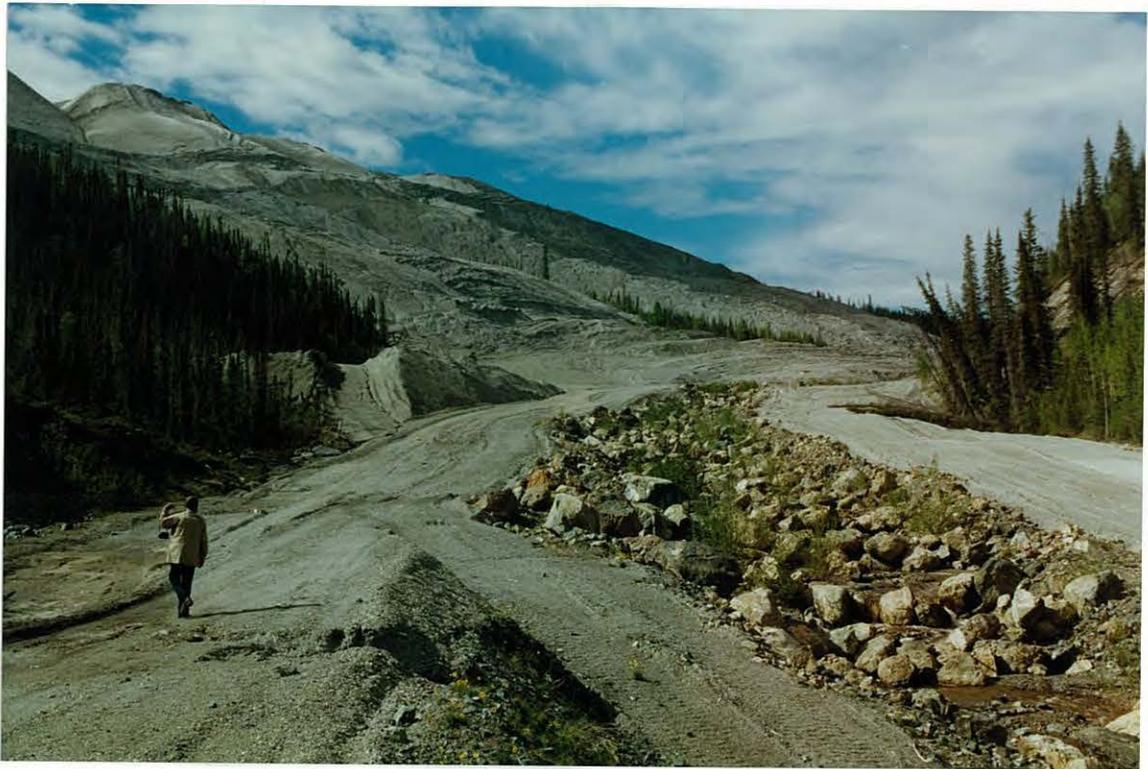
In 1987, the flow was similarly to the previous year, divided into two channels at the downstream end of the south pile. A majority of the flow this year is through the armoured channel with drop weirs (Photo 22). The secondary channel, eroded along the east side of the valley, appeared to carry less flow than in 1987 (Photo 23).

Photo 22: View of the armoured channel and the tailings pile in the background.

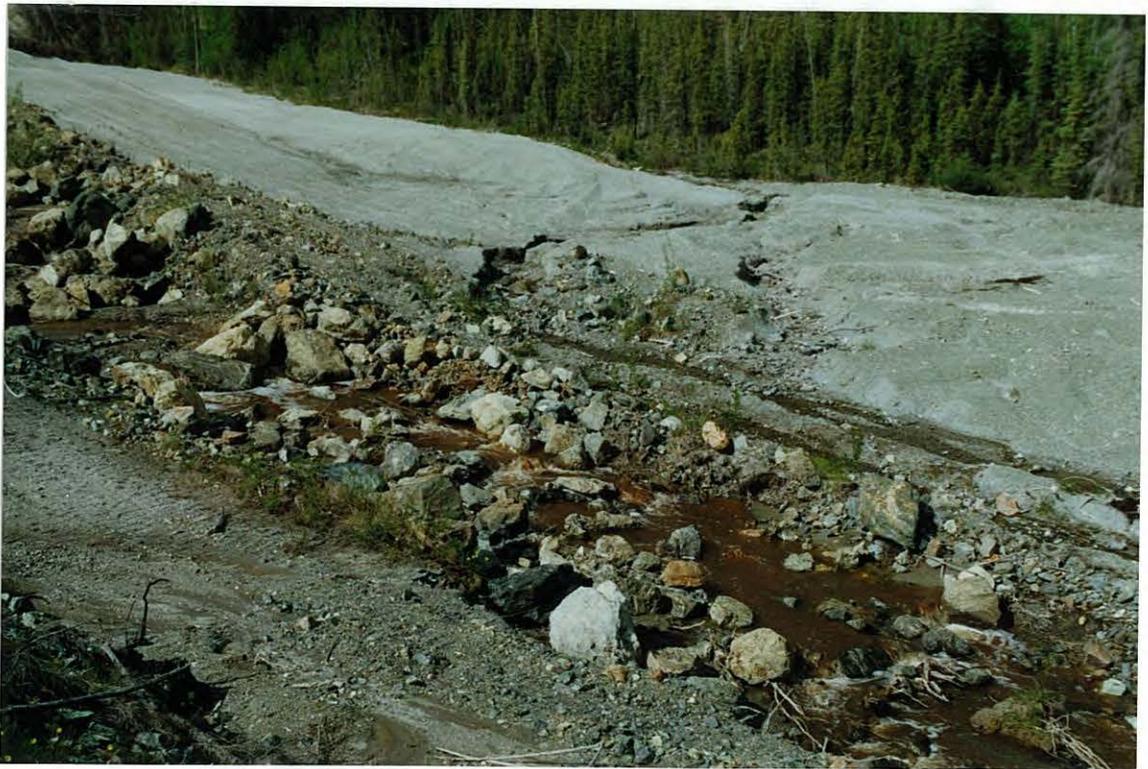
Photo 23: The creek flows mainly through the armoured channel, rather than through the secondary one (Compare with Photo 19 of the 1987 report).
