**Project No: 60160515**

**Regarding: Former Clinton Creek Asbestos Mine - Site Inspection on 23 August, 2010**

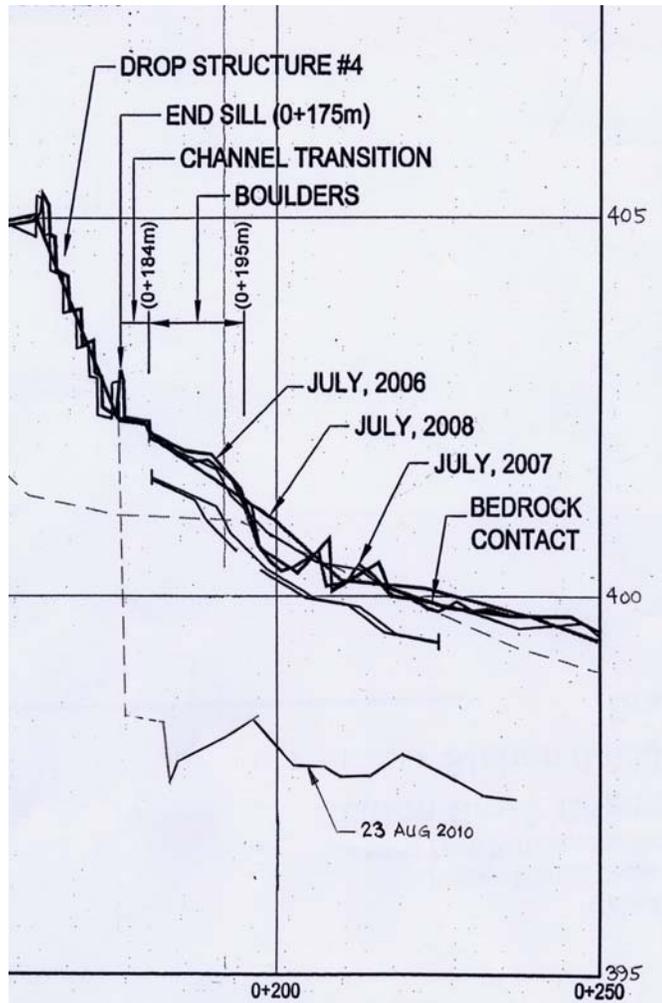
- No significant damage to the gabion steps was seen.
- Immediately downstream of the structure, the channel has degraded 4-5 m and undercut the structure apron. The undercutting extends to approximately 1-2 m downstream of the original lowest step. The material observed under the now hanging gabion apron appeared to consist of waste rock material that was surprisingly dry – minor seepage were observed in a few isolated spots. The 1-2 m of the apron closest to the original lowest step appeared to be supported by waste rock material.

- The bed profile of the channel immediately downstream of Drop Structure #4 was surveyed to get a better understanding of the current conditions. The surveyed profile is listed in the table below and plotted in the following figure.

STA	Elevation (m)
STA 0+182	398.34
STA 0+183	397.53
STA 0+184	397.83
STA 0+192	398.17
STA 0+196	398.36
STA 0+202	397.79
STA 0+207	397.74

STA	Elevation (m)
STA 0+210	397.63
STA 0+214	397.62
STA 0+219	397.93
STA 0+222	397.81
STA 0+227	397.61
STA 0+232	397.35
STA 0+237	397.32
