Former Clinton Creek Asbestos Mine 2010 Site Inspection

AECOM

60160515 (402.3.1)

March, 2011

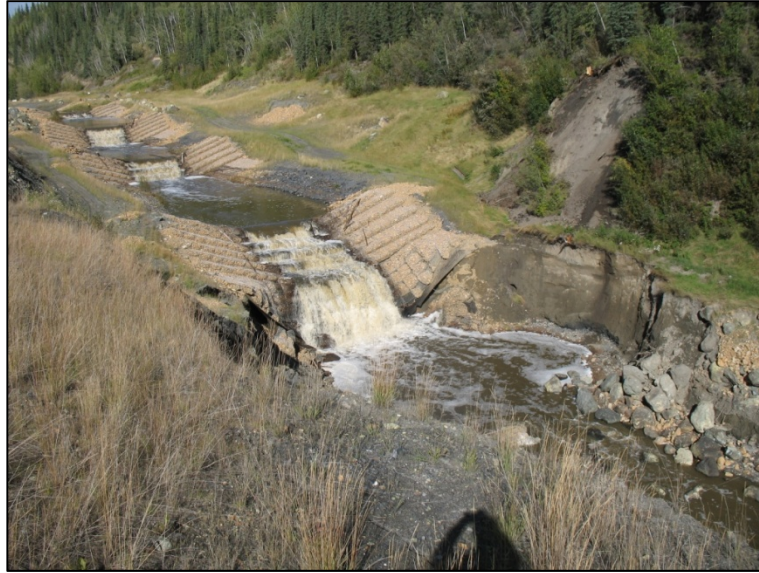
Figure 43 Clinton Creek Channel – DS#4 on August 23, 2010

- No significant damage to the gabion steps was seen.
- Immediately downstream of the structure, the channel has degraded 4-5 m and undercut the structure apron. The undercutting extends to approximately 1-2 m downstream of the original lowest step. The material observed under the now hanging gabion apron appeared to consist of waste rock material that was surprisingly dry – minor seepage were observed in a few isolated spots. The 1-2 m of the apron closest to the original lowest step appeared to be supported by waste rock material.

Repairs to the drop structures following the August 2010 event could not be completed before winter conditions stopped work at the site. A site visit is planned in the spring of 2011 to re-assess the condition of the Clinton Creek channel and drop structures and the rock lined channel on Wolverine Creek. A repair strategy will need to be developed and implemented in 2011.

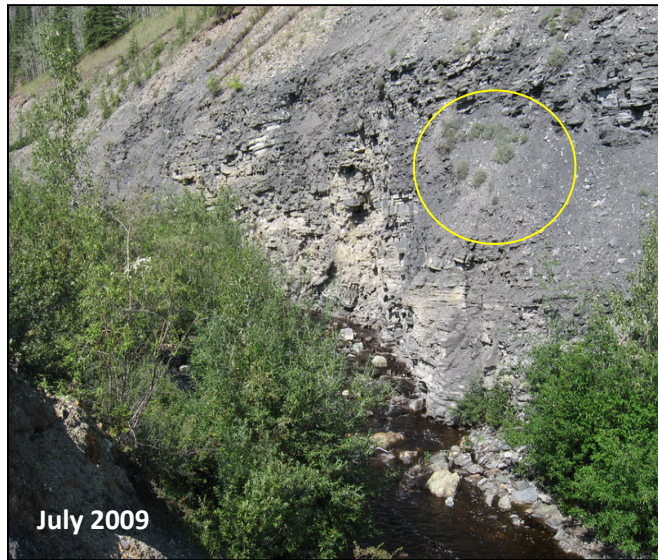
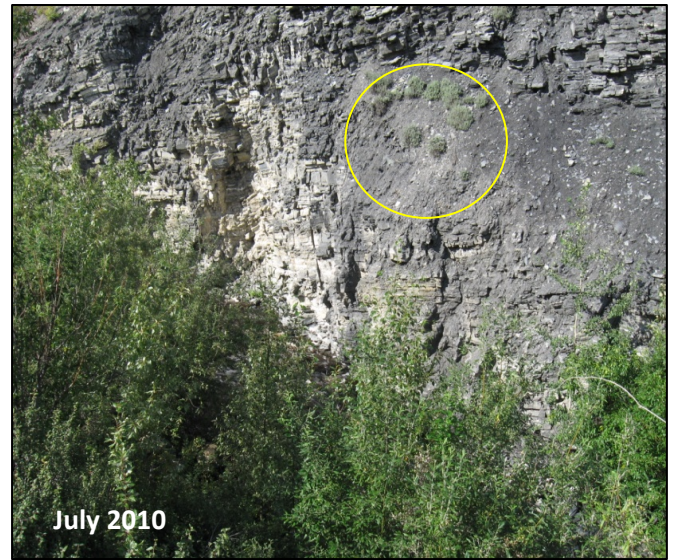
Figure 03 Station 0+600 at WP 339 in 2009 and 2010, U/S view

The bedrock channel bottom and outcrop visible on the LHS of the channel from approximately Station 0+600 (Drawing 01) compare well with what was observed in 2009 from Waypoints 339 and 340 (Figures 03 and 04, respectively).

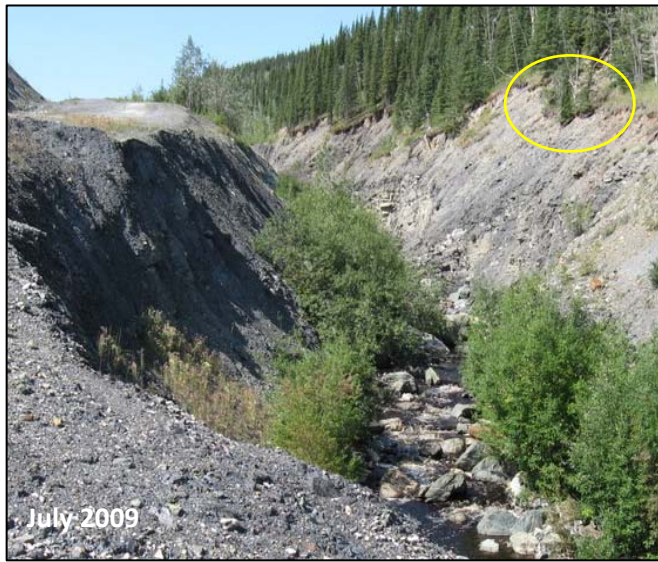
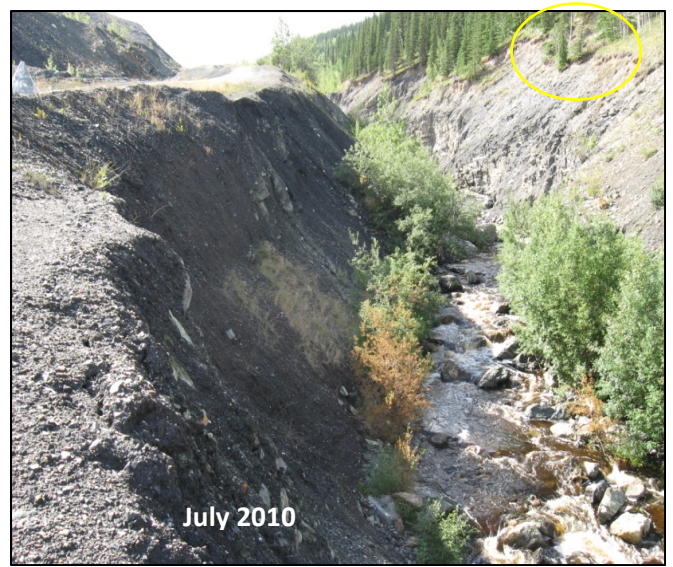
Figure 05 Station 0+560 at WP 341 in 2009 and 2010, U/S view

Farther upstream, at approximately Station 0+560, the physical features and vegetation along the LHS and RHS of the channel, as well as the channel bottom do not appear to have significantly changed from 2009 as seen on Figures 05, 06 and 07 taken from WP 341. A similar set of photos were taken at WP 342, located at approximately Station 0+470 in an upstream direction (Figure 08), cross-channel (Figure 09) and downstream (Figure 10); No significant changes in the condition of the channel over the one year period from July 2009 to July 2010 were noted.

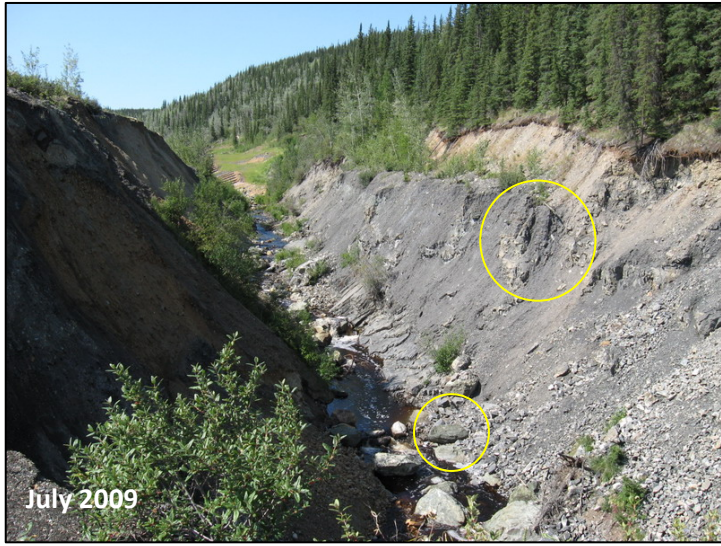
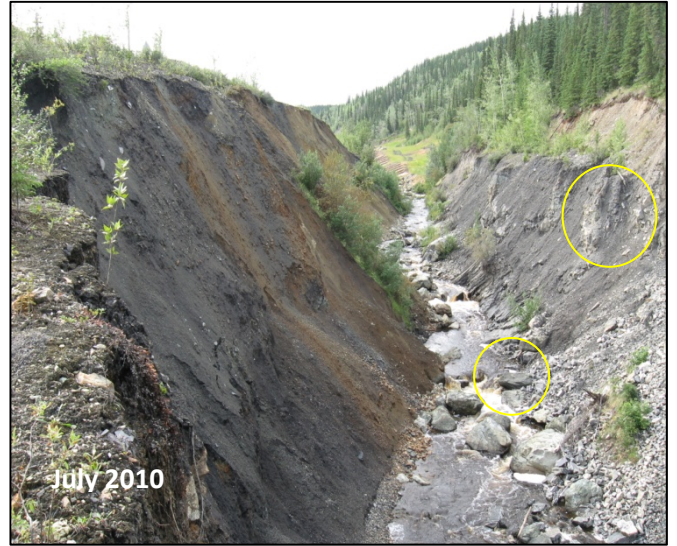
Figure 11 Station 0+360 at WP 344 in 2009 and 2010, U/S view

Figures 11 and 12 illustrate the channel condition at Station 0+370 m, 170 m downstream of the gabion drop structures. The photos in these two figures were taken from the same location (WP 344) but at a different magnification. This is the portion of the channel where down-cutting could impact on the stabilization works (drop structures) and is therefore considered a critical area to review during site inspections and when reviewing the creek profile for the performance monitoring program. Comparison of the 2009 and 2010 photos does not suggest any significant changes in the channel over this time period which is consistent with the 2010 creek channel profile survey (AECOM, 2011a). Several boulders and other channel features do not appear to have changed.

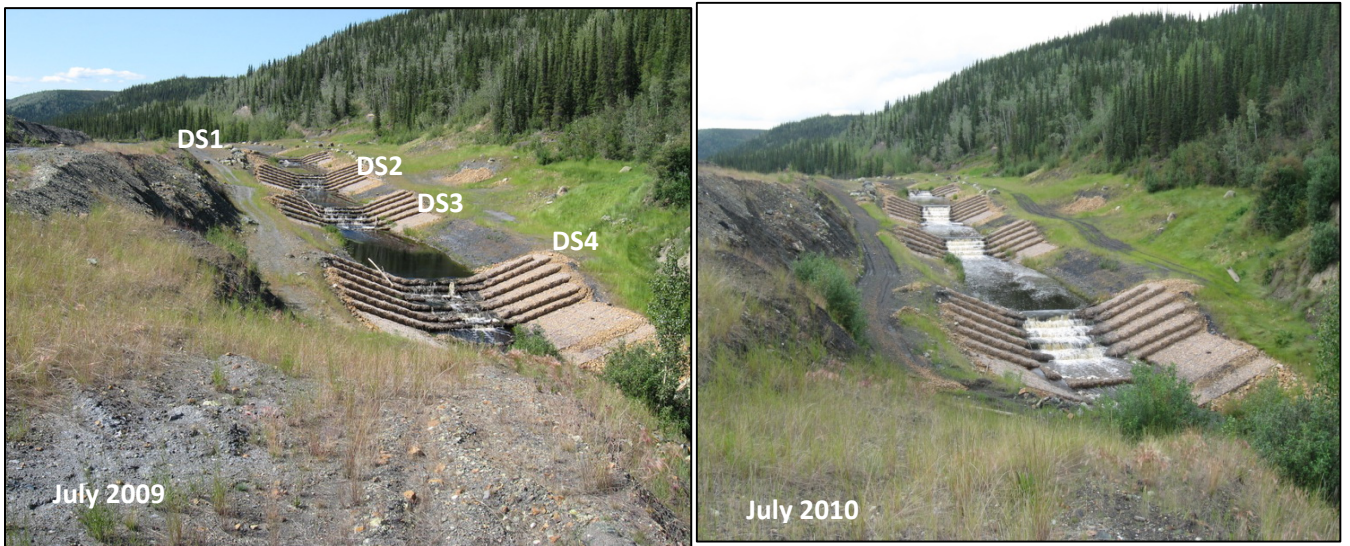
Figure 14 Gabion Drop Structures from WP 346 in 2009 and 2010, U/S view

The gabion drop structures downstream of the Hudgeon lake outlet were photographed in 2009 and 2010 from WP 346 at approximately Station 0+230. From this vantage point, no significant change in the overall condition of the channel or structures located between the lake outlet (Station 0+000) and Station 0+184 was observed (Figure 14). In 2009, the structures were damaged during the 2009 spring freshet (AECOM 2010) and repaired in the fall of 2009 (AECOM 2011). While the damage was severe enough to warrant repair before the next spring freshet, it was concluded that overall, the structures were performing as intended because they continued to provide erosion protection immediately downstream of the lake outlet and mitigate the risk of a breach and rapid lowering of Hudgeon Lake.

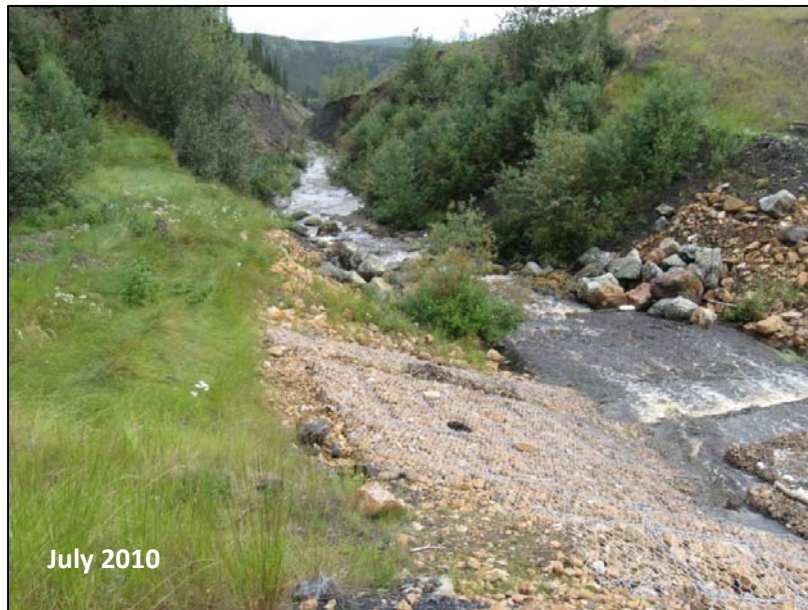
Figure 15 Channel directly D/S of DS#4 in 2010

Drop Structure #4 consists of a drawdown weir with 6 tiers that provide a 2.5 m drop in channel grade and an end sill on the bottom tier. The transition from the drop structures to the natural channel is illustrated on Figure 15. Figure 16 compares the overall condition of the structure in 2009 and 2010. Of the overall damage from 2009, the most significant damage occurred to Drop Structure #4. Several of the wire baskets at the top of the structure including the drawdown weir and tiers 4, 5 and 6 were deformed and some of the baskets were torn open with the rock fill partially or completely missing (Figures 16 to 18). The lower tier of the structure was repaired by placing another layer of gabion baskets on the floor of the structure, as noted on Figure 16. The remainder of the damage was repaired by infilling the gabion baskets as required, re-fastening the lids and patching the wire mesh. The damaged end sill was not replaced.

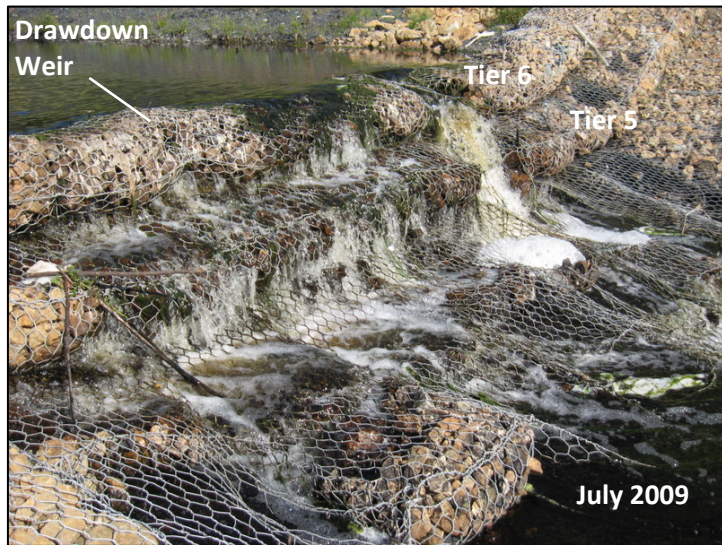
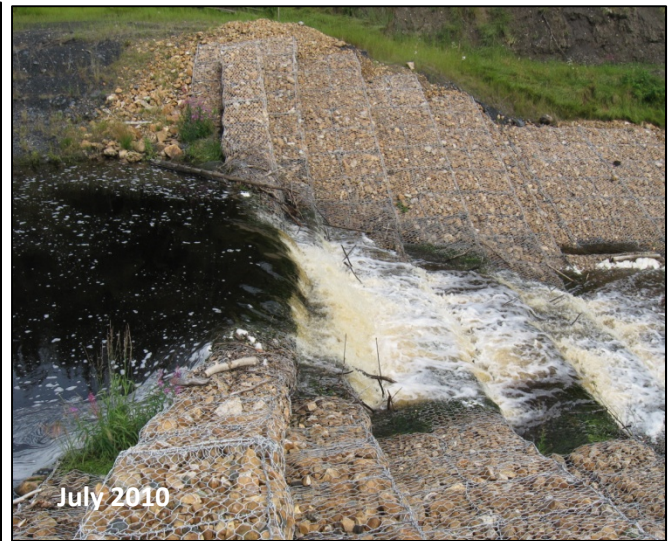
Figure 17 DS #4 Tier 5 and Tier 6 in 2009 and 2010, view North

The repaired structure did not appear to have suffered any damage in the 2010 spring freshet. The upper most tier (Tier #6) and the overlying draw down weir are tilted in the upstream direction (Figure 17). The tilting may have occurred during the 2009 spring freshet. Other than the tilting observed, the structure and the creek channel directly downstream appeared to be in good condition.

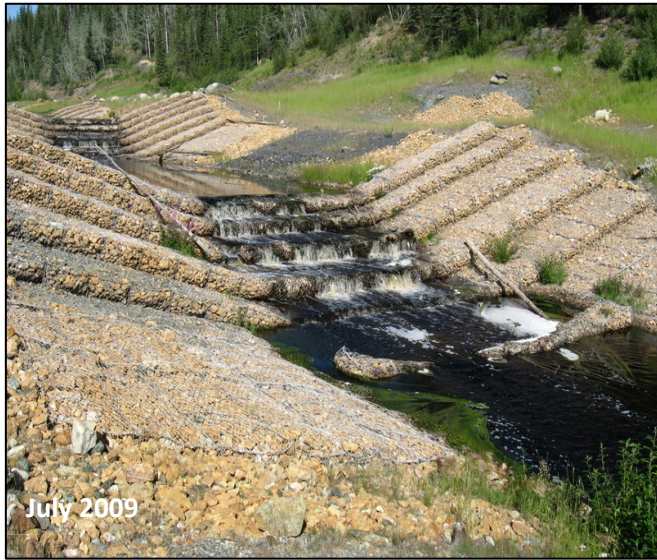
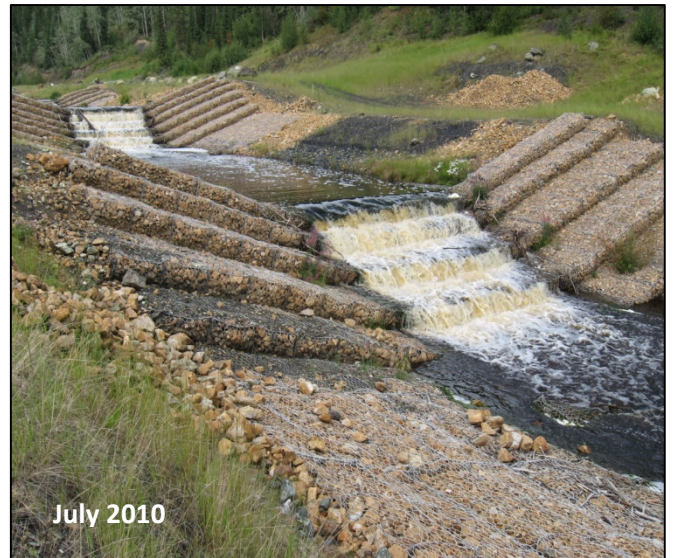
Figure 19 DS #3 in 2009 and 2010, U/S view

Drop Structure #3 consists of a drawdown weir with 5 tiers that provide a 2 m drop in channel grade and an end sill on the bottom tier. Figure 19 illustrates the overall condition of the structure in 2009 and 2010. Cross-channel views of the structure are shown on Figure 20. The damage to Drop Structure #3 observed in 2009 included deformation of baskets, some small holes in the tops or downstream sides of individual baskets and the end sill was badly deformed but intact.

The repairs completed in 2009 held up well during the 2010 spring freshet and the structure appears to be in very good condition. The water flow over the weir was slightly uneven suggesting that RHS of the upper most tier may have settled a small amount relative to the LHS. The channel slopes between DS #3 and DS#4 (Figure 21) are in good condition with no signs of erosion other than high water marks.

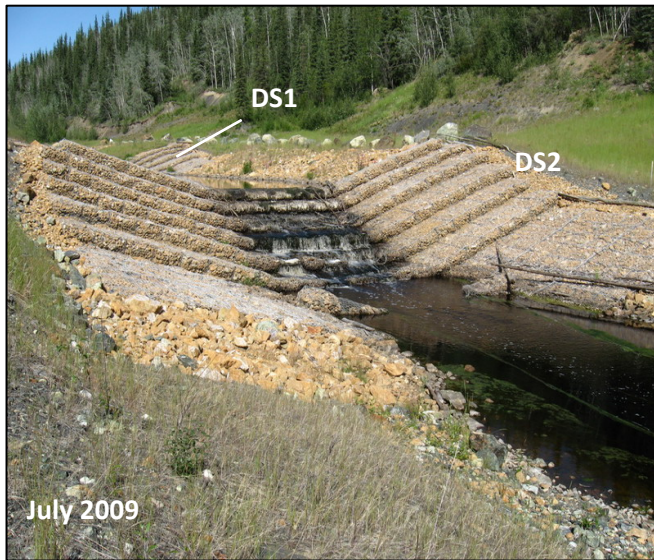
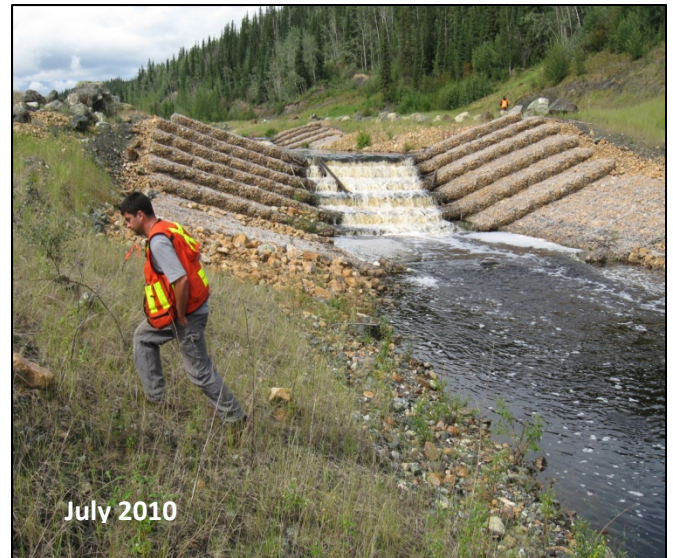
Figure 22 DS #2 in 2009 and 2010, view U/S

Drop Structure #2 consists of a drawdown weir with 6 tiers that provide a 2.5 m drop in channel grade and an end sill on the bottom tier. A comparison of the structure in 2009 and 2010 is illustrated on Figures 22 and 23. The damage observed in 2009 included the drawdown weir which was leaning downstream, loss of gabion fill from the end sill and several of the baskets on Tiers 2, 3 and 5. The end sill was also deformed.

The repairs completed in 2009 held up well during the 2010 spring freshet and the structure appears to be in very good condition. The channel slopes between DS #2 and DS#3 are in good condition with no signs of erosion other than high water marks.

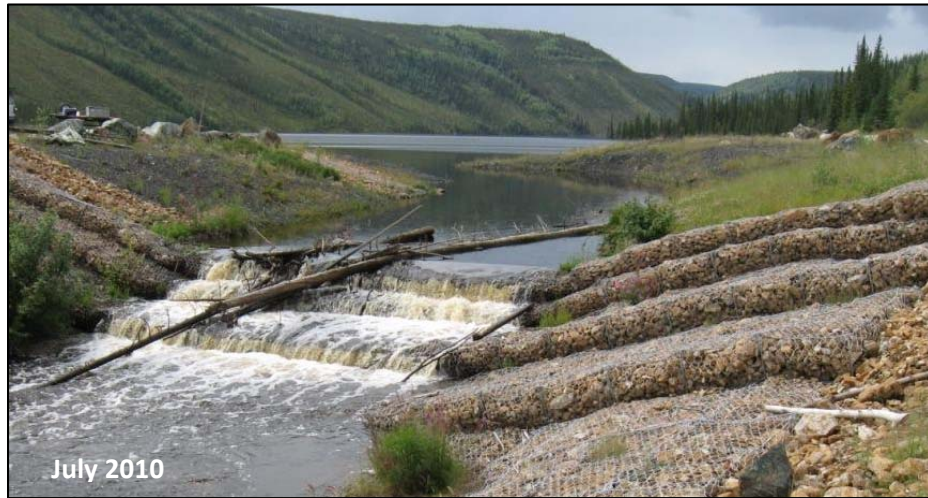
Figure 26 Lake outlet channel U/S of DS #1 in 2010

Figure 26 illustrates the general condition of the lake outlet channel upstream of DS 1 in 2010. No signs of bank erosion or instability were observed.

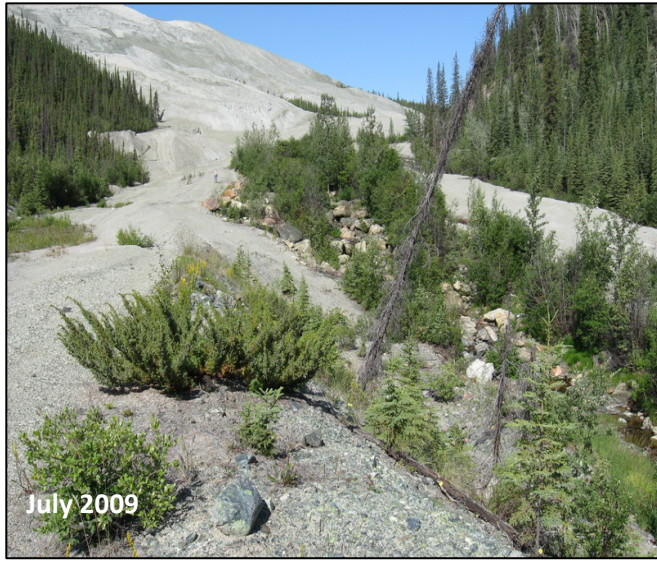
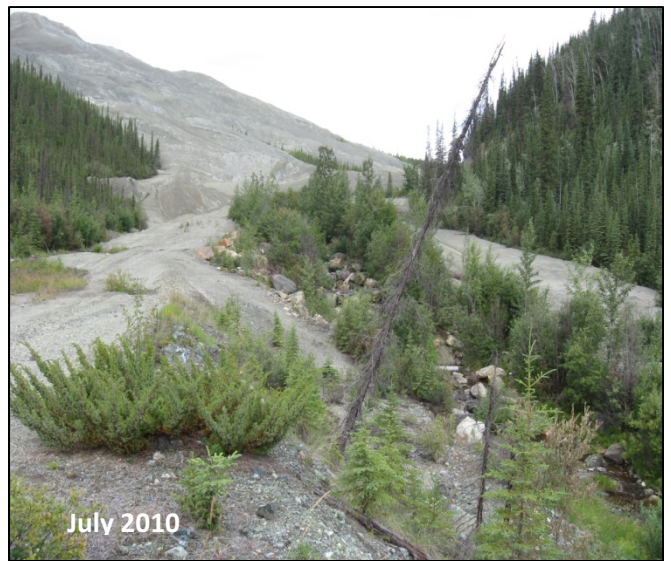
Figure 27 View U/S at Rock Lined Channel in 2009 and 2010, from WP 75 (UGL Tag #482)

A comparison of the channel in 2009 and 2010 is shown on Figures 27 and 28 at Waypoints 75 (UGL Tag 482) and 335. No significant changes in the condition of the channel from 2009 to 2010 were observed. As noted in the 2009 Inspection Report (AECOM 2010) vegetation, including trees, is gradually re-growing in the channel after brush removal work was carried out in 2007. The brush clearing work was limited to the removal of the trees and brush from the bottom of the channel only and not the channel banks. The rock weirs are in good condition and there is minimal erosion along the bottom and sides of the channel. Some of the rocks in the weirs have shifted around over the years but the weirs are still clearly visible. It is anticipated that some maintenance of the rock weirs will be required at some point in the future.

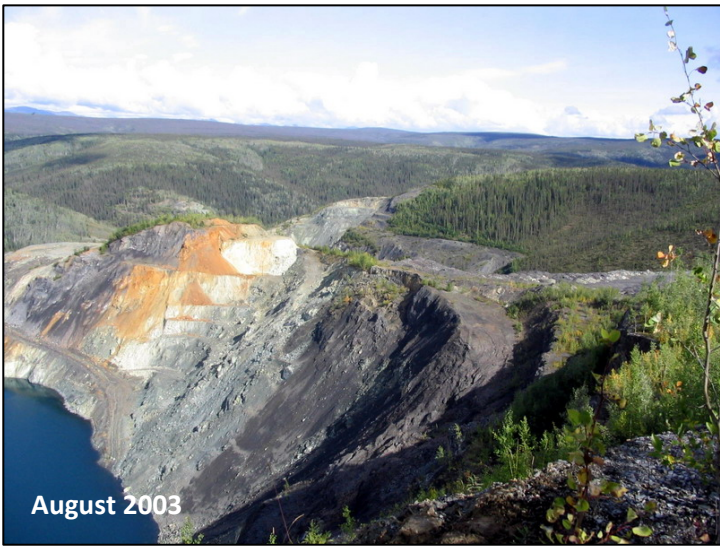
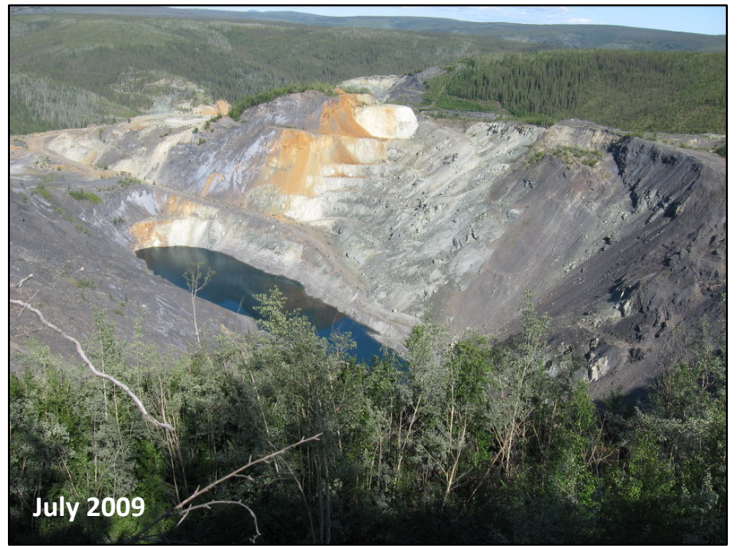
Figure 33 View NE Across Porcupine Pit in August 2003 and from WP 358 in July 2009

A series of photographs taken in 2003 and 2009 illustrate the overall condition of the open pit (Figures 33 and 34). Figure 35 shows the open pit from the east side and Figure 36 illustrates the condition of the pit from the north side in 2010. Waypoint (WP) locations for the photographs are shown on Drawing 02. A ditch has been excavated around the south and west sides of the Porcupine pit to restrict access. The approximate alignment of the ditch is shown on Drawing 02. Excavated material from the ditch has been placed as a berm and warning signs have been posted.

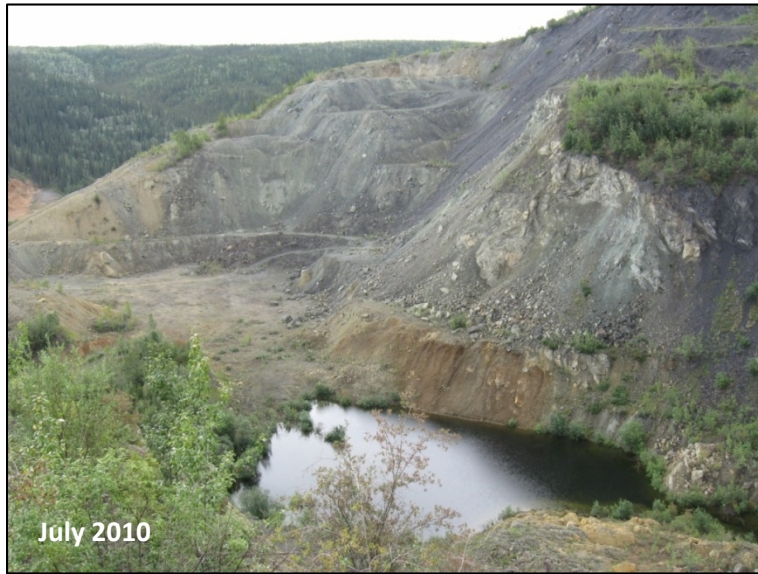
Figure 37 View of Snow Shoe Pit from WP 87 in July 2010, view North East

Figure 37 illustrates the general condition of this open pit in 2010 from WP 87. Photos should be taken from this Waypoint in future inspections.

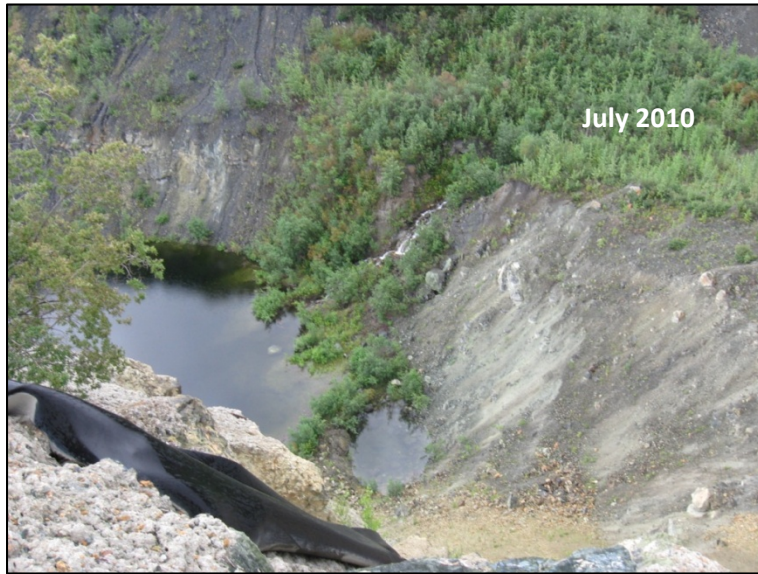
Figure 38 View of Creek Pit from WP 89 in July 2010, view East

Figure 38, taken from WP 89, illustrates the general condition of this open pit in 2010. Note the level of water in the pond and the flow from the Porcupine Waste Rock Dump, which is located directly upstream of the pit. Some sloughing of the west wall of the Creek Pit was observed in 2010 as shown on Figure 39 taken from Waypoint 90. Photos should be taken from this Waypoint in future inspections.
