2007 Geotechnical Closure Studies, Keno Hill, YT

Project Reference Number
SRK 1CE012.000

March 2008

Elsa Reclamation and Development Company Ltd.

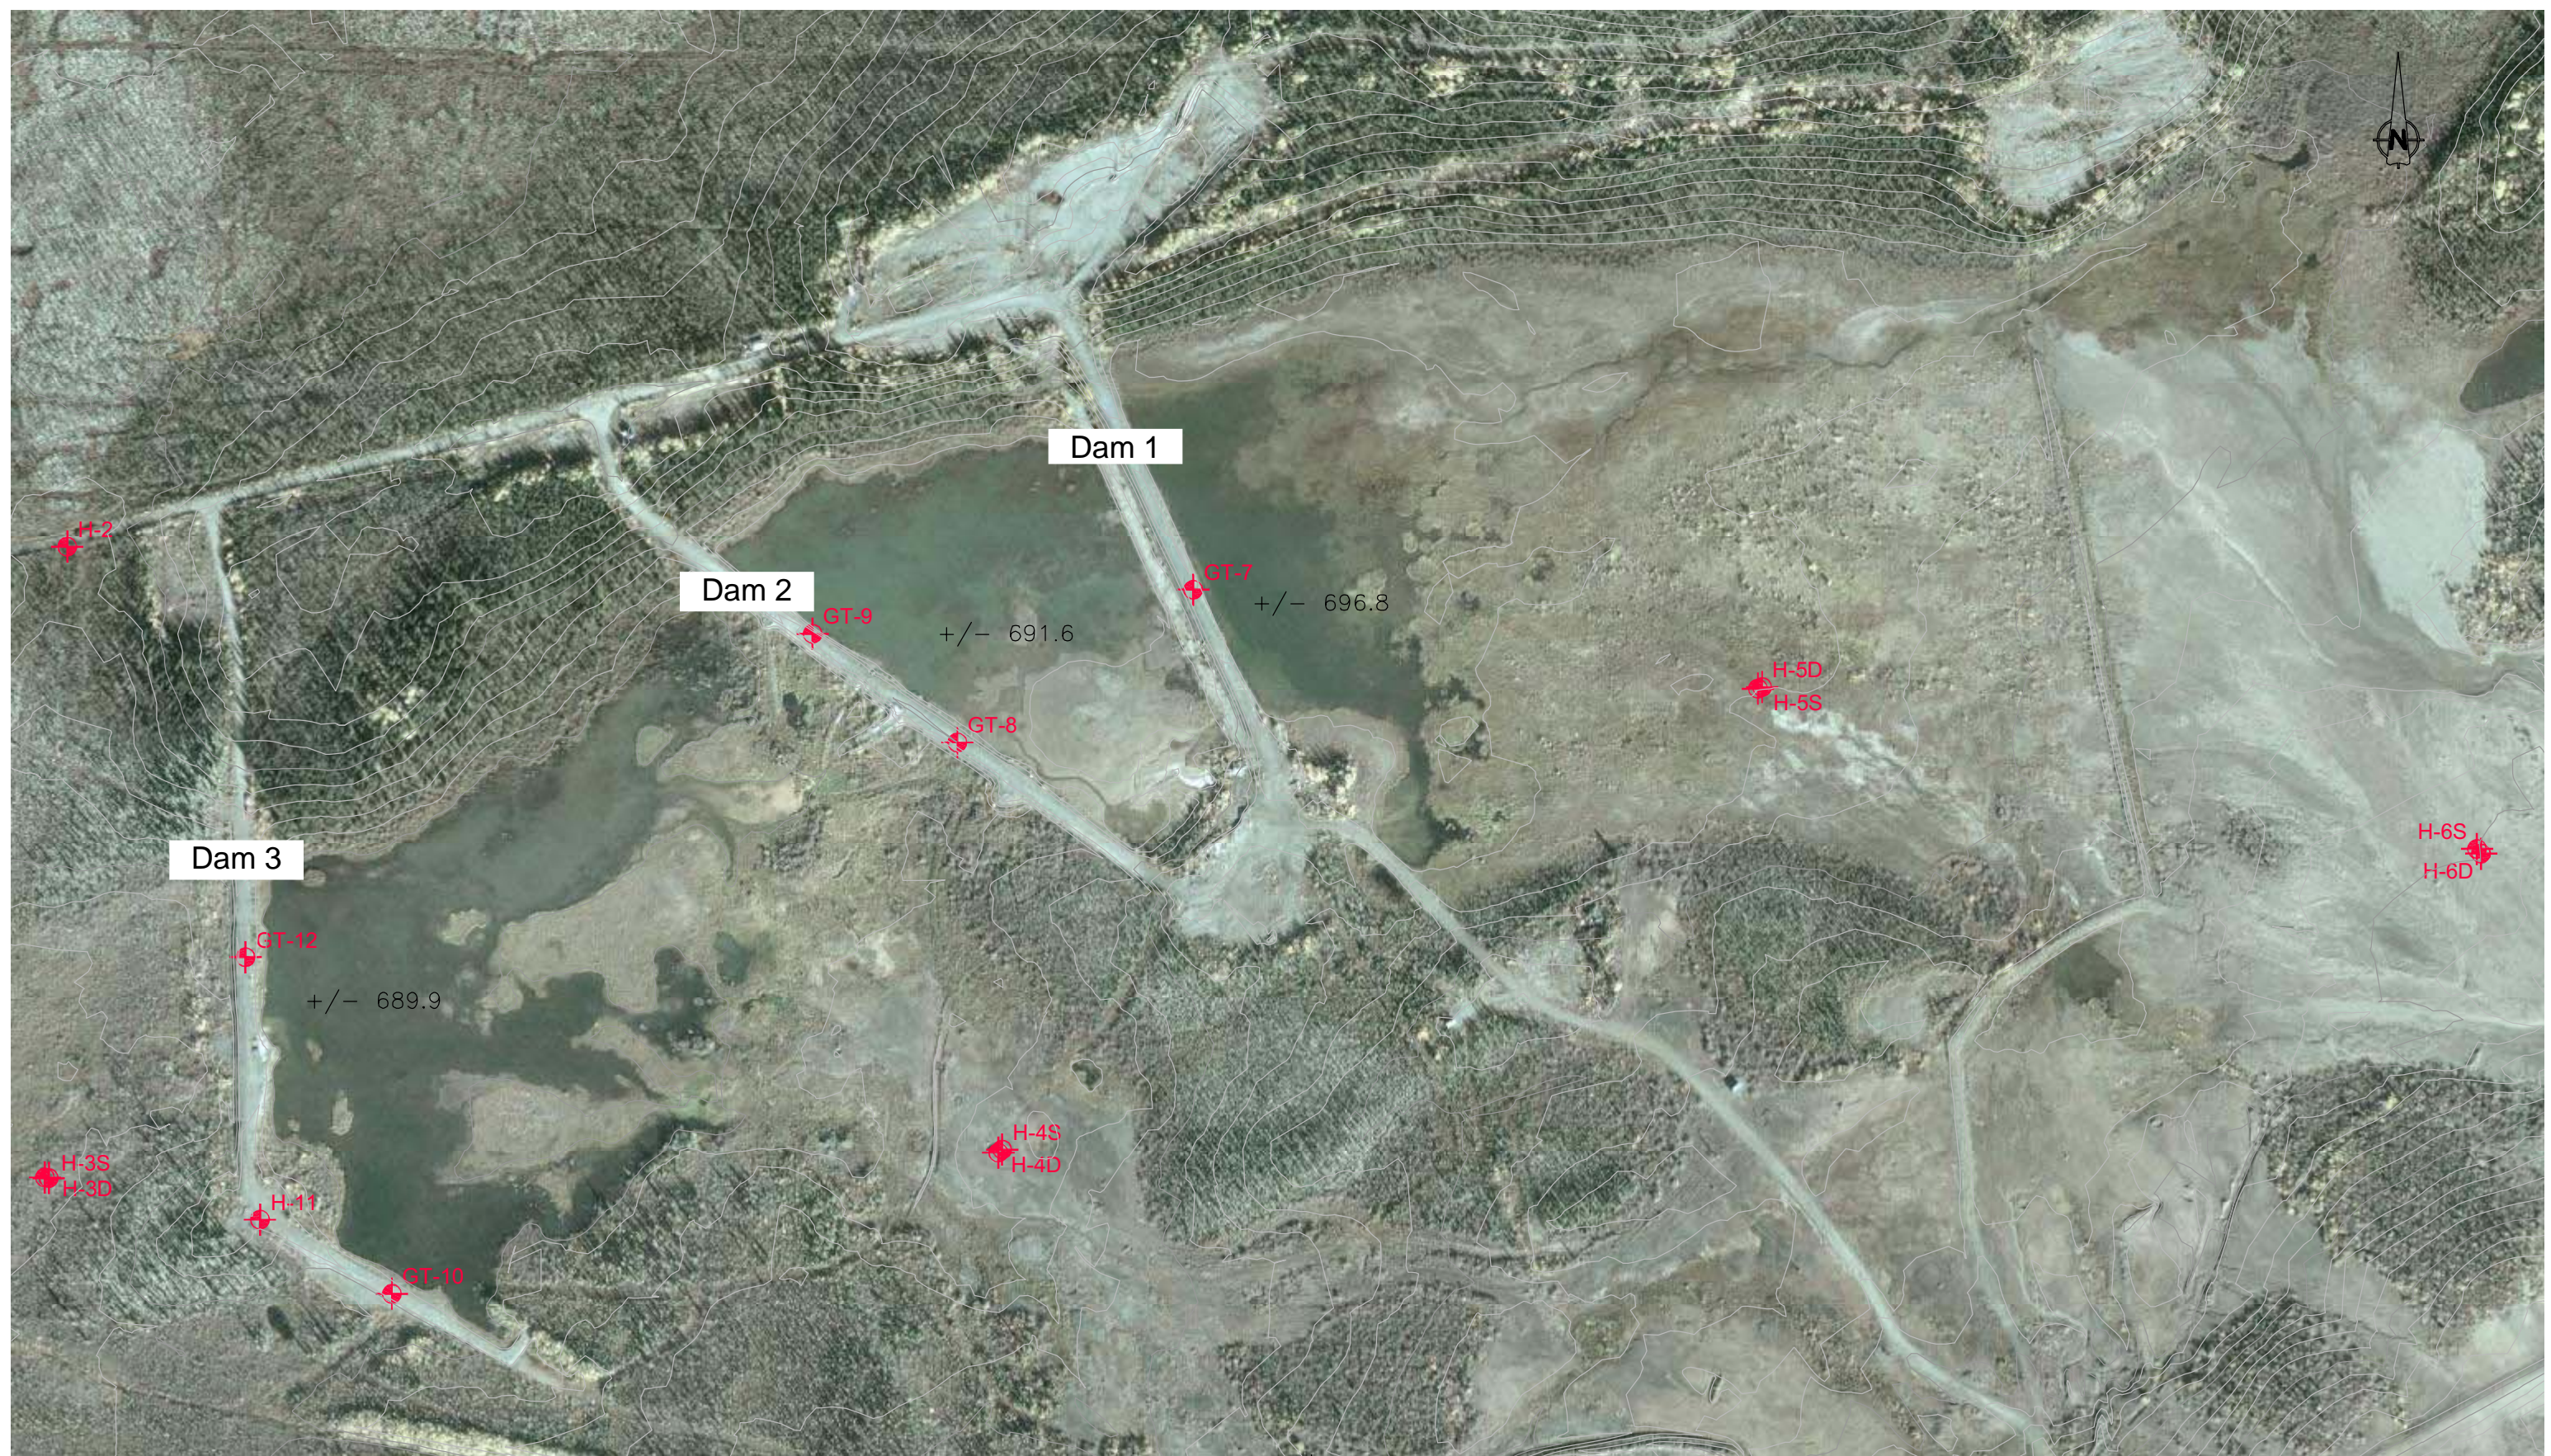
Fall 2007 Borehole Locations

Borehole GT7 was drilled to refusal at a depth of 17.46 m on the upstream crest of Dam #1 (Figure 1). Sample recovery from GT7 was generally good over the borehole except in the wet till below the peat. Recovered soils did not contain permafrost and the hole was dry at the bottom at the time of drilling, with refusal in bedrock. A monitoring well and a thermistor cable were installed at this location.
