**KENO HILL PROPERTY**  
**VALLEY TAILINGS REVEGETATION ASSESSMENT**  
**2008**

**DRAFT**  
**JANUARY 2008**

# Valley Tailings Revegetation Assessment - Elsa Silver Mine

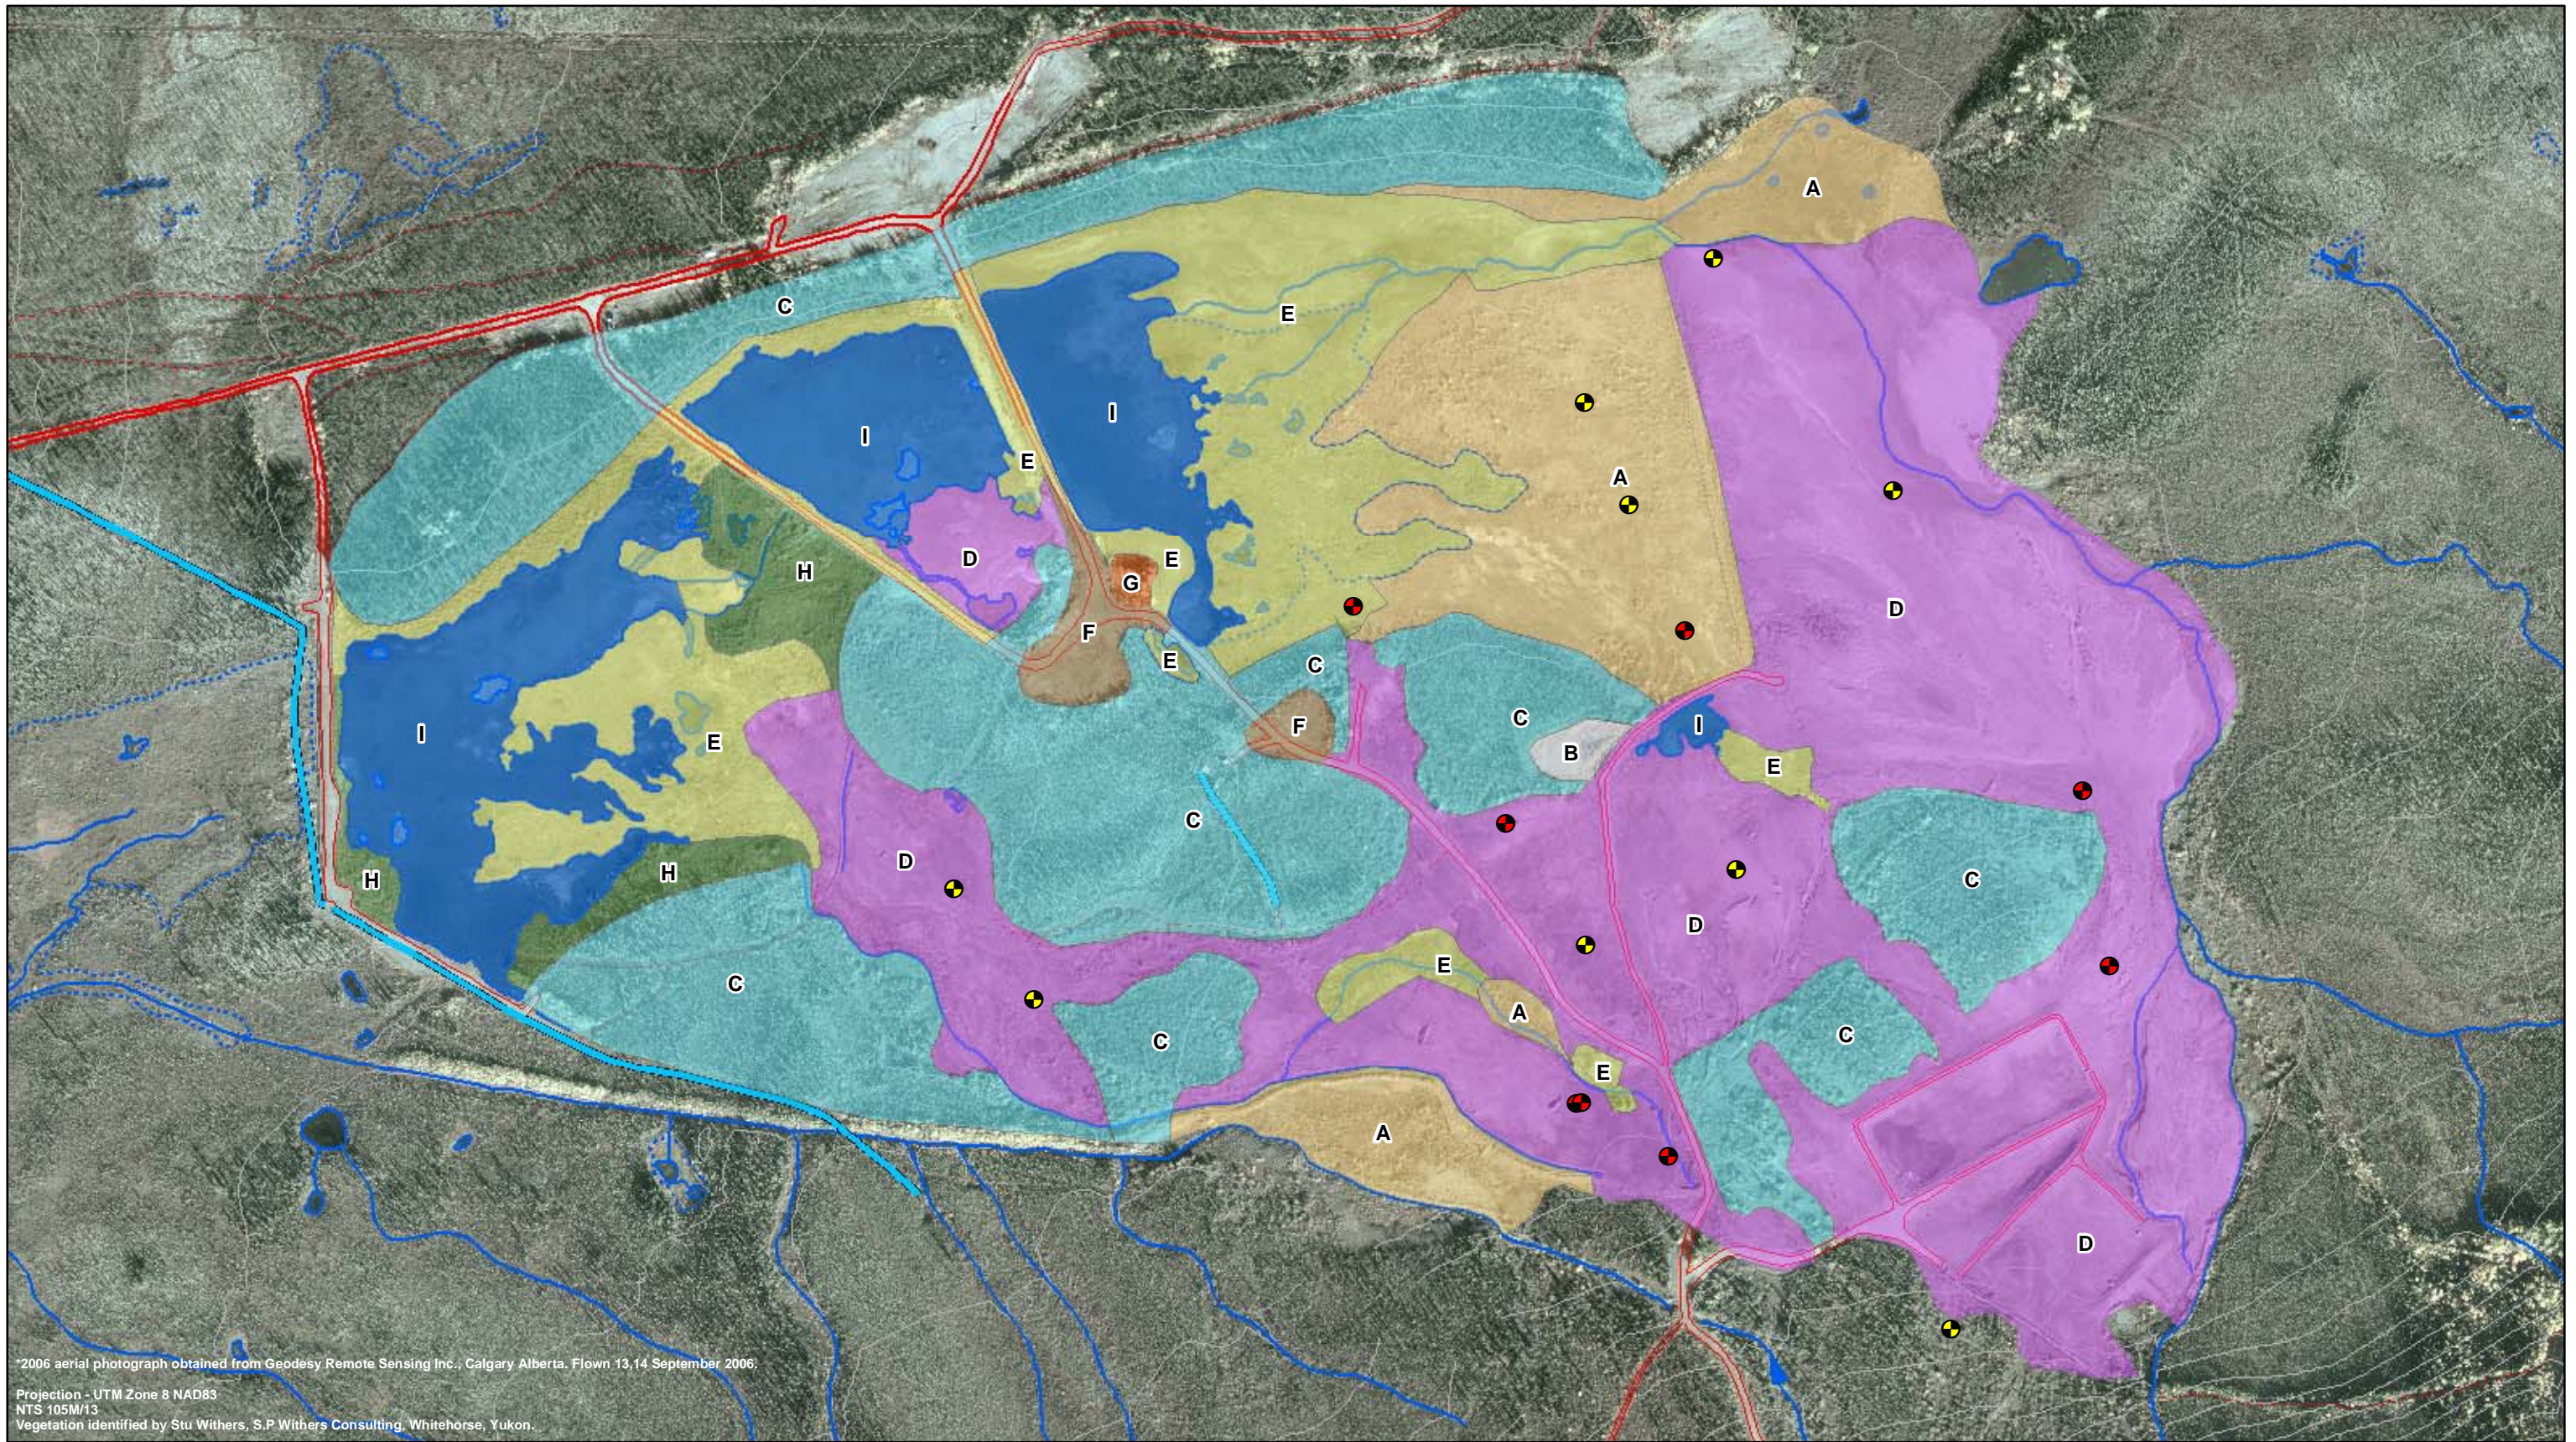
**VALLEY TAILINGS VEGETATION TYPES**

The following vegetation types were observed on the valley tailings during the 2007 assessment (the approximate extent of each vegetation type is delineated on the accompanying aerial photograph):

These barren areas are void of vegetation. Some of these areas are higher dry ground while other areas are seasonally flooded.

Of the ha of current tailings impoundment, approximately ha remain almost void of vegetation (see areas delineated as Barren on attached air photo). These barren zones include sections of both the east and west tailings areas. In order to resume efforts to revegetate these areas, while benefiting from the insight gained from the earlier field trials, the following steps are recommended:

The results of these analyses should help characterize the current state of the impounded tailings. The results may also shed some light on why there is no vegetative growth on the barren areas of the tailings, Vegetation Type D (Barren) on the air photo, compared to the areas where natural revegetation is occurring, particularly Vegetation Type A (Willow Regeneration).

- A field survey of the unvegetated area of the tailings should include (at a minimum) a series of transects with in-situ measurements of soil pH and moisture content at rooting depths (2-10 cm) and an examination of the current surface penetrability.

- If the character of the unvegetated tailings has not altered significantly since the field trials of the early 1980's, experimentation with soil caps should commence. This could include the establishment of test plots with differing thicknesses granular material and soil, followed by applications fertilizers and seed mixes.
