KENO HILL PROPERTY

PHYSICAL HAZARD REDUCTION PROGRAM

2007

February 2008

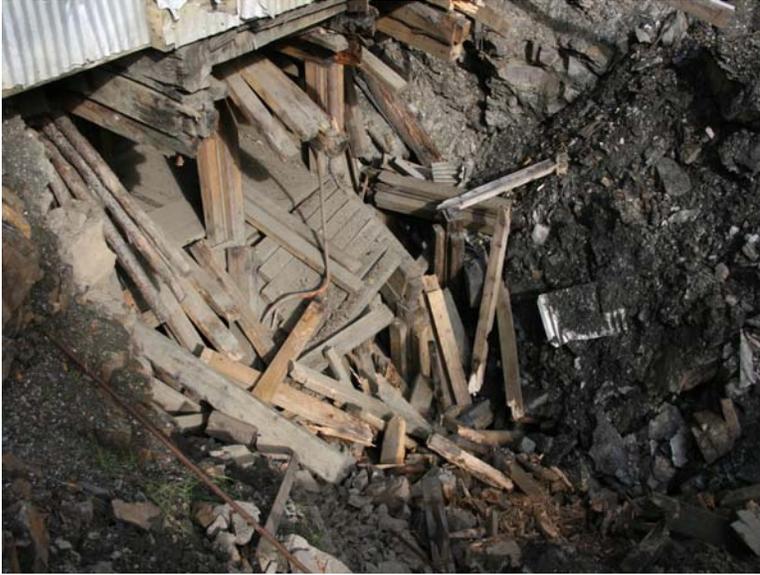
Plate 1: Ruby Shafthouse - Before

At the Ruby location, it was identified that the "Ruby shaft area has collapsed on skip; area in front of house has failed also; shaft house accessible" (field notes from personnel on site). As well, a smaller shaft approximately 5 meters deep was exposed. A Hitachi 270 excavator was used to remove debris and timber. Material from the adjoining waste dump at the Birmingham pit was used to backfill and seal the shafts. The remediation for this shaft followed the SRK general backfilling guidelines (see Appendix B), which consisted of filling the shaft with

adequately sized material that would compact enough to lessen the likelihood a future subsidence over the shaft. The building material was burned and the remaining metal debris was loaded and transported to the approved commercial dump site at Elsa. A burn permit was secured prior to burning the remnant building. In the summer of 2008 the larger shaft will be visited for additional work as sinking is likely to occur. Refer to Appendix C, Plate 1 and 2, for photo documentation of remedial works on Ruby Shafthouse.

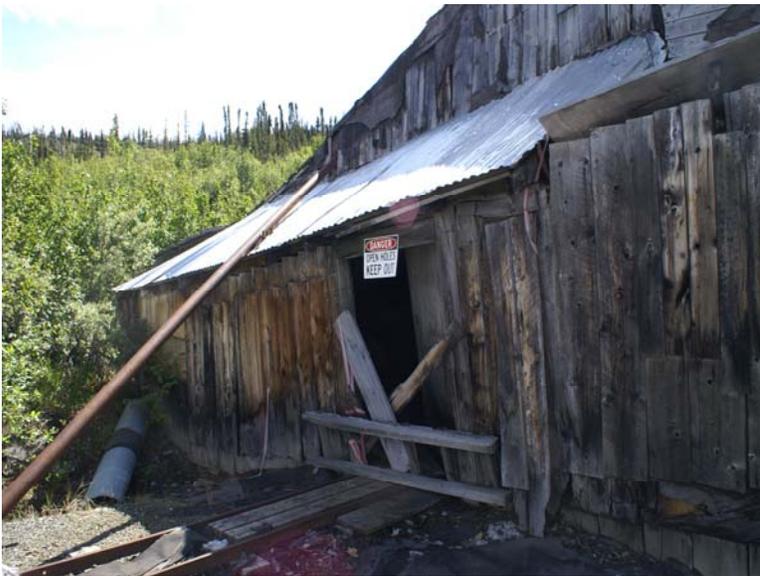
Plate 3: Brefalt Shafthouse - Before

No Cash 500 adit inaccessible	ACG Site Characterization	Low	Occasional	Possible	1	Low		
				Brefalt shafthouse is accessible	PWGSC Baseline Assessment	Critical	Occasional	Possible	100	Extreme	Secured doors and windows with 10 cm wire mesh.	✓
				Garage accessible.	PWGSC Baseline Assessment	Low	Occasional	Possible	1	Low		
				Lunch Room accessible.	PWGSC Baseline Assessment	Low	Occasional	Possible	1	Low		
8	Betty	Old trailheads extend northeast from the No Cash mine towards the Betty mine site.	479251E, 7088632N	One shaft collapsed due to permafrost; retaining approximately 1ft of water.	ACG 2006 Site Inspection	Low	Remote	Rare	0.01	Low		
9	Hector Calumet	Located on the northwest slope of Galena Hill, on the Calumet Road.	480900E, 7088300N	Underground opening present in west corner.	SRK 2005 Site Inspection	Critical	Occasional	Possible	100	Extreme	excavated and backfilled	✓
				Other concern would be berming the open pits and wall failure in some areas.	SRK 2005 Site Inspection	Critical	Occasional	Possible	100	Extreme

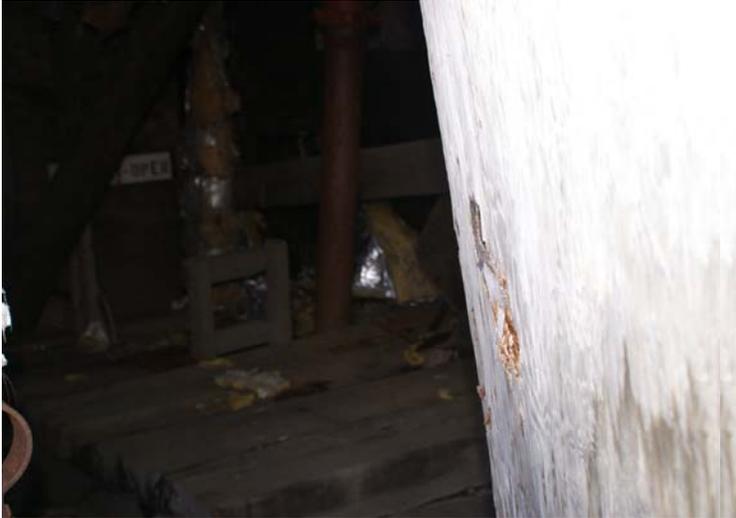
Plate 5: No Cash 100- Before

Adit level 100 at No Cash had partially collapsed causing an “extreme” physical hazard description on the risk registry. Excess wire was resting on the ground causing a hazard to humans and wildlife alike. The adit was cleaned of old timber and debris and backfilled with rock as per SRK specifications (Appendix B). The large rock was covered with topsoil and duff to cover the disturbed area. Wire was collected, cut and removed from the site. Windows and doors were secured with 10 cm wire mesh to prevent access into the Brefalt Shafthouse. Refer to Appendix C, Plate 3 and 4, for photo documentation of remedial works on Brefalt Shafthouse and Plate 5 and 6, for photo documentation of remedial works on No Cash 100.

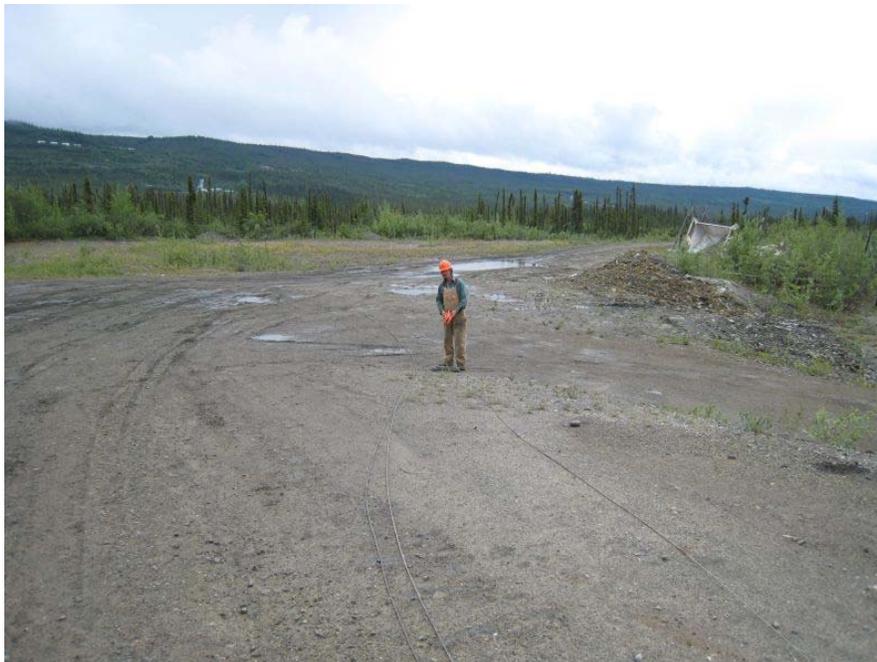
Picture of personnel hand rolling wire in the Tailings Dam Area

Work around the tailings area dam began on June 25th. Short lengths of both telephone and power cable were scattered in this area. This wire was hand rolled because of the location, and relatively short length of the various wire strands. All hardware associated with this cleanup was deposited in the wire lay down area. Approximately 2 km of wire was recovered from this area. Cleanup of this area took a total of 87.5 man hrs to complete.

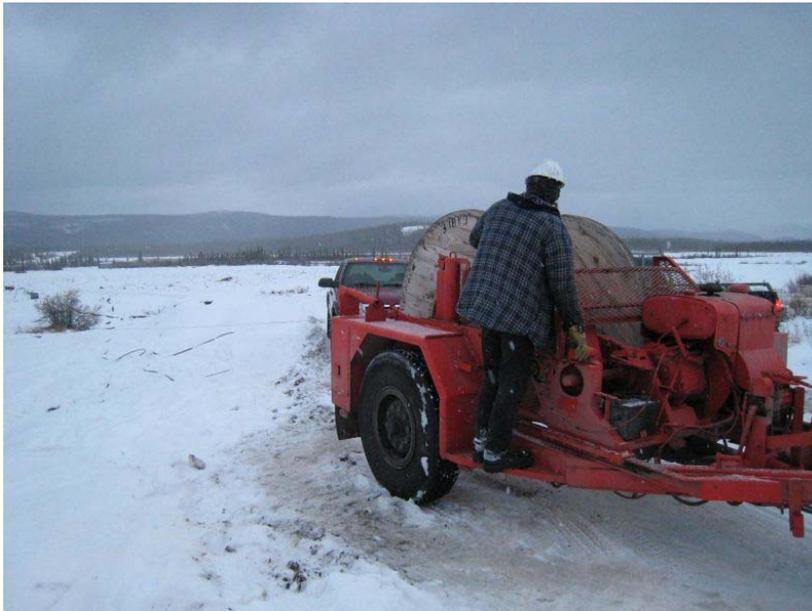
Photo of personnel operating wire spooler in the Framing Yard to Tailings Area section

A crew of 2-3 labours worked on this line. Any remaining standing poles were cut, the wire and all hardware was removed from the poles. All hardware was stored in the wire lay down area. The wire was then freed from any underlying brush and to ready the line for rolling. This portion of the project took approximately 222 man hrs to complete.

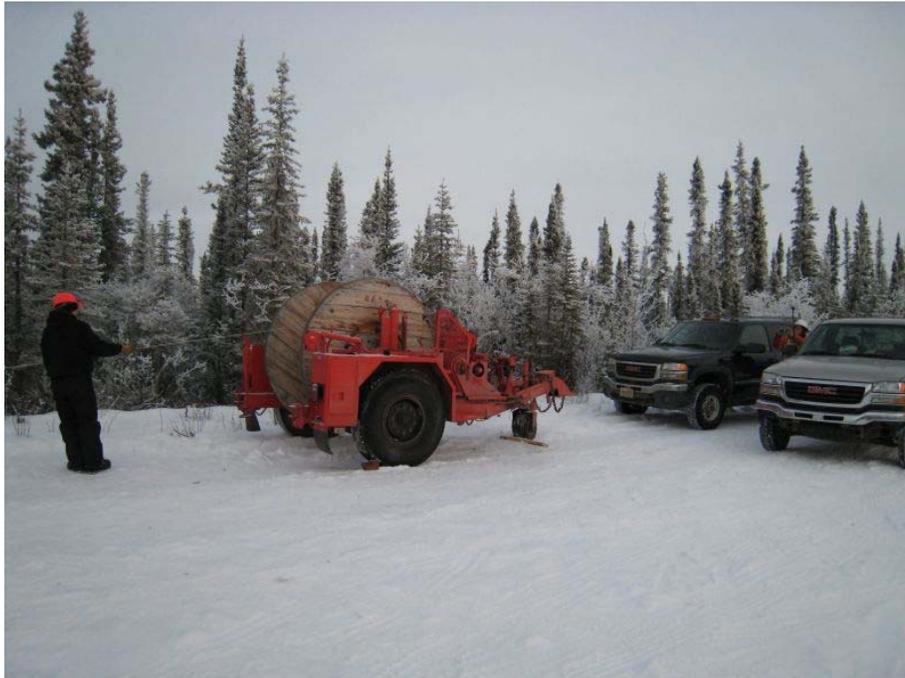
Labourer helping to feed line onto wire spooler in the Tailings to McQuesten River Area.

Wire rolling commenced from the Framing Yard to McQuesten River on October 31st. One labourer and one equipment operator rolled the freed wire onto a spool and stored the spool in the wire lay down area. Approximately 15 km of steel core aluminum power cable was rolled during this time. This portion of the project took an estimated 265 man hrs with 3 wks rental of a wire spooler and 7 hrs of other equipment time.
