**Subject: 2008 Annual Tailings Facility Inspection
United Keno Hill Mines Property, Elsa, YT.**

TAILINGS FACILITY INSPECTION - AUGUST 2008
 UNITED KENO HILL MINES - ELSA, YT

2008 SUMMARY OF INSPECTION NOTES AND DETAILS OF RECOMMENDED REPAIRS

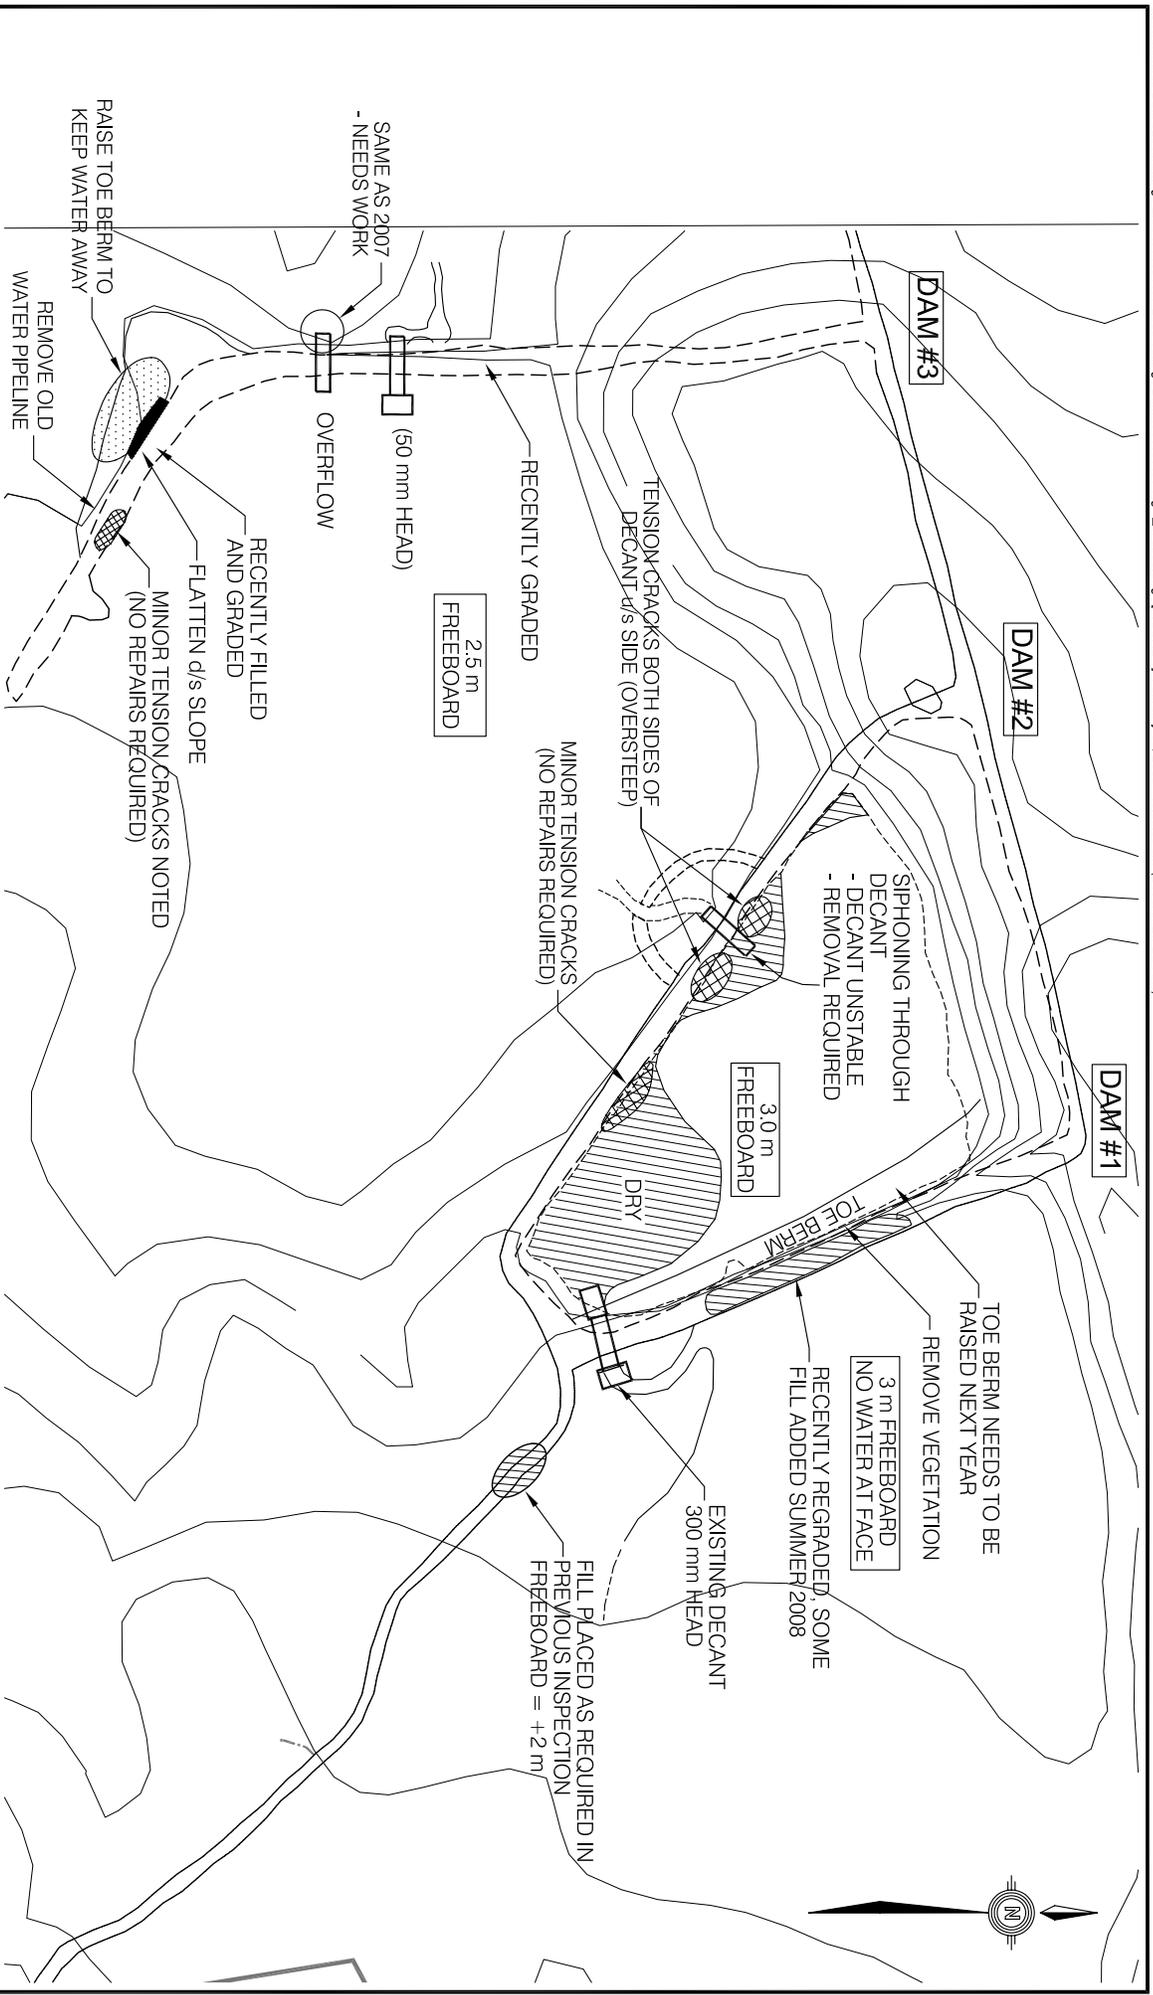
Figure 1

- LEGEND**
- PERMAFROST THAW SETTLEMENT AREAS REQUIRING FILL
 - TENSION CRACK AREAS

The downstream toe berm will require some work next summer to repair the effects of on-going settlement. As noted on Figure 1, all woody vegetation should be removed, and free-draining granular fill added to raise the surface of the toe berm to a constant elevation of approximately 1/3 of the dam height, per the original design intent. Fill used to raise the downstream toe berm should consist of free-draining granular material, similar to that used in the original construction. After the vegetation must be removed, the surface should be scarified to about 150 mm depth, and new fill added in maximum lift thicknesses of 300 mm, with each lift compacted using available equipment. The surface of the new toe berm should be surveyed and constructed as level as possible, to assist in future monitoring.

1. The ponded water on the downstream side of the south leg of the dam has created permafrost thaw settlement, resulting in oversteep downstream slopes. This area (see Figure 1) requires the placement of additional granular fill to displace water away from the toe, and to buttress the slope.
2. The “old” water pipeline (see Photo 3) along the downstream crest of the dam must be removed to facilitate inspection and maintenance work.
3. The existing overflow pipe is too short, and discharges onto the downstream face (see Photo 4). The pipe should be lengthened by about 2.0 m, the area around the discharge backfilled to create a uniform dam width, and the outlet of the pipe provided with riprap protection.

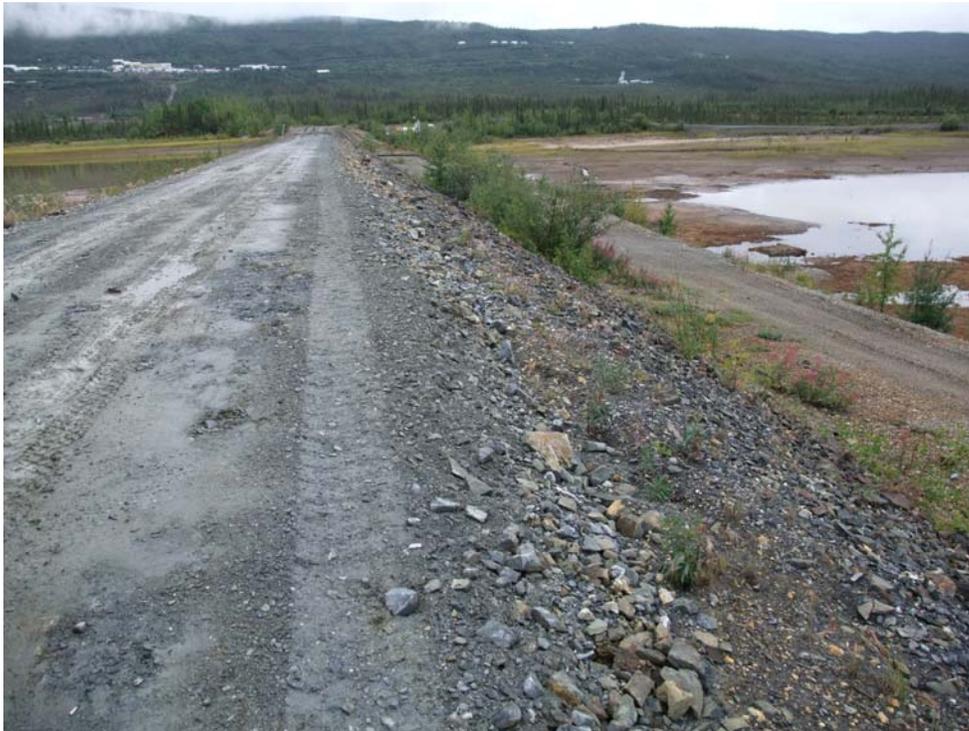
At the time of the inspection, Pond 1 was noted to have a minimum 3.0 m freeboard, with no standing water at the face. The dam crest had been recently graded and was in reasonably good shape with no observed slumps, significant settlements, or tension cracks (see Photo 1). Adequate

riprap had been placed as recommended after the 2007 inspection. No active seepage zones were observed on the downstream slope of the dam.

Photo 1: Dam #1 showing vegetation to be removed, and toe berm requiring additional fill (August 5/08)

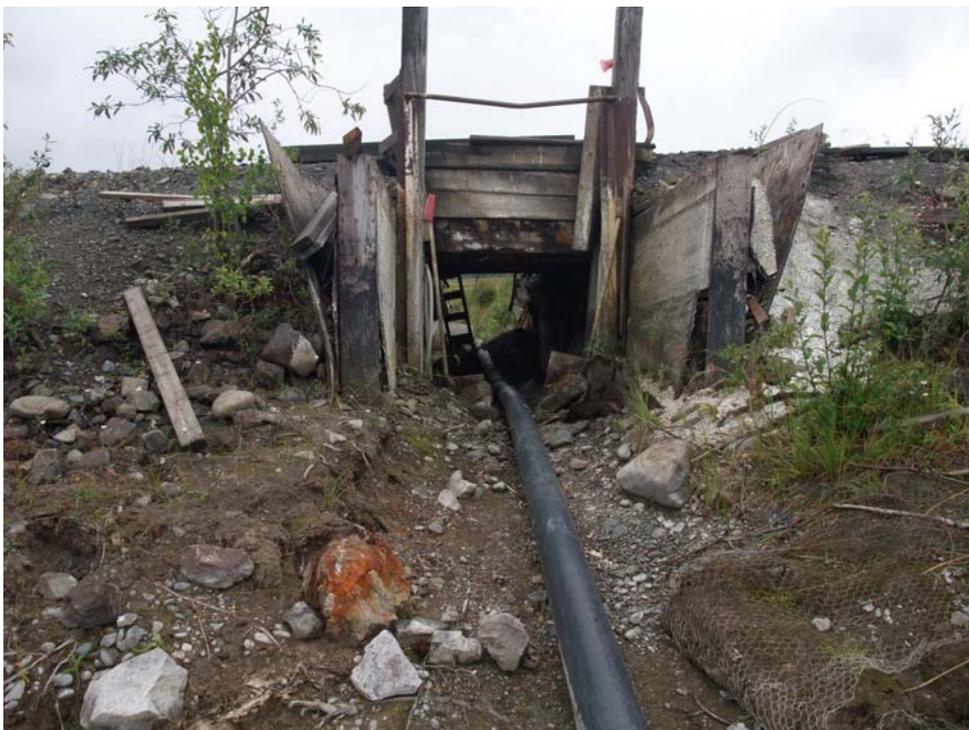
Photo 2: Decant through Dam #2 requiring immediate removal (August 5/08)

The existing wooden decant (see Photo 2) through Dam #2 must be replaced as it is a safety hazard. When it is removed, consideration should be given to significantly lowering the invert to provide a better drawdown of Pond 2.

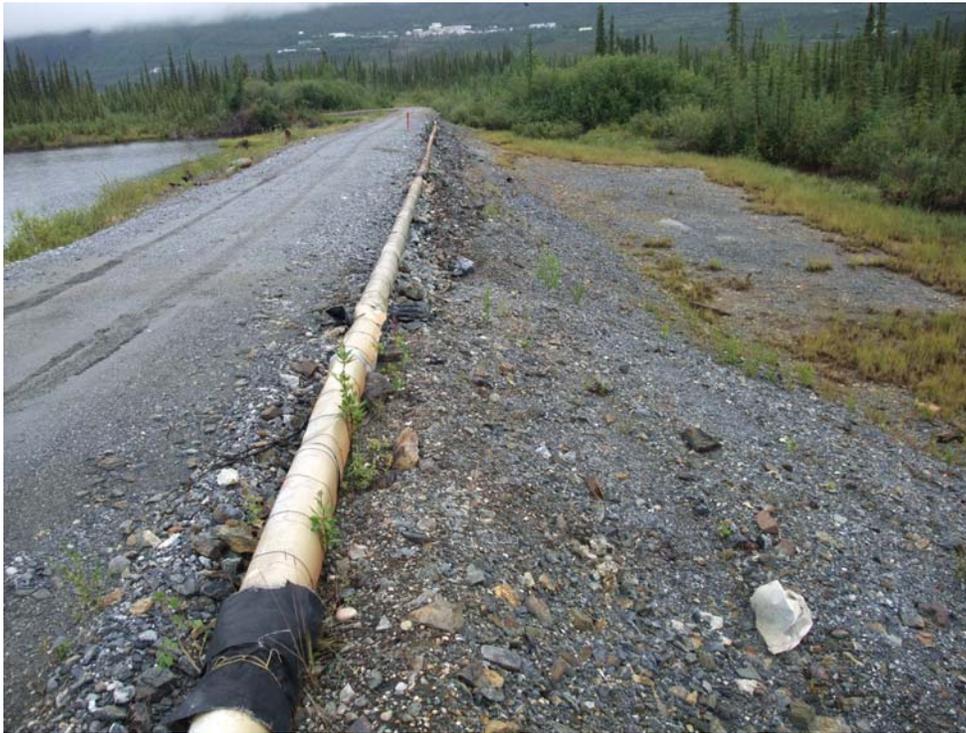
Photo 3: Dam #3 – water line to be removed, view towards area requiring additional fill on downstream side – see Figure 1 for location (August 5/08)

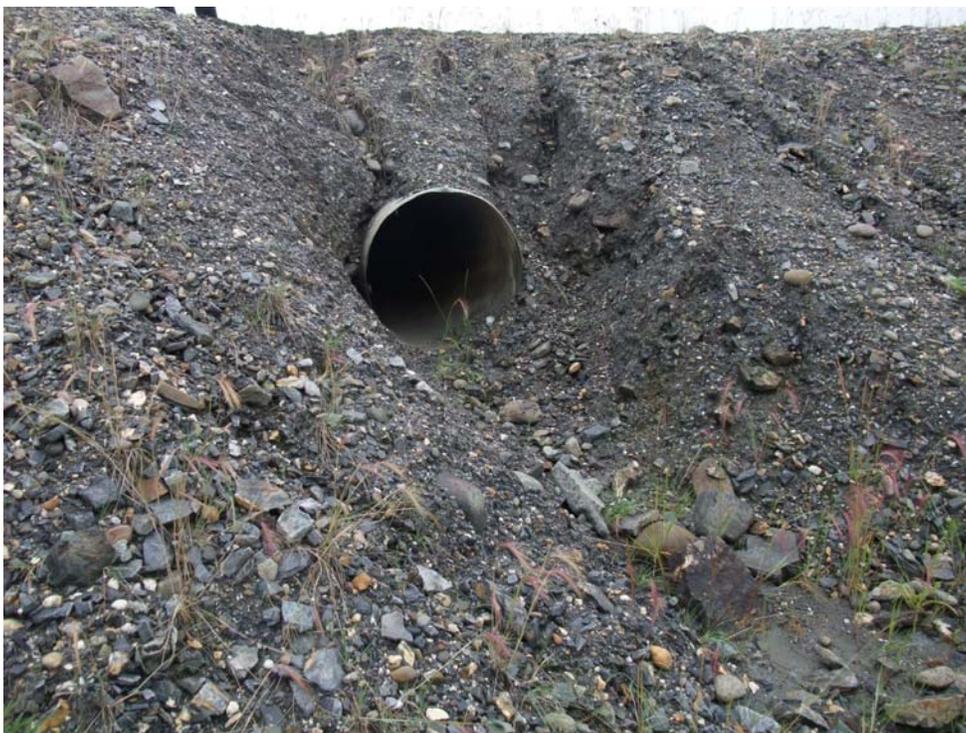
Photo 4: Pond #3 overflow requiring culvert extension and proper riprap around the outlet (August 5/08)
