**Memo To:** Rob McIntyre, R.E.T, Access Consulting Group

**Date:** June 29, 2004

**Subject: Detonation of Picric Acid Container at Elsa Townsite**

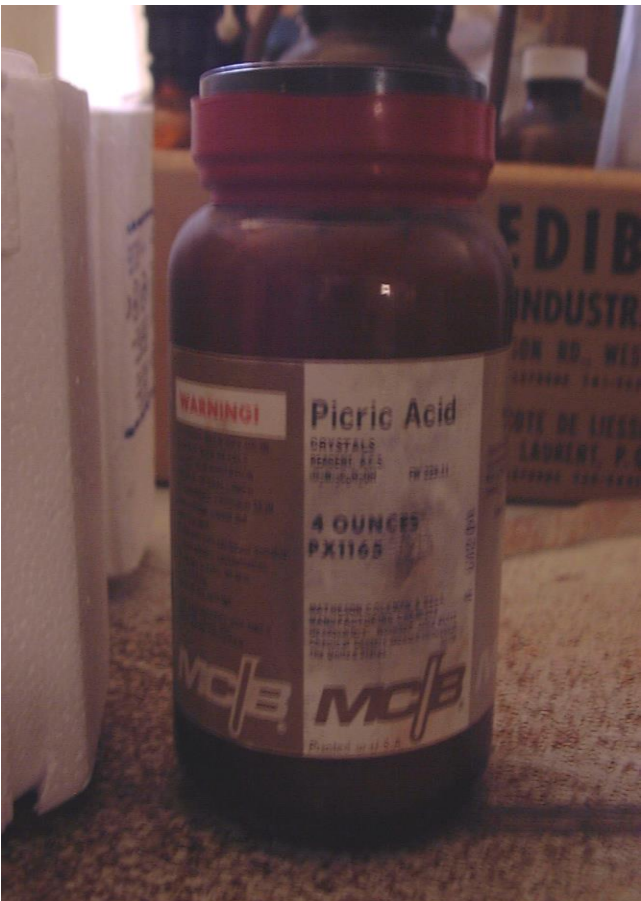
During a preliminary hazardous materials investigation of the Elsa Townsite on May 19<sup>th</sup> by Dan Cornett and Scott Keesey from Access Consulting Group (ACG), Ken Nordin of Laberge Environmental Services (LES) and Glenn Mickie of General Waste, a 4 oz. container of picric acid (trinitrophenol) was identified in the collection of assay chemicals stored in the First Aid building (Fig. 1). A once common assay chemical, picric acid in its liquid state is relatively stable with minimal risk associated with handling and storage. In a dry or desiccated state however, picric acid is highly explosive (TDG Class 1.1) and rapid combustion can be triggered simply by physical or electrostatic shock due to shaking or opening of container. The contents of the container in Elsa were fully desiccated, and as such deemed an immediate priority for disposal.

**Fig. 1 – Container of picric acid (trinitrophenol) in assay lab chemical storage in First Aid building.**

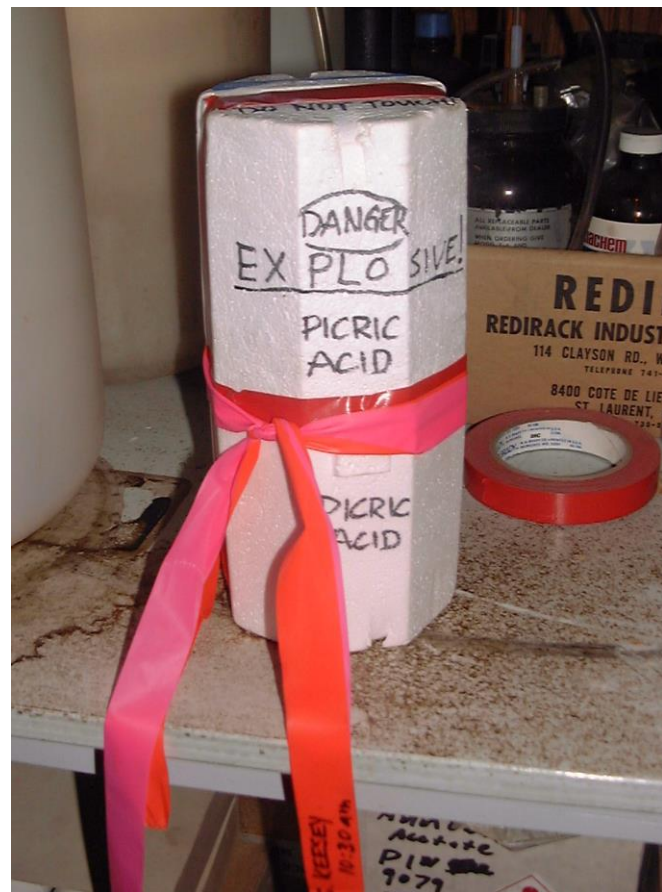
**Fig. 2 – Contained and labelled picric acid container.**

On June 15<sup>th</sup>, Scott Keesey packed and labelled the container in Styrofoam packing and isolated it from the main chemical storage area (Fig. 2 and 3). The item was placed in an empty cupboard that was labelled and signed with warning placards (Fig. 4). The lock on the front entrance was changed and Scott retained the only key. This entrance was also signed with warning placards (Fig. 5) and the site staff was instructed to refrain from entering the building or using heavy machinery in the vicinity of the structure.

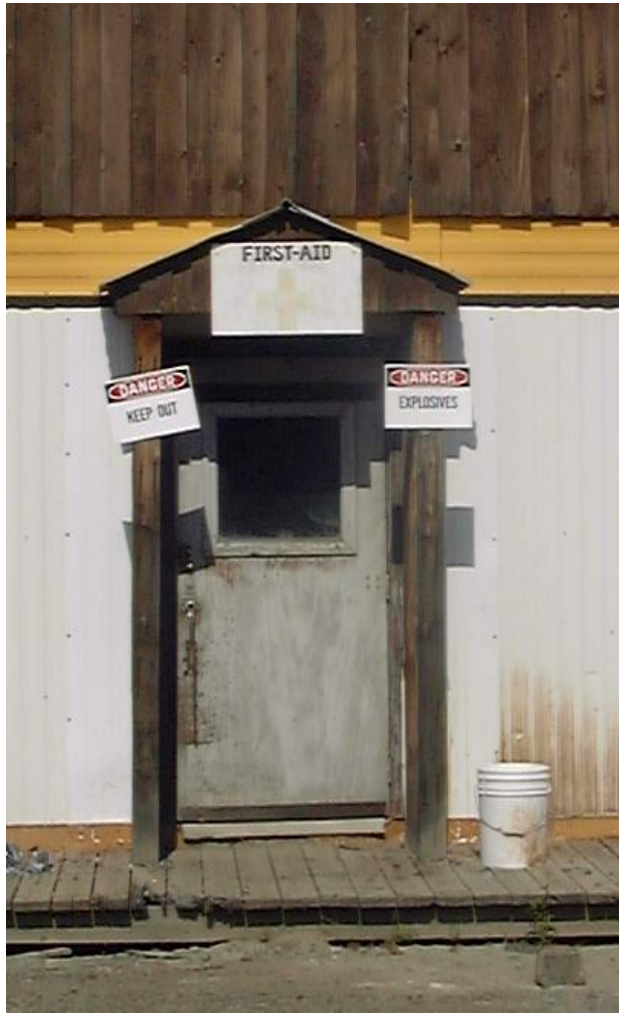
**Fig. 3 – First Aid building at Elsa Townsite, with explosive hazard identified and door locked.**

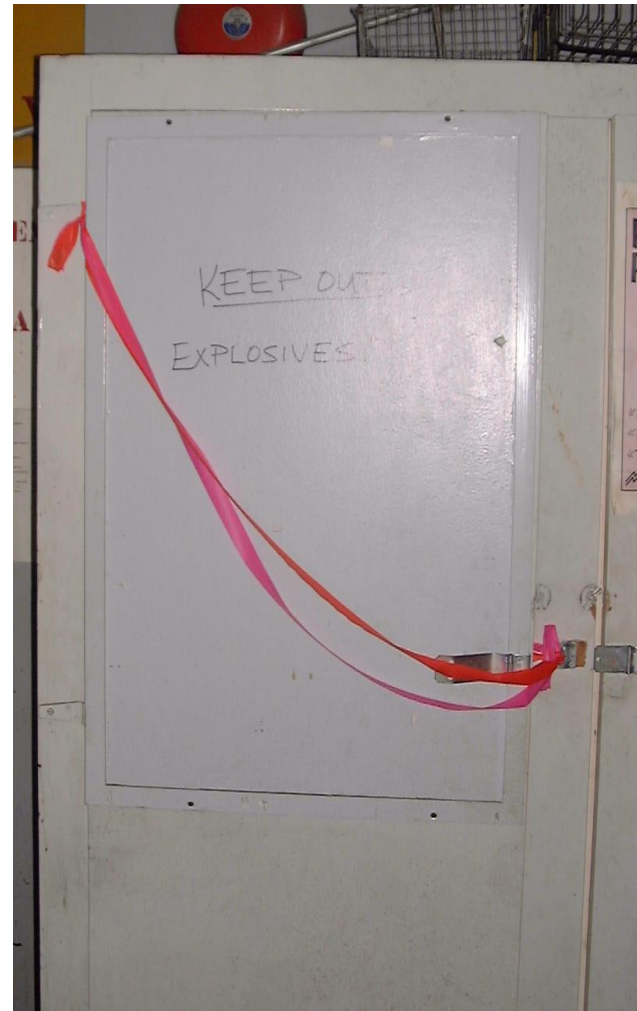
**Fig. 4 – Signed and flagged cabinet in First Aid building containing packaged Picric Acid container.**

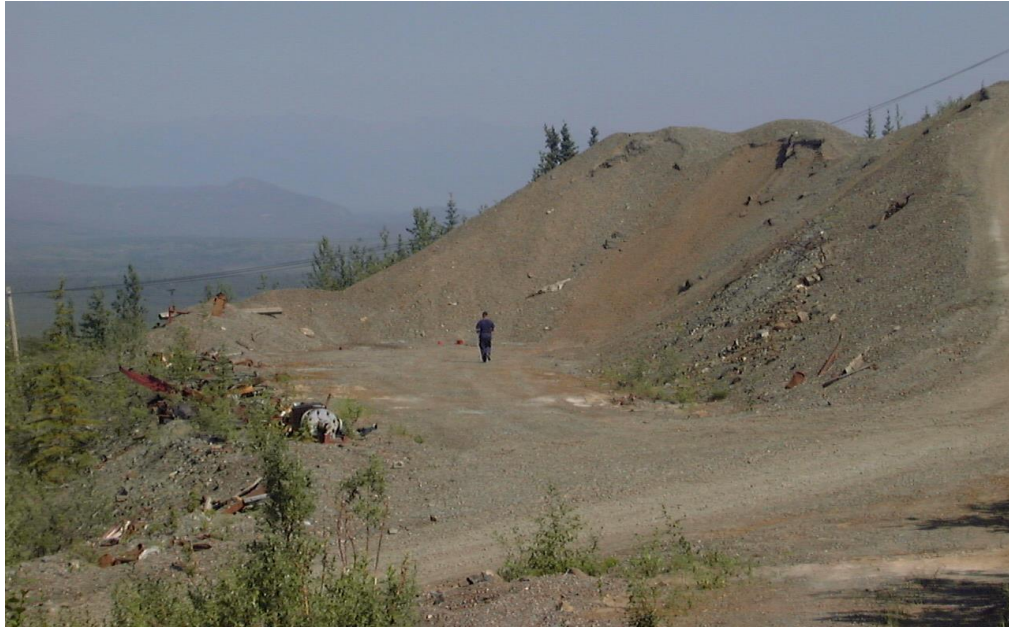
**Fig. 7 – Sgt. R. Fraser walking picric acid container to detonation site.**

The detonation lines were set from the site to a secure location approximately 150 m to the west by Const. Gork. Scott admitted Sgt. Fraser to the First Aid building and returned to the safe detonation site with Const. Bouchard. Sgt. Fraser placed the container in sawdust within a small Rubbermaid tub, and walked it to the detonation site. He opted not to use their bomb suit due to the hot air temperature and the potential for tripping on the steep road down to the site. The container was removed from the Styrofoam packing, doused with a small amount of gasoline as an accelerant and wired with a detonator. Upon detonation the magnitude and colour of the percussion indicated significant volatility, exceeding the expectations of the EDU. The impact residue and depression confirmed the volatile nature of the picric acid. Free traffic movement was reinstated and the stand-by tanker truck was released for resumption of lime slurry transportation.

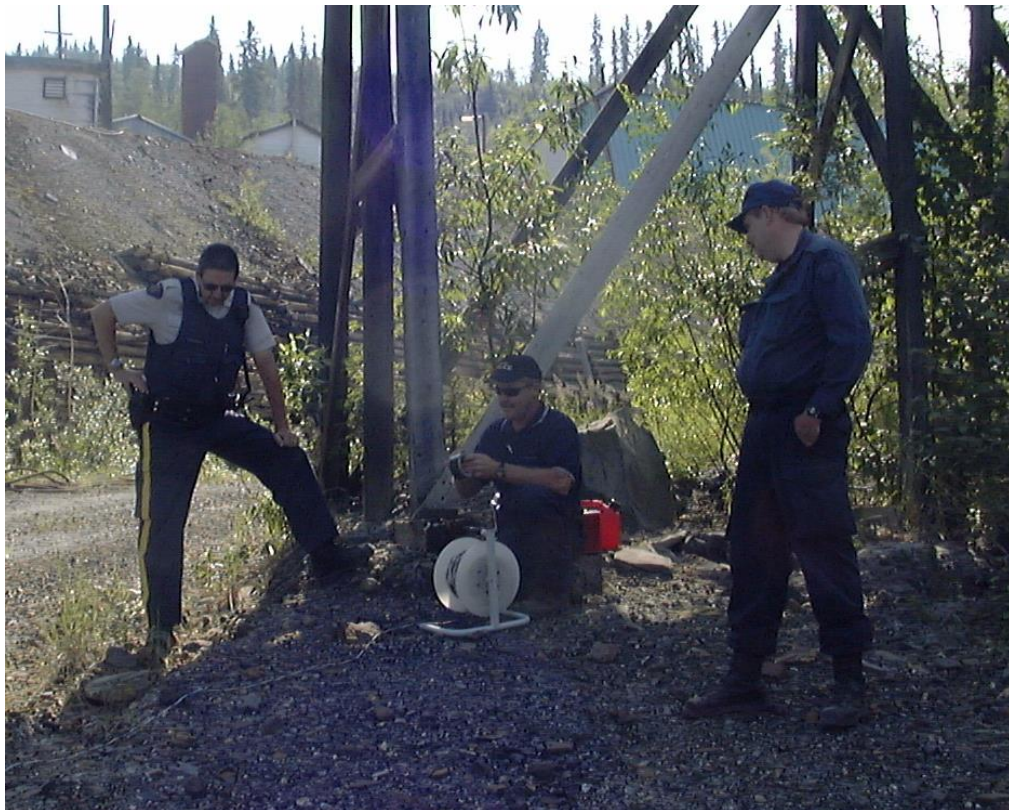
**Fig. 8 – Sgt. R. Fraser preparing detonation wiring.**

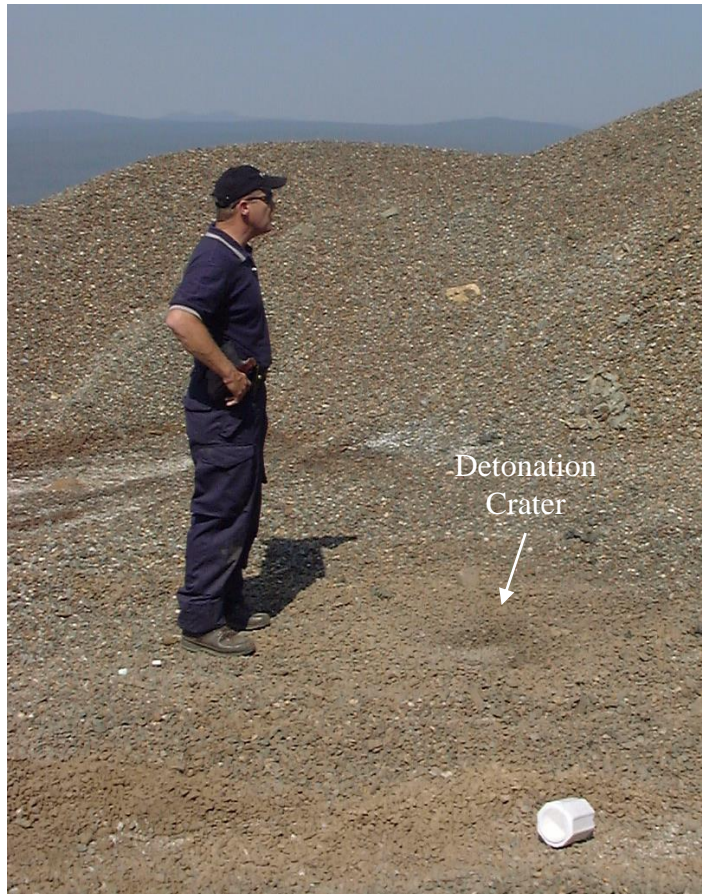
**Fig. 9 – Sgt. R. Fraser inspecting site after detonation.**
