# Faro Mine Care and Maintenance Project Faro, Yukon

## Electrical Assessment Report

28 December 2009

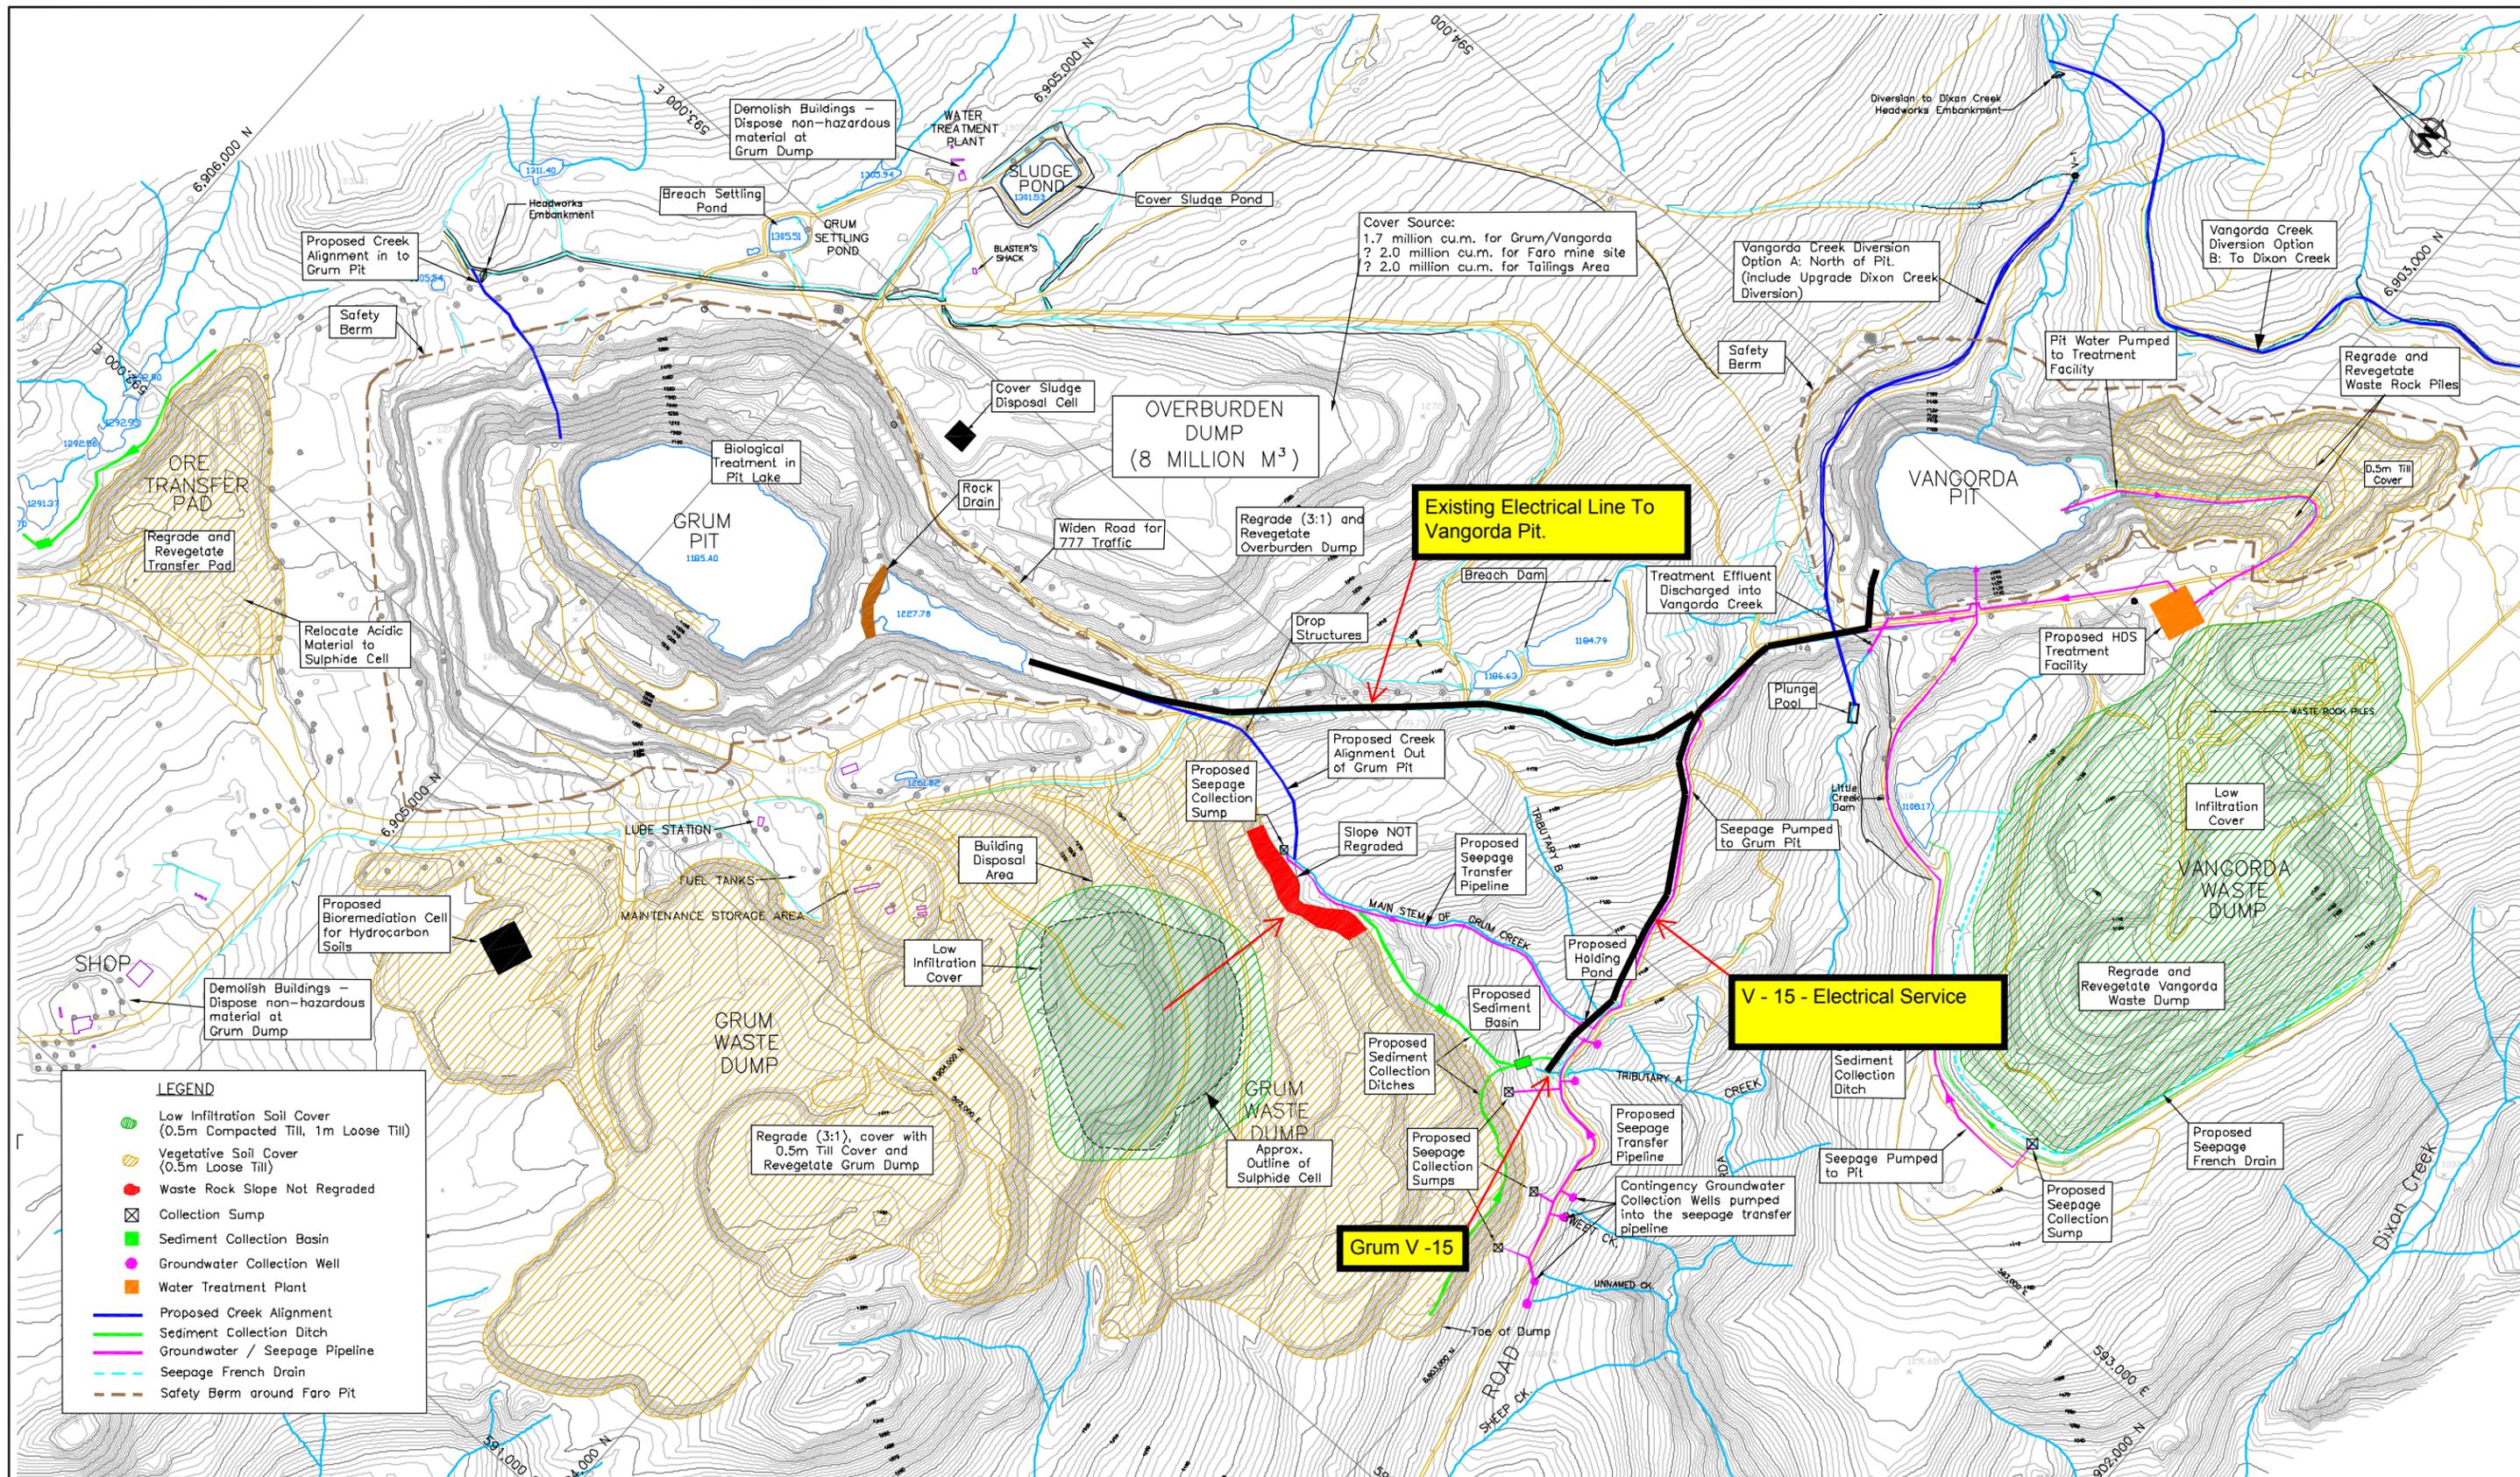
POWER LINE ROUTING

There is currently no power available at this site. It is recommended that 5 kV Grum distribution be extended to this area. HP requirement has not been determined but assuming a #2 conductor there will be capacity in excess of expected requirements.

Proposed routing of the 5 kV line extension is indicated as V-15 Option #1 and Option #2 on the site plan figure 2 Appendix A.

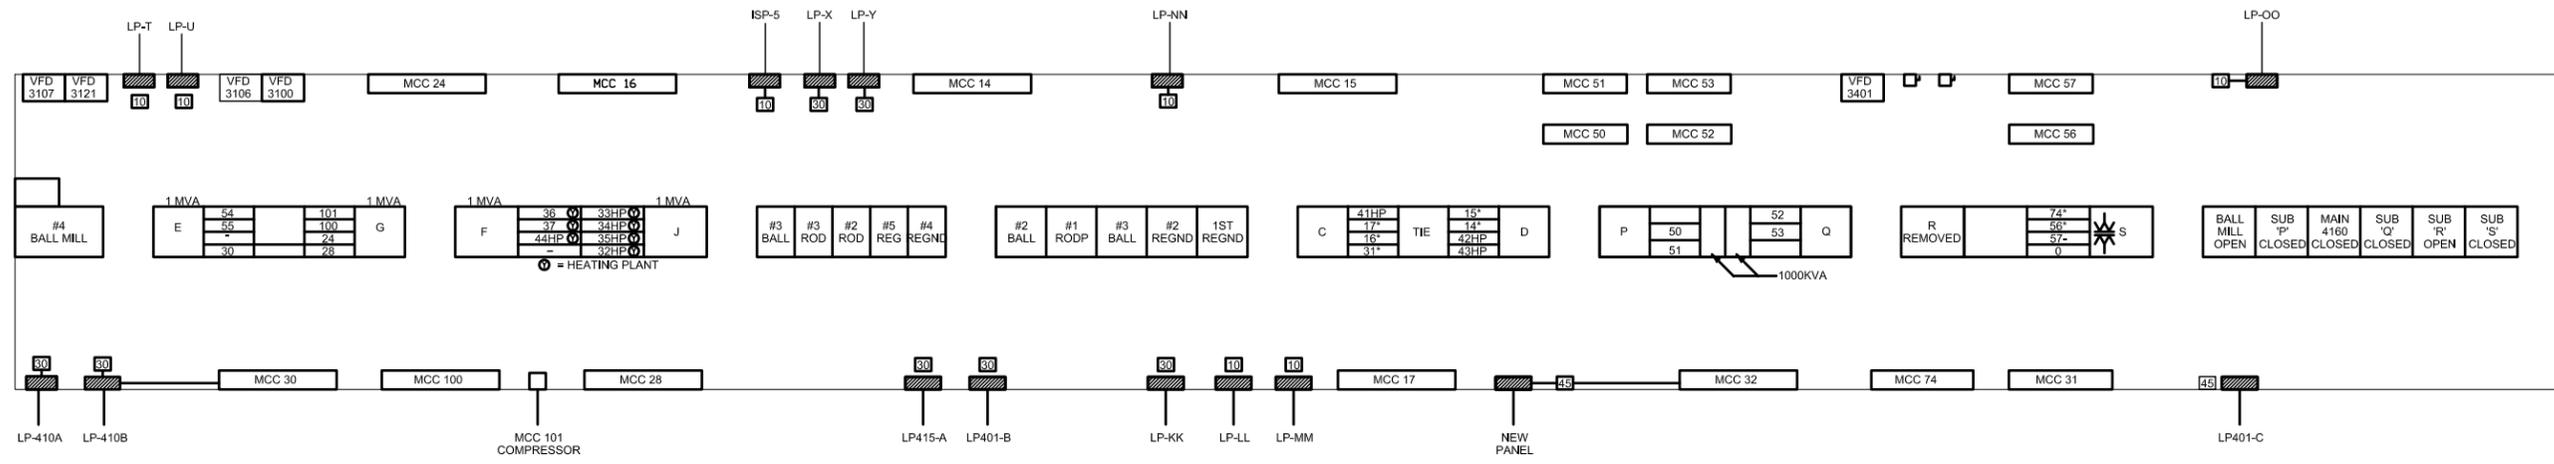
1 MCC ROOM #3  
E1

The mill treatment operation utilizes a small portion of an extensive mill electrical system and there are transformers operating inefficiently under small loads.

In many locations 5 kV substations are energized for the sake of one or two motors or 120/208 panels. Operating this way is inefficient as core losses are a constant regardless of loads.

In order to save energy, simplify operations and improve safety it is recommended that the various Motor Control Centres (MCC's) in use be consolidated and supplied from one or two substations.

As Built layout drawings of the MCC rooms have been prepared and are attached in Appendix "D"
