**REFERENCE No.** 1410944-011-TM-Rev0-2016

**TO** Ms. Carrie Gillis  
Faro Mine Remediation Project

**FARO MINE REMEDIATION PROJECT - SEPTEMBER 2016 SITE VISIT**

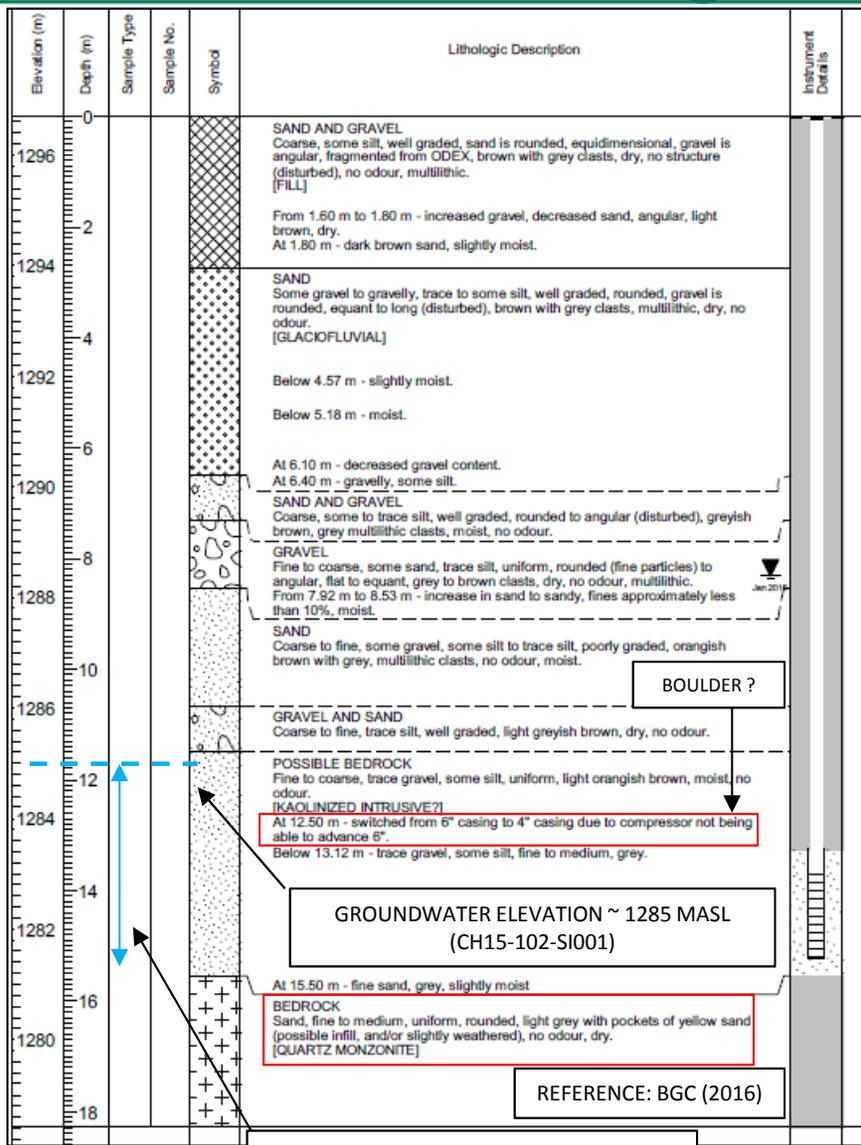
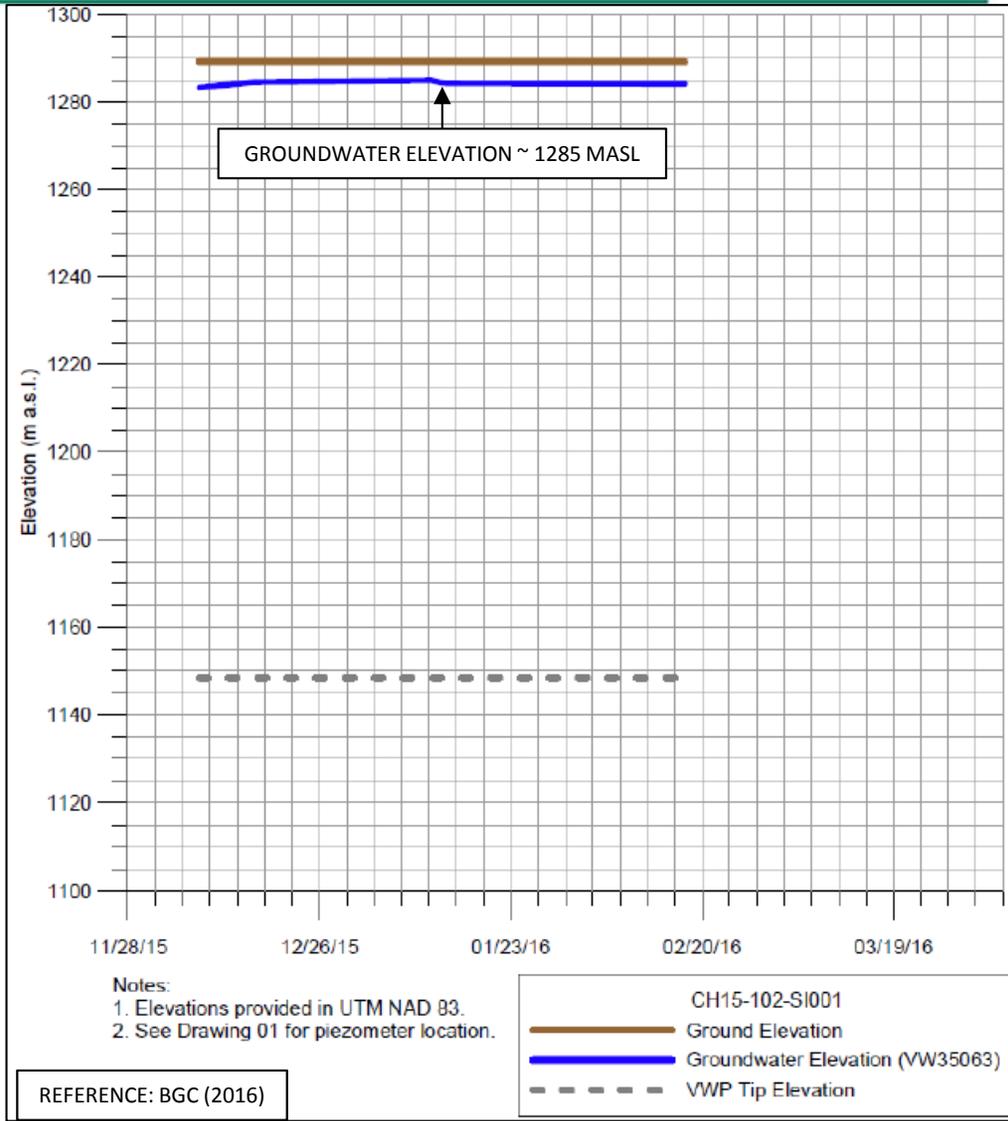
# Overburden Crest Regression Area – Drillhole Log #CH15-102-MW001

**BEDROCK  
~ 12- 16 m  
BELOW  
GROUND  
SURFACE**

**GROUNDWATER ELEVATION ~ 1285 MASL  
(CH15-102-SI001)**

**SEEPAGE ZONE ~ 3.5 m IN HEIGHT**

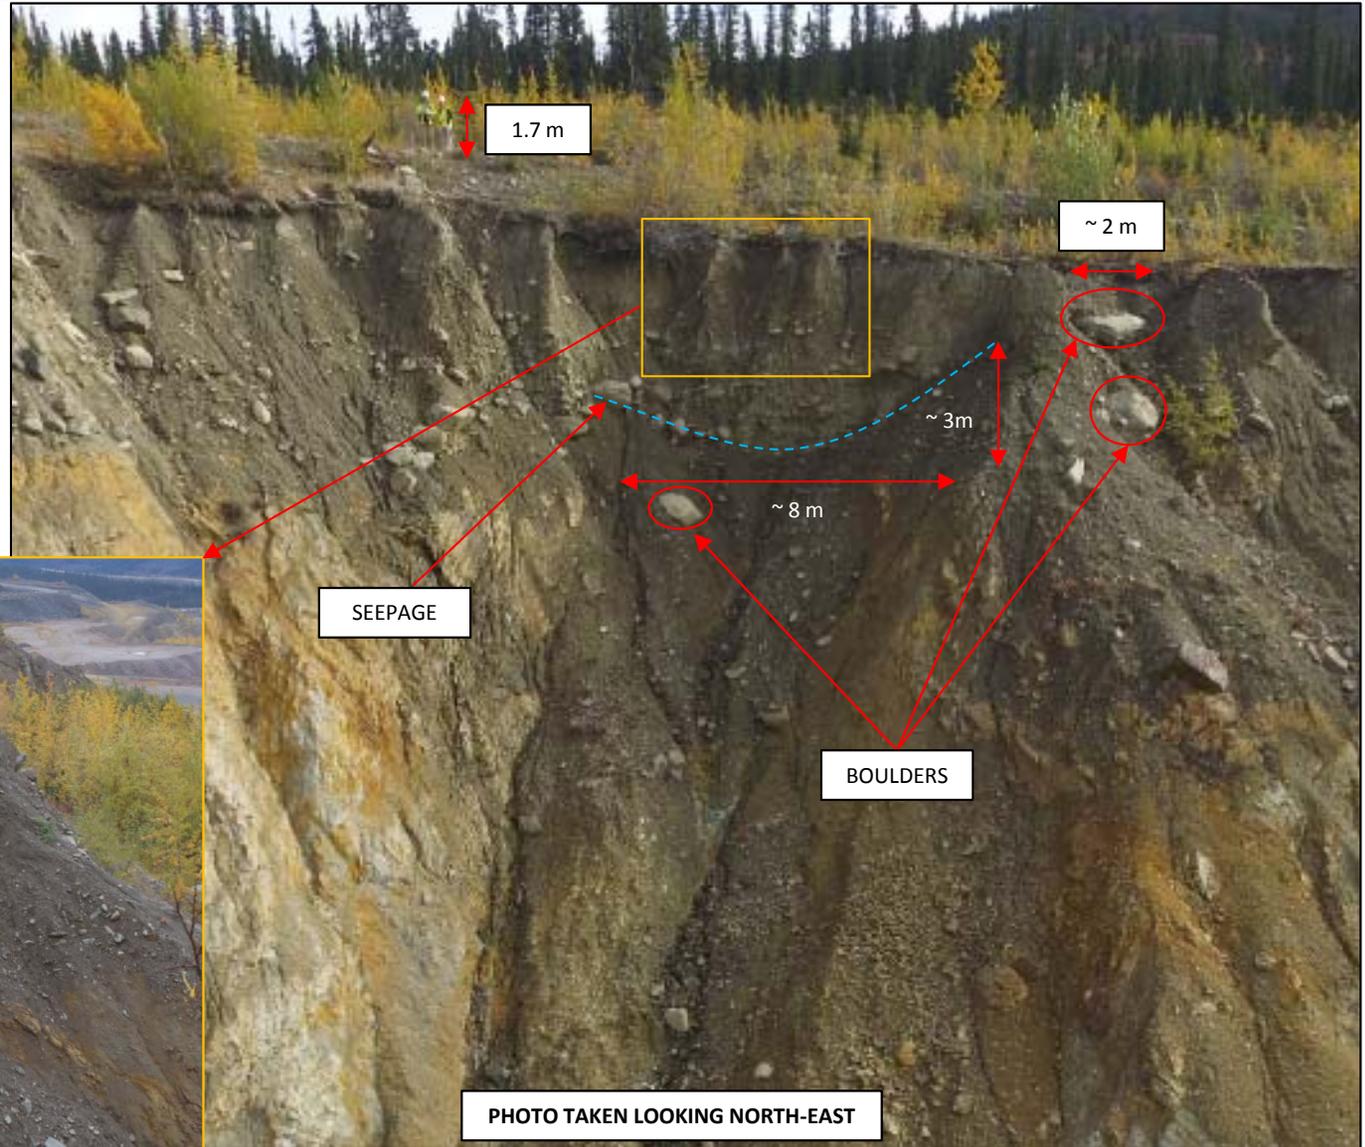
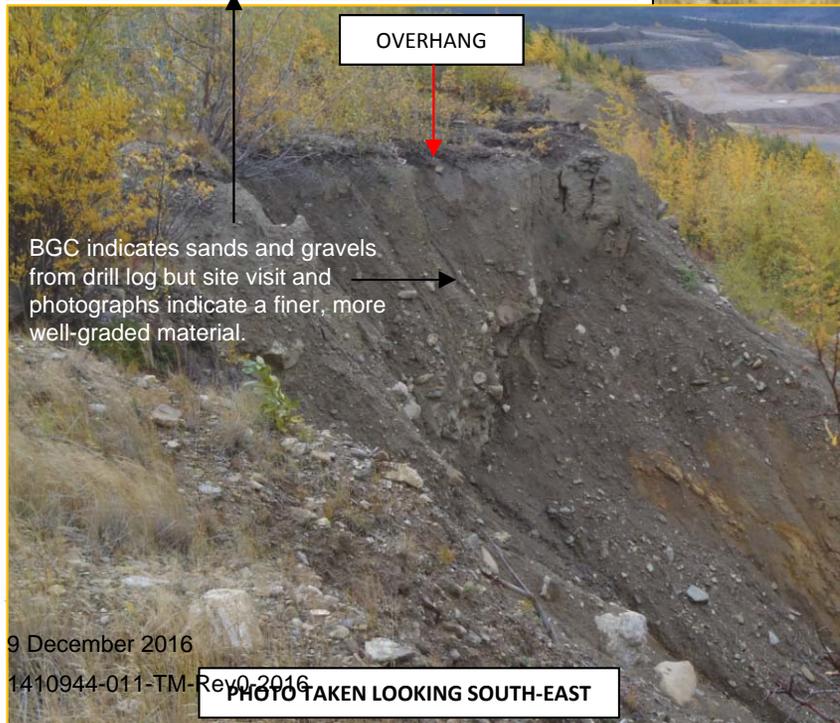
PHOTO TAKEN LOOKING NORTH-EAST

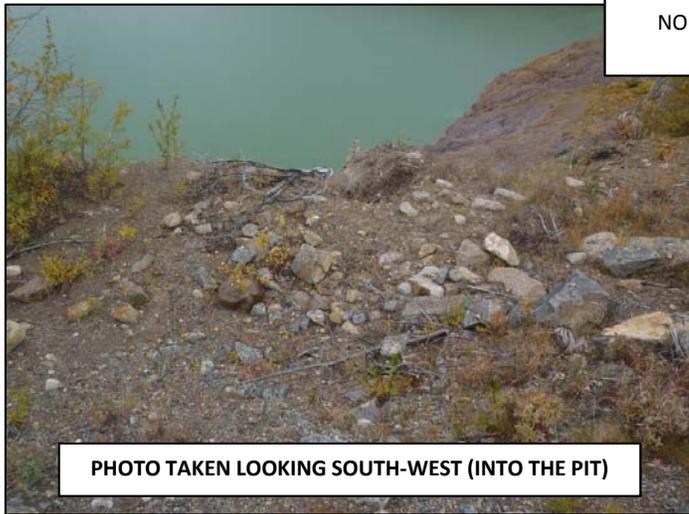
PHOTO TAKEN LOOKING SOUTH-WEST (INTO THE PIT)

NO VISIBLE SIGNS OF INSTABILITY ON SURFACE OF NARROWEST SECTION  
BETWEEN PIT AND FCD – NO CRACKS

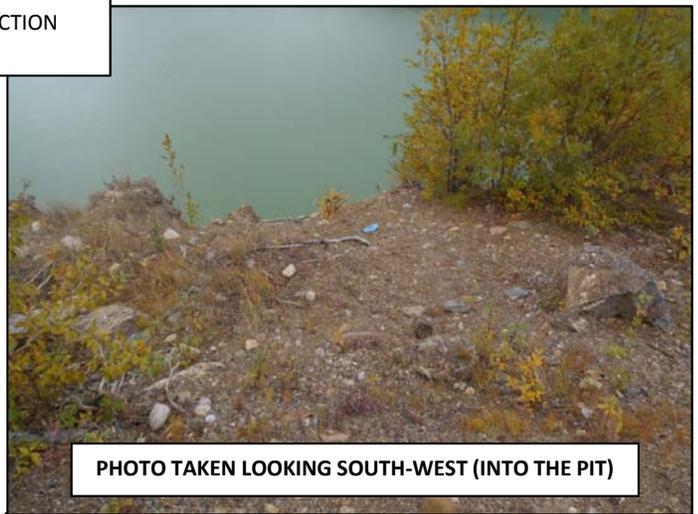
PHOTO TAKEN LOOKING SOUTH-WEST (INTO THE PIT)

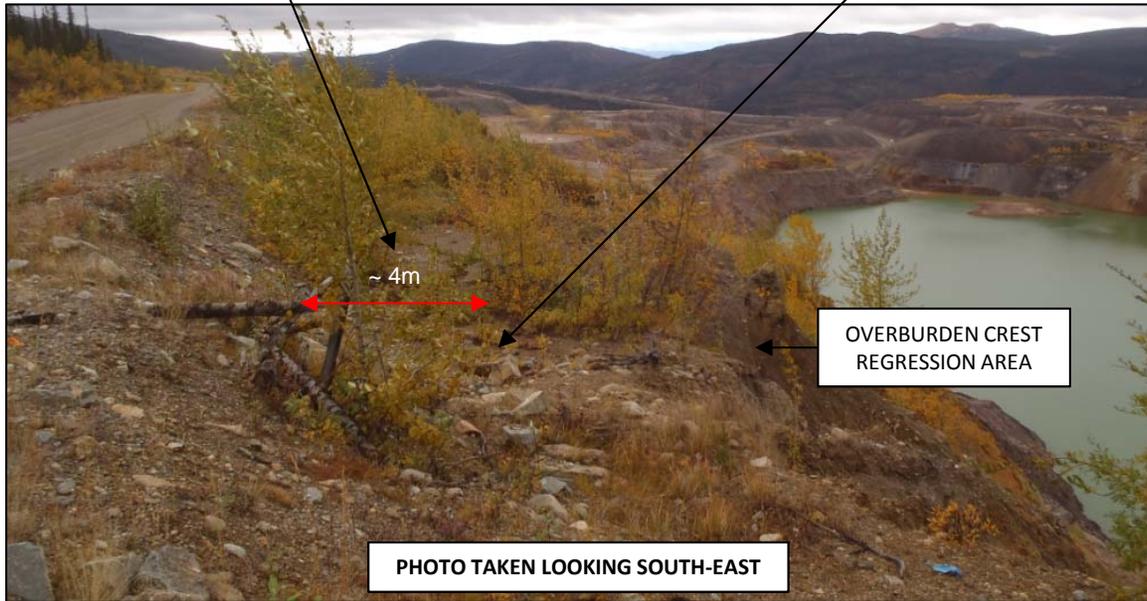
PHOTO TAKEN LOOKING SOUTH-EAST

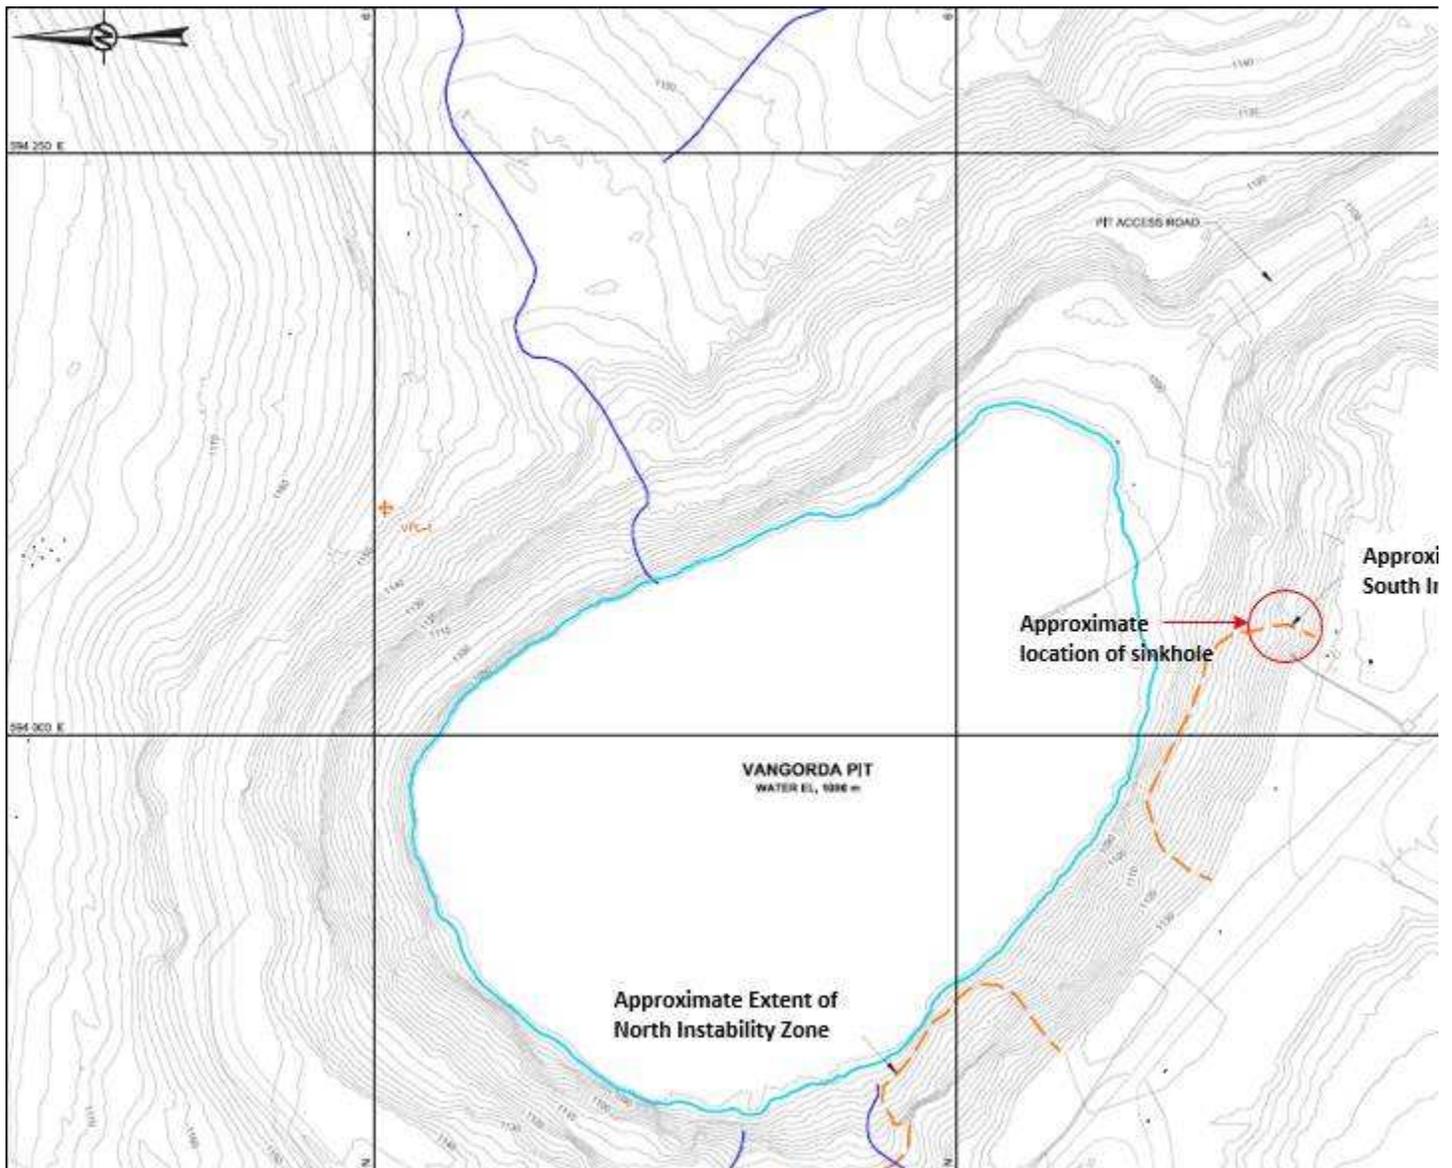
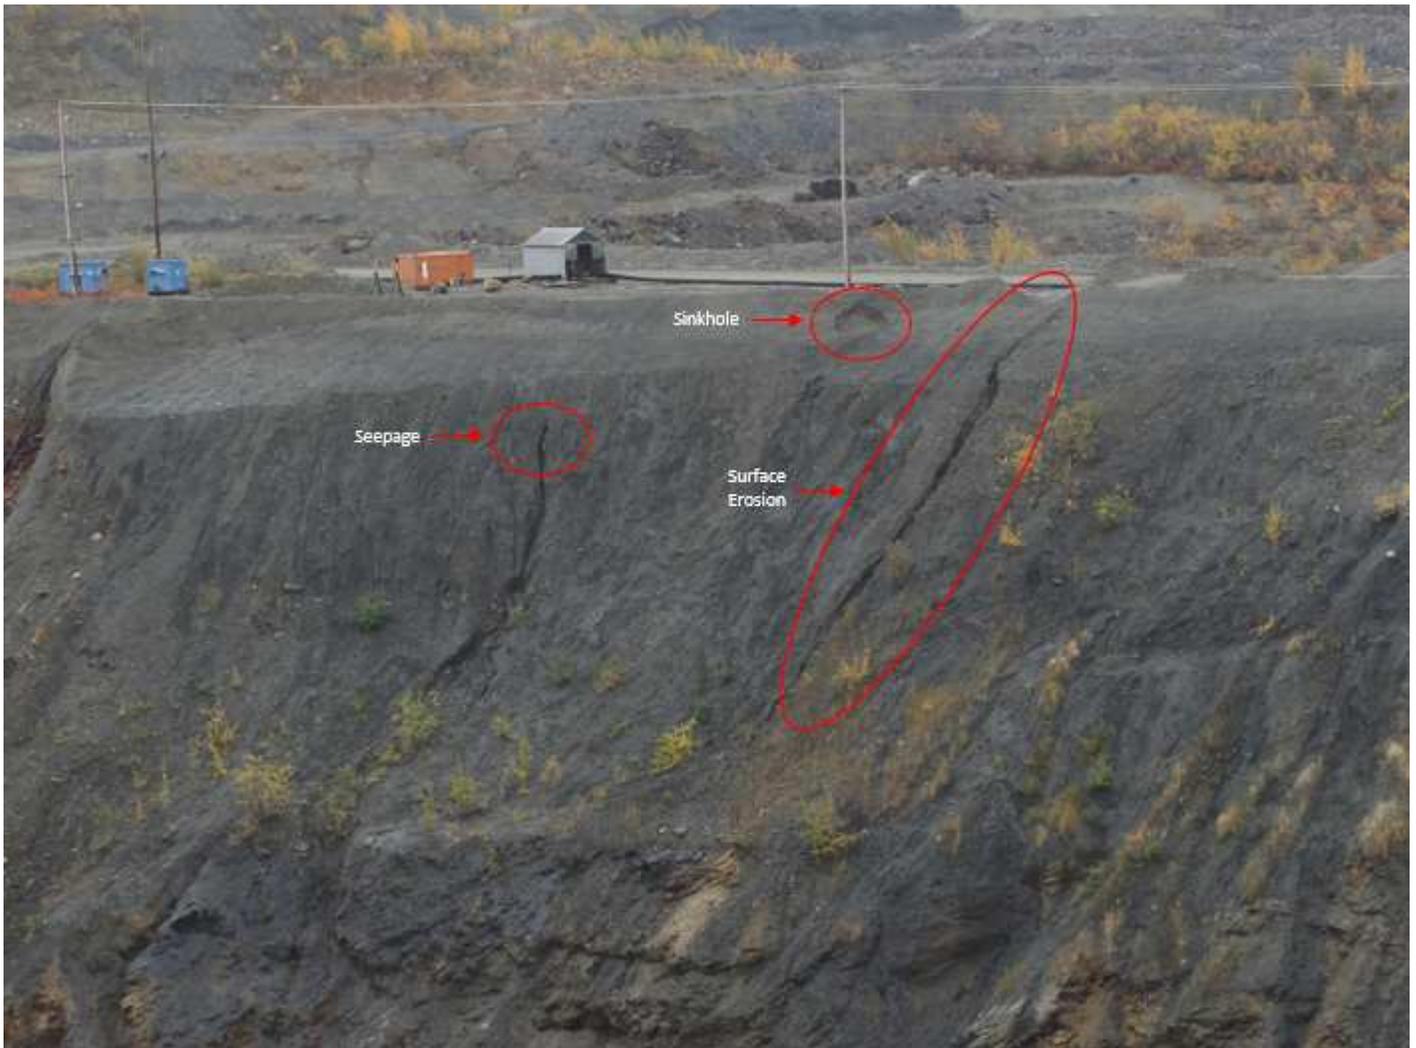
We've discussed the sinkhole that has formed in the overburden on the southern crest of the Vangorda pit (see images below).

It is our understanding that the sinkhole was first seen a week before the 2015 Golder site visit, and that it was recommended, as part of the 2015 site inspection report, that the crest be sloped back in this area. Subsequently the area was sloped back in 2016 by the site staff, however, the sinkhole reappeared on the 7/8 September 2016.

Based on the information available, it appears that water may be seeping and running off from the ditch (in which the pipeline sits) upstream of the sinkhole area. Seepage from this area may be causing the sinkhole, and runoff from this area is likely causing the erosion gully adjacent to the sinkhole. The water may be coming from rainfall or breaks in the pipeline - either by accident or maintenance.

- the sources of ponded water upstream of the sinkhole area are identified and diverted away from this area to prevent ponding - which may be the source of the seepage seen.
- the pipeline is inspected for leaks/breaks and these be repaired.
- the drainage in the area and ditched is remediated such that the surface run-off is diverted away from the pit crest and not channeled into the erosion gully adjacent to the sinkhole.
