Golder Associates Ltd.

February 8, 2006

05-1413-044

RE: FARO PIT SLOPE MOVEMENT MONITORING

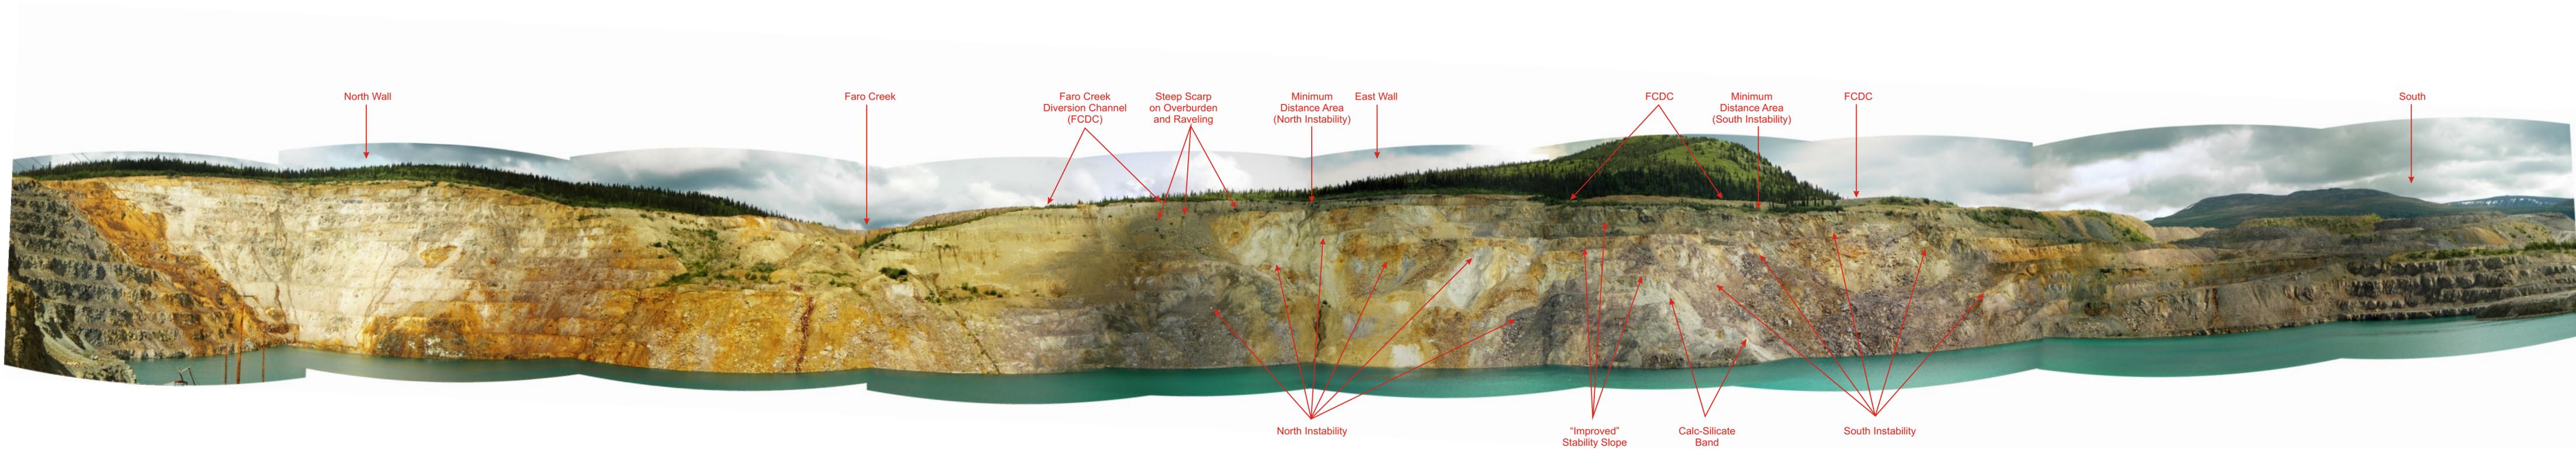
The North and South instability zones are apparently separated by the north/south trending band of calc-silicate rock, as panoramically shown in Photograph 1. The North instability zone is located to the north of the band of calc-silicate rock, and the South zone is located to the south.

The east wall instability is still characterized by two failure zones, as the North and South instabilities separated by the calc-silicate band zone, as shown on Photographs 1 and 2. A broad overview inspection of the east wall indicates that the instability has not progressed significantly, as major change or increase in displacement is not apparent.

Photograph 1 : Panoramic overview of the Faro Pit East Wall, August 2005.

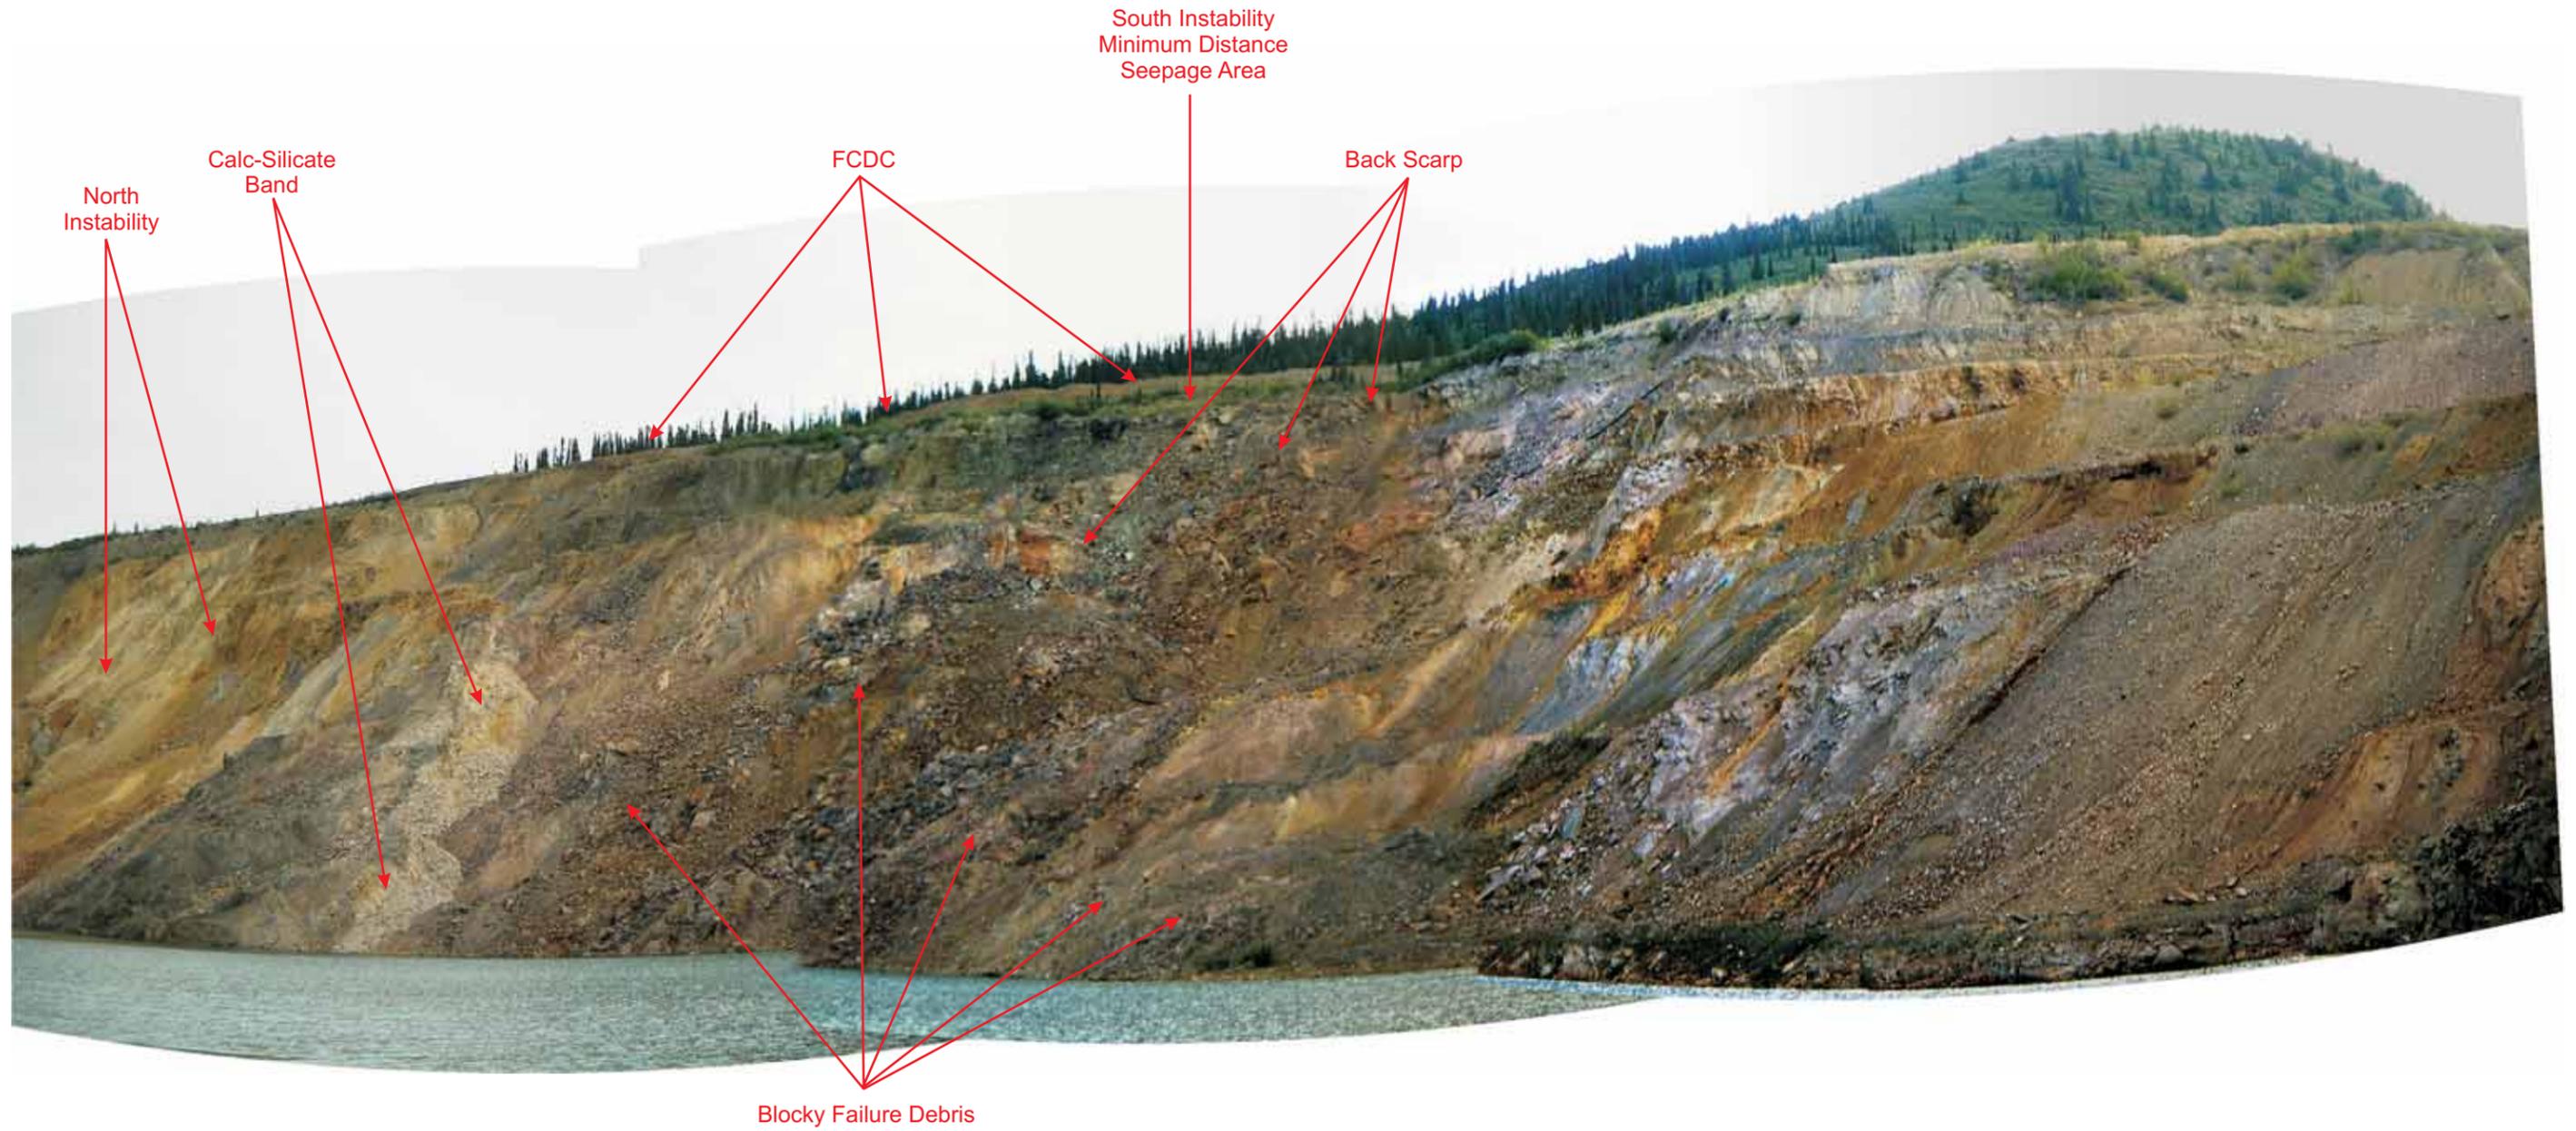
The current South instability is characterized by highly blocky failure debris at the base of the slope and back scarp in a generally more massive rock mass. This portion of the slope is shown on panoramic Photographs 2 and 3. The blocky failure debris is accumulated along the slope. Failure debris has formed variable thickness talus deposits with evidence of large displacement as previously assessed, as shown in Photograph 4. Raveling is observed to affect the steep back scarp. The back scarp consists of more competent jointed rock mass.

Photograph 2 : Panoramic view of the South Instability, August 2005.

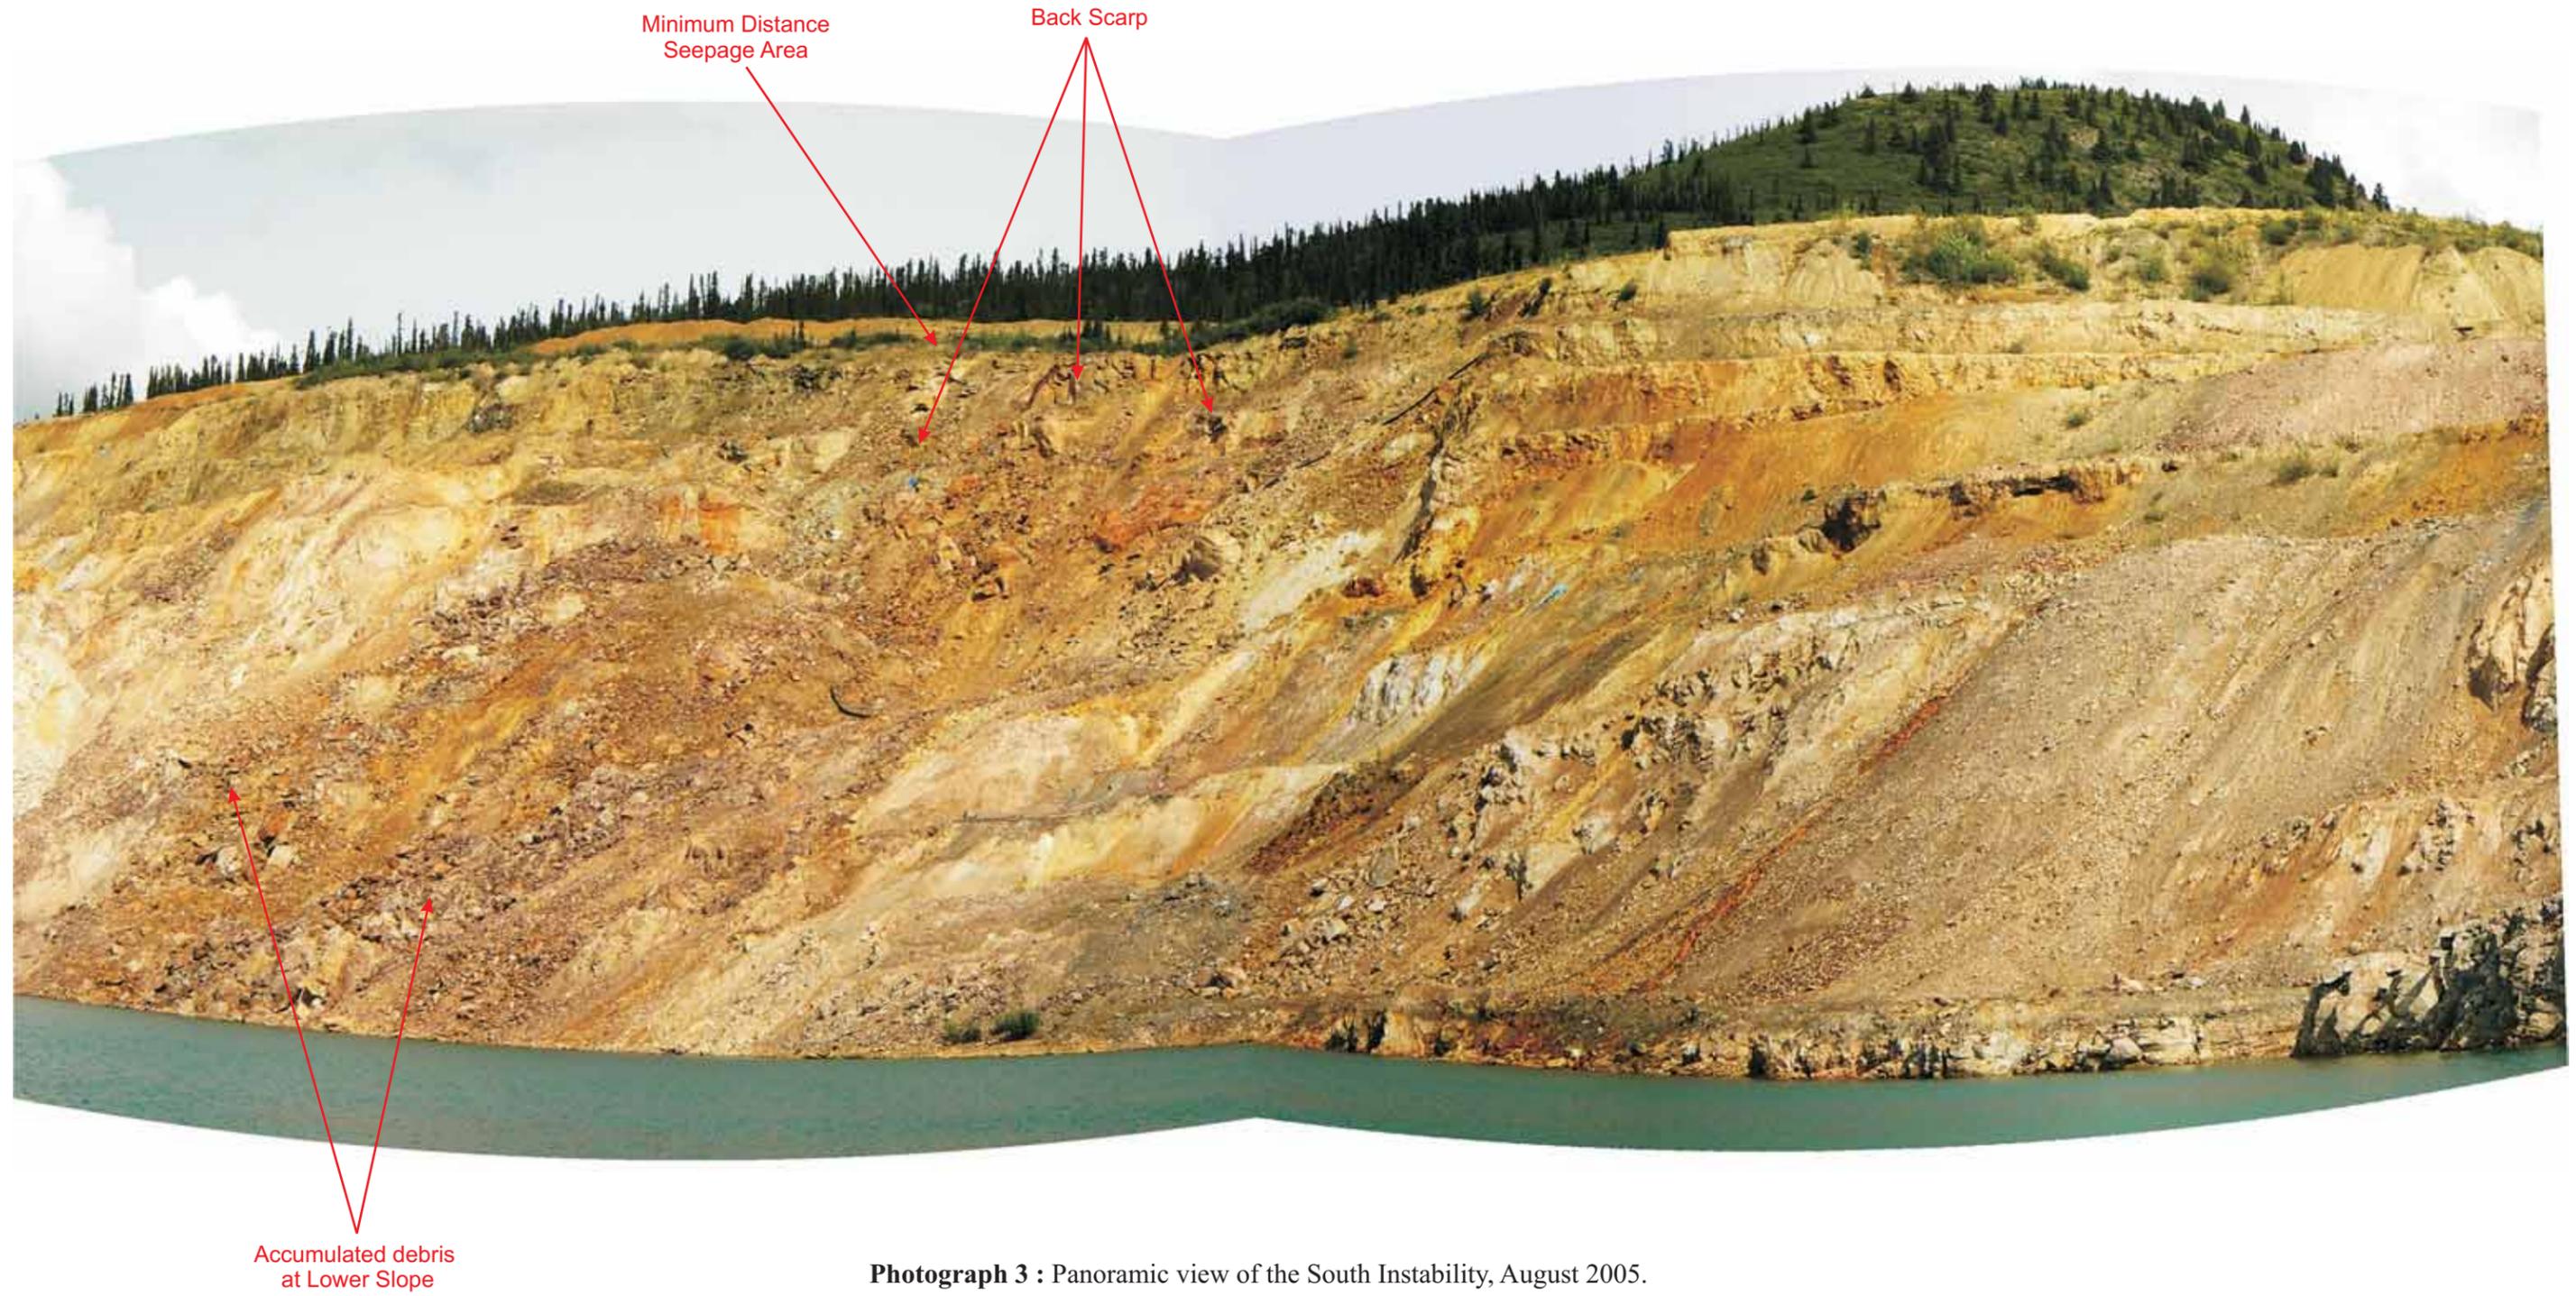
Photograph 3 : Panoramic view of the South Instability, August 2005.

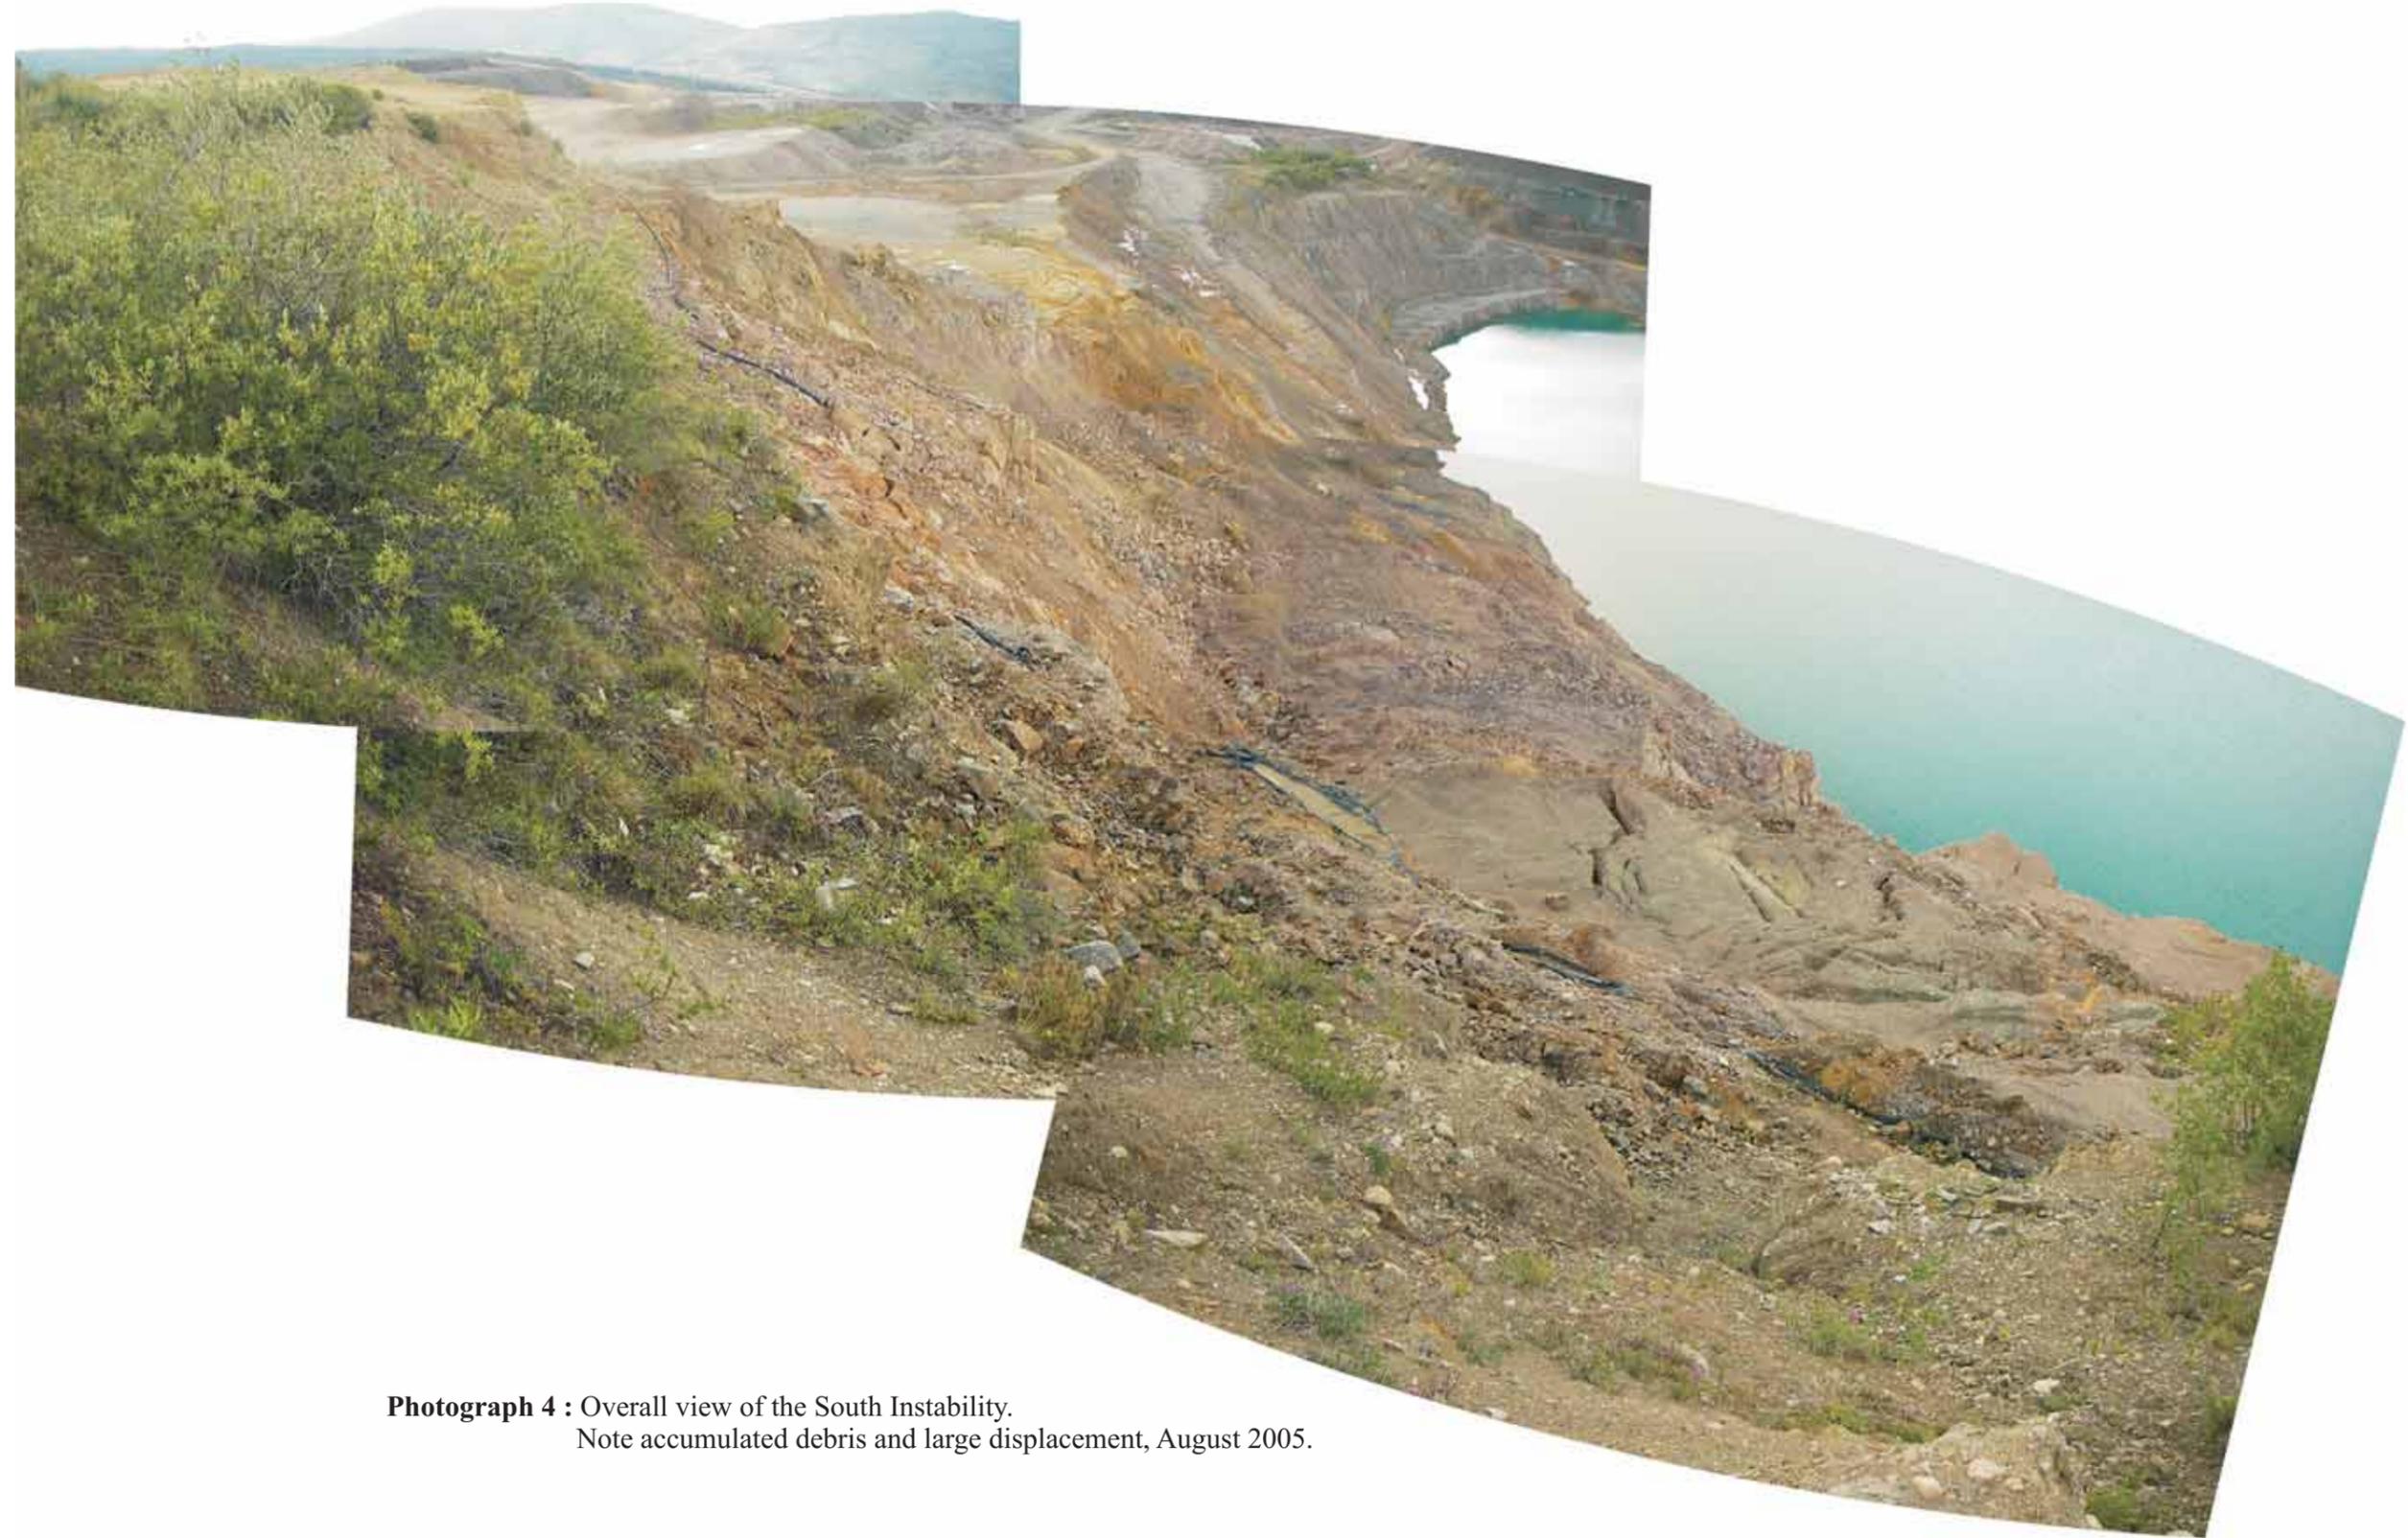
Photograph 4 : Overall view of the South Instability.
Note accumulated debris and large displacement, August 2005.

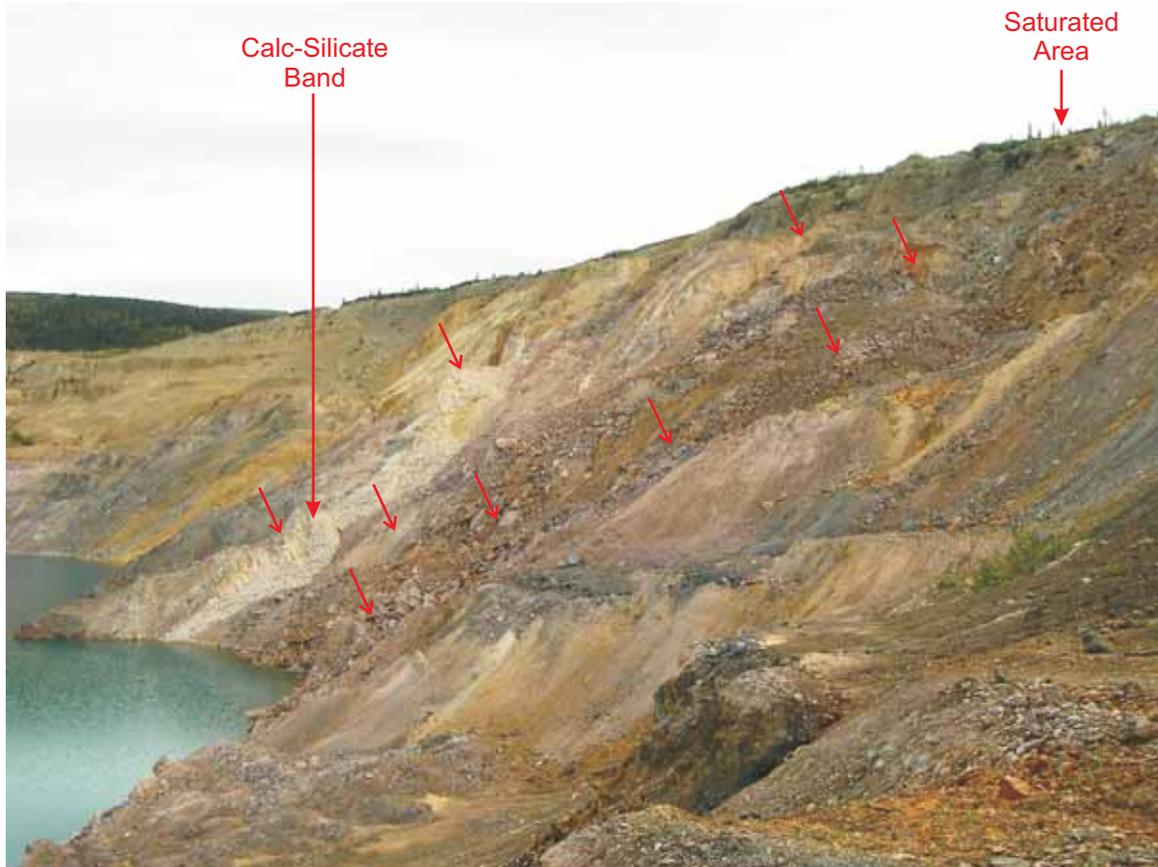
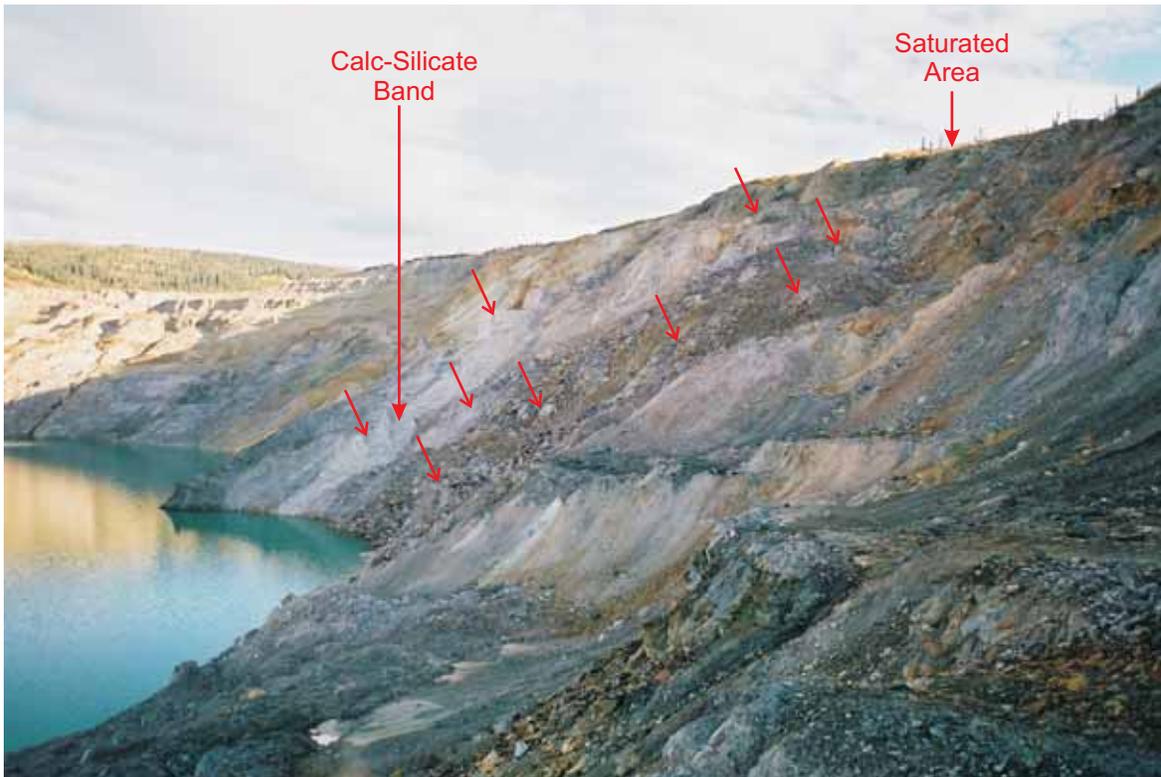
- Photographs 5a and 5b show that the north boundary of the South instability has not significantly changed since the previous assessment from a visual inspection perspective. The back scarp at the north end does not show any perceptible regression or degradation. Only some settlement and downward displacement appears to have occurred on the accumulated debris.

Photograph 5a : South instability and calc-silicate band, August 2005. View to North. Comparison photograph.

Photograph 5b : South instability and Calc-Silicate band, September 2002. View to North. Comparison photograph.

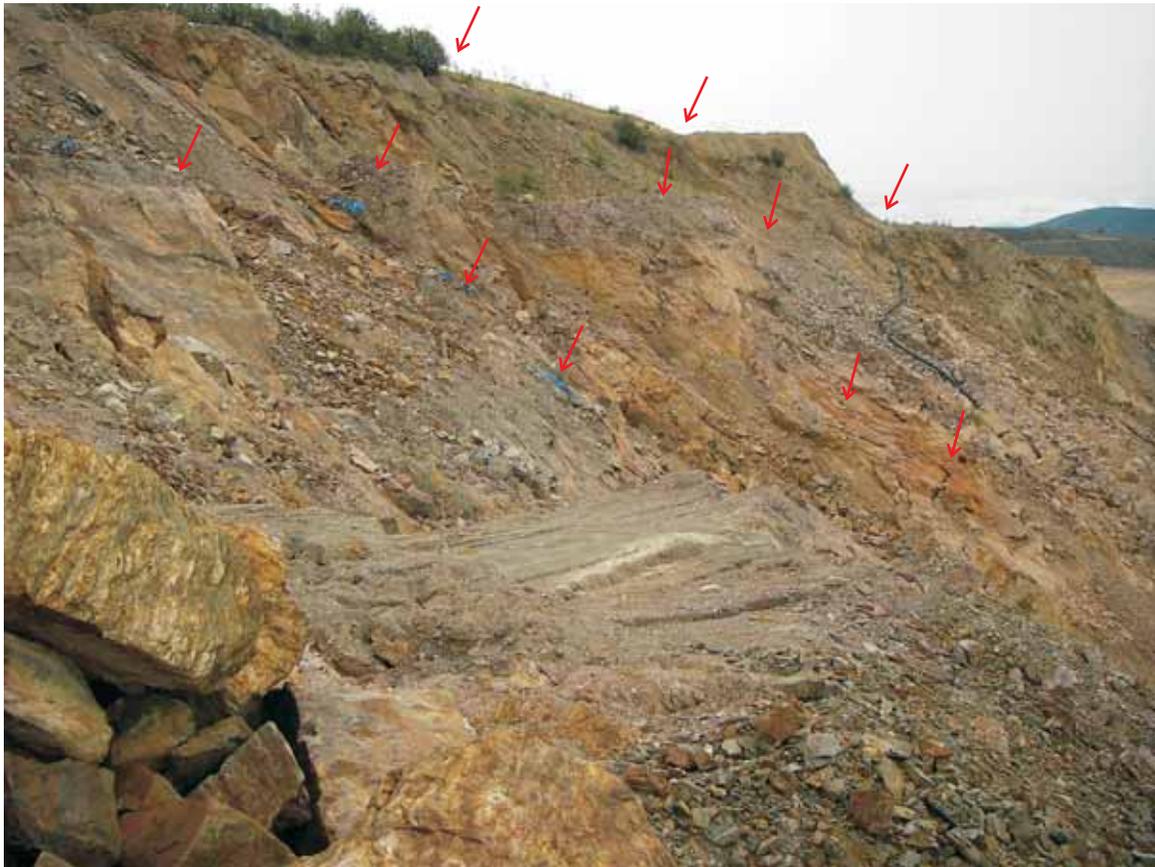
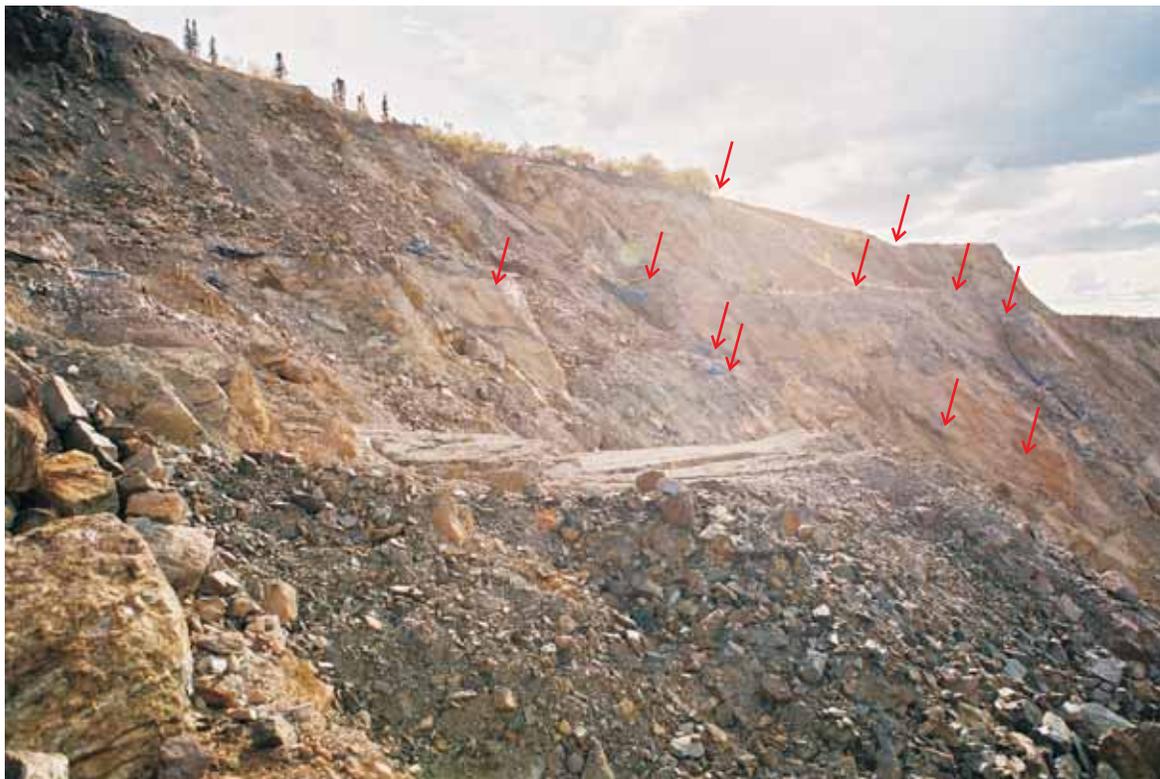
- Photographs 6a and 6b show that the crest at the South instability has not changed perceptibly since the previous assessment from a visual inspection perspective. The crest at back scarp does not show significant regression or degradation. Some settlement and downward displacement have occurred on the accumulated debris. Downward displacement also appears to have occurred on the “stepped” bench at the centre of the photographs. The most significant change occurred at the south limit of the South instability. A remnant bench failed underneath the slope crest, apparently controlled by west dipping joints. The same slope face is seen “intact” in the 2002 photograph and displaced with several cracks and accumulated debris in the recent photograph. As a consequence, the back scarp resembles now a continuous unbenched slope up to the crest at this portion of the wall (Photograph 7). It must be emphasized that up to now, this failure does not appear to have affected the previous existing crest, as there are no cracks behind the crest, as shown on Photograph 8.

Photograph 6a : Back scarp crest at the South instability, August 2005. View to South. Comparison photograph.

Photograph 6b : Back scarp crest of the South instability, September 2002. View to South. Comparison photograph.

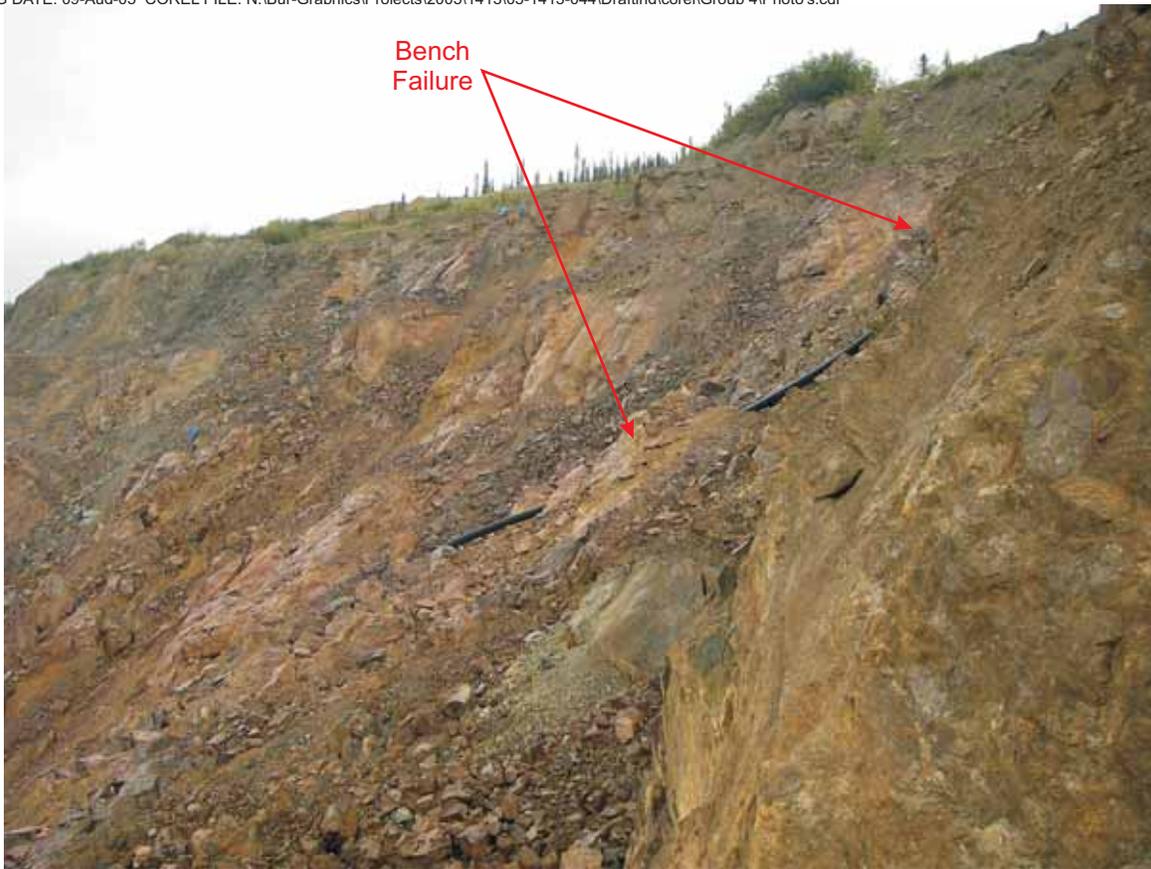
Photograph 7 : View of South instability back scarp. Note “recent” bench failure at the South end of the instability, August 2005.

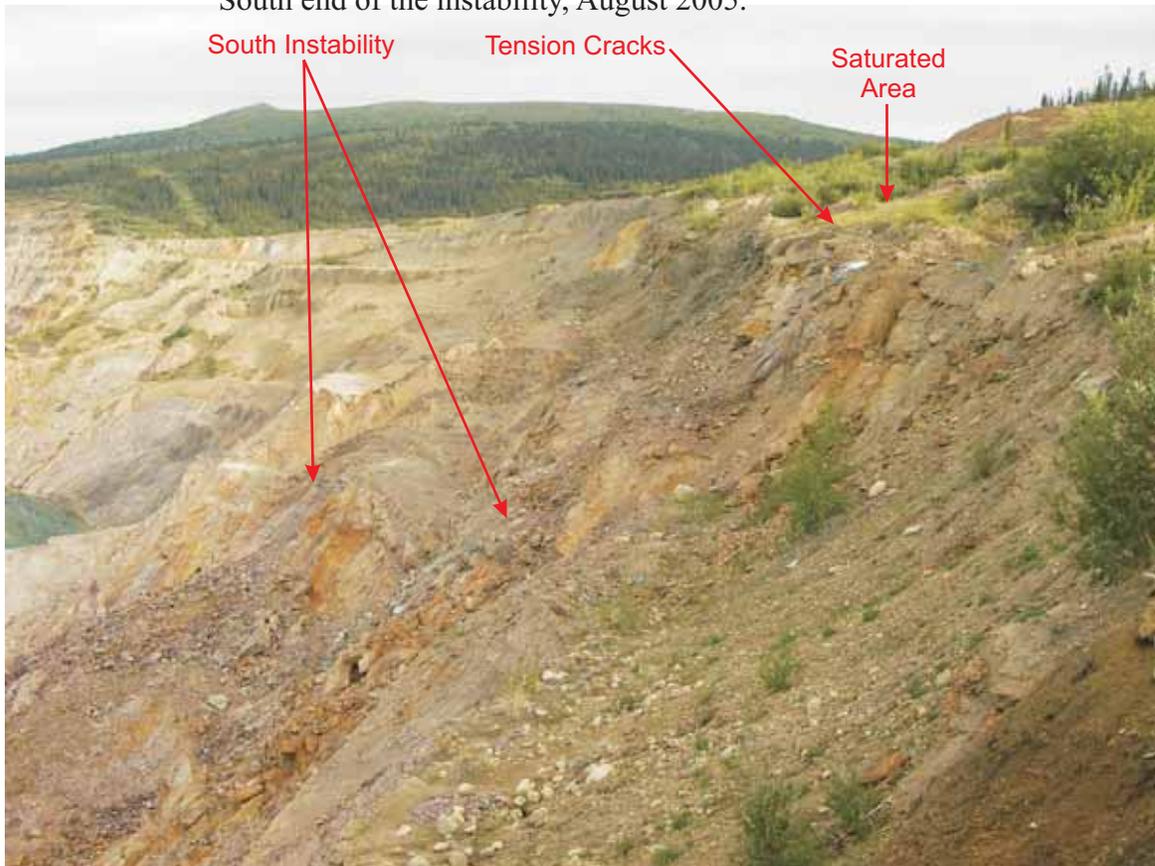
Photograph 8 : East wall crest at the South instability, August 2005.

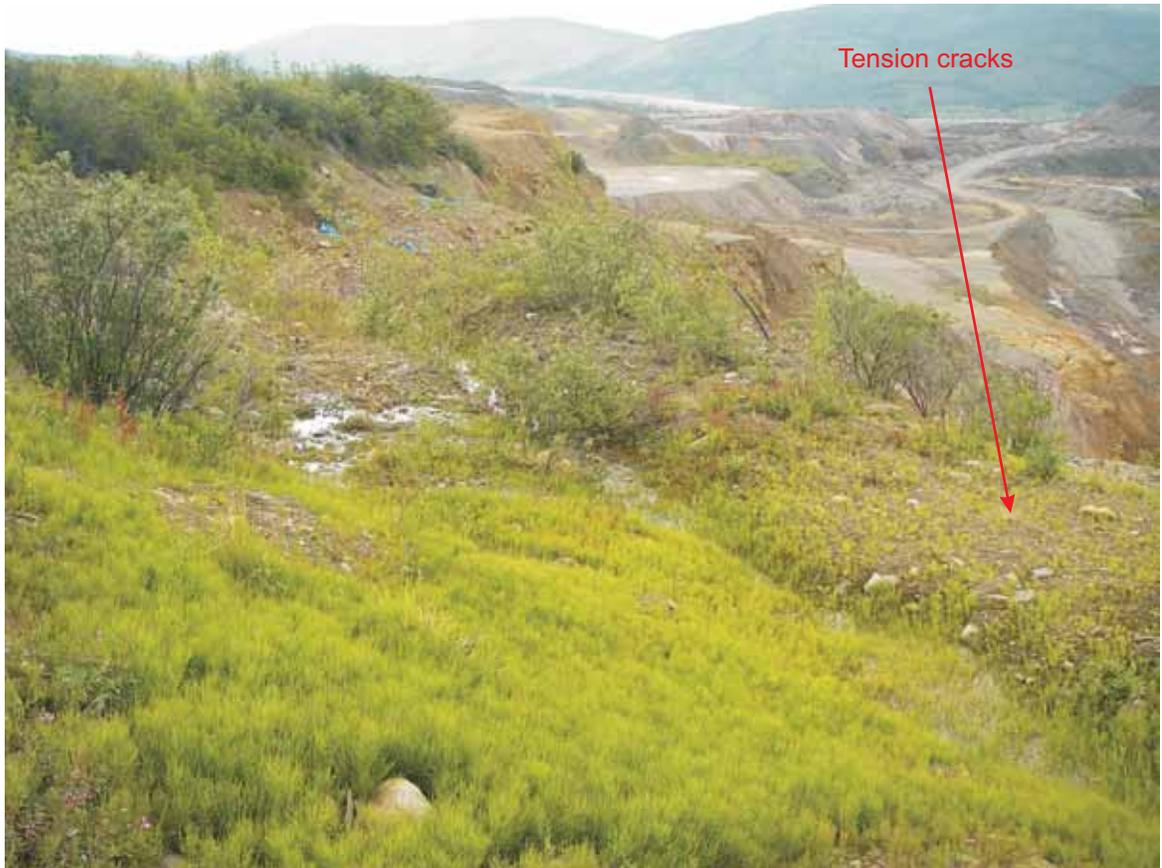
Photograph 9 : Saturated ground, South instability, August 2005.

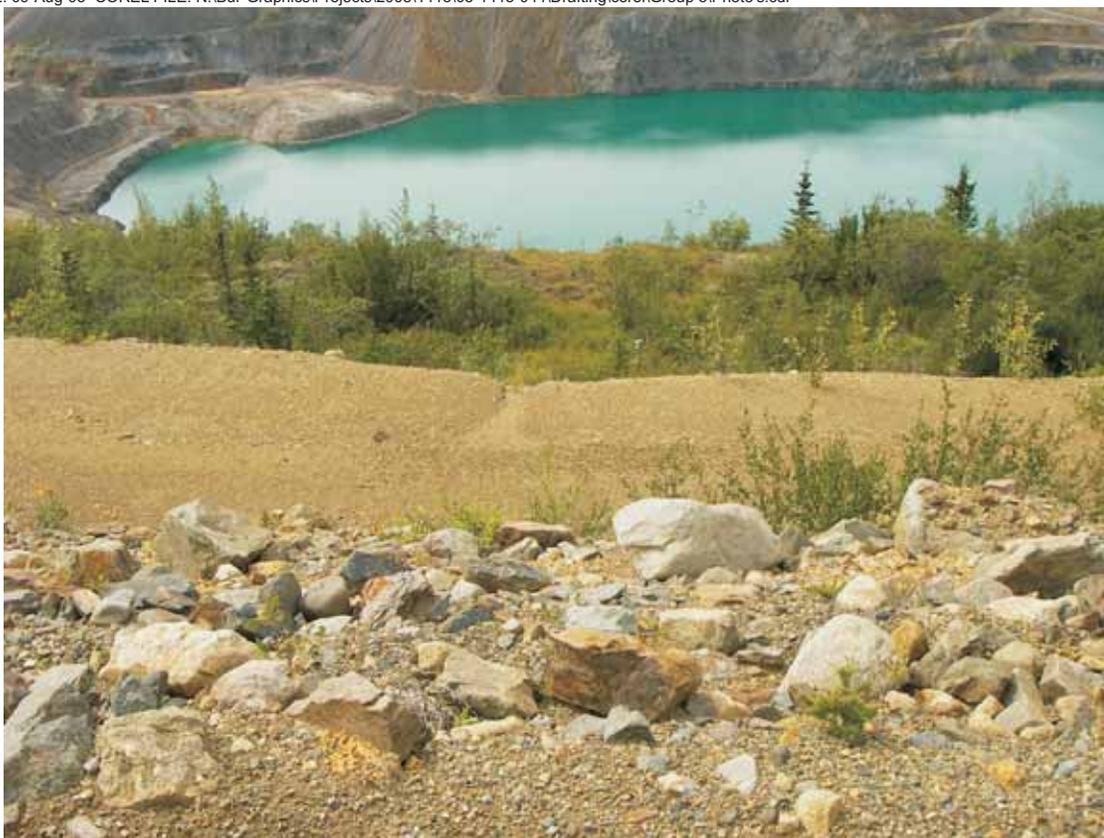
Photograph 11 : Alignment at the minimum distance from scarp crest by the FCDC at the South instability, August 2005.

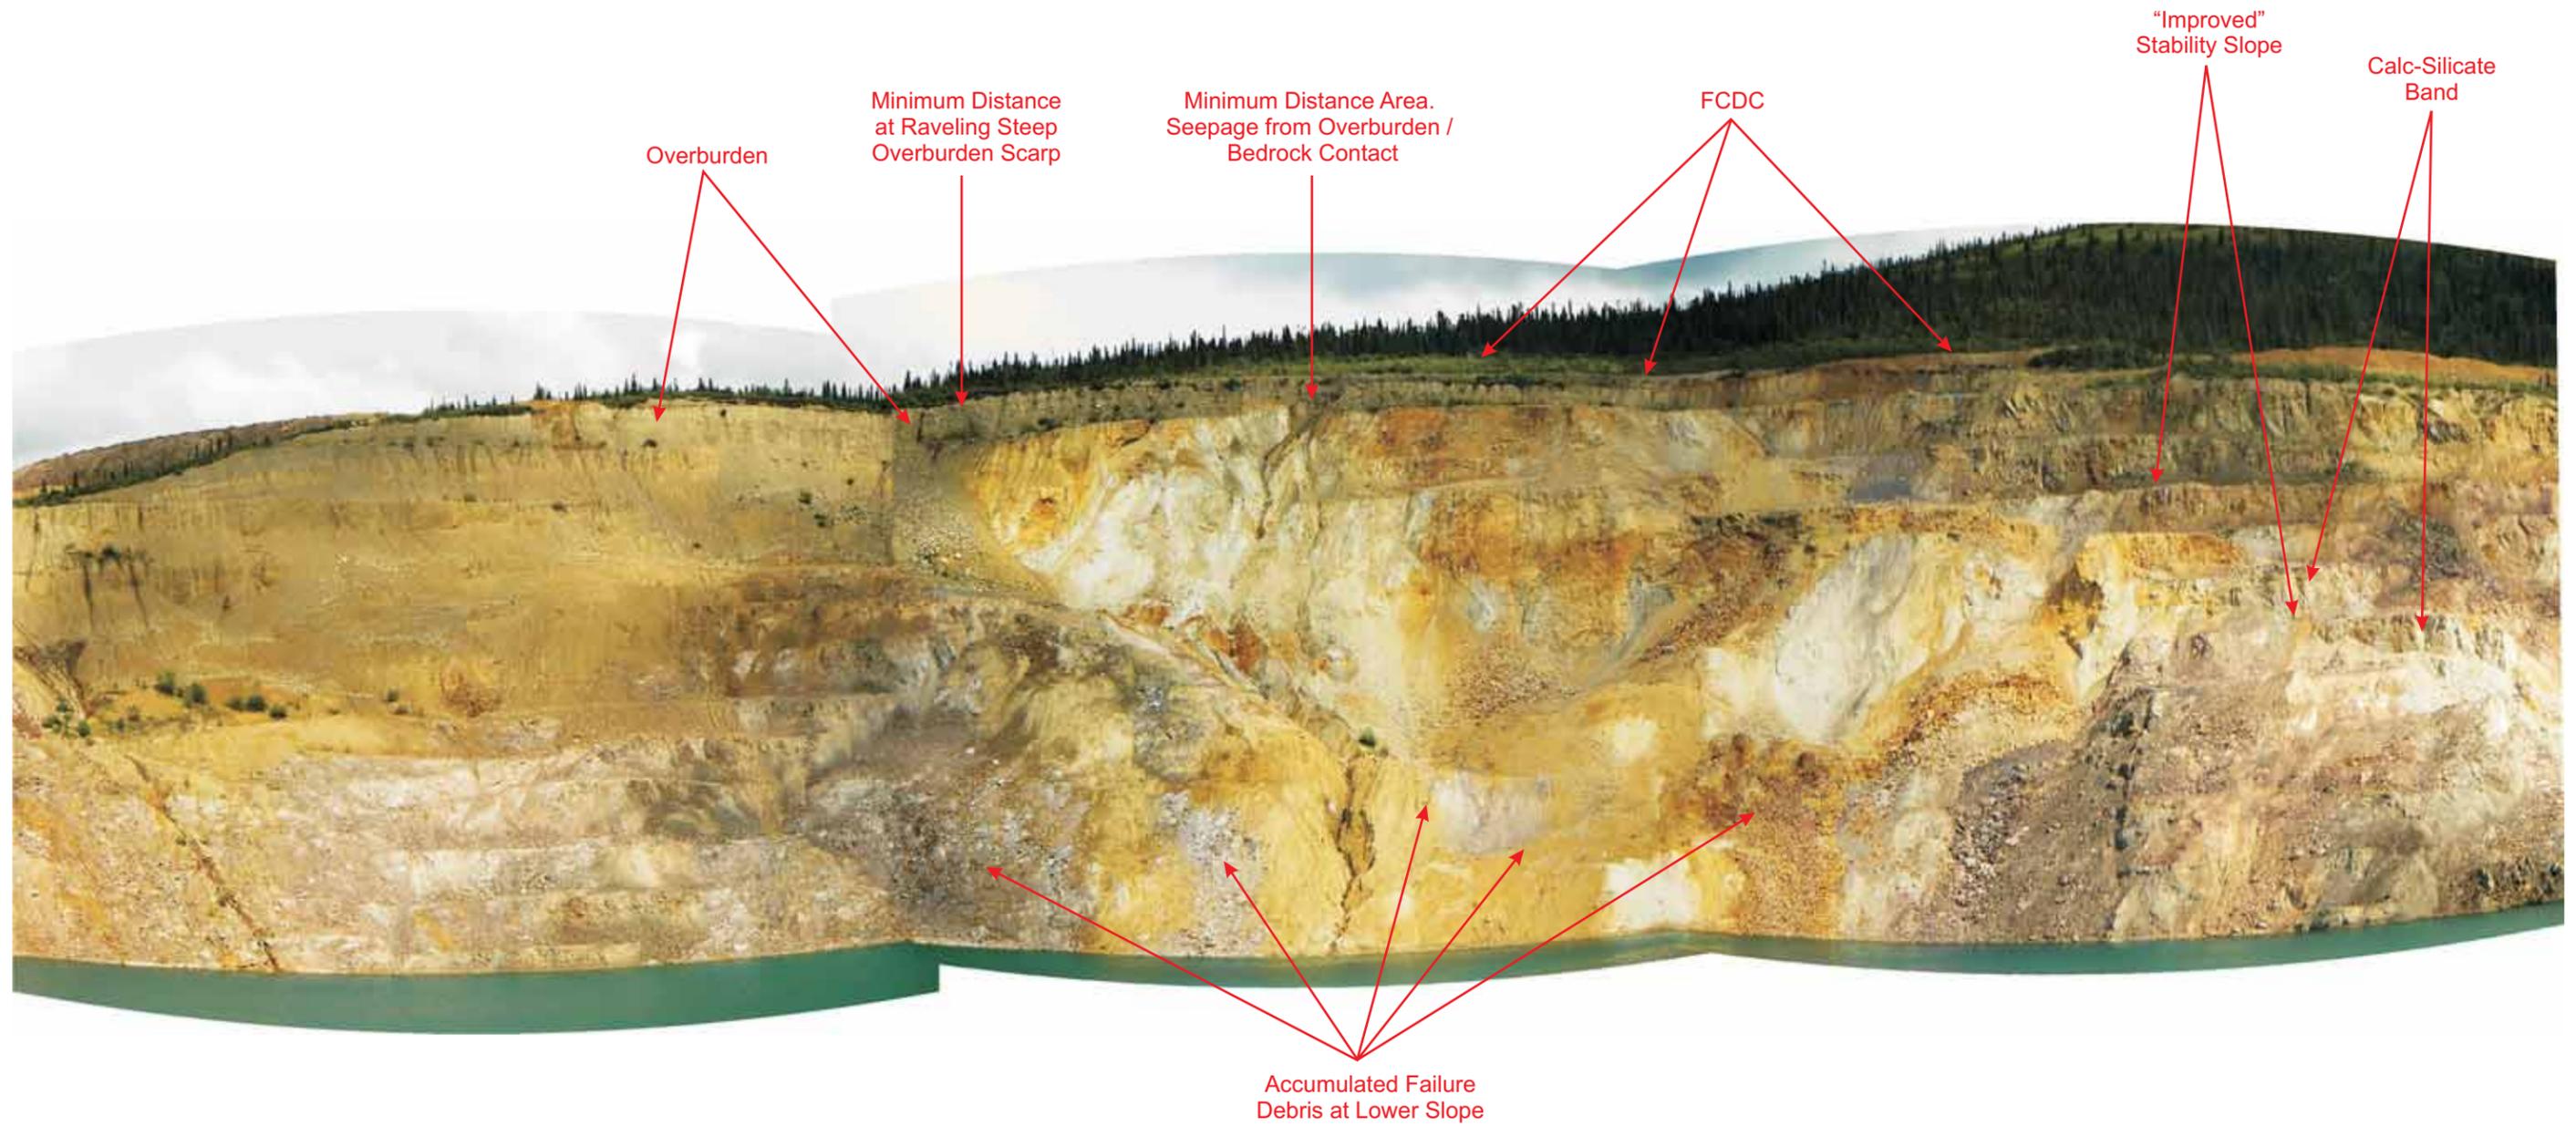
The current North instability is shown on Photograph 13. The instability zone is characterized by accumulated failure debris at the base of the slope and a steep back scarp at the crest of the slope, to the north of the calc-silicate band. The accumulated debris is much finer-grained and more bleached and altered than the debris in the south failure zone. The steep backscarp was formed in more competent rock at the crest of the slope. However a steep scarp is also exists in the overburden deposits at the crest of the slope, unlike the South instability.

Photograph 13 : Panoramic view of the North Instability. Faro Pit East Wall, August 2005.
