Golder Associates Ltd.

February 8, 2006

05-1413-044

RE: FARO PIT SLOPE MOVEMENT MONITORING

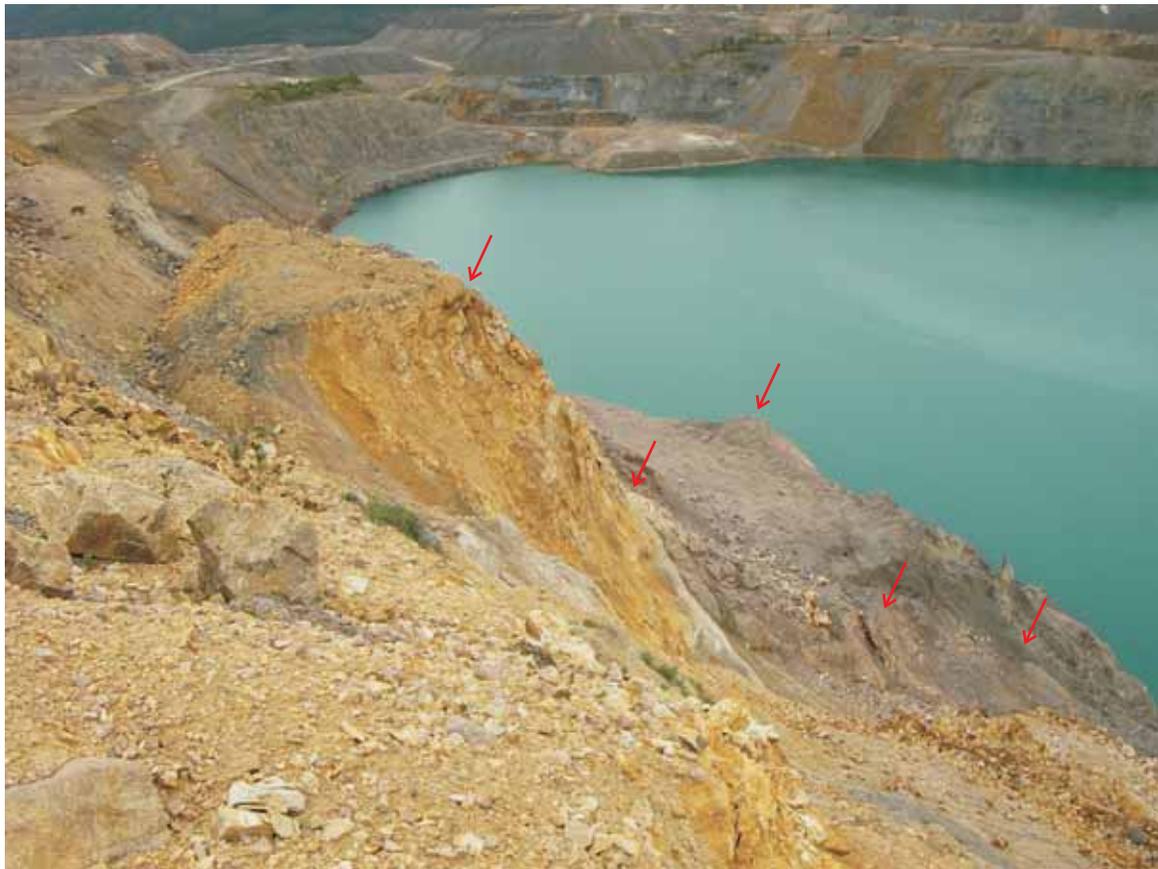
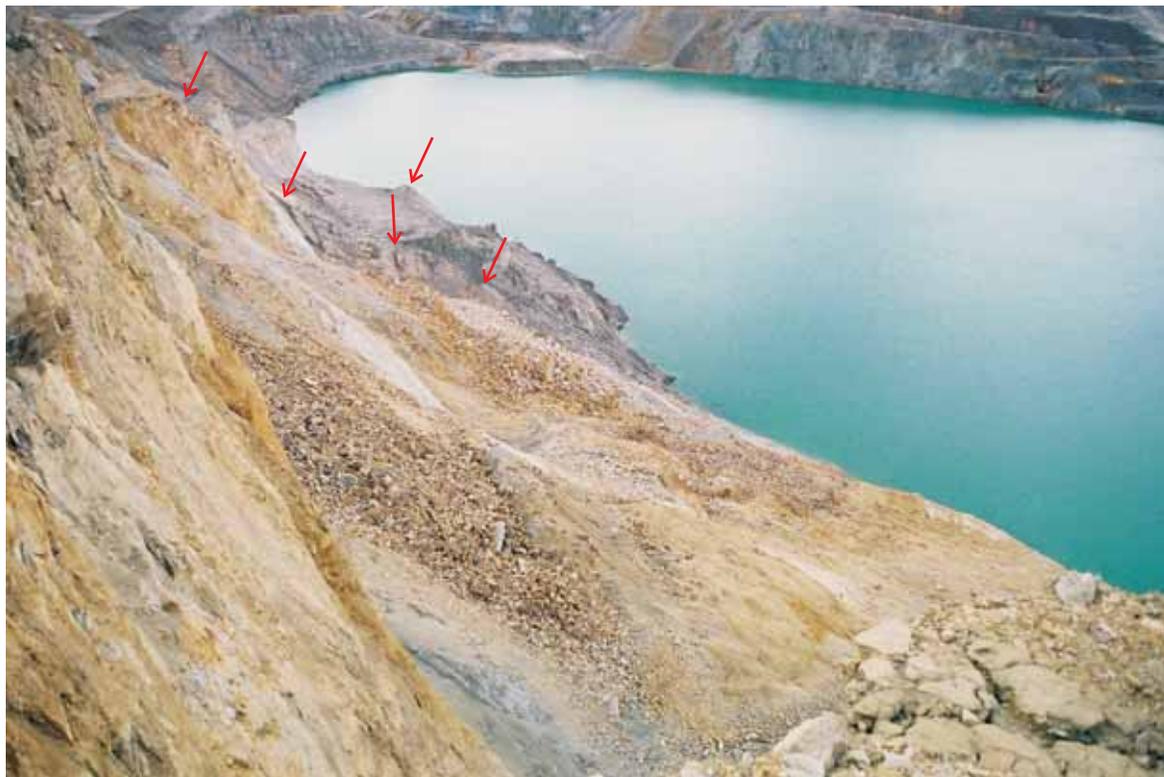
- Photographs 14a and 14b show generally that the lower slope at the south boundary of the North instability, i.e., along the north side of the calc-silicate band, appears to have not changed significantly since the previous assessment;
- Photographs 15a, 15b, 16a and 16b show that the north boundary of the North instability zone appears to have not changed perceptibly since the previous assessment from a visual inspection perspective, and down slope displacement of the failure debris appears to have been limited. The previous existing erosion gully has deepened on the debris at the lower slope (Photograph 15a); and
- Photographs 17a, 17b, 18a, 18b, 19a, 19b, 20a and 20b illustrate that the crest and the back scarp of the North instability show no perceptible regression or significant degradation since 2002.

Photograph 14a : South boundary of the North instability, August 2005.
Comparison photograph.

Photograph 14b : South boundary of the North instability, September 2002.
Comparison photograph.

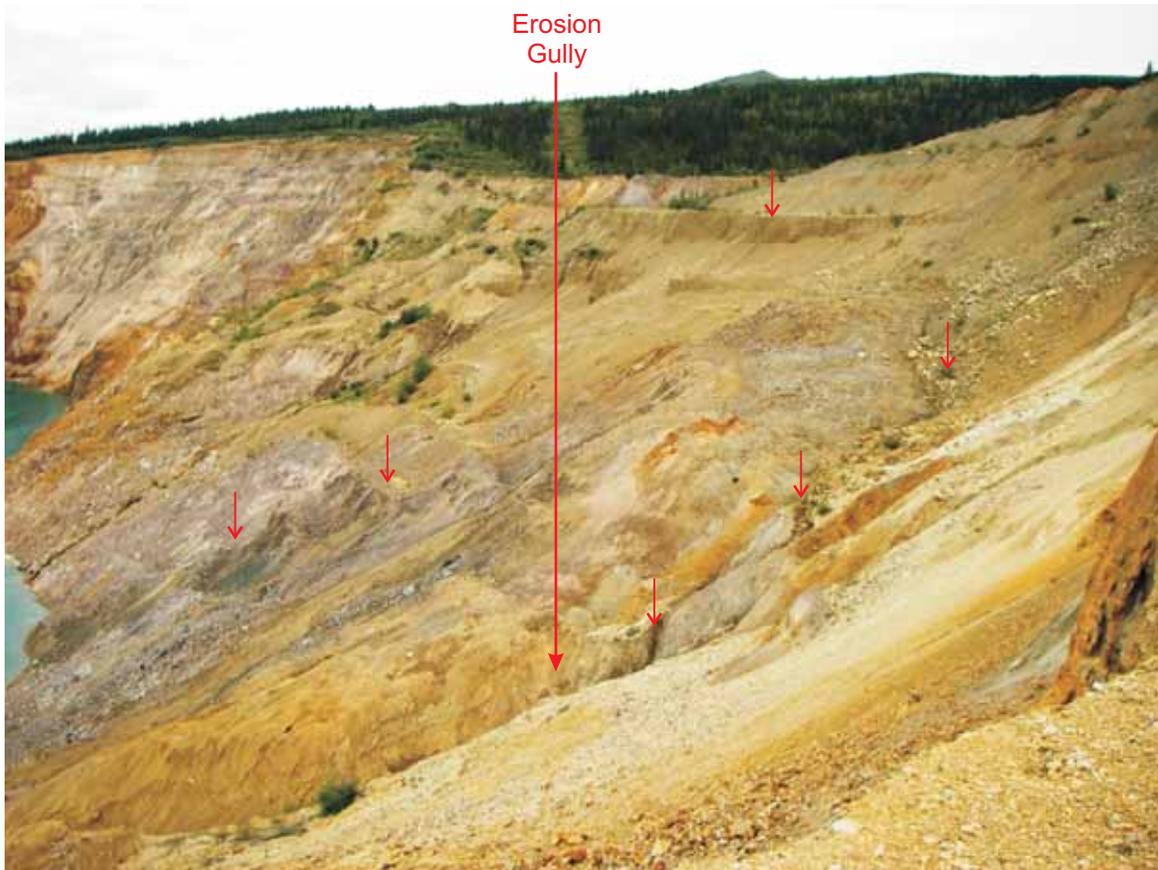
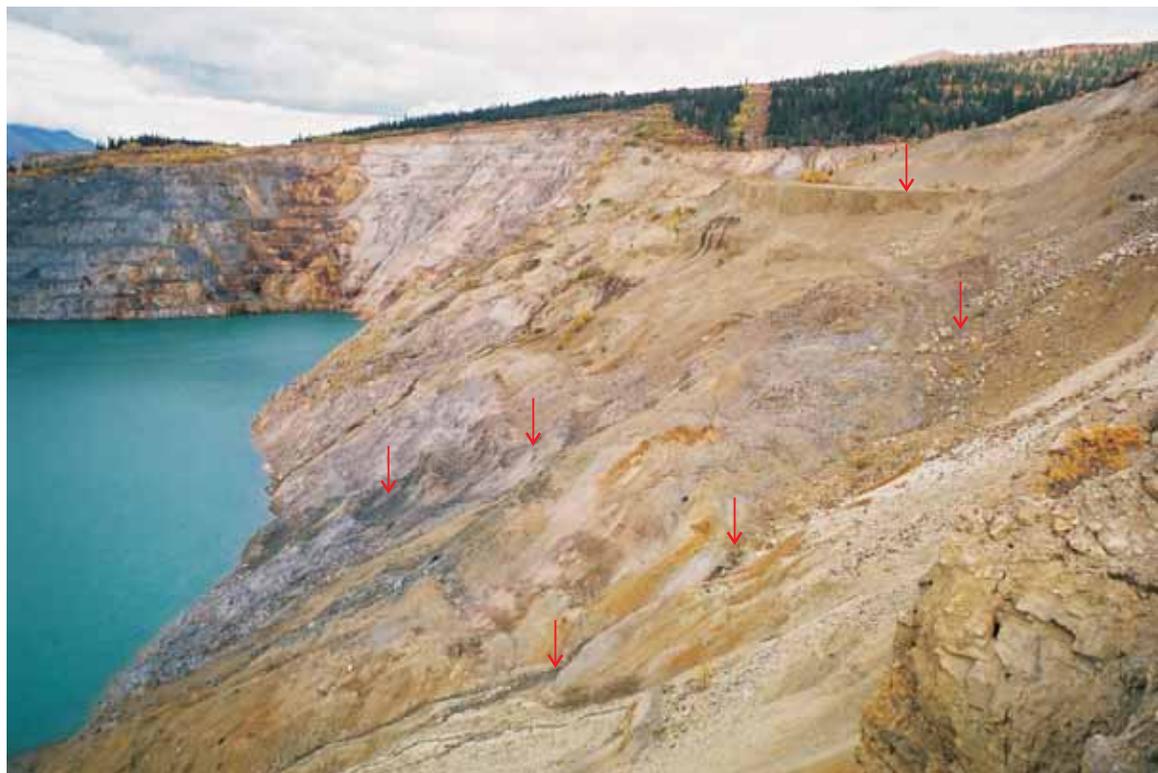
Photograph 15a : North instability, view to north, August 2005. Comparison photograph.

Photograph 15b : North instability, view to north, September 2002. Comparison photograph.

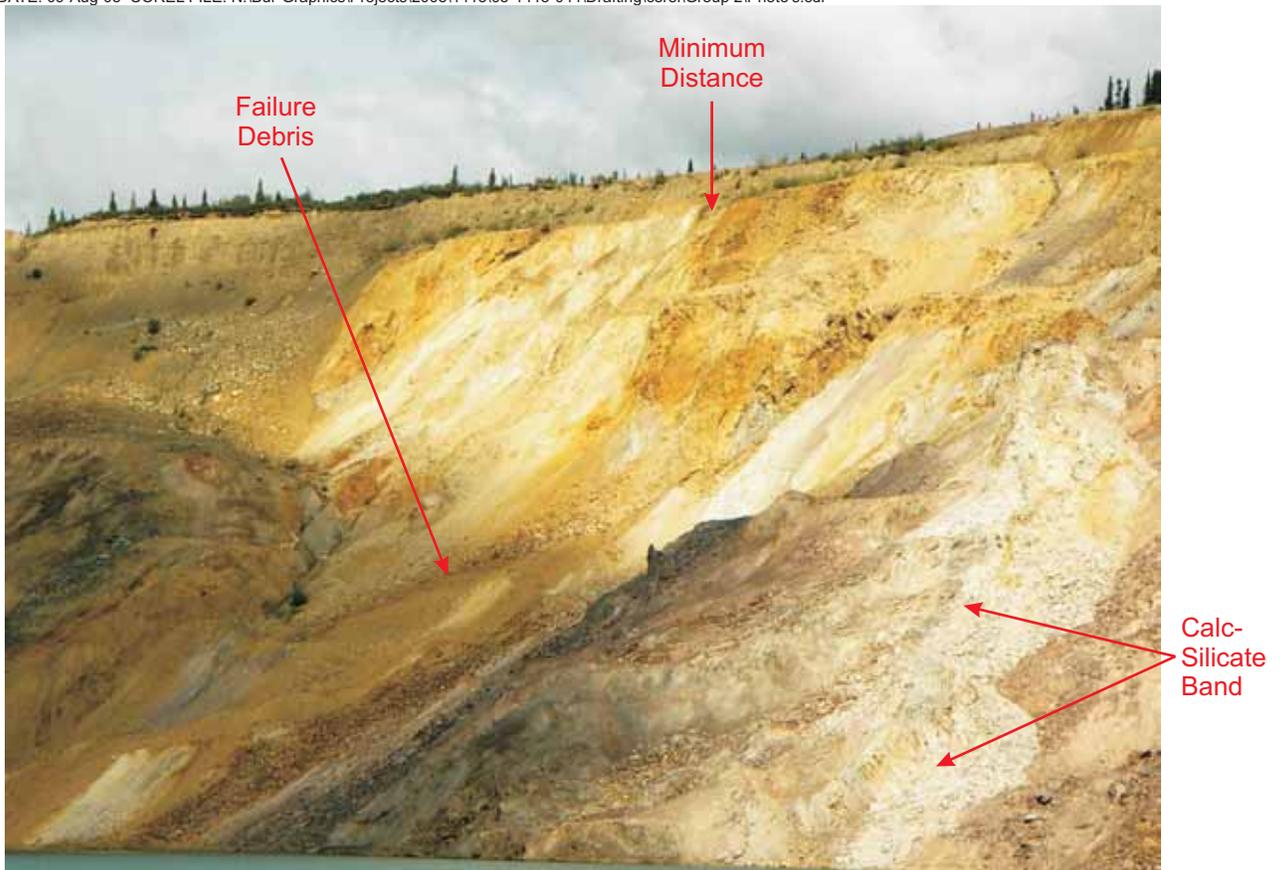
The minimum distance from the crest of the east wall instability to the FCDC occurs in the middle of the North failure zone (Photographs 14, 21 and 22). Prior to any comparative assessment of the 2005 and the 2002 minimum distances to the FCDC, two important remarks must be emphasized about this particular location where the minimum distance was measured (Photographs 23 and 24).

Photograph 21 : North instability, August 2005.

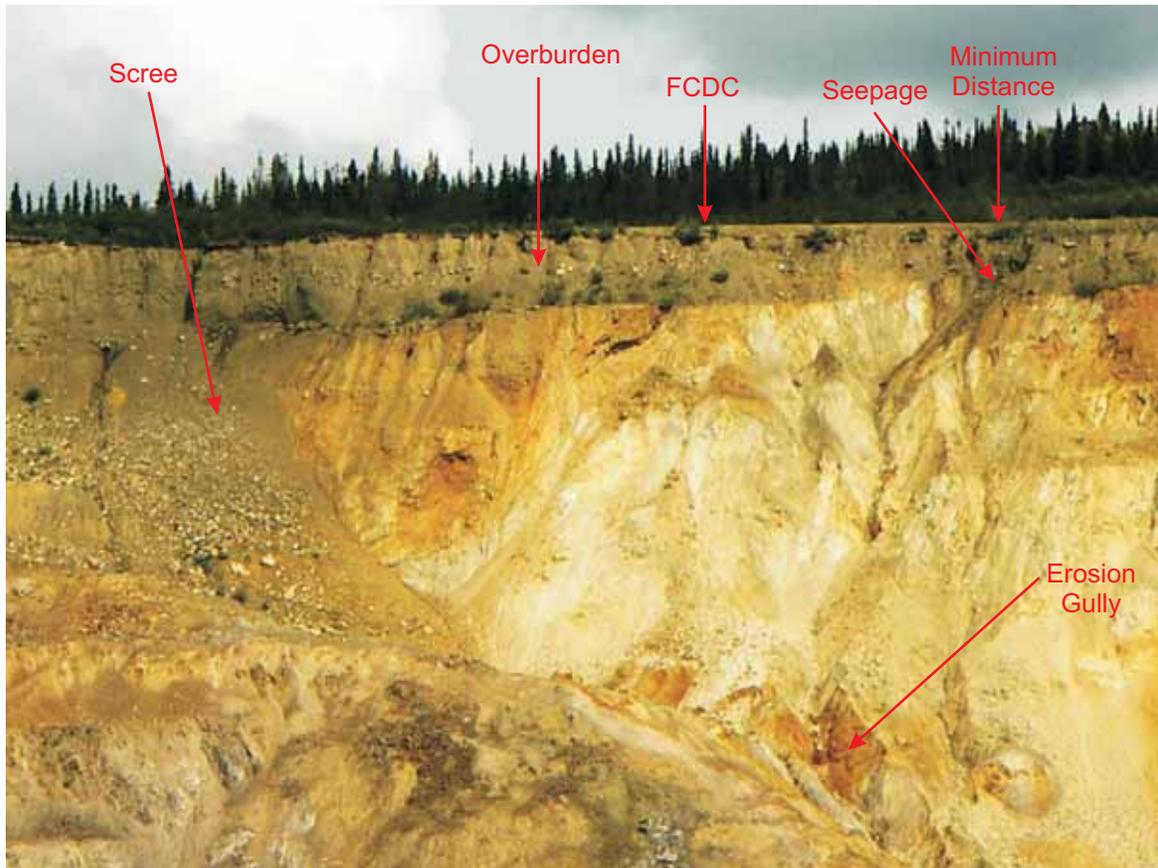
Photograph 22 : North instability. View of overburden crest and minimum distance area, August 2005.

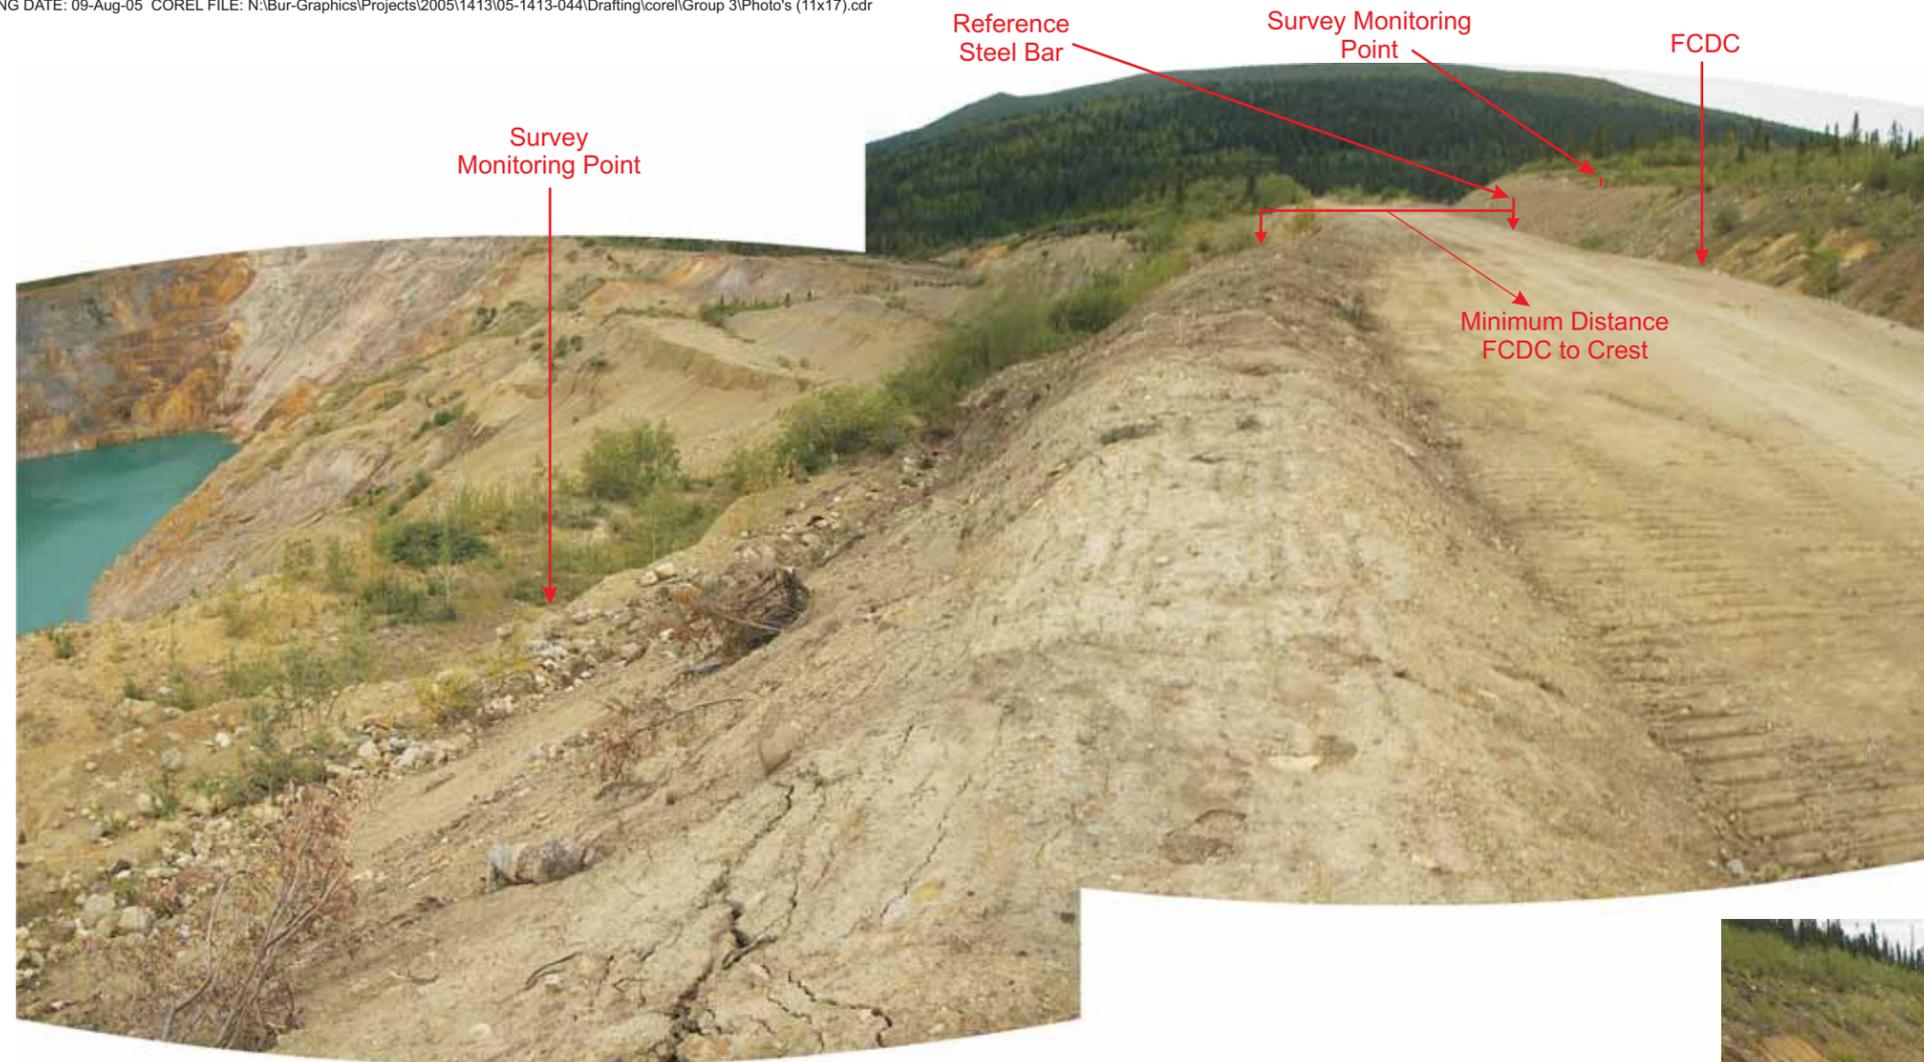
Photograph 23 : Crest of east wall above the North instability, August 2005.
Suggested locations for reference bar and survey monitoring points.

- One reference bar should be placed where the distance between the crest of the scarp and the FCDC is at a minimum at the North instability (Photographs 23 and 24). It is recommended that this bar should be placed to the west of the FCDC at the east side of the access road, due to presence of loose fill material and the proximity of the scarp crest at the west side of the road.

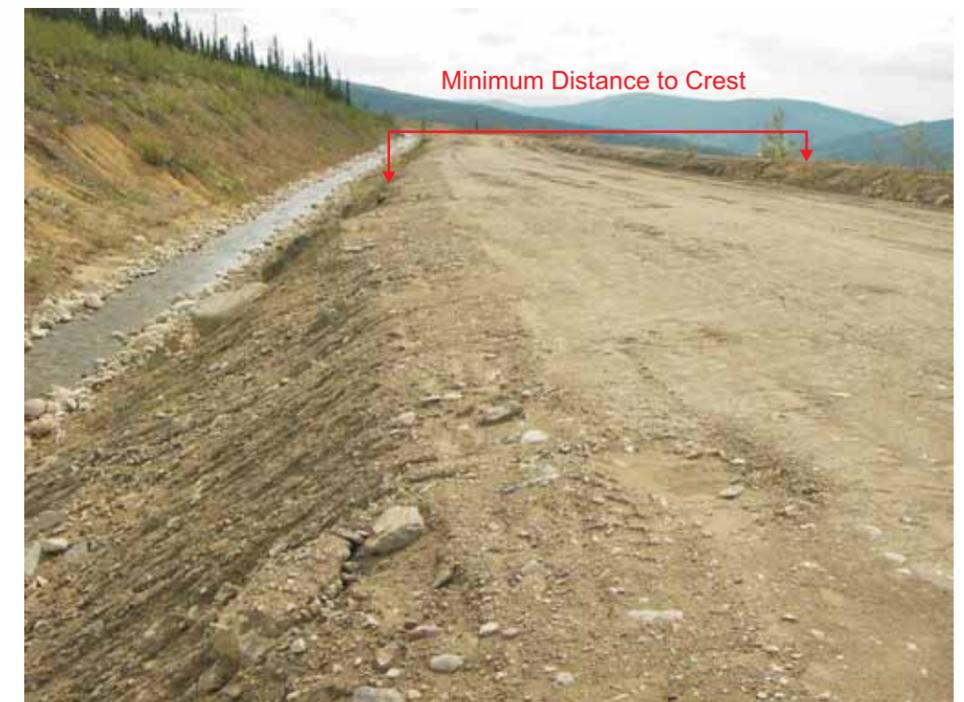
Photograph 24 : View of the Faro Creek Diversion Channel (FCDC) above the North instability.

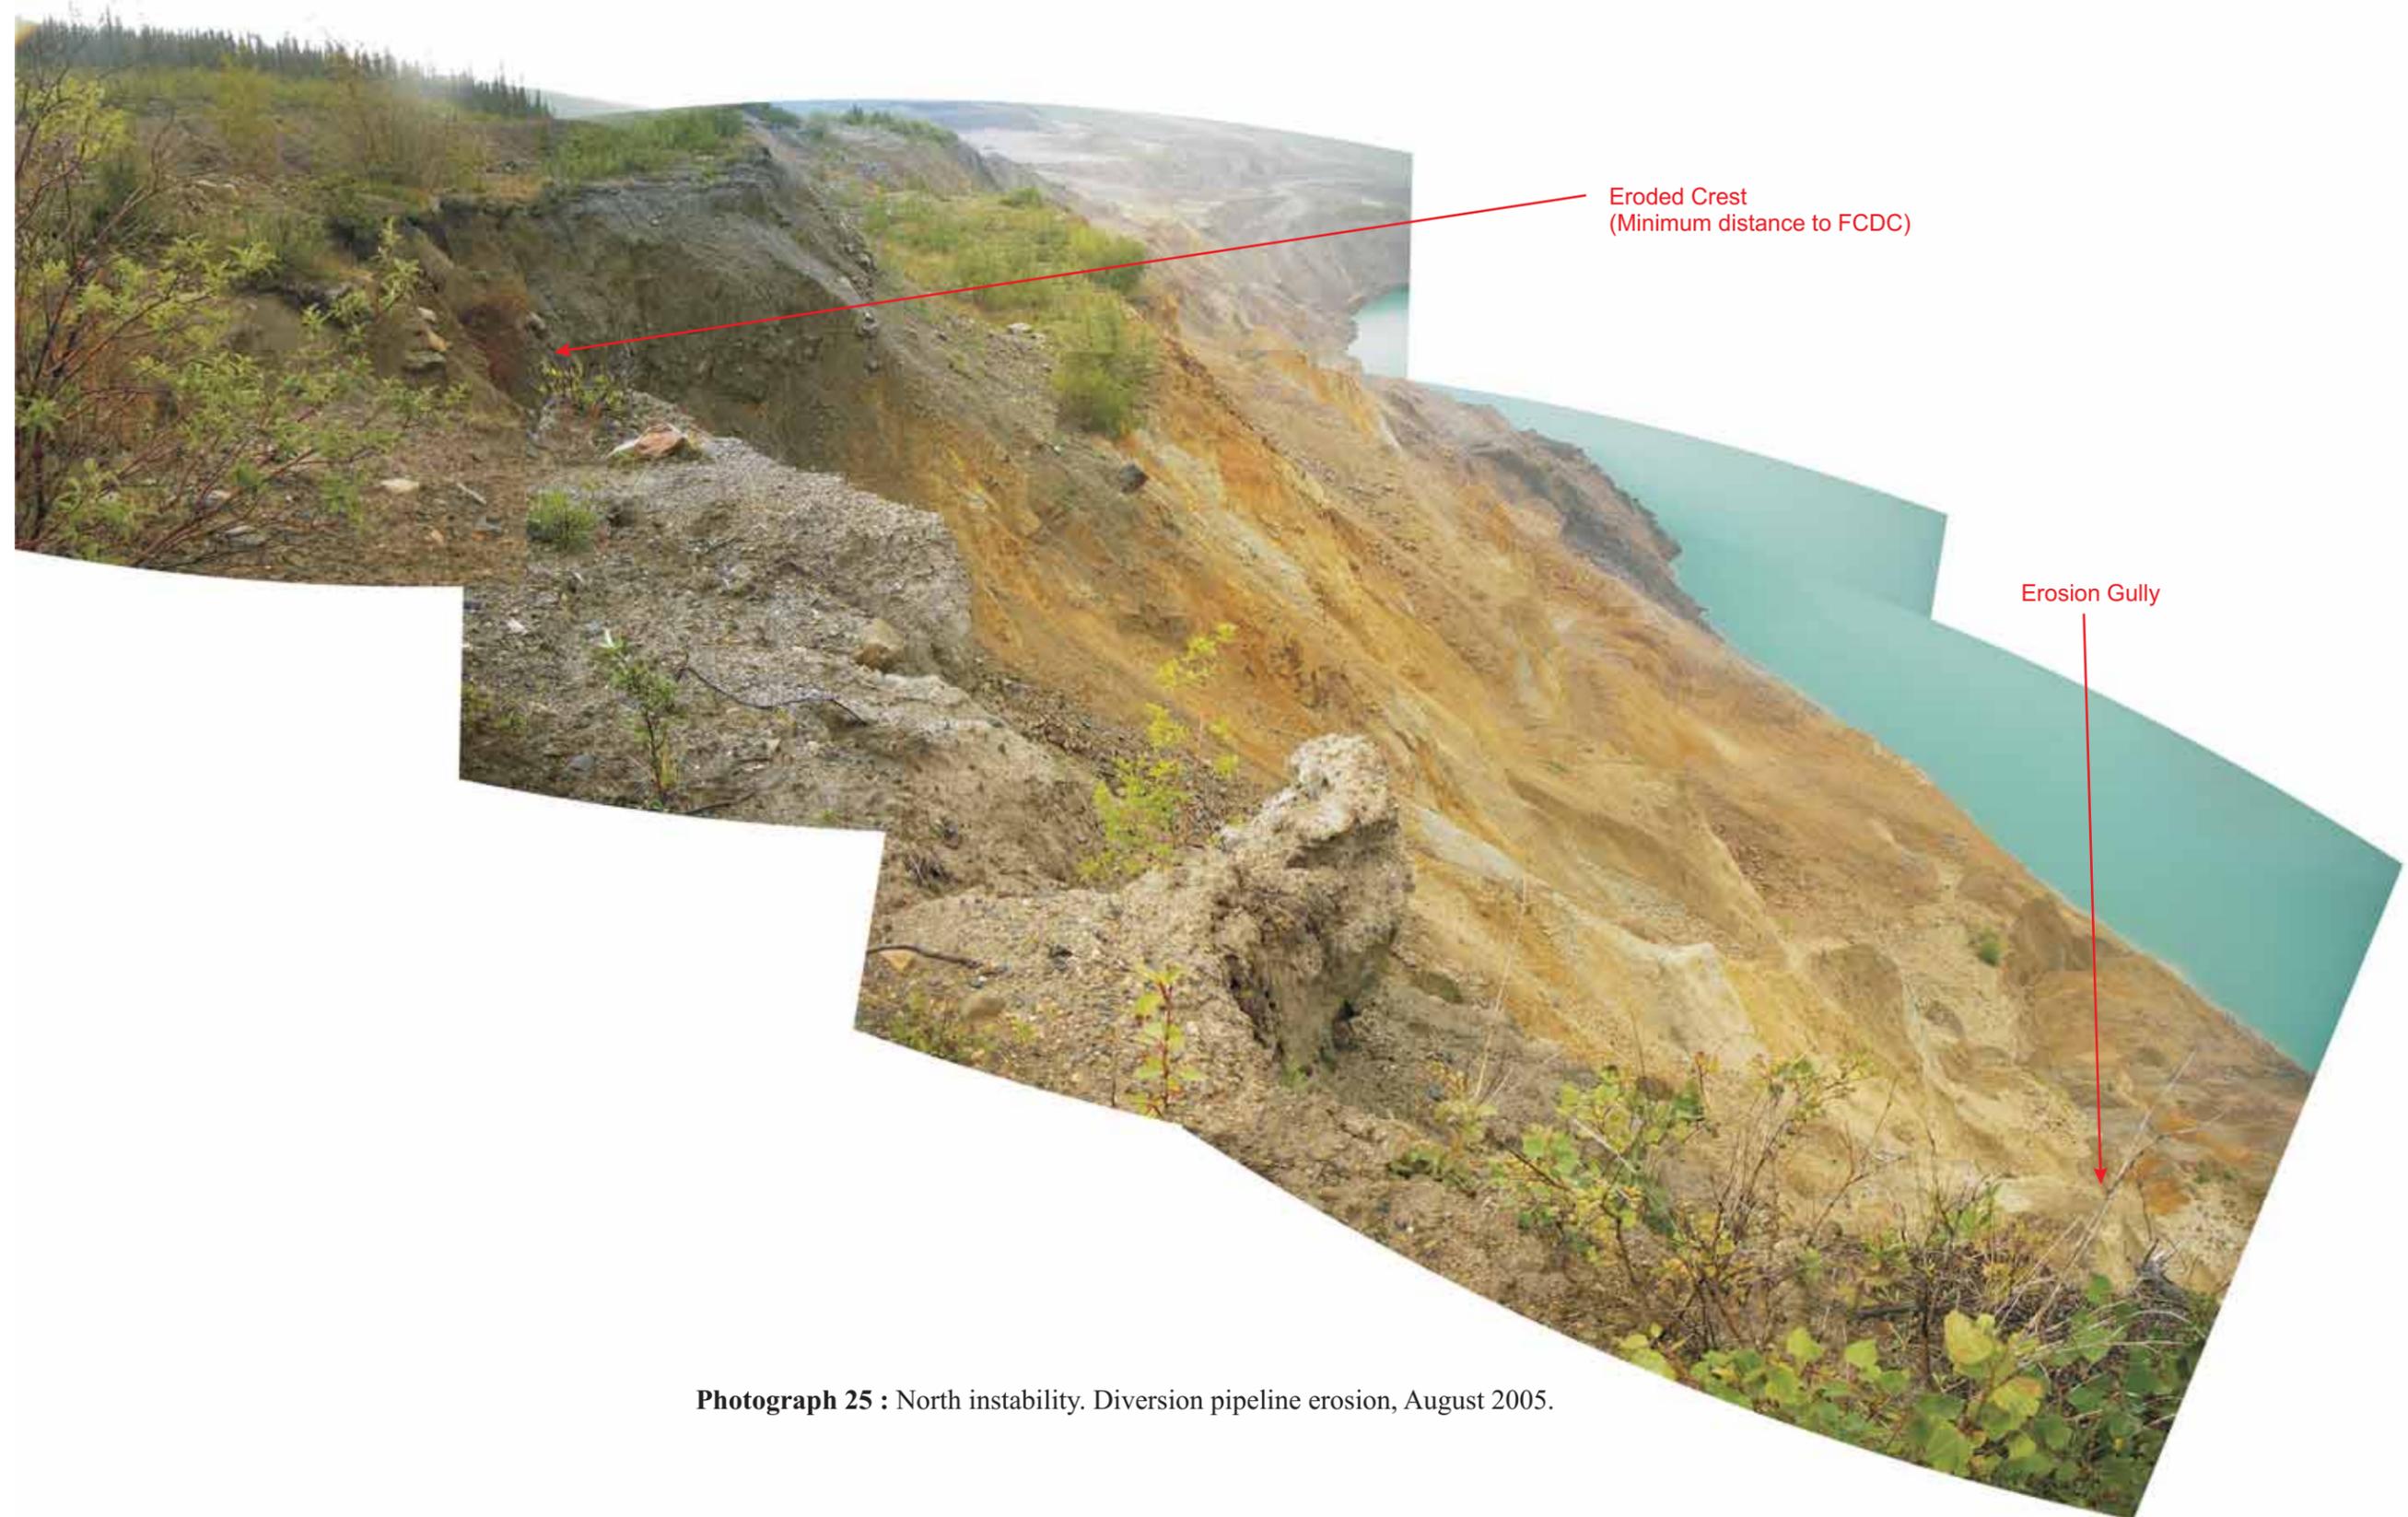
Firstly, during the remedial construction works of the FCDC, a severe water leakage occurred from a temporary pipeline, according to Faro's staff. The pipeline was set up as a water diversion from the channel during the execution of construction works. The leakage flowed through the slope crest at the minimum distance location, and an erosion gully was formed on the steep overburden scarp and affected the debris accumulated at the lower slope (Photograph 25). The leakage was eventually controlled, and the erosion gully was reconstructed with till material (Photographs 26).

Photograph 25 : North instability. Diversion pipeline erosion, August 2005.

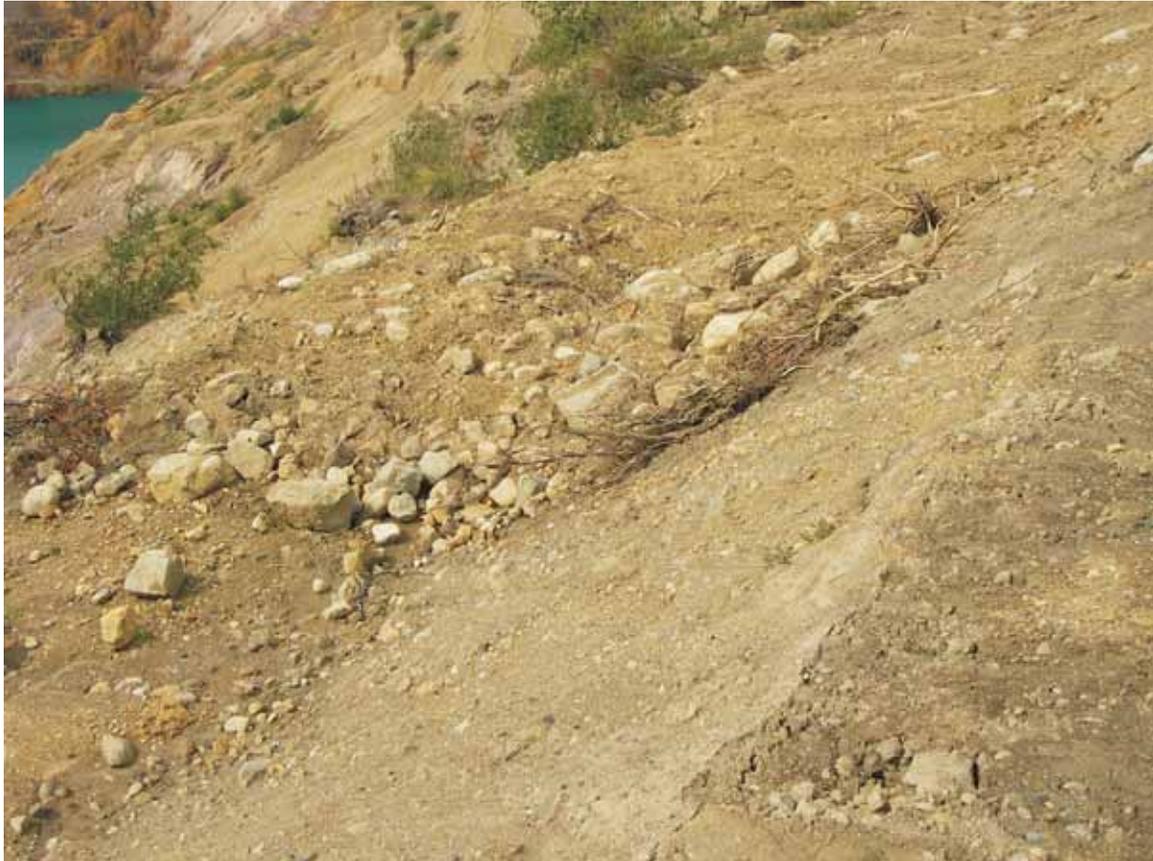
Photograph 26 : Reconstructed crest above North instability at the minimum distance from the FCDC, August 2005.

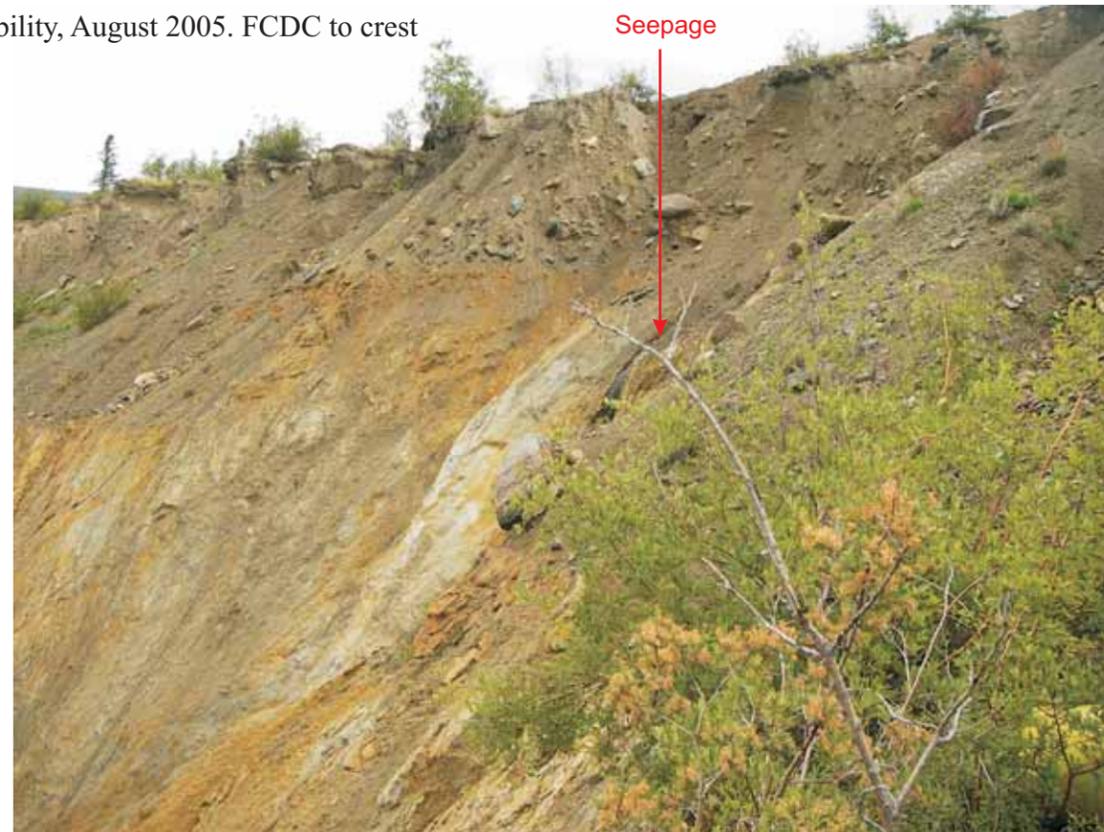
Photograph 29: Seepage at Overburden / bedrock contact. FCDC to scarp crest distance at minimum, August 2005. North instability.

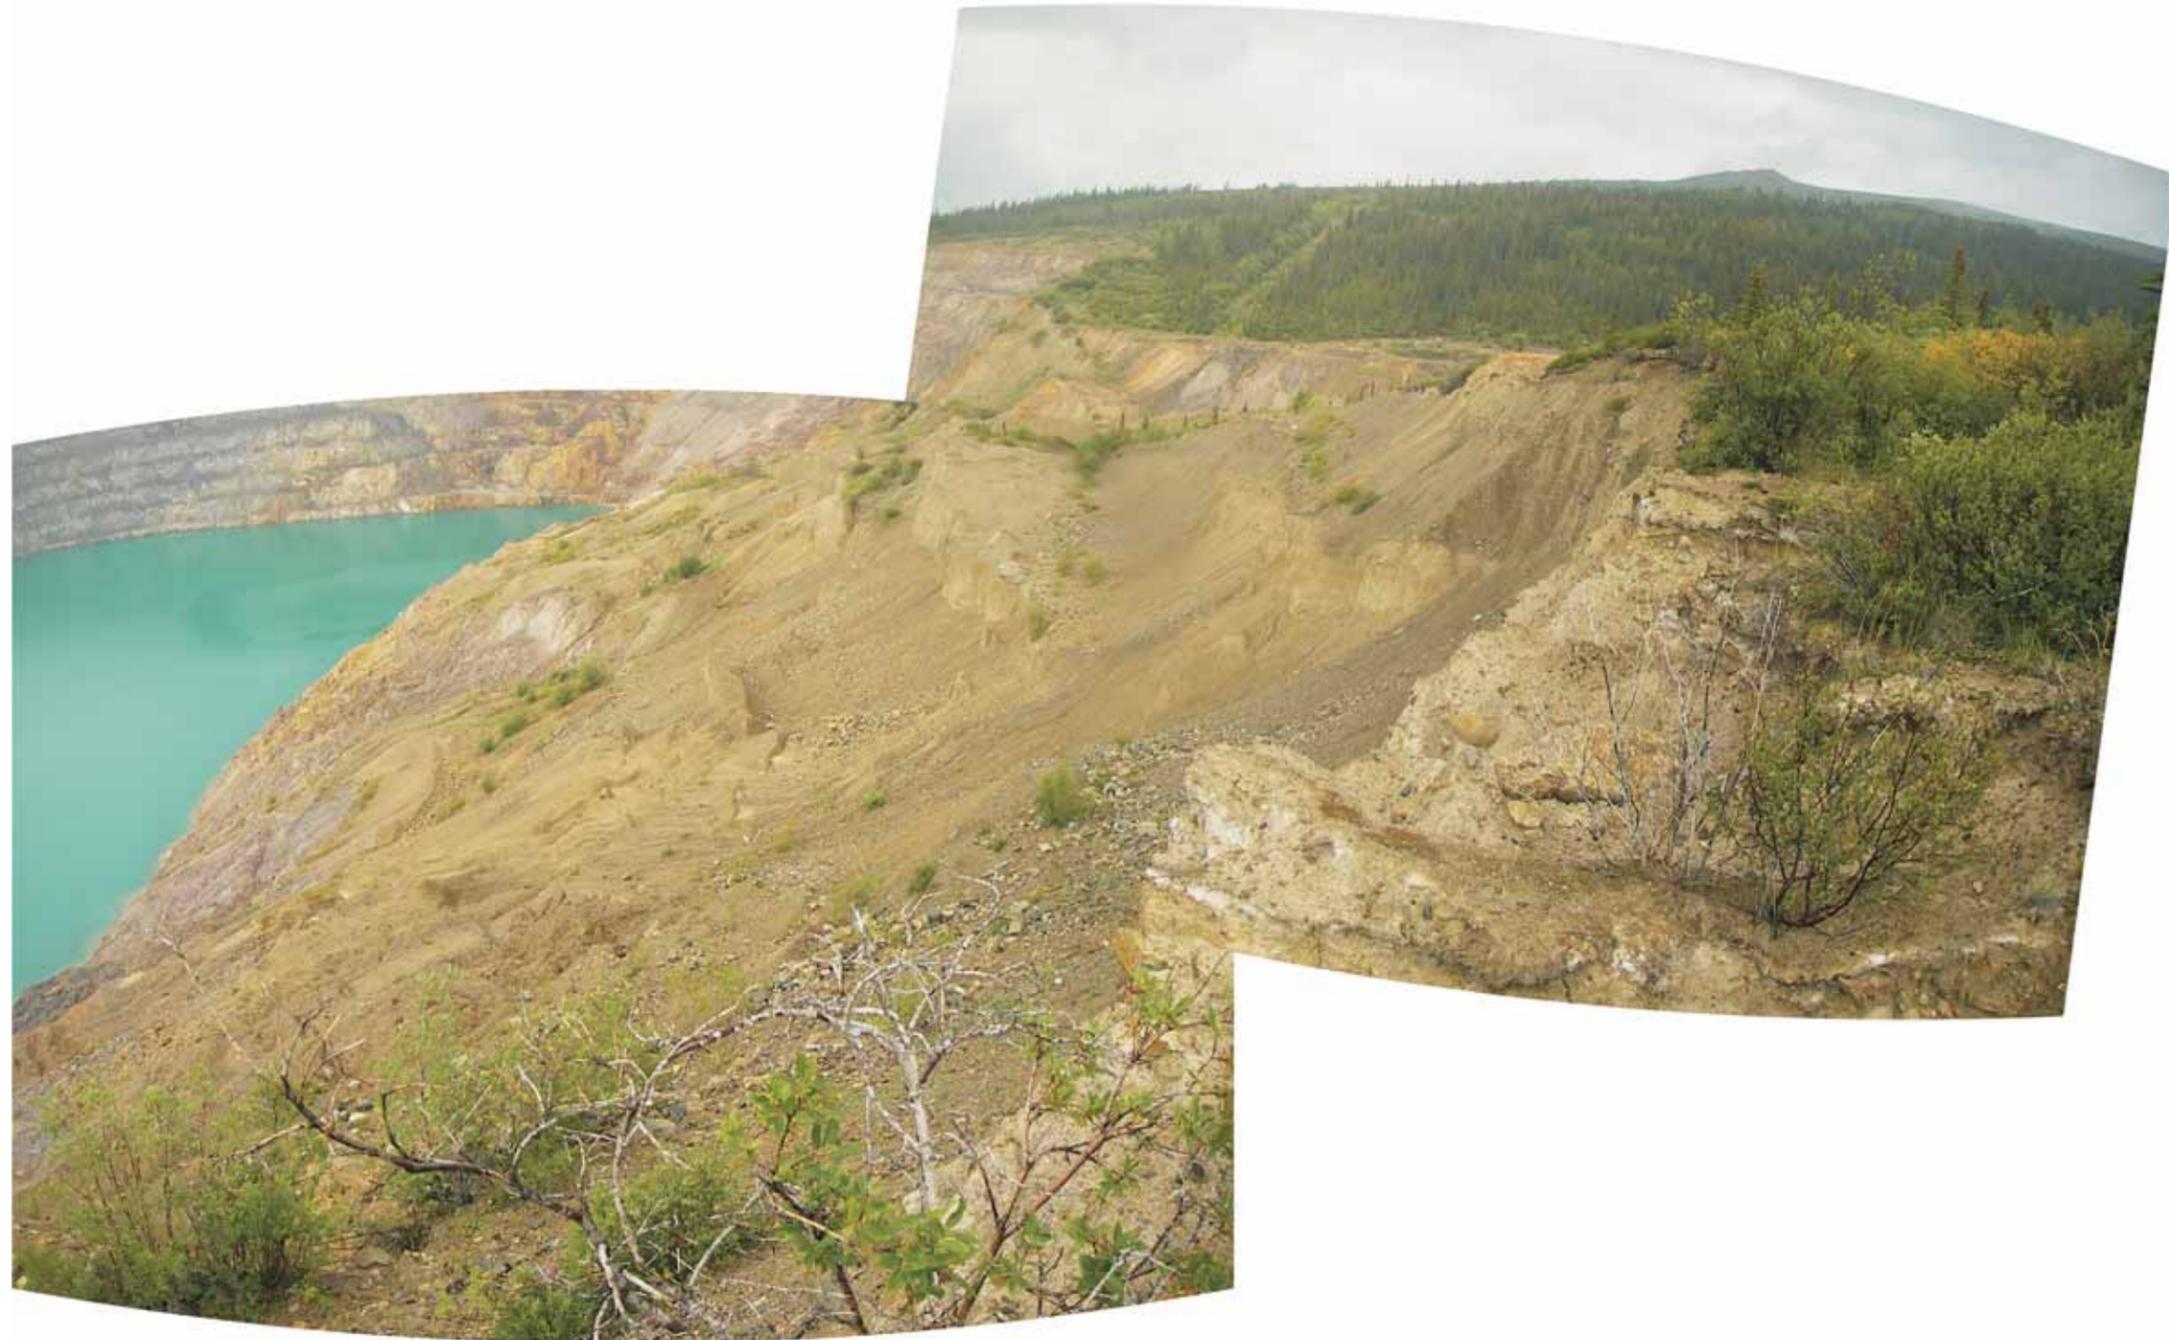
Photograph 30 : Overburden scarp above North instability, August 2005.
Note raveling process.

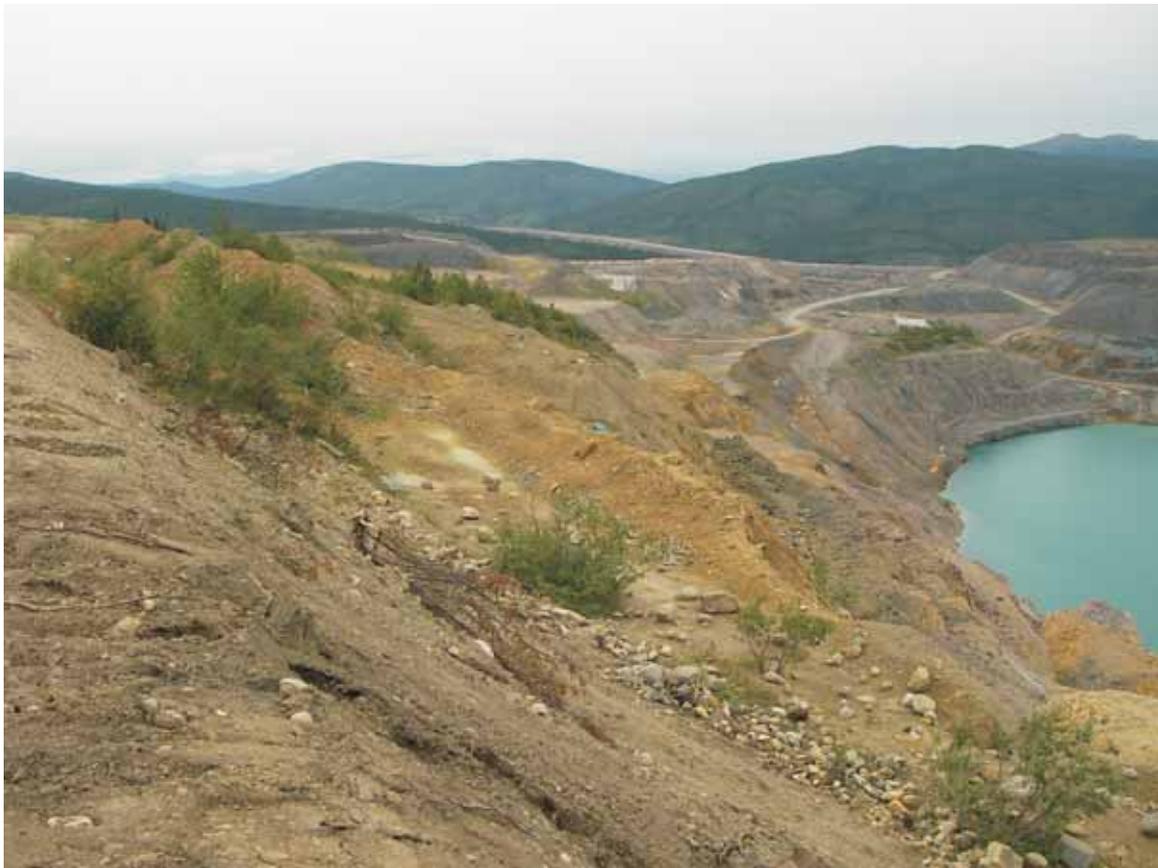
Photograph 31 : Slope benches above North instability. Suggested location for survey monitoring points, August 2005.
