**PROJECT:** Mount Nansen Dam Safety Assessment

**GEOTECHNICAL DATA REVIEW REPORT  
Mount Nansen Tailings Dam Safety Evaluation**

Project No. 0201-99-14108

December, 1999

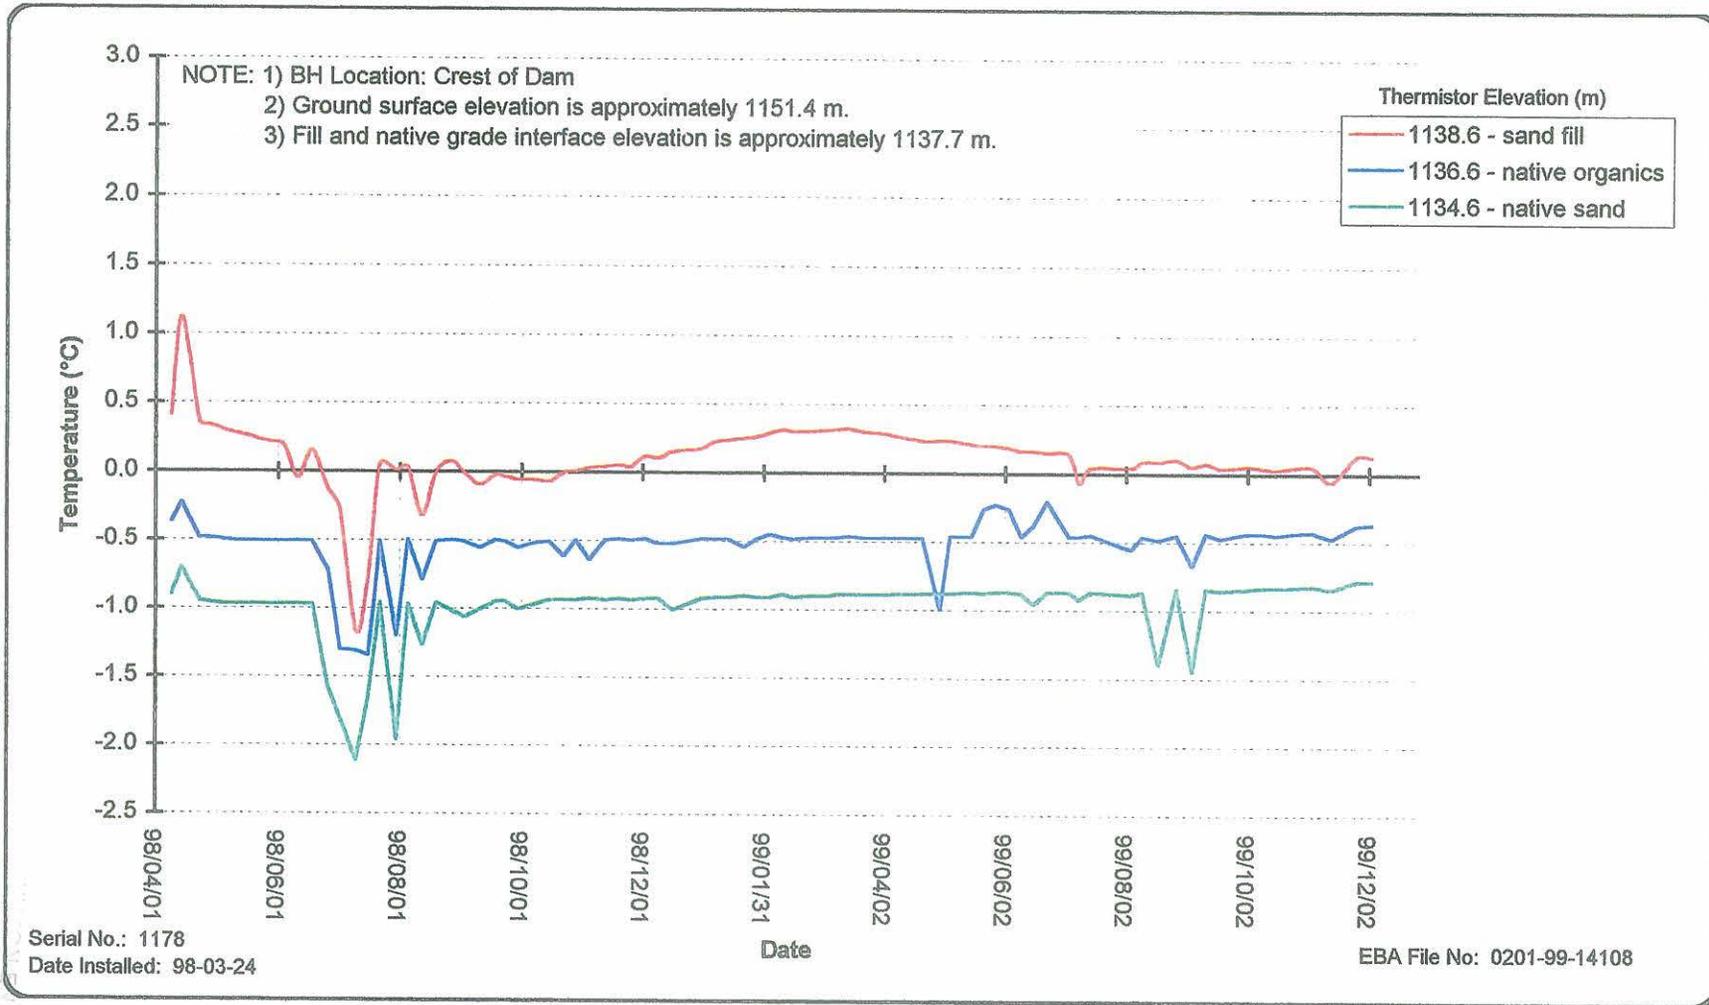
Figure A-1  
Ground Temperature History  
BH 12861-01

The depth to the 0°C isotherm is estimated to be near the fill and native soil interface and has extended upward into the fill slightly at some times. Generally, the location does not seem to have experienced any significant thaw of native foundation soils.

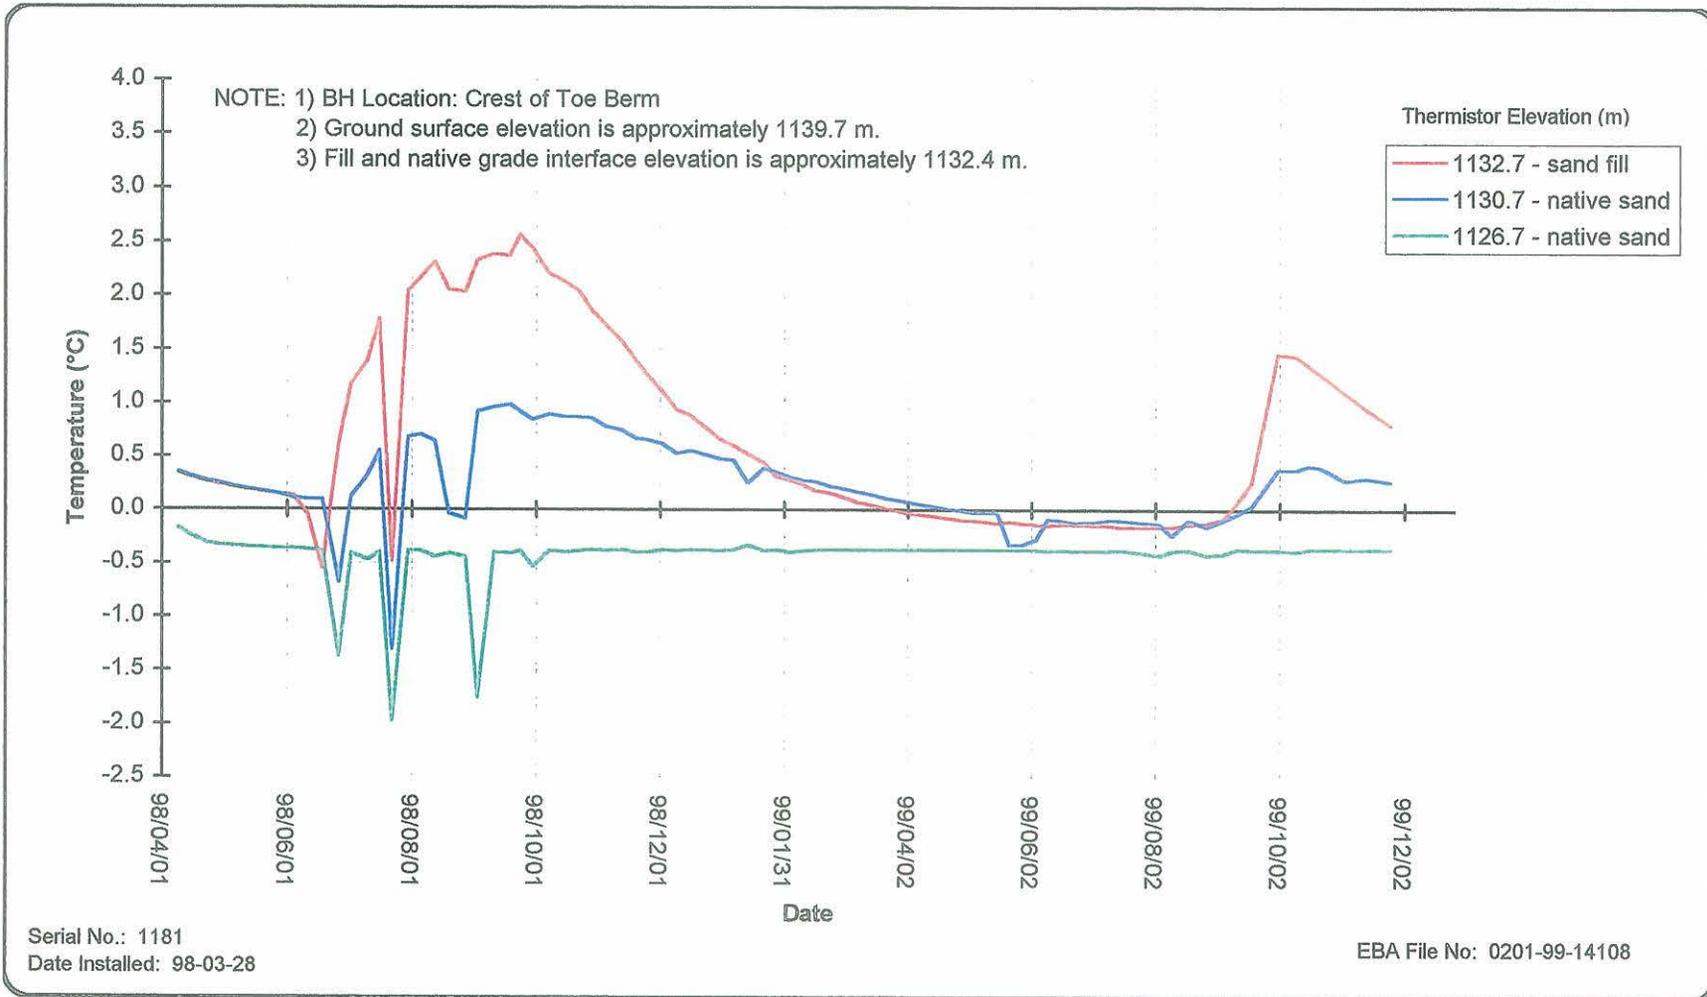
Figure A-4  
Ground Temperature History  
BH 12861-05

Unlike the thermistor data from the dam crest, the seasonal variation of ground temperatures indicated by the upper two thermistor beads follows the classical lagged pattern prevalent in permafrost areas. This typically results in the warmest ground temperatures (greatest depth of thaw) occurring the late fall and the coldest temperatures (deepest seasonal frost penetration)

occurring the late spring or early summer. Hence, the ground temperature variations lag behind the ambient air temperature variations. At this installation, the highest ground temperatures were observed during late September to early October, while the coolest temperatures were in mid summer (July).

The third thermistor bead at this location lies below the permafrost table and has not been noticeably affected by seasonal temperature changes. It has maintained a temperature in the range of  $-0.4^{\circ}\text{C}$  to  $-0.3^{\circ}\text{C}$ ; however, it does appear to be gradually warming.

The depth to the  $0^{\circ}\text{C}$  isotherm inferred by the thermistor data varies widely over the course of measurement. Even ignoring the data from the initial spring following installation, the range is from a depth of less than 7 m to over 11.8 m. Thus the permafrost table varies from some unknown height above the fill interface to as much as 4.5 m below the fill interface.

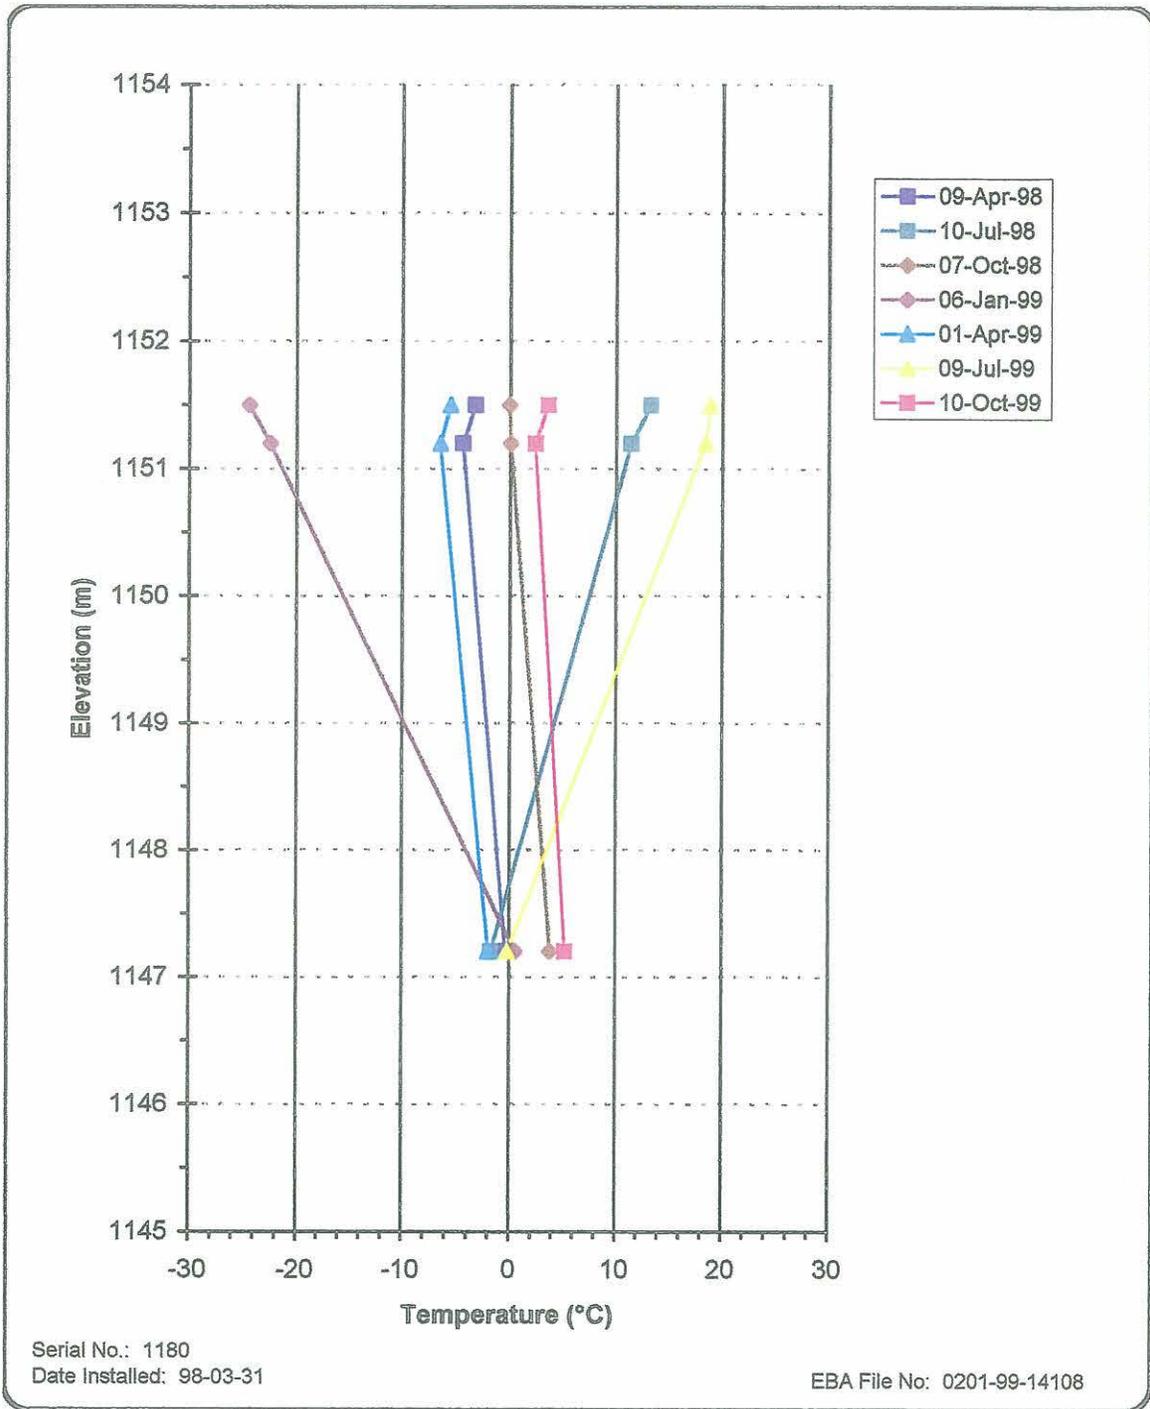
Figure A-3P  
Ground Temperature Profile  
BH 12861-03

Ground temperature data from this borehole is presented on Figures A-3 and A-3P. As was discussed in Section 3.1, the three thermistor beads at this location are located near the crest of the dam and do not provide any information on the permafrost table position at this location. Nevertheless, the three shallow thermistor beads do provide some correlation between air temperatures and ground temperatures that may be useful for additional thermal modelling.

In terms of thawing of native soils at this location, the only known depth is derived from the drilling program where permafrost was encountered at an elevation of 1133.3 m. Given that the fill interface is estimated to be between an elevation of 1136.9 m to 1138.2 m, the depth of thaw was estimated to range between 4.9 m to 3.6 m at the time of the drilling program.
