Glaciation Assessment and Remediation

Of The Dome Creek Diversion Channel

At the Mount Nansen Site

December 12, 2011

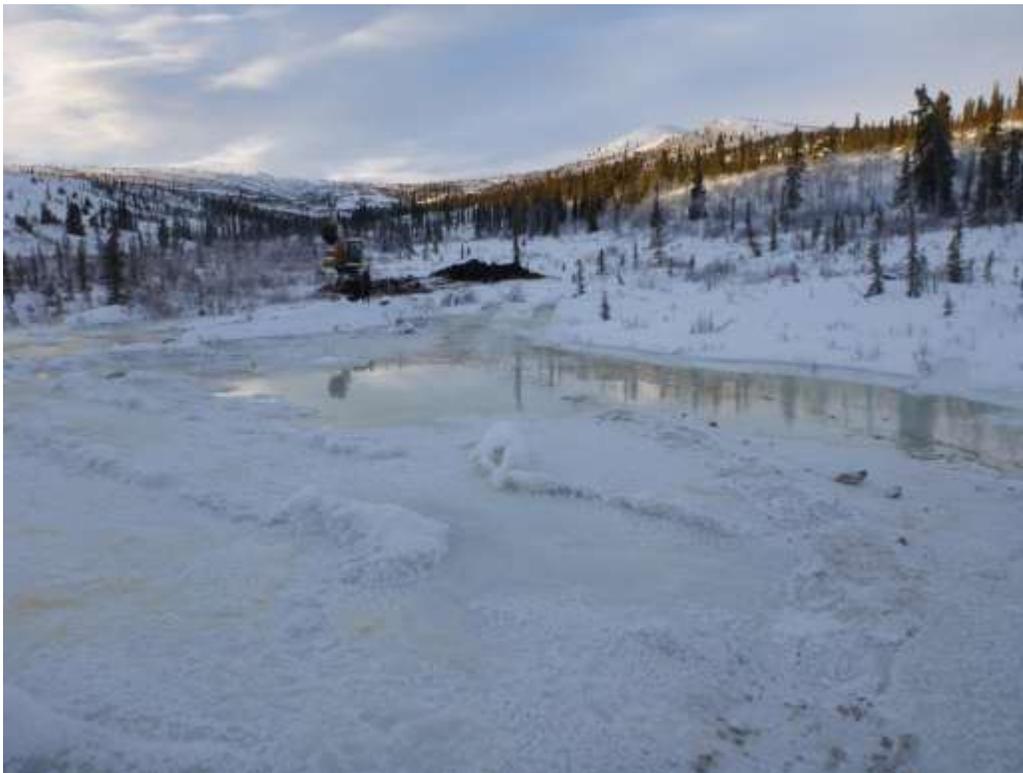
Water quality and flow monitoring activities necessitating excavations through the ice caused further surface flow (estimated to be 3-4 L/s) due to the release of pressure under the ice layer. Water had been constrained by the sealing effect of the ice and restrictions to flow in the subsurface channel. If the surface flow were allowed to continue unabated there was a concern that subsurface flow would be reduced and significant surface build-up of ice would result. The area of the up-welling water was then excavated and connected to the spur trench through which the water had previously been passing. Excavation of the area resulted in a higher flow observed (estimated at 6 to 8 L/s). The trench was bermed to increase hydrostatic head on the subsurface water passage and potentially increase flow. Water flow did not appear to be slowing; however it was obvious that a portion of the water flowing from the recently excavated trench headwater was significantly less than that released as surface flow. It was concluded that a portion was dissipating through the subsurface passage.

Photo 1 - Surface Flow

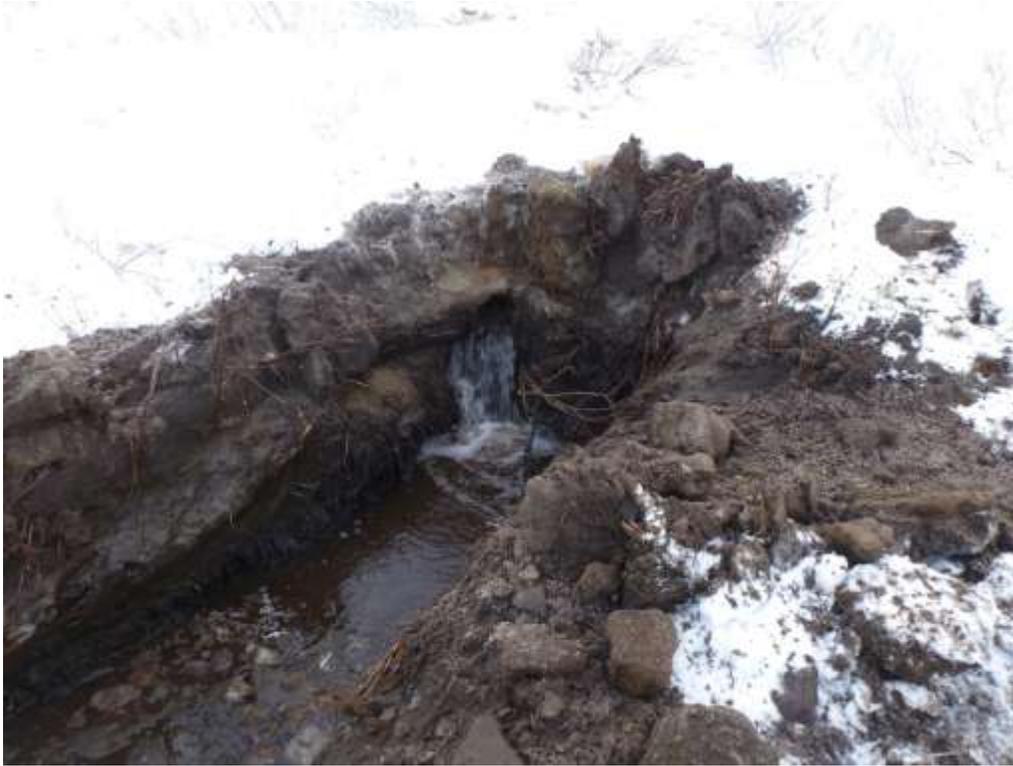
Photo 2 - Increased flow from excavation activities

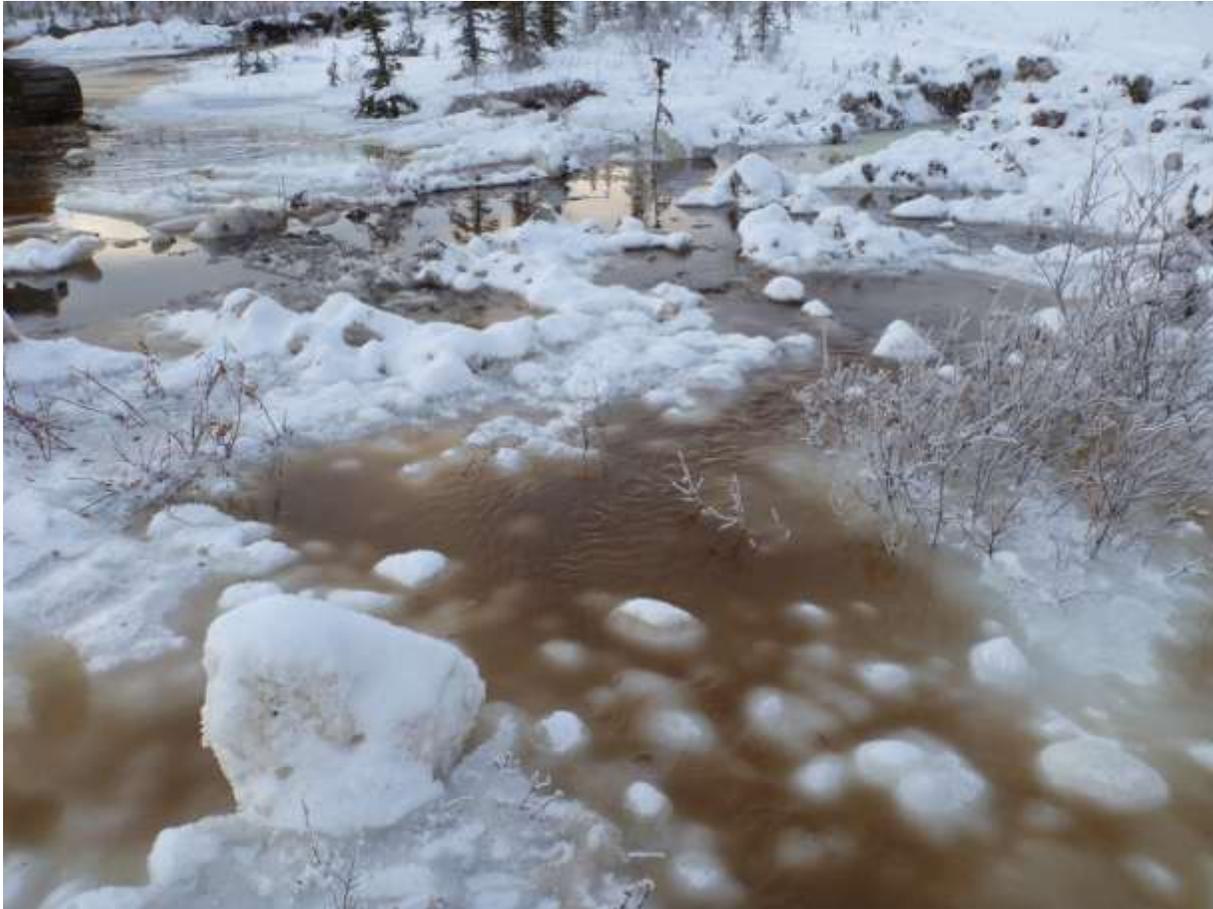
Photo 3 - Increased surface flow caused by trench excavated from upper left corner of picture

Further to release from the trench the water flowed on top of the ice to the next spur trench. In an attempt to reduce the flow and perhaps allow some water to be released under the ice, a hole was excavated into that spur trench. This resulted in a further release as the spur trench was under some hydrostatic pressure.

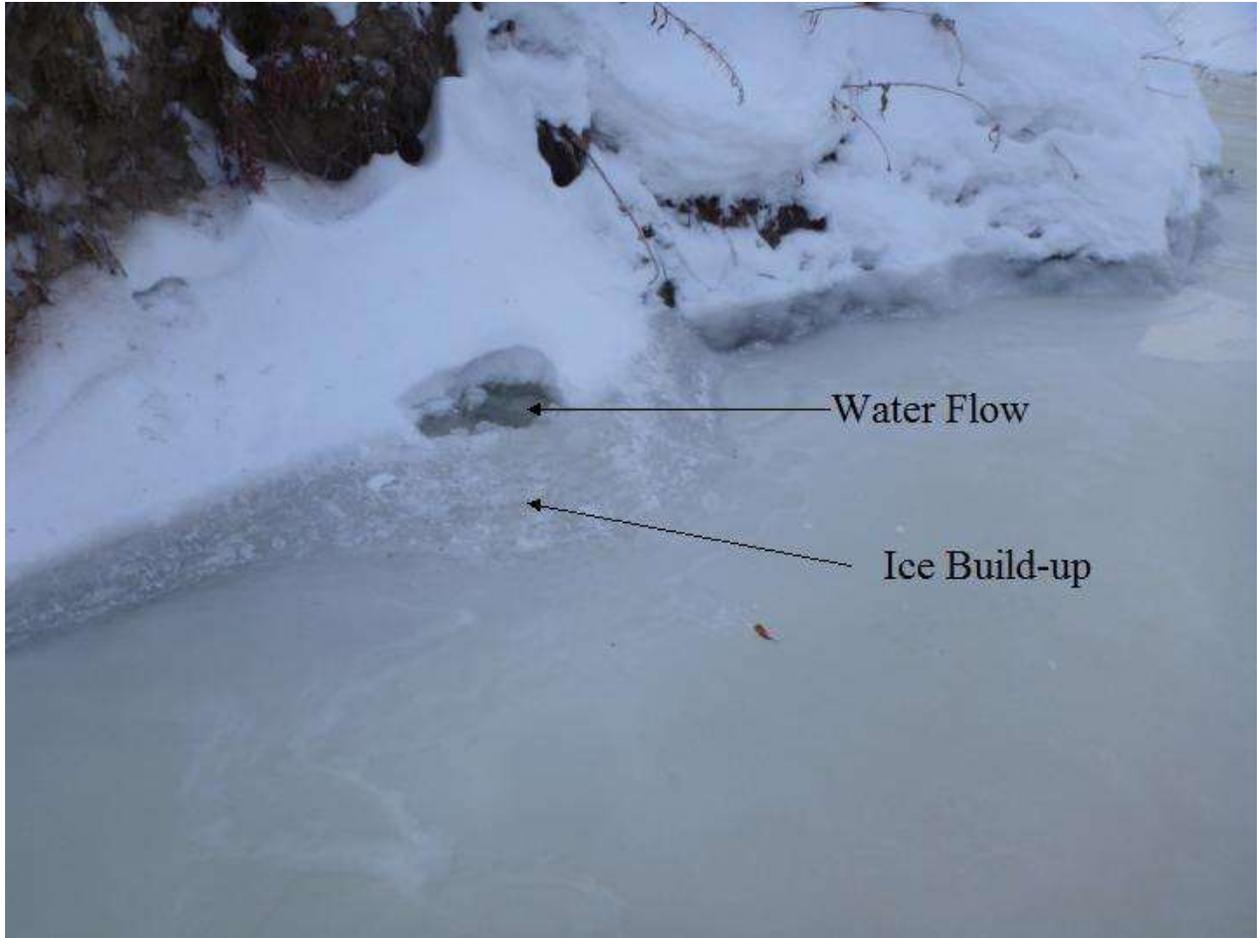
During the site visit it was observed that more water was entering the channel from the south east at the head of the channel near the confluence of two drainage ditches. While the volume of the water was not large it was travelling along the edge of a drainage channel at a higher elevation held in place by an ice build-up at the ice / snow interface, causing ice build-up on the road. Flows are very small and prevention of build-up may be difficult which will likely require machine excavation if it persists.

Photo 4 - Water flow along the edge of the drainage channel

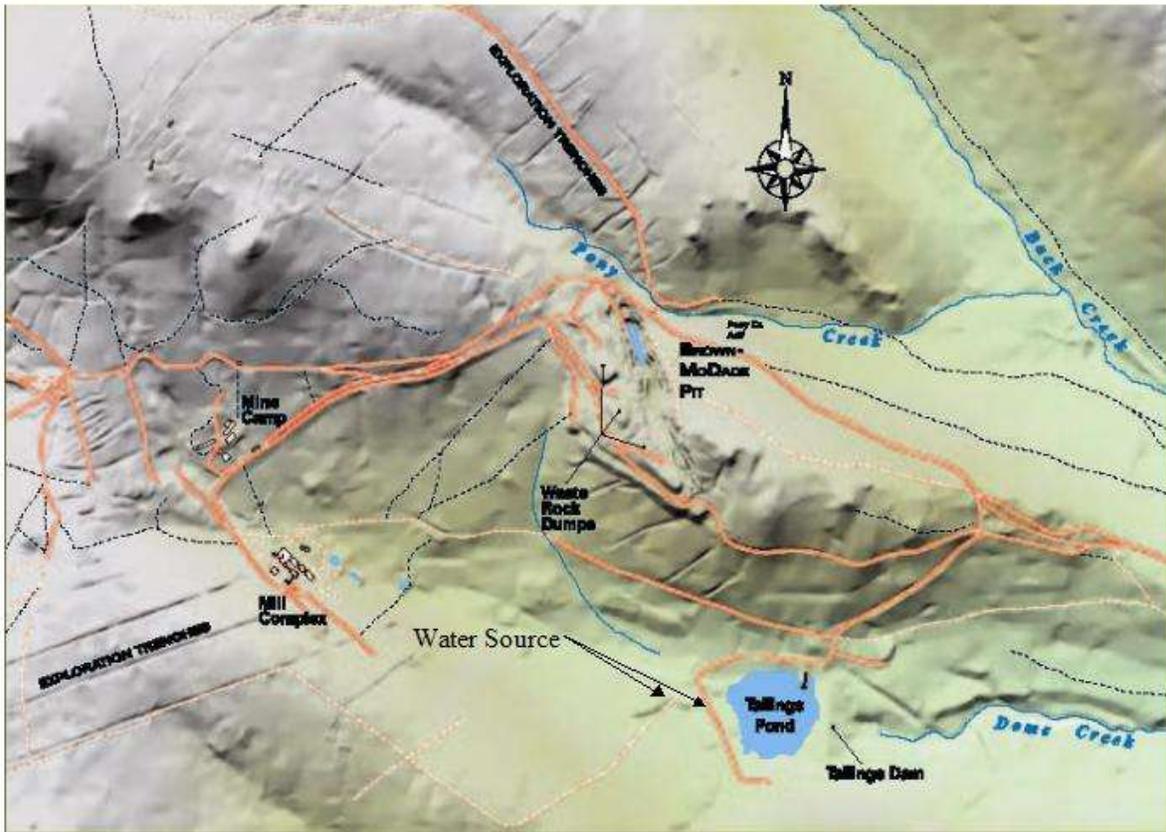
Photo 5 - Water source from drainage channel

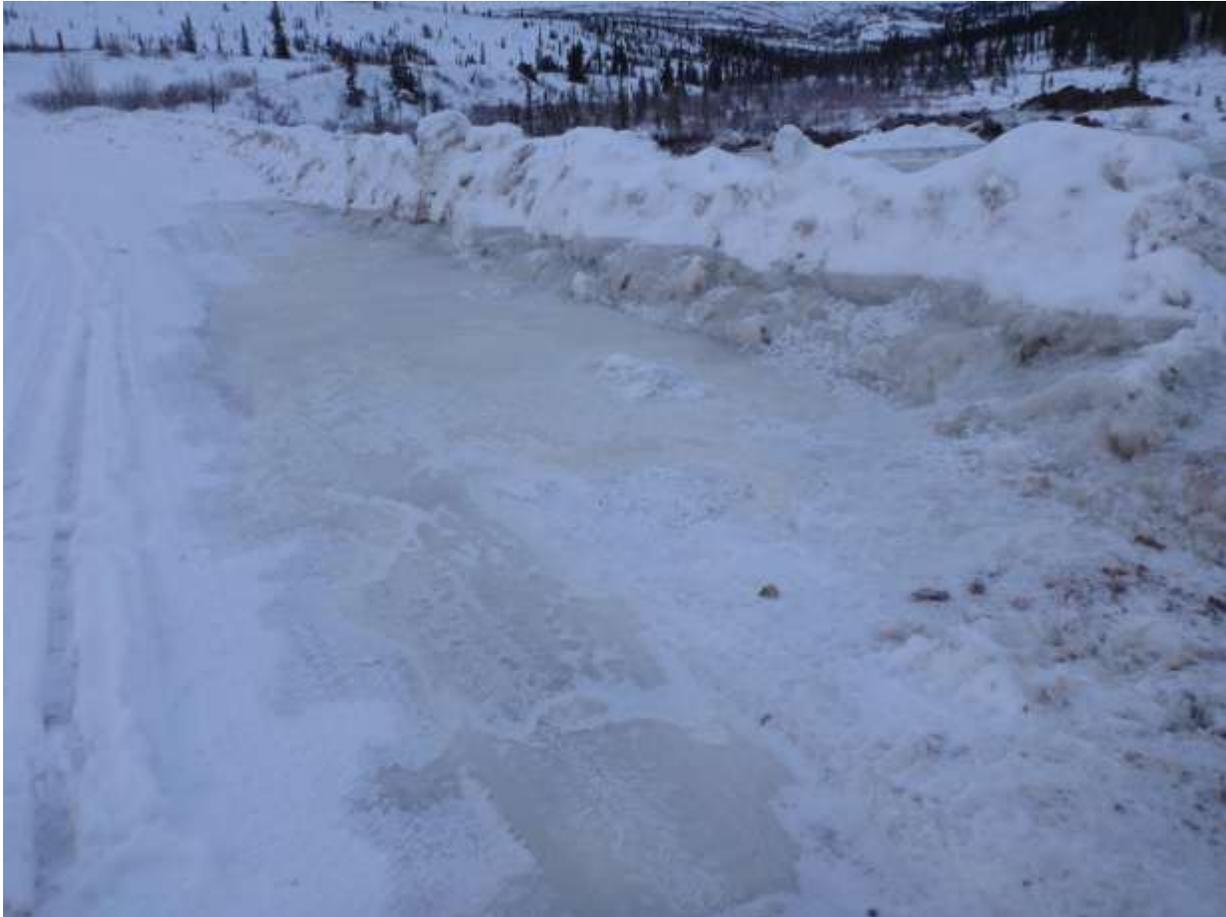
Flow was still apparent from the drainage channels along the south east edge of the diversion channel and had spread out onto the road somewhat further than previous as illustrated in photo 6.

Photo 6 - Ice on road near drainage channel. Note the height of the ice along the snow bank.

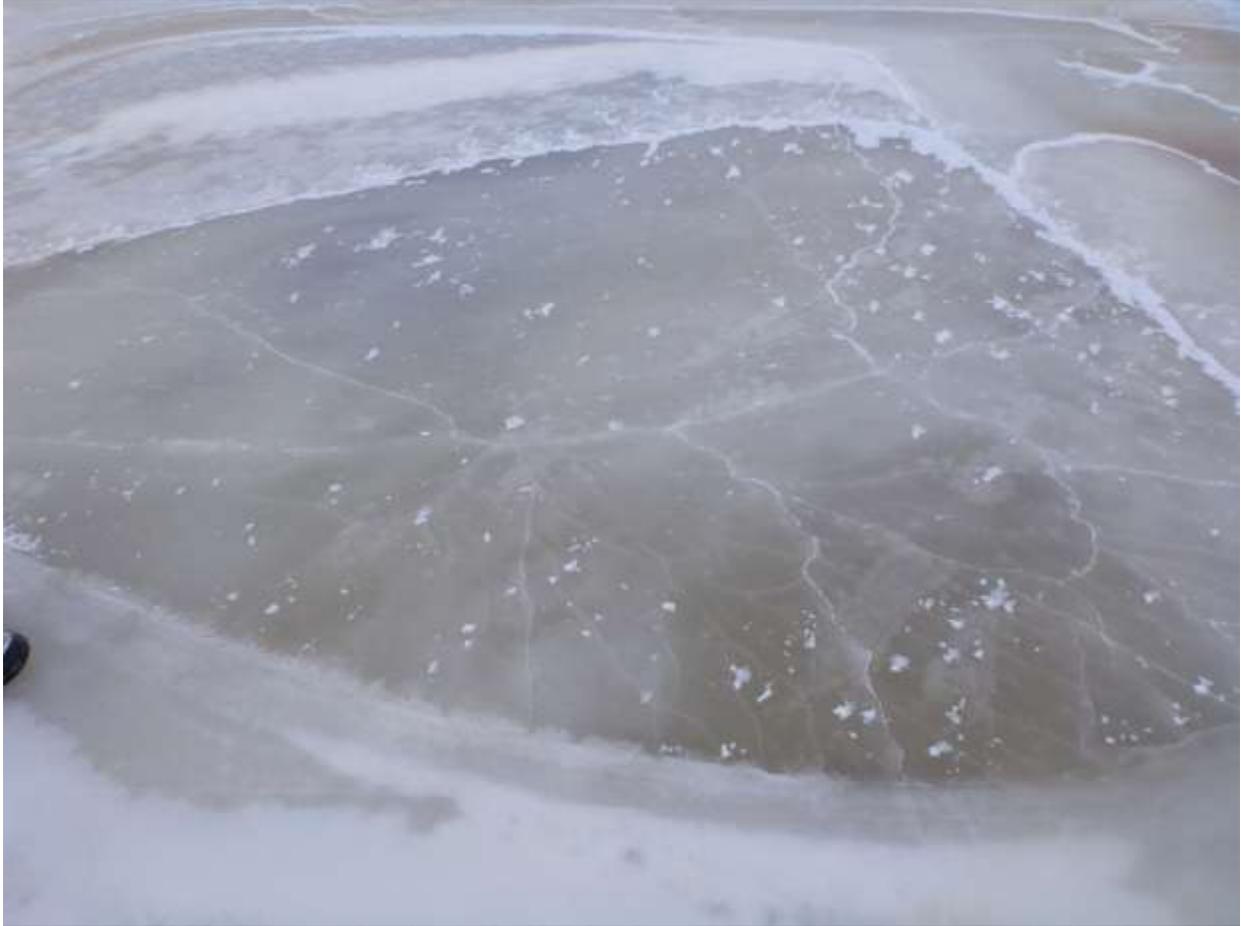
Several areas on the surface of the ice were observed that had been forced upwards, presumably by the subsurface hydrostatic pressure. The ice had developed a bulge and cracked radially from the center of the bulge as depicted by photos 7 and 8.

Photo 7 - Bulging ice showing radial tension cracks

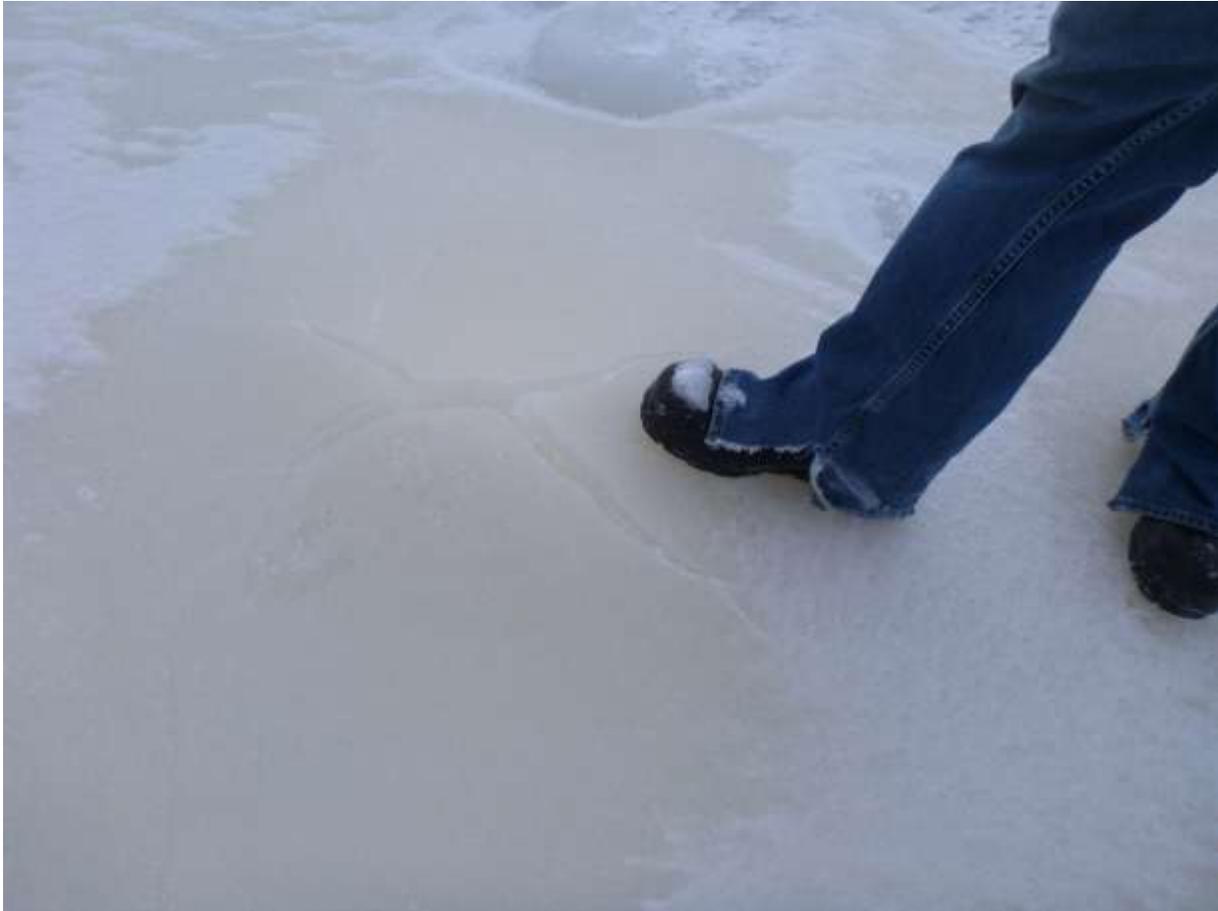
Photo 8 - Bulging ice showing radial tension cracks

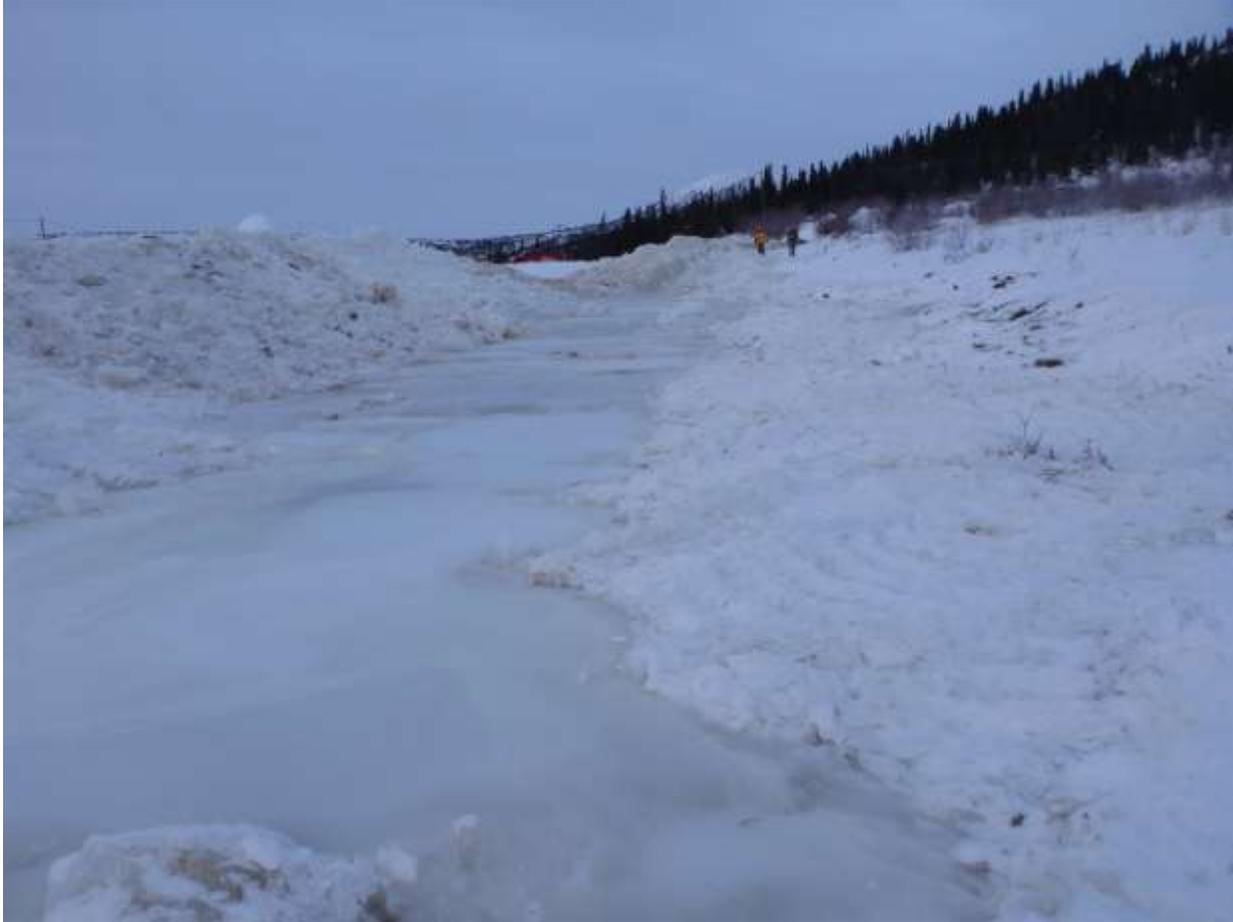
That portion of the channel directly below the bridge had seen extensive build-up where the water is released from the trench and evaporated to the atmosphere (Photo 9). A concern is that the ice will continue to build-up and prevent the water from escaping the trench to the diversion channel downstream. For this reason the Site Operator has been instructed to excavate that material from the channel to allow the water to flow. This will need to be done regularly over the winter.

Photo 9 - Ice build-up downstream of bridge. Note the large volume of excavated ice on the left.

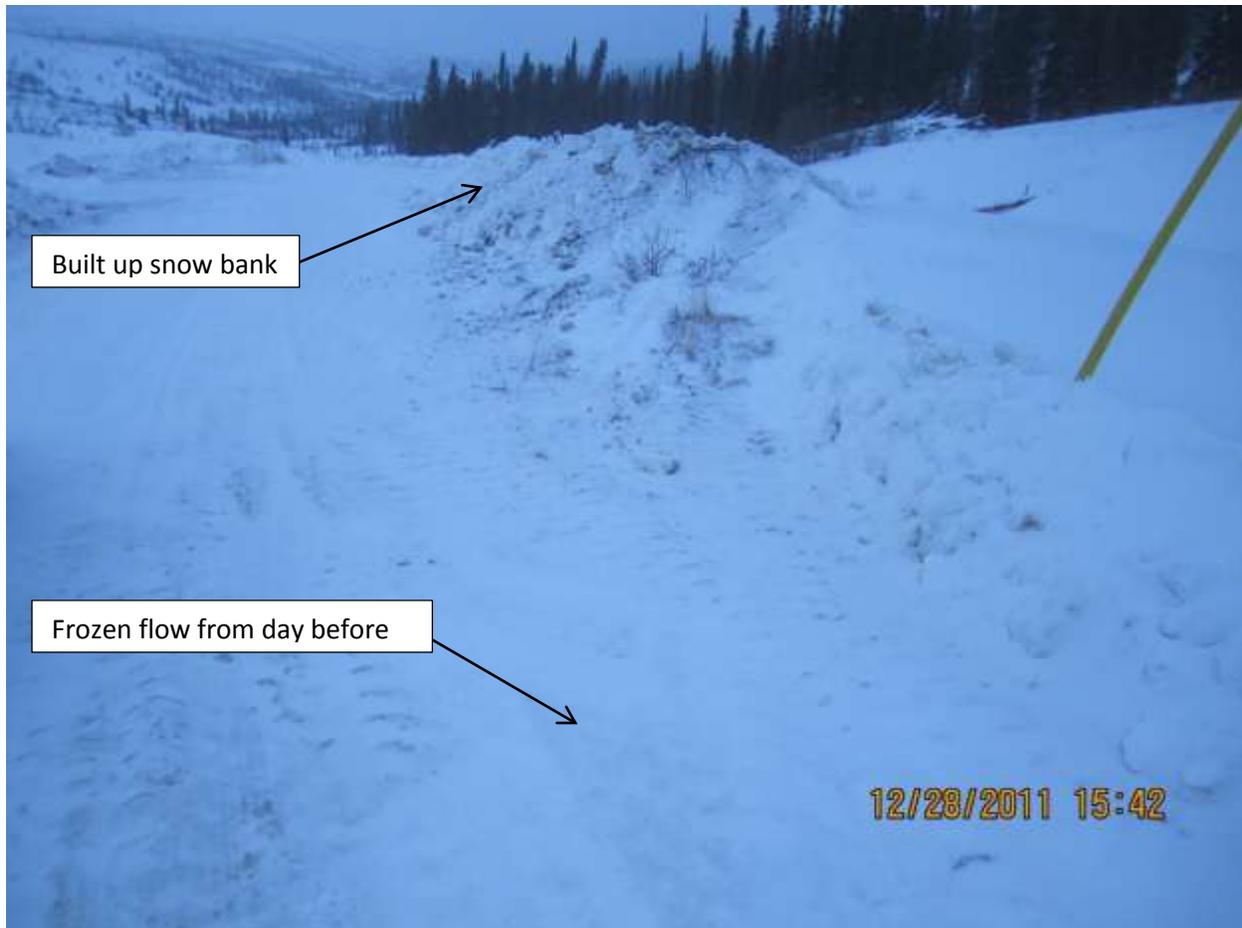
Warm weather over the past week has caused some further surface flow originating from the north (uphill) bank, and approximately half way along the channel. This flow has migrated across the channel and surfaced on the road in the low spots which had previously been used to access the channel. Machinery had been crossing the snow bank to access the channel and as a result reduced the effectiveness of the snow bank as a barrier to flow. The front end loader on site was used to carry snow to these locations and build up the bank.

Photo 10 – Snow bank built up to reduce flow from channel onto road

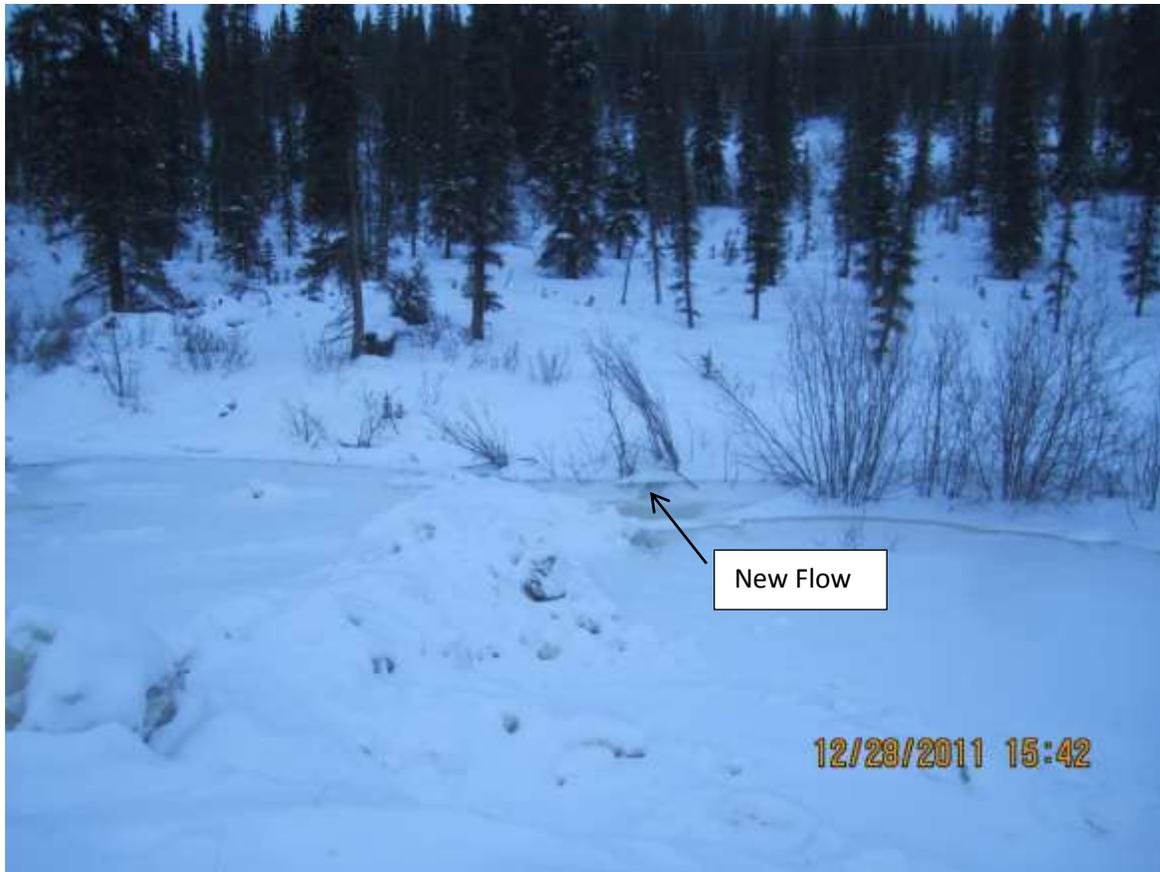
Very little flow was observed from the uphill side of the channel, although when it does appear it is generally from a new location. This may be because the hydraulic gradient of the subsurface waters is decreasing due to restricted flows through the channel in the diversion.

Photo 11 – New flow from the uphill bank, minor volume.

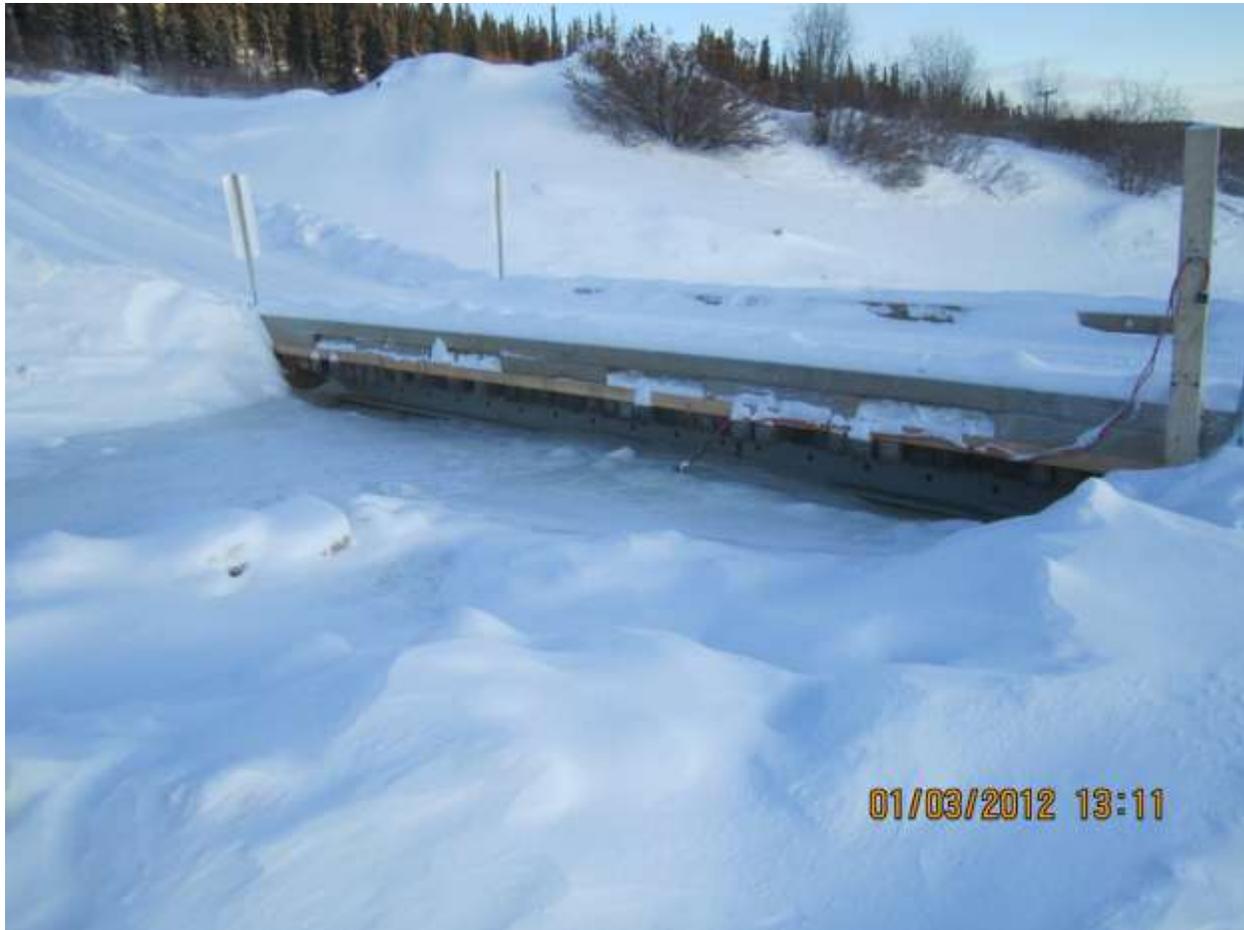
Significant amounts of water had been released onto the surface of the channel over the last few days which resulted in a build-up of ice directly upstream of, and underneath, the bridge. Ice had built up to the point that the lower flange of the upstream side bridge beam was covered with ice. The ice by itself is not likely to damage the bridge however the indirect results of the ice could have drastic consequences for the structure. Of specific concern is the cause of the overflow, whether the channel under the ice had closed off to prevent the water from moving or for another reason.

Photo 12- Ice build-up to bridge beams

If the ice is allowed to remain in place and a second overflow event occurs, water passage will be blocked at the bridge. This will result in an ice build-up to the level of the deck of the bridge which will result in significant lateral forces during spring freshet and any melting event. Also another concern of importance will be the water movement during spring freshet, as the water will either run around the bridge causing erosion of the abutments or will find a passage over the diversion channel berm, which could erode the berm resulting in a loss of the diversion channel.

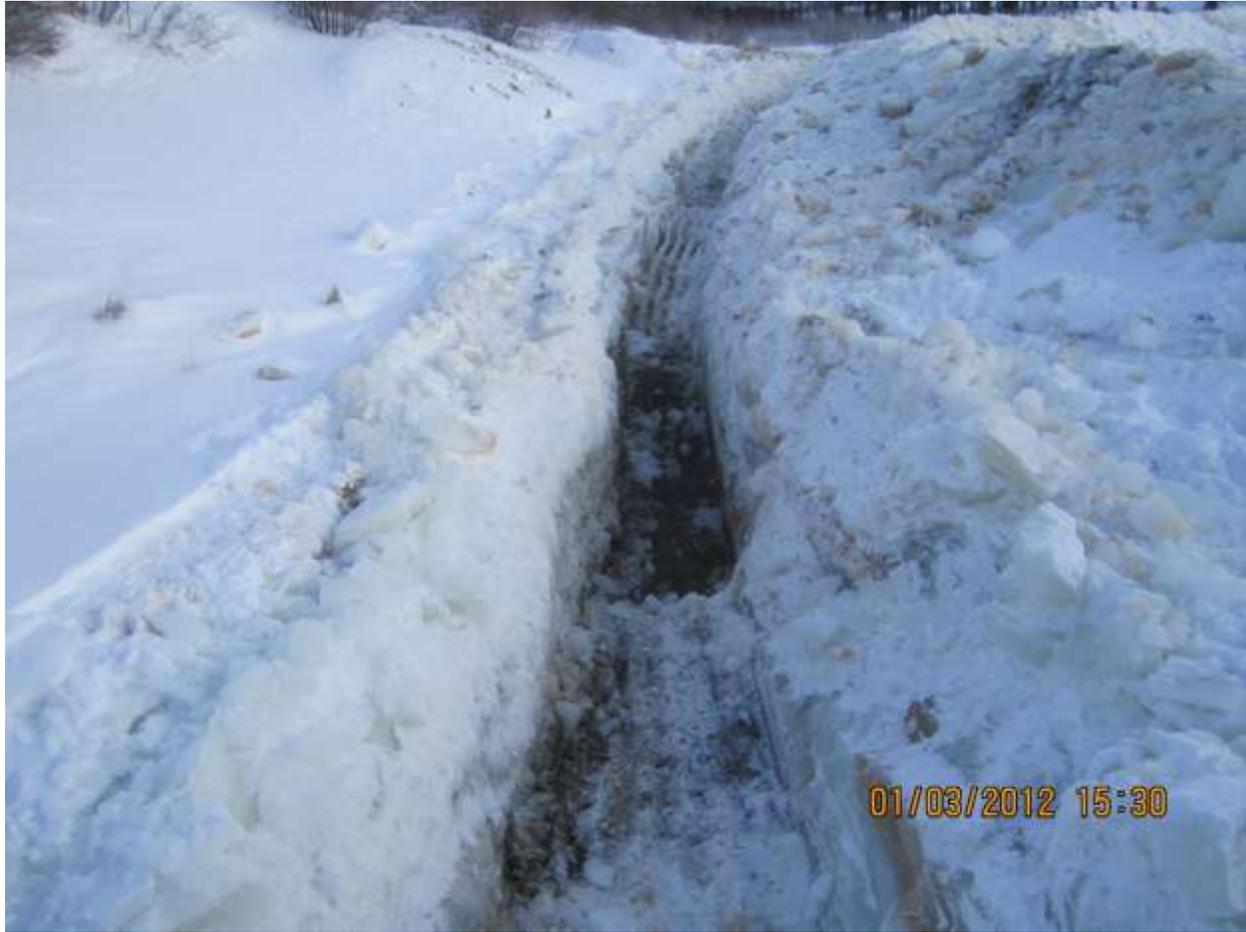
One potential reason for the assumed blockade was that the outlet from the channel had frozen to result in a backup of the water and an increase in channel hydraulic pressure near the bridge. The site Care and Maintenance Operator was asked to excavate the channel below the bridge starting from the outlet. The channel was found to be frozen throughout the area downstream of the bridge.

Photo 13 - Dry channel below bridge

The excavator then excavated a channel on the upstream side of the bridge. Approximately 100 m of channel was excavated, to the point where water began to flow again. This water was released from under the ice and contributed a significant flow to the excavated channel. Water travelled down the recently excavated channel to flow around and over the ice under the bridge. Sufficient room was available for the water to pass under. A further passage existed in the previous channel where the heat trace prevented freezing.

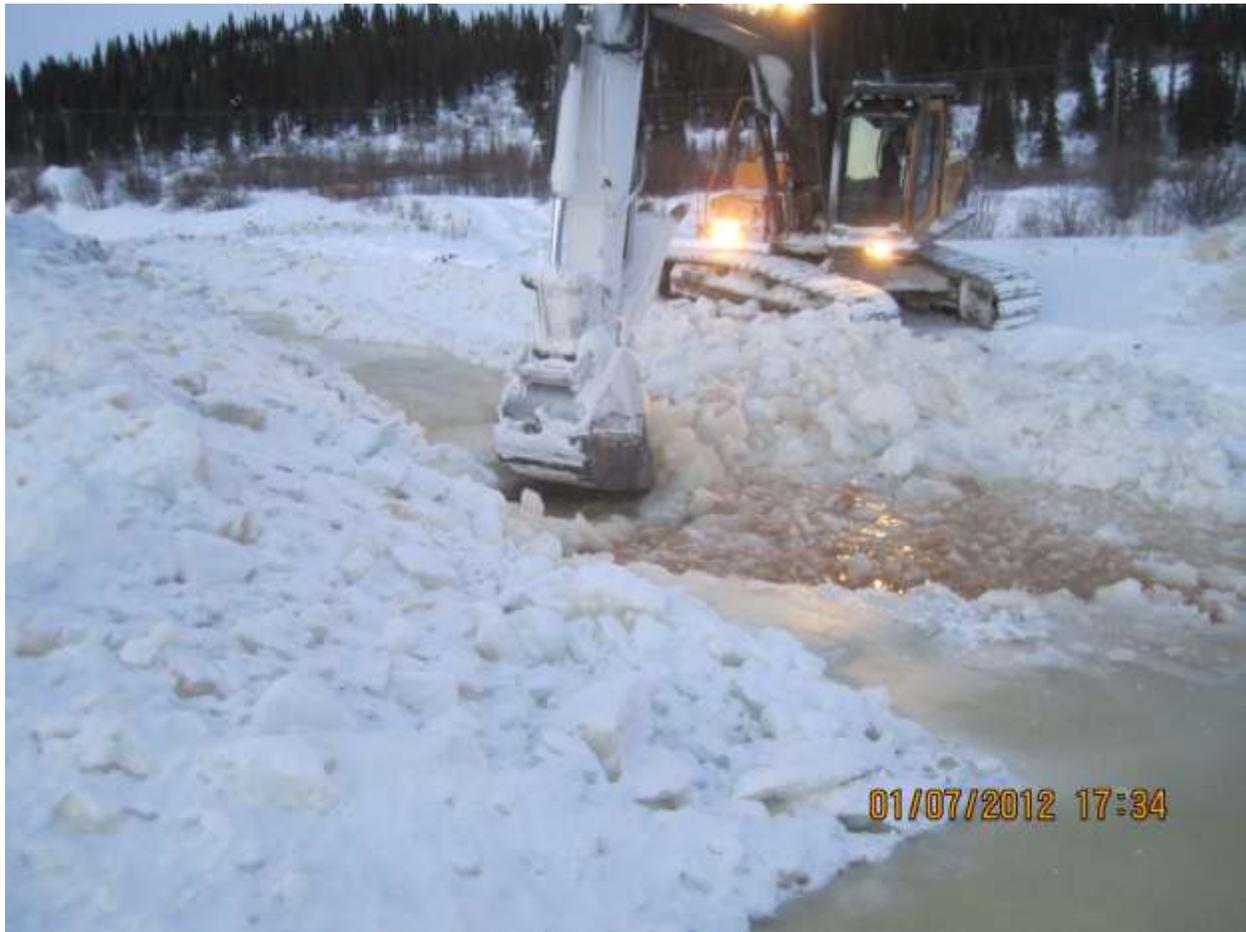
Photo 15 - Excavation of channel ice

The Volvo excavator had no problem excavating the ice, whereas the care and maintenance operator's machine was not able to remove it without the CAT dozer ripping it first. That evening, the channel ice was removed upstream of the bridge as far as the pipes across the channel and effort was resumed again the next morning.

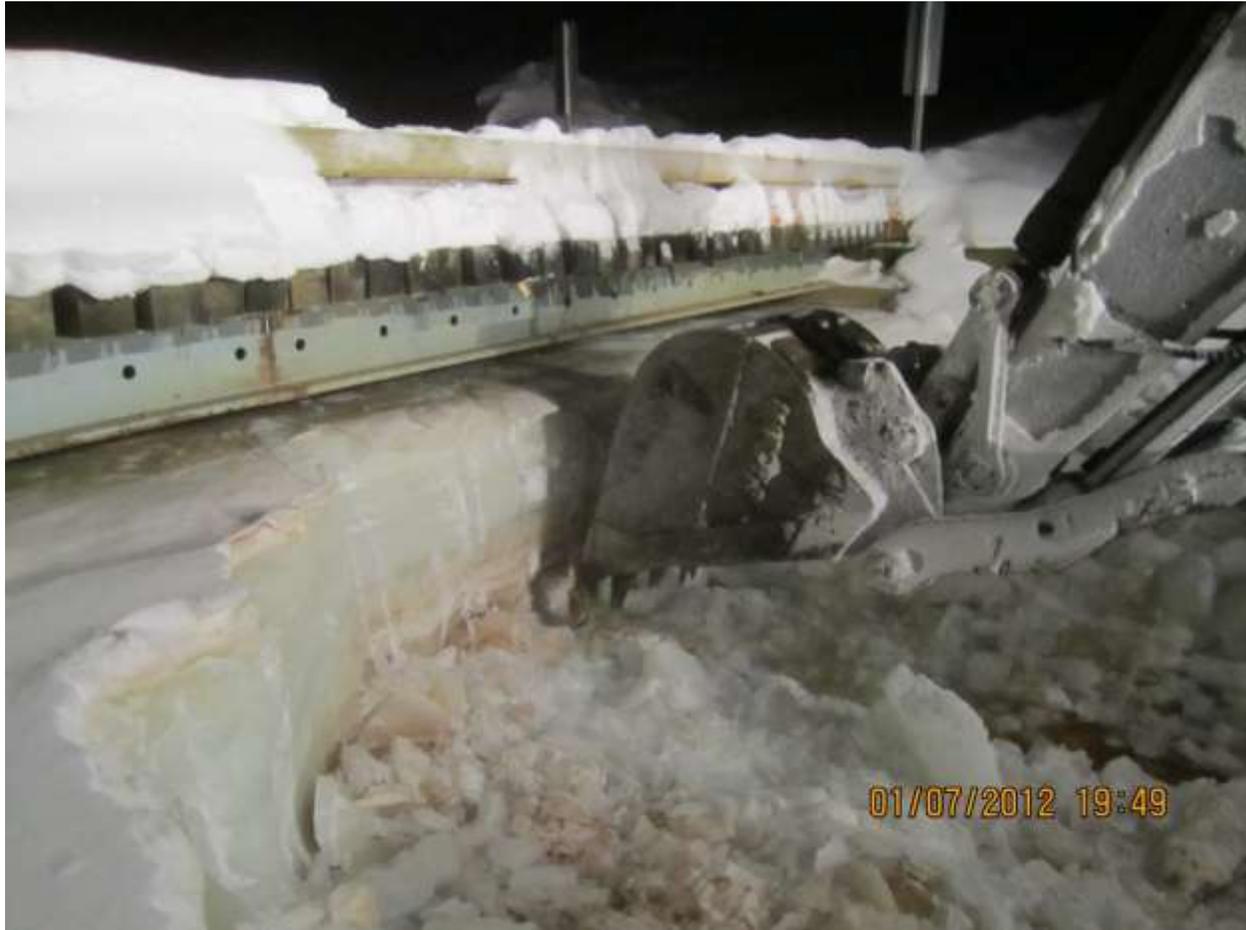
Due to the size of the excavator it could not reach under the bridge and the ice was not removed other than to a straight up and down “wall” on either side of the bridge (Photo 16).

Photo 16 - Ice removal to form a straight wall

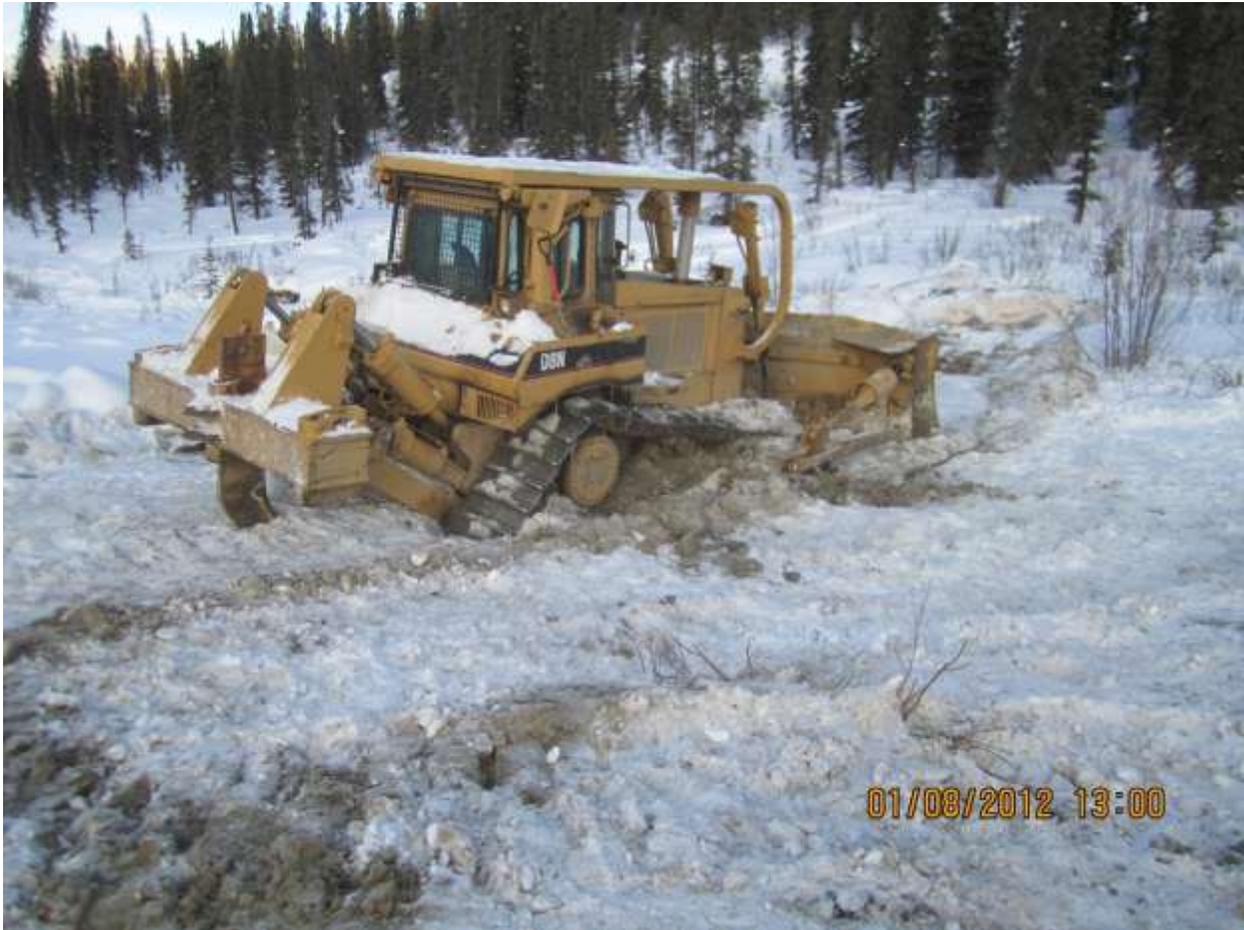
During clearing operations, the dozer got stuck in the diversion channel and the blade and ripper were used to hold it up out of the water (Photo 17). After the water level subsided on the afternoon of January 8 the excavator broke the ice out from around the dozer and pushed enough under the machine to allow it to climb out of the channel. The machine lifted itself using its blade and ripper so that the excavator operator was able to push ice under the machine.

Photo 17 - Dozer stuck in channel with blade and ripper holding it up out of the water

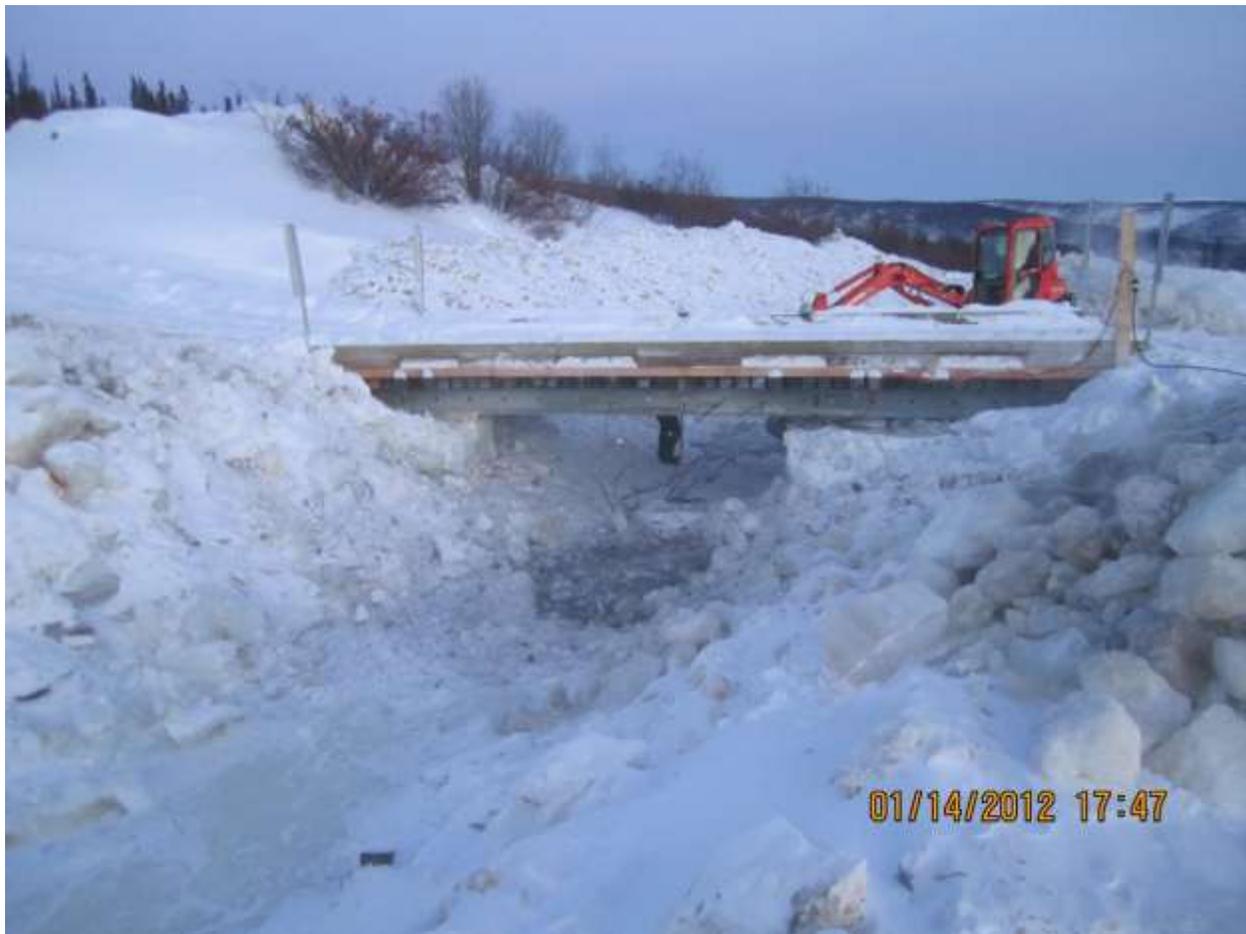
Photo 18 - Excavation complete with heat trace installed on bottom of the channel.

After the channel was excavated a new heat trace was installed on the bottom of the channel to ensure that a part of the channel would remain open. This had been done previously however the trace was hit by an excavator bucket rendering it useless.

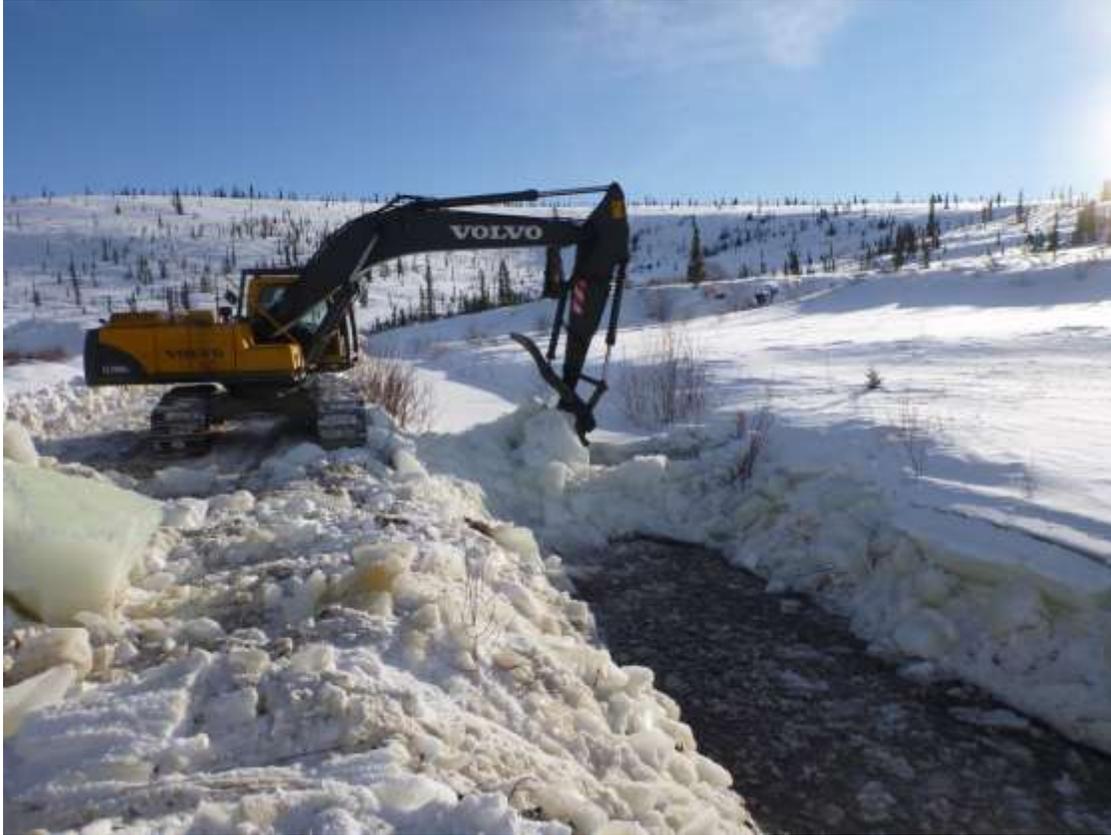
Photo 19 - Excavation upstream of Diversion Channel

On February 17 excavation of that section of the channel near the overflow area continued. Ice was removed to the location where the water had flowed across the road and beyond by approximately 25 m and was pushed to one side by the dozer. Excavation of the ice took some 6 hours using the EC 290 Volvo Excavator and the D8N Dozer to push the excavated ice away from the excavator. The ice was pushed toward the settling pond, which will eventually result in that amount of water entering the pond. Dean Hassard of Deadman Creek Enterprises advised that EBA Engineering Consultants personnel had authorized the placement.

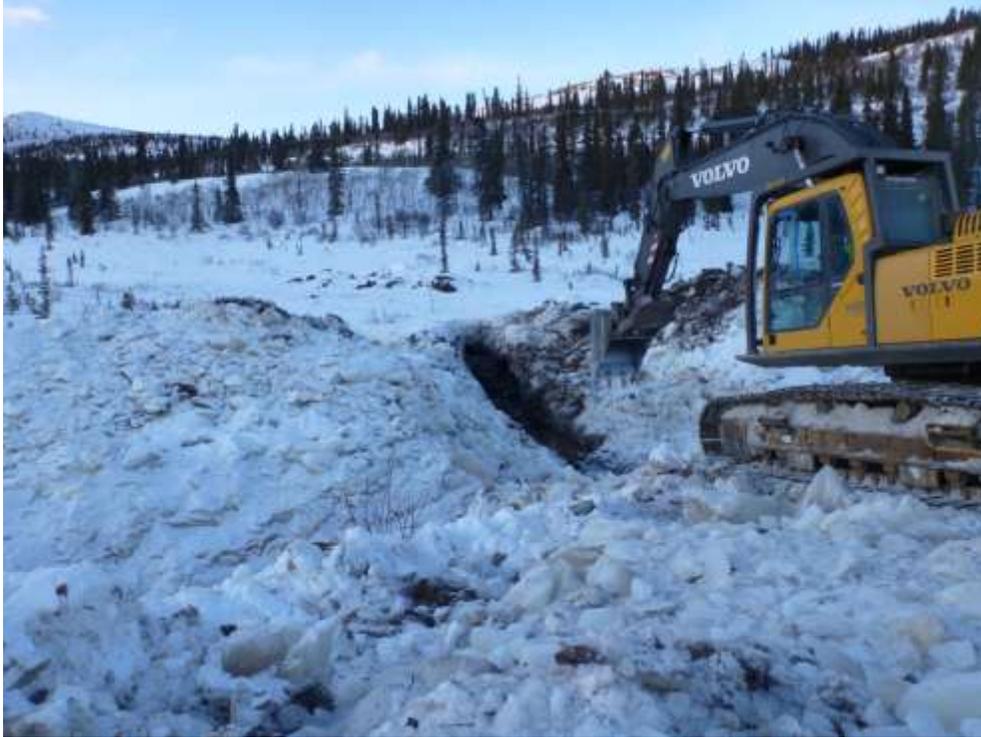
Photo 20 - Excavation at the entrance to Dome Creek

Following completion of the excavation, a channel was further cleared at the entrance to Dome Creek in an attempt to drain that section of the creek above the entry point. Some water was encountered however not as much as was expected. There was some concern on the part of the excavator operator that the ice would not support the machine so he did not excavate further.
