Glaciation Assessment and Remediation

Of The Dome Creek Diversion Channel

At the Mount Nansen Site

December 12, 2011

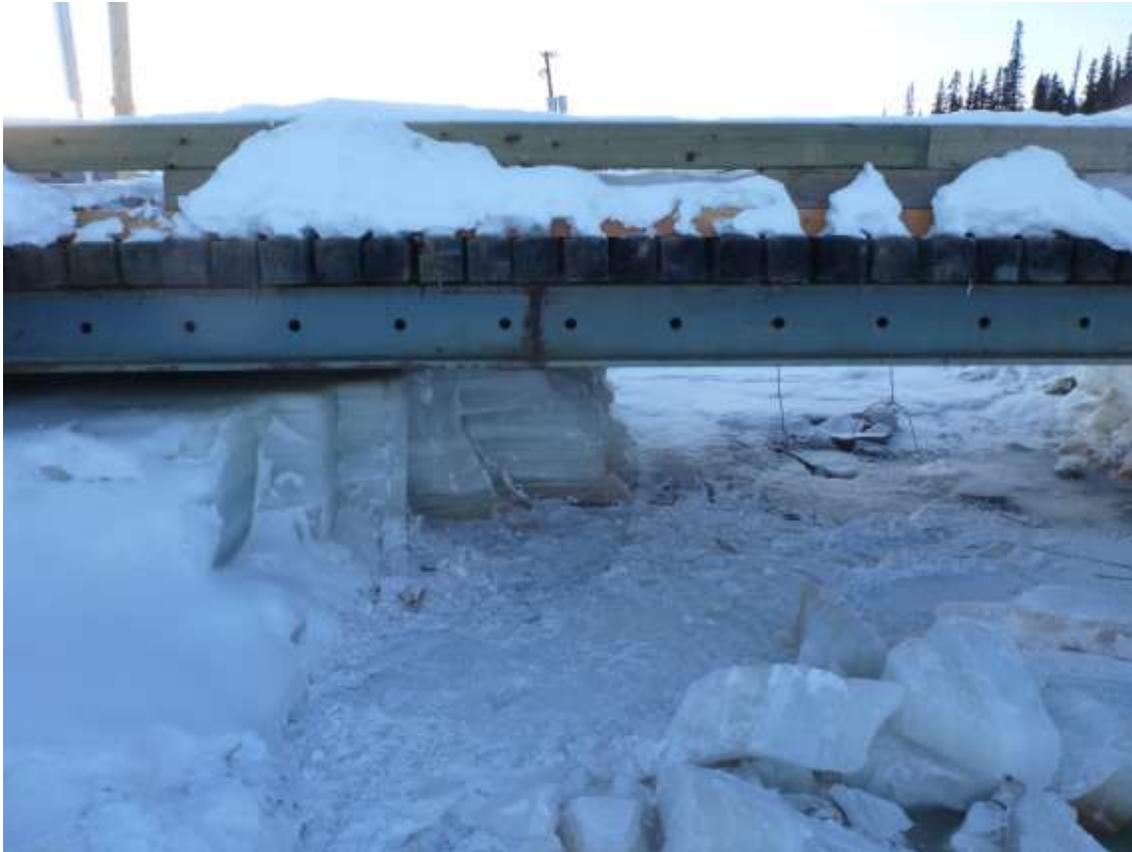
Photo 21 - Clearance between the ice and the beams of the bridge

At the March 1 site visit approximately 0.75 m clearance existed between the ice and the beams of the bridge. Warm daytime weather has been allowing water to leave the channel without freezing, slowing ice build-up.

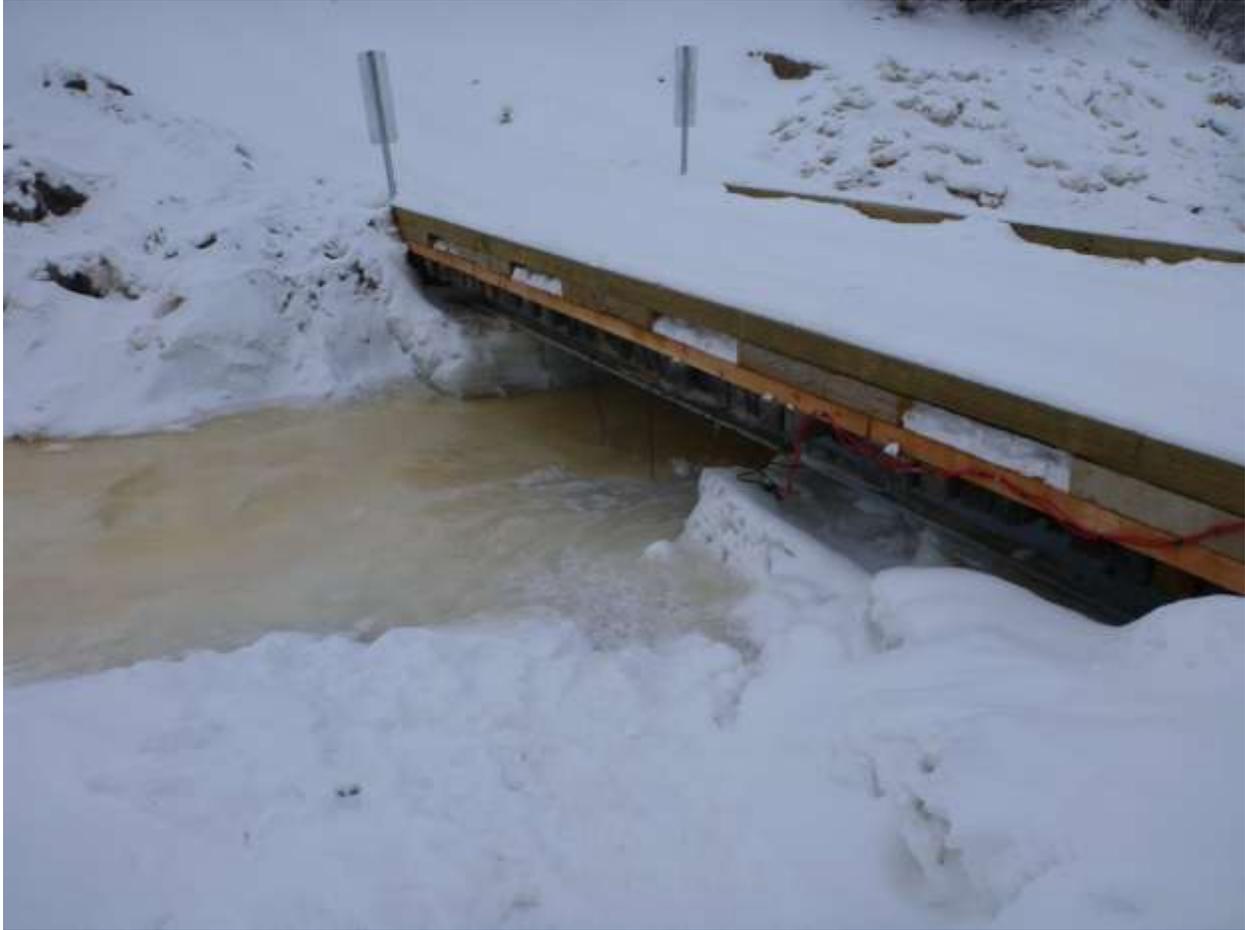
Photo 21 - March 1 Ice build-up at bridge

Excavation of the ice should commence from the very lowest part of the outfall and continue to the bridge, and as close to the bridge as feasible without risking damage to the structure or deck. Excavation at the upstream side of the bridge should be restarted, again as close as reasonable without causing damage, excavating to the bottom of the channel continuing to the upper extents. After the ice is removed from the channel a significant block of ice will remain under the bridge. BEL will supply tarps and a “Master Heater” to thaw the ice. The tarps will be laid over the bridge and down both sides to keep the heat in, and place the heater so that it blows warm air directly under the bridge. This will thaw the ice and remove it in a much safer manner than a chainsaw and labour. It must be recognized however that the previous method was successful.

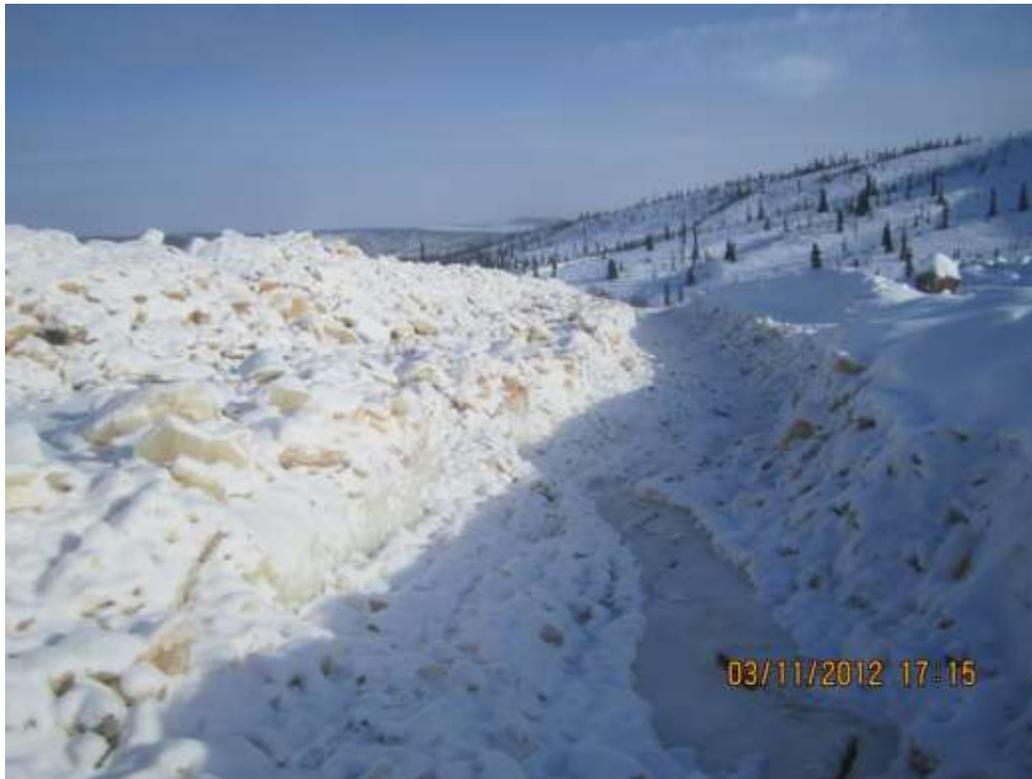
Significant ice build-up both under the bridge and throughout the lower end of the channel required that the ice be removed. Excavation began on Saturday March 10 and continued through to March 11. The CAT 324D Excavator belonging to Boreal Engineering had no problems to excavate the ice with no CAT ripping assistance. The D6R dozer was to push the ice away from the excavation however a hose broke on the dozer while it was coming to the site and it was broken down until a new hose could be purchased, likely Monday. Ice was stacked alongside the excavation and will be pushed away to make room for the next time the ice is removed.

Photo 22 - Lower diversion channel with ice stacked on either side.

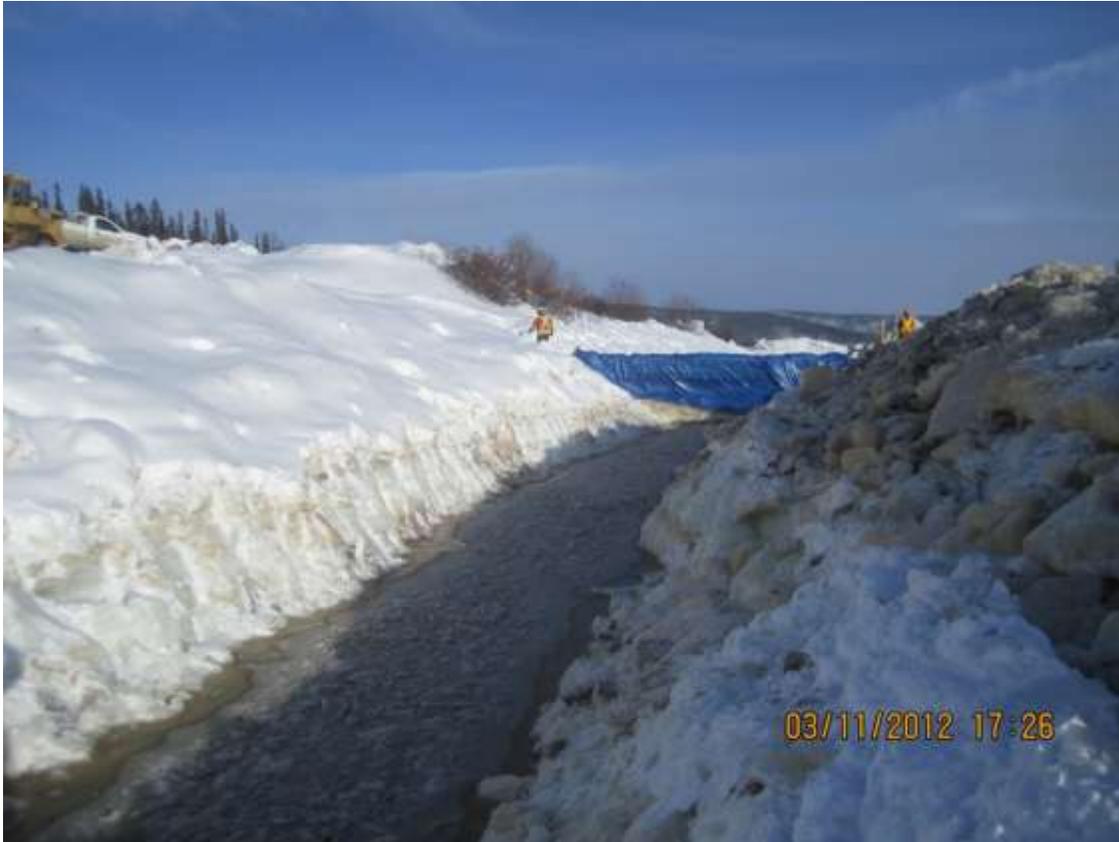
Depth of ice excavated was between 1.0 m to 2.5 m. The ice was removed down to original ground as far as the downstream side of the bridge and as close as possible to the bridge. The ice was then removed up to approximately 30 m upstream of the bridge. At that point water began to flow into the excavated channel so the machine work was stopped. The concern was that if too much water flowed into the channel it would fill the channel and possible overflow the ice under the bridge, making ice removal under the bridge very difficult. A small channel under the ice, created by the previously installed heat trace, was allowing the water to pass however flow was intermittent, possibly due to ice blockage of the passage.

Photo 23 - Upstream of bridge showing water in channel

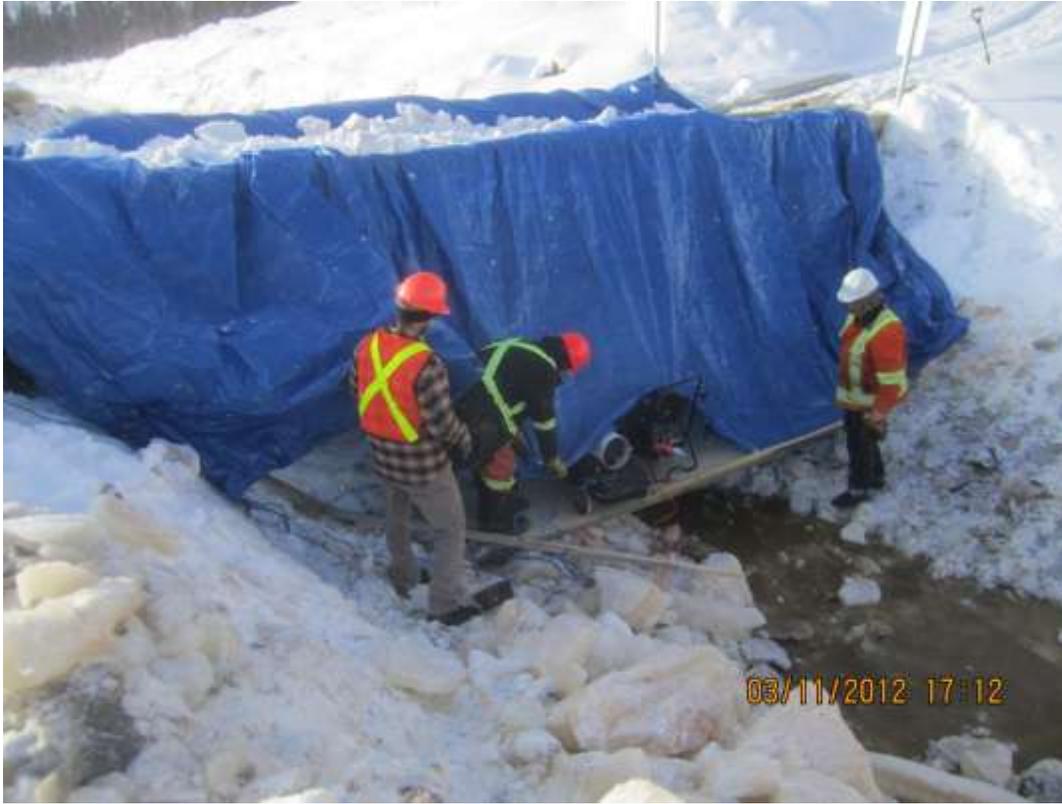
Photo 24 - Heater installation under the bridge

Due to the amount of labour required to physically remove the ice under the bridge by manual methods, it was determined that master heaters to thaw the ice should be used instead. The bridge has been wrapped with a large tarpaulin and 2 heaters have been installed. A2x6 m plywood bridge was temporarily installed across the channel to support the heaters above the bottom of the stream bed. The concern is that if a large amount of water were to be released the heaters would remain above the flow. Initial results are encouraging as the heaters were able to melt a large volume in a fairly short time. Maintenance crews on site will refuel the heaters as required and monitor the progress until the ice is gone.

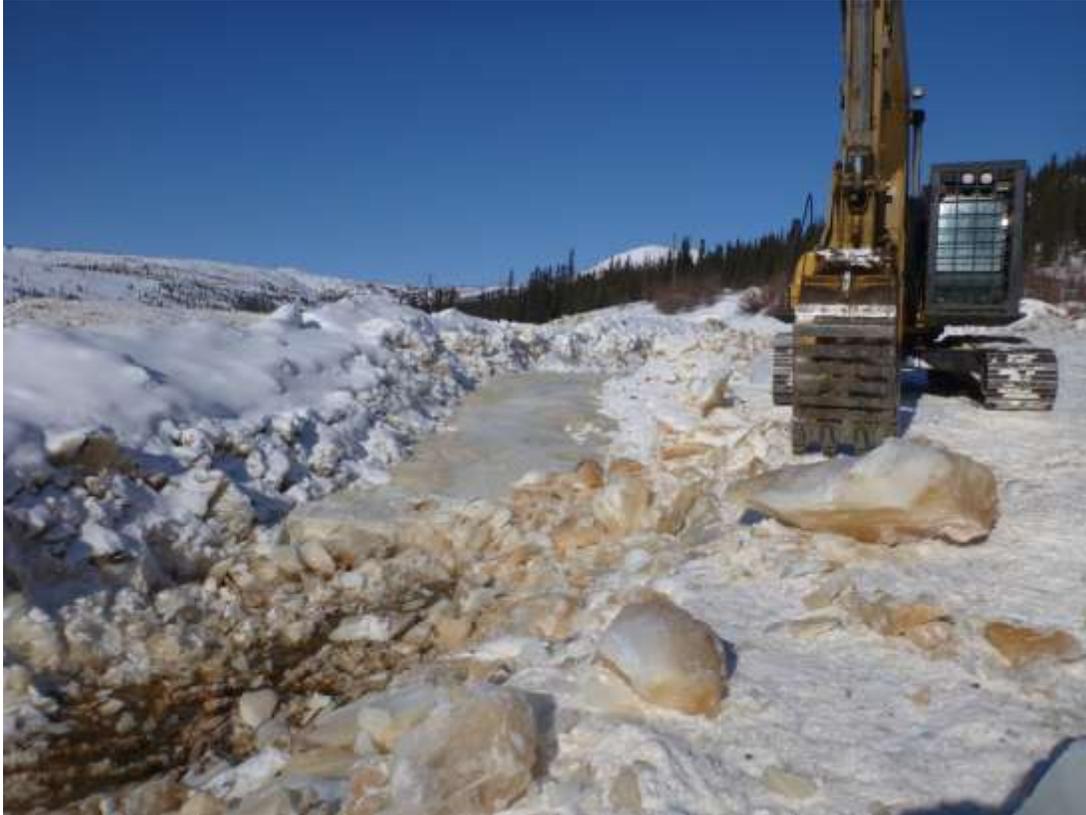
Priority for ice removal on March 23 was the lower end of the channel and some 50 m above the bridge. The intention was to ensure that the ice did not build further under the bridge causing more work to remove it. Significant ice growth had occurred during the previous two weeks when it was last excavated.

Photo 25 - Ice build-up in channel below bridge Mar 23

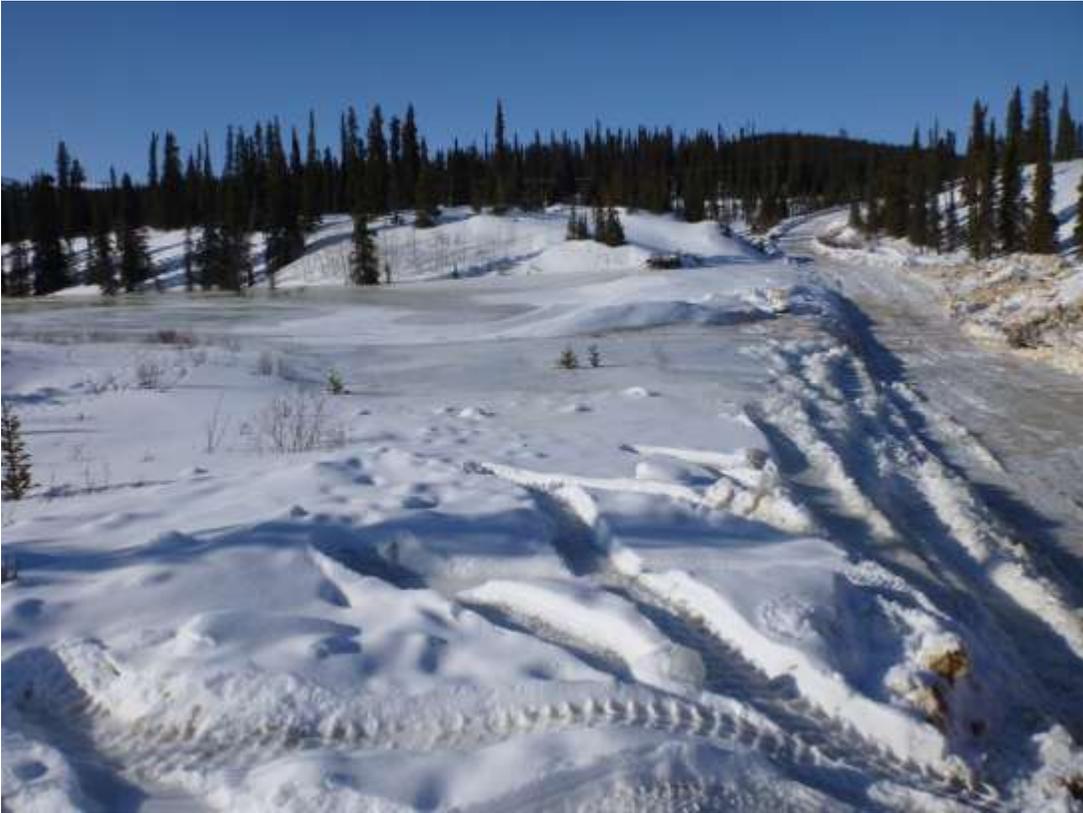
Highways Maintenance personnel were able to open the culvert at Dome Creek crossing on March 22, allowing the trapped water to flow. An exodus of water resulted in a settling of ice above the road by approximately 1 to 1.5 meters.

Photo 26 - Dome Creek at Mount Nansen Road showing relaxed ice March 23.

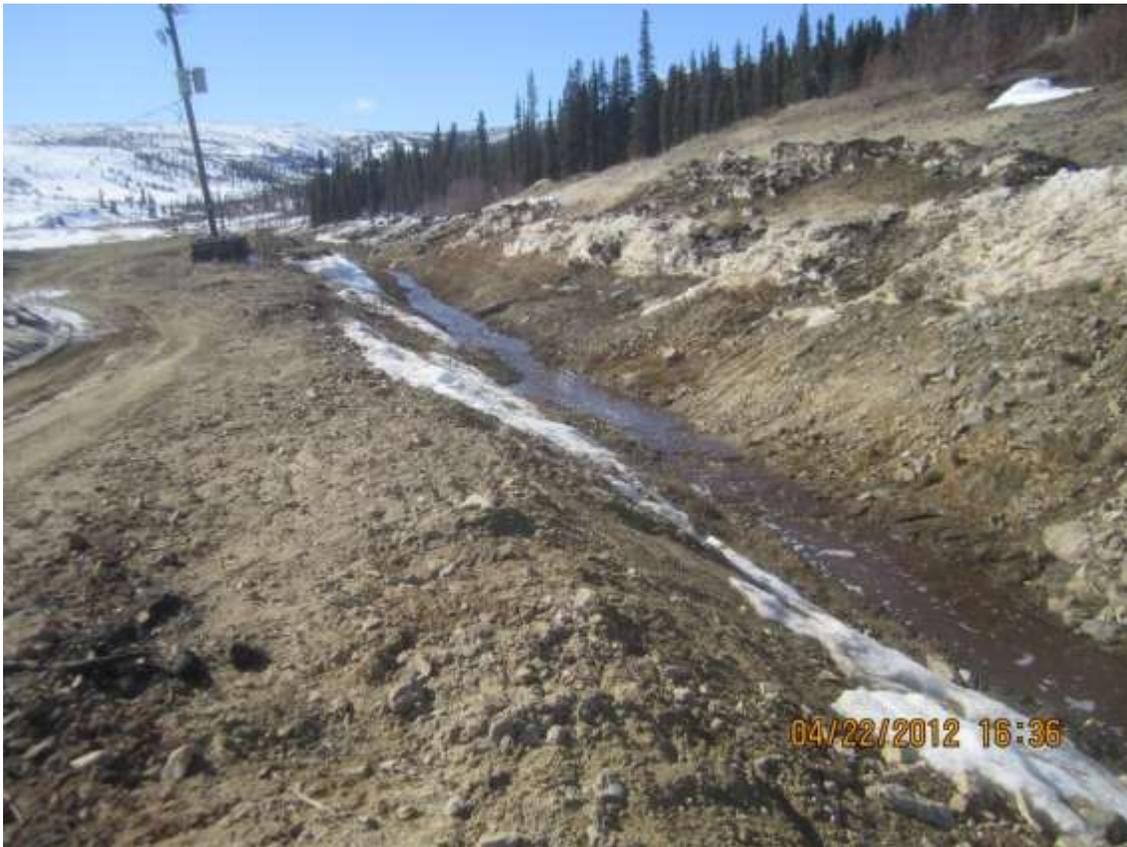
At this time the channel is free of ice for the most part although the areas which are not exposed to the sun in early morning have ice along the edge.

Photo 27 - Channel is free flowing and generally free of ice at water level

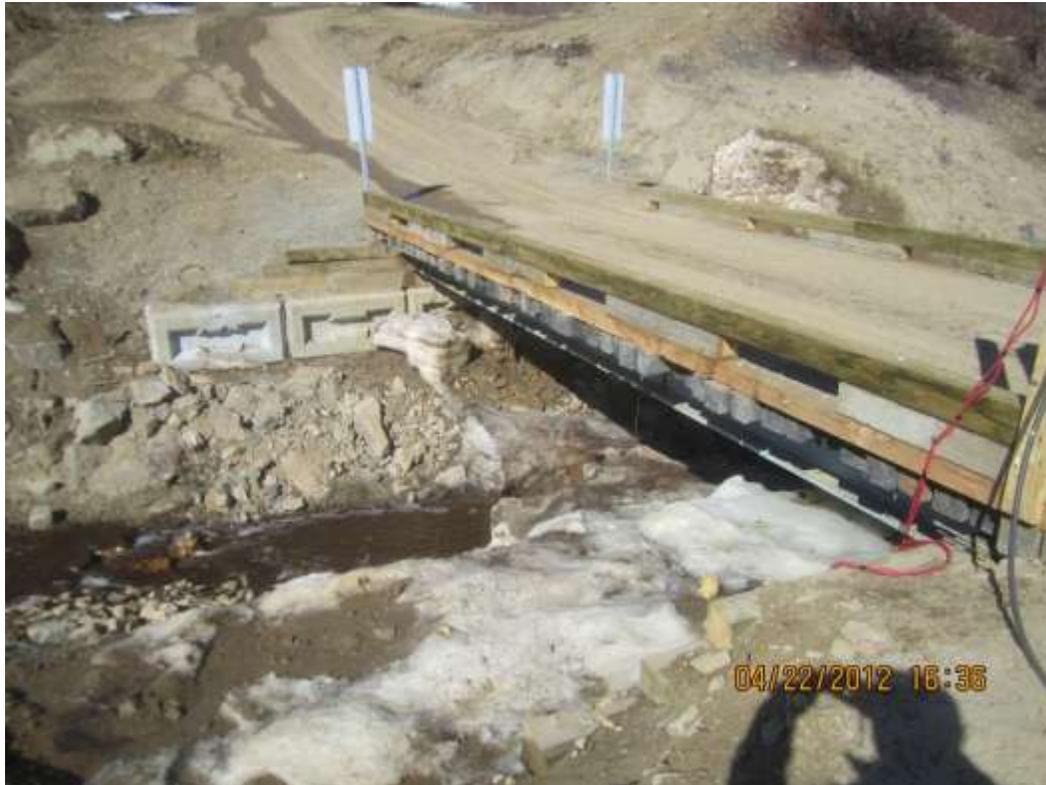
At this time the water is flowing freely under the bridge and the channel remains open. Some ice does remain within the channel and under the bridge however it is not considered a problem. This ice will thaw and disappear over the next several weeks.

Photo 28 - Ice remaining under the bridge.

Due to the warming weather it is not expected that ice build-up will be a problem from this point on. It is recommended that once weather warms and freezing at night does not occur that the heat trace be removed from the channel along with the electrical supply cord.

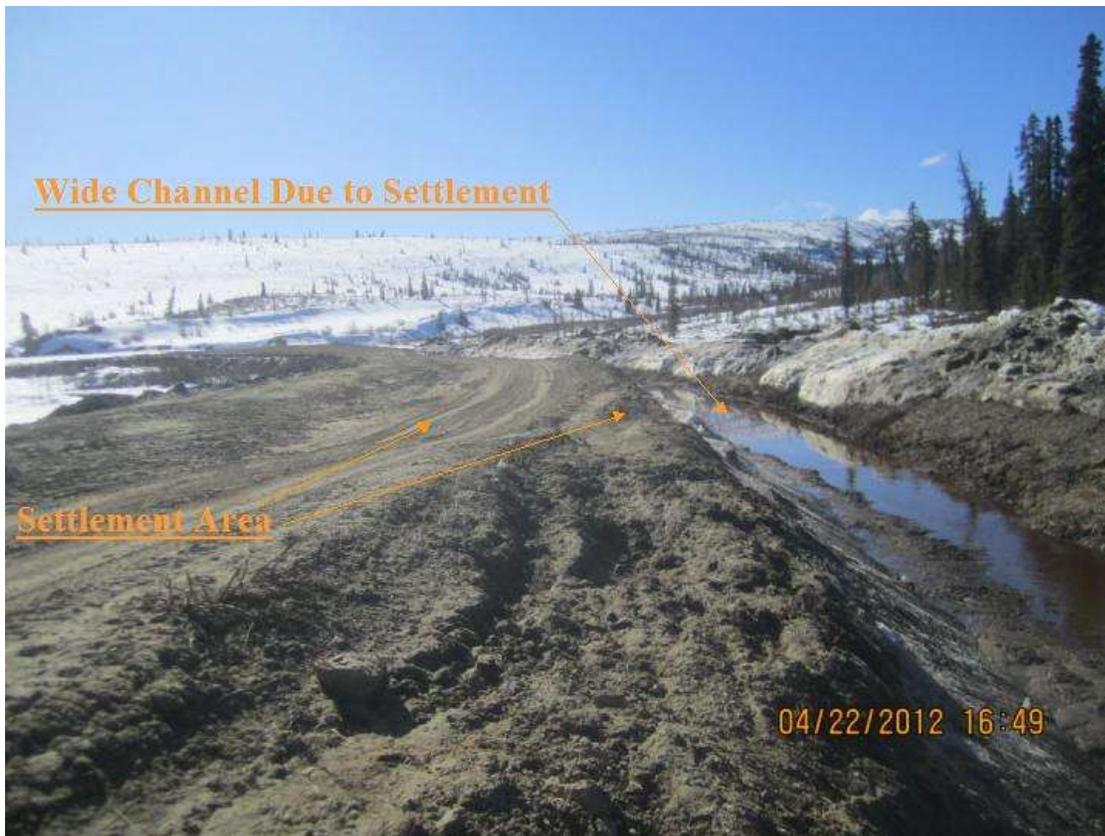
Further observation shows that the surface of the berm has settled in some locations, with the subsidence appearing to be extending into the channel. Settlement of this type within the area of disturbance and current activity could possibly be due to drainage of previously frozen soils. Sub surface ice lenses that are common within permafrost may melt and result in surficial settlement.

Photo 29 - Slide showing settlement area including the widened channel and slow moving water directly adjacent

A historical review of the channel through acquisition of as-built drawings should be undertaken to determine the physical shape when constructed. A current topographical survey would be useful to compare the existing condition of the berm with as-builts to determine the manner in which the berm and channel have changed since initial construction. In the event that the area is surveyed, the surveyor

The entire berm should be drilled to acquire soils information below the berm. Samples should be taken at approximately 1m depth intervals plus at any changes in soil conditions. Drilling should be completed at approximately 15m intervals and to a depth of a minimum of 10m. Particular care should be taken to ensure that the areas of settlement are investigated. Furthermore, some investigation of soils on the uphill side of the channel should be undertaken to gain an understanding of the permafrost and soils conditions in that area. This information will be important in the event of reconstruction.
