YUKON GOVERNMENT

GRUM SULPHIDE CELL COVER, FARO MINE

2014 REVIEW

PROJECT NO.: 0533-006
DATE: March 11, 2015

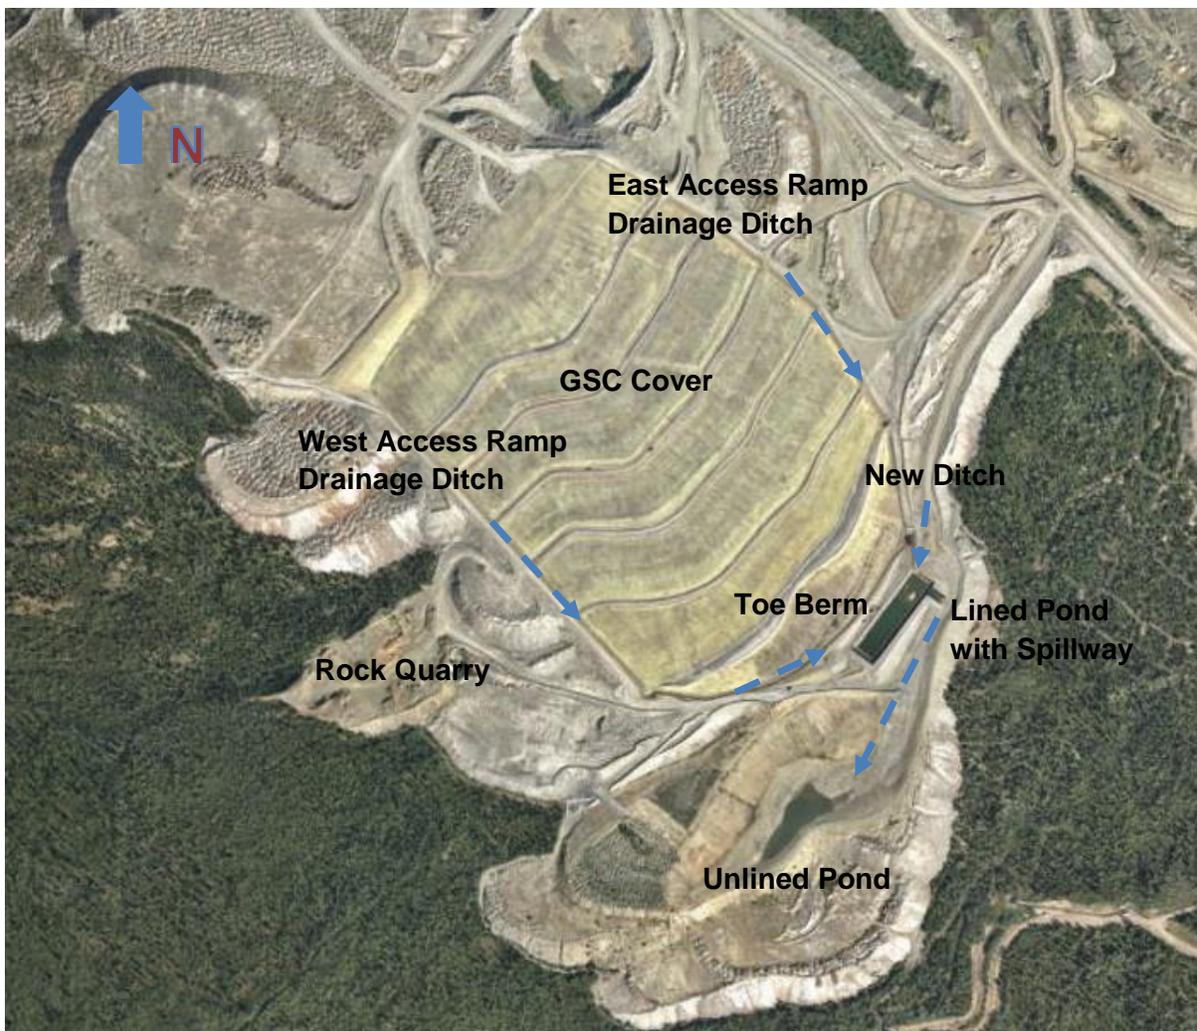
Photo 2-1. Aerial view of the GSC cover, perimeter ditches and associated ponds, and water flow direction arrows, relative to overall Grum Dump. V15 and Grum Creek seep water collection located in right foreground at Y in the road. V15 monitoring station located at sump approximately 150 m west of Y in the road.

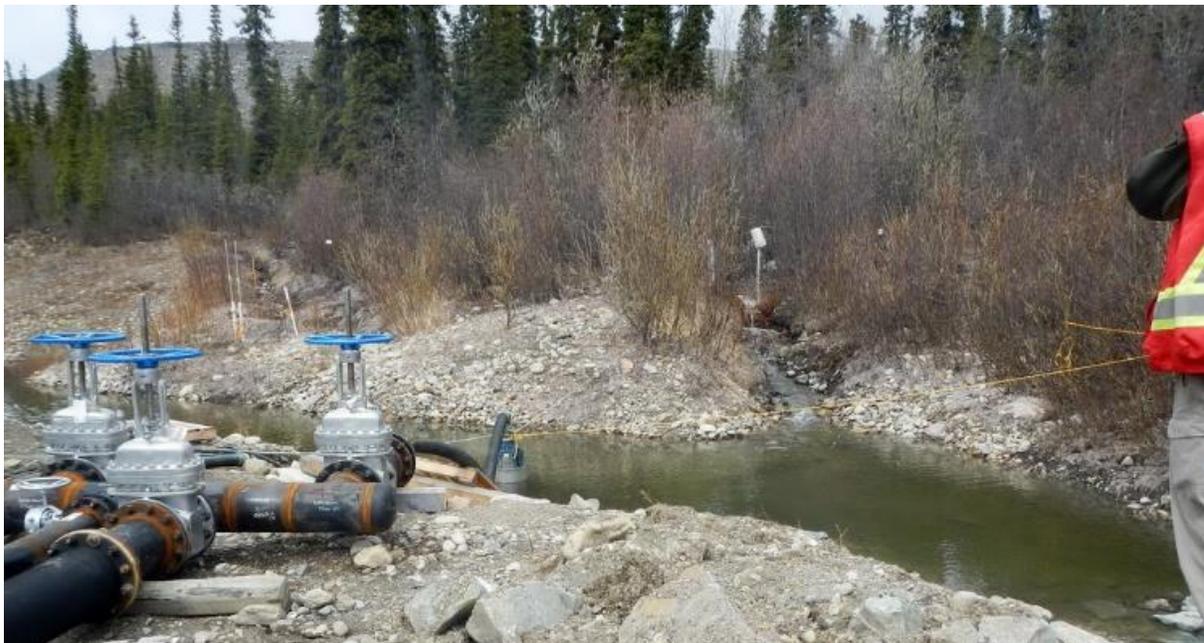
Photo 2-2. View of water collection and pumping elements at Pumping Station V15 at the confluence of V15 seep and Grum Creek seep (May 21, 2014). V15 water comes in from the southwest portion of the dump from the left channel. Grum Creek emerges from under the northeast corner of dump and flows over monitoring location GC Weir (white container marking channel at right-center of photo).

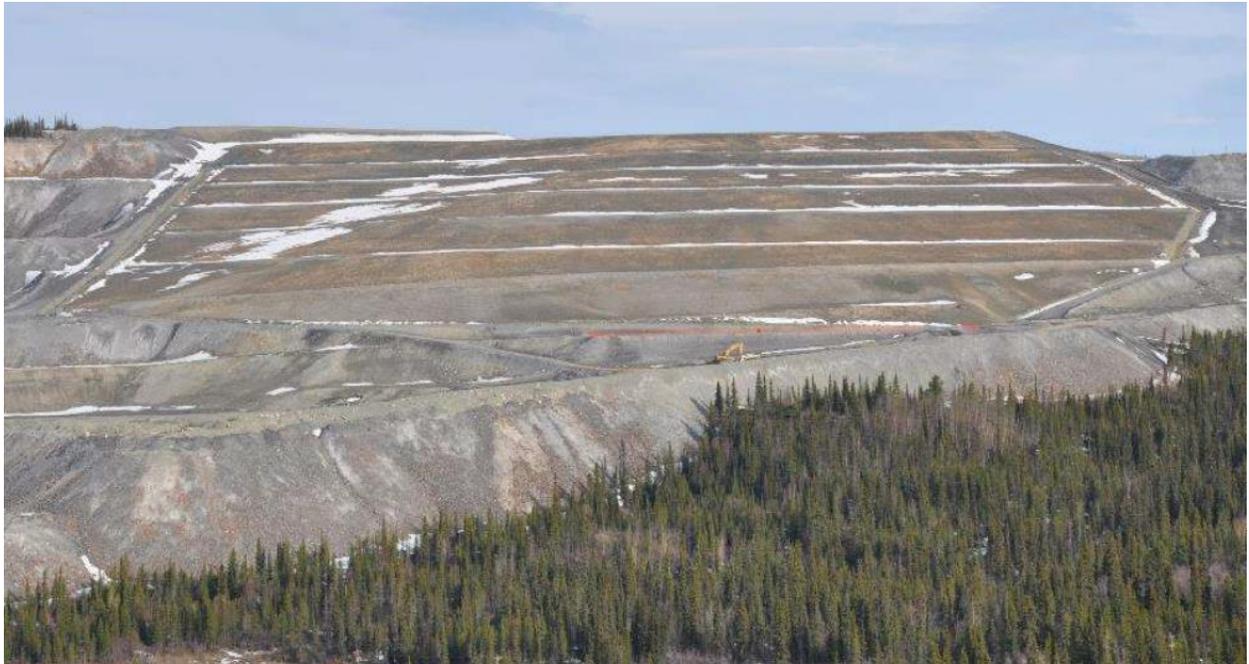
- The highest flow volume into the Lined Pond occurred at approximately 6:00 pm on May 6, 2014.
- By that time, the vast majority of the snow cover on the GSC cover had melted, except for some minor accumulations located on longitudinal bench drains, as shown on Photo 2-3:

Photo 2-3. Snow cover melted by freshet except for horizontal longitudinal benches, proximal to both perimeter ditches and the oblique accumulation on the west (left) side of the cover (May 6 or 7, 2014).

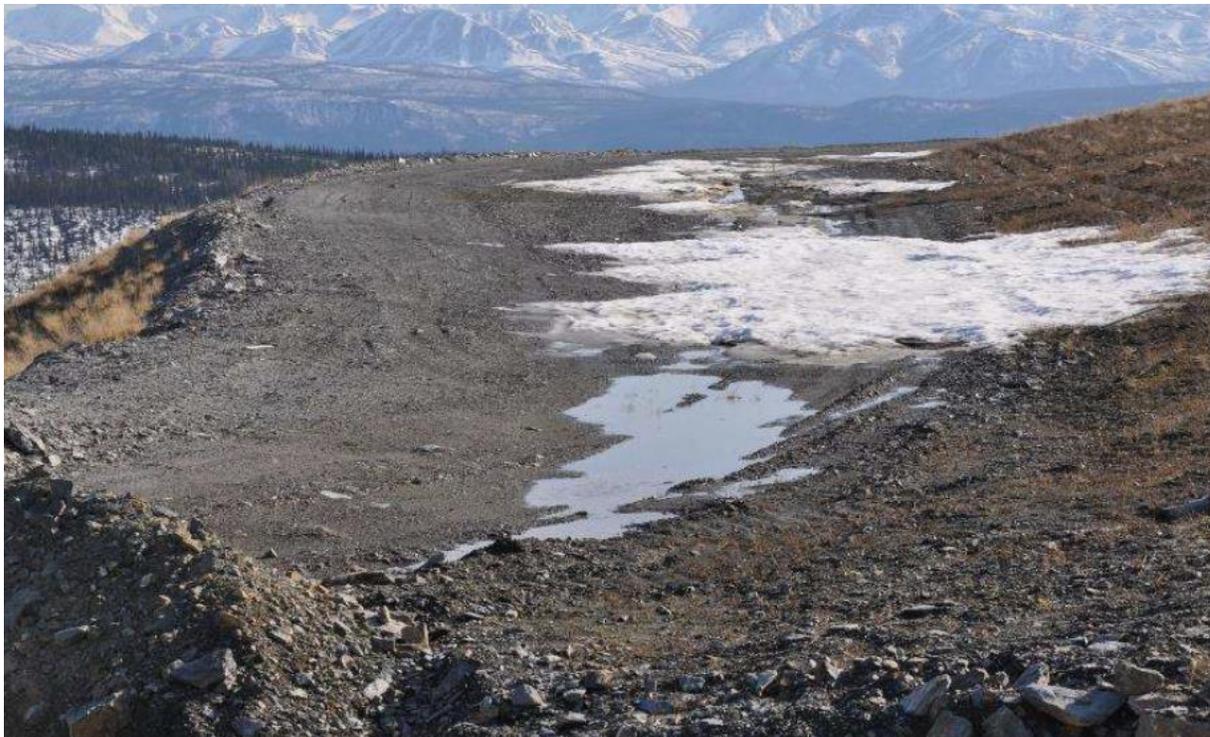
- Water appeared to be flowing under the snow cover in the East Drainage Ditch.
- Minor slumping noted in the toe berm slope.
- Standing water noted with snow accumulation of the toe berm bench as shown in Photo 2-4:

Photo 2-4. Melting snow cover and standing water on top of Toe Berm bench, looking west (May 6 or 7, 2014).

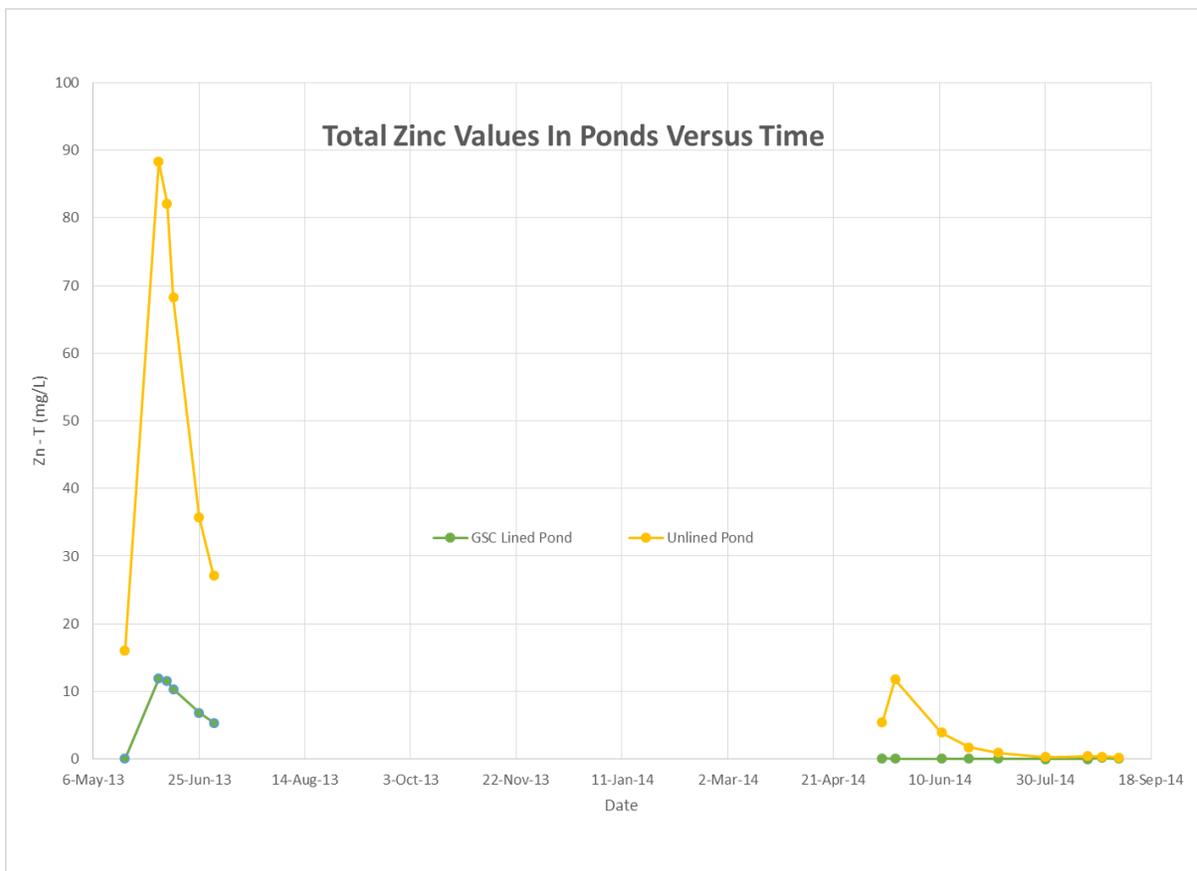
Comparing the total zinc values for the two ponds, the Lined Pond values were generally lower than 0.1 mg/L (compliant) while the Unlined Pond values ranged from greater than 5 mg/L (non-compliant) to a range of 0.23 to 0.4 mg/L (compliant). These zinc values demonstrate that the Lined Pond has lower concentrations and its run-off comes from the remediated (and cleaner) cover surface while the Unlined Pond water comes from the unremediated waste dump surfaces. For comparison sake to 2013, Table 3-2 within BGC (2013) provides similar summaries regarding analytical testing for the two ponds. The later season (post-freshet) total zinc values for the Lined Pond were 0.198 to 0.047 mg/L in 2014 but were 5.3 mg/L in 2013, so the values were much lower in 2014. For the Unlined Pond, later season total zinc values ranged from 0.23 to 0.4 mg/L for 2014 but they were >27 mg/L in 2013, indicating lower concentrations in 2014 again. The lower zinc concentrations in 2014 are both lower than 2013 and compliant for discharge (although not for TSS on occasion), likely driven by the smaller amount of cover erosion and vegetative cover taking hold, as discussed further in Section 3.1.

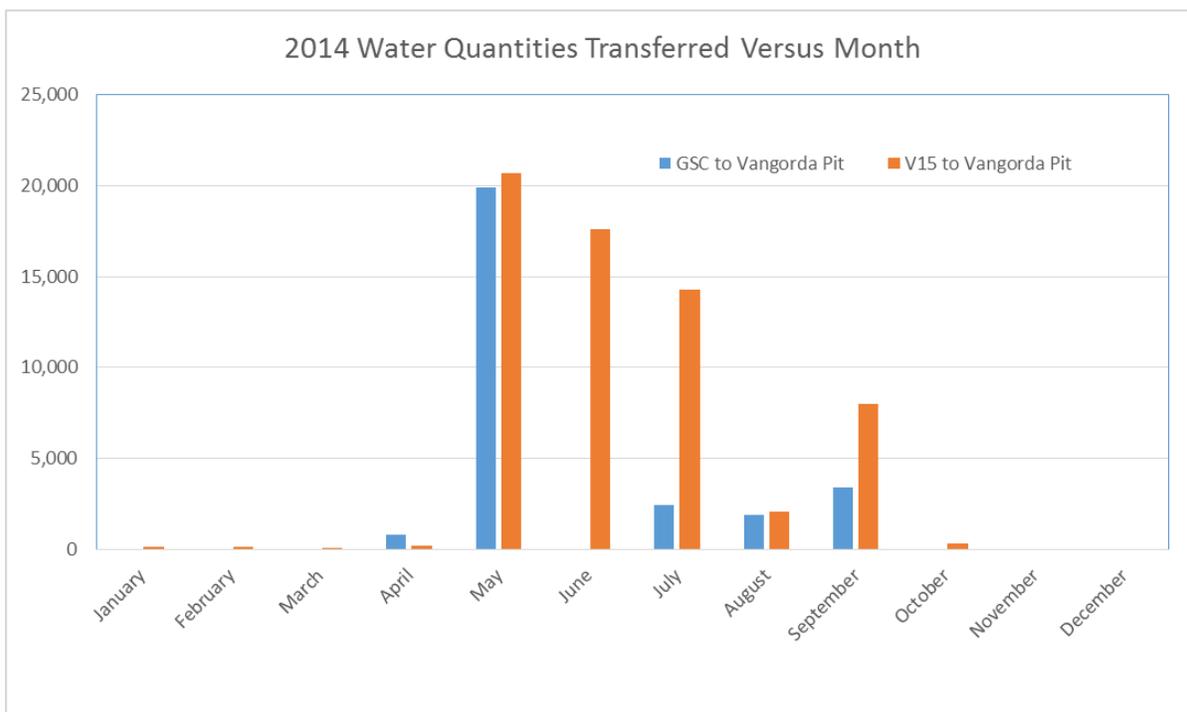
Figure 2-2. 2014 Water Quantities Transferred to Vangorda Pit

The main transfer quantities occur in May as expected, following the inflow of spring freshet. Minor transfer occur in other months from the Lined Pond (likely in response to rainfall events) while significant transfer occur in most of the summer months from the V15 collection stations (which collects both surface flow from other areas and seepage from the dump). Total yearly quantities for the Lined Pond and V15 were 28,526 and 63,571 m³, respectively.

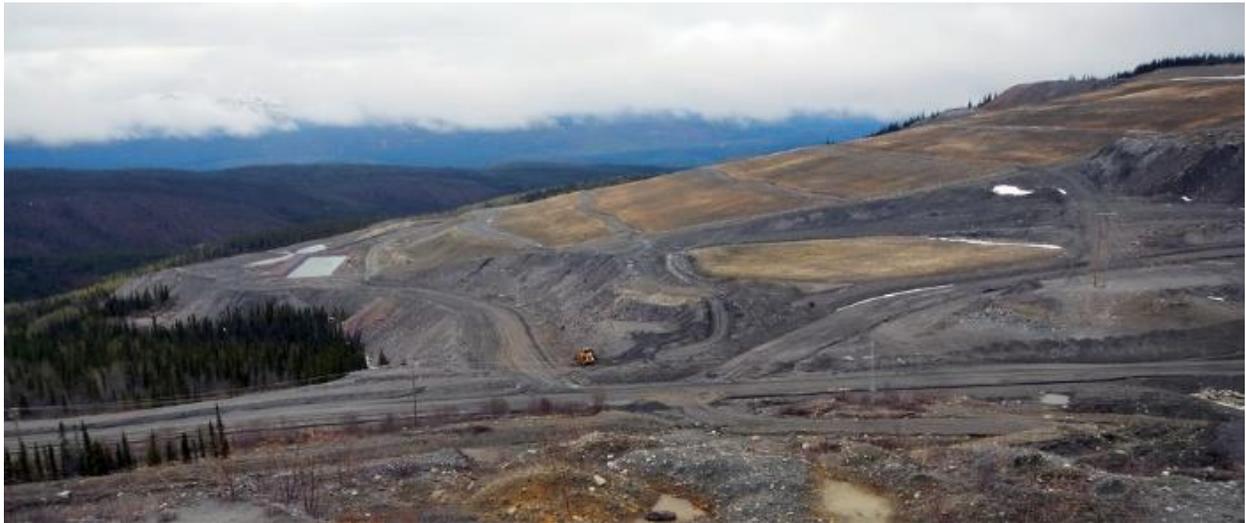
1. Generally, the GSC cover and water collection system has performed as intended, with run-off water contained within the two ponds, following the spring 2014 run-off. A general view of the cover is provided in Photo 3-1:

Photo 3-1. View of the lower portion of the GSC cover, with the Vangorda Access Road in the foreground. Olive brown vegetation cover now pronounced. Note the water retained in both the Lined and Unlined Ponds located at the toe of the cover (May 21, 2014).

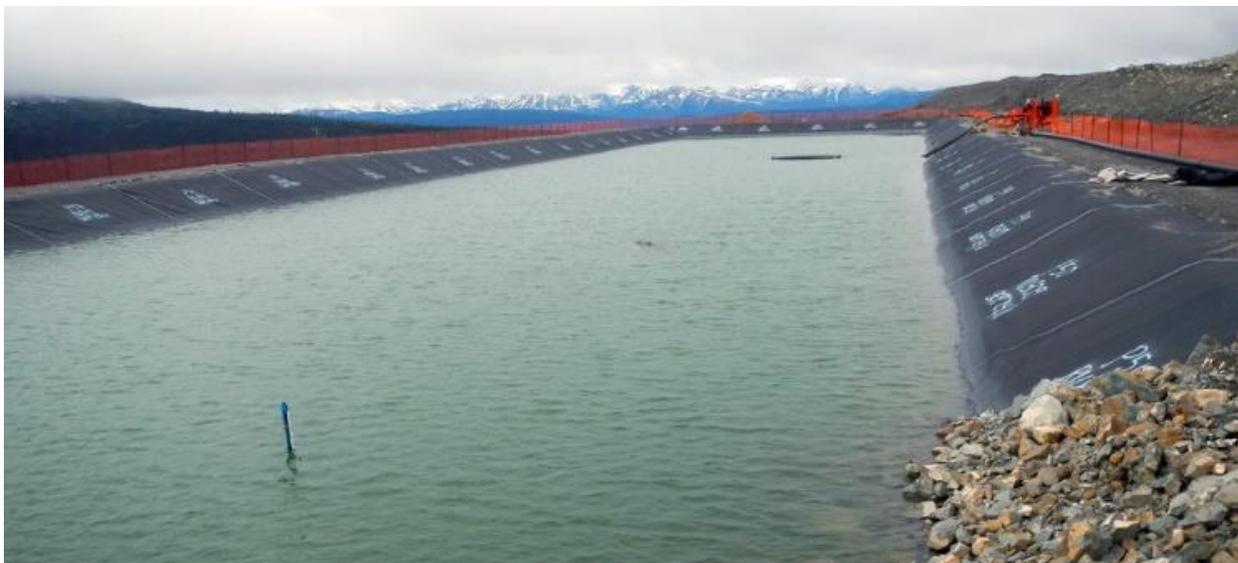
Photo 3-2. View of the Lined Pond and staff gauge, looking west (May 21, 2014).

2. Run-off water flowed into the Lined Pond, shown on Photo 3-2, but collected water did not flow out of the spillway.

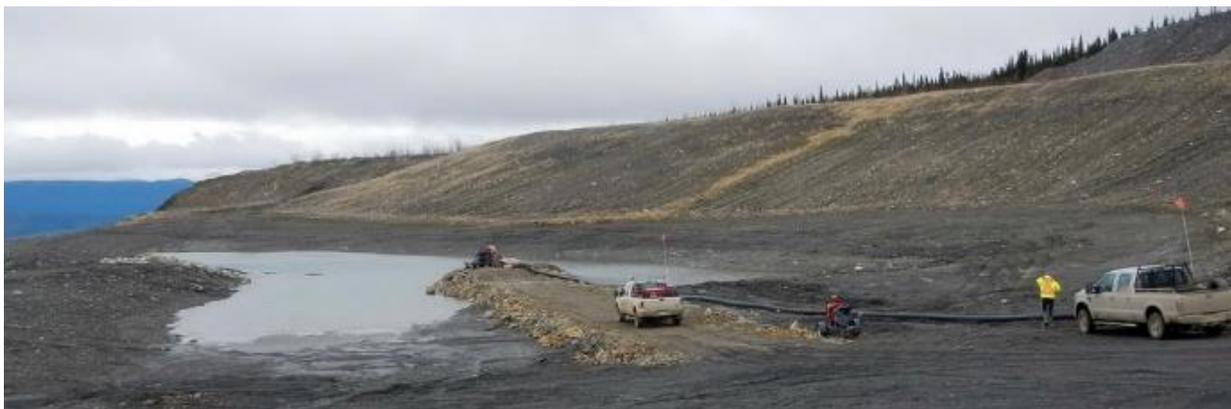
Photo 3-3. View of the Unlined Pond and pump arrangement (May 21, 2014).

3. A small amount of run-off water collected within the Unlined Pond, as shown in Photo 3-3, resulting from dump run-off to the southwest of the GSC cover. No water was discharged from this pond to the environment.

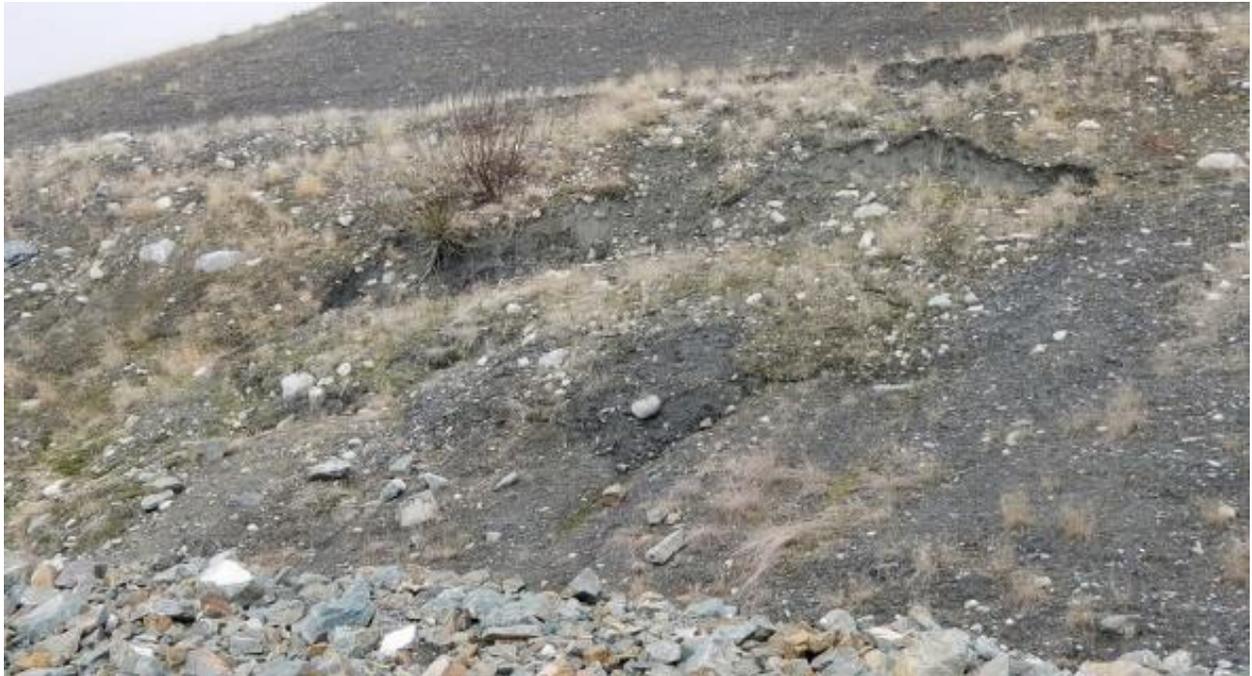
4. A new ditch was created on the uphill side of the access road running down to the Lined Pond. The ditch directs water into energy dissipation pond directly uphill from the Lined Pond.
5. Two small sloughs noted on the slopes directly above the Lined Pond area; first slough is 8 m wide on toe berm slope ($\sim 25^\circ$ to 27° slope), shown on Photo 3-4, and second slough (seen last year) is 12 to 14 m wide on slope above toe berm ($\sim 27^\circ$ to 30° slope). Third small slough also noted further west of the slope face.

Photo 3-4. View of the small slough on slope face above diversion ditch (May 21, 2014).

- Repair and regrade the three sloughs on the slope above and below the toe berm bench, including any flatly graded surfaces above sloughs where water may accumulate. Repairs must be carefully done to ensure minimal disturbance to the remaining slope and prevent further any channelization of upslope run-off and associated erosion.

- Regrade and repair localized erosional gullies located on the dump faces to the southwest of the unlined pond area (example shown in Photo 3-4). These gullies are partially generated by run-off that comes down from the old "rock quarry" location higher up in the dump section.
- Review water quality sample results (if any available) from "old rock quarry" area located south of the GSC cover. If compliant for discharge, then construct appropriate surface measures to divert this surface water into the forest and dump toe, rather than letting water drain into the unlined pond area. When undertaking these measures, ensure water is not focused into narrow or singular discharge points where additional erosion and sedimentation could occur. This water diversion is a short term measure

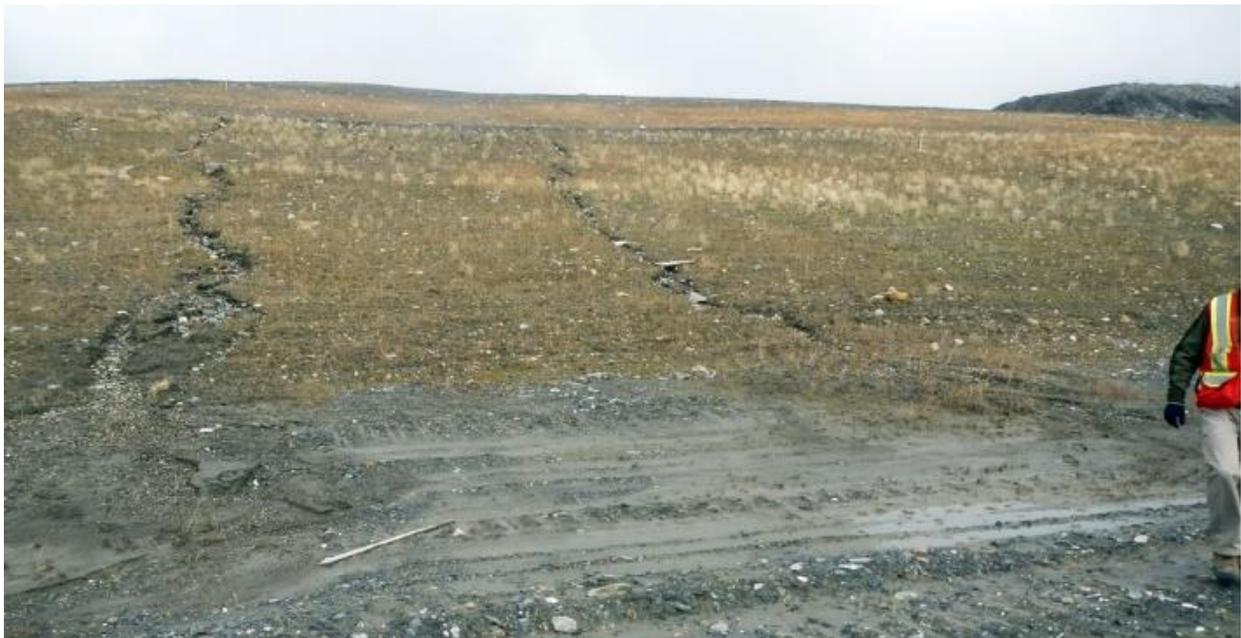
6. Minor erosional gullies continue to erode into the upper surface of the cover, even in fairly gentle slopes and in areas with vegetative bio-mass, as shown on Photo 3-5. Other erosional gullies noted on the cover; in some cases, carried minor sediment at the lower ends and partially blocked the longitudinal ditch on the bench faces.

Photo 3-5. View of two minor erosional gullies continuing to downcut into the cover, even on fairly gentle slopes (May 21, 2014).

- Erosional rills and gullies on the GSC cover (as shown in Photos 3-5 and 3-6) should be repaired with granular material, reggraded, and revegetated to prevent any further erosion.

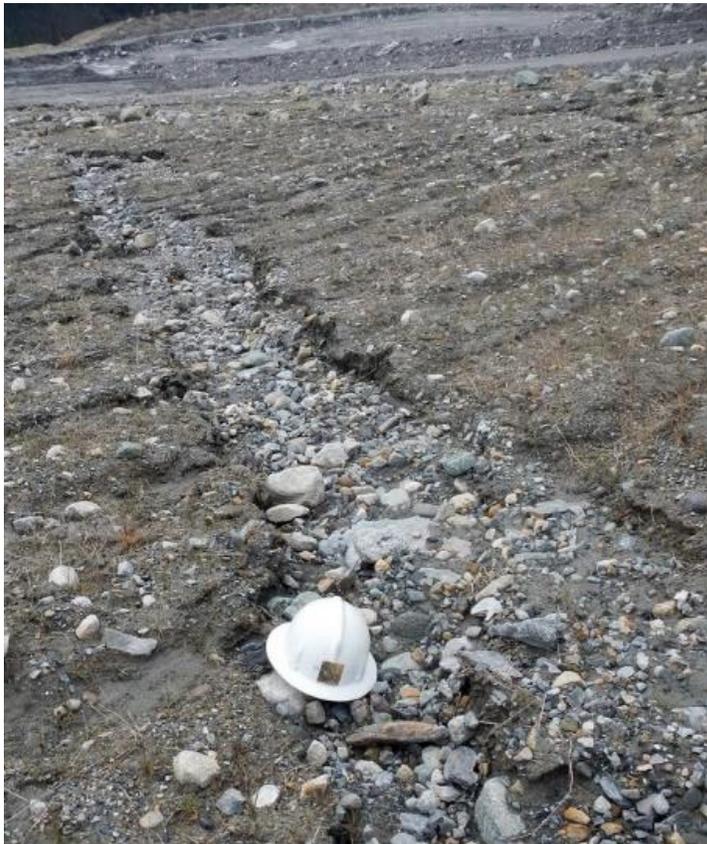
7. In select locations, run-off water from various dump aspects located southwest from the GSC cover continue to erode significant gullies into dump faces southwest of the Unlined Pond. Some run-off water reports to the Unlined Pond and some flows farther downhill. These erosional gullies should be repaired to prevent any further erosion from occurring.
8. Another significant, but shallow erosion gully, is shown on Photo 3-6. Granular soils should be used to repair this gully.

Photo 3-6. View of wide but approximately 0.5 m deep erosional gully that runs obliquely across the west side of the cover to West Drainage Ditch (May 21, 2014).

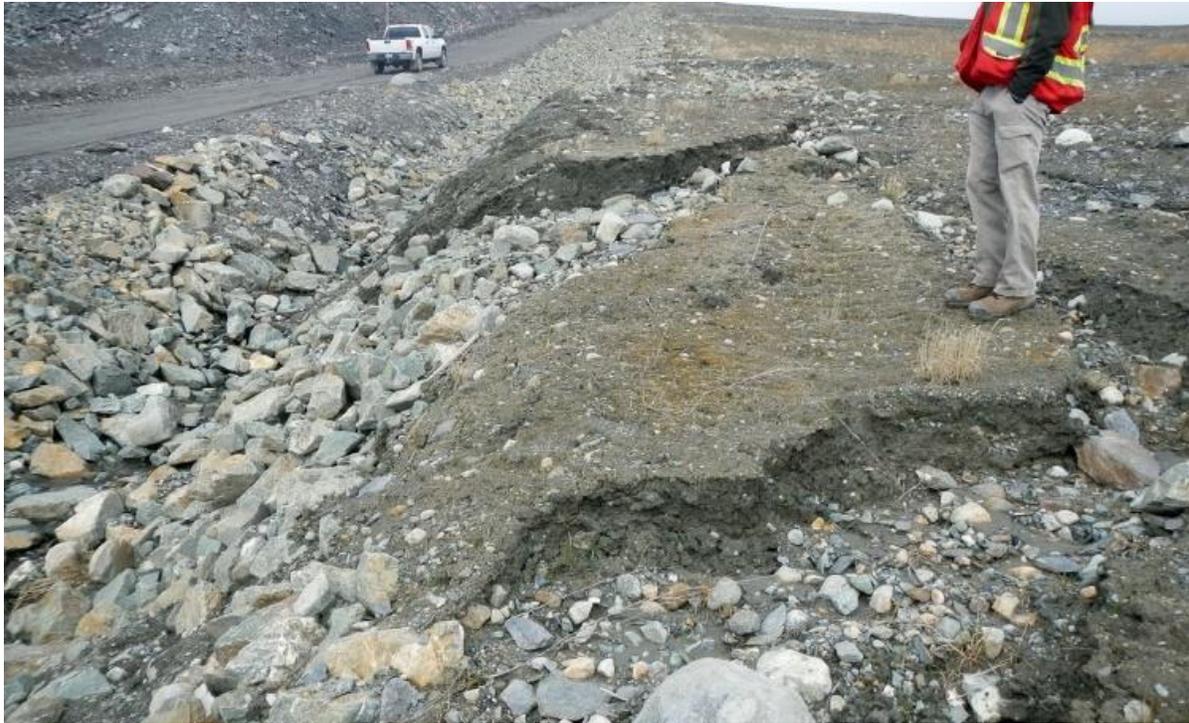
9. Overland flow and possible ditch blockage (due to snow and ice) lead to localized erosion gullies and sloughing of the cover till soil into the rip rap lined perimeter ditch at select locations as shown on Photos 3-7 and 3-8. These erosional gullies should be repaired to support cover and prevent any additional localized sloughing into the West Drainage Ditch.

Photo 3-7. View of two erosional gullies that run into the West Drainage Ditch (May 21, 2014).

- Repair and regrade any erosional gullies and associated slough material from the two occurrences in the West Drainage Ditch (as shown in Photos 3-7 and 3-8); granular material may be required for steep gullies. From the photo in YG (2014), it appears that one of these erosional occurrences may have been associated with a snow stockpile located uphill from this area. The grading and stockpiling of snow on the GSC cover should be undertaken with caution to ensure water blockages do not occur during freshet.

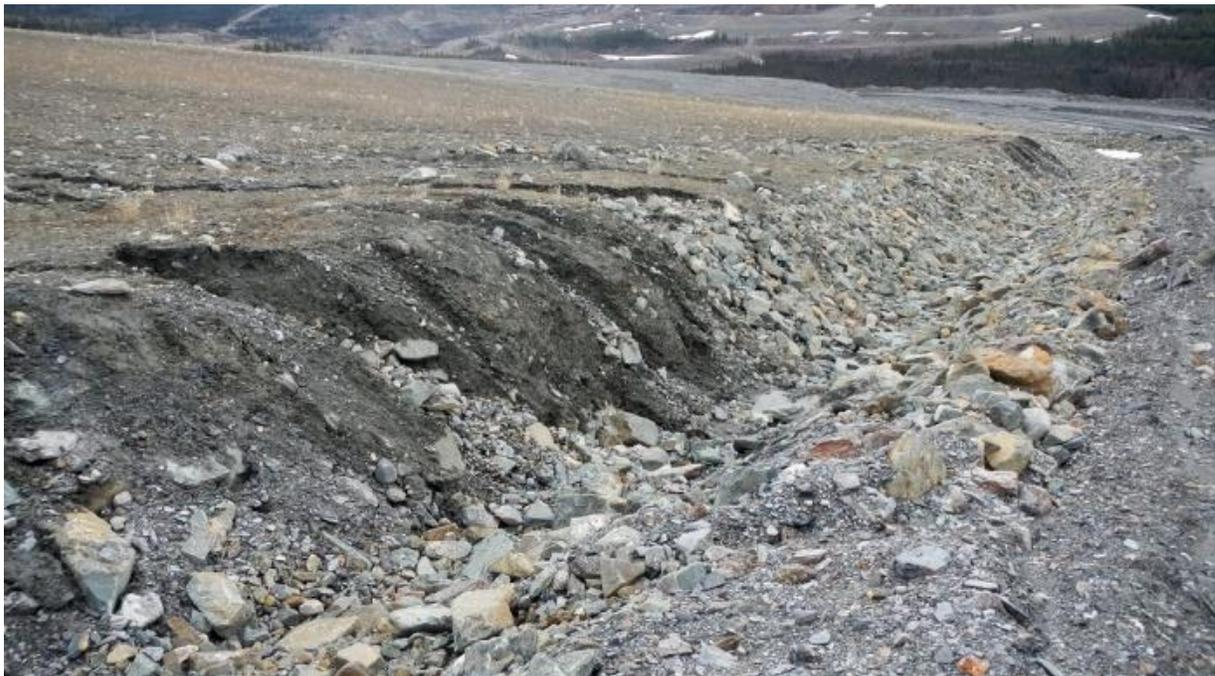
Photo 3-8. View of more erosional gullies that run into the West Drainage Ditch (May 21, 2014), located at higher elevation than gullies seen in previous photo.

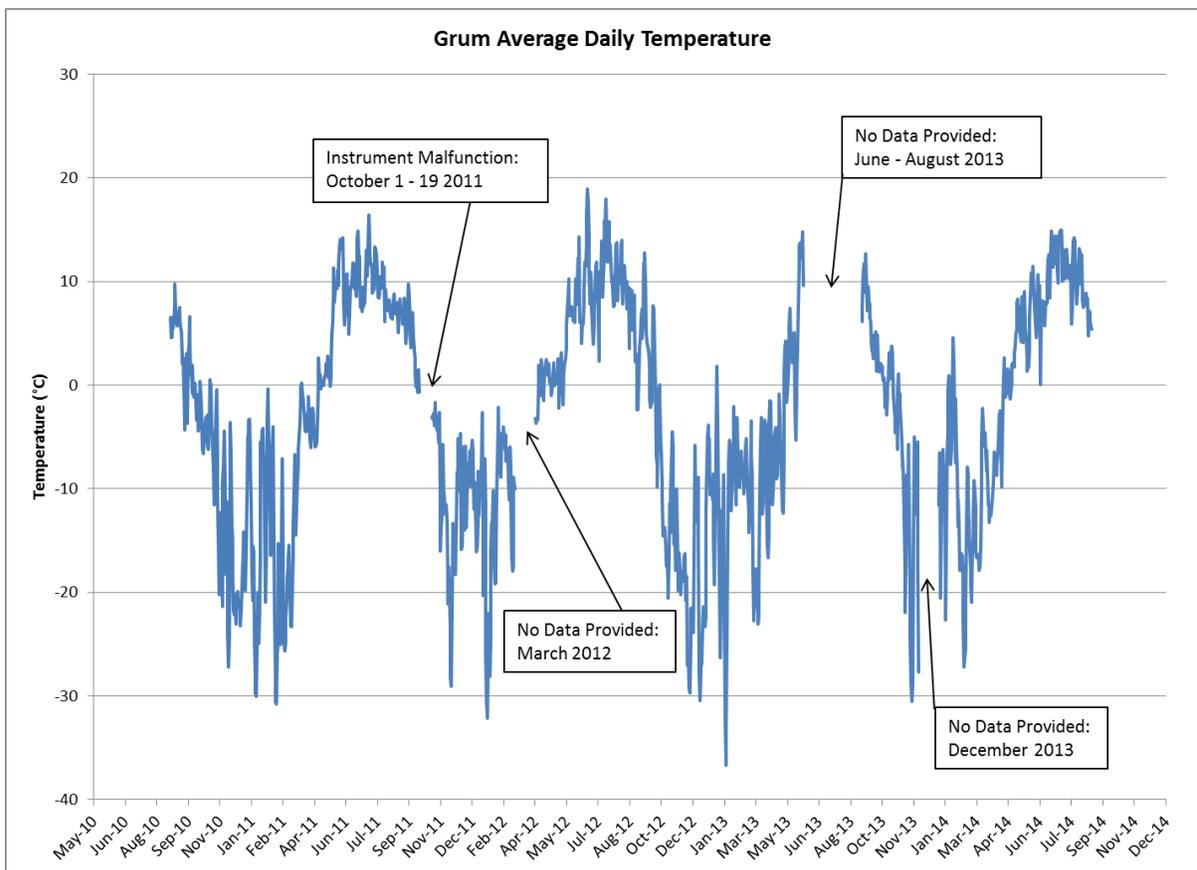
Figure 3-1. Grum Station Average Daily Temperatures

Temperature ranges recorded in 2014 were generally in agreement with previous years, although summer 2014 appeared cooler than summer 2012 (incomplete data for summer 2013). Precipitation values in 2014 were similar to ranges from previous years with two specific comments; rainfall fell in January 2014 (also occurred in January 2013) and two significant rainfalls occurred in summer 2014. Unfortunately, specific snow pack depth and density measurements are not available for the cover for the various years. This data would be useful to understand the water equivalent quantity trapped in the late winter snowpack, but this data was not provided to BGC. The snowpack data would provide context for the quantity of run-off while the temperature data review provides context on its intensity.

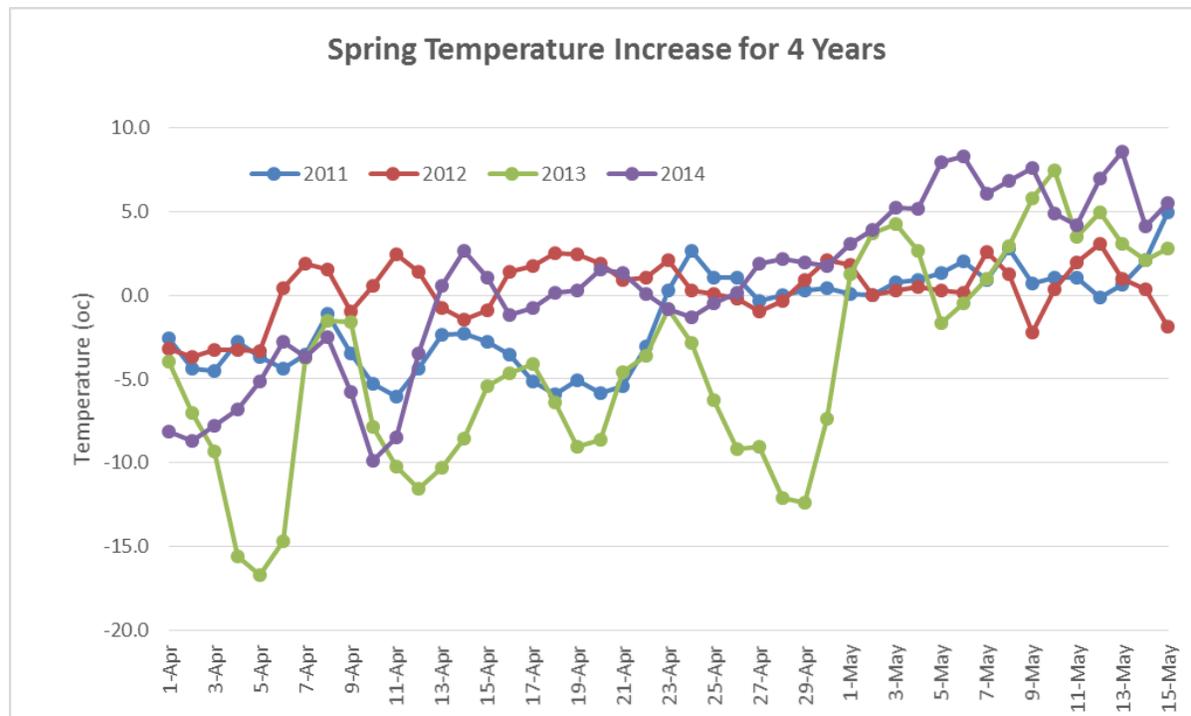
Figure 3-3. Spring Temperature Daily Values for Four Years

The plot shows that in the springs of both 2011 and 2013, the air temperature rise from subzero to above zero was rather rapid (on the order of four days for 2011 and 2013), resulting in a rapid melting of the snowpack. In spring 2012 though, the daily temperatures oscillate around zero for weeks (perhaps on the order of 30 days), which may have been partially responsible for a slower melt of the snowpack, releasing run-off at a slower rate. The warming trend in 2014 also showed an oscillating behavior (around 0°C) over 13 days between April 13 and 26, warming above zero consistently thereafter. The slower warming of the snowpack appears to result in less erosion to the cover, although no assessment of the snowpack water equivalent has been made.
