GRUM SULPHIDE CELL COVER, FARO MINE COMPLEX

2016 REVIEW

FINAL REPORT

PROJECT NO.: 0533-017
DATE: March 31, 2017

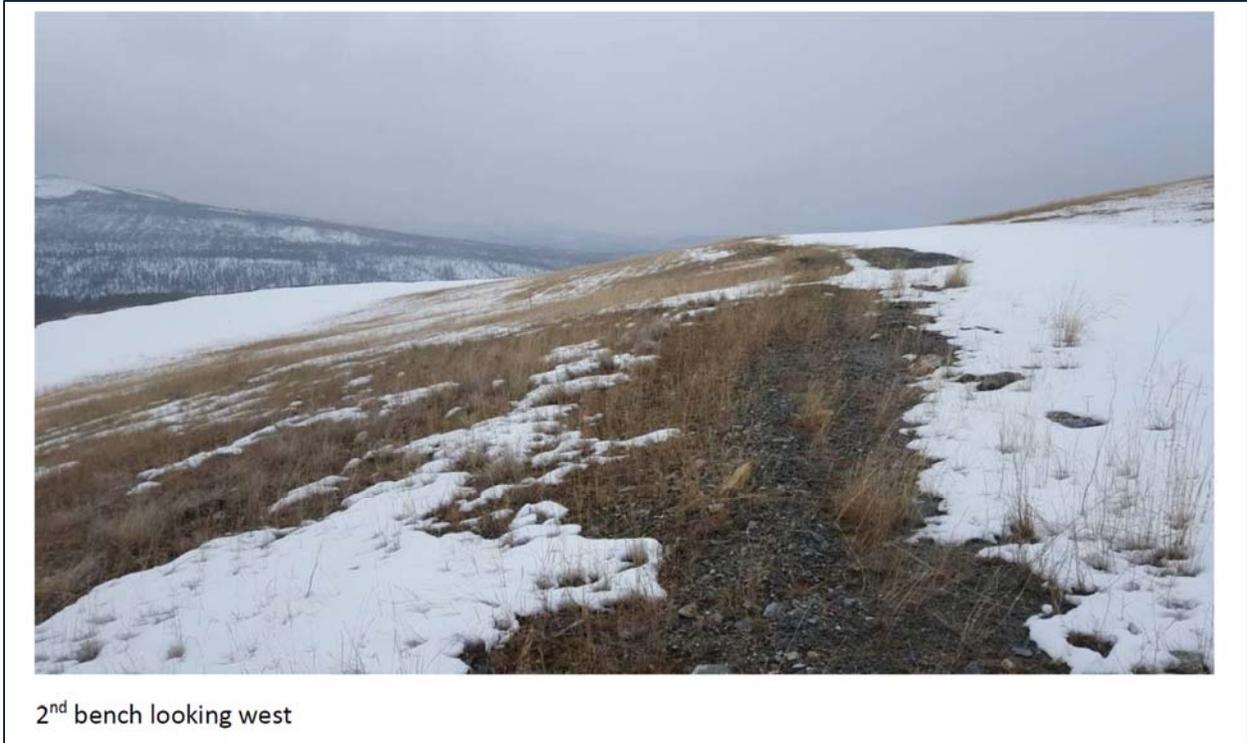
Plate B-1. April 5 observations showing relatively bare slopes and drifted in benches (DST 2016)

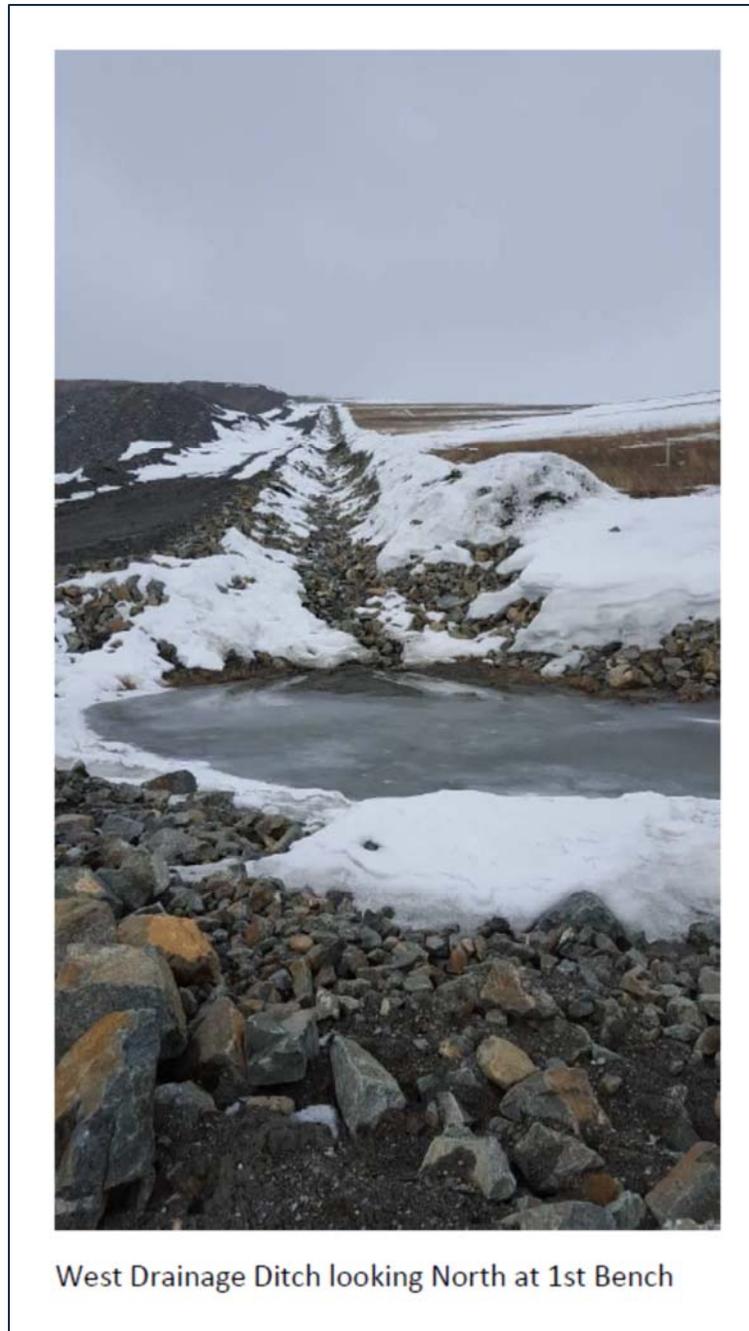
Plate B-2. April 5 observations showing West Perimeter Ditch and West Dissipation Pool relatively free from snow (DST 2016).

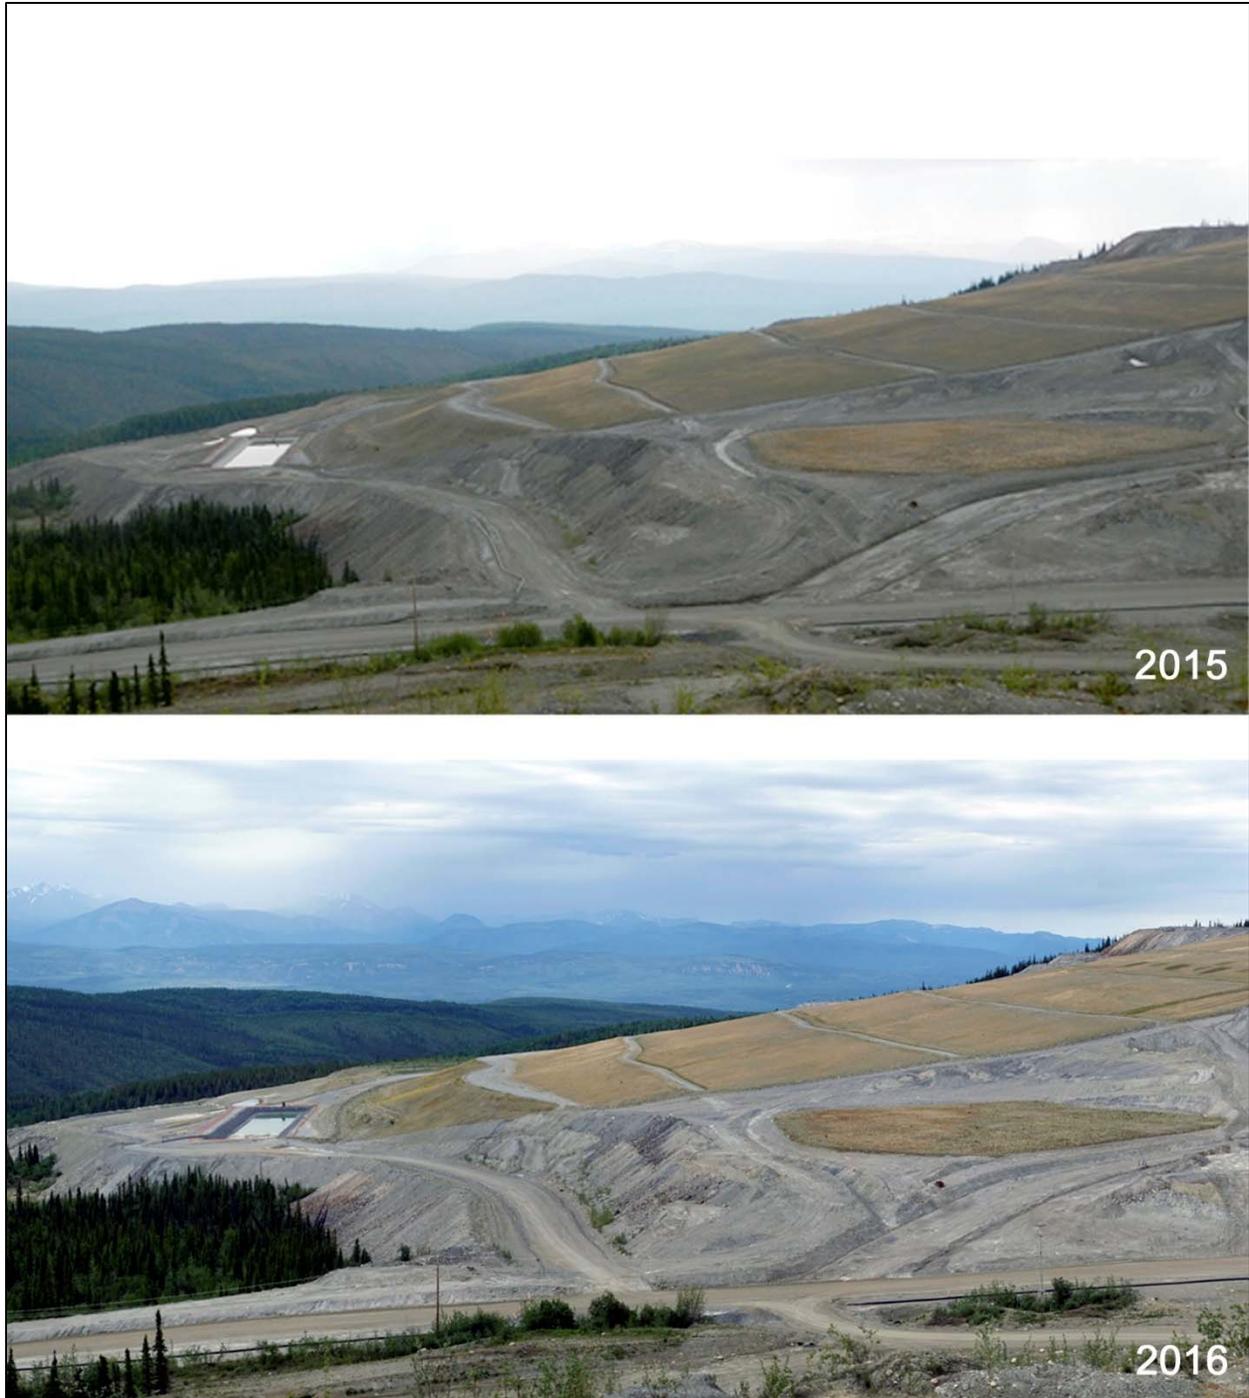
Plate B-3. Repeat photography for GSC as viewed from Grum Overburden Stockpile (GPS 480). Upper photo is May 26, 2015. Bottom photo is June 29, 2016.

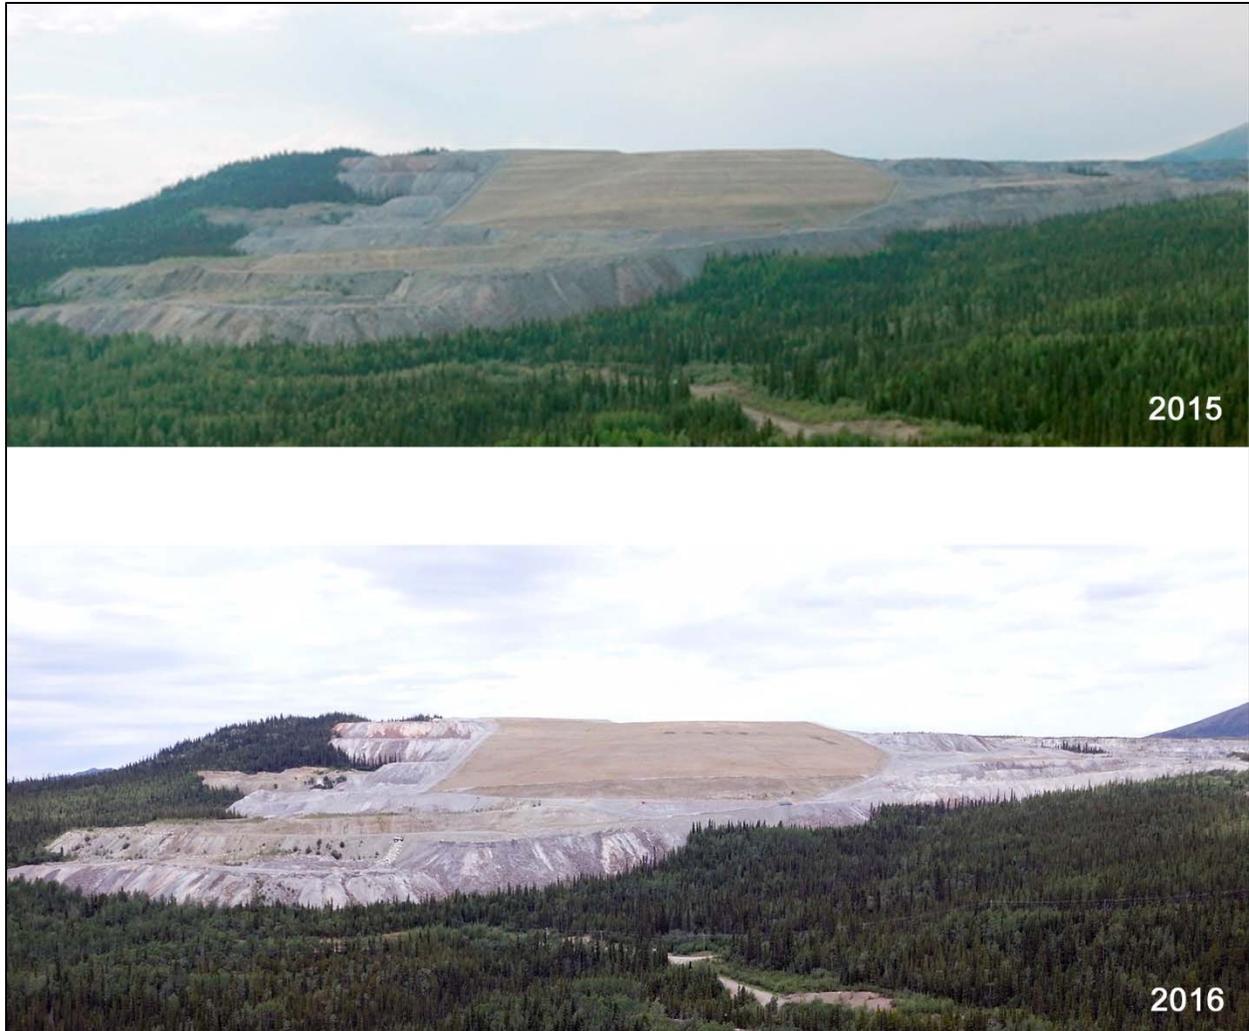
Plate B-4. Repeat photography for GSC as viewed from Vangorda Waste Rock Dump (GPS 481). Upper photo is May 26, 2015. Bottom photo is June 29, 2016.

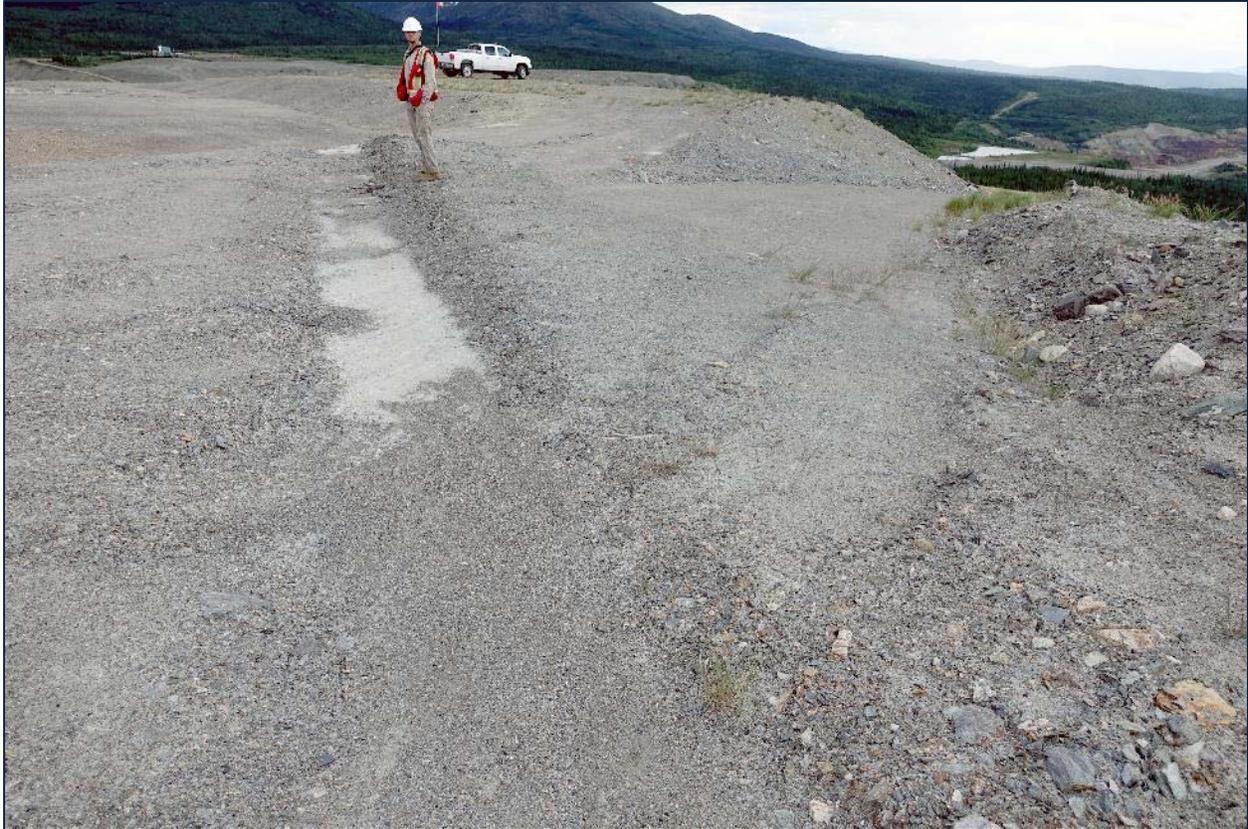
Plate B-5. Upper run-on diversion berm and ditch/swale (GPS 483).

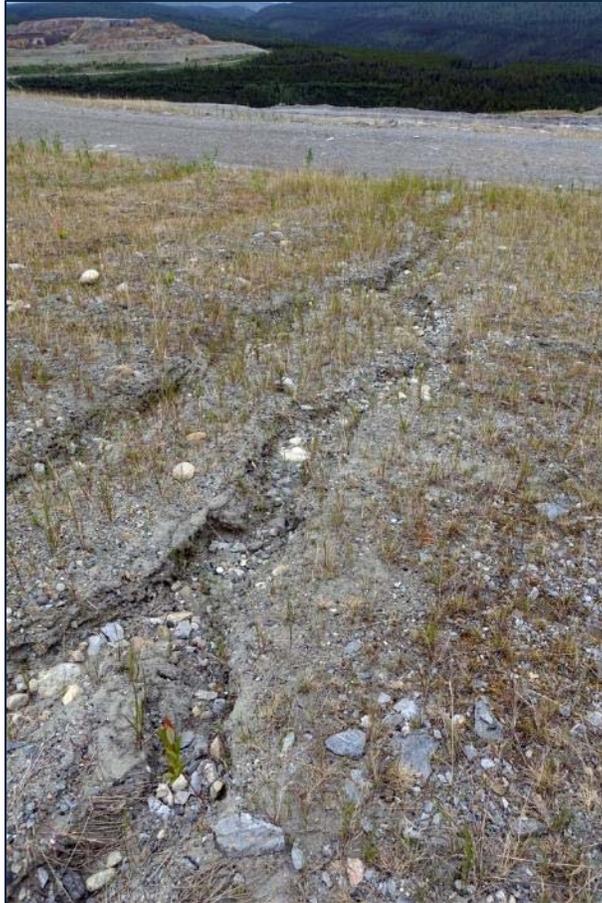
Plate B-6. Sparse vegetation and rilling of cover materials below the 1244 bench (GPS 515).

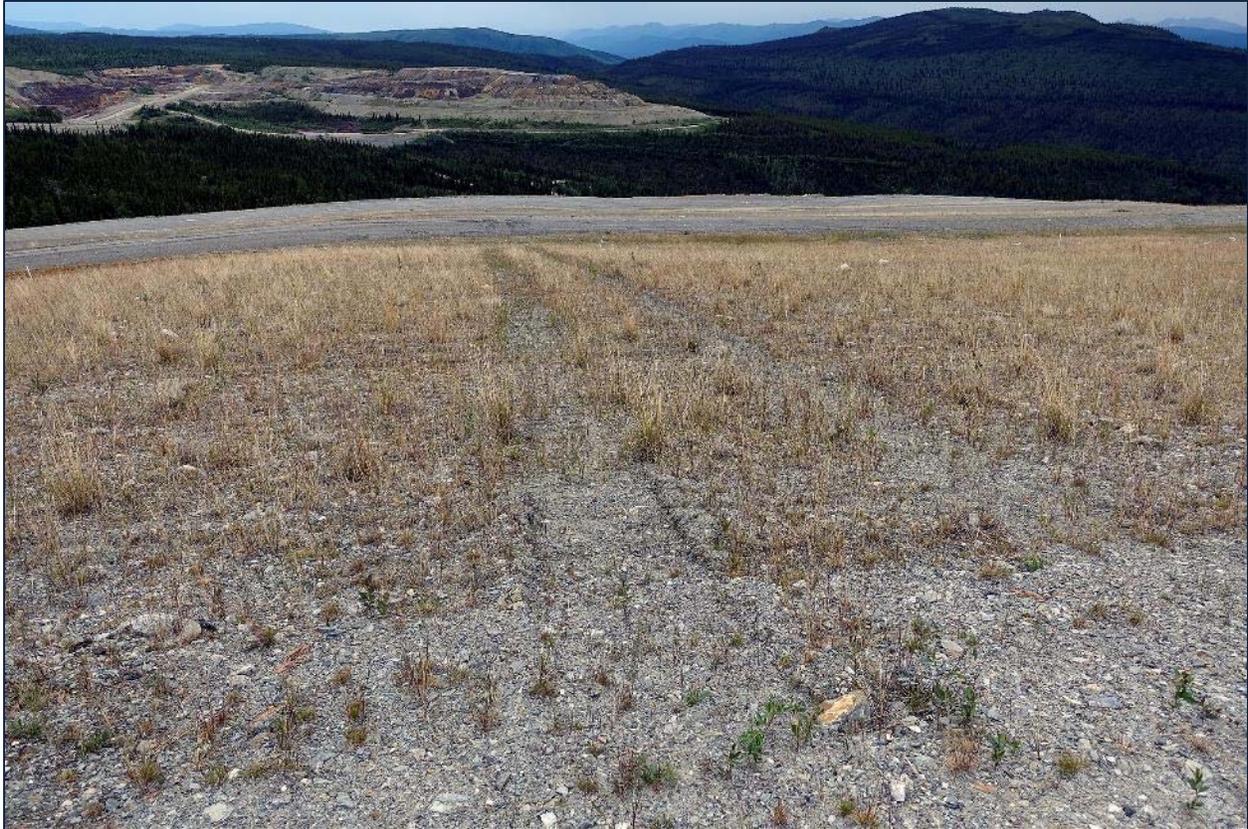
In previous inspections, damage from earthmoving equipment was noted. The ruts and damage to vegetation have either been repaired or have partially self-revegetated prior to the 2016 inspection. Plate B-7 shows an example of a previously damaged area.

Plate B-7. Damage due to equipment tracks (from a previous year) below the 1258 Bench. (GPS 505).

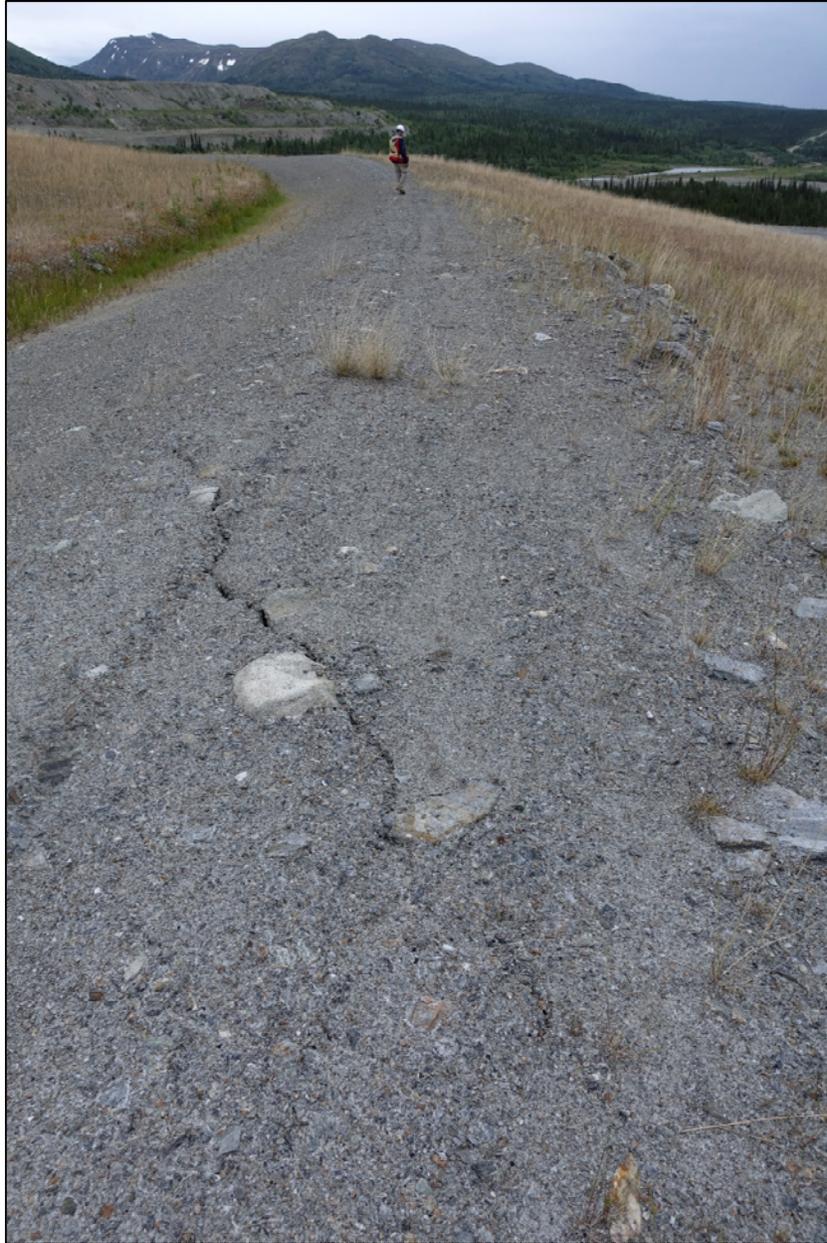
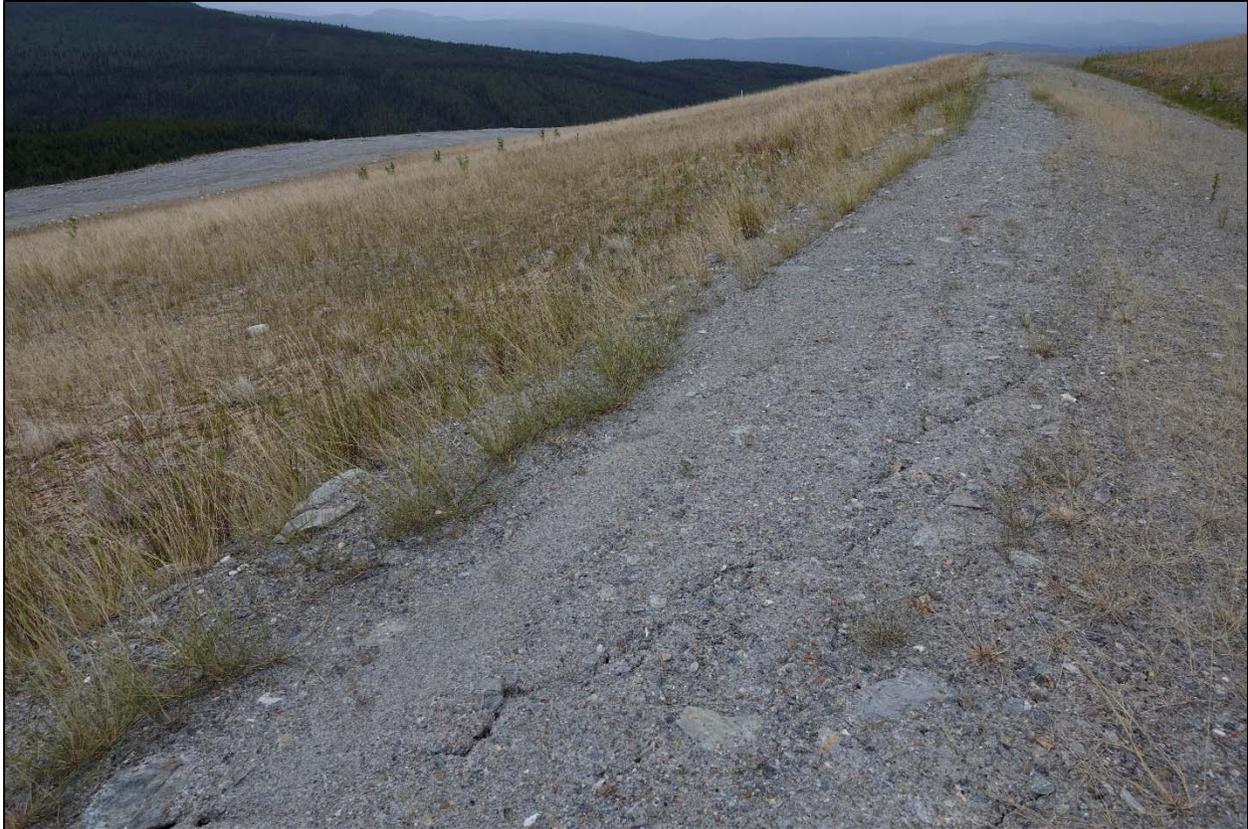
Cracking (see Plates B-8 and B-9) was noted in two locations on the 1227 Bench. The cracks ranged from 10 to 25 m long, with 1 to 2 cm aperture with no vertical offset. There was no visible distress in the slope immediately downslope of the cracks, though the downslope areas appeared slightly wetter than most other areas of the cover. The mechanism for the crack is unclear; they may perhaps be due to freeze-thaw or wetting-drying expansion. The cracks were not present during the 2015 inspection. See Section 4 regarding recommendations to seal these cracks in 2017.

Plate B-8. New cracking on the 1227 Bench (GPS 518).

Plate B-9. New cracking on the 1227 Bench (GPS 518).

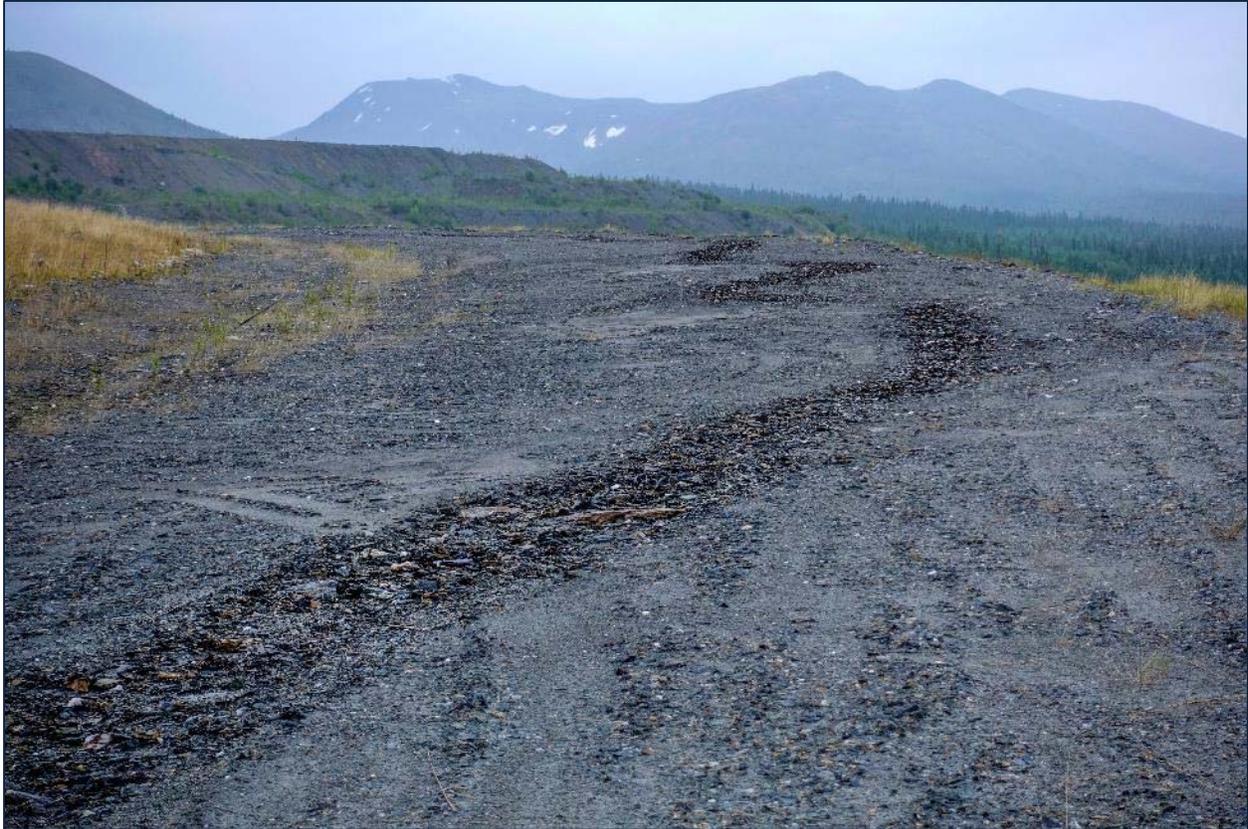
The benches are perhaps the most vulnerable part of the cover system and are prone to blockage by sediment fans and especially snow drifts. Plate B-10 shows a wavy pattern on the Toe Berm Toe Road at GPS 523 that is the result of lateral flow along the bench around the toe of snow drifts. Fines have been stripped away and other material deposited along this small channel. The greatest cause of erosion to date has been where such flowing water overtops the bench, and starts to downcut forming one or more rills, then a gully, to form immediately downslope of bench. The regrading efforts of 2011 have been beneficial here to reduce the vulnerability but overflow and erosion are still occurring.

Plate B-10. Remnants of a channel skirting a recent snow drift are visible in this photo on the Toe Berm bench (GPS 523). The photo has been enhanced to show the channel more clearly. This site will require repairs to a gully below and grading of the bench.

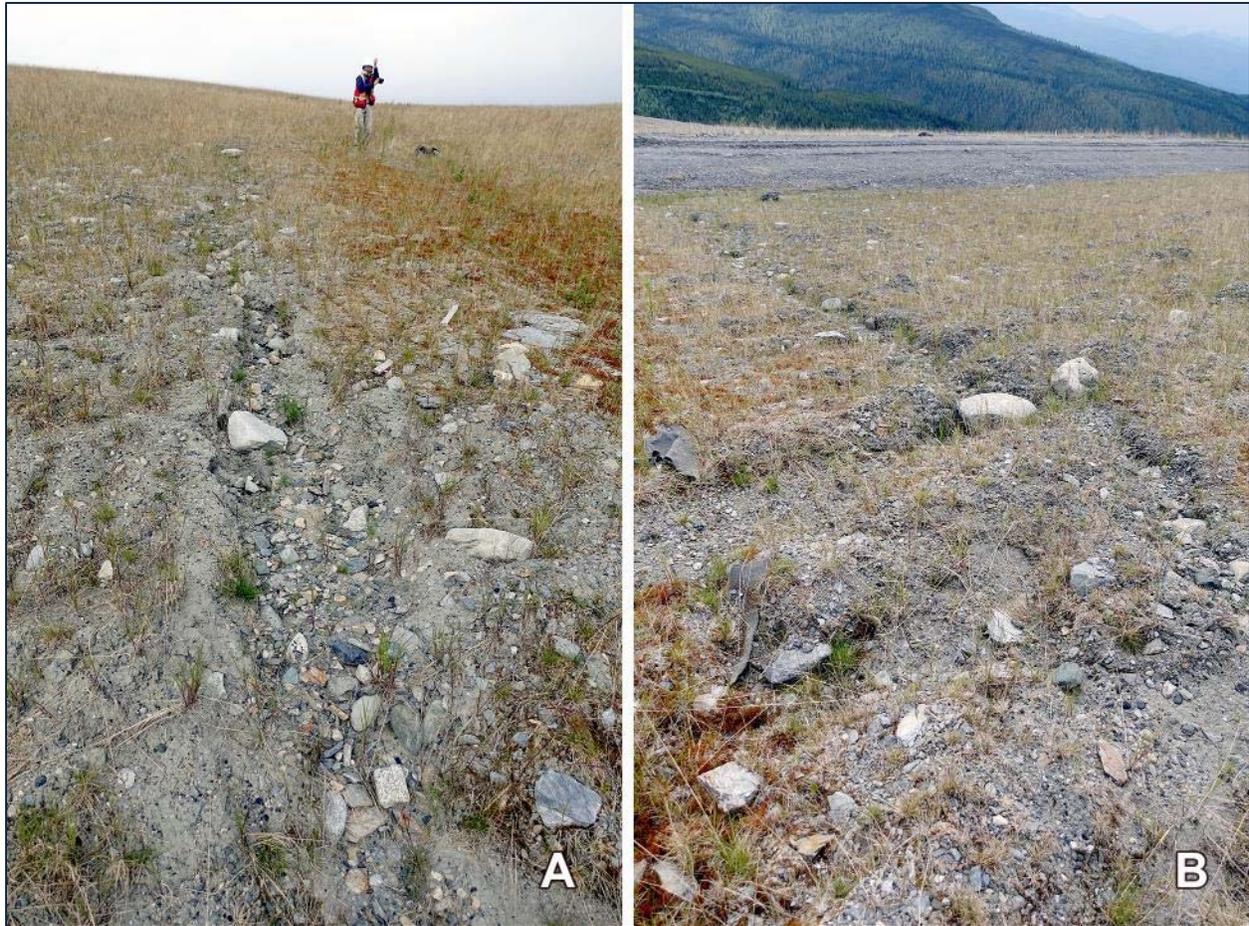
Plates B-11 through B-14 provide examples of the rills noted during the inspection. The plates show some self-armoring by larger clasts, but in most areas, this has yet to develop to the extent where downcutting is arrested (or even slowed). Vegetation is not generally establishing much in the erosion channels but some is invading the depositional fans. Rill erosion also leads to sediment deposition on the bench surfaces, potentially blocking lateral flows. There are several small gullies that flow into the West Perimeter Ditch as noted in Table C-1.

Plate B-11. Rilling above 1284 Bench (GPS 487). These active rills appear to be new since 2015 inspection.

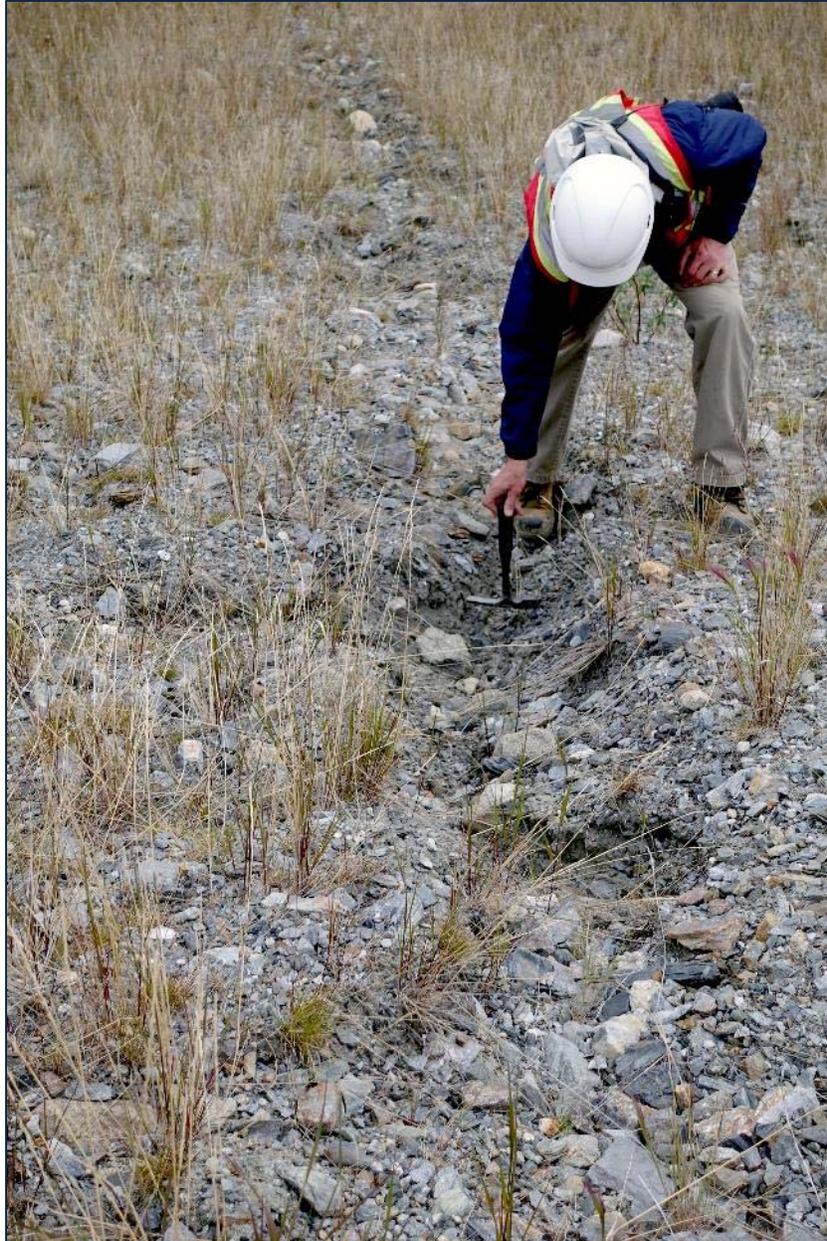
Plate B-12. Rilling below the 1258 Bench. GPS (504). The photo illustrates some rock armoring but little vegetative armoring of the rill. They appear to be new since 2015.

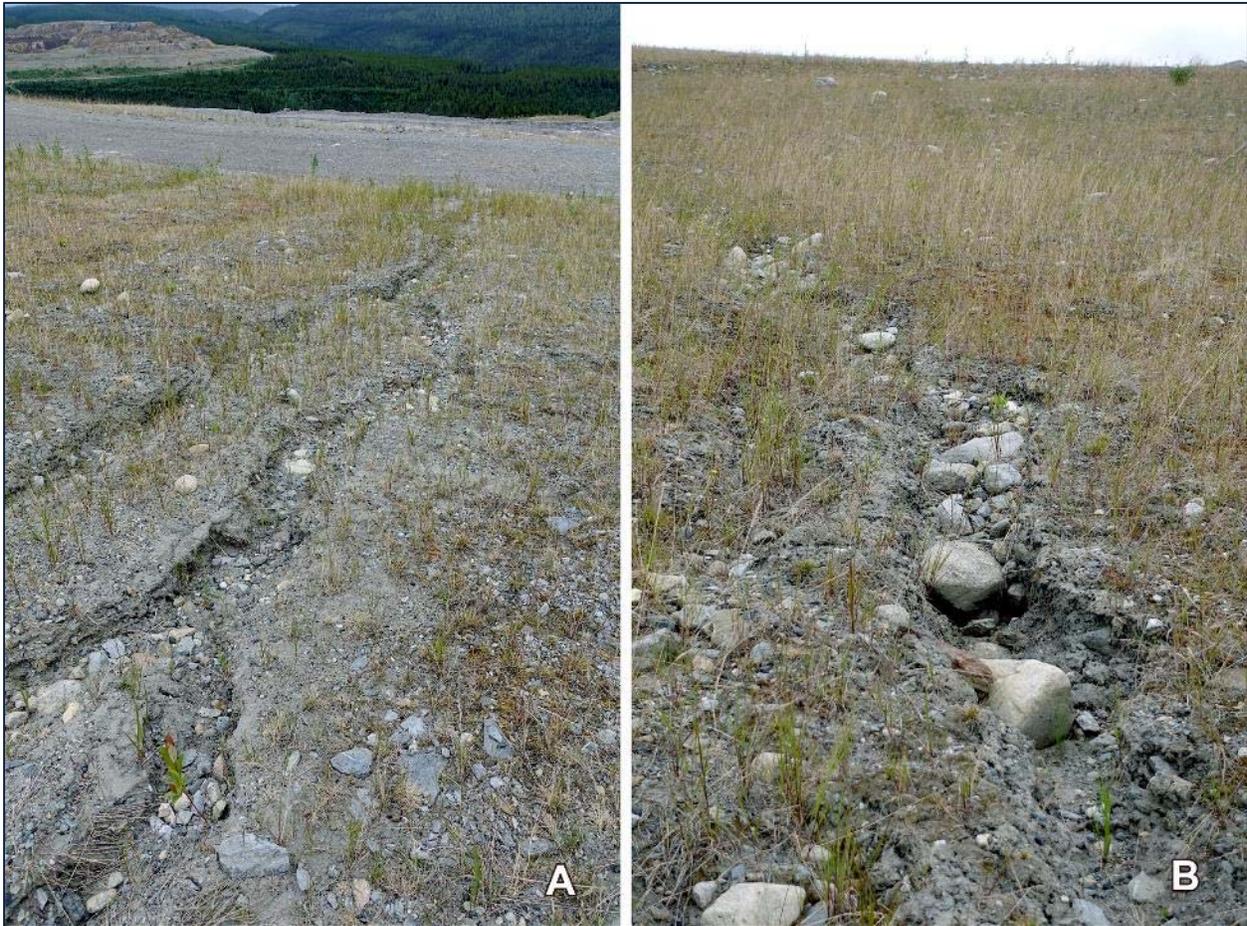
Plate B-13. Rilling below the 1244 Bench. (GPS 515). Rills are each 10 m long x 0.1 m wide x 0.05 m deep and appear to be new since 2015 inspection.

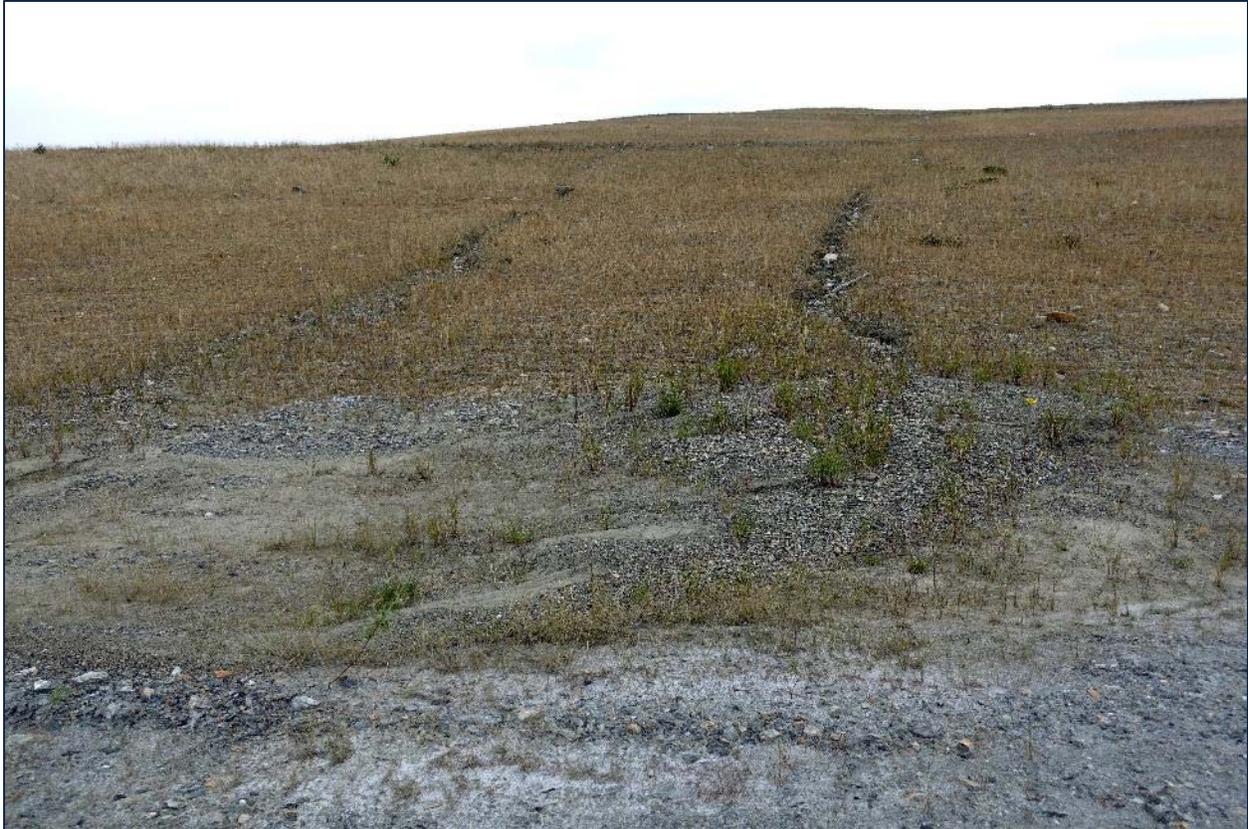
Plate B-14. Rilling with fan deposition onto the Toe Berm Bench. This fan deposition, if left unchecked, could block flow in the lateral berm channel (GPS 522). Noted in action log for repair of gully and removal of fans.

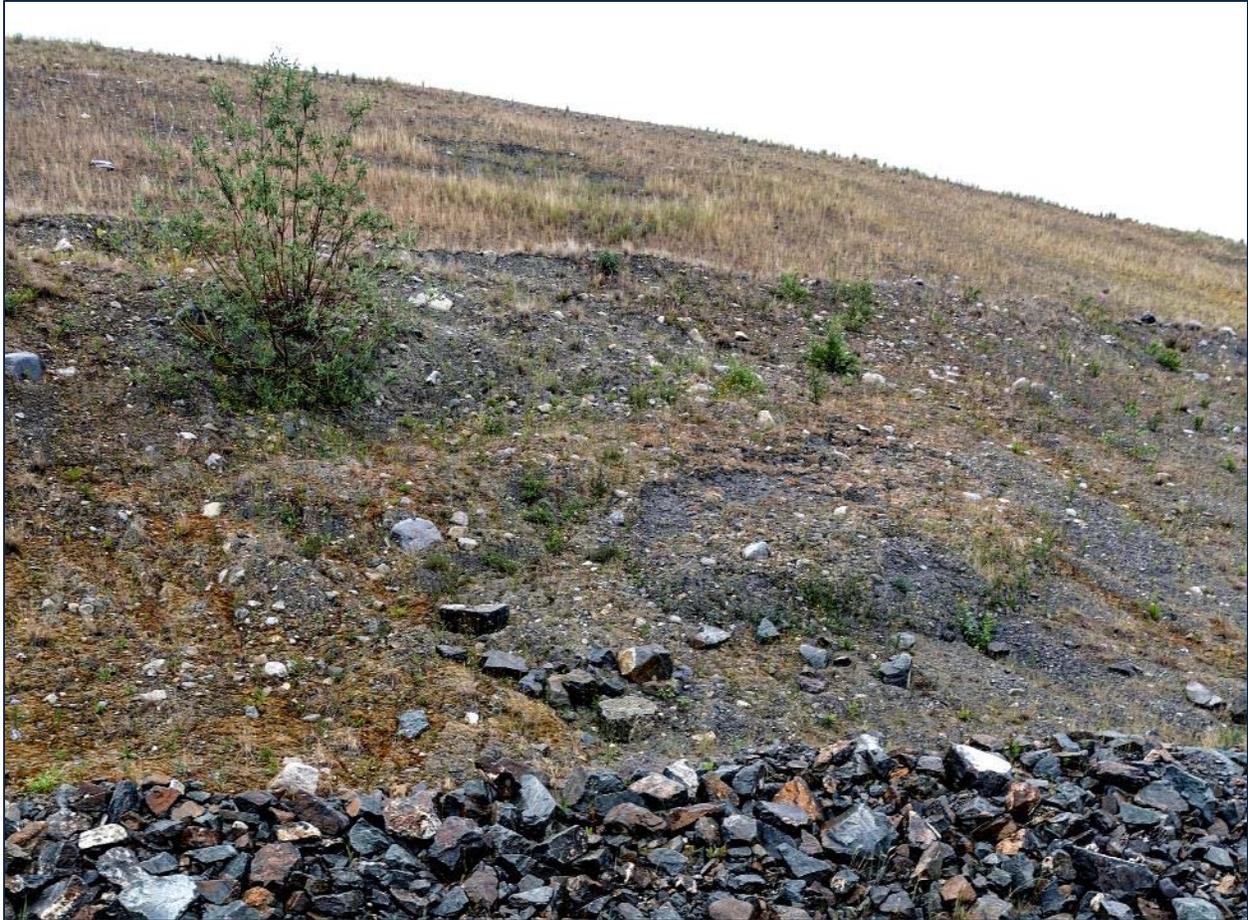
There are three small slumps on the oversteepened slope below the Toe Berm (GPS 529) that had been previously identified in 2014. Vegetation patterns indicate they are showing minor continued movement, but with no new cracks. The slumps are indicative of the oversteepened slope and at least in one case, the failure may be related to excess pore-water pressure on the liner. Plate B-15 shows two of the slumps.

Plate B-15. Two of the slumps on the Toe Berm Slope (GPS 529) Movements of the lower slump are due to the oversteepened slope and possibly excess pore-water pressures at the liner. Vegetation patterns indicate the slump is still active.

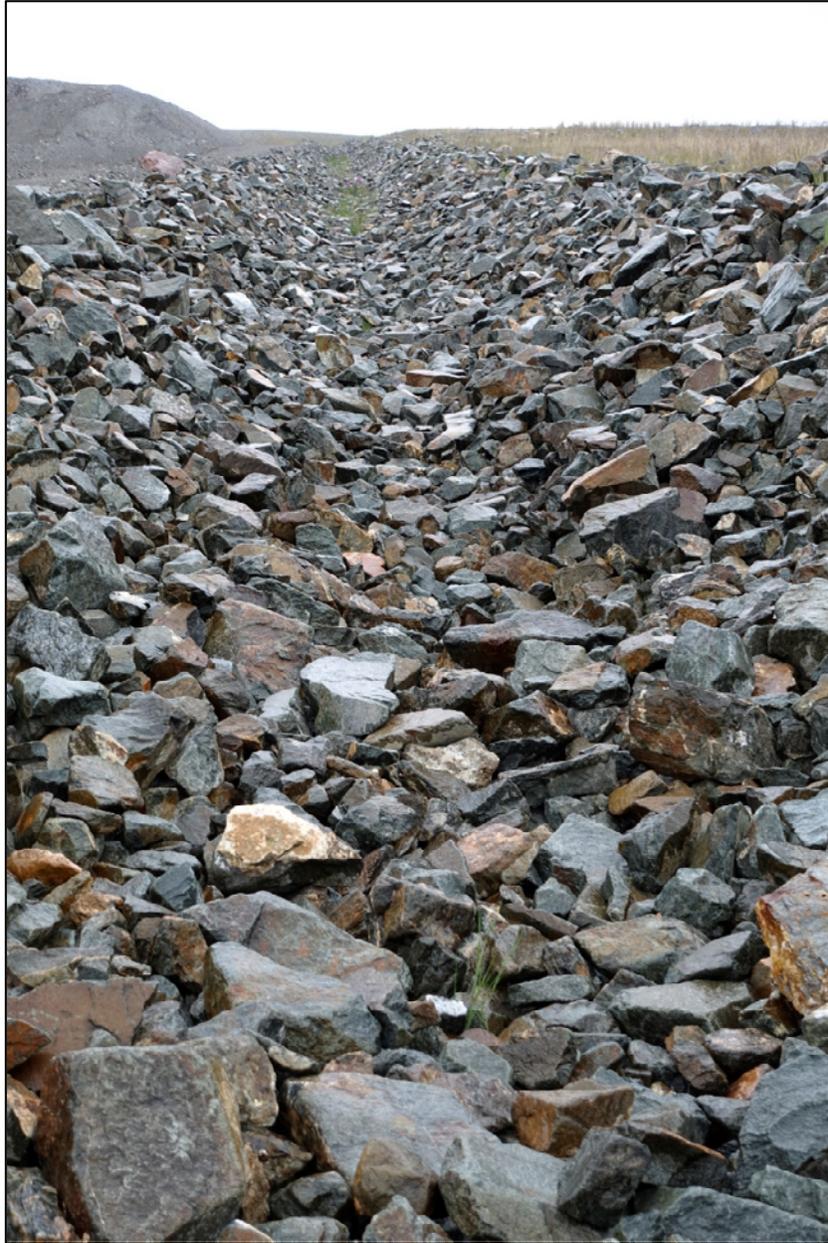
Plates B-16 through B-18 show examples of the perimeter ditches and the two dissipation pools. No evidence of blockage, erosion, or significant sediment accumulation was observed.

Plate B-16. West Perimeter Ditch (GPS 525) showing good performance. Looking upslope from near 1227 Bench.

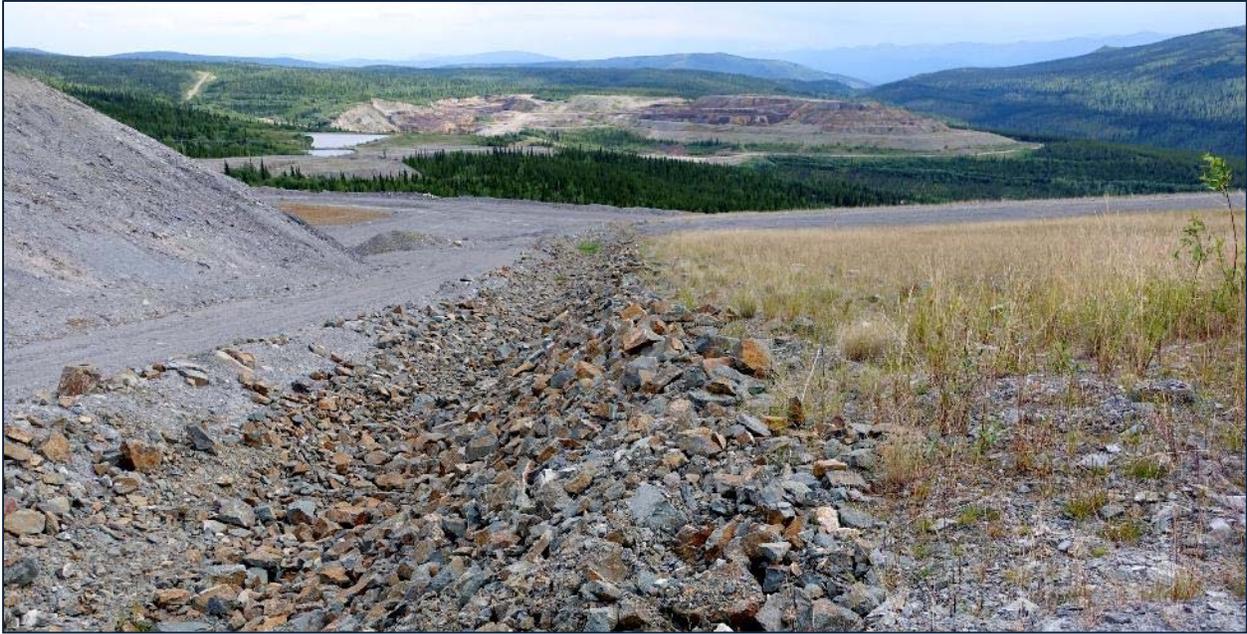
Plate B-17. East Perimeter Ditch at Bench 1284 (GPS 495). No signs of blockage or flow channelization.

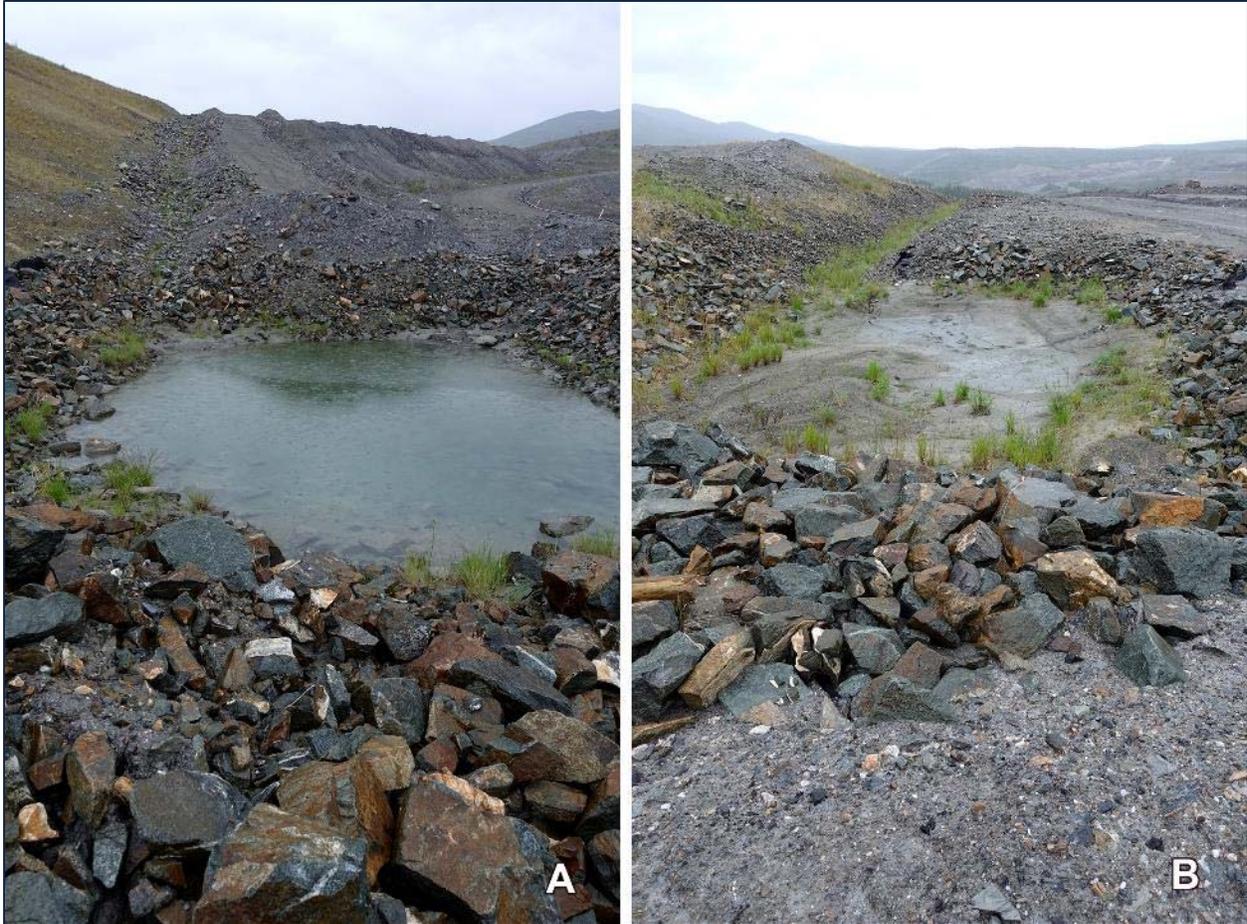
Plate B-18. Dissipation pools at base of perimeter ditches (A: East Dissipation Pool, GPS 530; B: West Dissipation Pool, GPS 526).

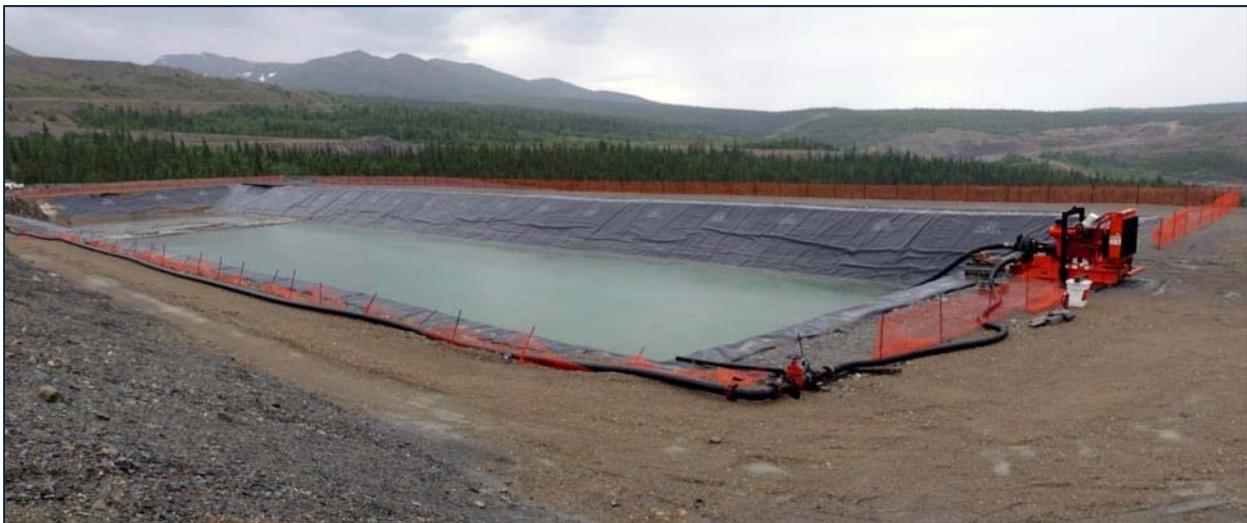
The Lined Pond (see Plate B-19) had been pumped down and there was a pump ready to take any new water to the Vangorda Pit. The safety fence around the Lined Pond has fallen from its posts. The liner has no obvious damage and the lined outlet shows no sign of blockage or erosion.

Plate B-19. Lined Pond (GPS 528). The liner is intact, and the pump at the ready, but the orange safety fence for wildlife entry is of need of repair.

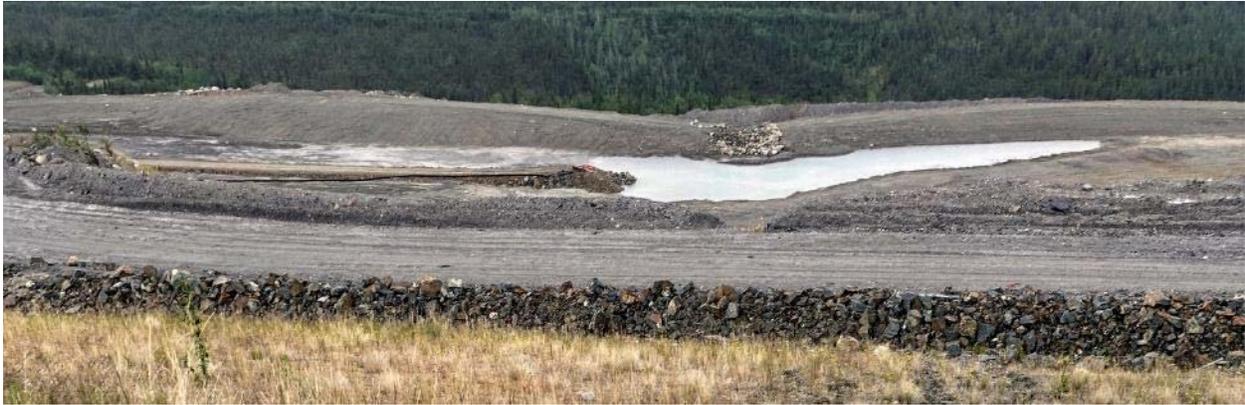
Plate B-20. Unlined Pond (GPS 532). The pump has been removed.

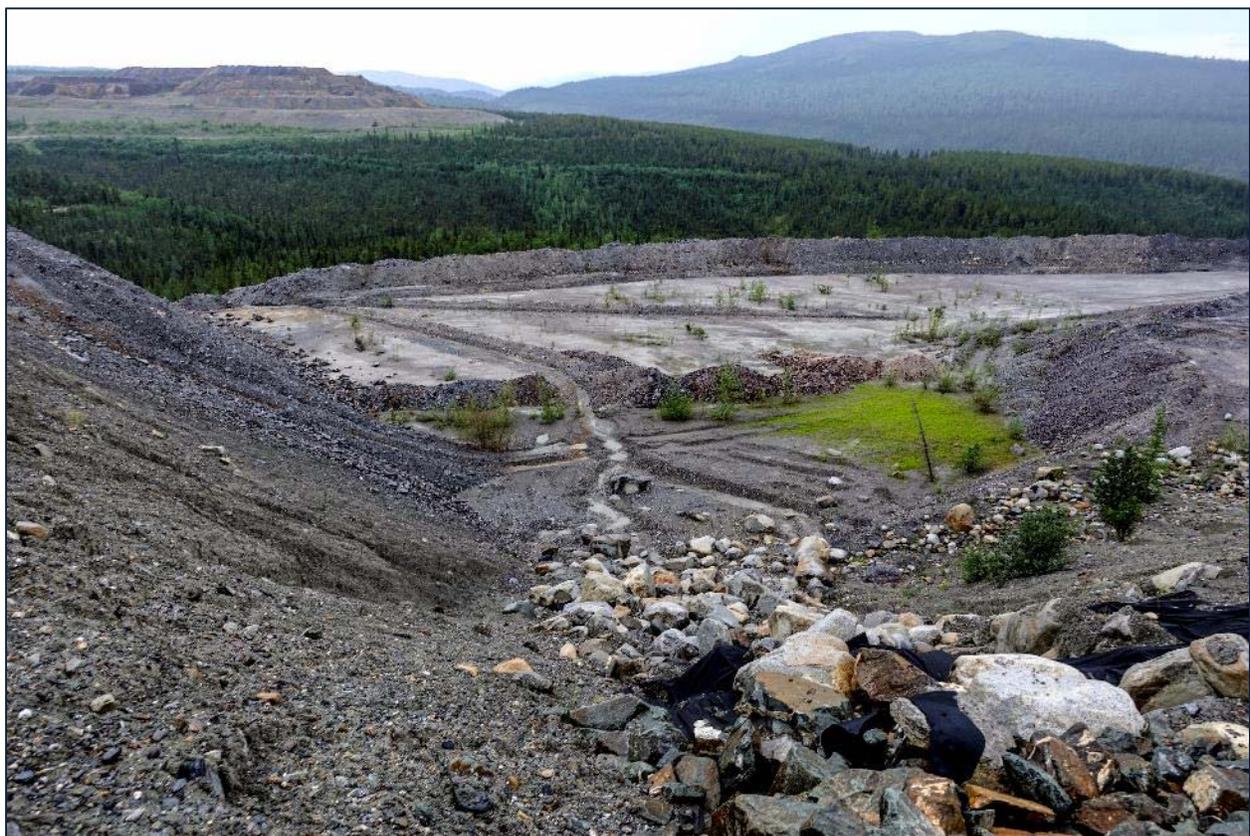
Plate B-21. Unlined Pond outlet channel (GPS 533)
