GRUM SULPHIDE CELL COVER, FARO MINE COMPLEX

2016 REVIEW

FINAL REPORT

PROJECT NO.: 0533-017
DATE: March 31, 2017

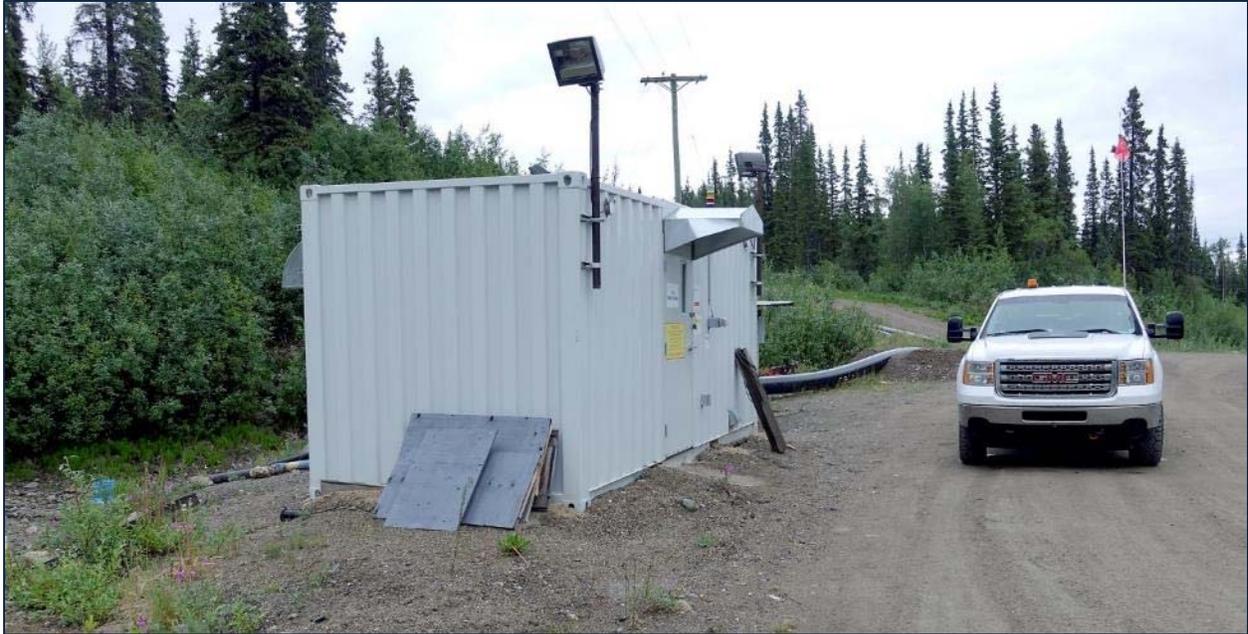
Plate B-22. Pumping station V15. (GPS 534).

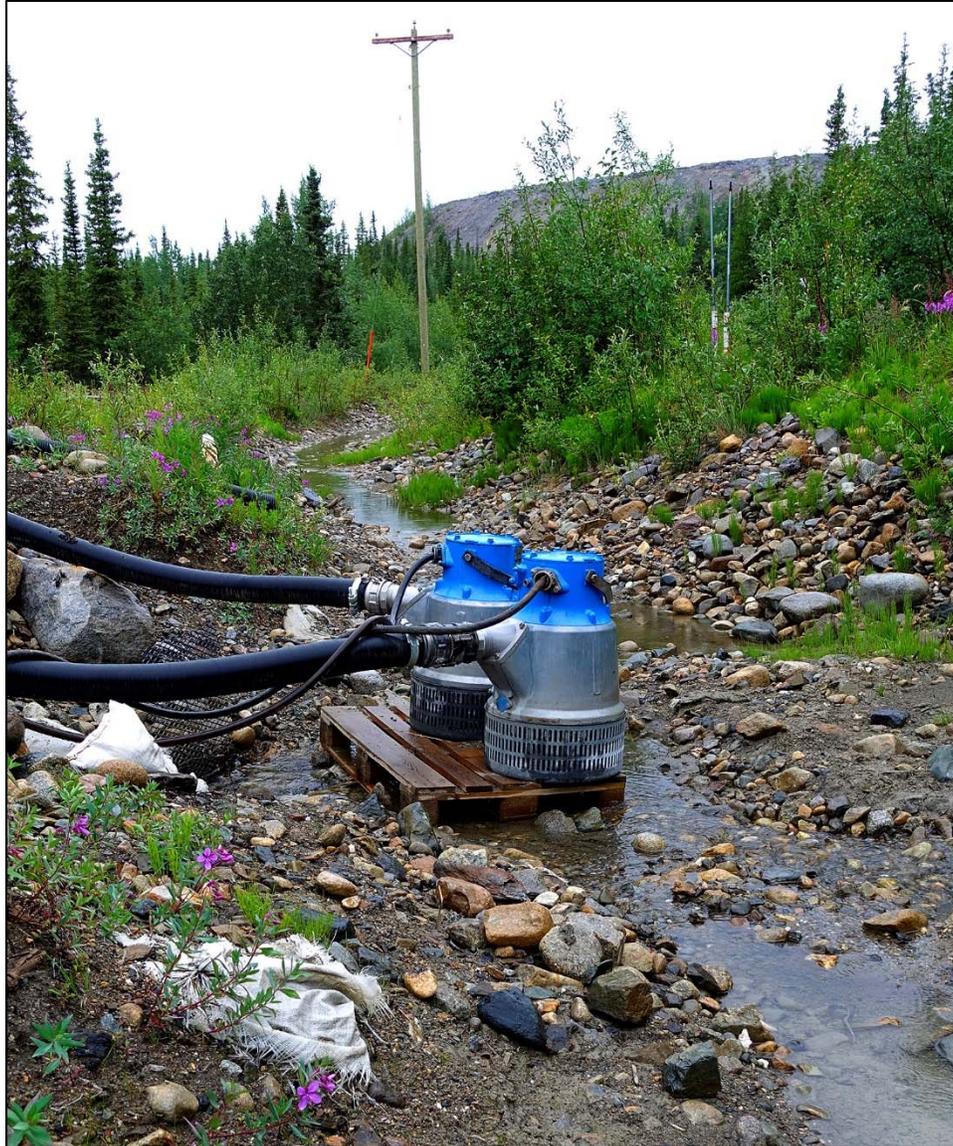
Plate B-23. Ditches and pumps at the Pumping Station V15 (GPS 534). The two high-flow pumps are sitting idle above the creek bed during this low-flow period.

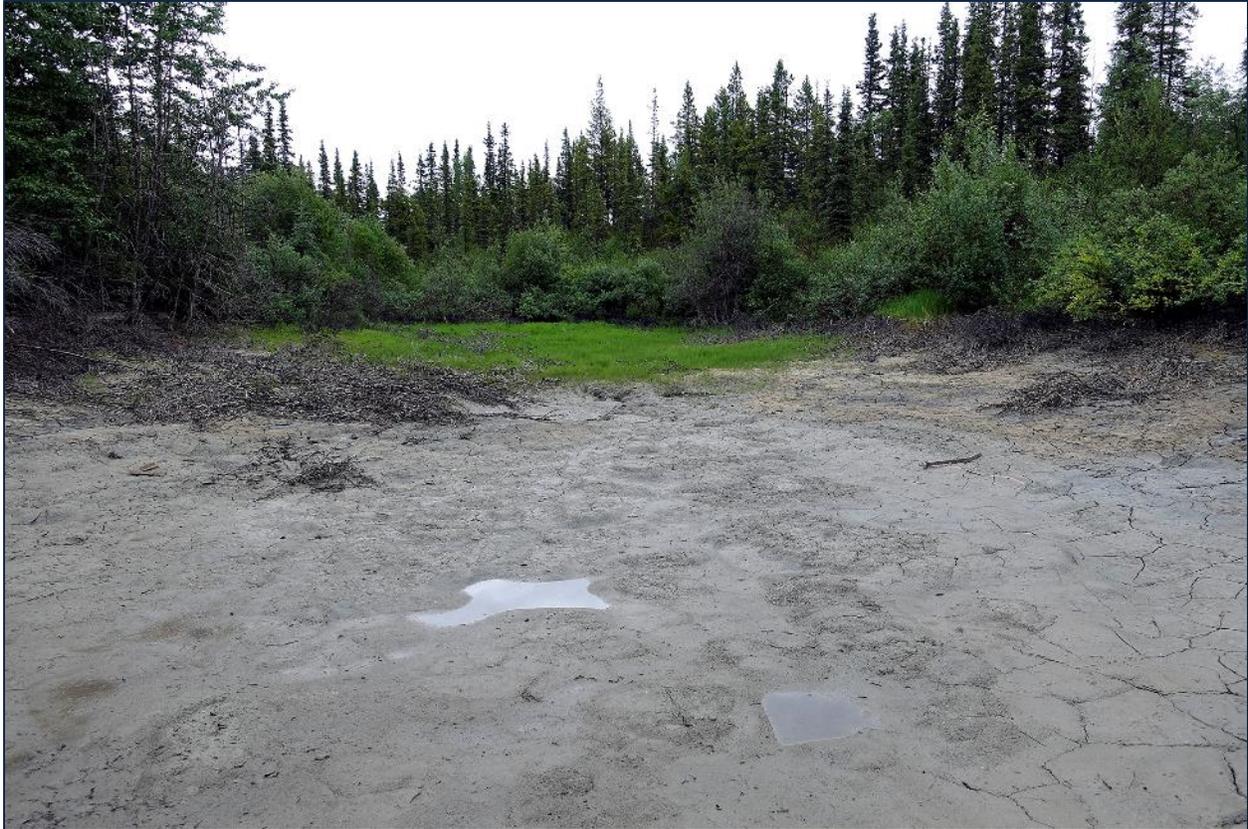
Plate B-24. The Moose Pond became dry after its water source was cut off. The base is muddy; some vegetation is invading. (GPS 535).
