# Territorial Diving Technologies

## **1.0 INTRODUCTION**

Anvil Range Mining Corporation contracted Territorial Diving Technologies, of Whitehorse to;

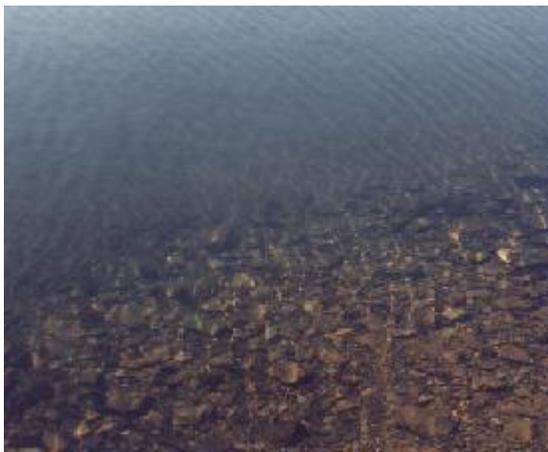
Picture 1.7

This photograph shows the visibility at the surface, it looks like it will be a couple of feet, with the assistance of the surface penetrating sunlight. The visibility was not this good at depth.

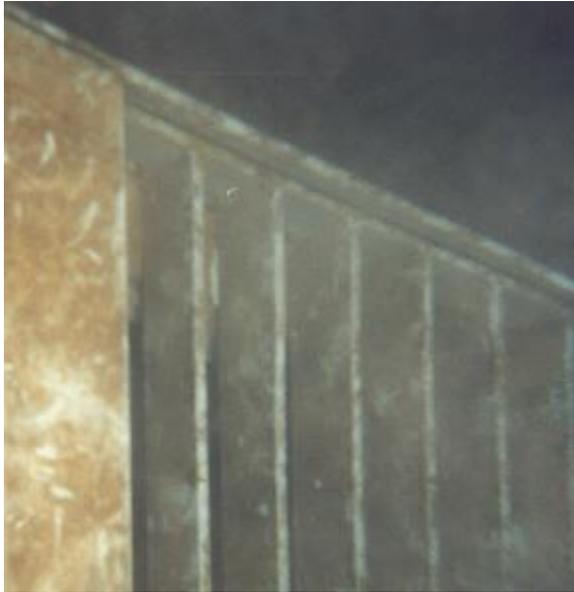
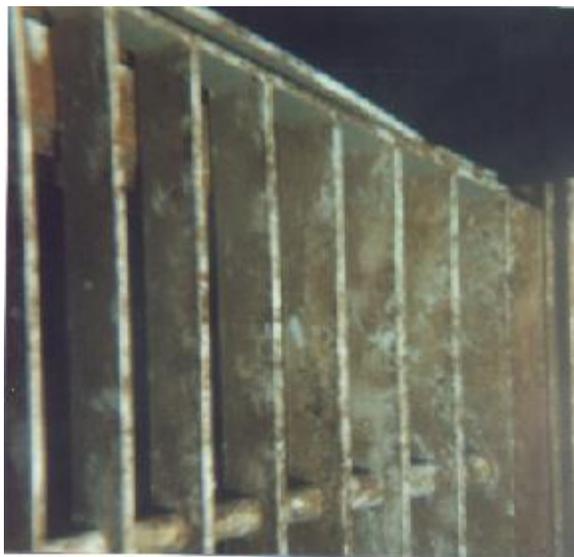
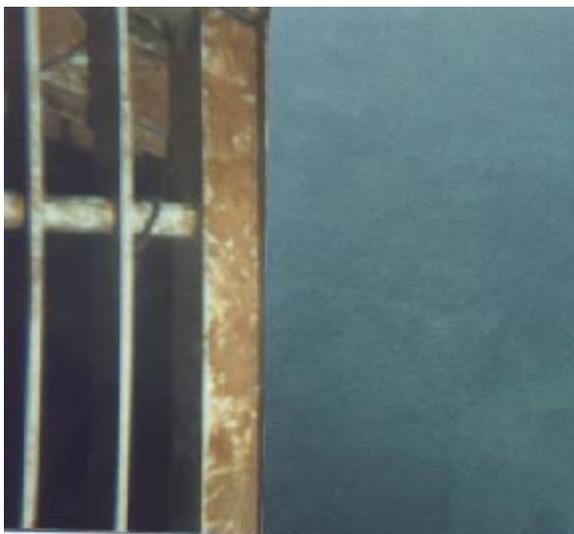
Picture 1.1

Clearly shows rack structure, very little growth or silt built up. Top of rack is located in 45 feet of water. Photograph was taken roughly at midday, one can see the visibility of available surface light. Divers had extra lights pointed at the rack to provide sufficient enough light for photograph to be taken. Photographer: Diver Richard VanderKley  
Equipment: Nikonos V with strobe attachment and extra lighting.

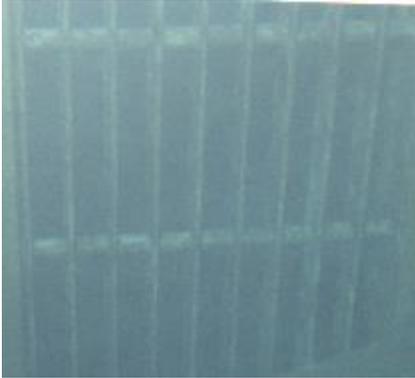
Picture 1.4

Shows rack from further back, you can see how rapidly we lose good visibility.

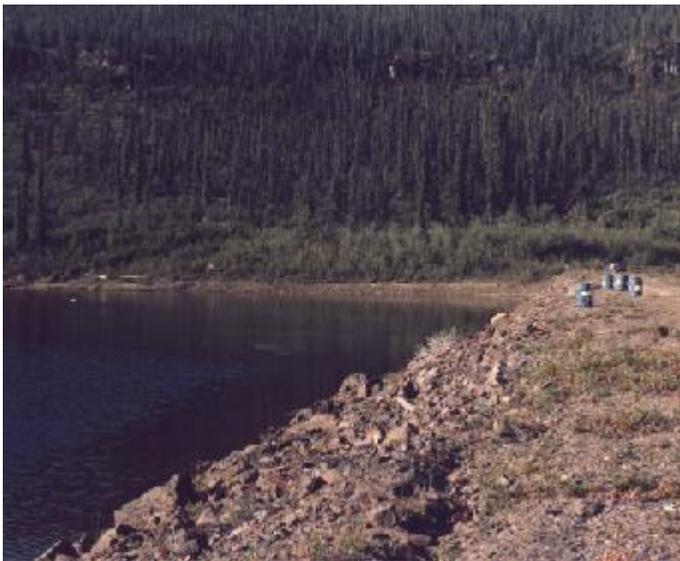
Picture 1.5

Surface photograph, one can see the marked float in the water showing the location of the "shark cage" rack. This gives a person an indication as to how far from shore the intake is.

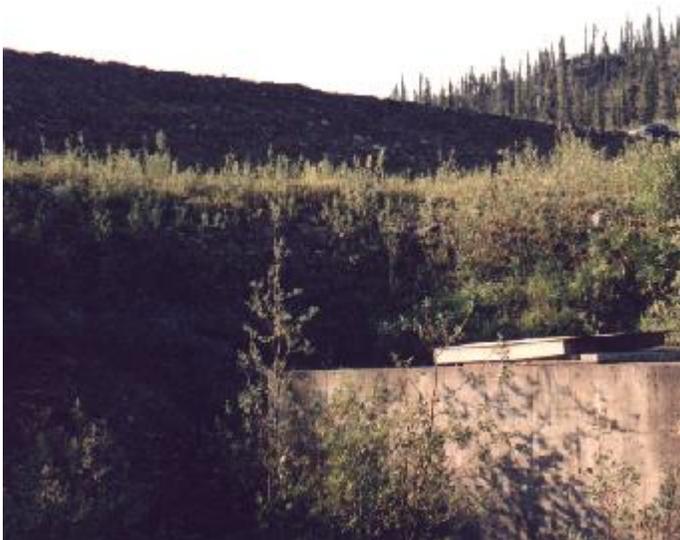
Picture 1.6

Front right hand side of photograph shows the gate house at the bottom and gives a person an idea of the height of the dike (full size Dodge 3/4 ton is shown in top right hand side of photograph)
