**Denison
Environmental
Services**
a division of Denison Mines Inc.

MEMORANDUM

TO: DES: Jon Bronson, Roy Morrell; YG: Kaori Torigai, John Brodie
DATE: February 8, 2010
FROM: Jay Cherian, Denison Environmental Services (DES)
SUBJECT: Jan 2010 Follow-Up to X3, X10 Review

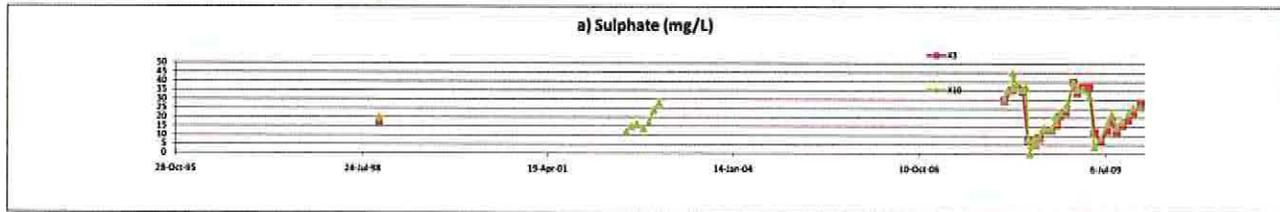
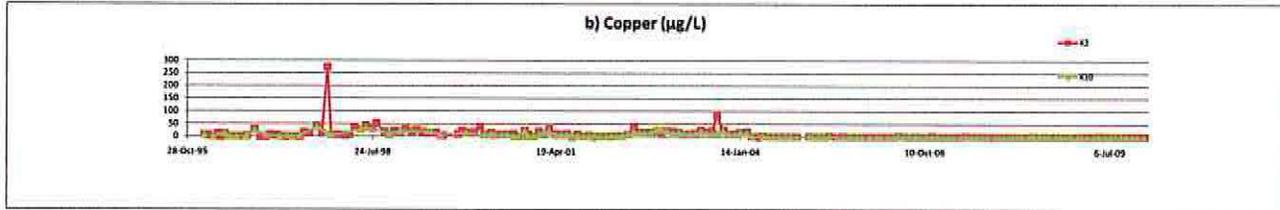
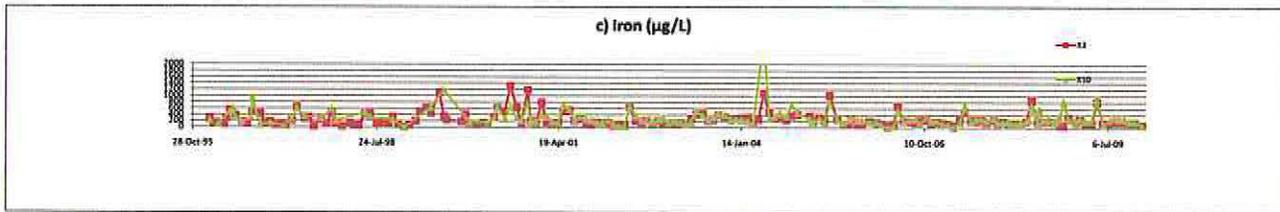
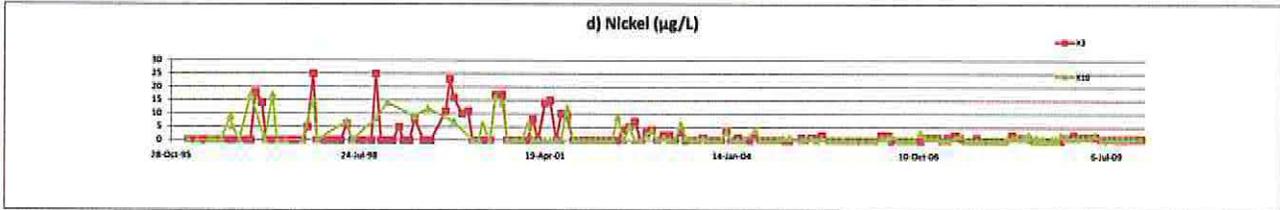
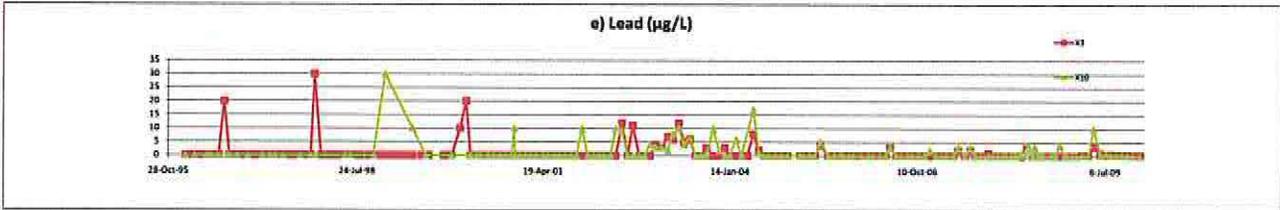
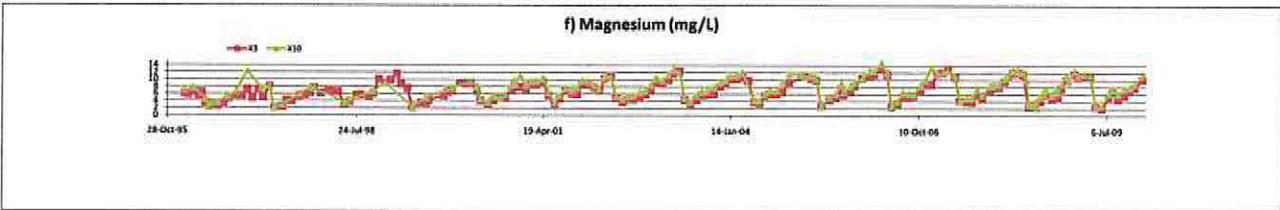
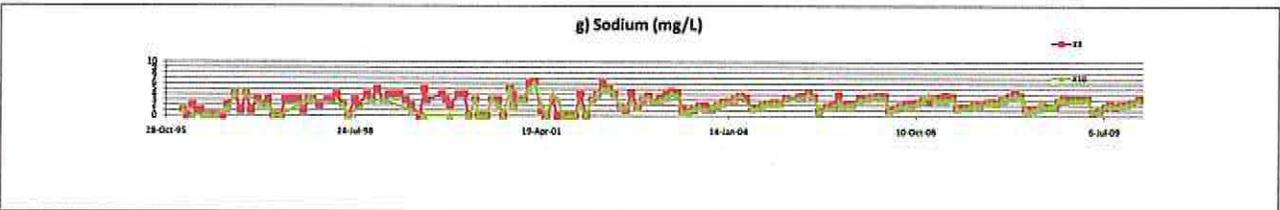
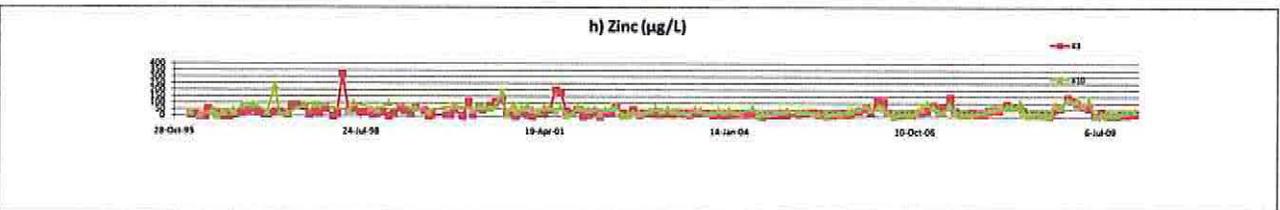
Figure 1a - h: Comparison of X3 and X10 for Select Water Quality Parameters

The attached Figure 1, illustrates a comparison of select analytes at X3 and X10 from late 1995 to the most recent sampling event of January 11, 2010.

As in the preliminary review, Figure 1 shows that for all the parameters reviewed (with the possible exception of magnesium, iron and zinc), the concentrations of X3 and X10 are comparable. Statistical analysis would be required to determine whether or not the differences are significant for magnesium, iron and zinc. In addition, the results for all parameters, including zinc show generally that trends at X3 parallel trends at X10, indicating that no increasing trend in concentrations at X10 with respect to X3 is observable.

While detailed statistical analysis of the iron, magnesium and zinc may show that there is some loading to the RCDC within the reach from X3 to X10. A visual review of the graphs on Figure 1 indicates that the concentrations for each of the reviewed parameters are not increasing with respect to historic rates.

Overall, water quality at X3 and X10 is comparable with historic water quality and it is possible that statistical analysis would show improved water quality due to the capture of groundwater in the S-Wells area.
