**KENO HILL PROPERTY**  
**PHYSICAL HAZARD REDUCTION PROGRAM**

**2006**

**Access Consulting Group Inc.**

**January 2007**

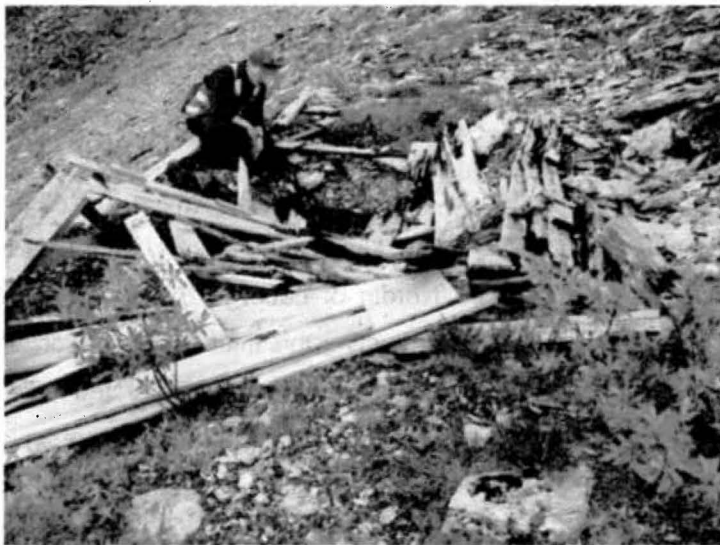
**Photo 1: D. MacGregor of SRK Consulting examines an abandoned shaft on Keno Hill.**

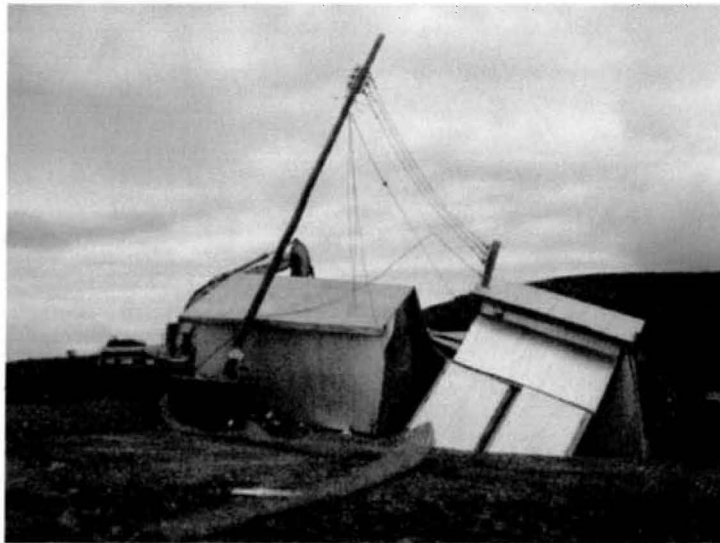
The most significant site remediated during the 2006 season was the Shamrock J vent raise. This site contained a building that was partially collapsed over an open vent raise, and vehicle track evidence in the past had provided indication that this site represented the highest priority danger for personal injury, particularly as tourists regularly frequented the area. A fence to prevent access had been previously installed but evidence suggested that tourists and the public were still able to access the site and a significant risk remained. The Shamrock J site is within a published tourist destination. Based on the design criteria provided by SRK, the building was first removed and stacked next to the vent raise. Prior to building removal, the fence was dismantled and transported offsite and is stored in Elsa for future use.

**Photo 2: View of Shamrock J building partially collapsed over open vent raise.**

Upon removal of the building, it was evident that the vent raise was collapsed with overburden material. A 325 excavator was used to assess if the vent raise was bridged with material. The excavator dug approximately 20 feet into the material and it continued to be competent and not bridged. The hole was then filled with local borrow material as per SRK specifications (see Appendix II). The top of the filled hole was capped with growth media and mounded to promote water runoff. The building material was burned and the remaining metal debris was loaded and transported to dump site at Elsa. A burn permit was secured prior to burning the remnant building.

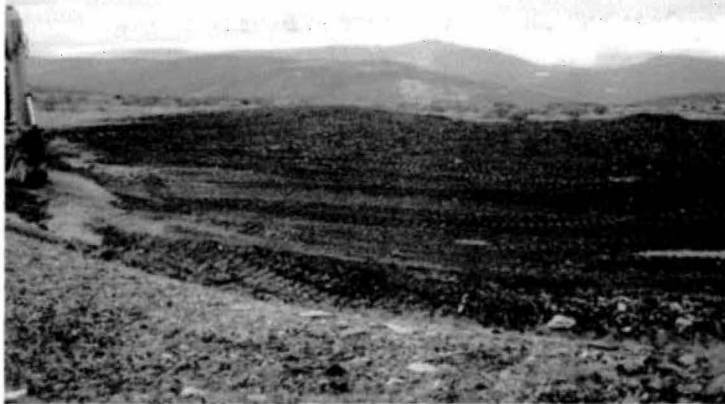
**Photo 3: View of Shamrock J vent shaft filled and mounded with building removed.**

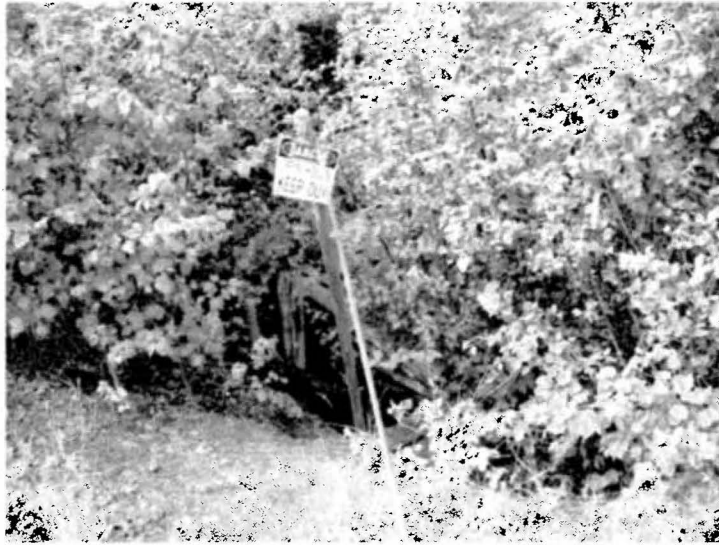
As part of the Bellekeno workings on Sourdough Hill, seven open holes and one trench were identified in the immediate vicinity of the road leading to the Bellekeno mine. All of the holes were mound filled with material as per SRK specifications (see Appendix II) as tourists and local residents frequently travel this road and the holes and shafts were easily accessible.

**Photo 4: Open hole along side of road to Bellekeno mine.**

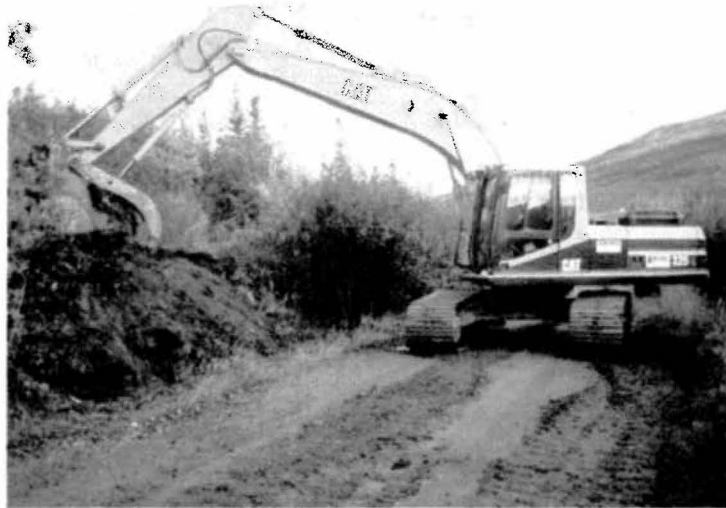
**Photo 5: Excavator filling open Bellekeno hole.**

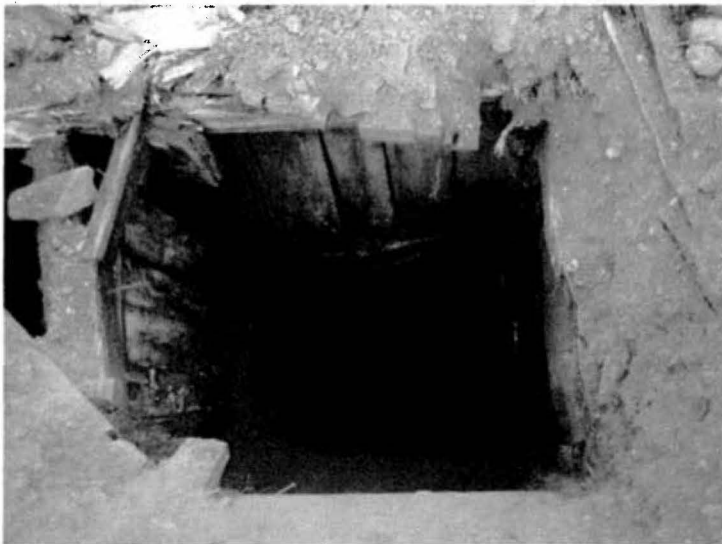
The shaft (commonly referred to as the Wernecke shaft) was timber lined and was open below the surface a significant distance. The remediation for this shaft followed the SRK general backfilling guidelines (see Appendix II), which consisted of filling the shaft with adequately sized material that would compact enough to lessen the likelihood of a future subsidence over the shaft.

**Photo 6: View of Wernecke shaft building located below the manager's house at the base of the hill.**

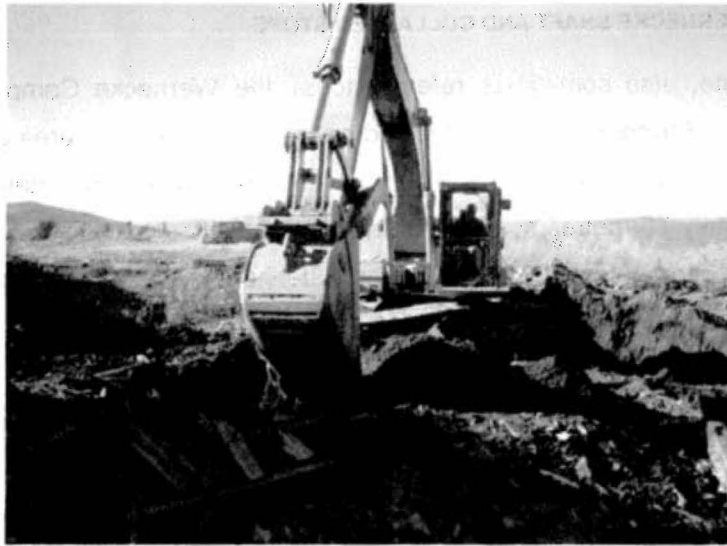
**Photo 7: View of Wernecke shaft being filled.**

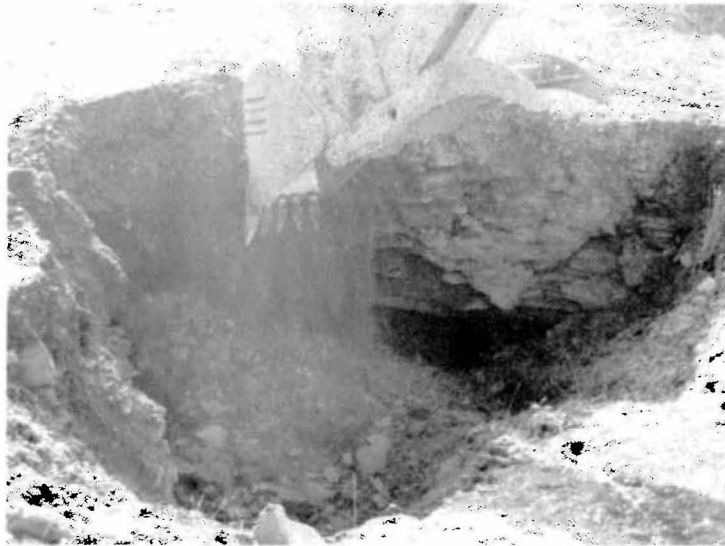
The collapsed stope was approximately 7 metres long by 4 metres wide, with the opening extending approximately 5 metres underground. Loose slabs in the back of the opening had fallen and could have posed a serious risk to persons exploring near the entrance of the collapse. Remediation of the collapsed stope consisted of excavating around the cavity, allowing the slab roof to collapse inward on itself and provide partial fill for the cavity. Then additional material was added from the surrounding soil to fill the remaining cavity.

**Photo 8: Excavator starting to fill collapsed stope.**

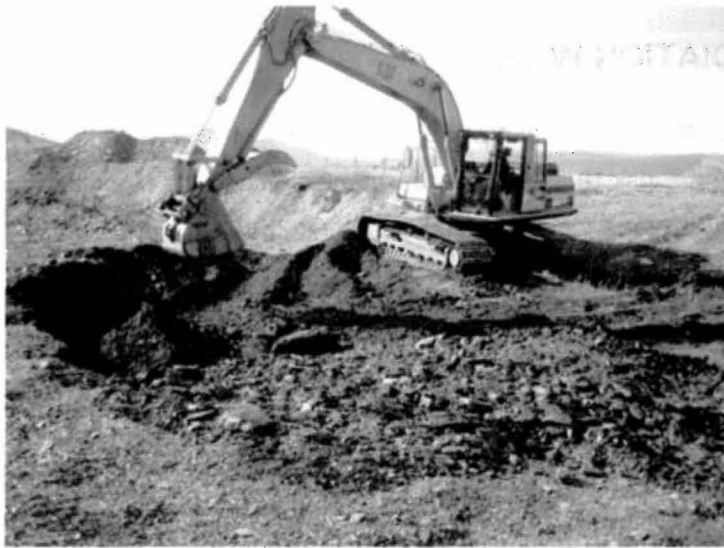
**Photo 9: Collapsed stope nearly filled to completion.**
