KENO HILL PROPERTY

PHYSICAL HAZARD REDUCTION PROGRAM

2007

February 2008

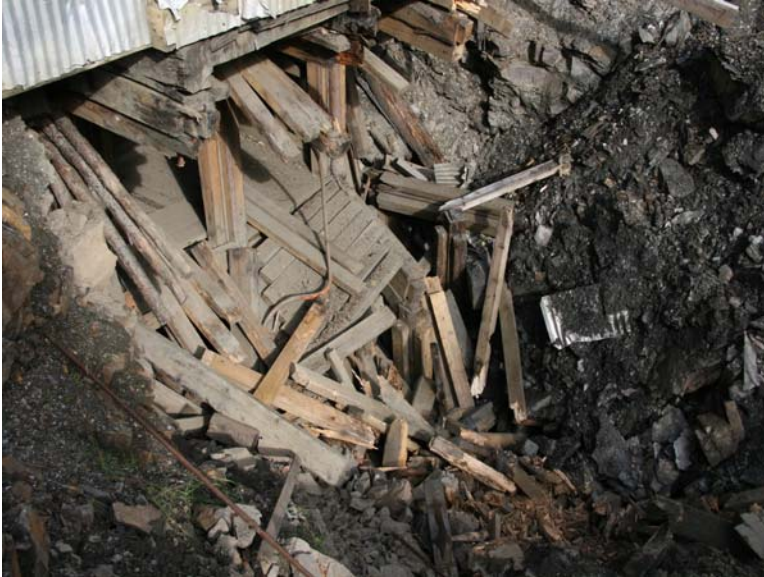
Plate 1: Ruby Shafthouse - Before

At the Ruby location, it was identified that the "Ruby shaft area has collapsed on skip; area in front of house has failed also; shaft house accessible" (field notes from personnel on site). As well, a smaller shaft approximately 5 meters deep was exposed. A Hitachi 270 excavator was used to remove debris and timber. Material from the adjoining waste dump at the Birmingham pit was used to backfill and seal the shafts. The remediation for this shaft followed the SRK general backfilling guidelines (see Appendix B), which consisted of filling the shaft with

adequately sized material that would compact enough to lessen the likelihood a future subsidence over the shaft. The building material was burned and the remaining metal debris was loaded and transported to the approved commercial dump site at Elsa. A burn permit was secured prior to burning the remnant building. In the summer of 2008 the larger shaft will be visited for additional work as sinking is likely to occur. Refer to Appendix C, Plate 1 and 2, for photo documentation of remedial works on Ruby Shafthouse.

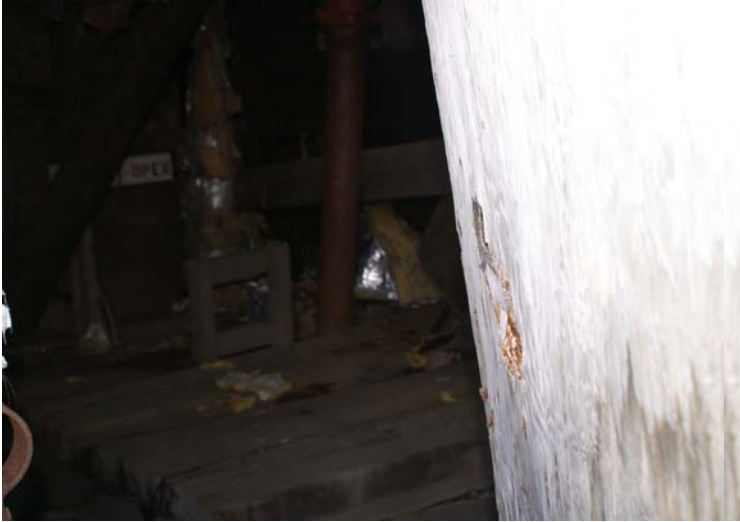
Plate 5: No Cash 100- Before

Adit level 100 at No Cash had partially collapsed causing an “extreme” physical hazard description on the risk registry. Excess wire was resting on the ground causing a hazard to humans and wildlife alike. The adit was cleaned of old timber and debris and backfilled with rock as per SRK specifications (Appendix B). The large rock was covered with topsoil and duff to cover the disturbed area. Wire was collected, cut and removed from the site. Windows and doors were secured with 10 cm wire mesh to prevent access into the Brefalt Shafthouse. Refer to Appendix C, Plate 3 and 4, for photo documentation of remedial works on Brefalt Shafthouse and Plate 5 and 6, for photo documentation of remedial works on No Cash 100.

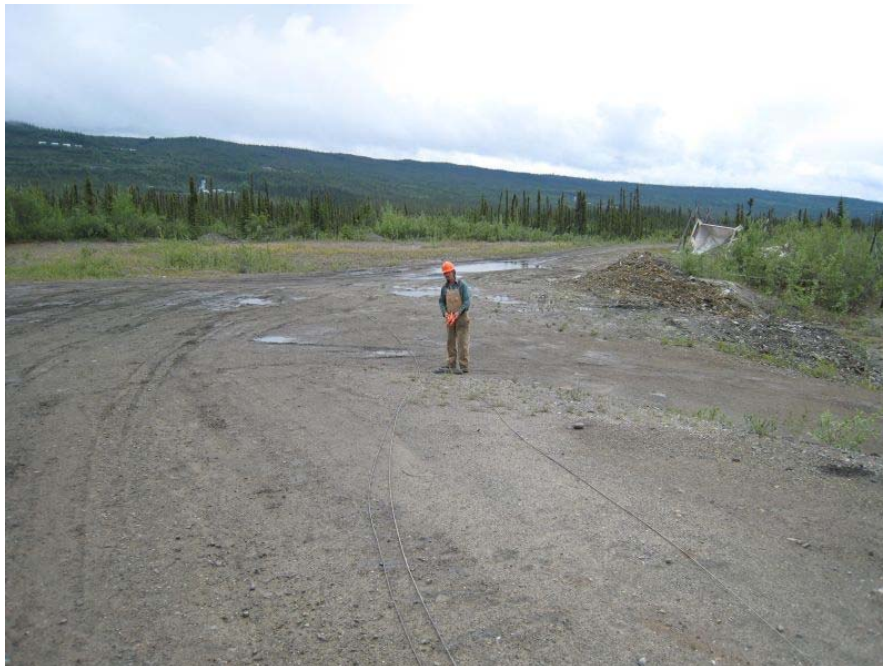
Picture of personnel hand rolling wire in the Tailings Dam Area

Work around the tailings area dam began on June 25th. Short lengths of both telephone and power cable were scattered in this area. This wire was hand rolled because of the location, and relatively short length of the various wire strands. All hardware associated with this cleanup was deposited in the wire lay down area. Approximately 2 km of wire was recovered from this area. Cleanup of this area took a total of 87.5 man hrs to complete.

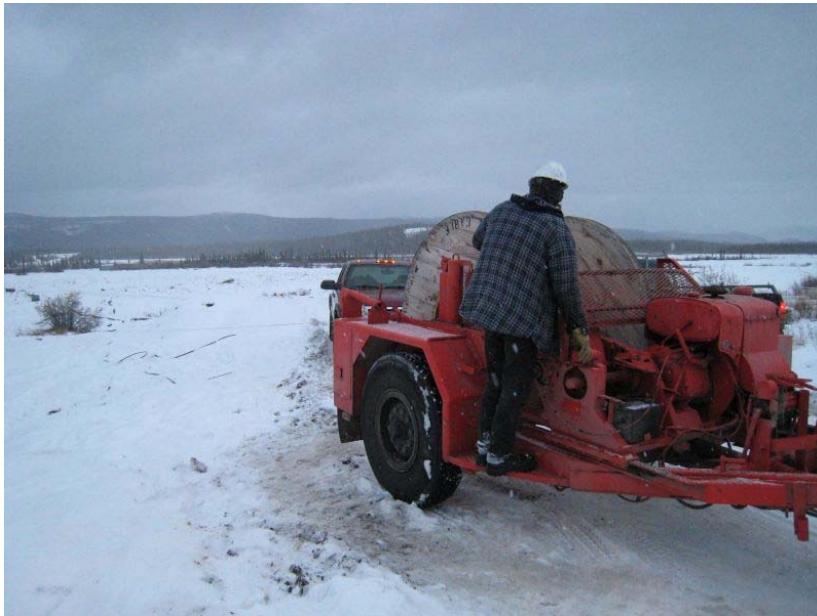
Photo of personnel operating wire spooler in the Framing Yard to Tailings Area section

A crew of 2-3 labours worked on this line. Any remaining standing poles were cut, the wire and all hardware was removed from the poles. All hardware was stored in the wire lay down area. The wire was then freed from any underlying brush and to ready the line for rolling. This portion of the project took approximately 222 man hrs to complete.

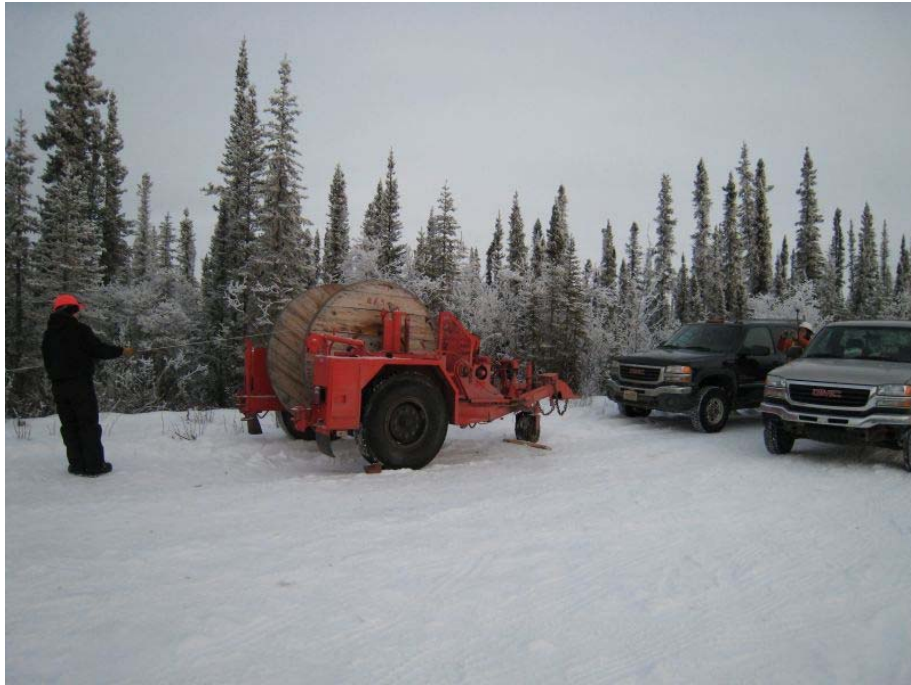
Labourer helping to feed line onto wire spooler in the Tailings to McQuesten River Area.

Wire rolling commenced from the Framing Yard to McQuesten River on October 31st. One labourer and one equipment operator rolled the freed wire onto a spool and stored the spool in the wire lay down area. Approximately 15 km of steel core aluminum power cable was rolled during this time. This portion of the project took an estimated 265 man hrs with 3 wks rental of a wire spooler and 7 hrs of other equipment time.
