## ***Landslide Dams and Creek Stabilization at the Former Clinton Creek Asbestos Mine***

Gil Robinson, P.Eng., Ken Skafffeld, P.Eng., Rolf Aslund, P.Eng.,

UMA Engineering, Winnipeg, Manitoba

### **1.0 Abstract**

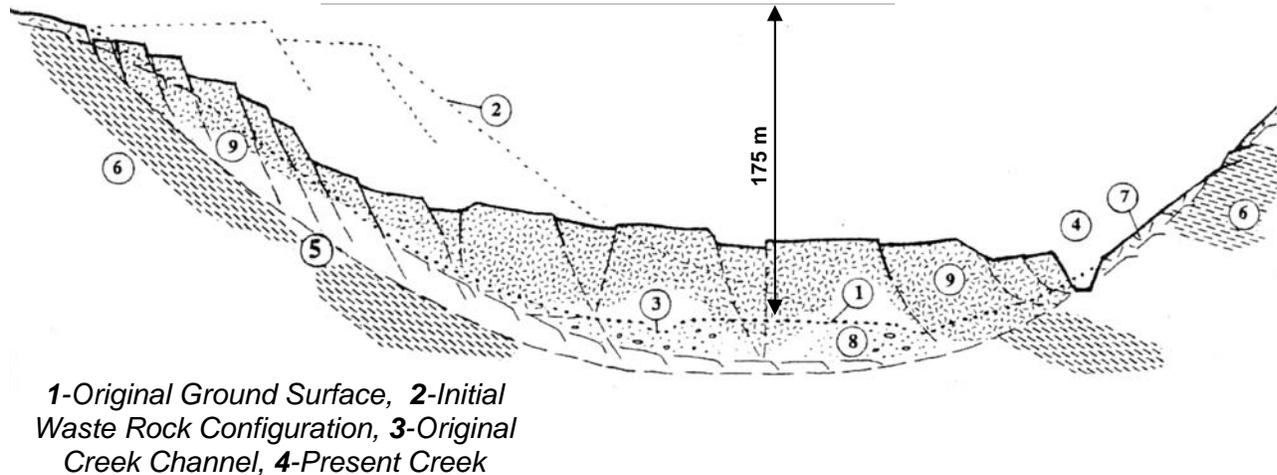
**Figure 03**  
**Channel Cross Section After Waste Rock Slide (View Upstream)**  
**(Reference: Stepanek & McAlpine, 1992)**

A significant slope failure of the waste rock dump into the Clinton Creek valley occurred in 1974 (Figure 03). The resulting landslide dam blocked natural drainage through the valley creating a 74 ha lake (Hudgeon Lake) as shown in Figures 02 and 04. Figure 02 also shows the valley before the landslide. Stability analysis indicates a weak foundation material is contributing to the continued horizontal displacements following the initial failure of the waste rock dump. The loss of strength may be related to a number of geological conditions unique to the site including ice content, soil type and the relationship between the rate of thawing and dissipation of excess pore-water pressures. It is likely that disturbance to the thermal regime, in particular thawing of permafrost beneath the dump, has resulted from filling of the upstream reservoir (Hudgeon Lake).

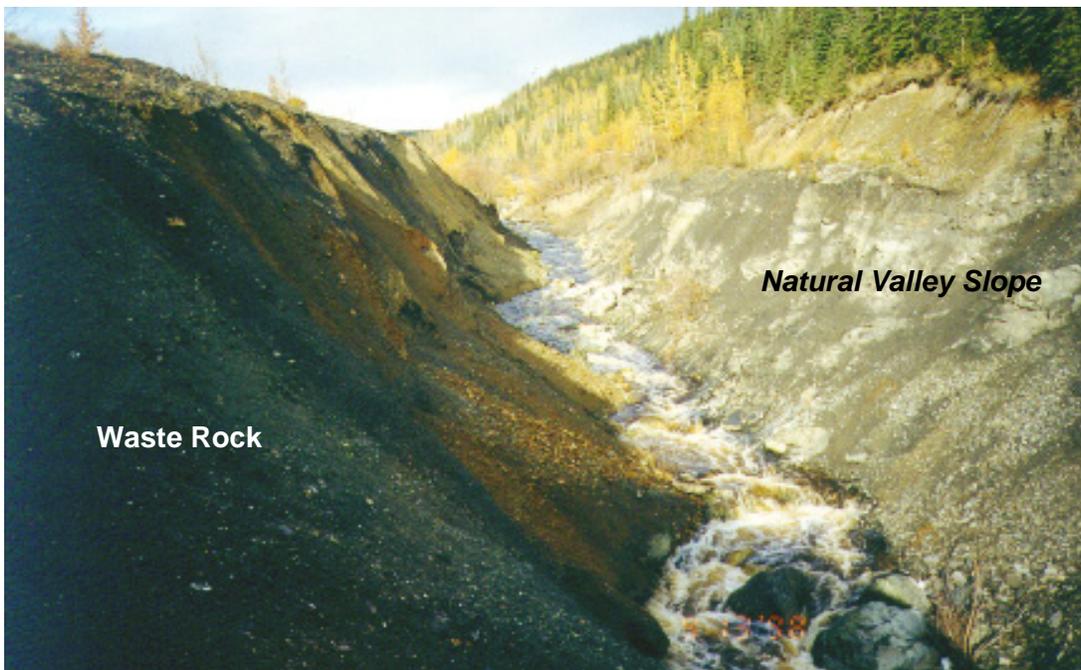
**Figure 05**  
**Clinton**  
**Creek**  
**Channel**

As illustrated in Figure 05, a new creek channel was subsequently formed along the interface between the landslide material and north valley slope, some 25 m above the original valley bottom at the Hudgeon Lake outlet. Within the area now occupied by the waste rock dump, the

creek channel is approximately 700 m long with a gradient ranging from about 3 to 6 percent compared to its natural gradient of approximately 0.08 percent.

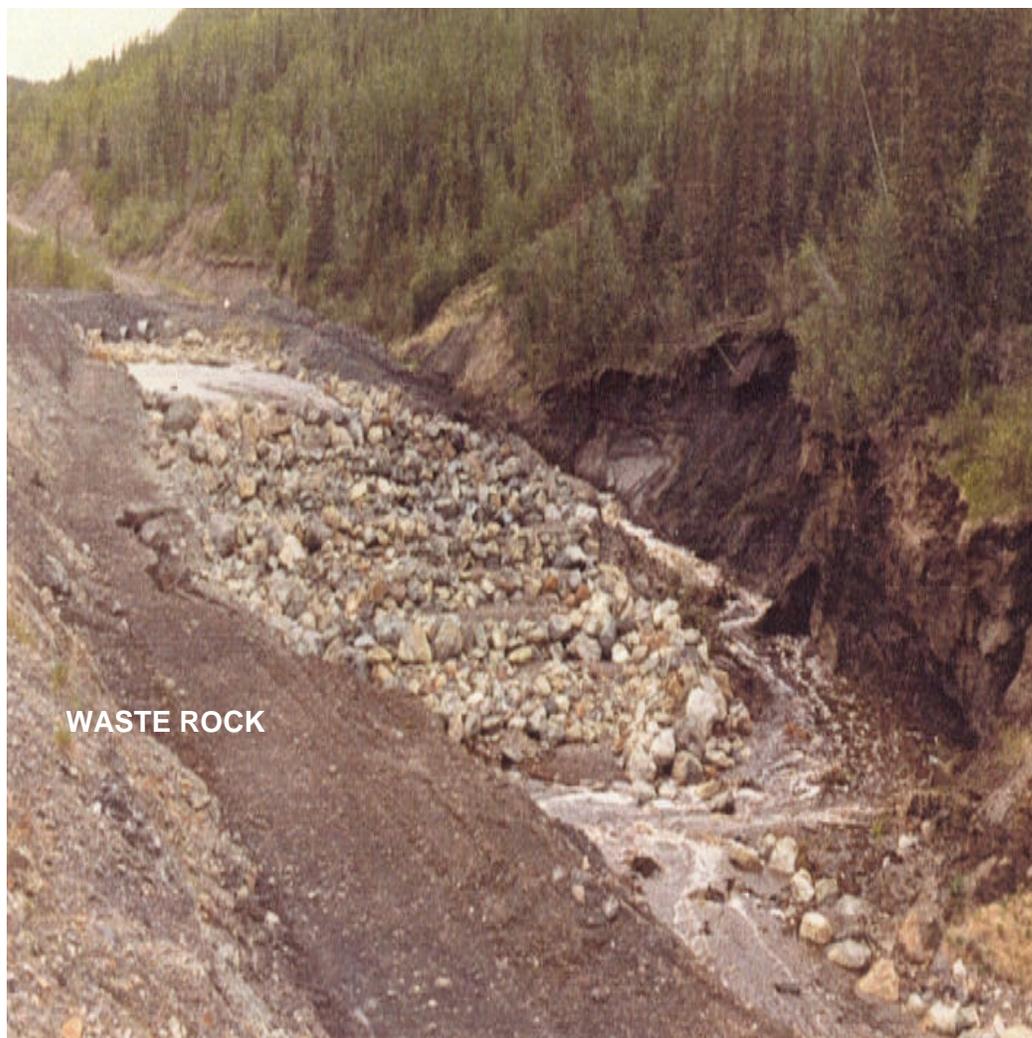
**Figure 06**  
**Hudgeon Lake Outlet (1982)**

The original channel erosion protection measures constructed just downstream of the Hudgeon Lake outlet in 1981 included a series of small rock weirs, which were by-passed in the spring of 1982 (Figure 06). The erosion control works, which were constructed using large boulders recovered from the open pits, have proven to be largely unsuccessful and by 1984 had been re-constructed twice. The erosion control works re-constructed in 1984 (Figure 07) were by-passed in a significant flood event in the spring of 1997 (Figure 08). Based on the creek profiles shown in Figure 09, approximately 3 m of channel erosion or head-cutting occurred immediately downstream of the outlet between 1986 and 1999. Farther downstream, less down-cutting was evident, likely because the creek channel has cut into the bedrock.

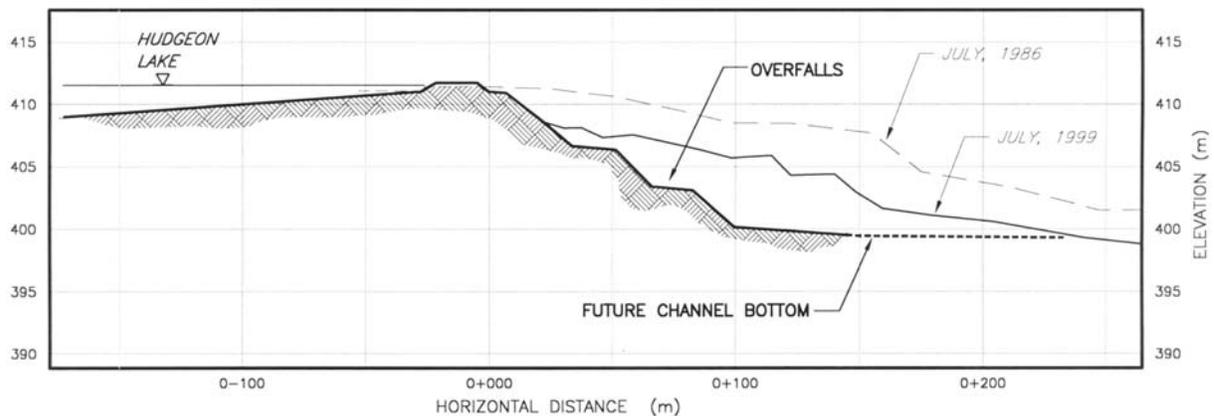
**Figure 09**  
**Channel Erosion at Hudgeon Lake Outlet**

Progressive head-cutting or incising of the Clinton Creek channel immediately downstream of and towards the Hudgeon Lake outlet has increased the likelihood of the development of a full breach of the landslide dam (Figure 09). Following the spring 1997 flood event when the erosion control works were effectively destroyed, a full breach at the lake outlet could have been triggered at any time and was not considered susceptible to any particular precipitation event i.e. a relatively minor inflow could trigger the failure mechanism necessary to initiate a breach. A full breach of the waste rock blockage at the Hudgeon Lake outlet would result in a peak discharge of approximately 500 m<sup>3</sup>/s and a maximum flow velocity of about 4 m/s. The flood peak quickly attenuates however, reaching a base flow level at the valley constriction downstream of Wolverine Creek.

Based on evidence of on-going deterioration of the Hudgeon Lake outlet (Figure 09), the implementation of remedial measures (i.e. creek stabilization) was considered necessary. Because the waste rock is still undergoing creep movements, and may do so for many more years, the channel stabilization measures had to be able to accommodate some movements of the waste rock pile and remain functional. This design requirement was met through the use of gabion drop structures that serve as grade control points connecting nearly flat channel sections. The waste rock movements are being monitored along with the measurements of the gabion drop structures to determine if the channel stabilization works are being impacted.
