2021 Annual Report Long-Term Performance Monitoring Program Clinton Creek Mine, Yukon

PRESENTED TO
**Government of Yukon
Department of Energy, Mines and Resources
Assessment and Abandoned Mines Branch**

JANUARY 11, 2022
ISSUED FOR REVIEW
FILE: 704-ENG.WARC03956-03

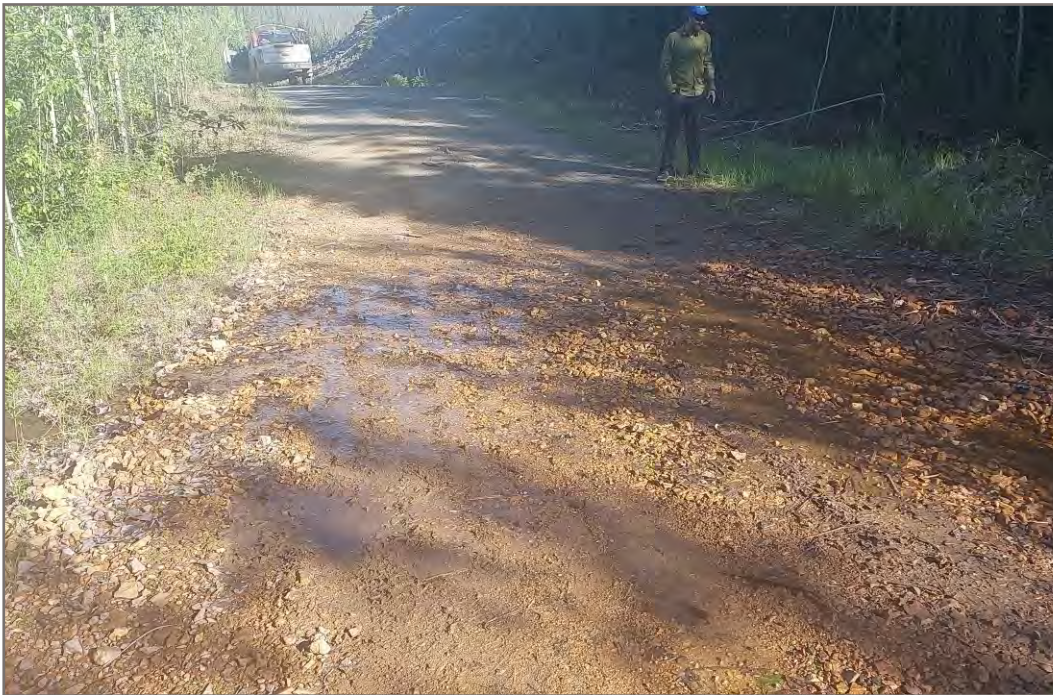
Photo 2: Water on road surface in area of 2020 repairs.
Clinton Creek Road km 34.6, facing northwest.
Photo taken by Shawn Matthies, June 16, 2021.

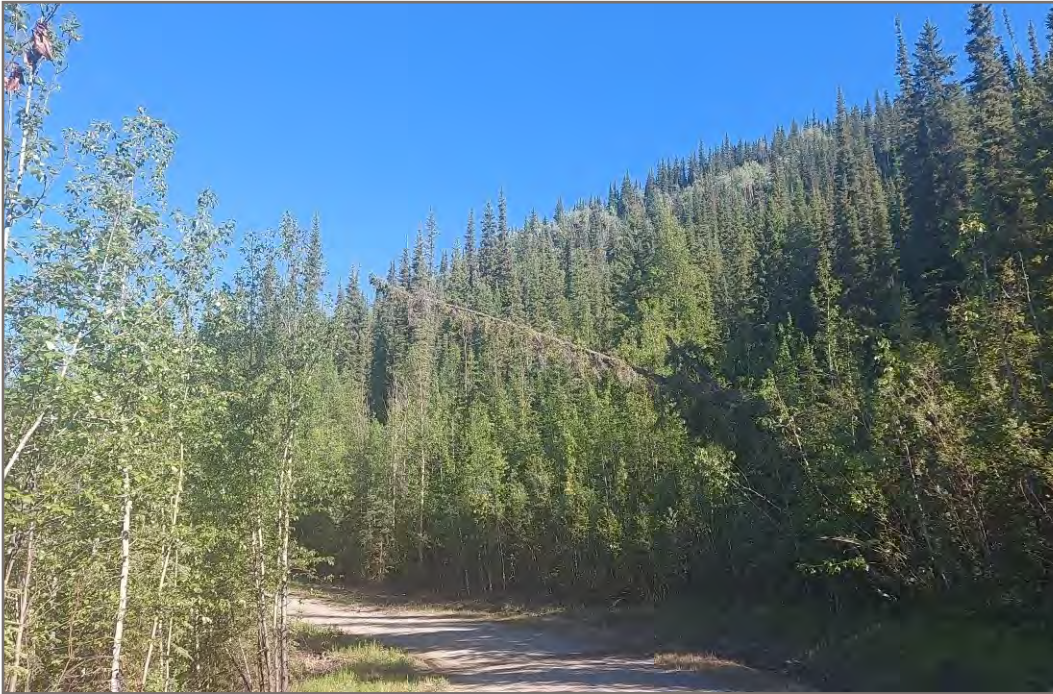
Photo 3: Overhanging tree above road.
Clinton Creek Road km 35.1, facing northwest.
Photo taken by Shawn Matthies, June 16, 2021.

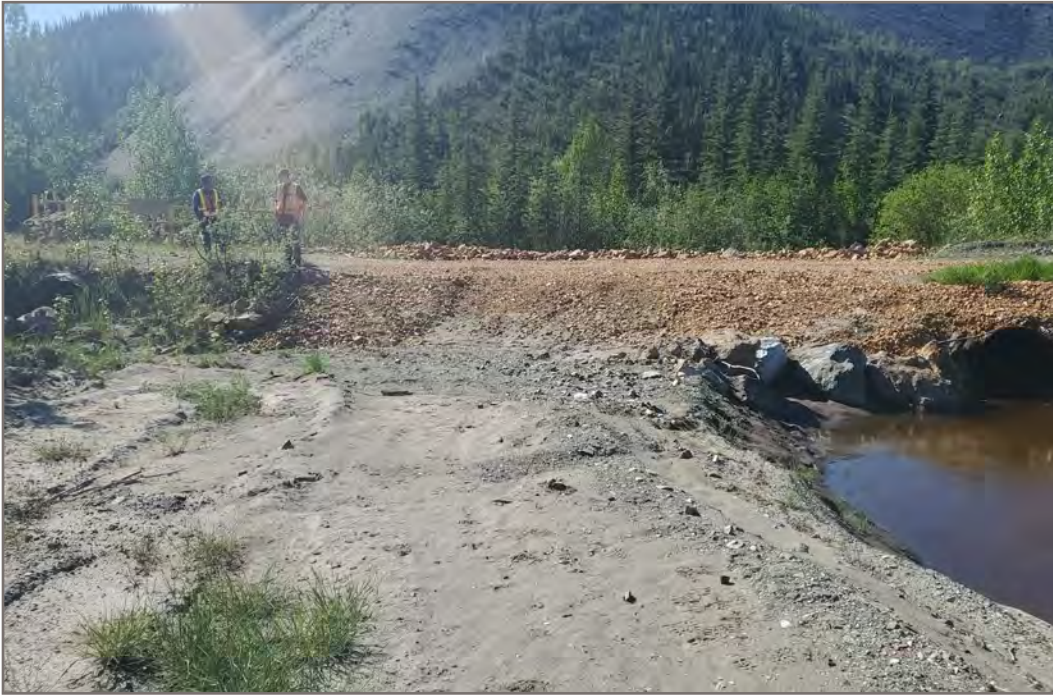
Photo 7: Washout repair just inside of the site access gate, facing south.
Photo taken by Adam Wallace, June 15, 2021.

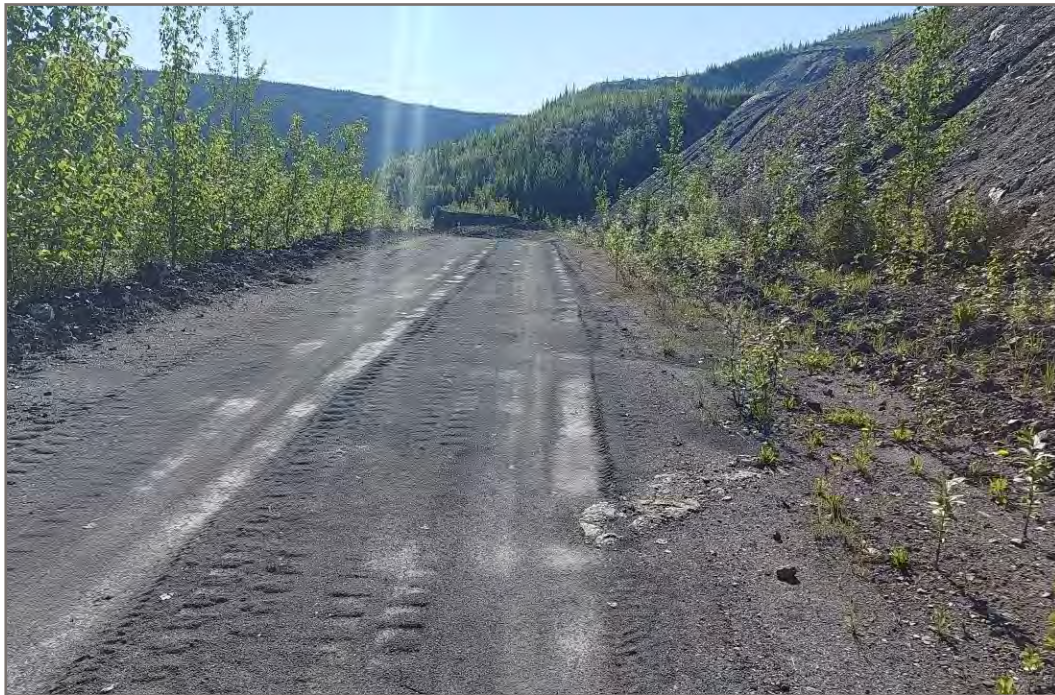
Photo 8: Minor rutting on road surface.
Access Road km 39.5, facing southeast.
Photo taken by Shawn Matthies, June 16, 2021.

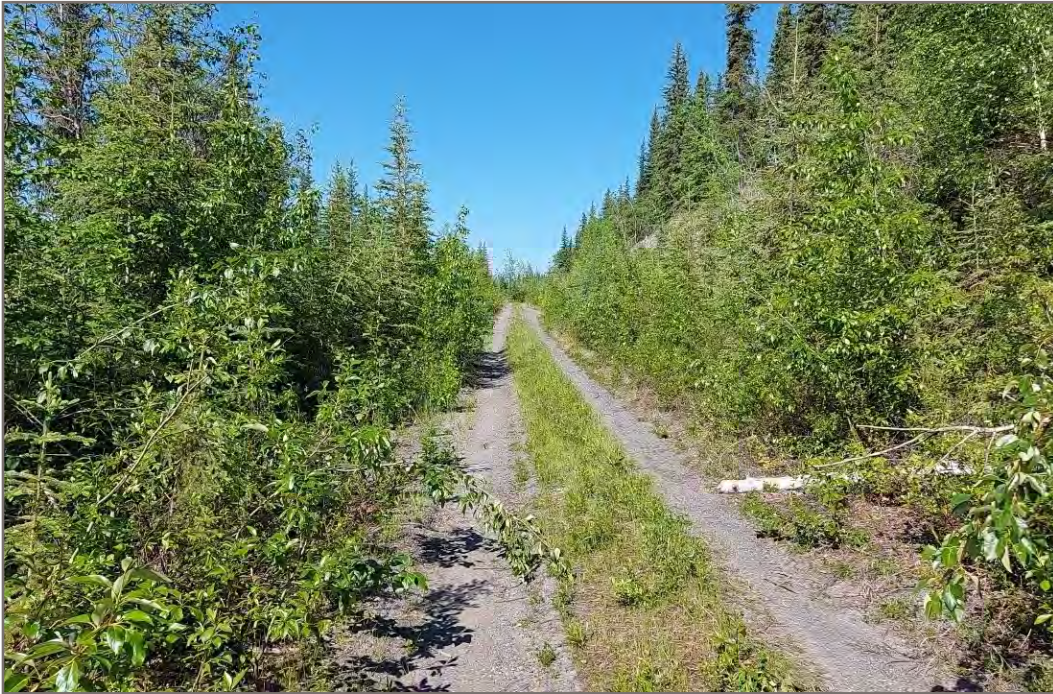
The section of the road beyond the second ford crossing, which climbs a long hill up to the former mill site, is relatively more rutted, gullied and overgrown. Some trees were found to have fallen and blocked the road during the site visit, and were removed by hand. The road remains passable to a light pickup truck.

Photo 13: Typical condition of road between Ford Crossing No. 2 and the former mill site.
Access Road km 41.0, facing west.
Photo taken by Shawn Matthies, June 16, 2021.

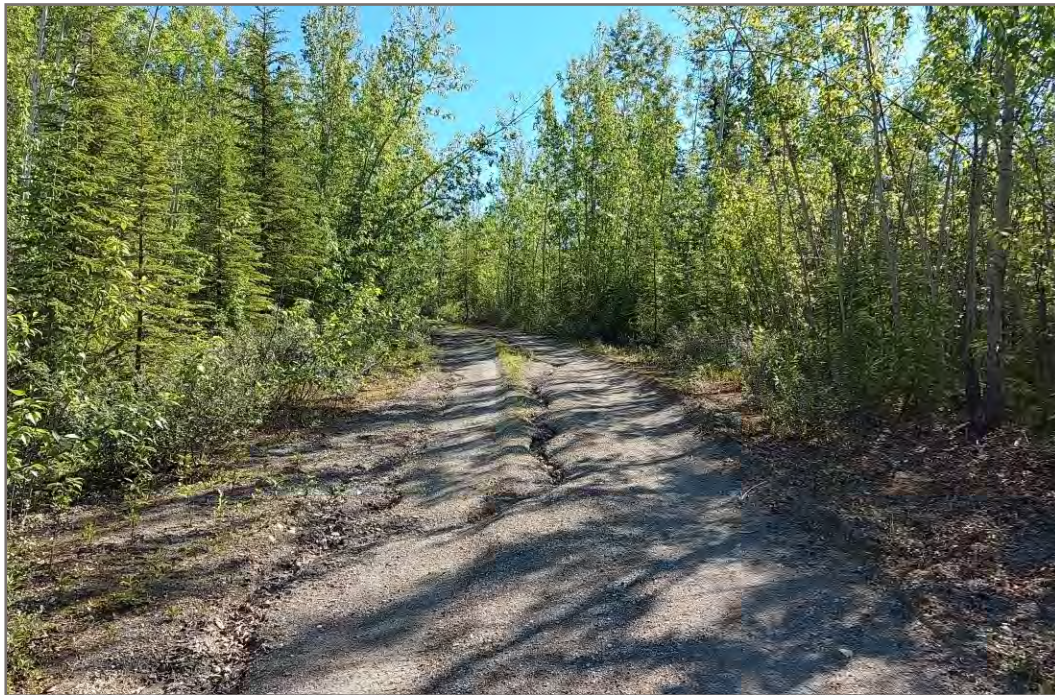
Photo 14: Leaning trees and erosion gullies on road.
Access Road km 41.9 facing east.
Photo taken by Shawn Matthies, June 16, 2021.

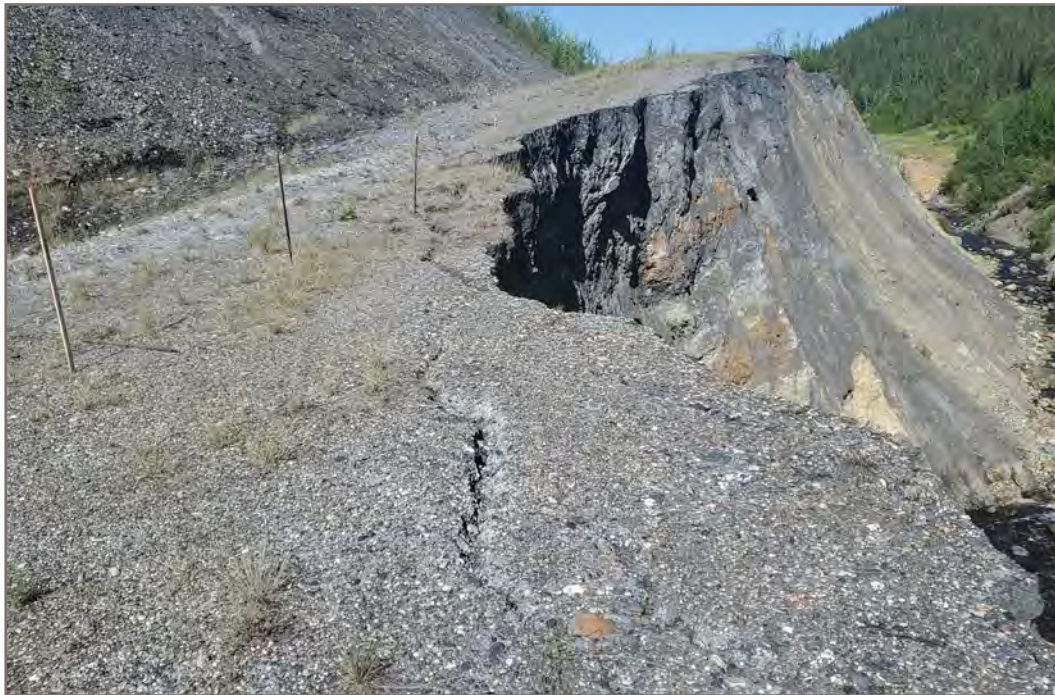
The closed section of the access road, which experienced major erosion and bank loss in 2020, appeared largely unchanged beyond ongoing development of tension cracks near the crest of the slope.

Photo 18: Tension cracks on closed section of access road, facing west.
Photo taken by Adam Wallace, June 16, 2021.

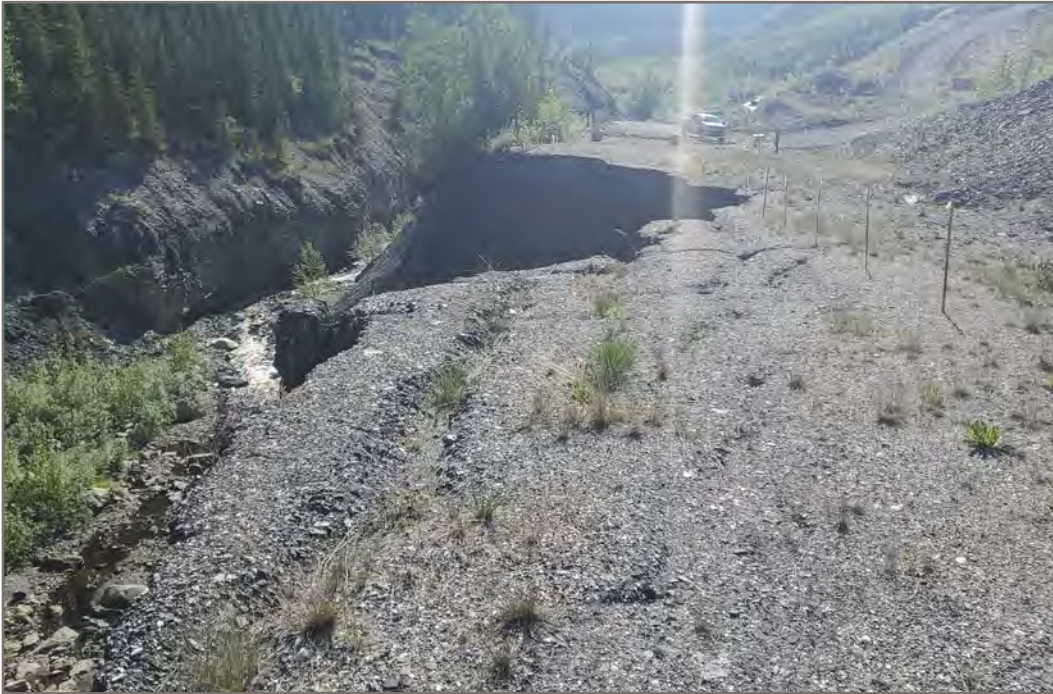
Photo 19: Tension cracks on closed section of access road, facing east.
Photo taken by Adam Wallace, June 16, 2021.

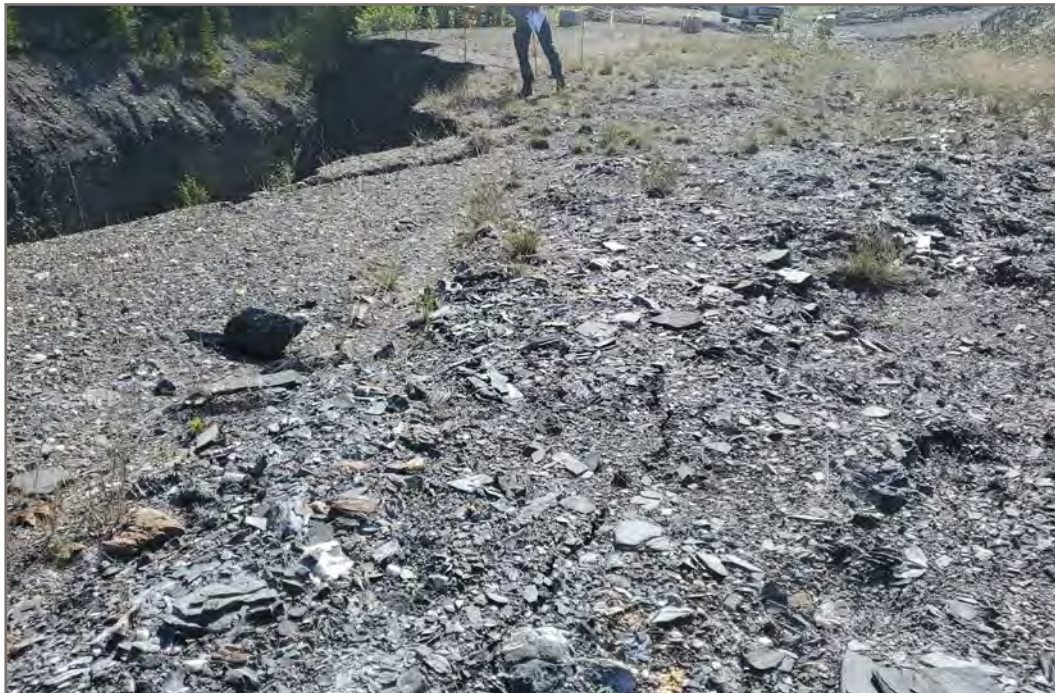
Photo 20: Tension cracks (centre) and shallow, ditch-like gully feature (upper right) on closed section of access road, facing west.
Photo taken by Adam Wallace, June 16, 2021.

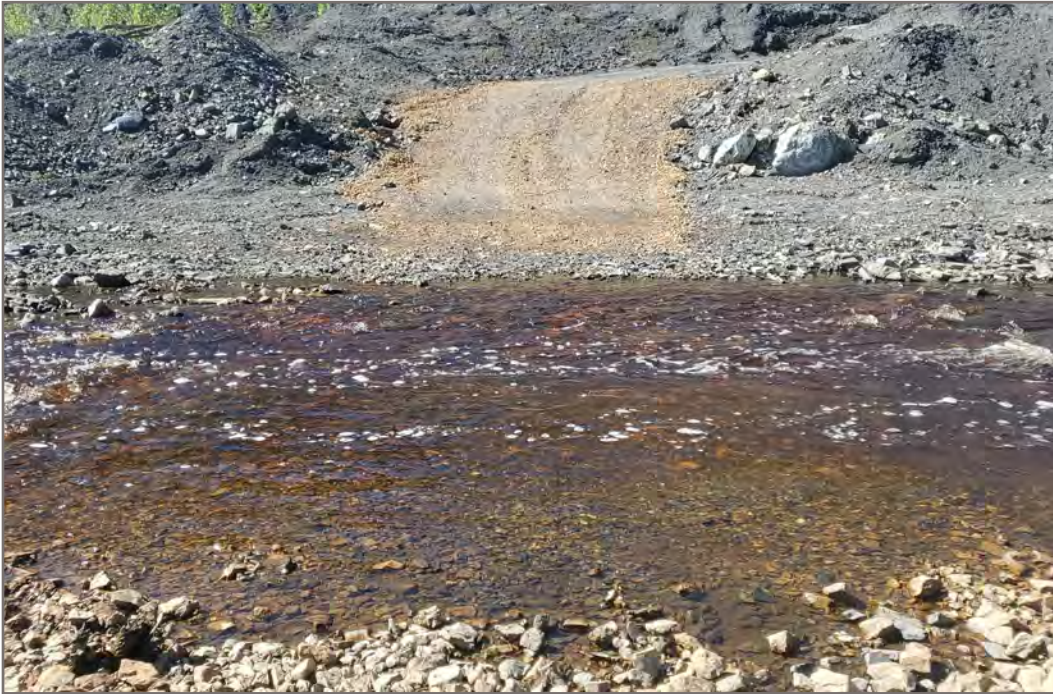
Both ford crossings were observed to be in very good condition in 2021.

Photo 21: Ford Crossing No. 1, facing south toward Clinton Creek waste rock dump.
Photo taken by Adam Wallace, June 15, 2021.

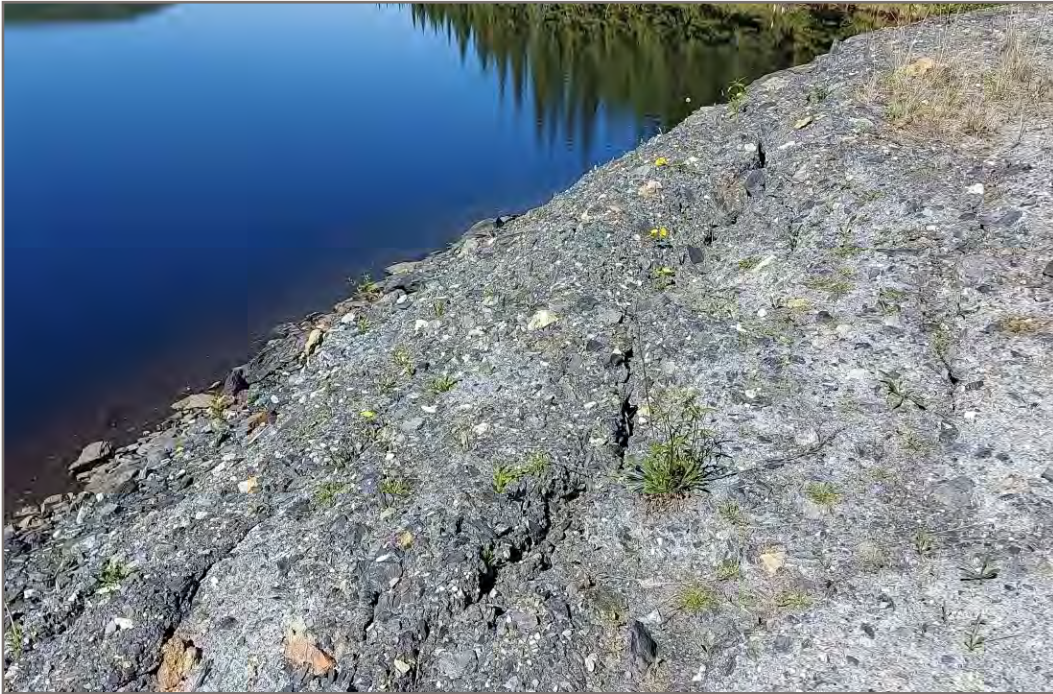
Cracking was observed around the log boom abutments and along the crest of the short slope above the lakeshore, but there was no sign of significant new cracking or erosion compared to previous years.

Photo 25: Tension cracks on the north bank of the Hudgeon Lake outlet, facing west.
Photo taken by Shawn Matthies, June 16, 2021.

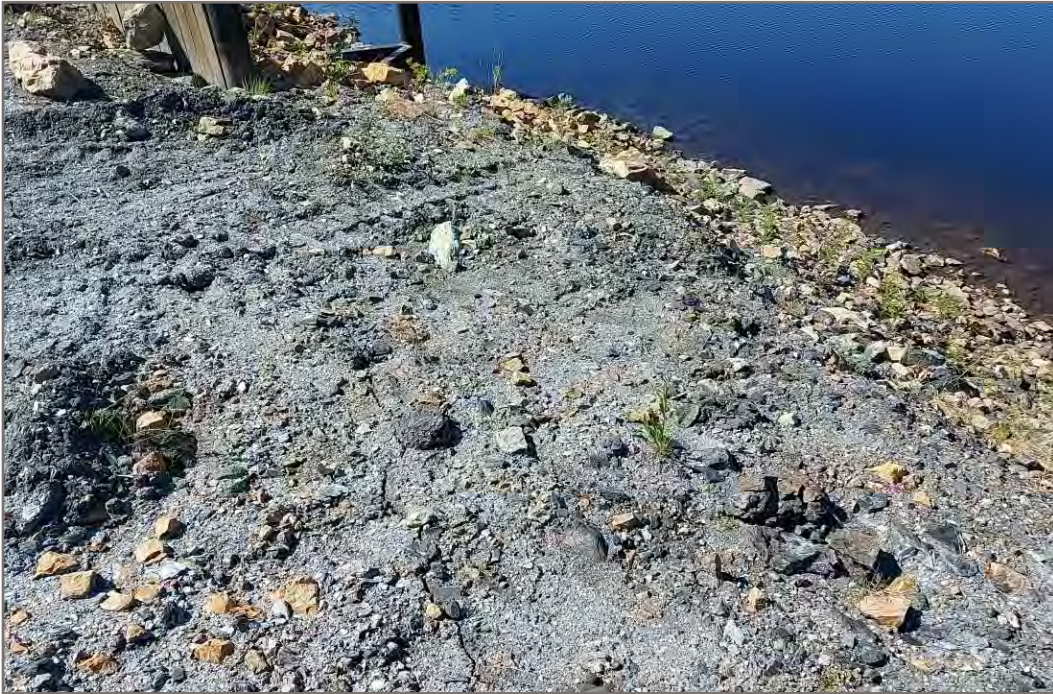
Photo 27: Tension cracks on the south bank of the Hudgeon Lake outlet facing north.
Photo taken by Shawn Matthies, June 16, 2021.

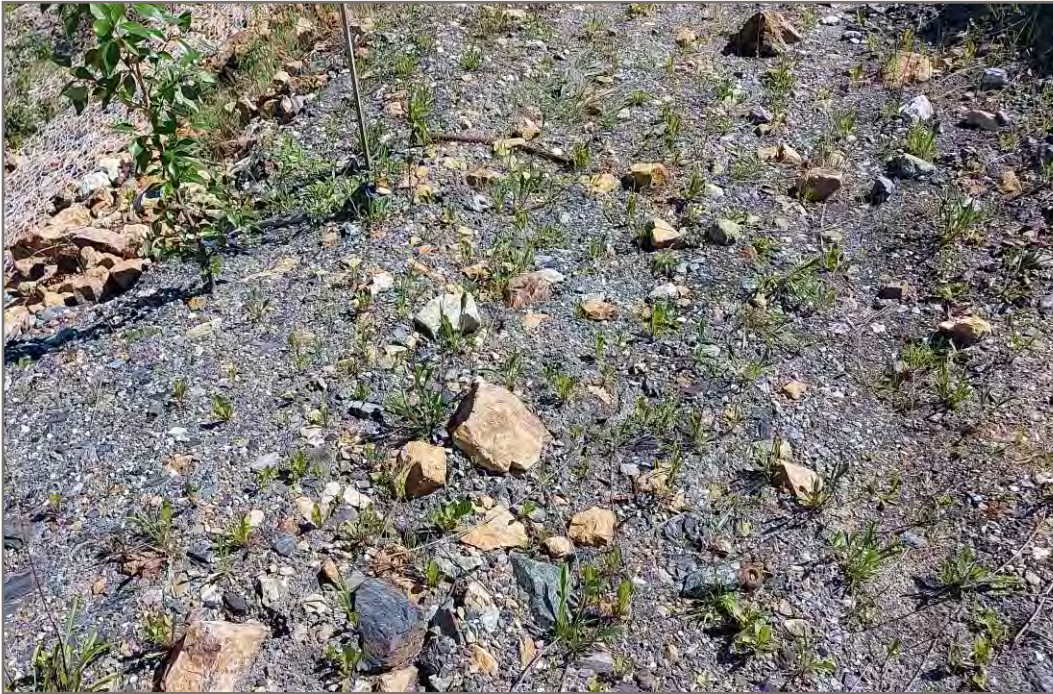
Photo 33: Tension cracks on south bank of DS3, facing east.
Photo taken by Shawn Matthies, June 16, 2021.

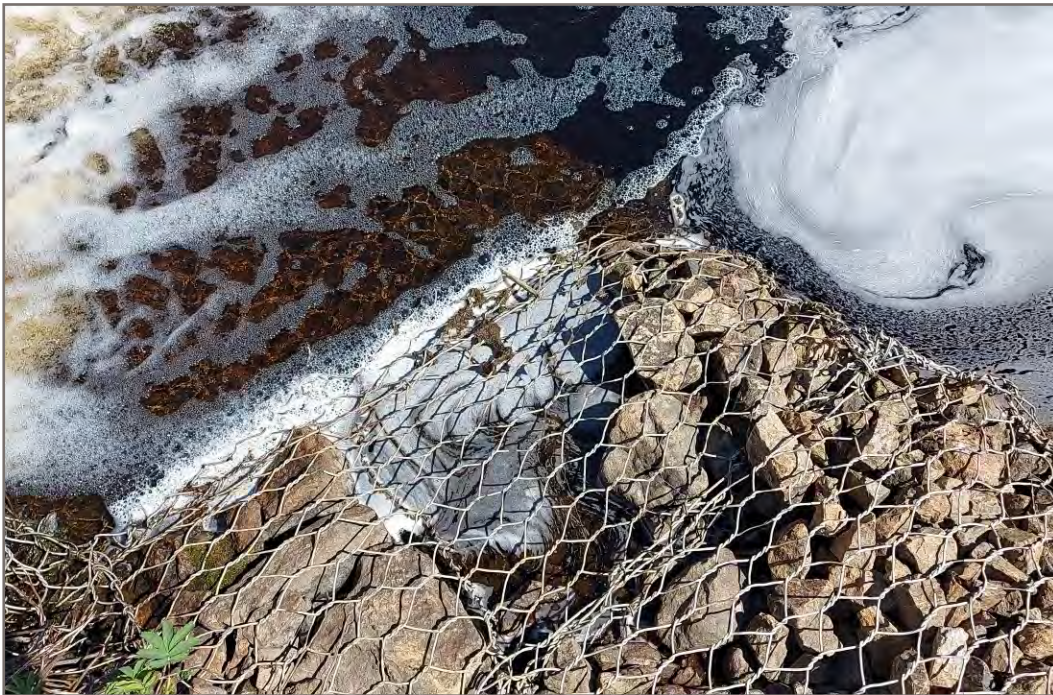
Photo 34: Void inside gabion basket at DS3, caused by loss of undersized gabion basket fill.
Photo taken by Shawn Matthies, June 16, 2021.

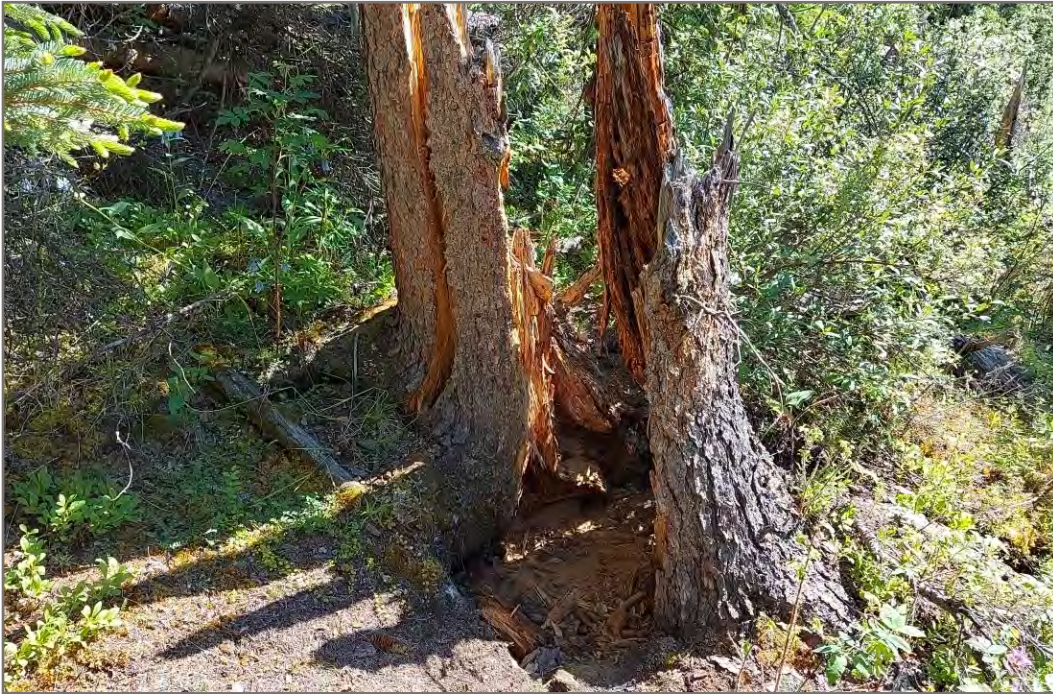
Photo 45: Tension crack on Clinton Creek natural slope (seen in previous years), facing west. 170 mm of movement was measured at the base of the split stump. Photo taken by Shawn Matthies, June 16, 2021.

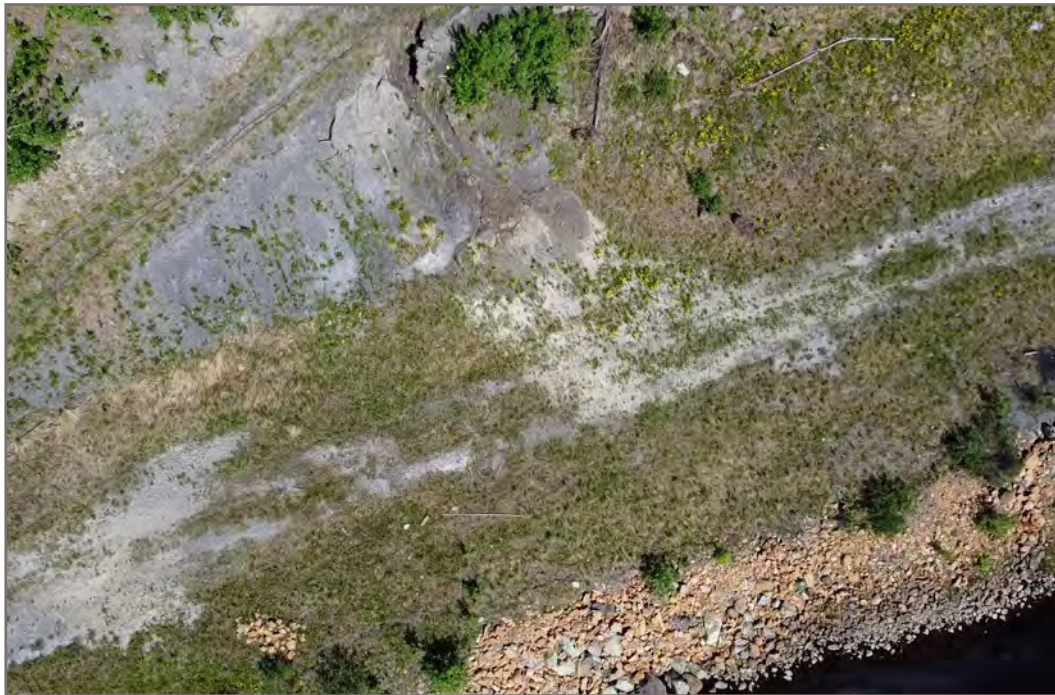
Photo 46: Desiccation cracking at previously wet area north of DS1 (centre); Erosion gully on trail to BH18-08 (top). Photo taken by Shawn Matthies, June 16, 2021.

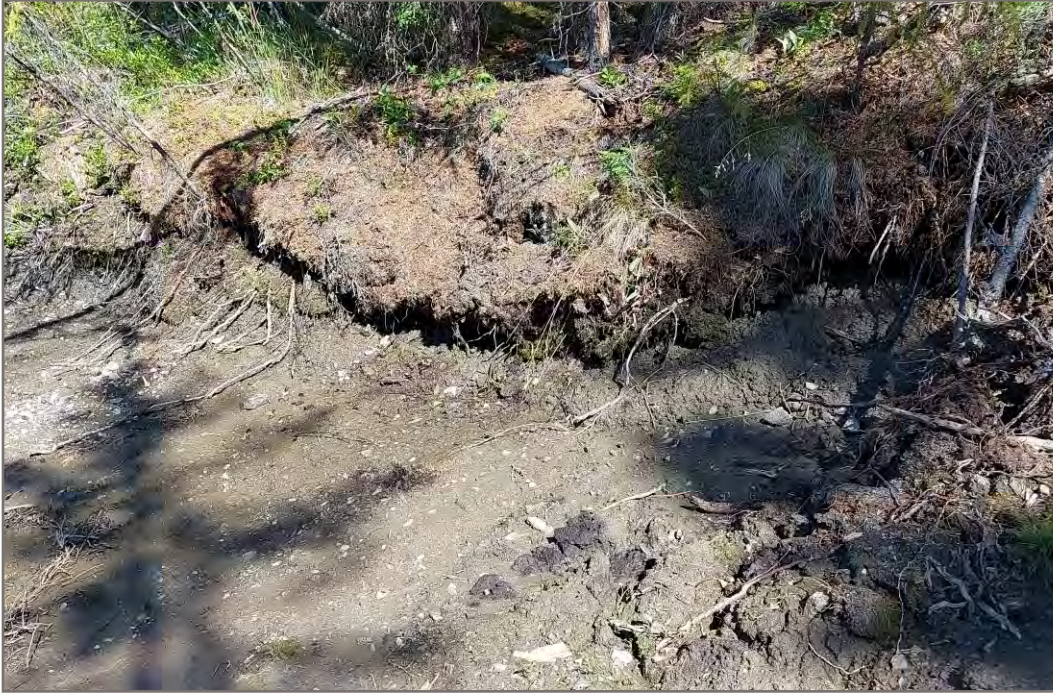
Photo 47: Seepage on upslope side of trail to BH18-08, facing northwest.
Photo taken by Shawn Matthies, June 16, 2021.

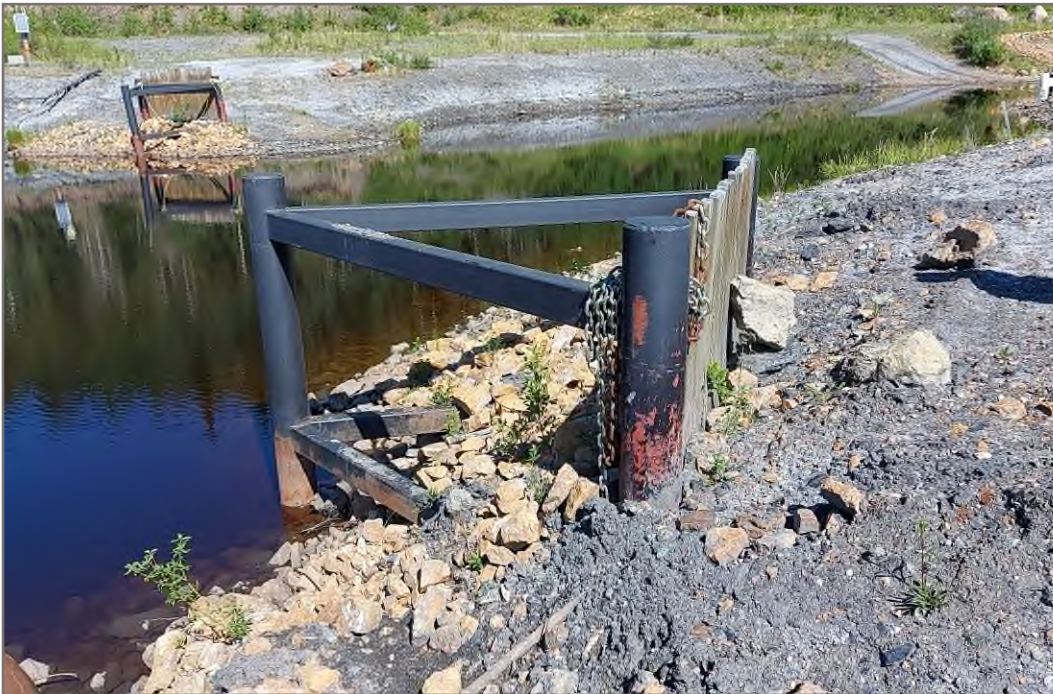
Photo 2: South Log Boom Abutment showing the condition during the 2021 geotechnical site visit, facing northeast.
Photo taken by Shawn Matthies, June 16, 2021.

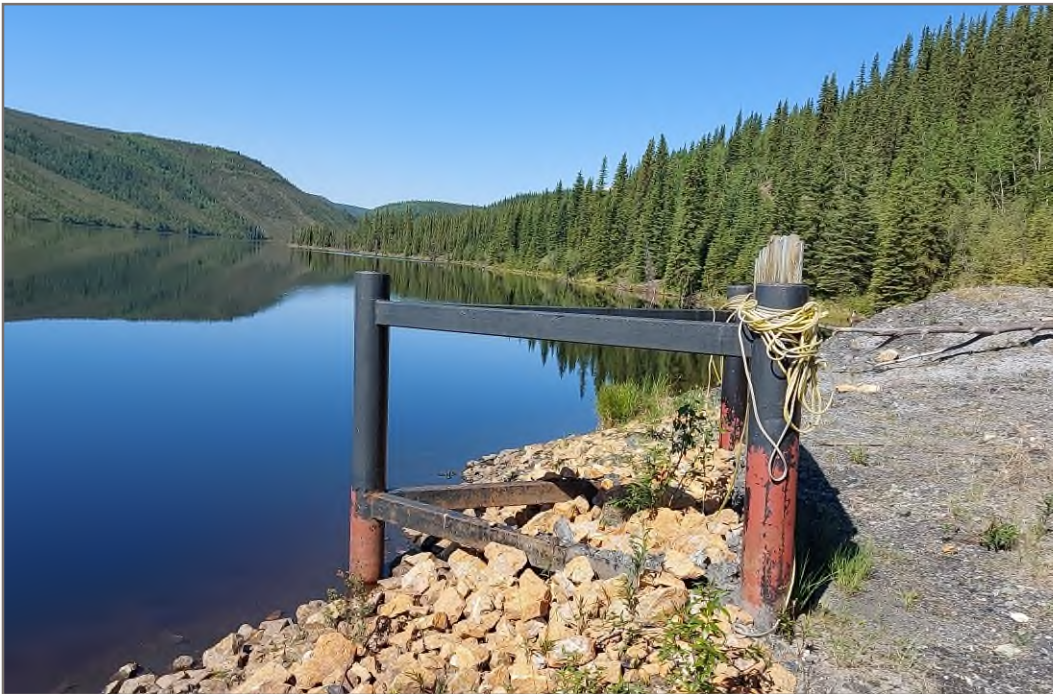
Photo 4: North Log Boom Abutment showing the condition during the 2021 geotechnical site visit, facing west.
Photo taken by Shawn Matthies, June 16, 2021.

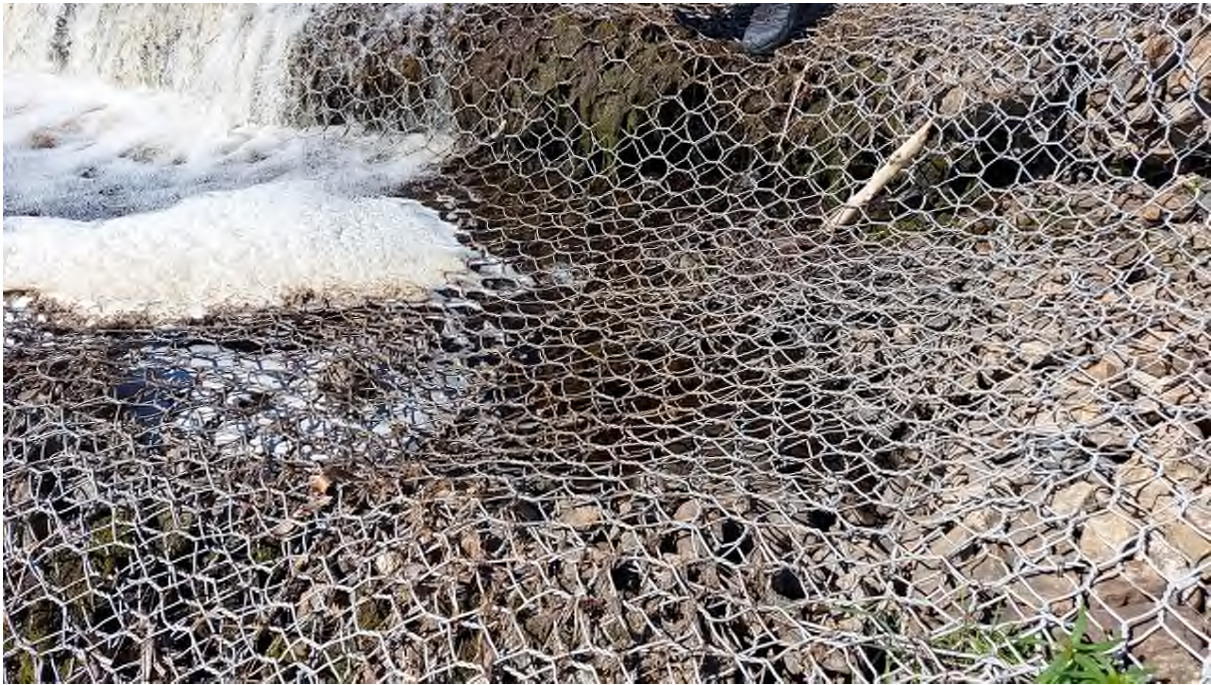
Figure 4: DS 3 Voids in Gabions

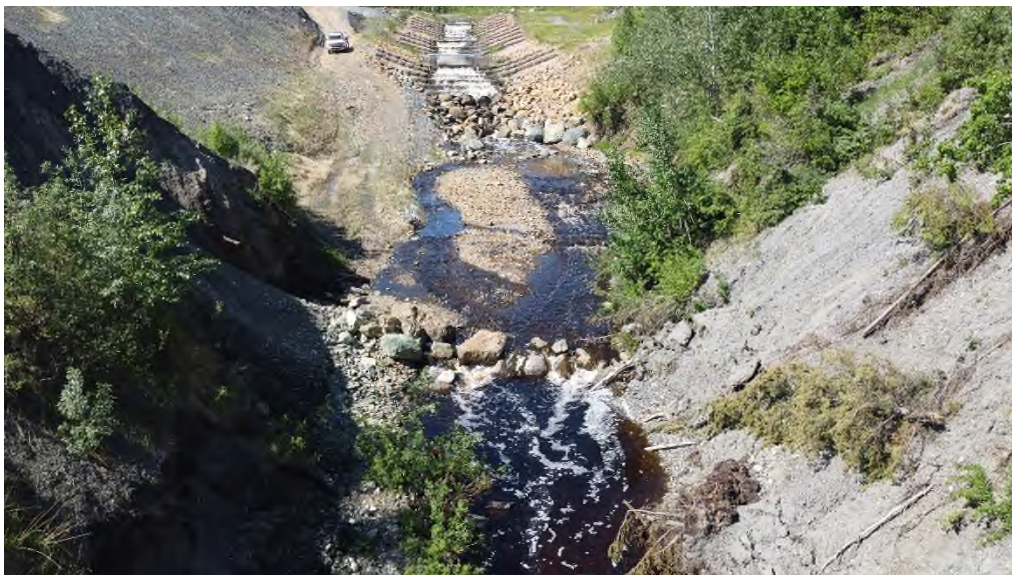
Figure 11: Eroded Embankment D/S of the Plunge Pool – June 2021

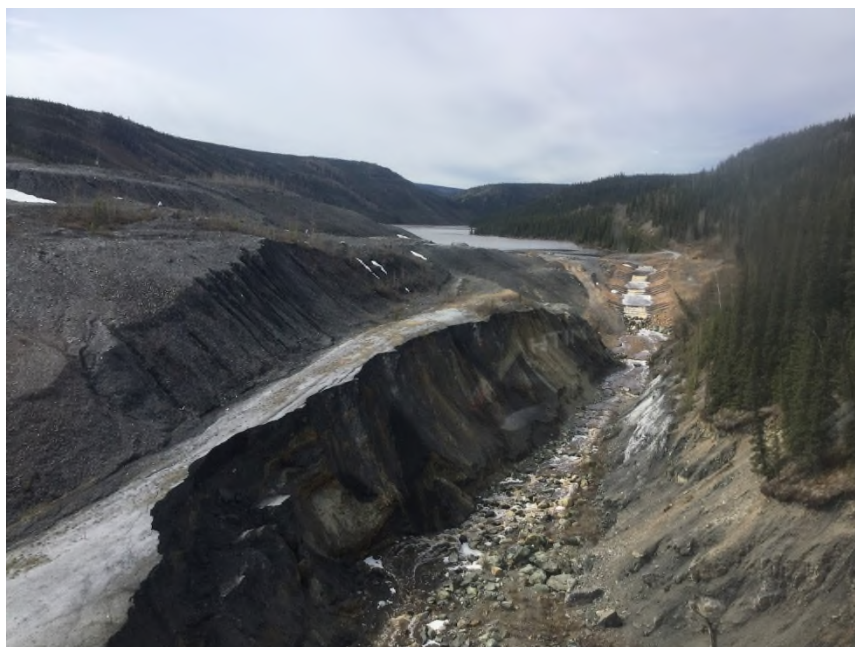
Figure 12: Eroded Embankment Along Clinton Creek – May 2020
