# **Monitor Trial Covers at Rose Creek Tailings Impoundment**

## **2004/05 Task 16b**

**SRK Project Number 1CD003.058**

**March 2006**

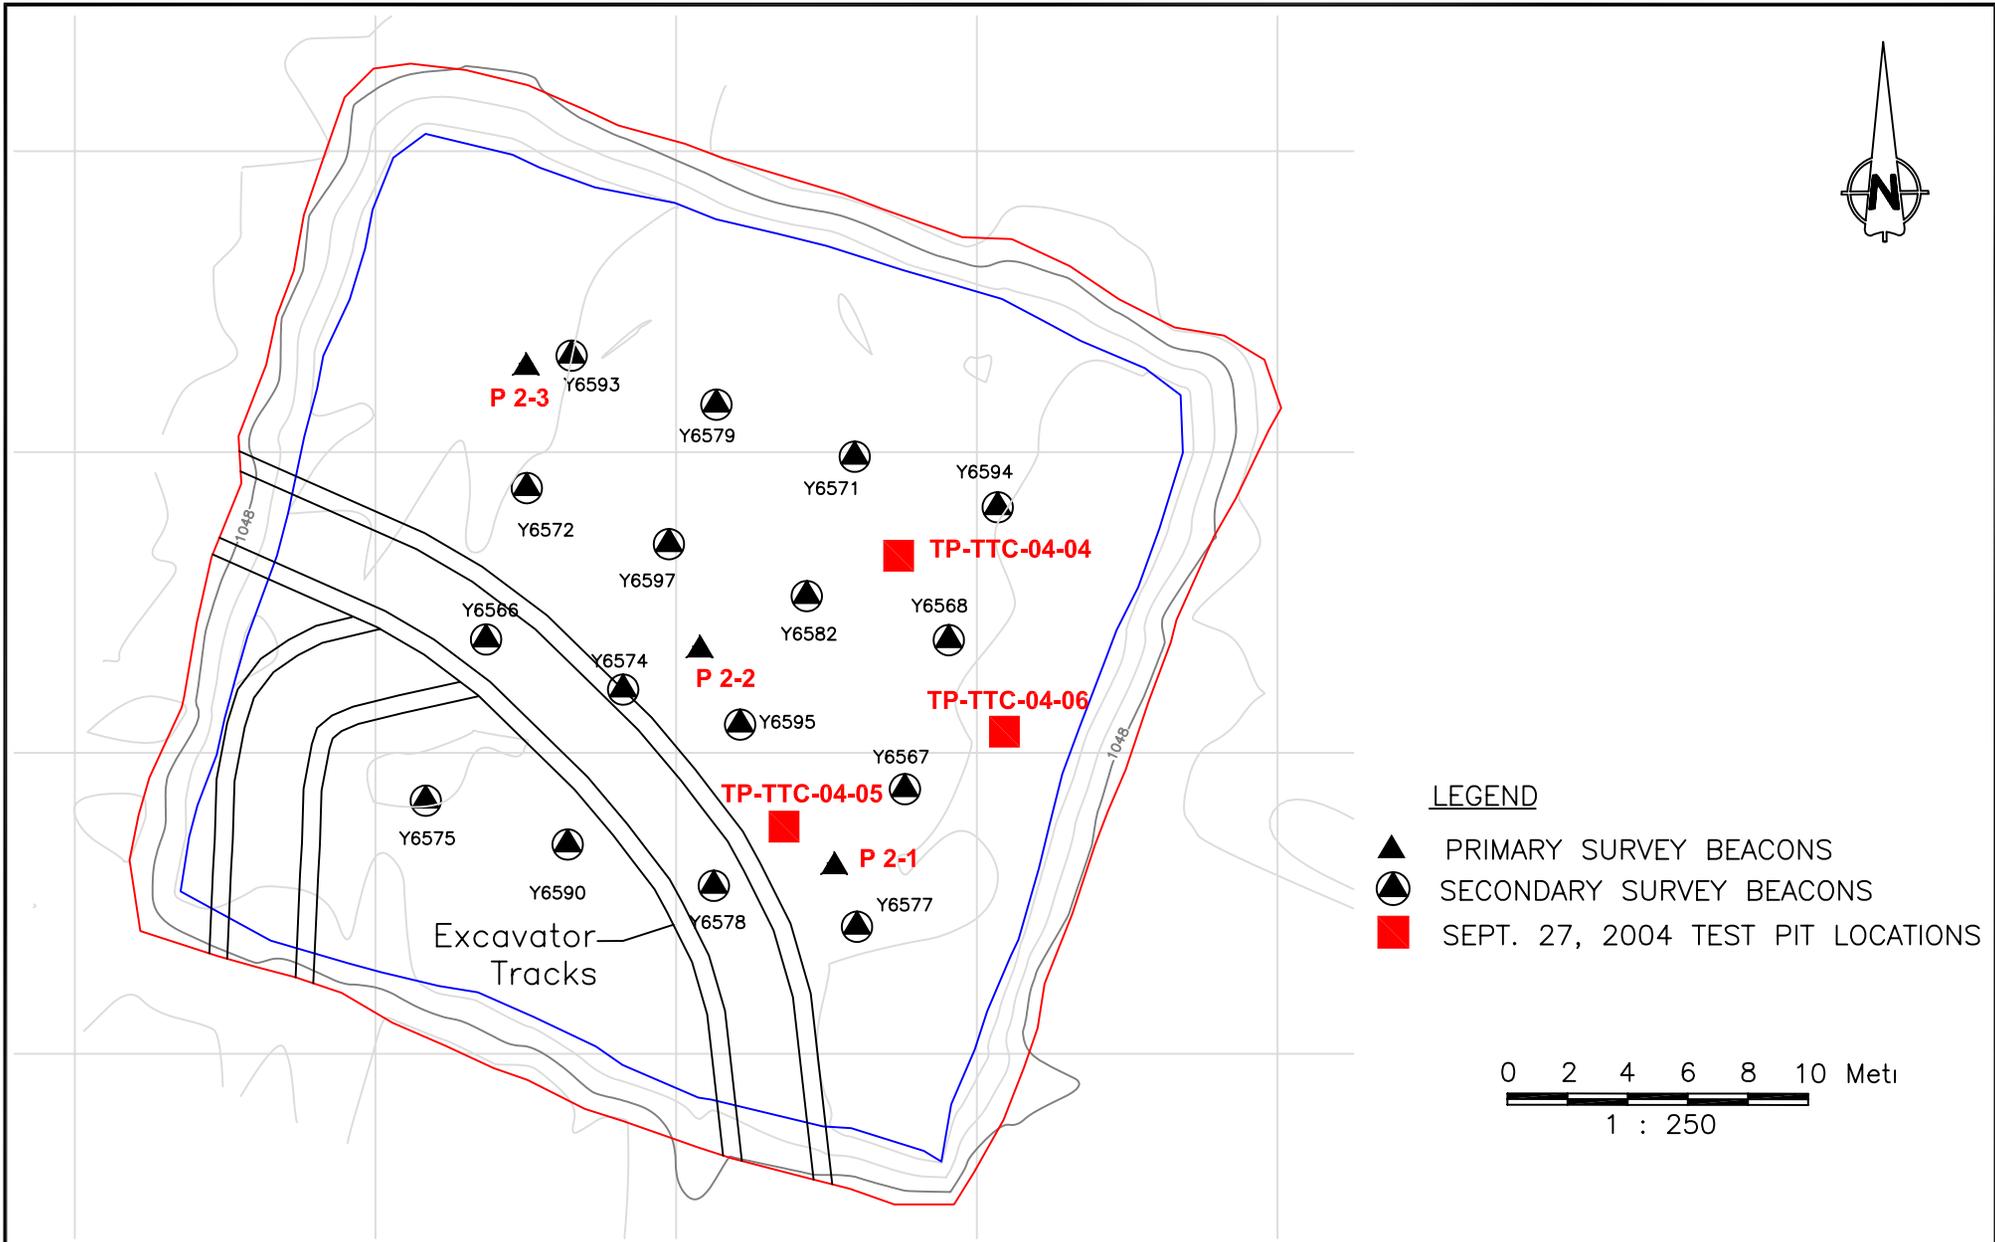
On June 17, 2004 ARMC was excavating a test pit approximately 10 m west of the West Pad using the ARMC CAT 235 tracked excavator. The excavator got stuck during this excavation and the ARMC D9 Dozer had to be used on the West Pad to allow recovery of the excavator, and upon recovery, the excavator crawled across the pad. This resulted in disturbance to the south-east corner of the pad as well as to secondary survey beacons 6566, 6574 and possibly 6578. The damage on the trial cover is presented schematically on Figure 3.

ANVIL RANGE MINING COMPLEX			
SCHEMATIC PRESENTATION OF DAMAGE TO WEST PAD ON JUNE 17, 2004			
PROJECT NO. 1CD003.058	DATE Nov.2004	APPROVED EMR	FIGURE 3

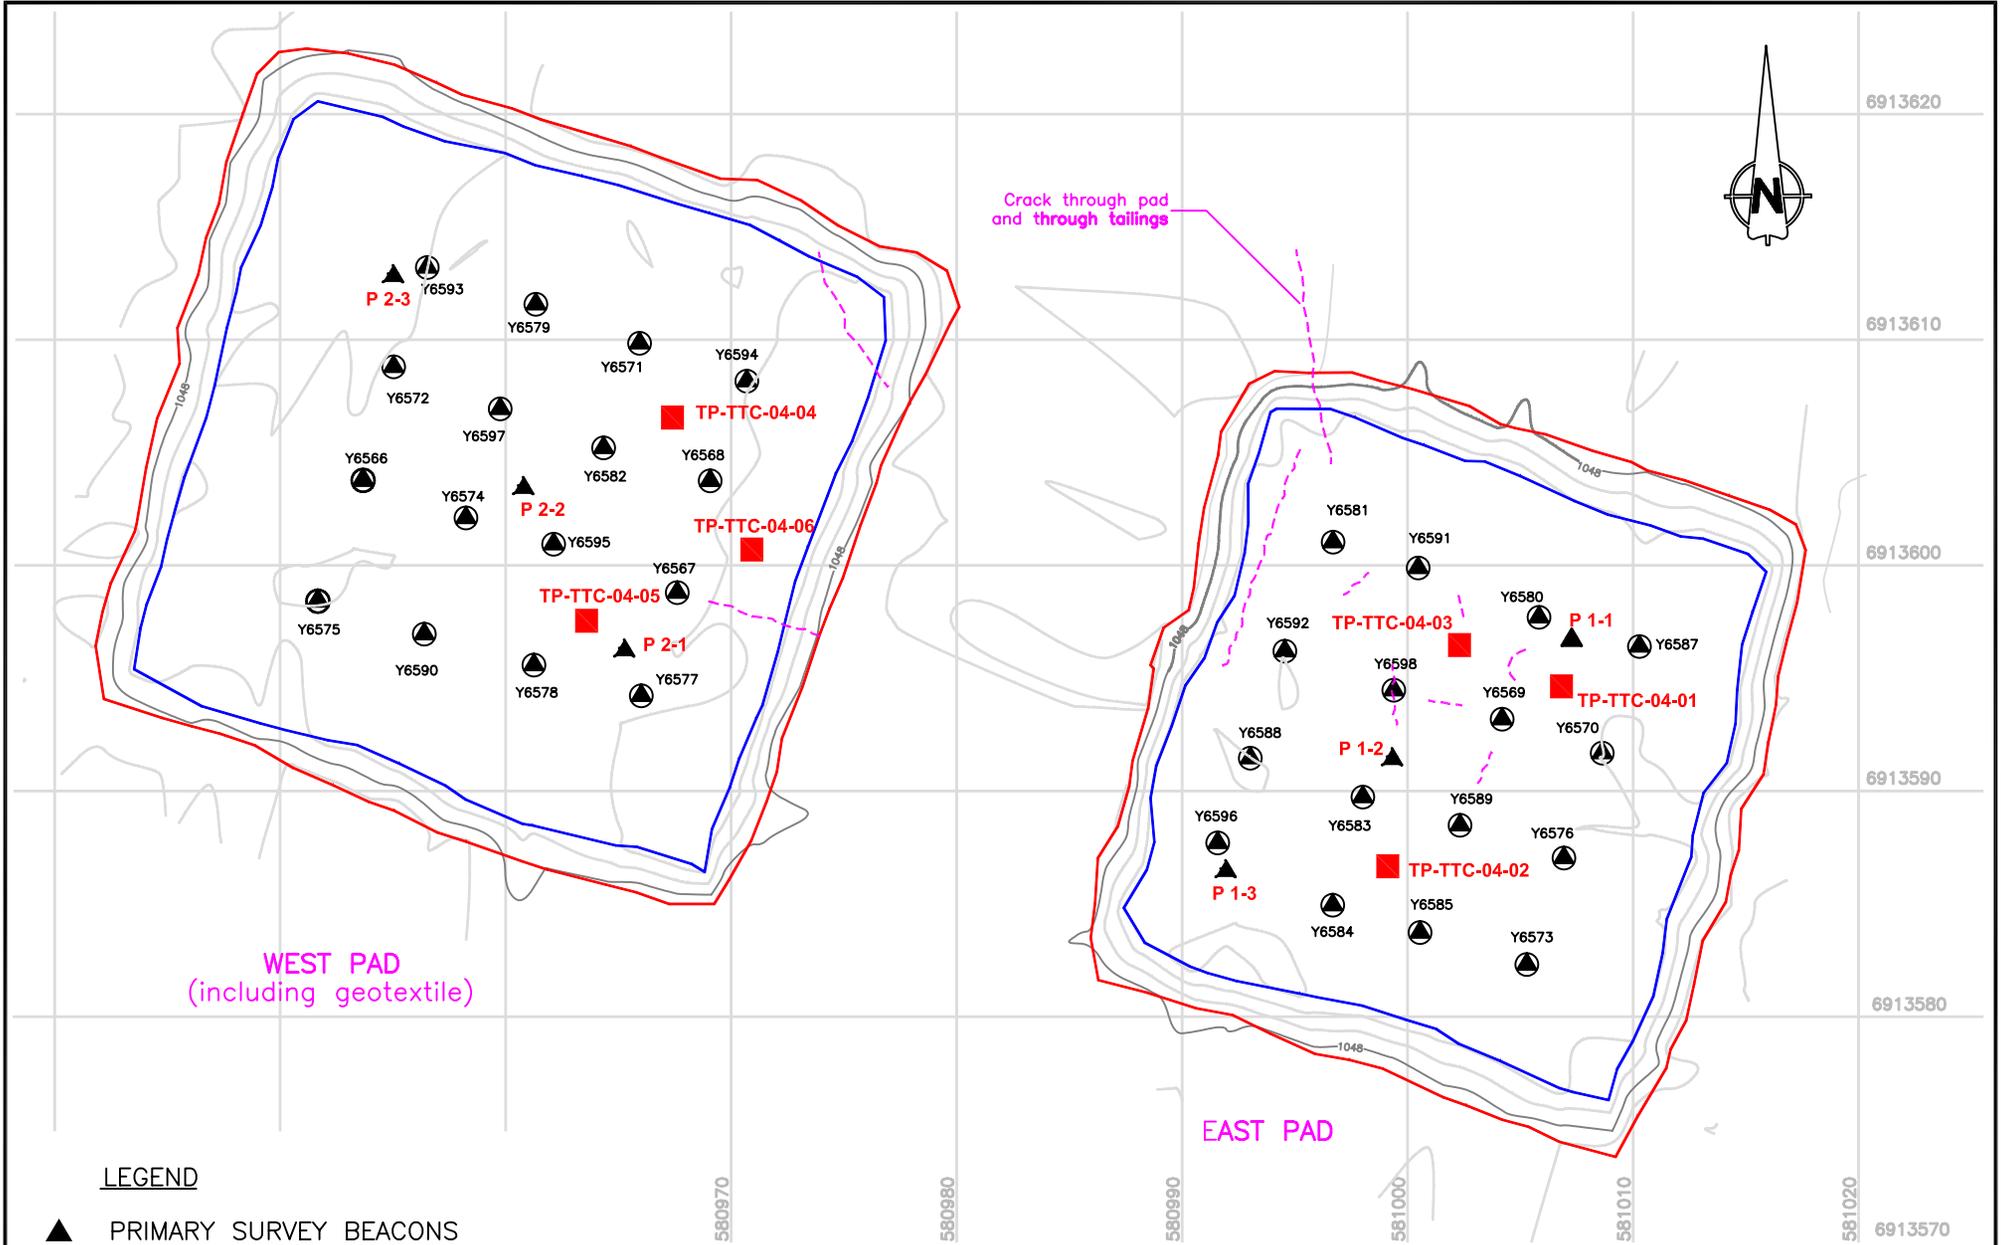
With the exception of the damage sustained to the West Pad as a result of the excavator extraction incident, the only noticeable feature during the inspections was surface cracking. A schematic of the extent of the cracks as observed during the August 29 site inspection is presented in Figure 4 and Appendix D contain photos of these features taken at the time. The surface cracks are randomly spaced across the pad surface, and vary in size from a few millimetres wide to more than 2 cm wide and approximately 10 cm deep (as probed from the surface). Surface cracks were first observed during the June 7 site inspection, and although a schematic similar to Figure 3 was not developed at the time, the inspector’s field notes and photos (Appendix C) suggest that cracking was less severe and slightly more common on the West Pad than on the East Pad. This trend was reversed during the August inspection, with significantly more cracks on the East Pad.

**SCHEMATIC PRESENTATION OF SURFACE CRACKS DURING AUGUST 29, 2004 SITE INSPECTION**

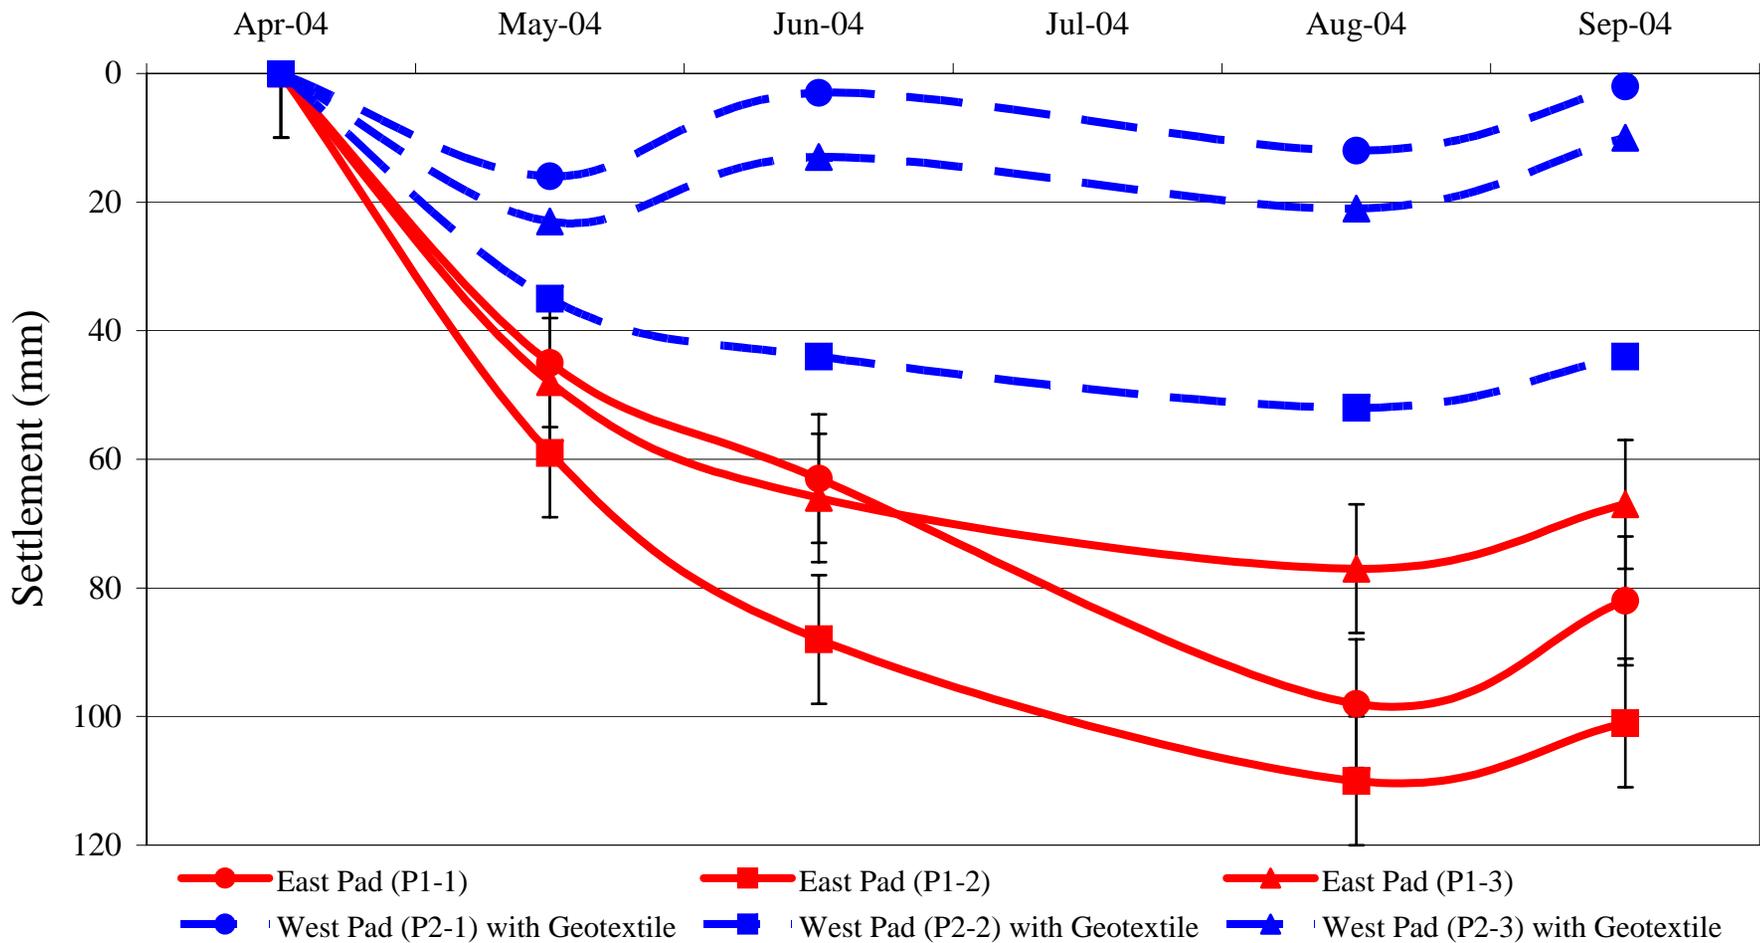
The pad foundation settlement, as presented by the three primary survey beacons installed in each test pad are presented in Figure 8, and again the apparent anomalous “rise” data is probably a reflection of the inherent degree of accuracy of the monitoring technique.

**Normalized corrected settlement data  
for the primary survey beacons**

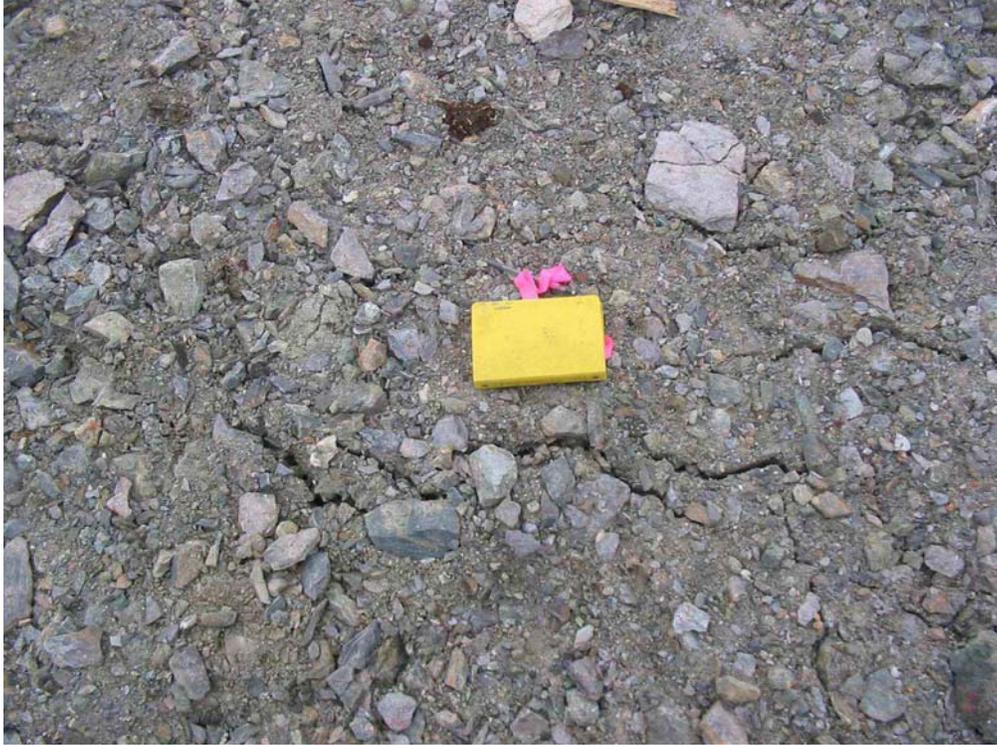
Figure 1. East test cover: Small cracks along eastern edge.

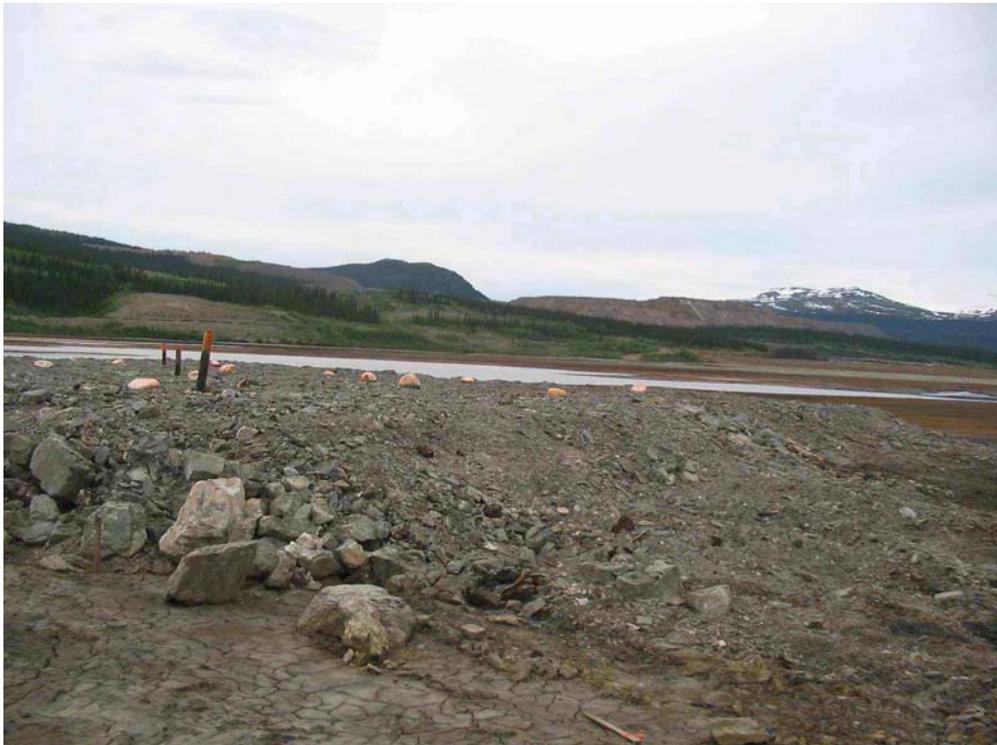
Figure 2. East test cover: Southwest steel column leaning to the southeast.

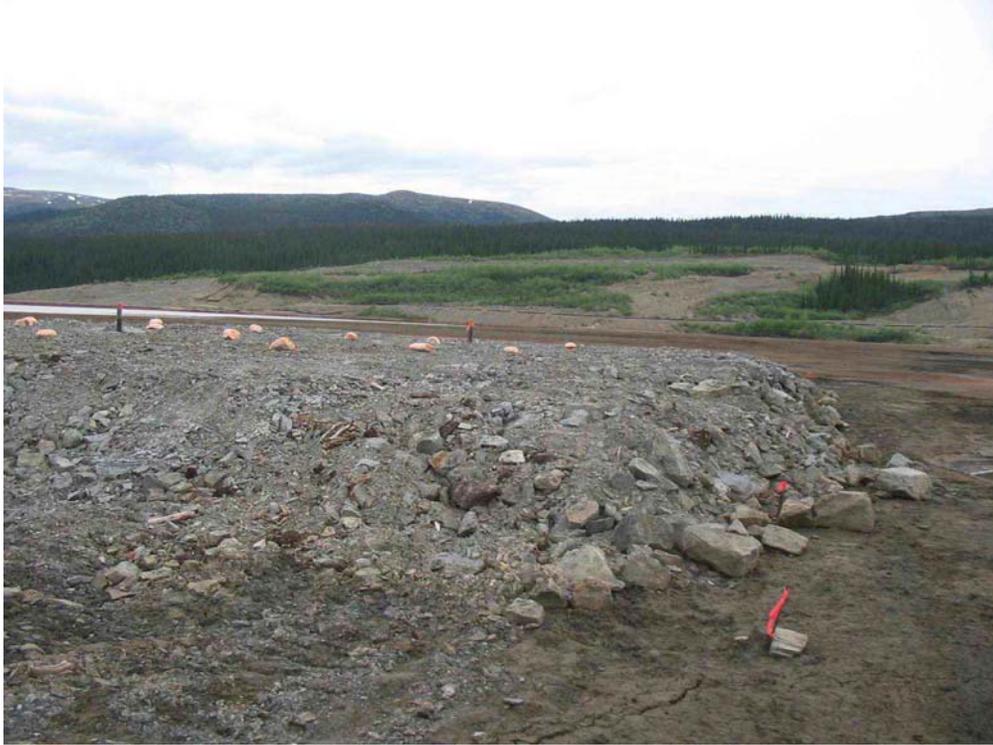
Figure 5. East test cover: Eastern edge, showing slightly undulating surface.

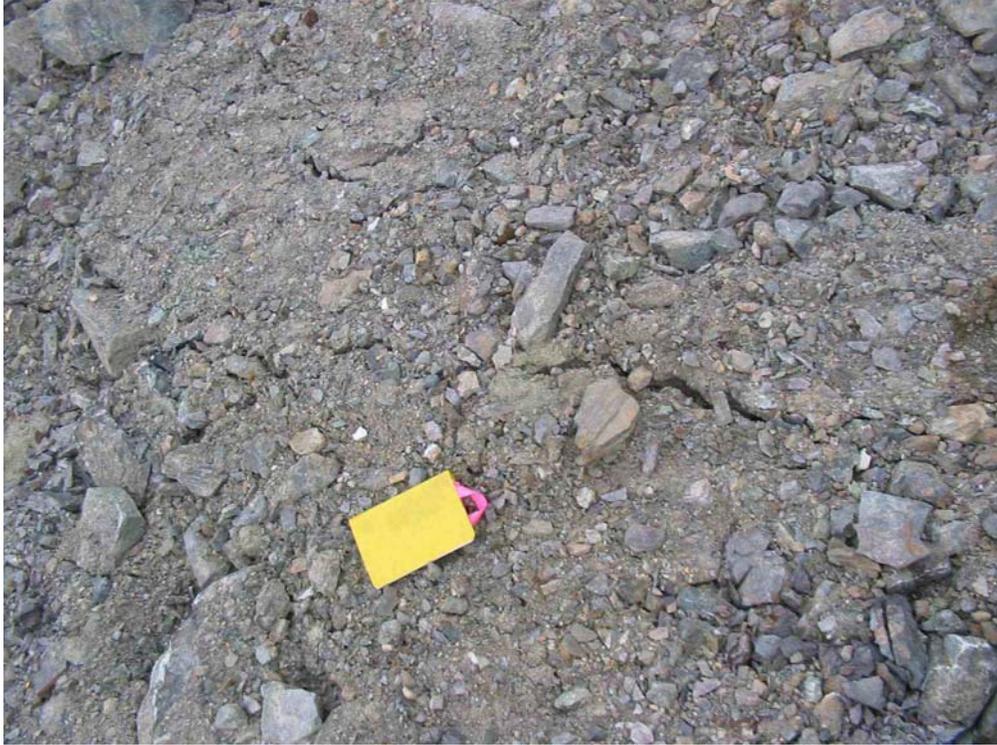
Figure 7. East test cover: Eastern edge, showing minor cracking.

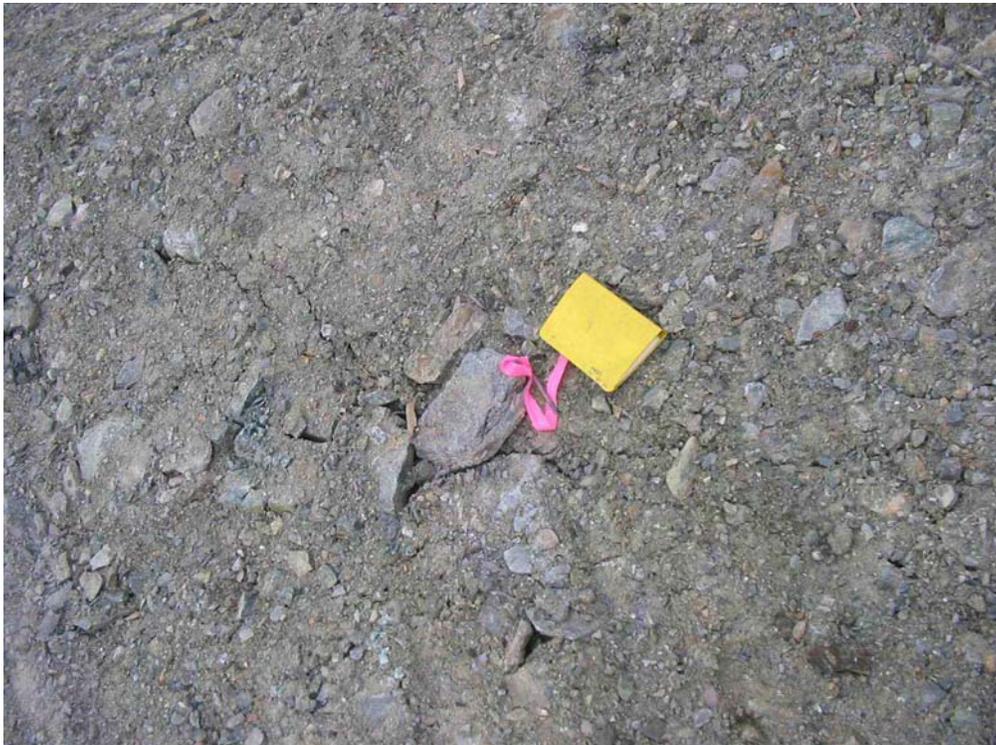
Figure 14. West test cover: Minor cracking along eastern edge.

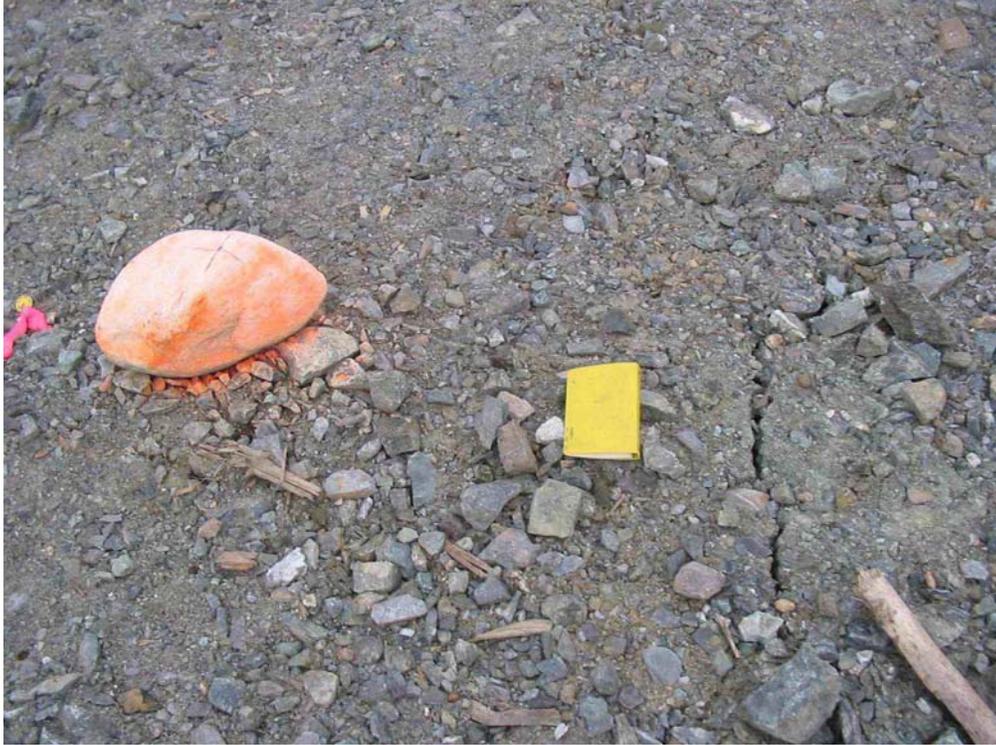
Figure 15. West test cover: Minor cracking near center of cover.

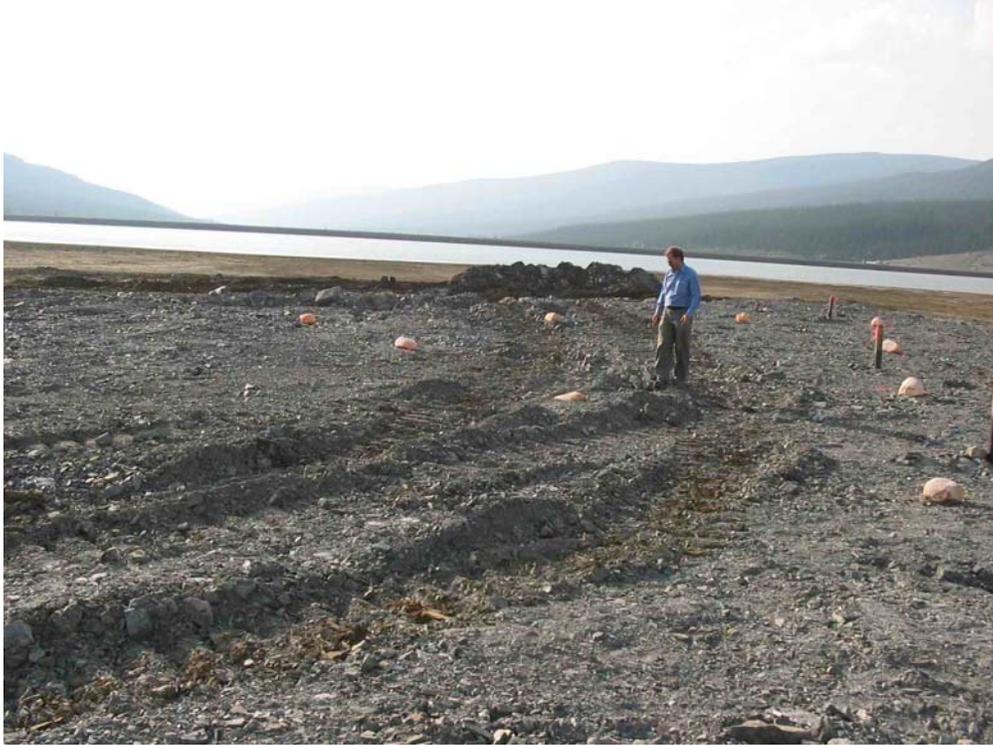
Figure 21. West test cover: Damage to surface of cover by equipment. Note disturbed marker stone in center.

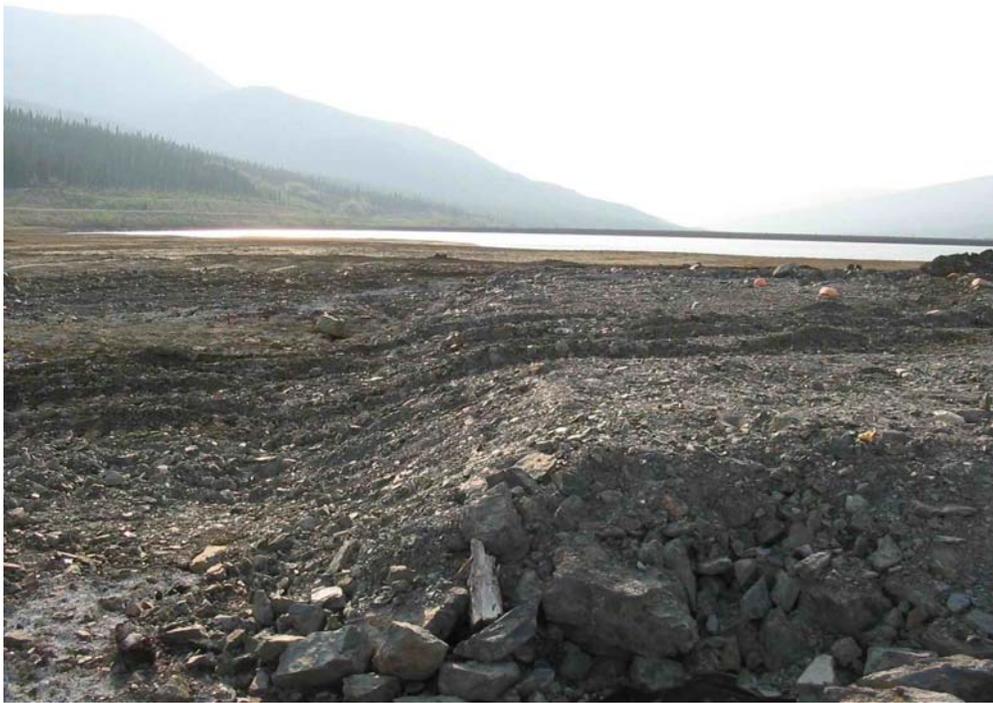
Figure 23. West test cover: Southern edge, showing damage from equipment.

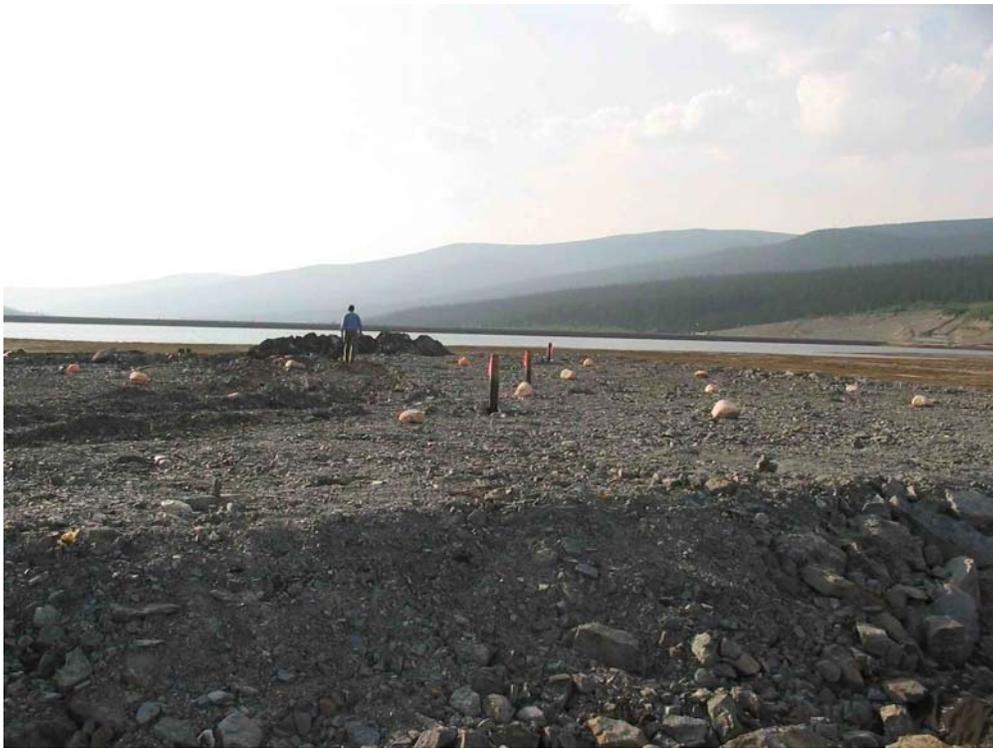
Figure 24. West test cover: Comparison of damaged SW and pristine NE portions of test cover.

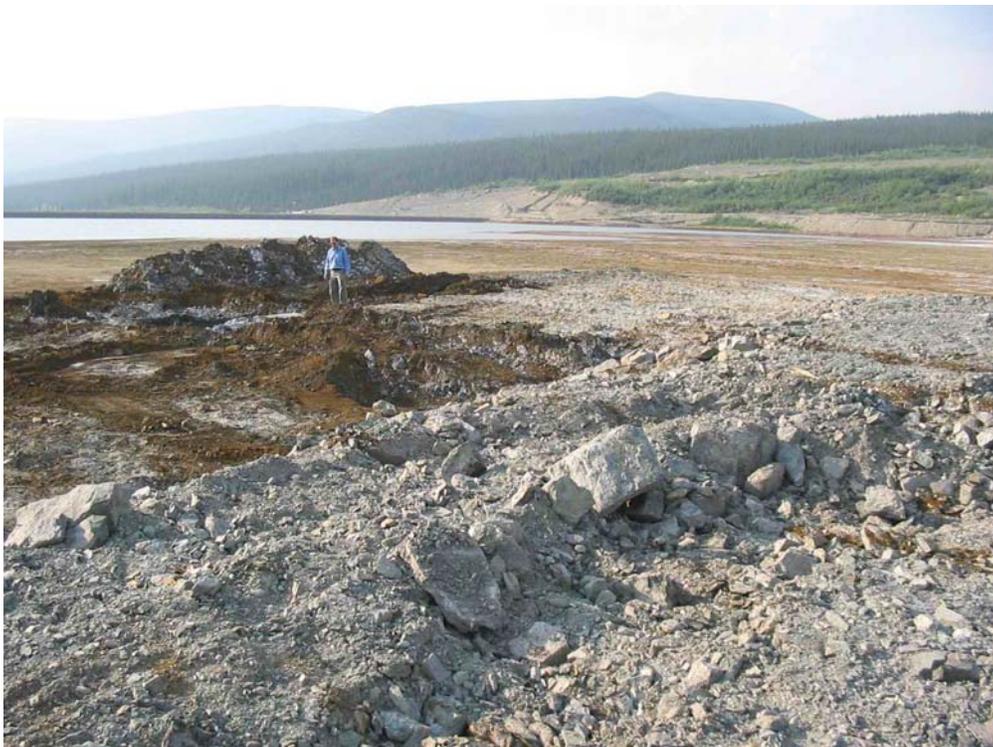
Figure 26. West test cover: Western edge and adjacent disturbed tailings.

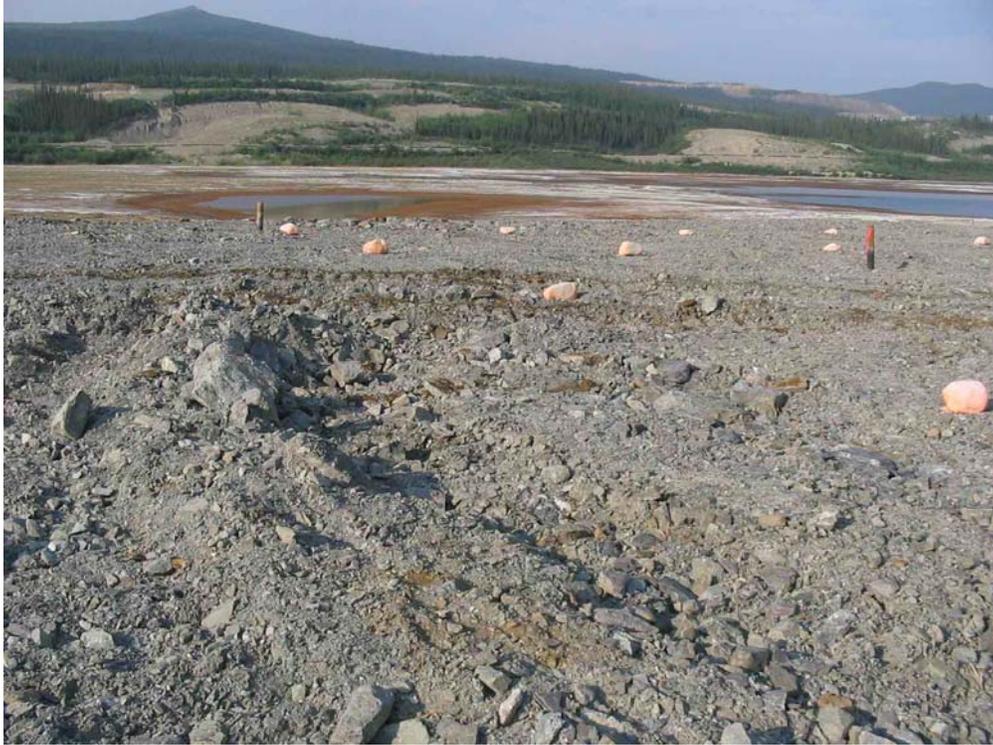
Figure 27. West test cover: Looking NE from SW corner, showing surface damage from equipment.

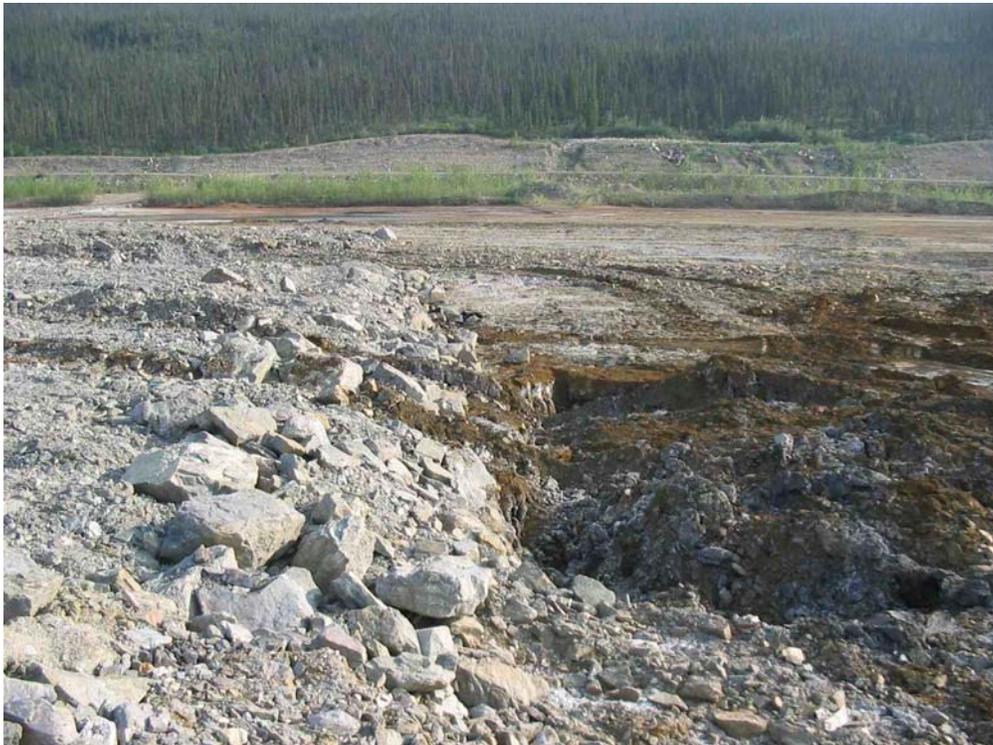
Figure 30. West test cover: Western edge, showing damage from equipment.

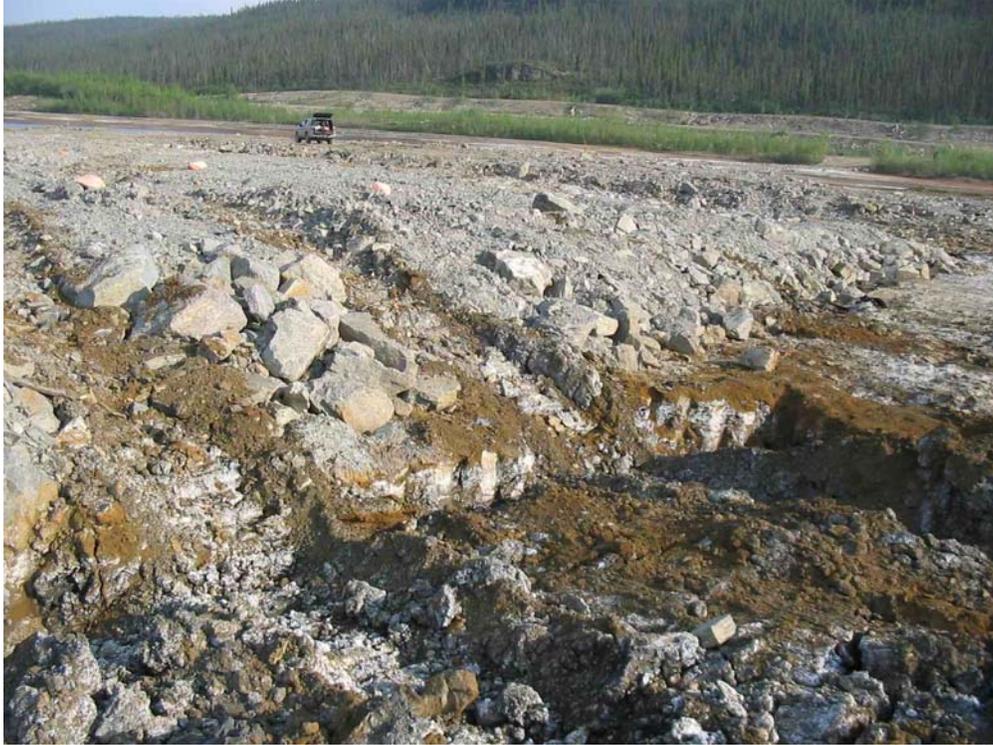
Figure 31. Western edge of west test cover showing equipment tracks in tailings and damage done to edge of cover by equipment.

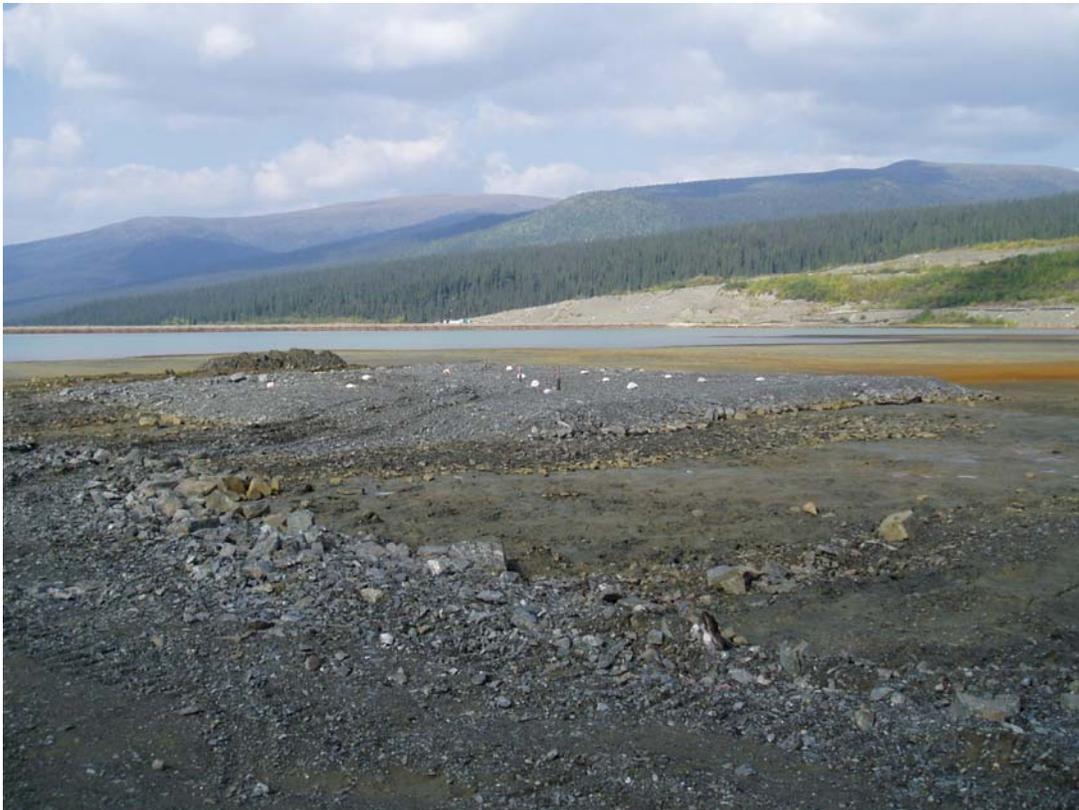
Photo 2: North-east view across the West Pad (including geotextile) surface. Note the dozer tracks leading onto the pad as a result of the excavator retrieval on June 17, 2004.

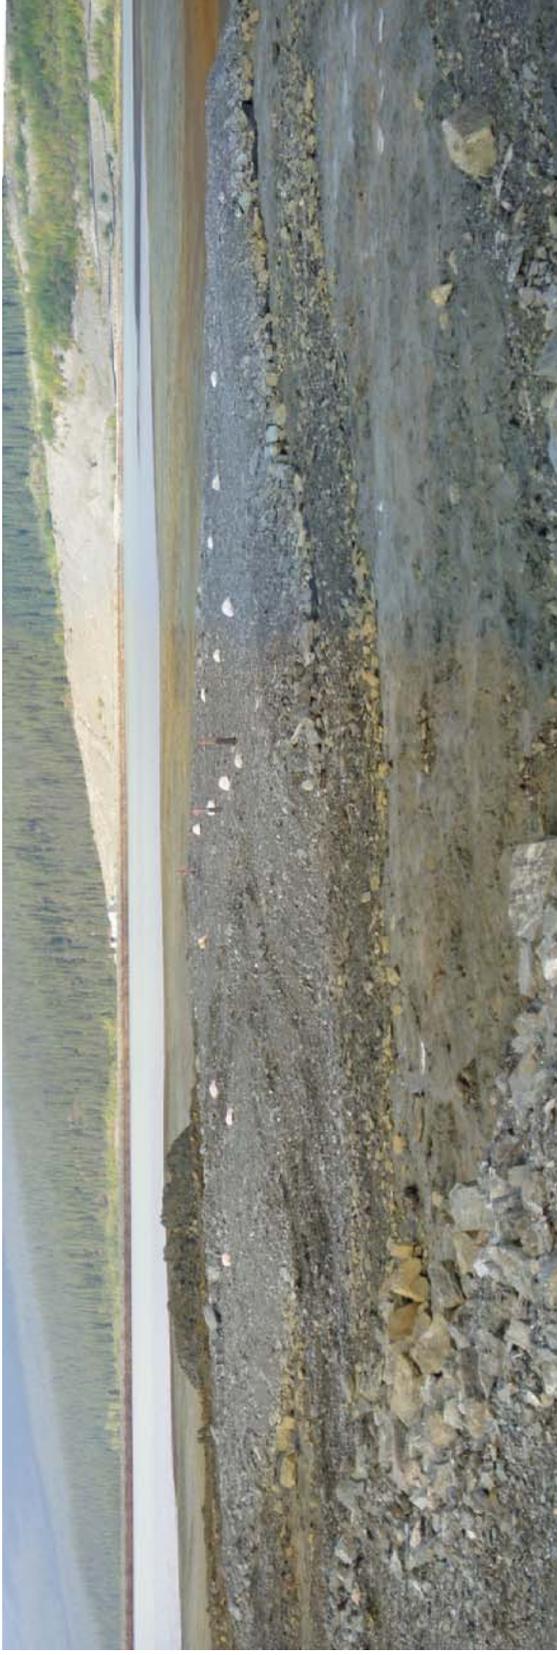
Photo 4: Panoramic view of the West Pad (including geotextile) from the south-west. Note the permanent pond in the background and the damage caused by the dozer in the foreground.

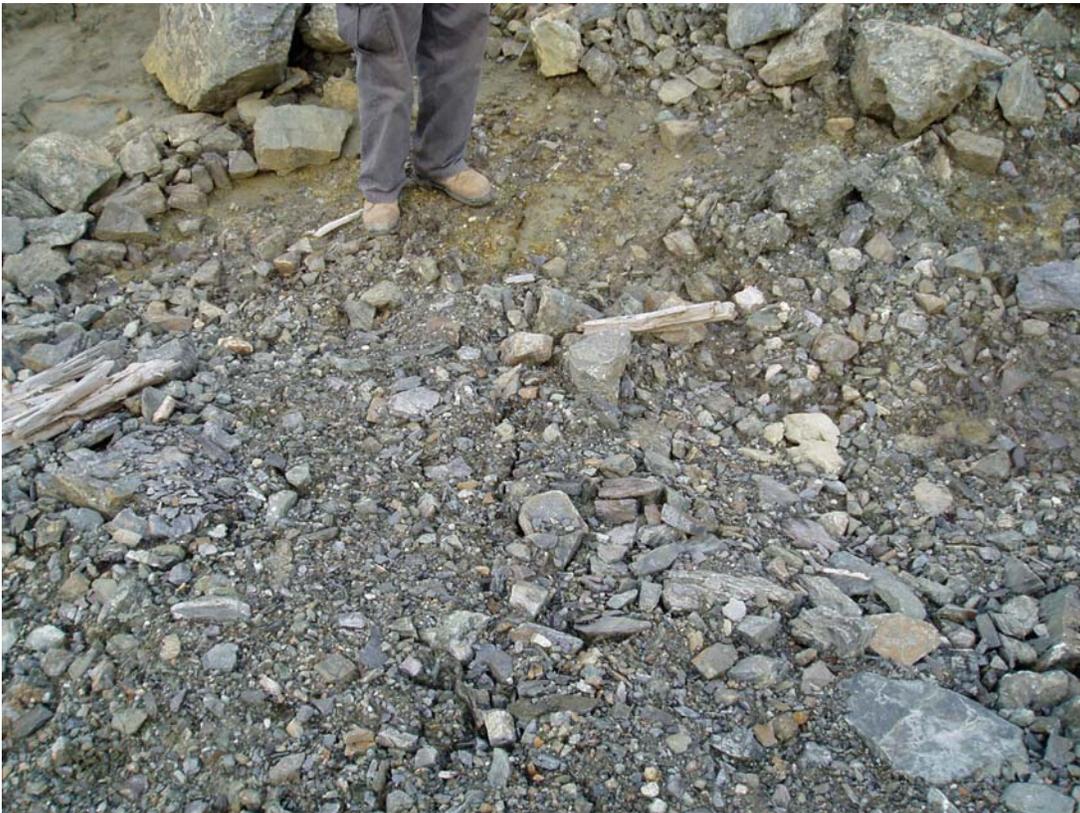
Photo 7: Close-up view of a crack on the corner of the East Pad. Note the crack continues from the tailings and on through the pad.

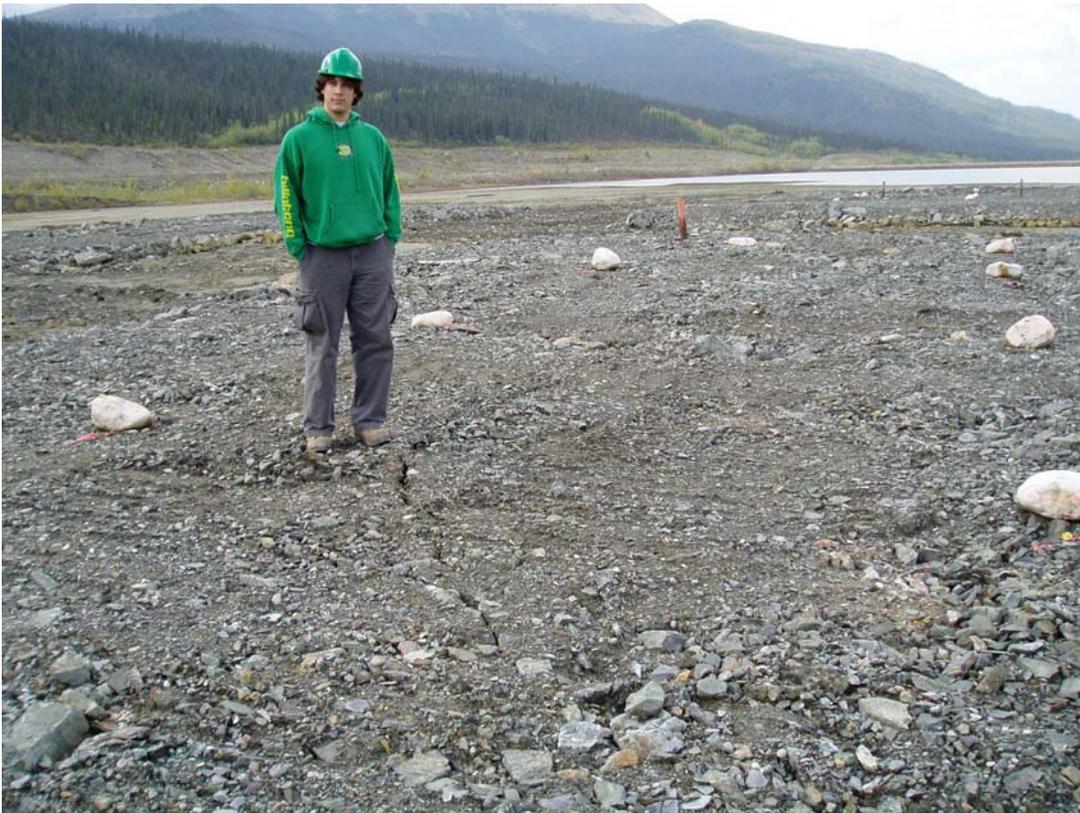
Photo 8: Close-up view of a crack on the surface of the East Pad. The crack is curved and measures approximately 5 m long, 10 to 20 mm wide and 10 to 100 mm deep.

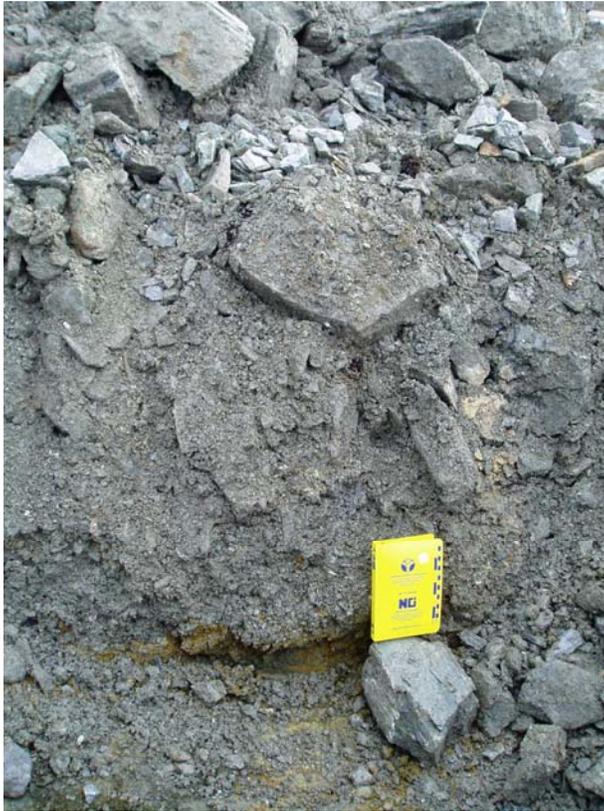
There is a definite mixed zone of tailings and cover material present at the base of the East Pad. However, there does not appear to be any indication of tailings fines physically migrating up beyond this zone. No material mixing has been observed for the West Pad, with the geotextile effectively separating the tailings and cover material.

Photo 1: TP-TTC-04-01 Profile of test pit showing the undulated interface between tailings and cover material where mixing has occurred.

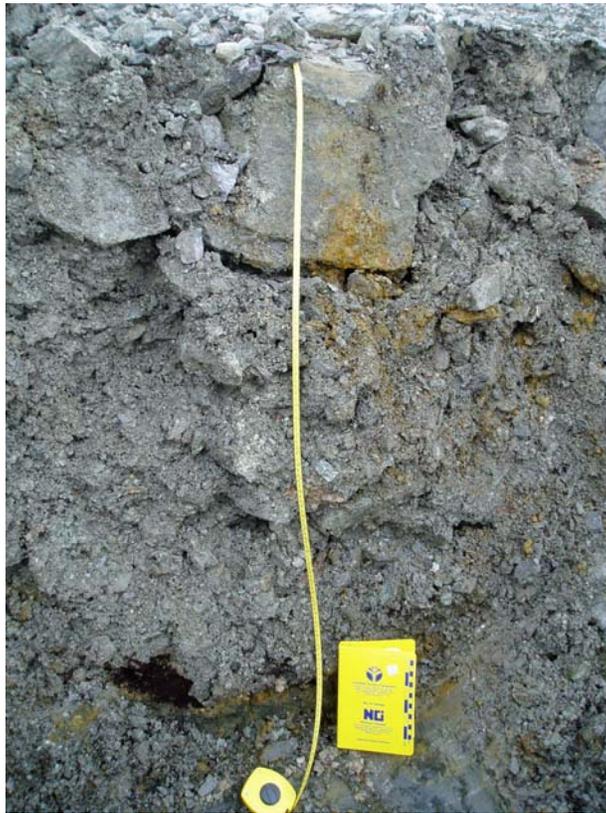
Photo 5: TP-TTC-04-02 Profile of test pit showing undulating bottom mixed zone.

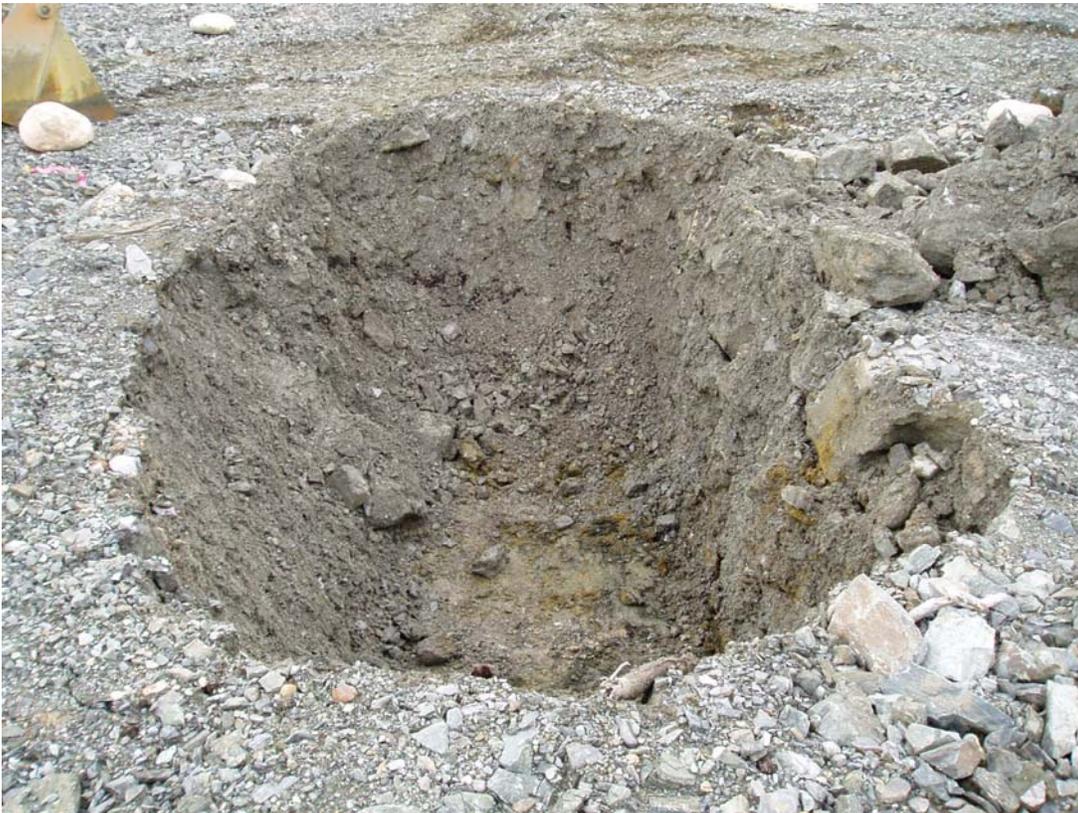
Photo 8: TP-TTC-04-02 Note the slope angle of the test pit walls. The material is very wet and the walls continuously caved in.
