# **Monitor Trial Covers at Rose Creek Tailings Impoundment**

## **2004/05 Task 16b**

**SRK Project Number 1CD003.058**

**March 2006**

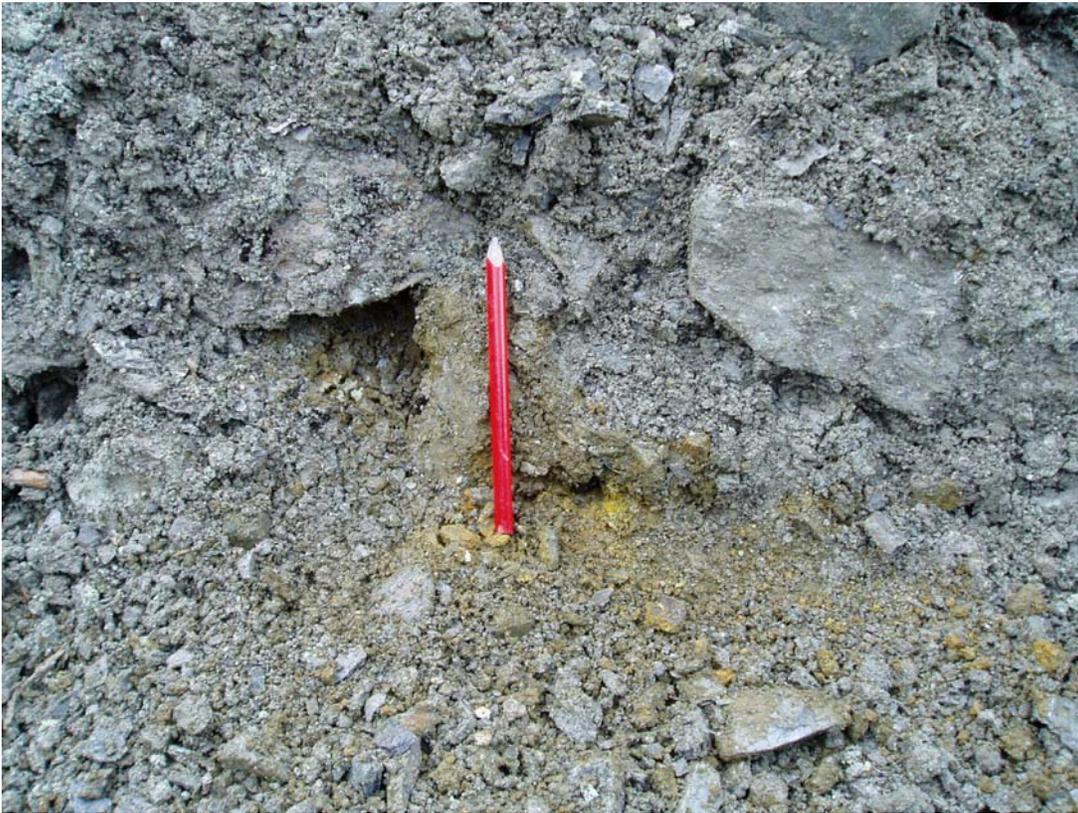
Photo 9: TP-TTC-04-03 Mixed zone of cover material and tailings of approximately 20 cm. The mixing appears to be dominated by larger boulders.

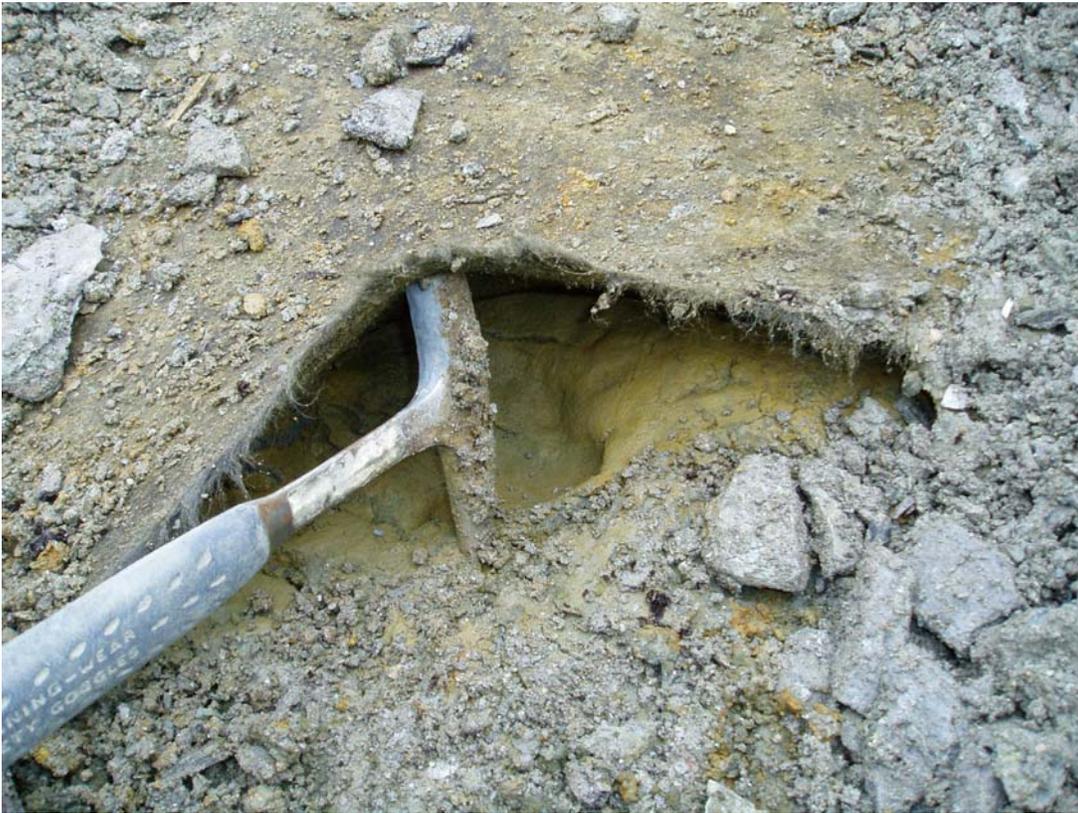
Photo 11: TP-TTC-04-04 Minor undulating surface at contact between cover material and tailings.

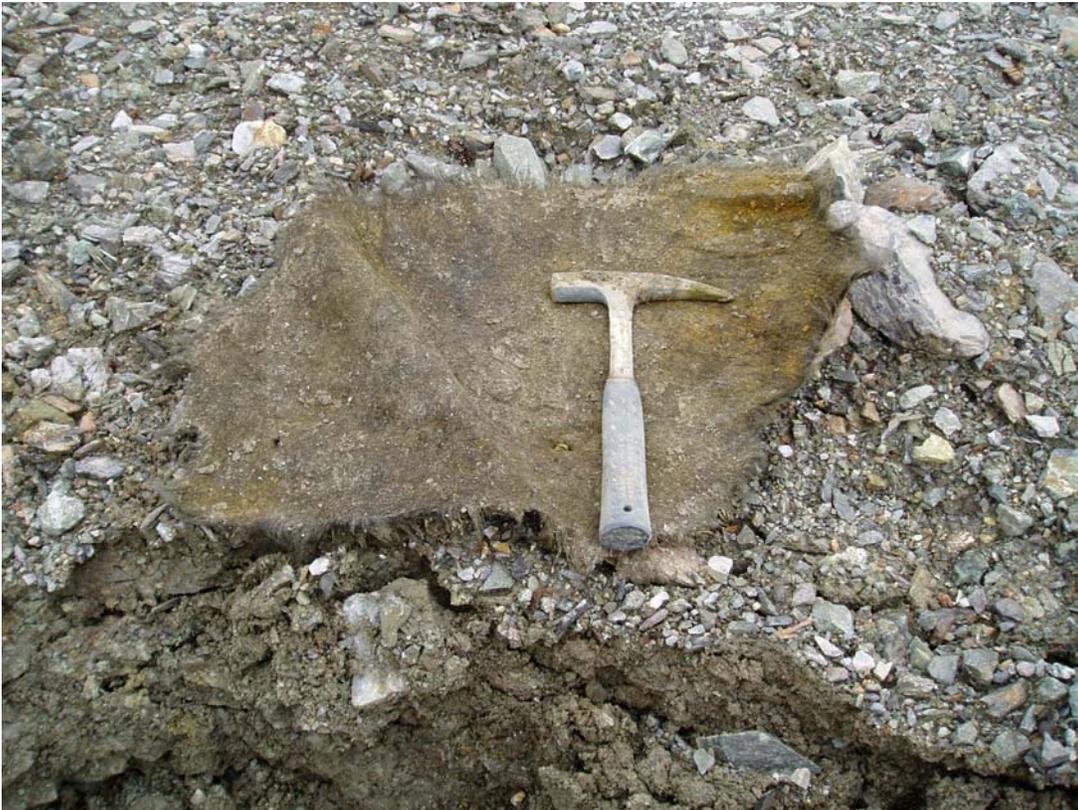
Photo 12: TP-TTC-04-04 The tailings has not migrated through the geotextile. Although both the tailings and the cover material were very wet, the geotextile was relatively dry.

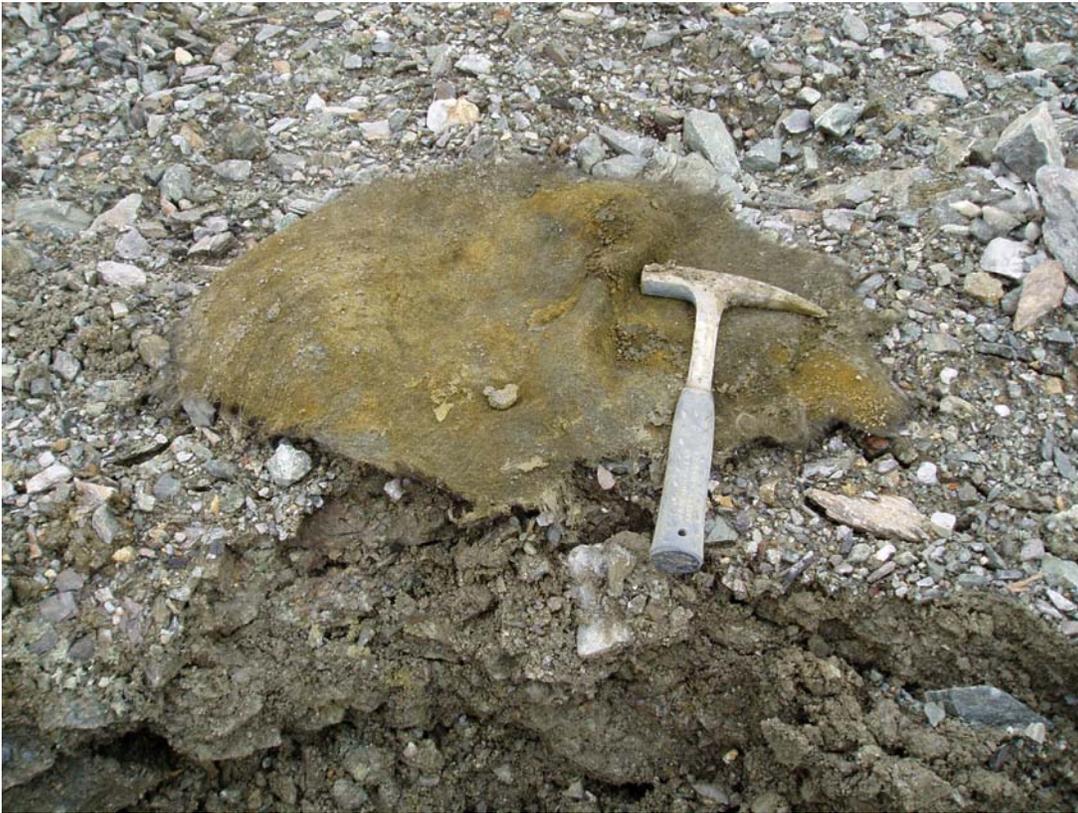
Photo 13: TP-TTC-04-04 The bottom of the geotextile is stained with tailings. It is possible that tailings is clogging the geotextile and subsequently slowing down the consolidation time.

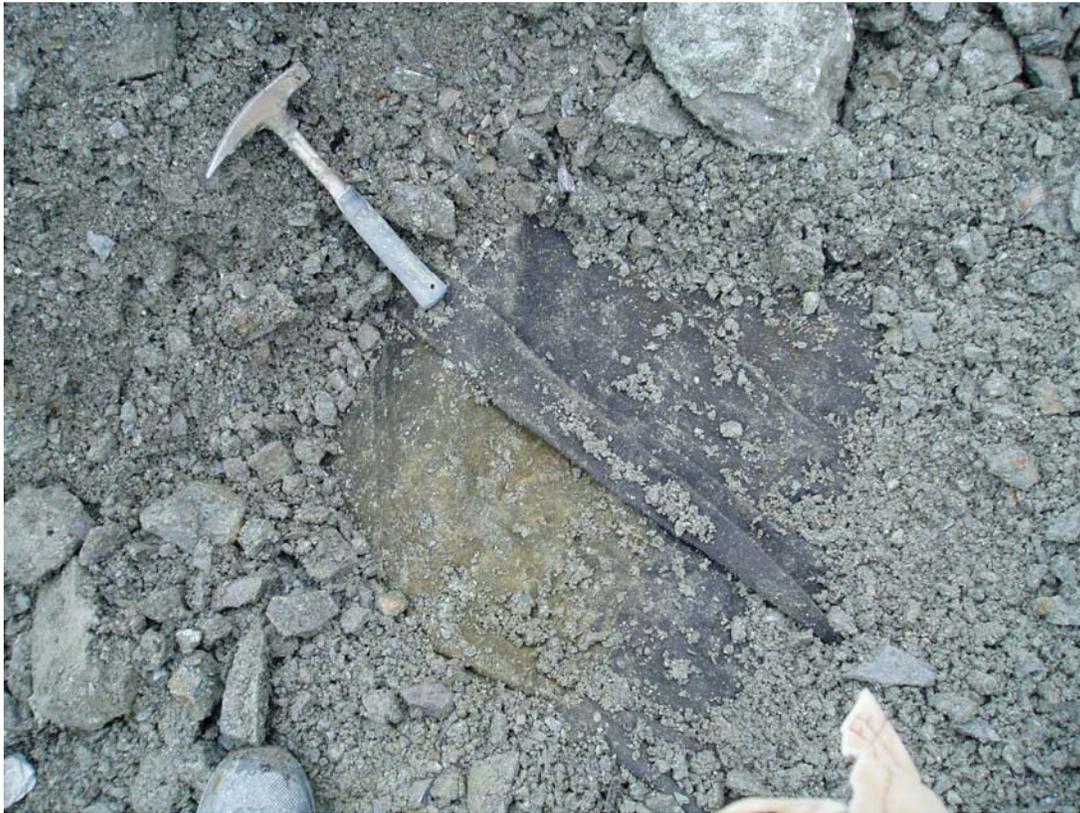
Photo 15: TP-TTC-04-05 Overlap section of the textile showing no signs of moving apart as a result of differential settlement. Also, no tailings are oozing through the seam opening.

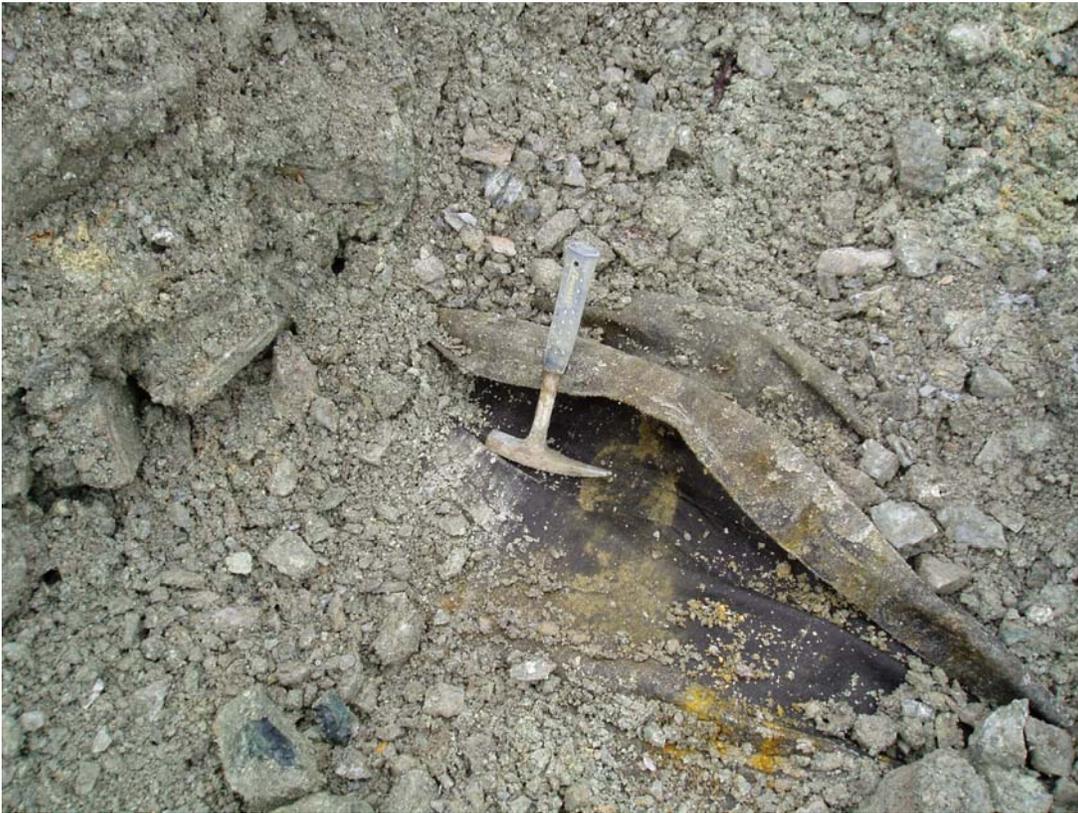
Photo 17: TP-TTC-04-06 Geotextile overlap showing no signs of tailings moving through the geotextile. The folds in the geotextile is as a result of rutting during construction caused by the trucks passing over the geotextile
