**Monitor Trial Covers at Rose
Creek Tailings Impoundment:
Task 16b**

Project Reference Number:
SRK 1CD003.058

November 2004

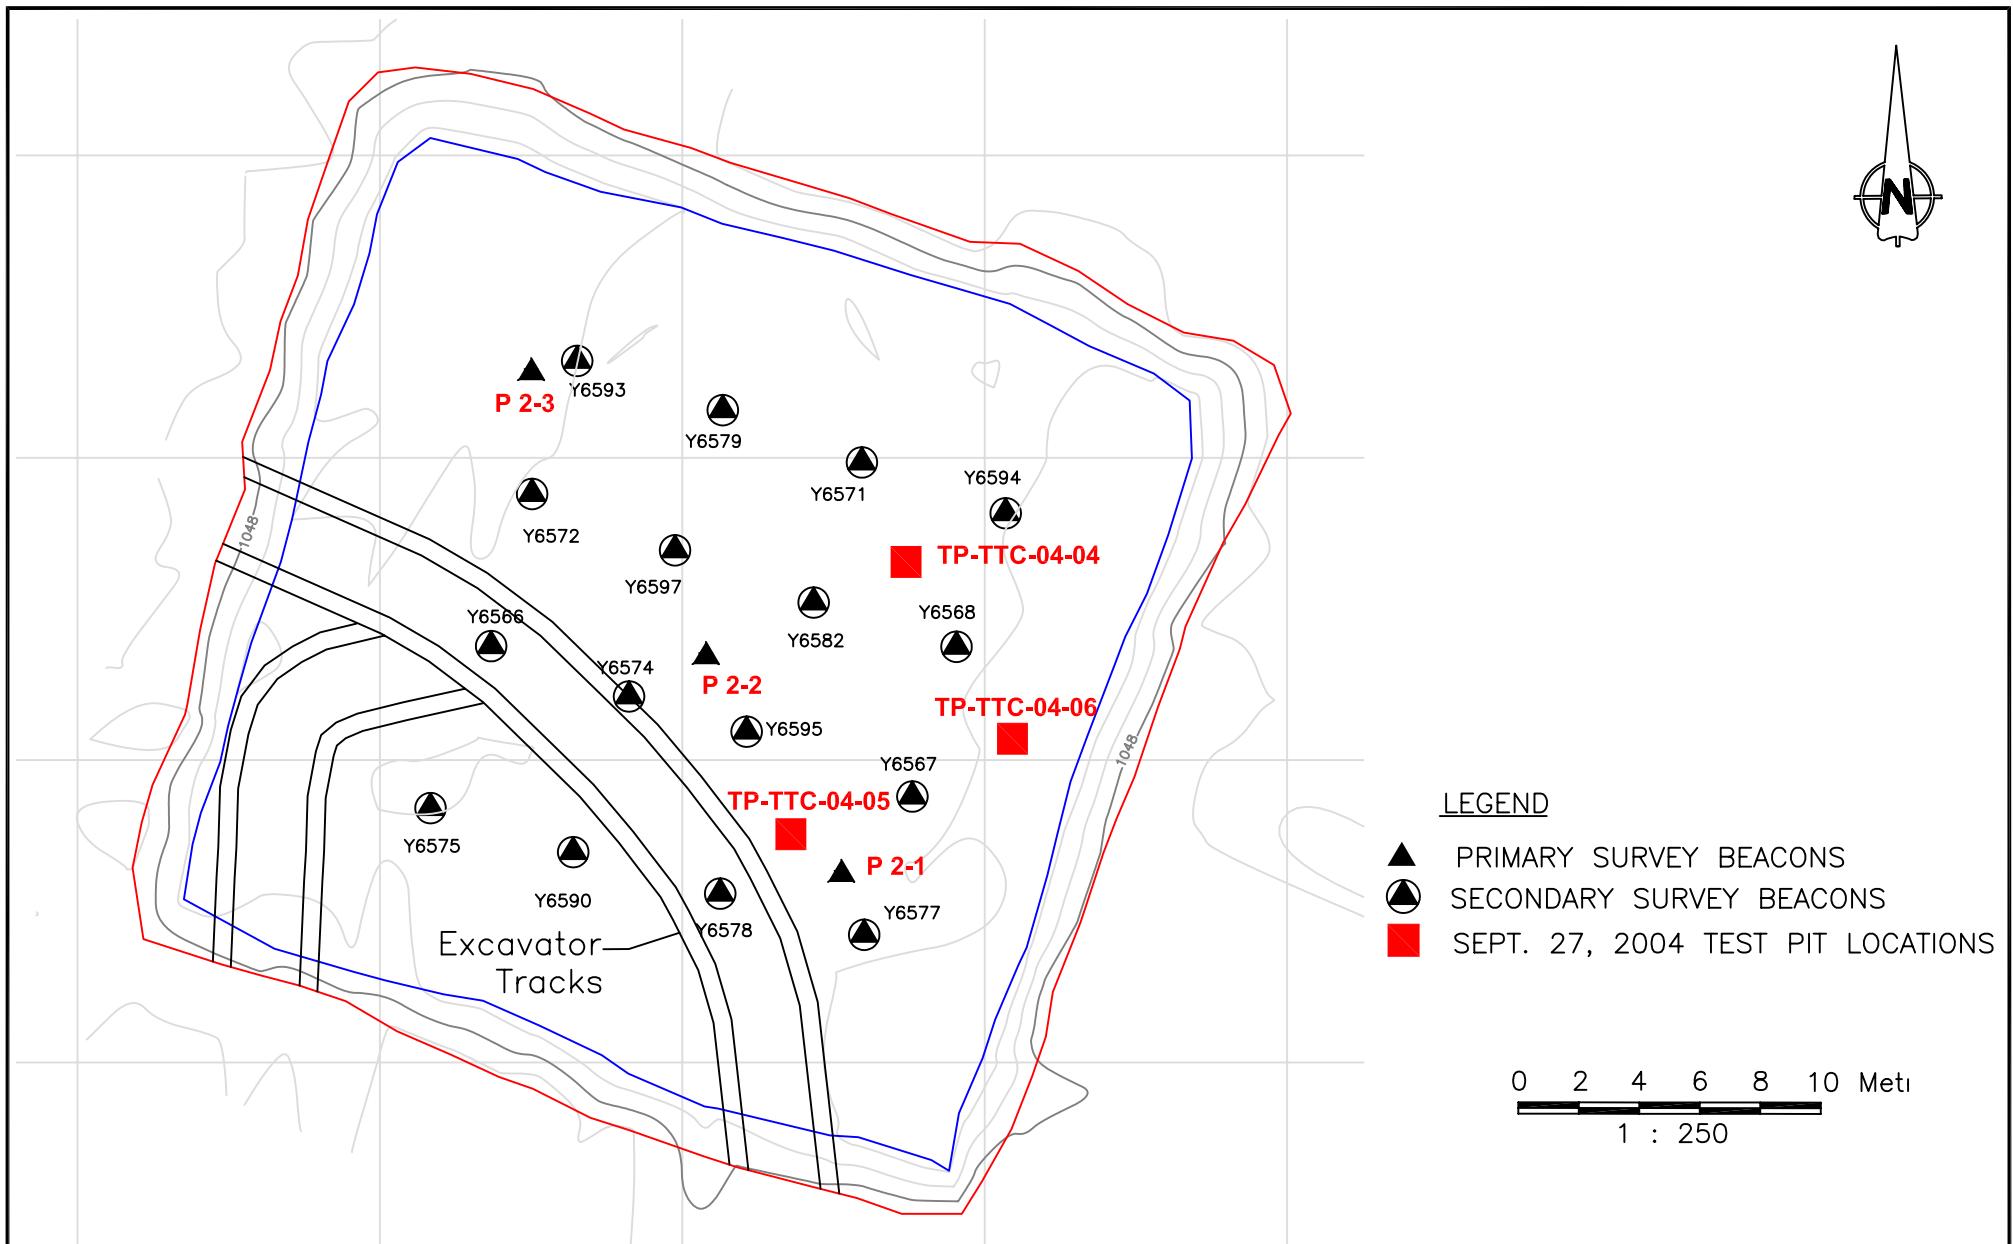
SCHEMATIC PRESENTATION OF DAMAGE
TO WEST PAD ON JUNE 17, 2004

On June 17, 2004 ARMC was excavating a test pit approximately 10 m west of the West Pad using the ARMC CAT 235 tracked excavator. The excavator got stuck during this excavation and the ARMC D9 Dozer had to be used on the West Pad to allow recovery of the excavator, and upon recovery, the excavator crawled across the pad. This resulted in disturbance to the south-east corner of the pad as well as to secondary survey beacons 6566, 6574 and possibly 6578. The damage on the trial cover is presented schematically on Figure 3.

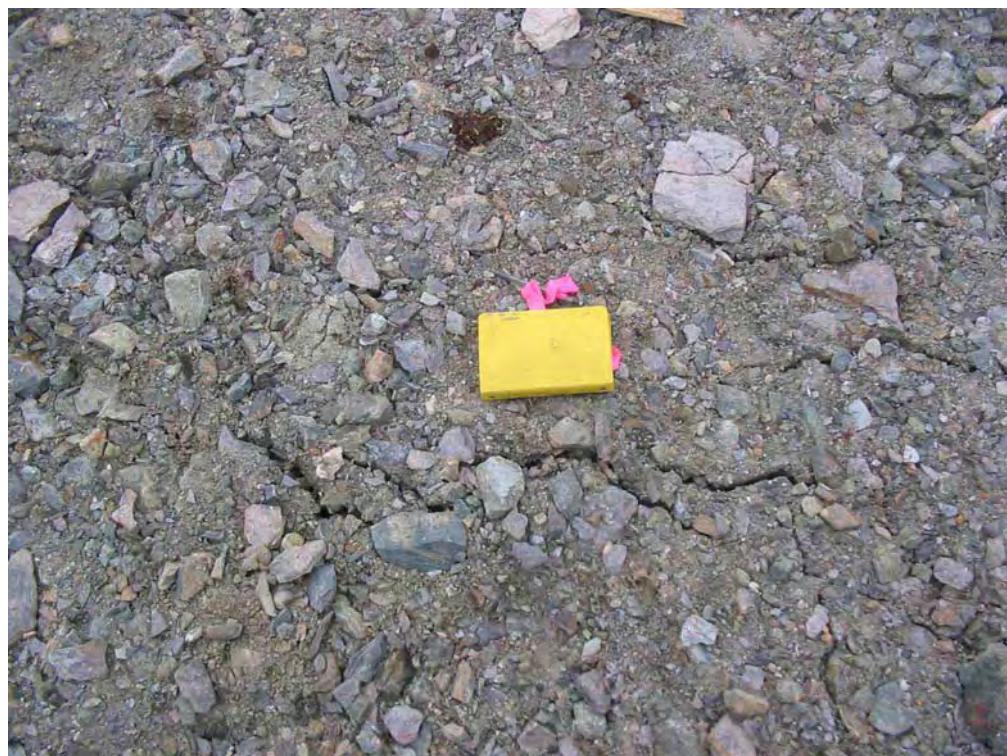
Figure 1. East test cover: Small cracks along eastern edge.

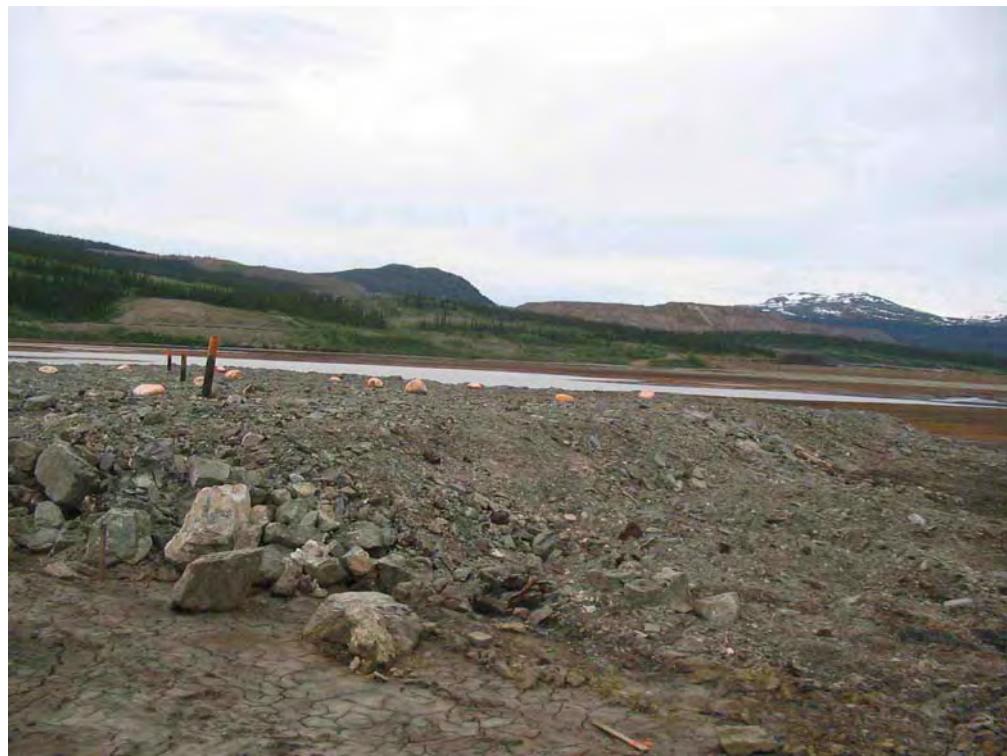
Figure 2. East test cover: Southwest steel column leaning to the southeast.

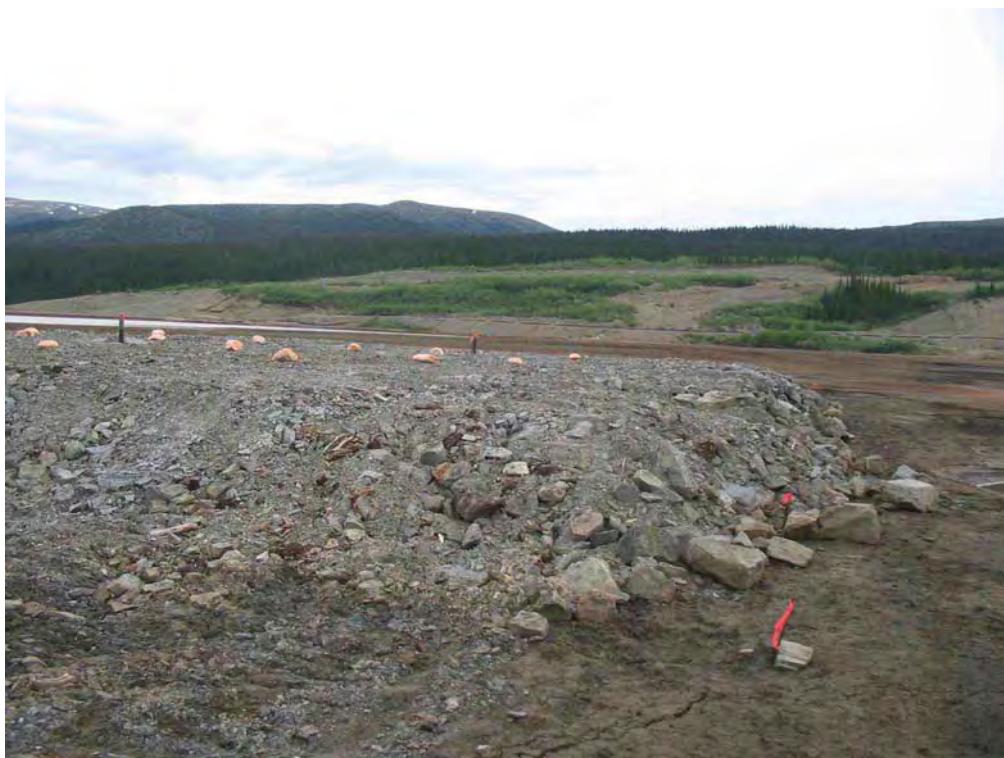
Figure 5. East test cover: Eastern edge, showing slightly undulating surface.

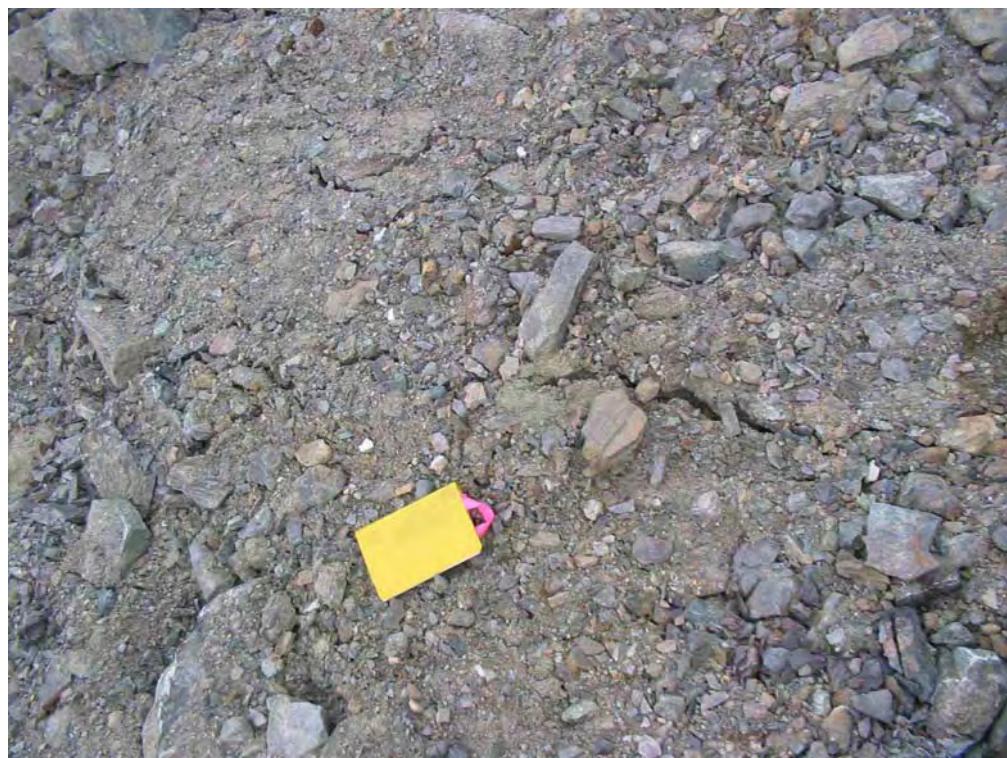
Figure 7. East test cover: Eastern edge, showing minor cracking.

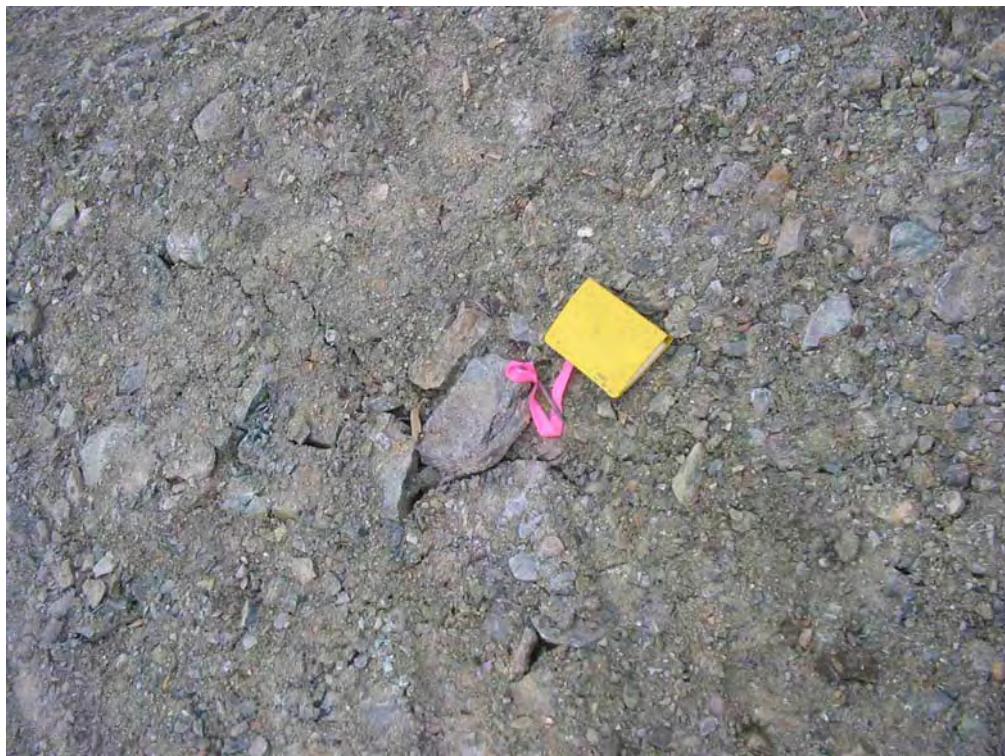
Figure 14. West test cover: Minor cracking along eastern edge.

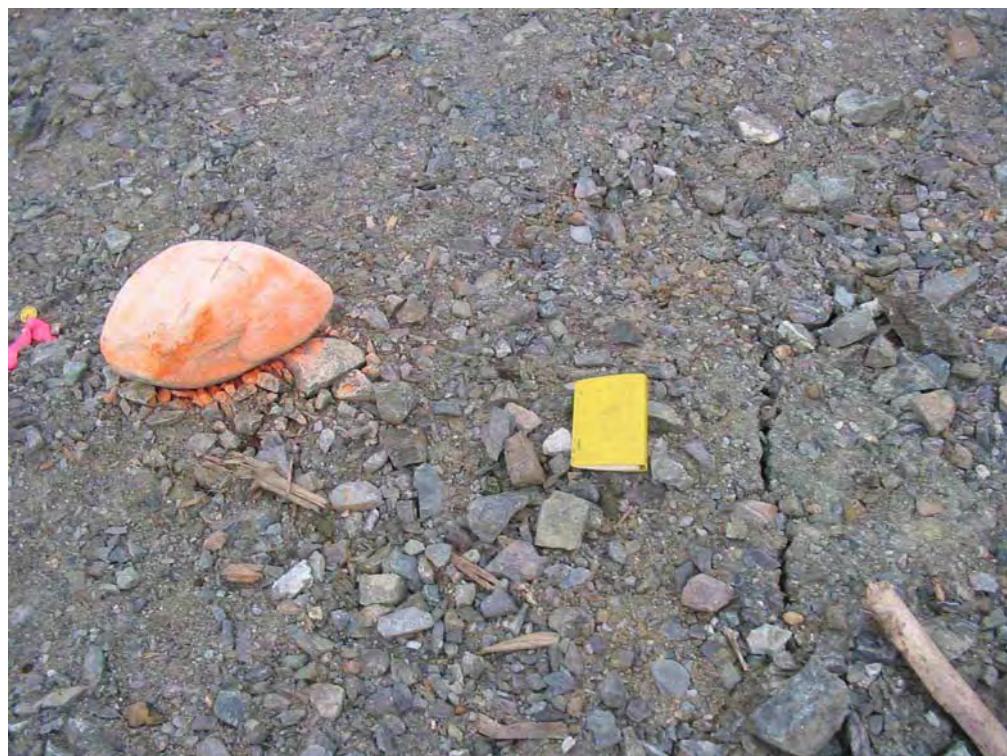
Figure 15. West test cover: Minor cracking near center of cover.

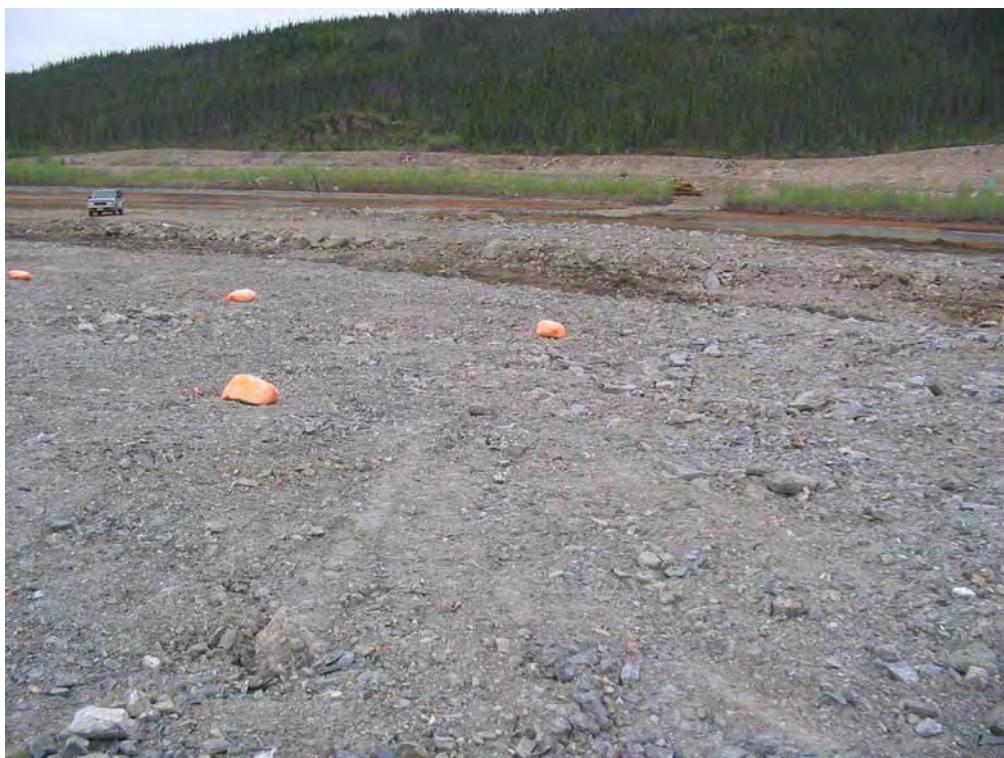
Figure 17. West test cover: Southern edge, from center of cover, showing minor equipment tracks.

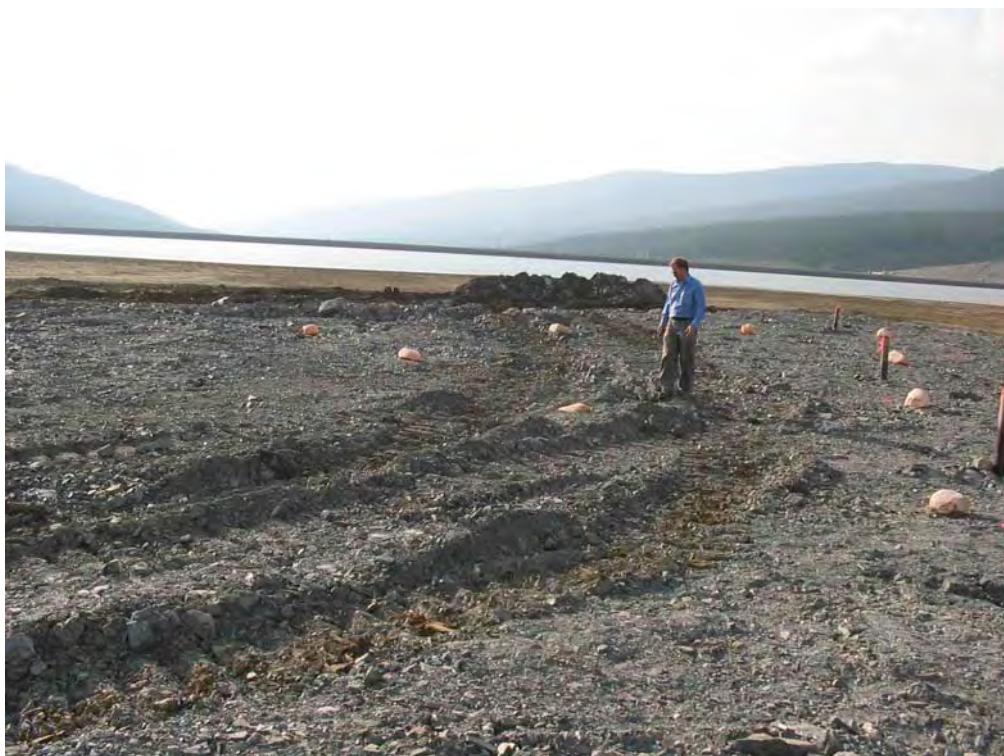
Figure 21. West test cover: Damage to surface of cover by equipment. Note disturbed marker stone in center.

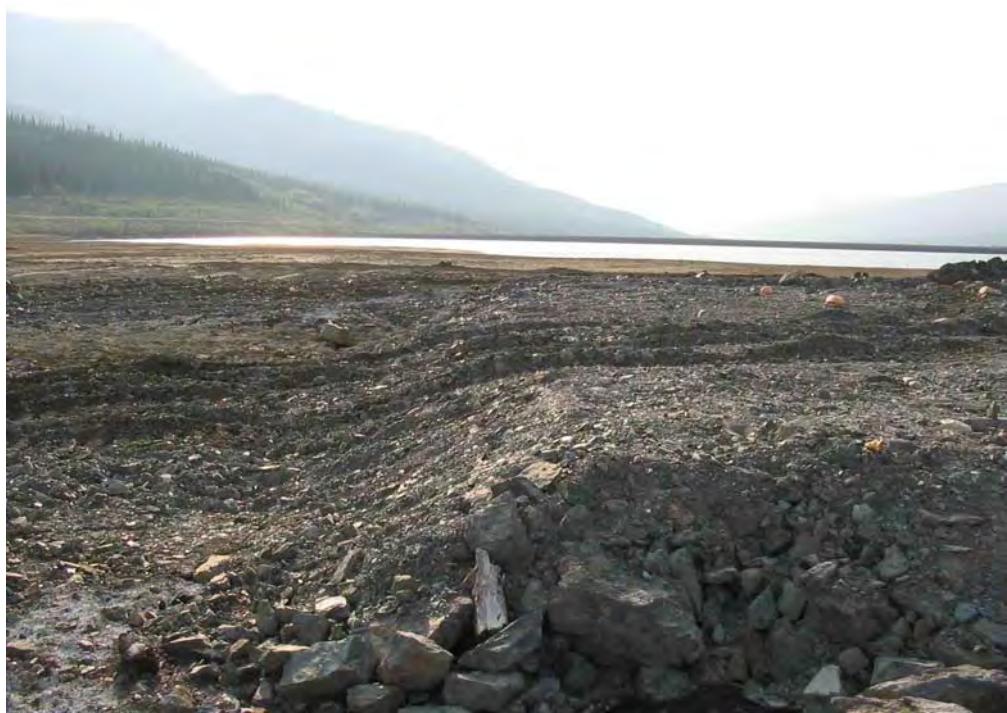
Figure 23. West test cover: Southern edge, showing damage from equipment.

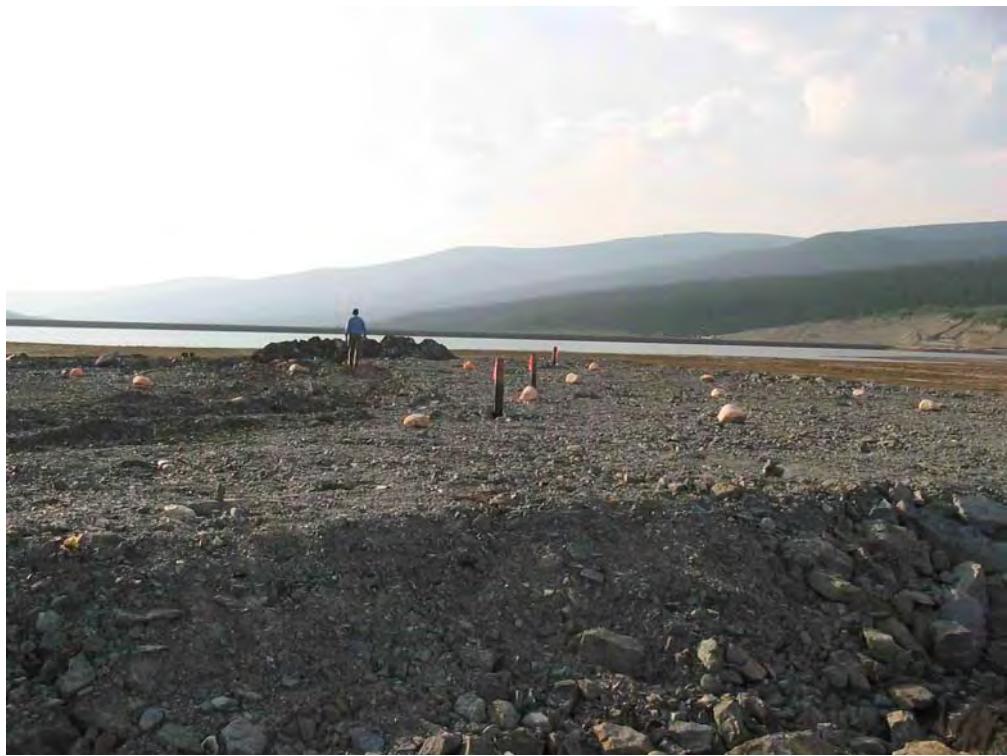
Figure 24. West test cover: Comparison of damaged SW and pristine NE portions of test cover.

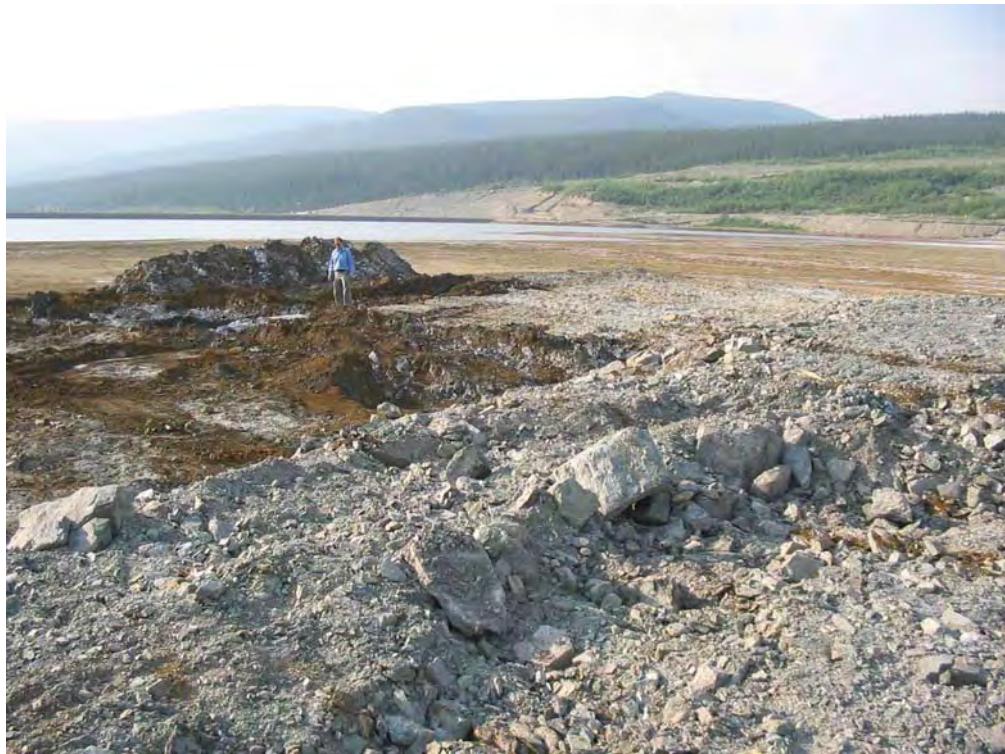
Figure 26. West test cover: Western edge and adjacent disturbed tailings.

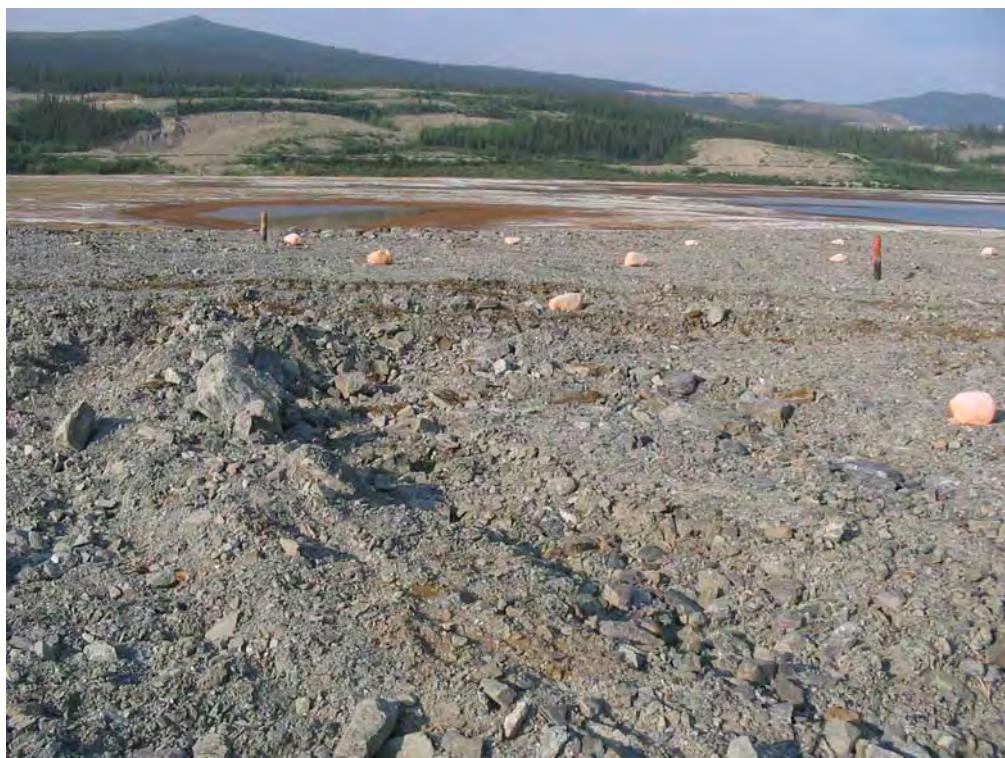
Figure 27. West test cover: Looking NE from SW corner, showing surface damage from equipment.

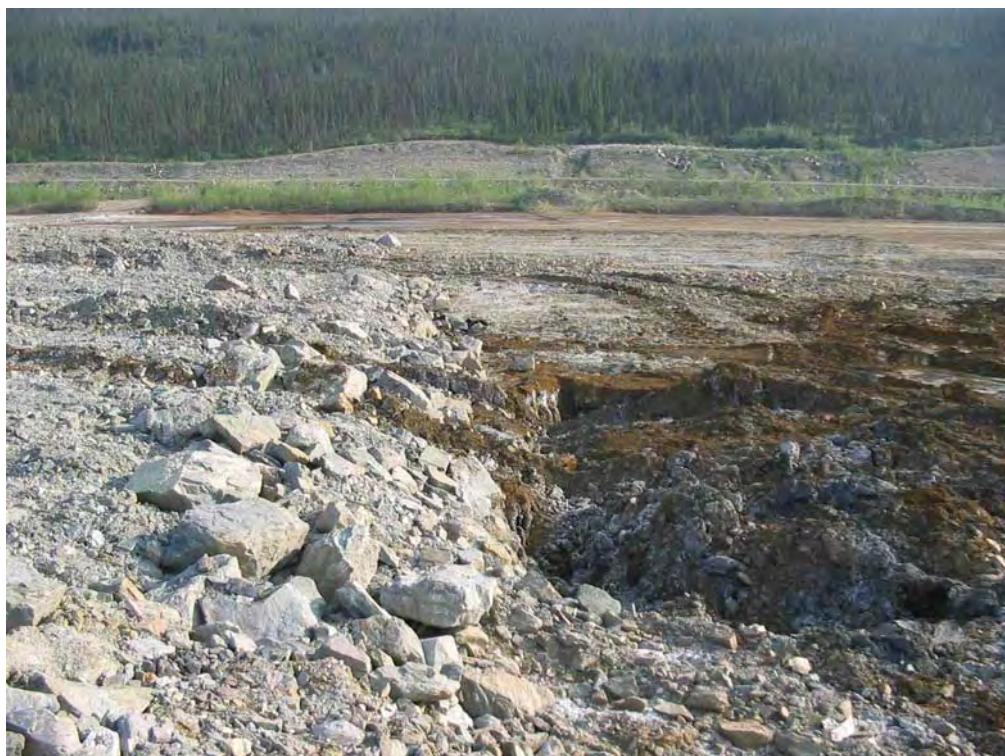
Figure 30. West test cover: Western edge, showing damage from equipment.

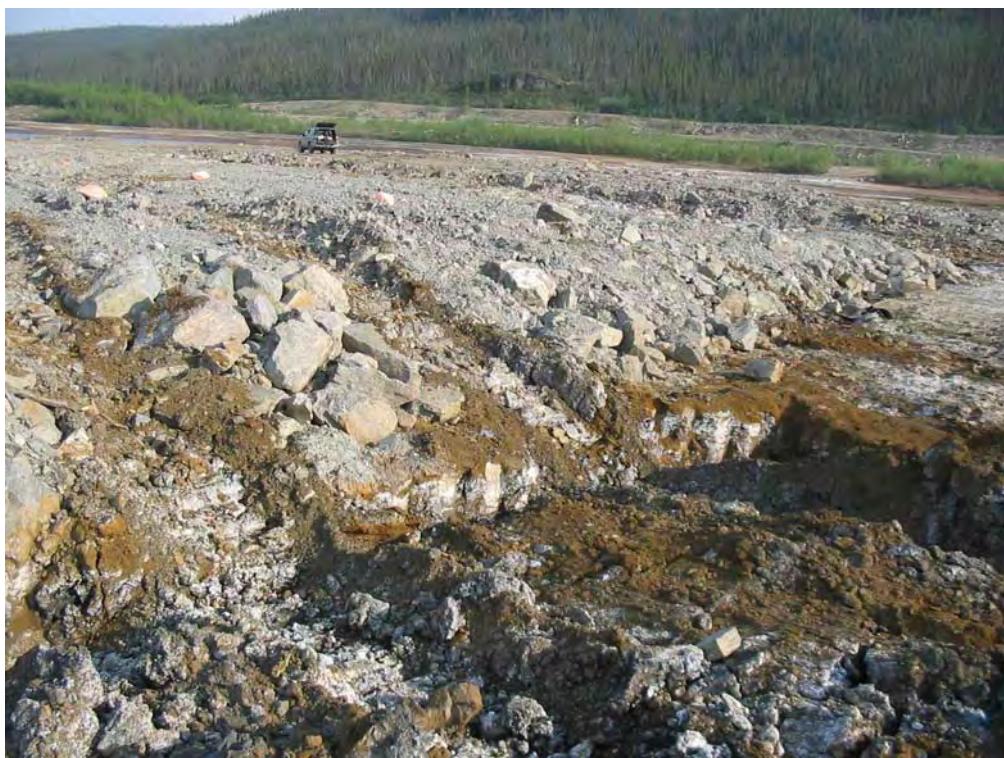
Figure 31. Western edge of west test cover showing equipment tracks in tailings and damage done to edge of cover by equipment.

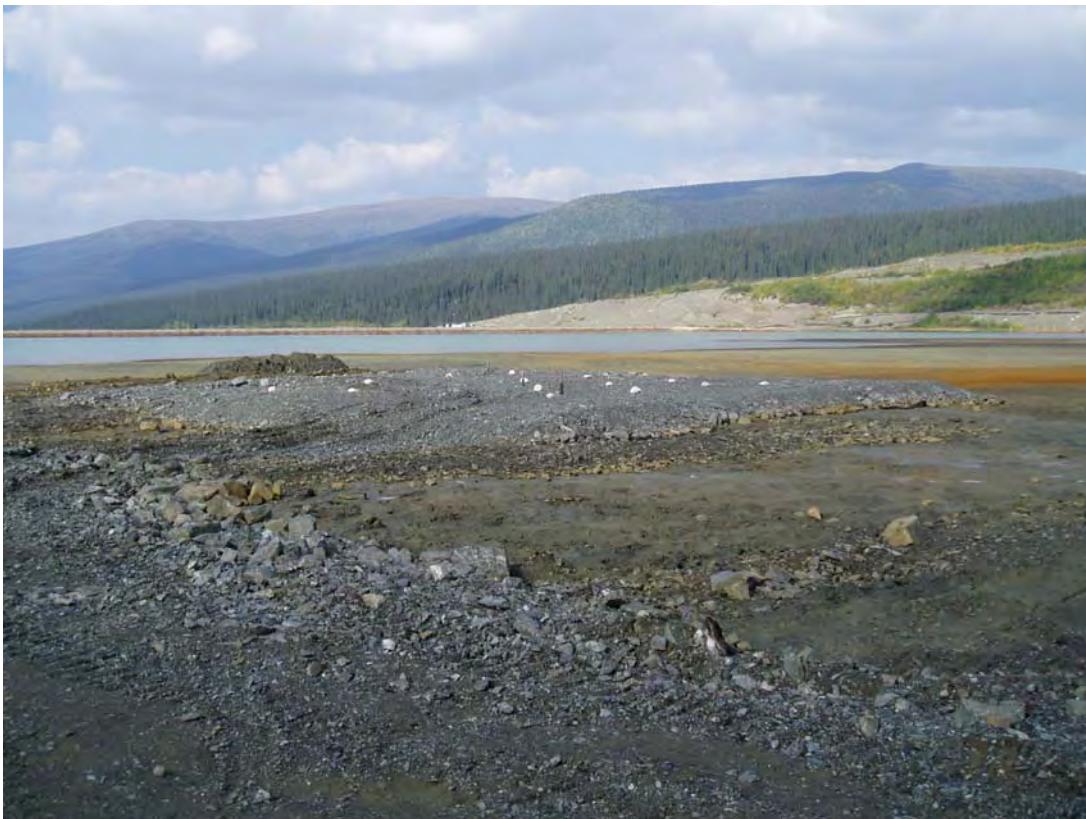
Photo 2: North-east view across the West Pad (including geotextile) surface. Note the dozer tracks leading onto the pad as a result of the excavator retrieval on June 17, 2004.

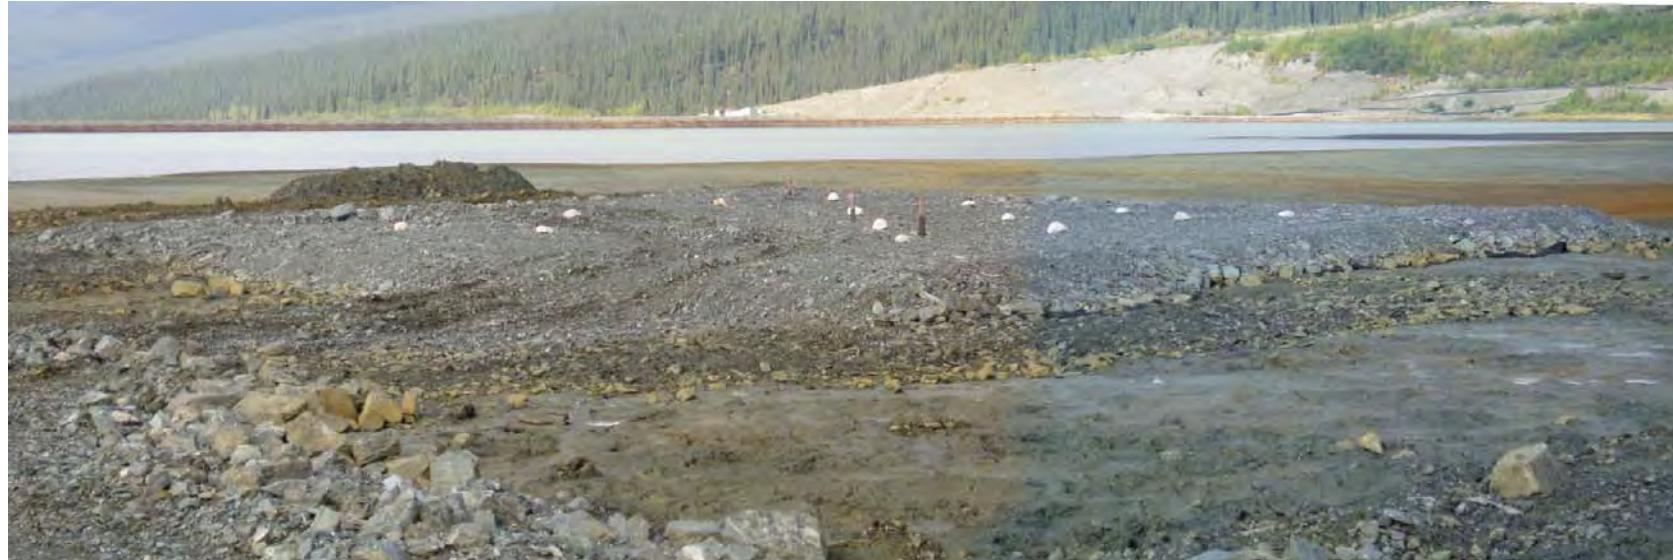
Photo 4: Panoramic view of the West Pad (including geotextile) from the south-west. Note the permanent pond in the background and the damage caused by the dozer in the foreground.

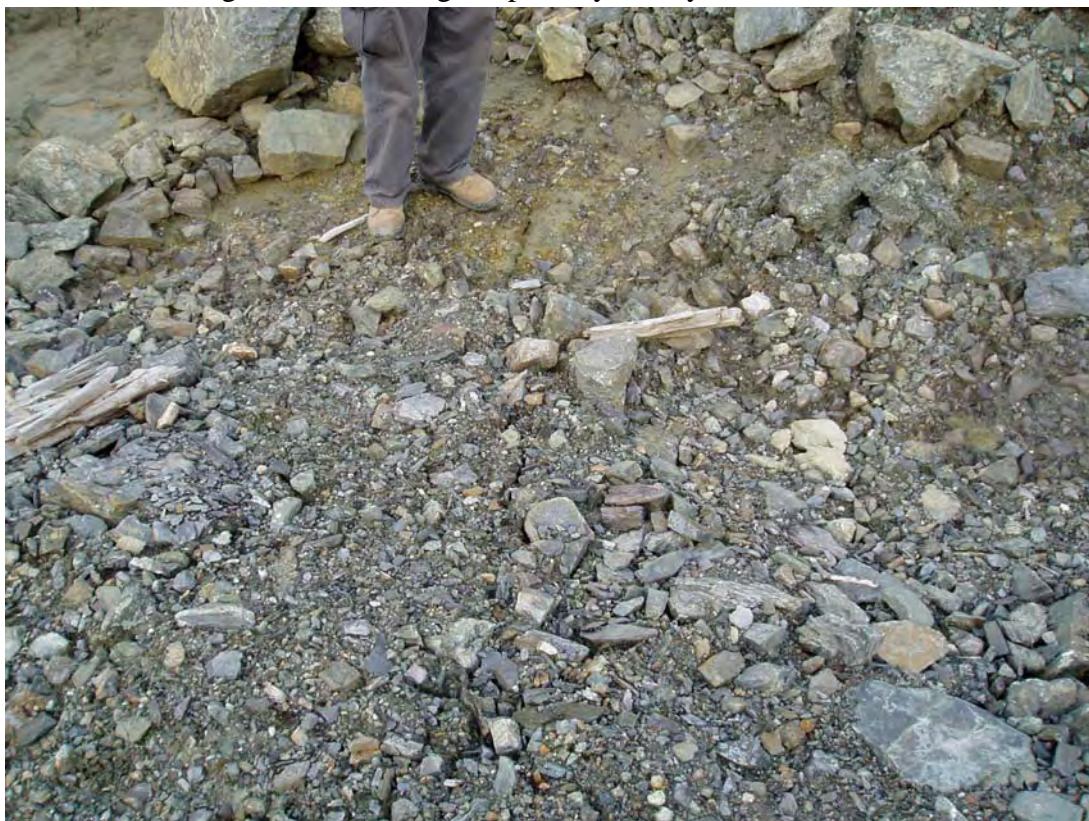
Photo 7: Close-up view of a crack on the corner of the East Pad. Note the crack continues from the tailings and on through the pad.

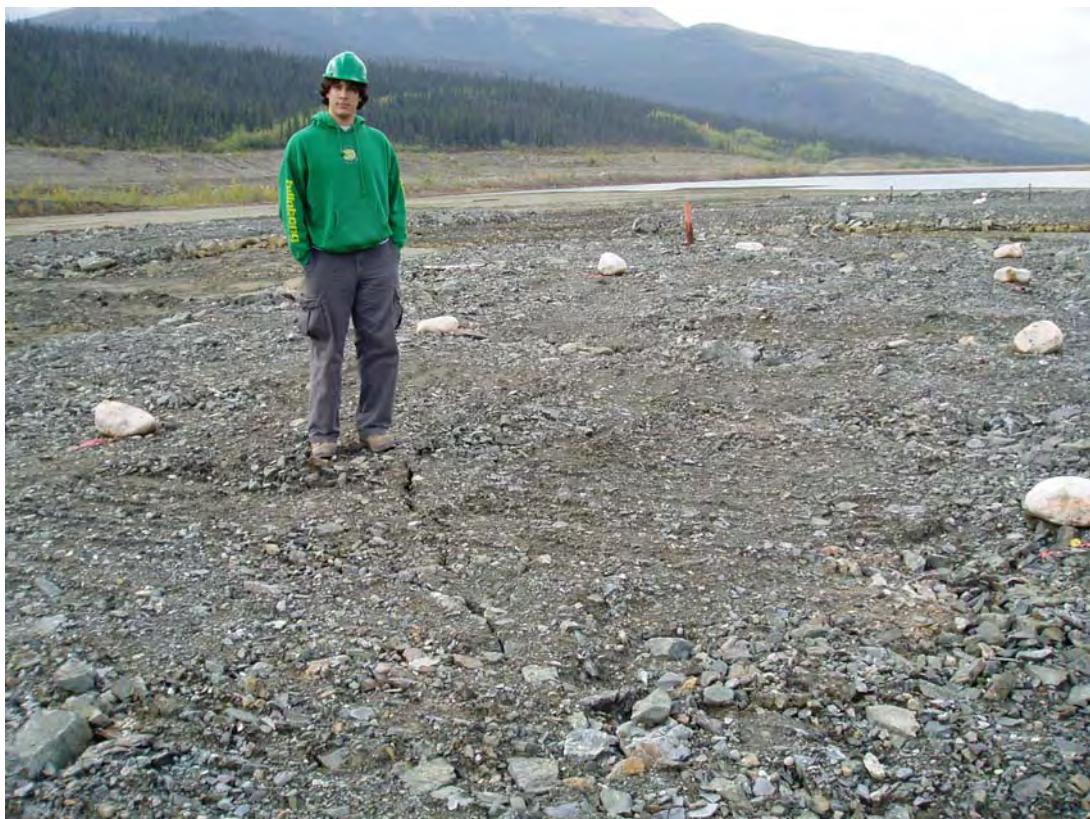
Photo 8: Close-up view of a crack on the surface of the East Pad. The crack is curved and measures approximately 5 m long, 10 to 20 mm wide and 10 to 100 mm deep.

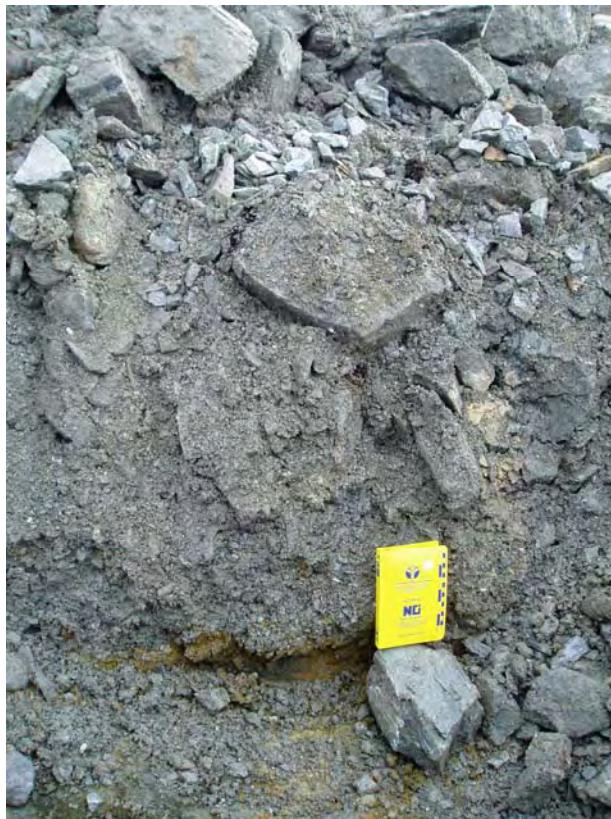
There is a definite mixed zone of tailings and cover material present at the base of the East Pad. However, there does not appear to be any indication of tailings fines physically migrating up beyond this zone. No material mixing has been observed for the West Pad, with the geotextile effectively separating the tailings and cover material.

Photo 1: TP-TTC-04-01 Profile of test pit showing the undulated interface between tailings and cover material where mixing has occurred.

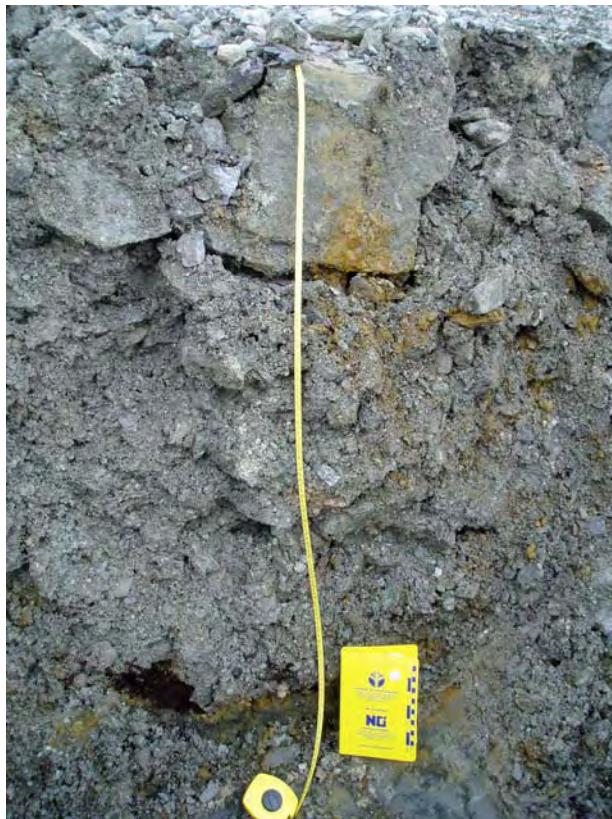
Photo 5: TP-TTC-04-02 Profile of test pit showing undulating bottom mixed zone.

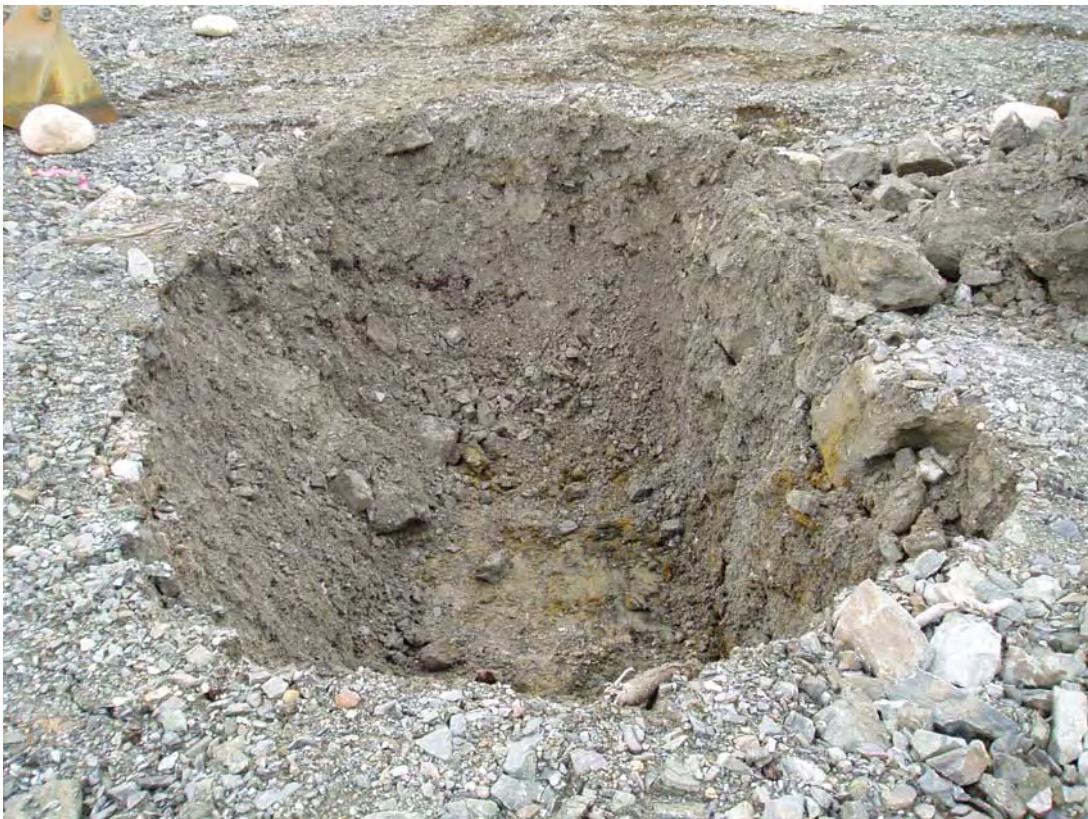
Photo 8: TP-TTC-04-02 Note the slope angle of the test pit walls. The material is very wet and the walls continuously caved in.

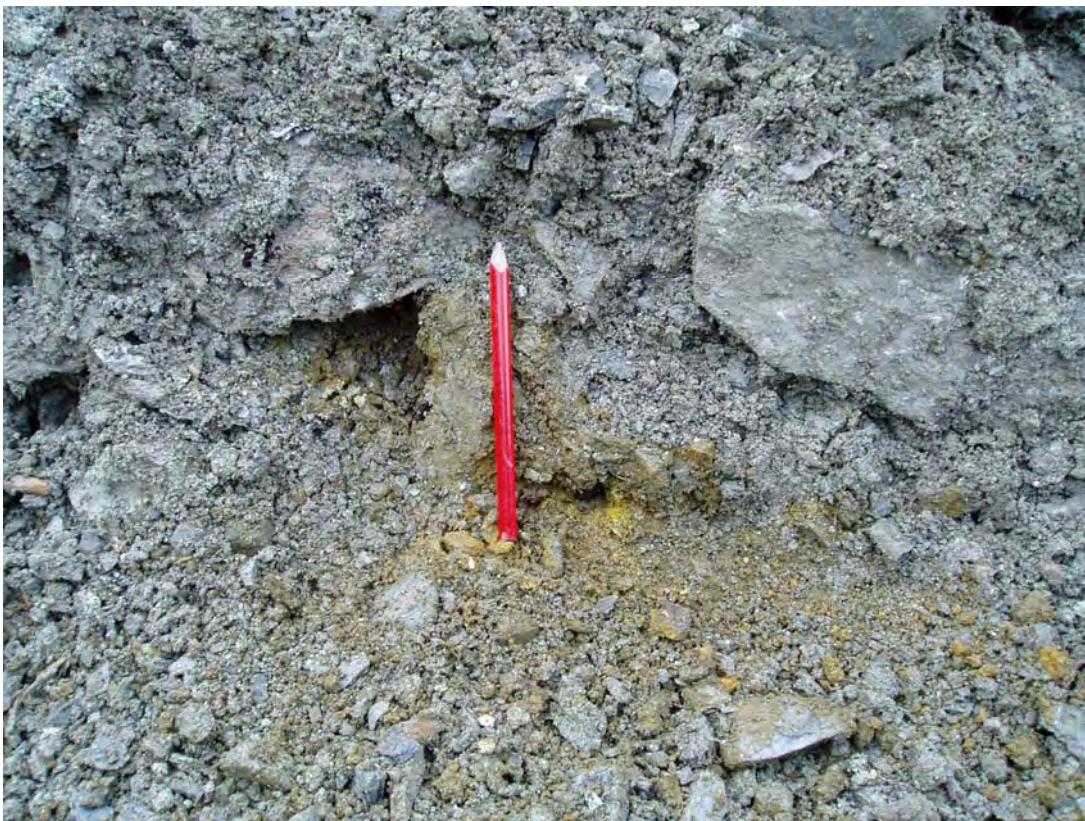
Photo 9: TP-TTC-04-03 Mixed zone of cover material and tailings of approximately 20 cm. The mixing appears to be dominated by larger boulders.

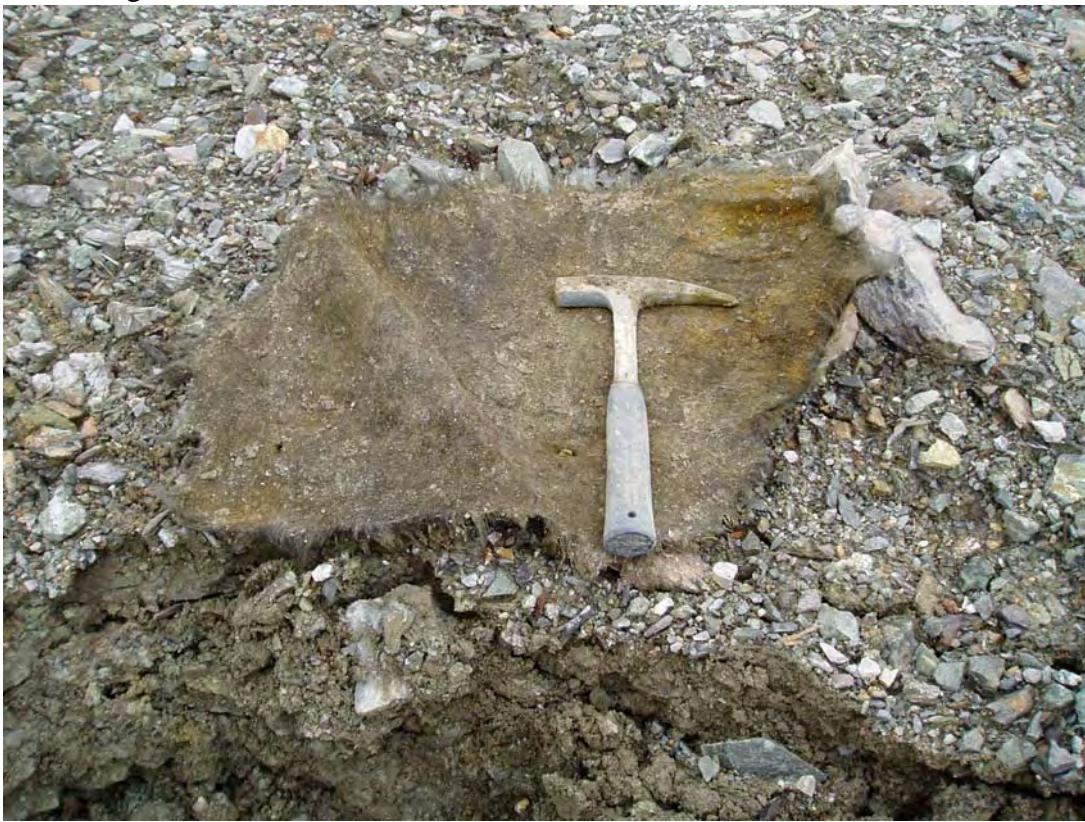
Photo 12: TP-TTC-04-04 The tailings has not migrated through the geotextile. Although both the tailings and the cover material were very wet, the geotextile was relatively dry.

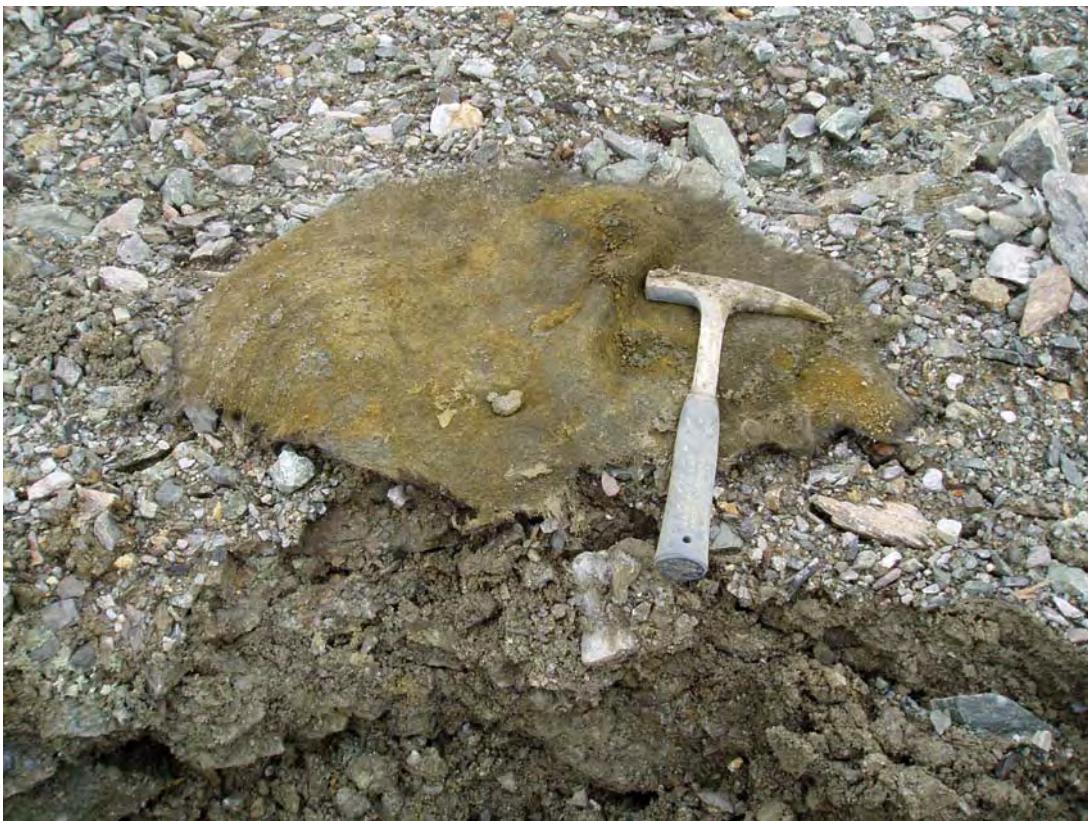
Photo 13: TP-TTC-04-04 The bottom of the geotextile is stained with tailings. It is possible that tailings is clogging the geotextile and subsequently slowing down the consolidation time.

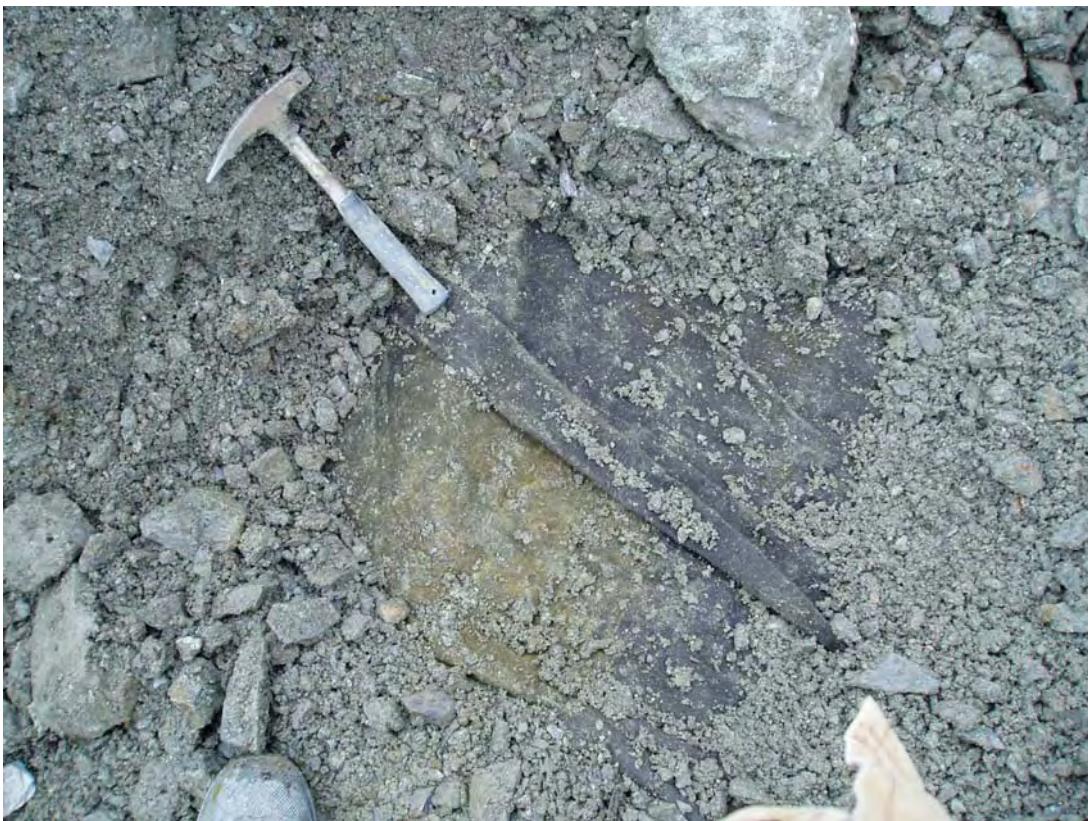
Photo 15: TP-TTC-04-05 Overlap section of the textile showing no signs of moving apart as a result of differential settlement. Also, no tailings are oozing through the seam opening.
