**Monitor Trial Covers at Rose
Creek Tailings Impoundment:
Task 16b**

Project Reference Number:
SRK 1CD003.058

November 2004

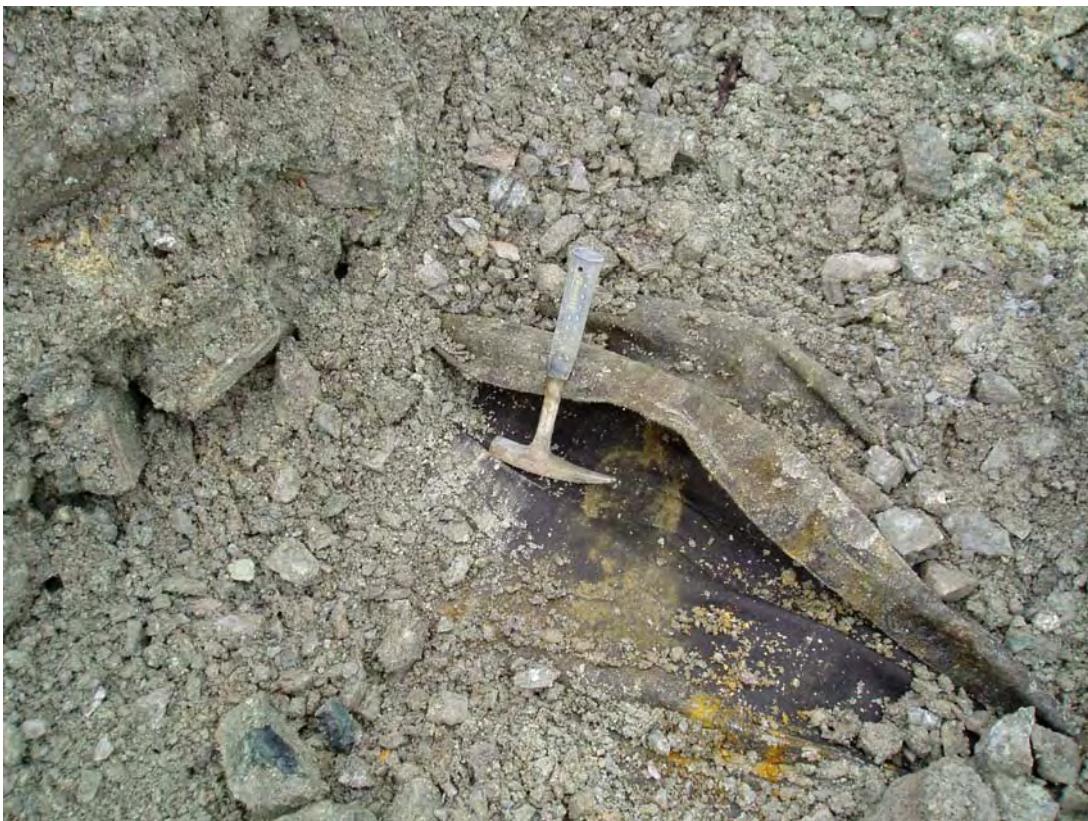
Photo 17: TP-TTC-04-06 Geotextile overlap showing no signs of tailings moving through the geotextile. The folds in the geotextile is as a result of rutting during construction caused by the trucks passing over the geotextile
