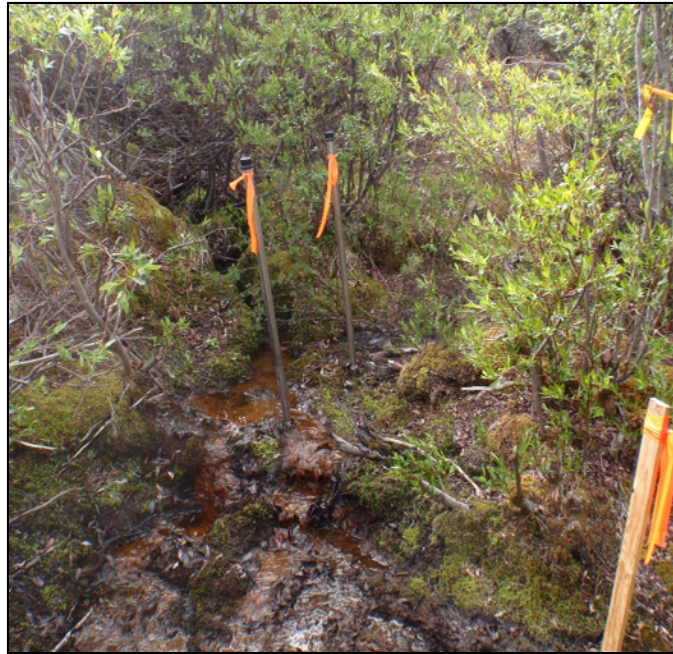
Photo 1: View of drive point wells GSI-DC-01A and GSI-DC-01B. Photo taken on June 26th, 2014.

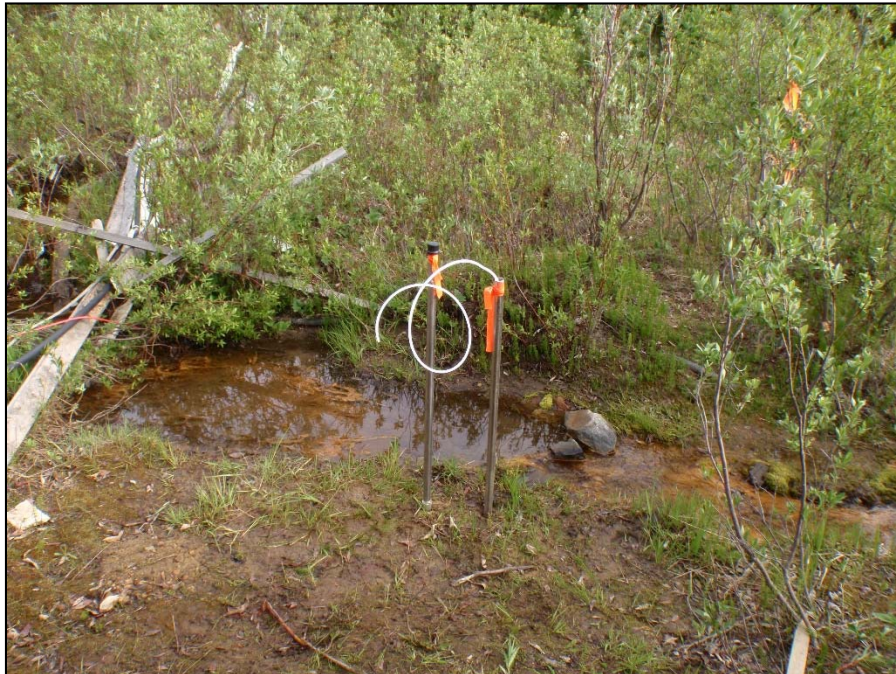
Photo 2: View of drive point wells GSI-DC-02A and GSI-DC-02B. Photo taken on June 27th, 2014.

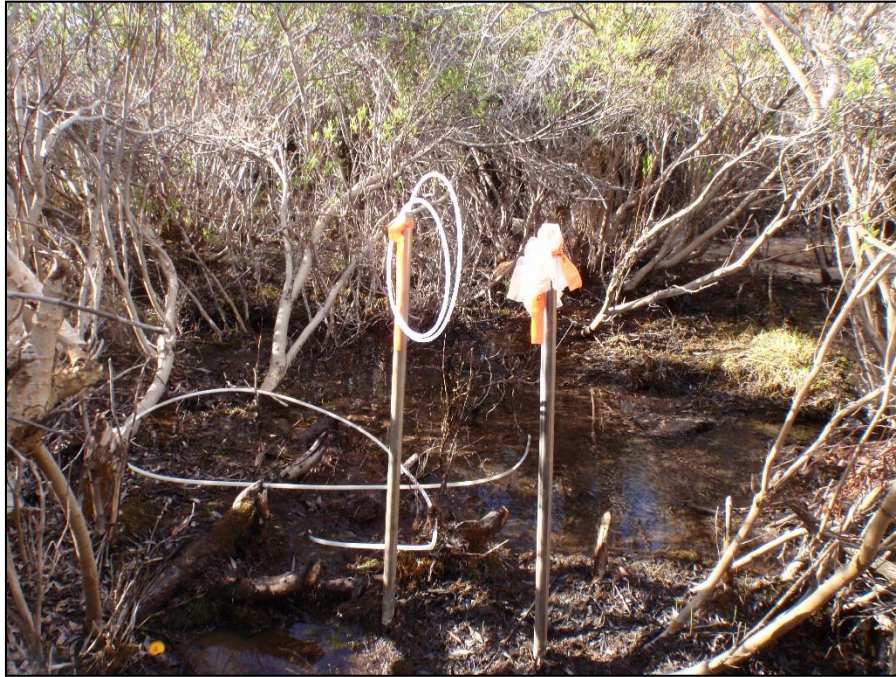
Photo 3: View of drive point wells GSI-DC-03A and GSI-DC-03B. Photo taken on June 27th, 2014.

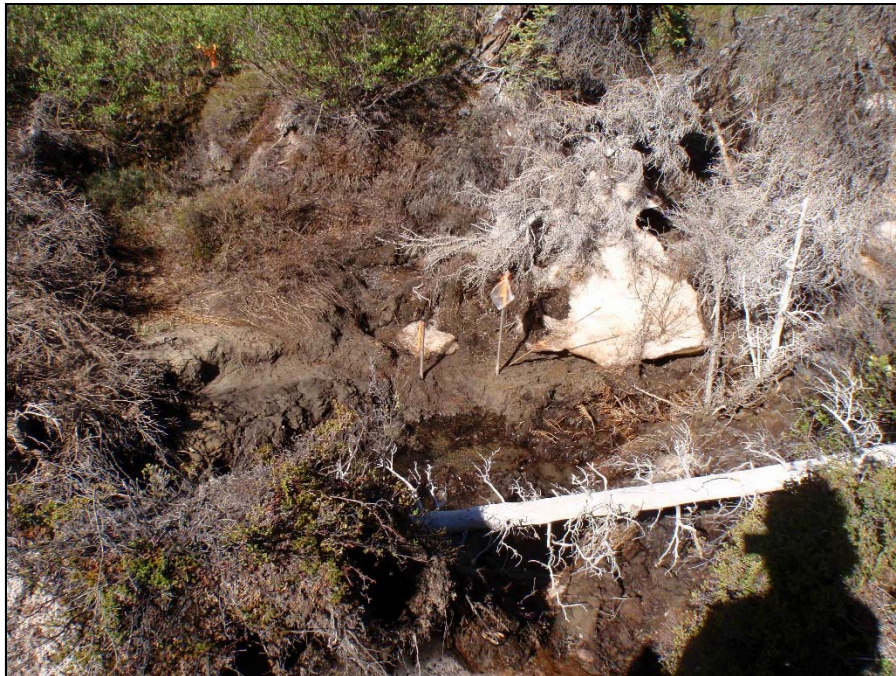
Photo 4: View of drive point wells GSI-DC-05A and GSI-DC-05B. Photo taken on June 27th, 2014.

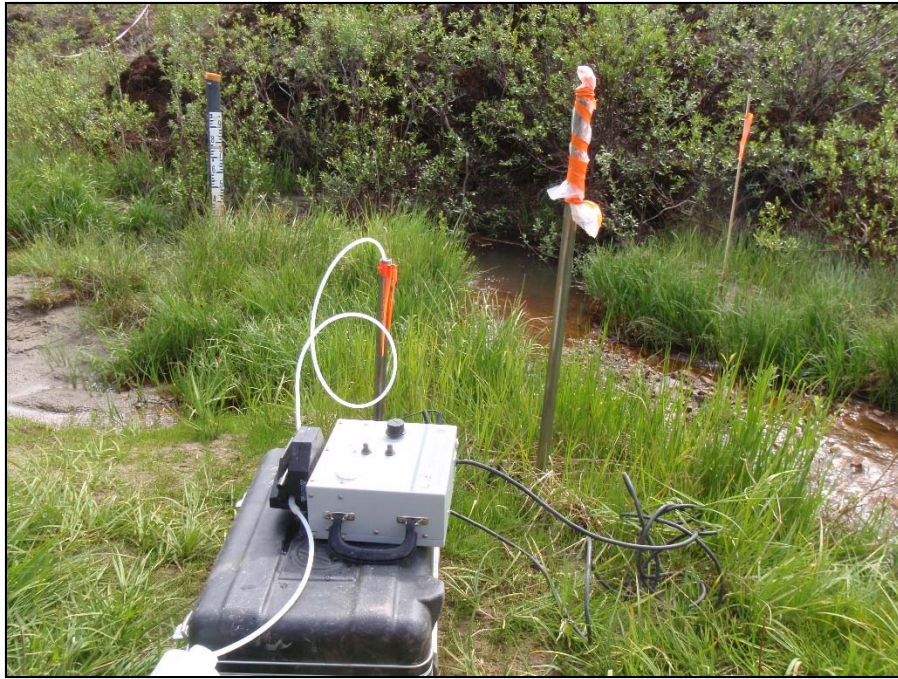
Photo 5: View of drive point wells GSI-DC-06A and GSI-DC-06B. Photo taken on June 29th, 2014.

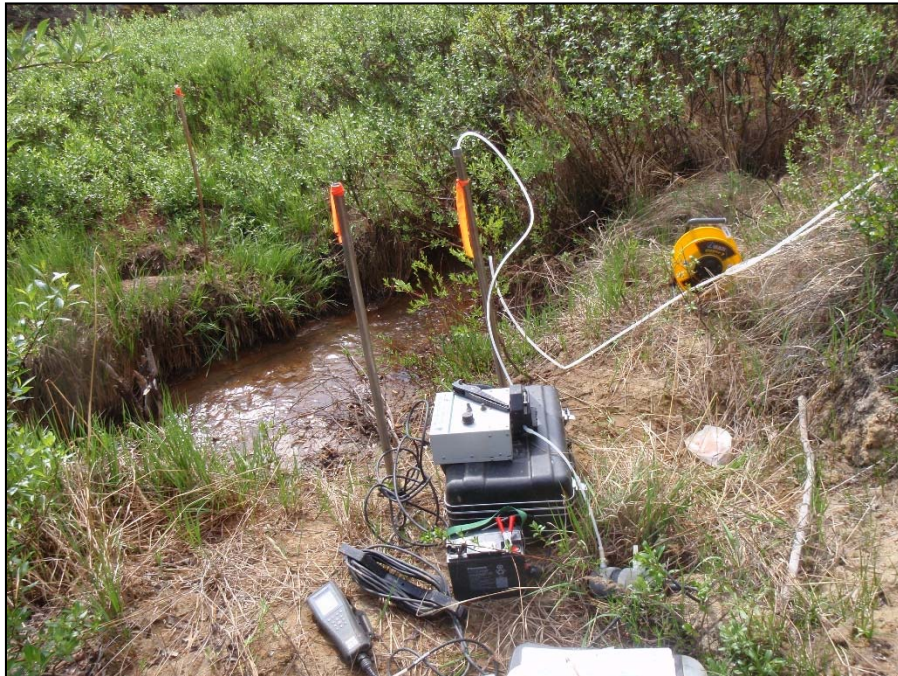
Photo 6: View of drive point wells GSI-DC-07A and GSI-DC-07B. Photo taken on June 29th, 2014.

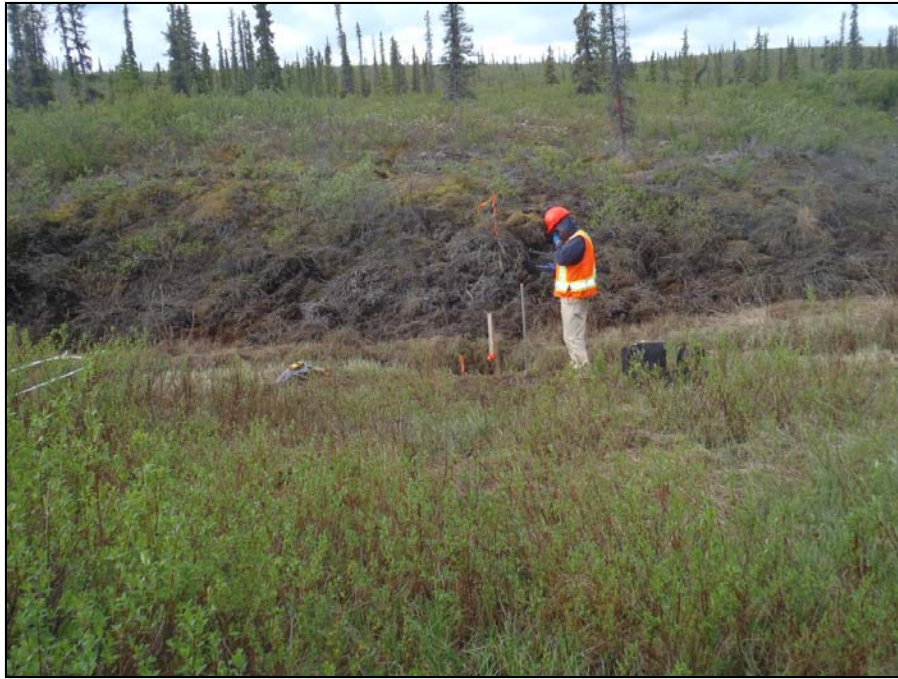
Photo 7: View of drive point wells GSI-DC-08A and GSI-DC-08B. Photo taken on June 29th, 2014.

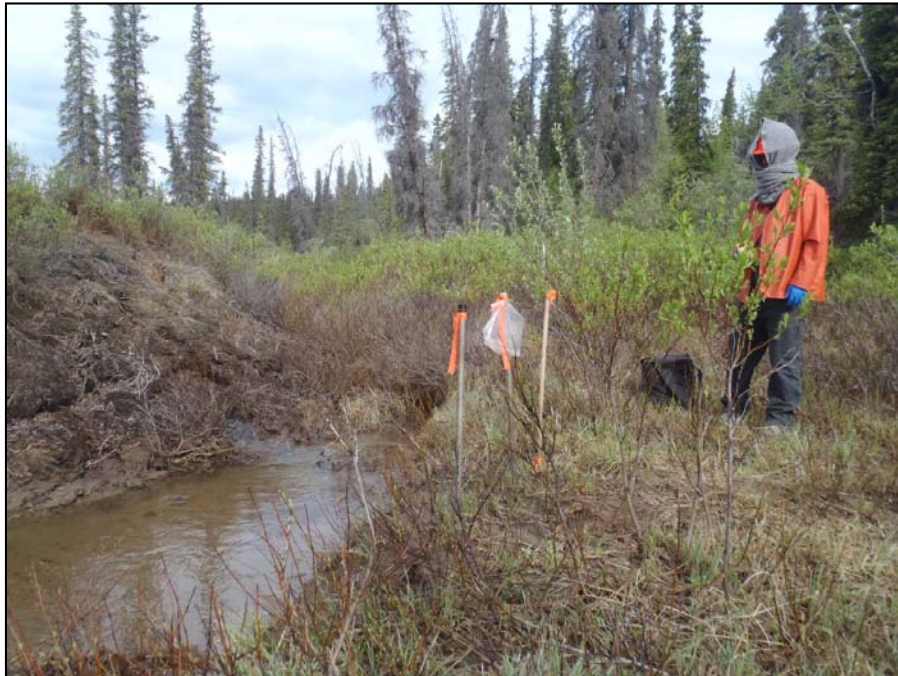
Photo 8: View of drive point wells GSI-DC-09A and GSI-DC-09B. Photo taken on June 29th, 2014.

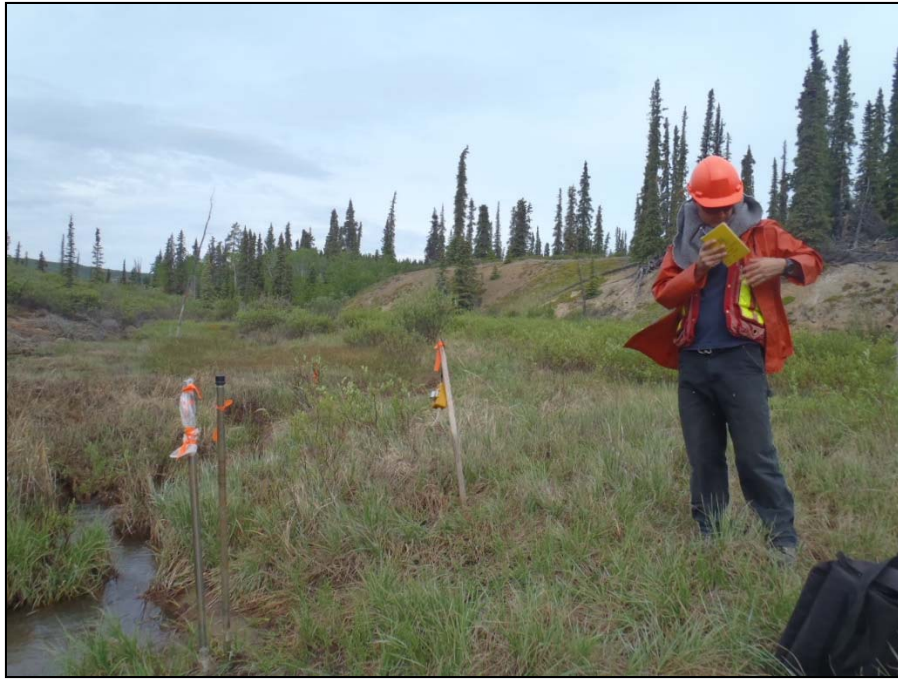
Photo 9: View of drive point wells GSI-DC-10A and GSI-DC-10B. Photo taken on June 29th, 2014.

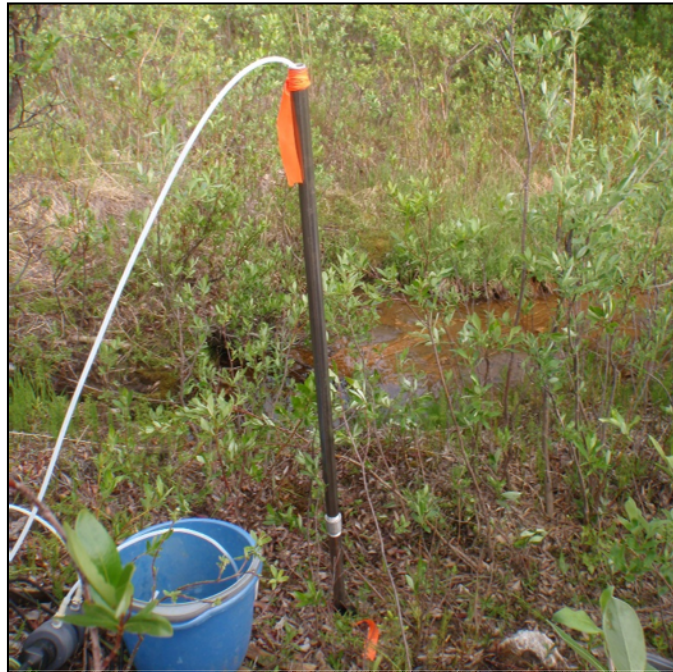
Photo 10: View of drive point well GSI-HA-01A. Photo taken on June 27th, 2014.

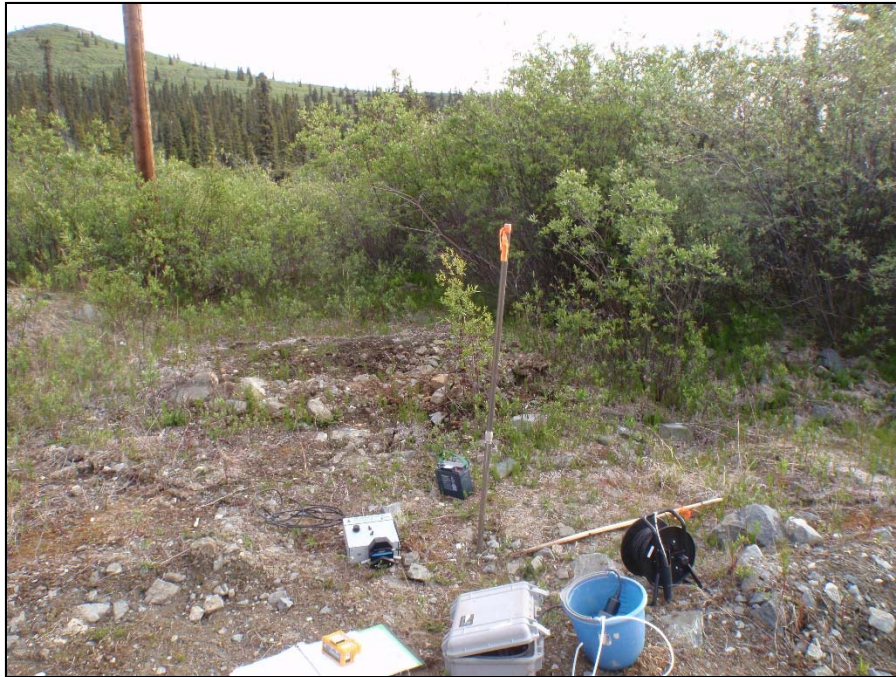
Photo 11: View of drive point well GSI-HA-02A. Photo taken on June 27th, 2014.

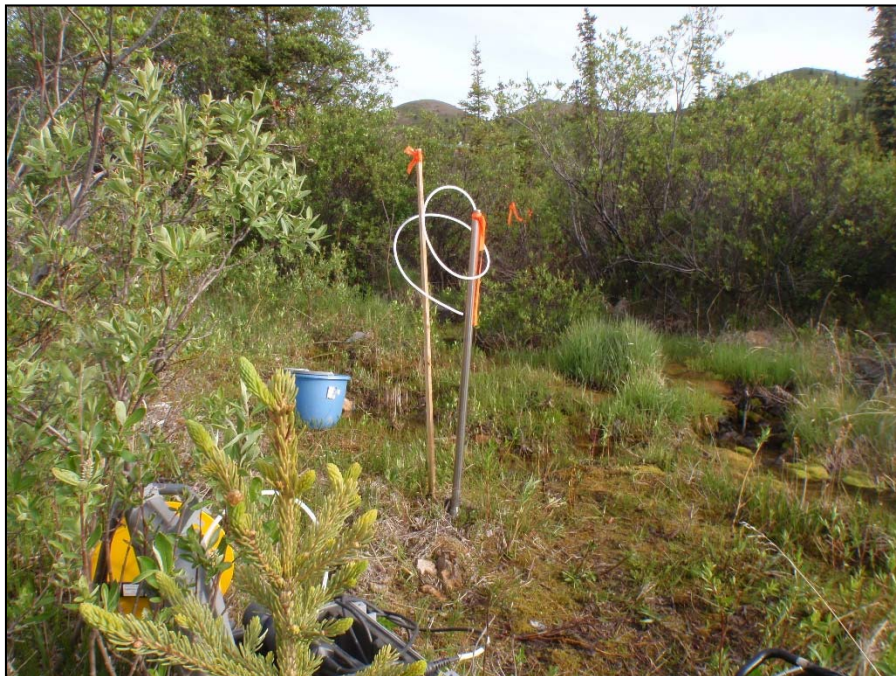
Photo 12: View of drive point well GSI-HA-03A. Photo taken on June 27th, 2014.

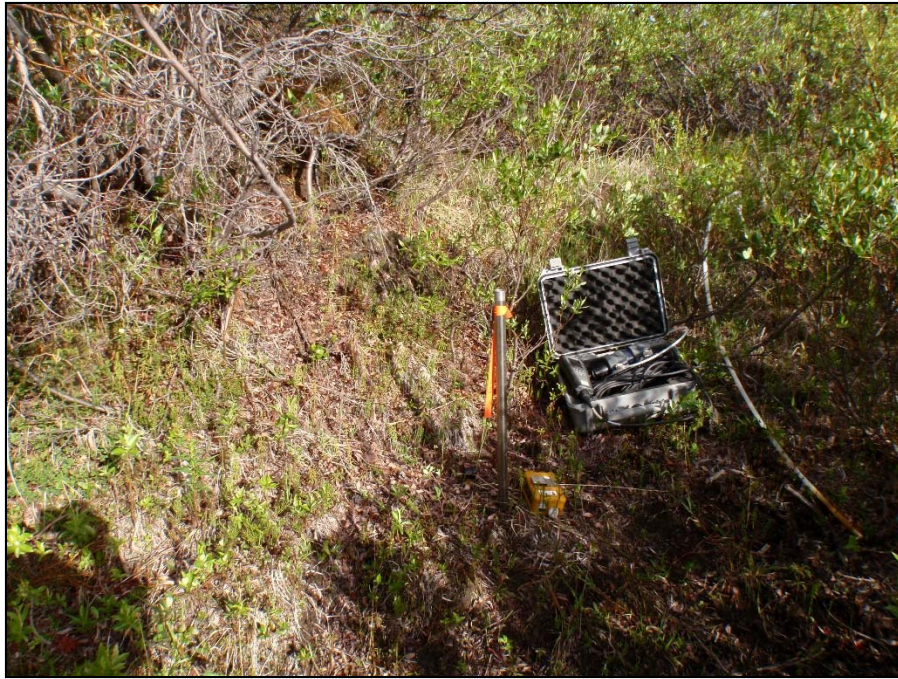
Photo 13: View of drive point well GSI-HA-04A. Photo taken on June 27th, 2014.

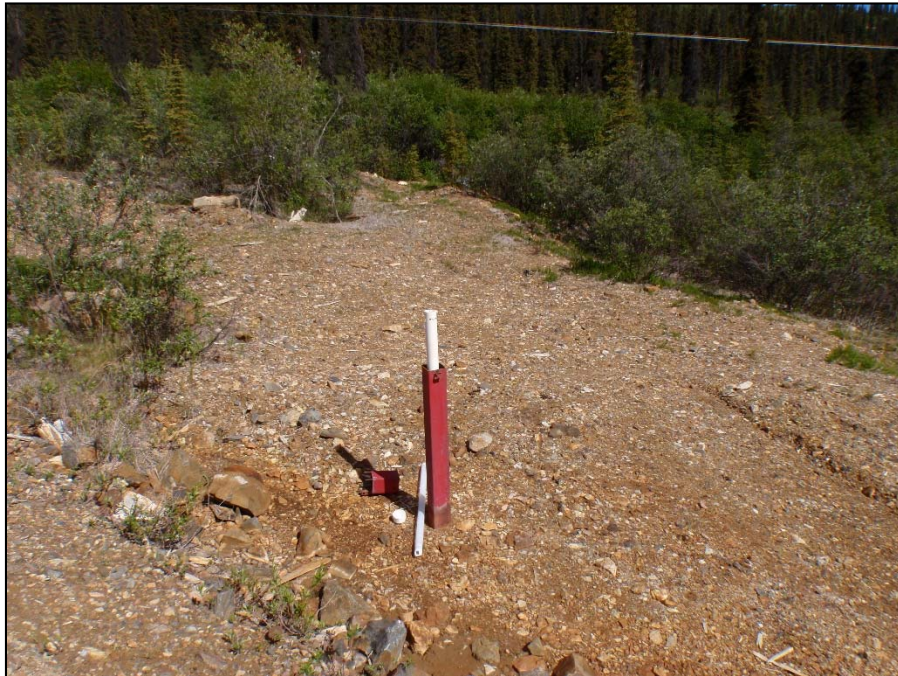
Photo 14: View of well MW09-16. Photo taken on June 26th, 2014.

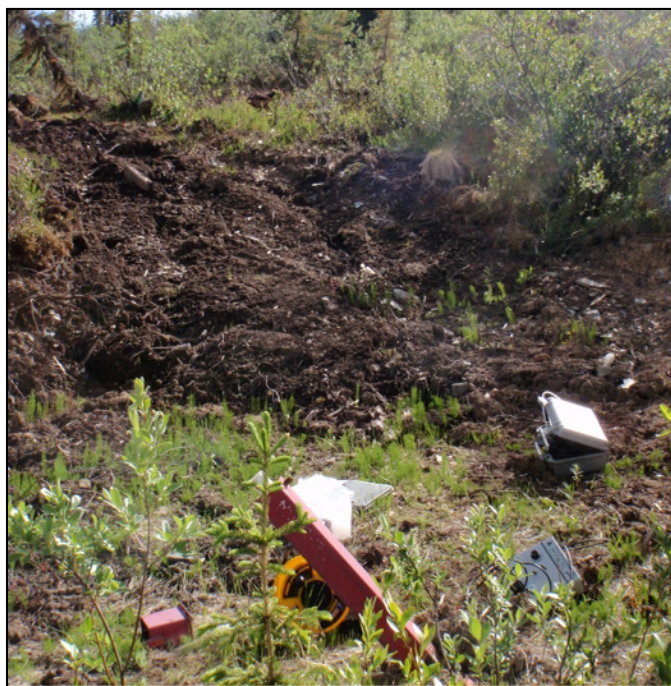
Photo 15: View of well MW09-17. Stick-up and steel monument broken upon arrival at site. Loose earth up earth above well suggests excavator could have damaged the well. Photo taken on June 26th, 2014.

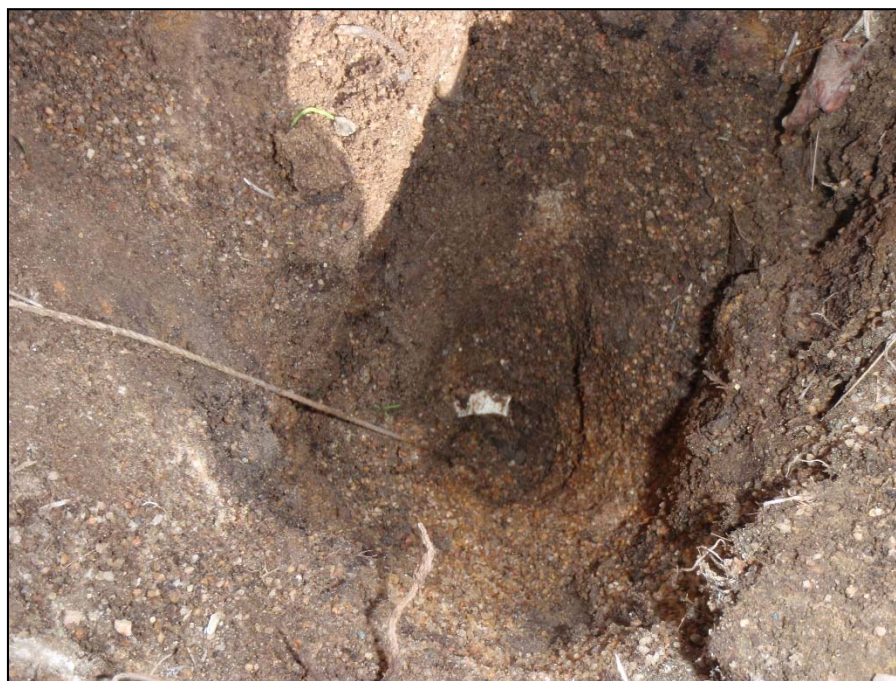
Photo 16: View of damaged well MW09-17. Existing bailer stuck in well due to large amount of soil that had fallen into well. Photo taken on June 26th, 2014.

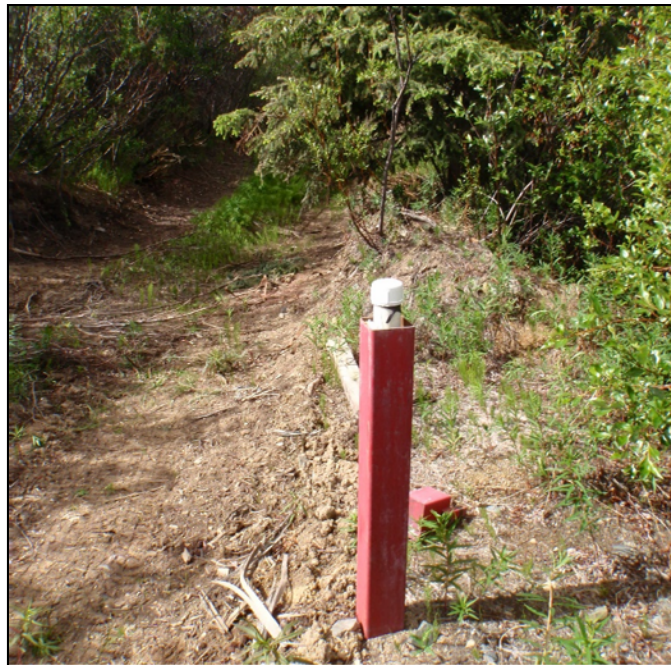
Photo 22: View of well MW09-18. Photo taken on June 26th, 2014.

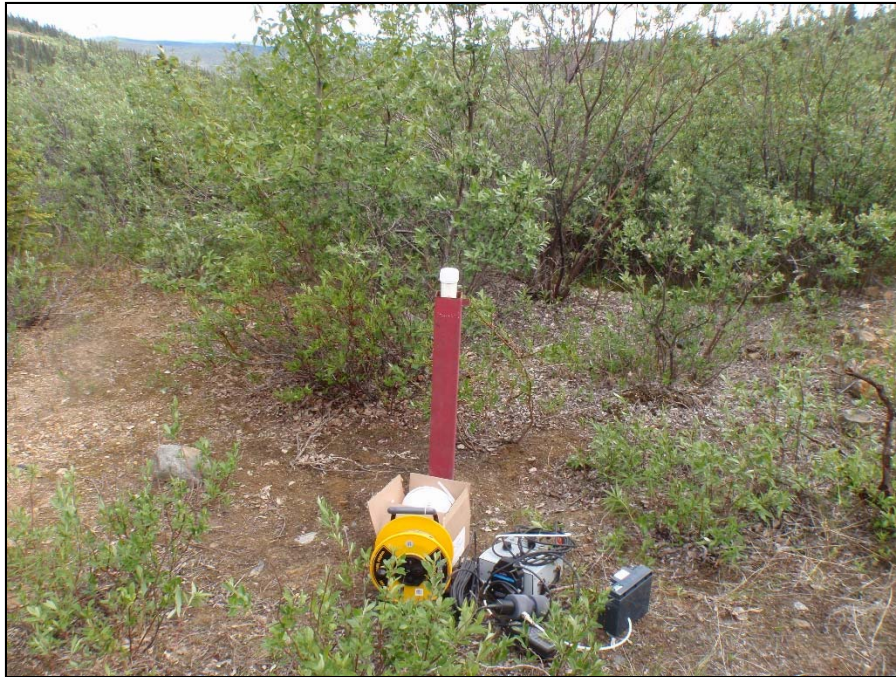
Photo 23: View of well MW09-19. Photo taken on June 26th, 2014.

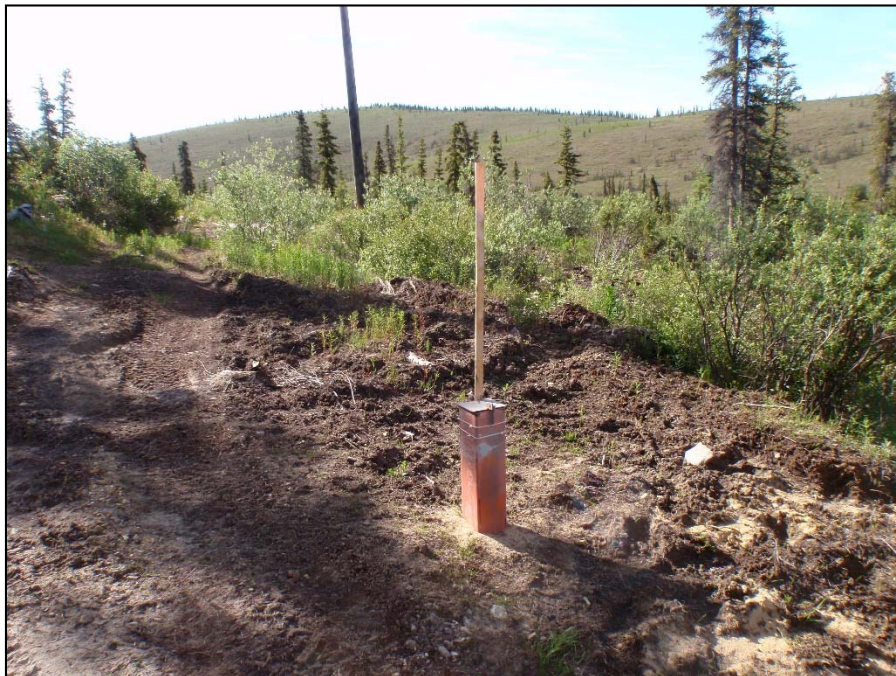
Photo 24: View of well CH-P-13-01. Photo taken on June 27th, 2014.

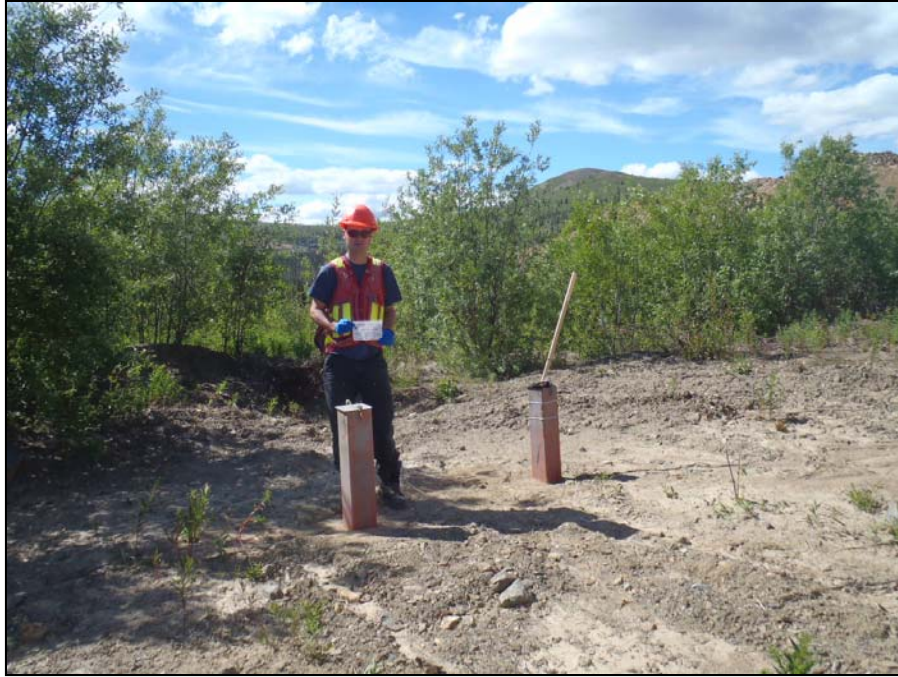
Photo 25: View of wells CH-P-13-03/10 and CH-P-13-03/50. CH-P-03/10 did not have a label on the well, however provided GPS coordinates show this well to be CH-P-03/10. Photos taken on June 27th, 2014.

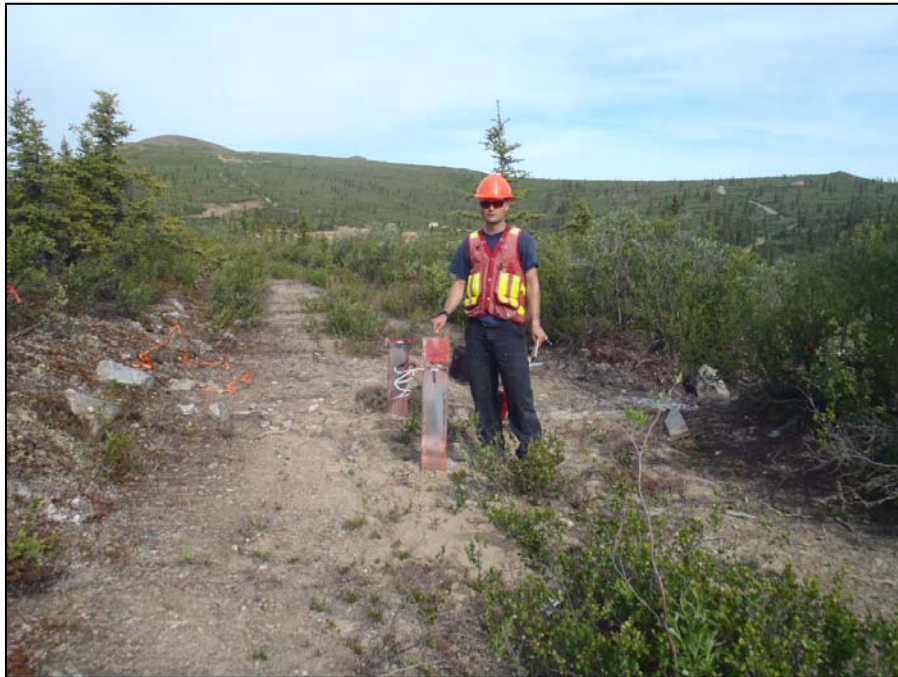
Photo 26: View of wells CH-P-13-04/10 and CH-P-13-04/35. Photo taken on June 28th, 2014.

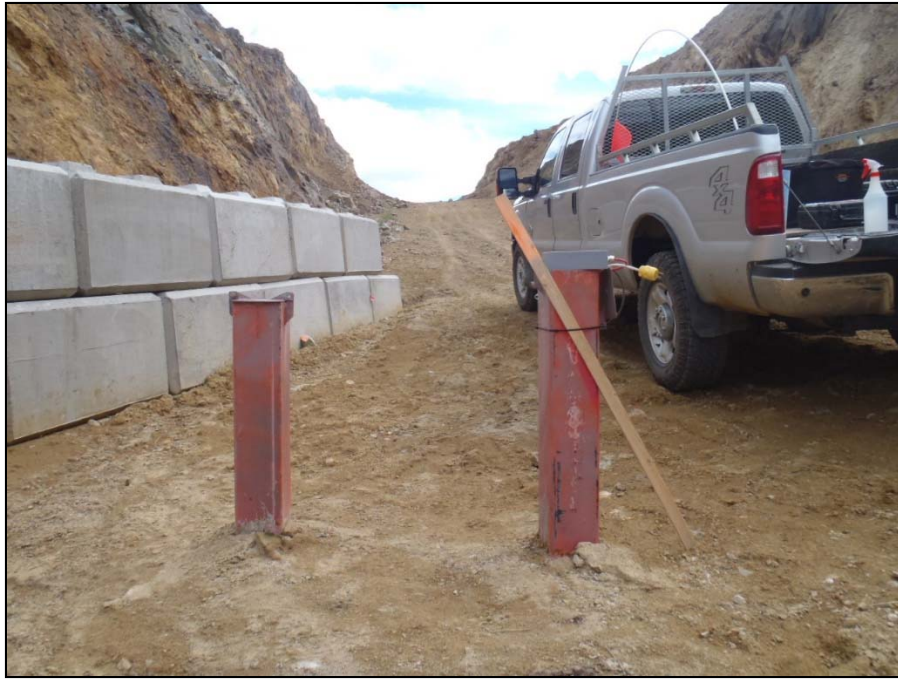
Photo 27: View of well CH-P-13-05/50. Photo taken on June 26th, 2014.

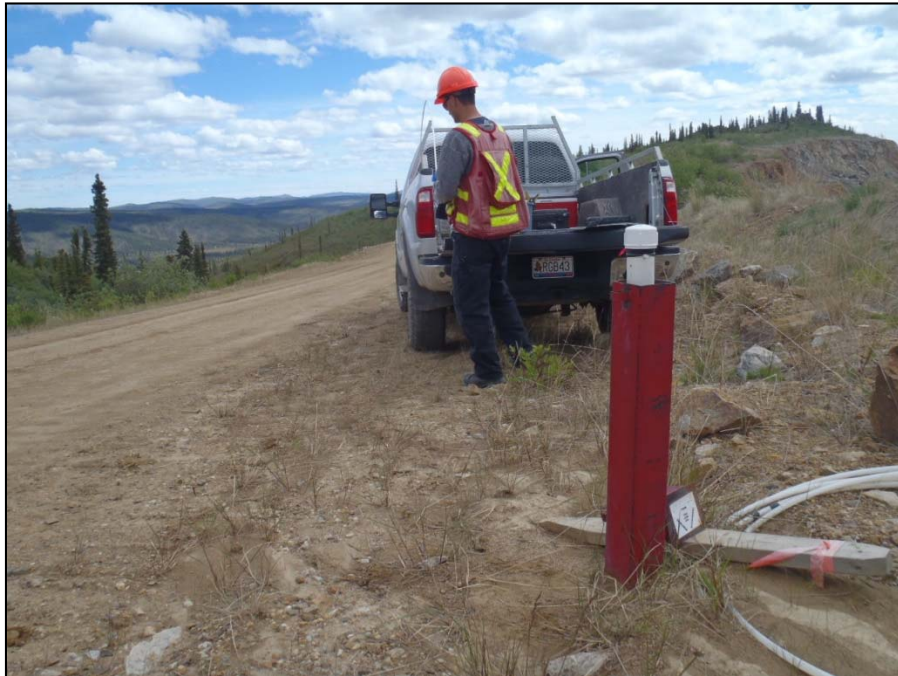
Photo 28: View of GLL07-01. Photo taken on June 26th, 2014.

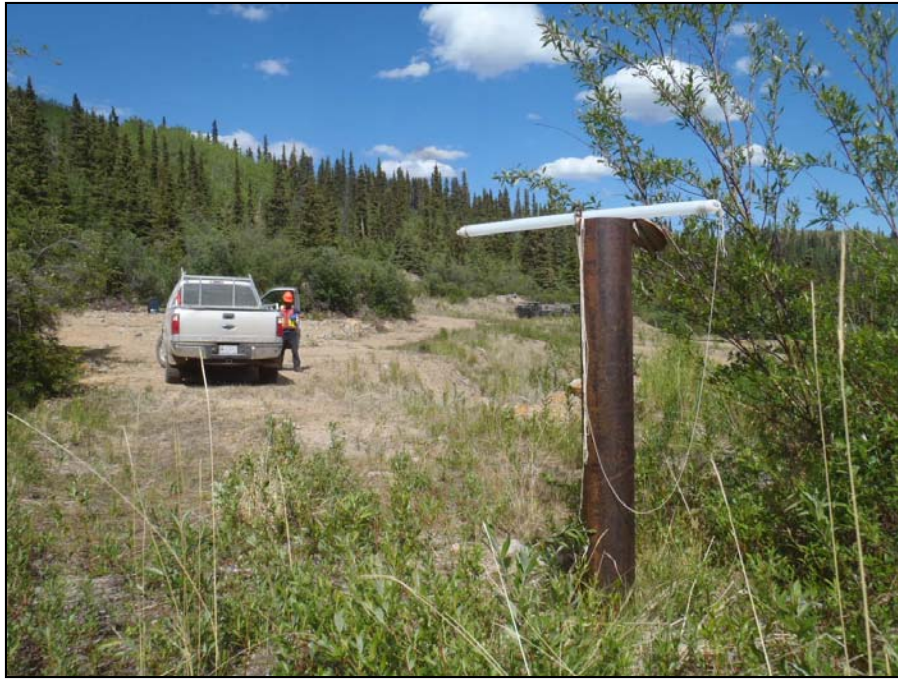
Photo 29: View of well GLL07-02. This well was found to be dry, but also had no proper stick-up inside steel monument. Photo taken on June 28th, 2014.

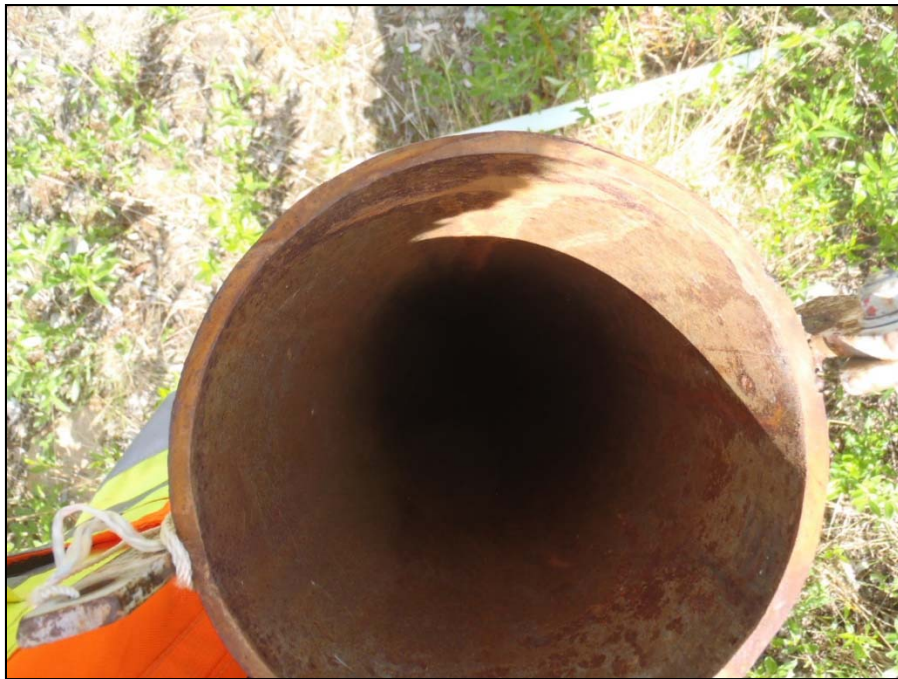
Photo 30: View of well GLL07-02 showing the absence of a stick-up. Photo taken on June 28th, 2014.

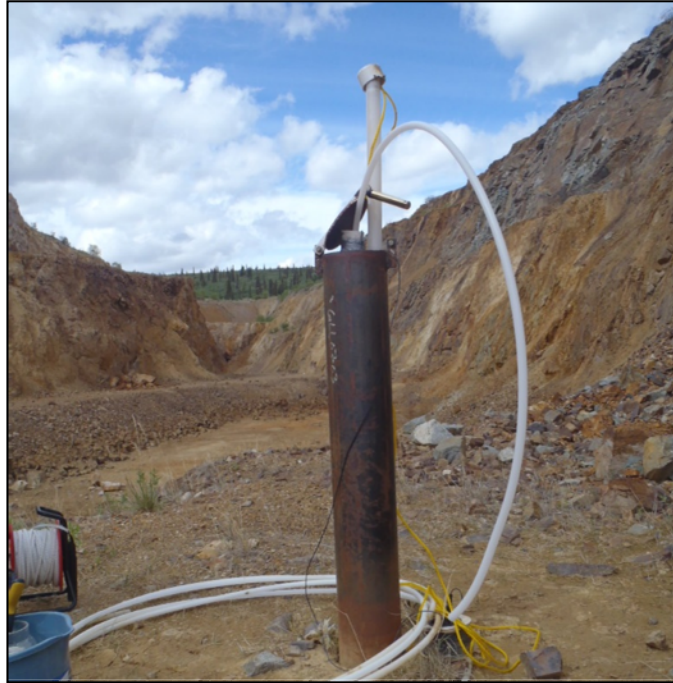
Photo 31: View of well GLL07-03. Photo taken on June 26th, 2014.

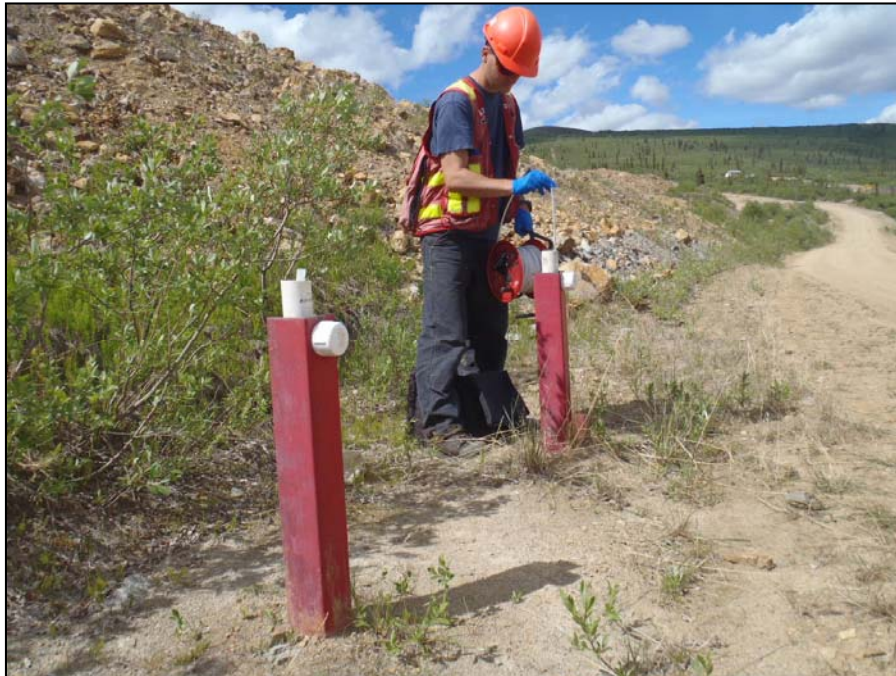
Photo 32: View of wells MW09-13 and MW09-14. Photo taken on June 27, 2014.

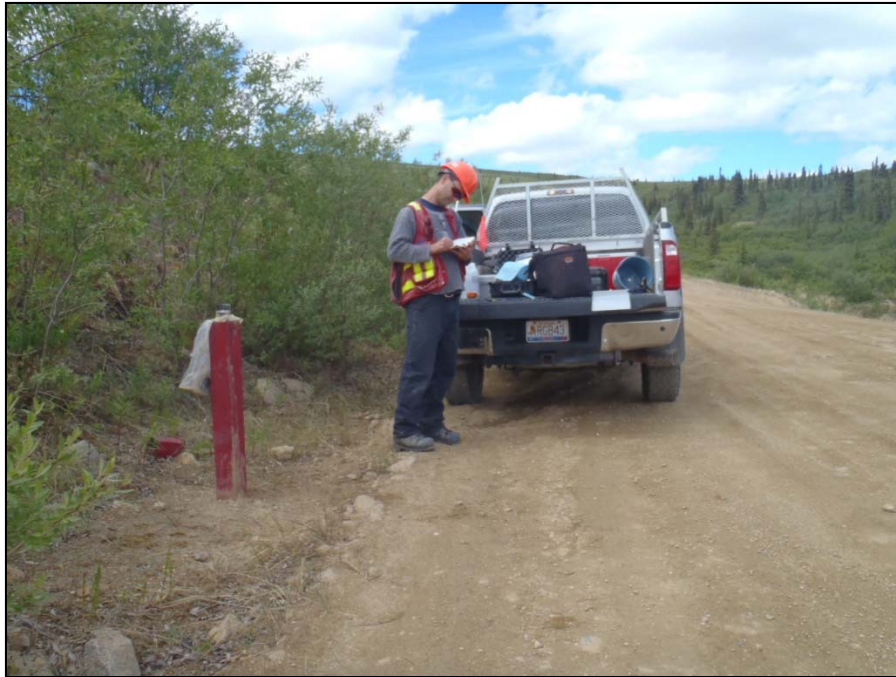
Photo 33: View of well MW09-15. Photo taken on June 26th, 2014.

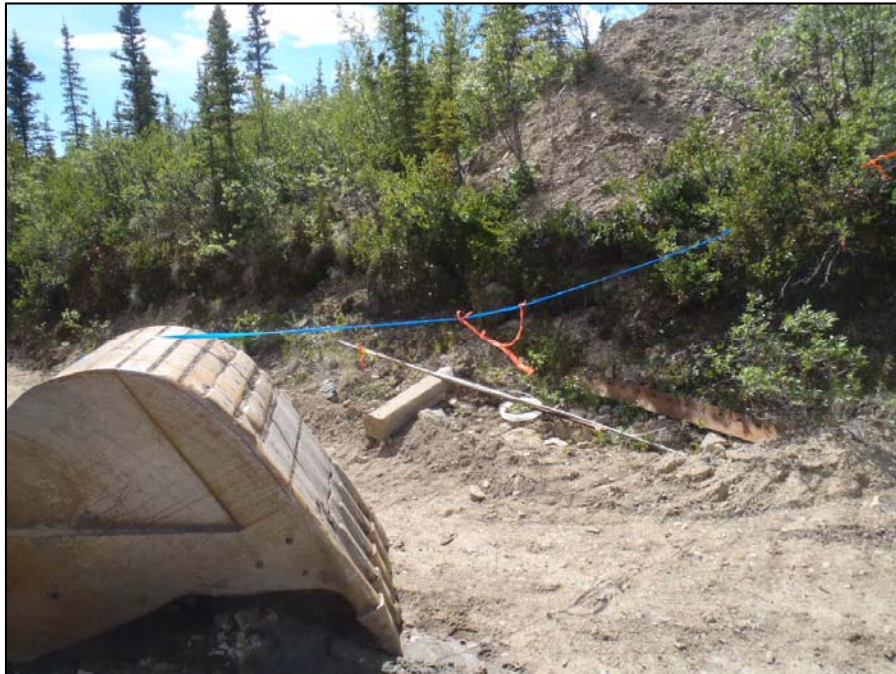
Photo 34: View of well GSI-PC-01A and GSI-PC-01B. Wells have been destroyed by excavator due to area being part of an active Placer Mine. Photo taken on June 27, 2014.

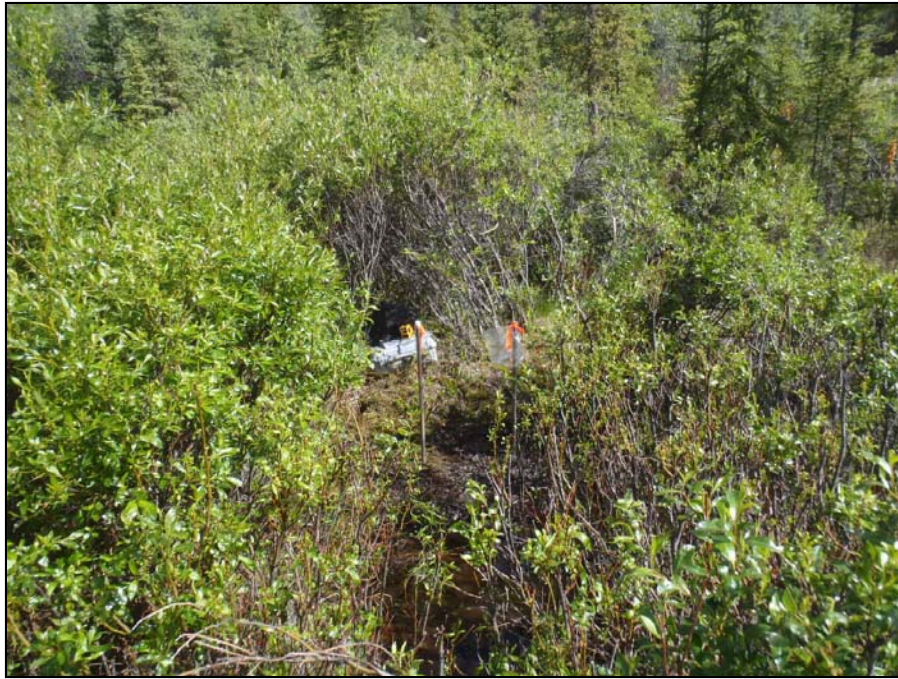
Photo 35: View of drive point wells GSI-PC-02A and GSI-PC-02B. Photo taken on June 27th, 2014.

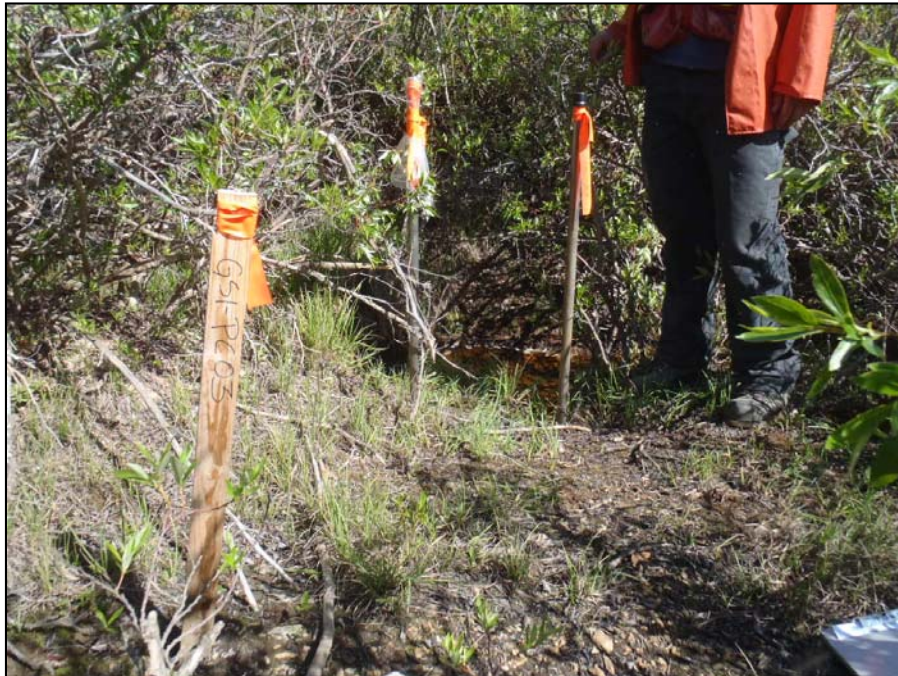
Photo 36: View of drive point wells GSI-PC-03A and GSI-PC-03B. Photo taken on June 28th, 2014.

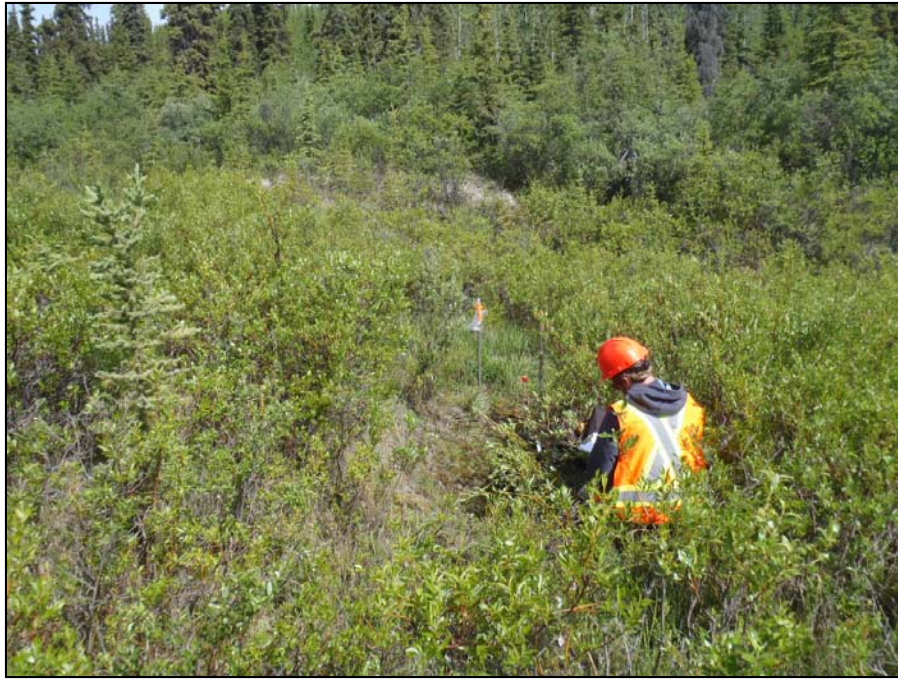
Photo 37: View of drive point wells GSI-PC-04A and GSI-PC-04B. Photo taken on June 28th, 2014.

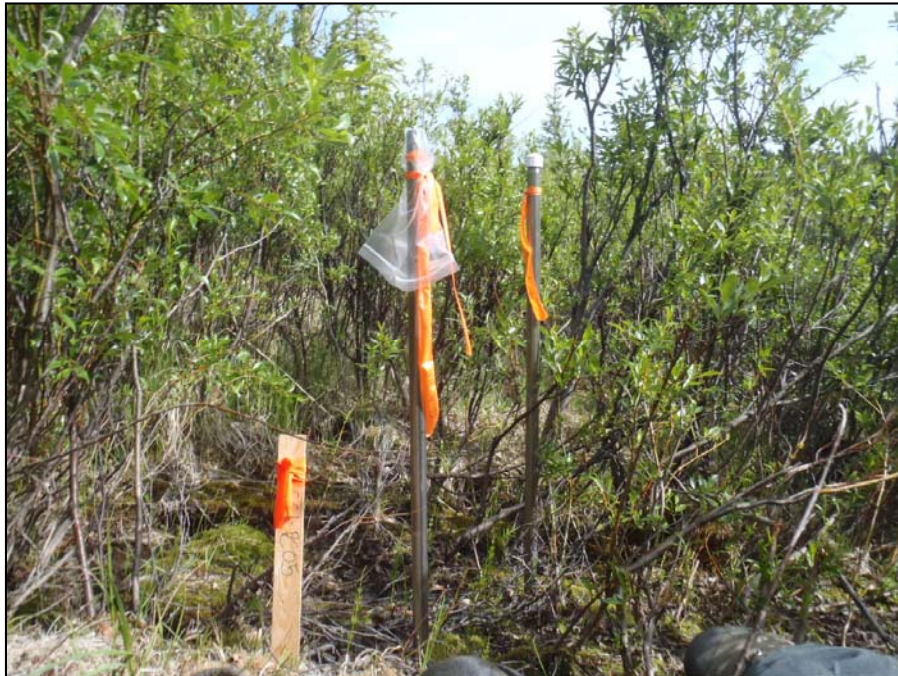
Photo 38: View of drive point wells GSI-PC-05A and GSI-PC-05B. Photo taken on June 28th, 2014.

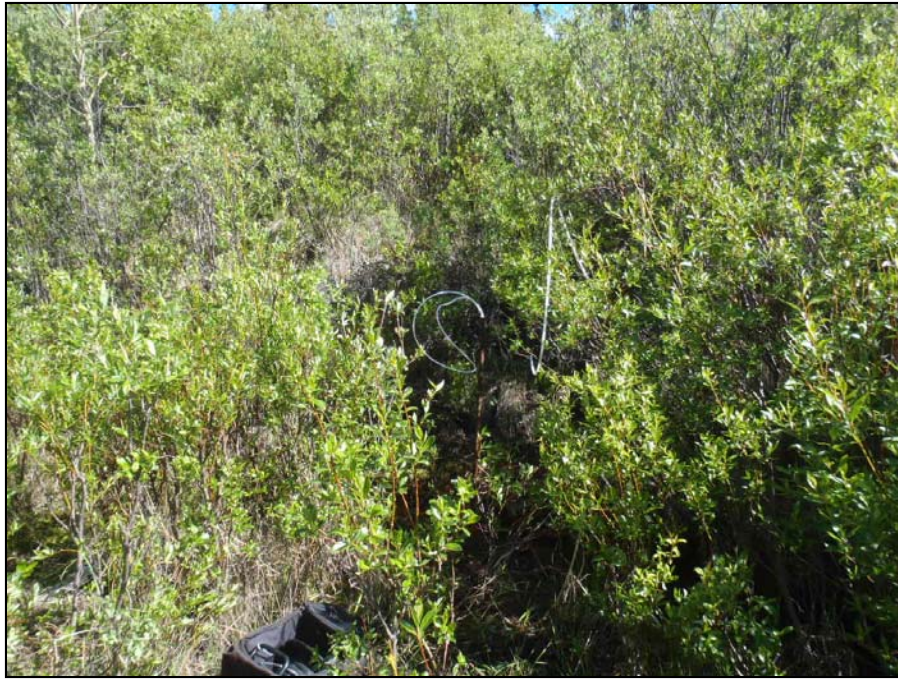
Photo 39: View of drive point well MP09-02. Photo taken on June 27th, 2014.

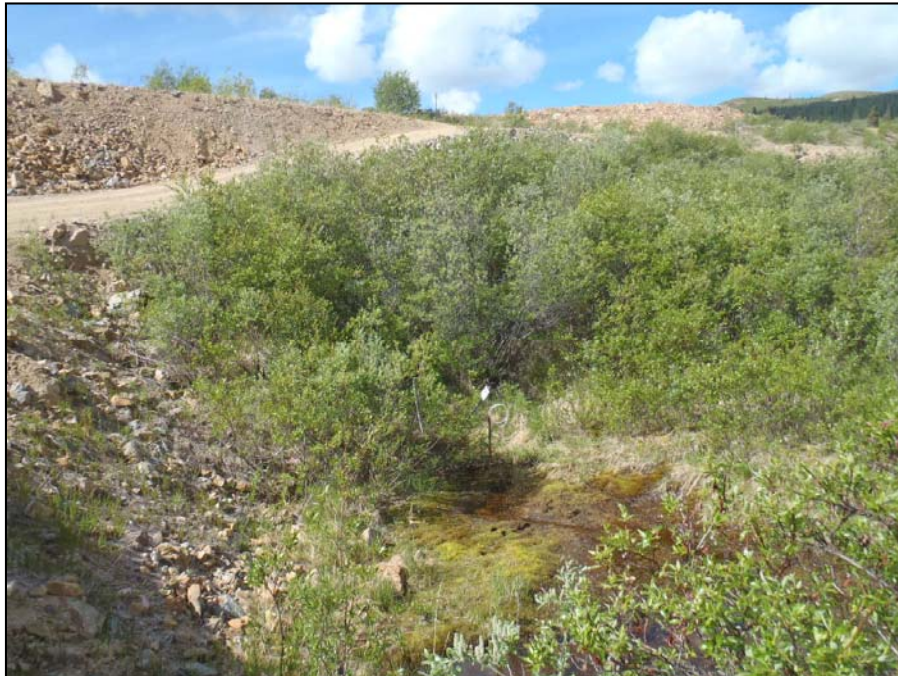
Photo 40: View of well MP09-03. Photo taken on June 27th, 2014.

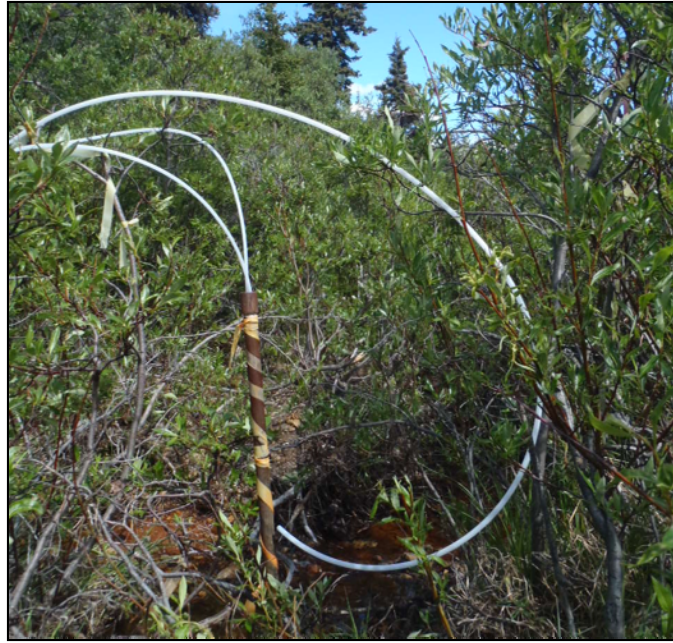
Photo 41: View of well MP09-08. Photo taken on June 27th, 2014.

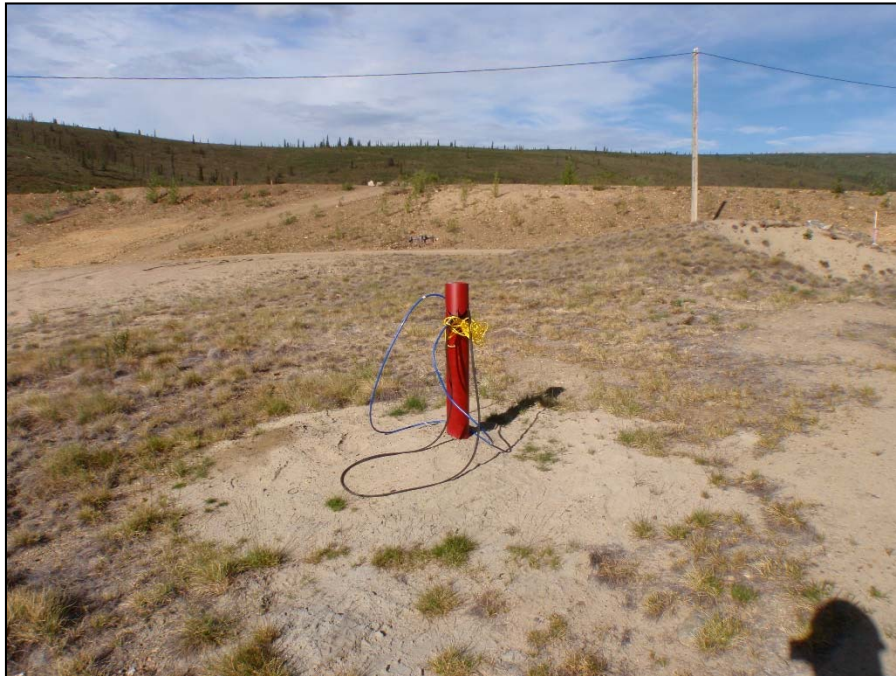
Photo 42: View of well W14103083BH01. Photo taken on June 28th, 2014.

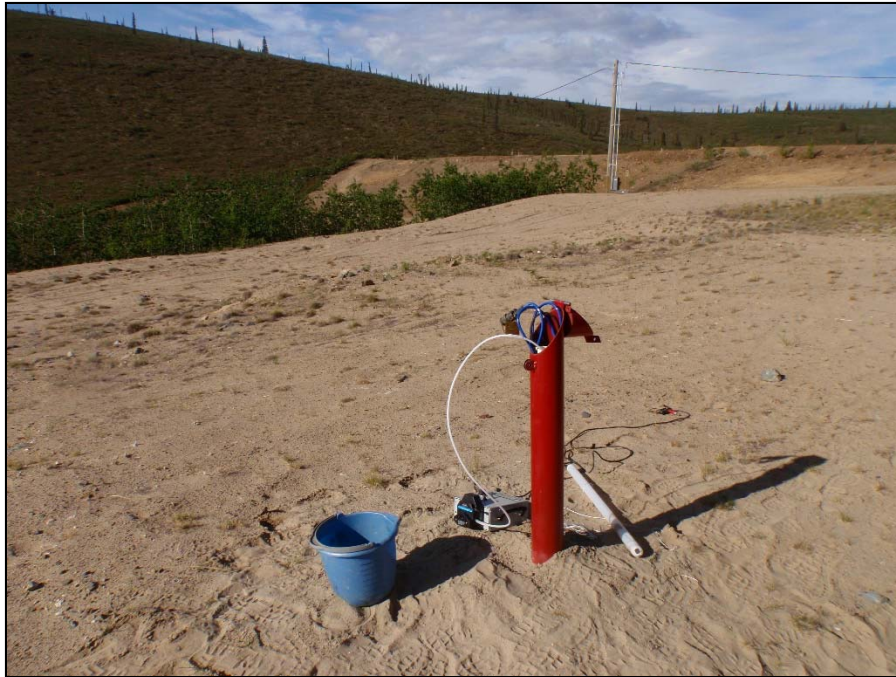
Photo 43: View of well W14103083BH02. Photo taken on June 28th, 2014.
