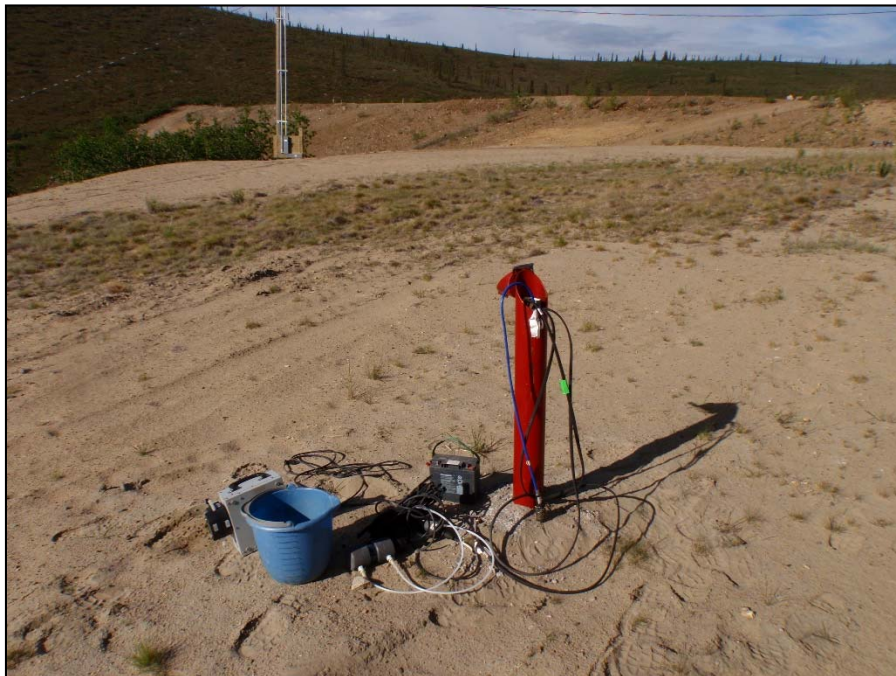
Photo 44: View of well W14103083BH04. Photo taken on June 28th, 2014.

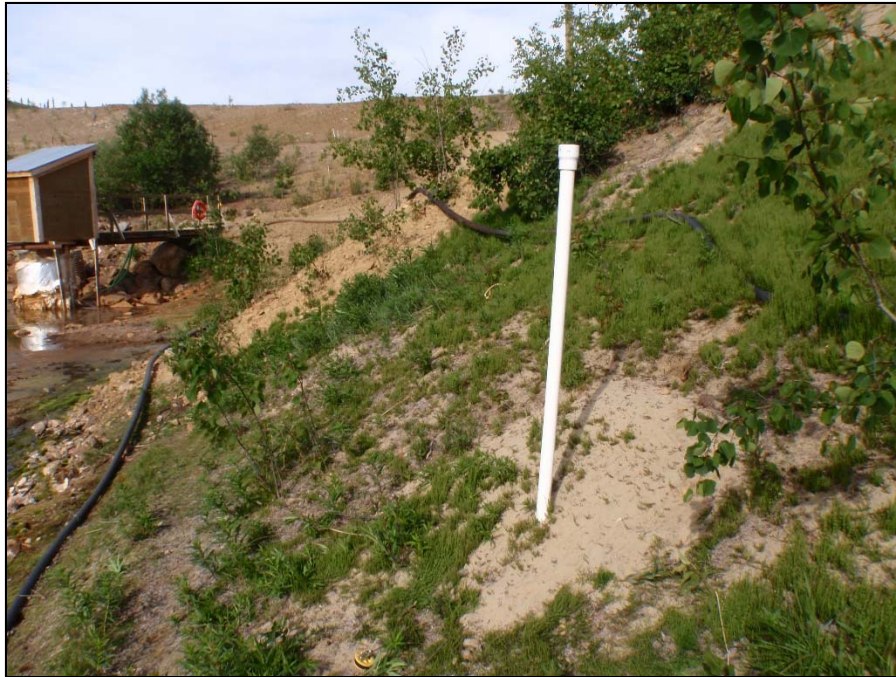
Photo 45: View of well MP09-04. Photo taken on June 28th, 2014.

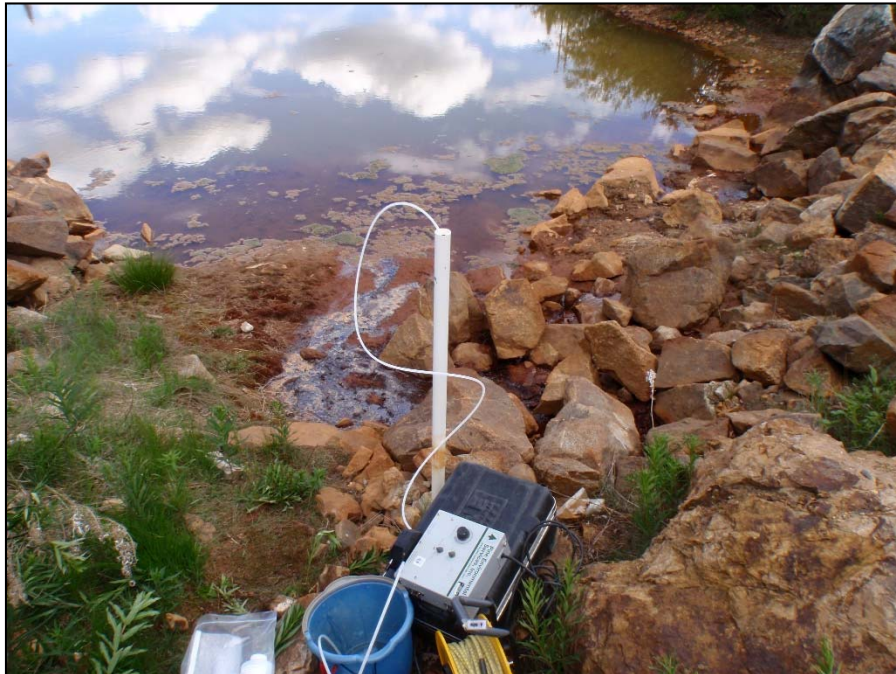
Photo 46: View of well MP09-05. Photo taken on June 28th, 2014.

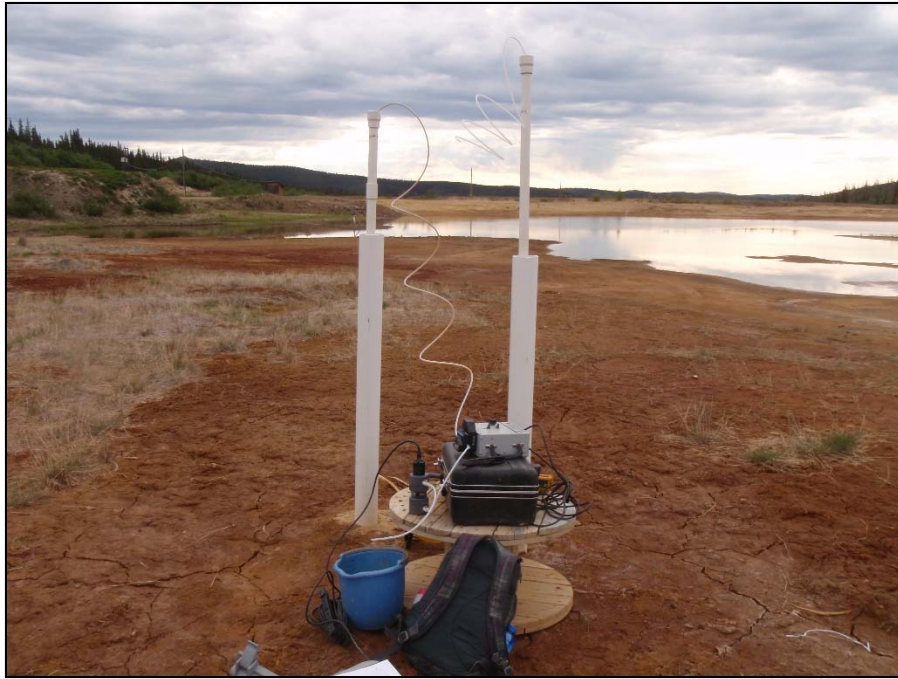
Photo 47: View of well MP09-09 and MP09-10. Photo taken on June 29th, 2014.

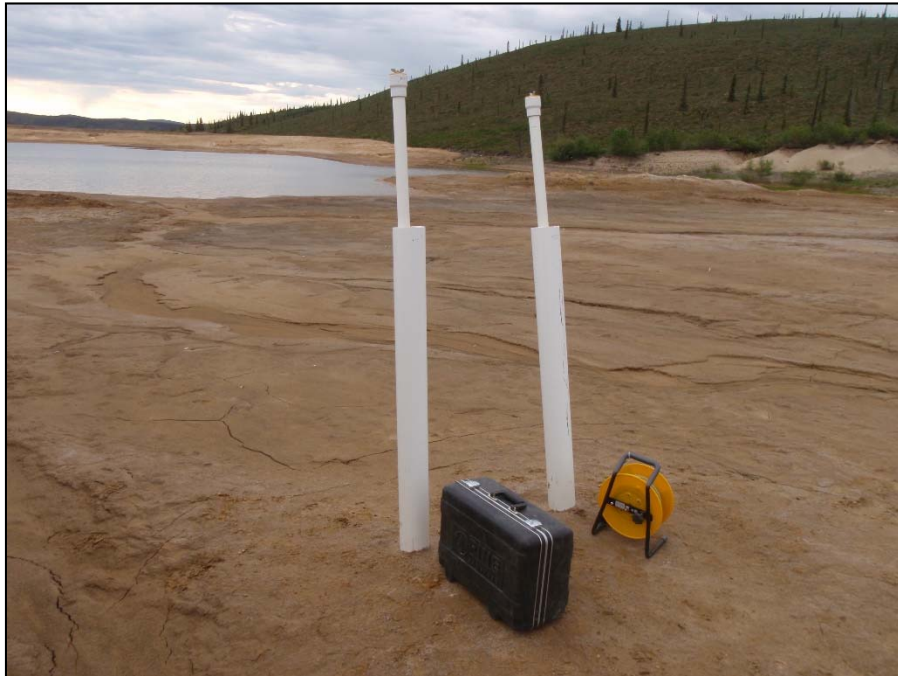
Photo 48: View of wells MP09-11 and MP09-12. Photo taken on June 29th, 2014.

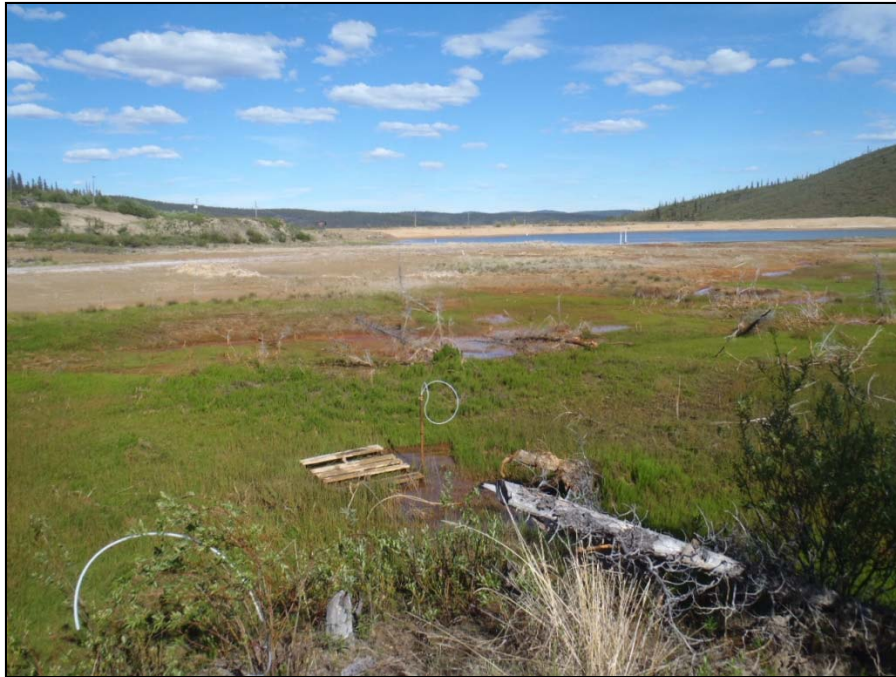
Photo 49: View of well MP09-14. Photo taken on June 27th, 2014.

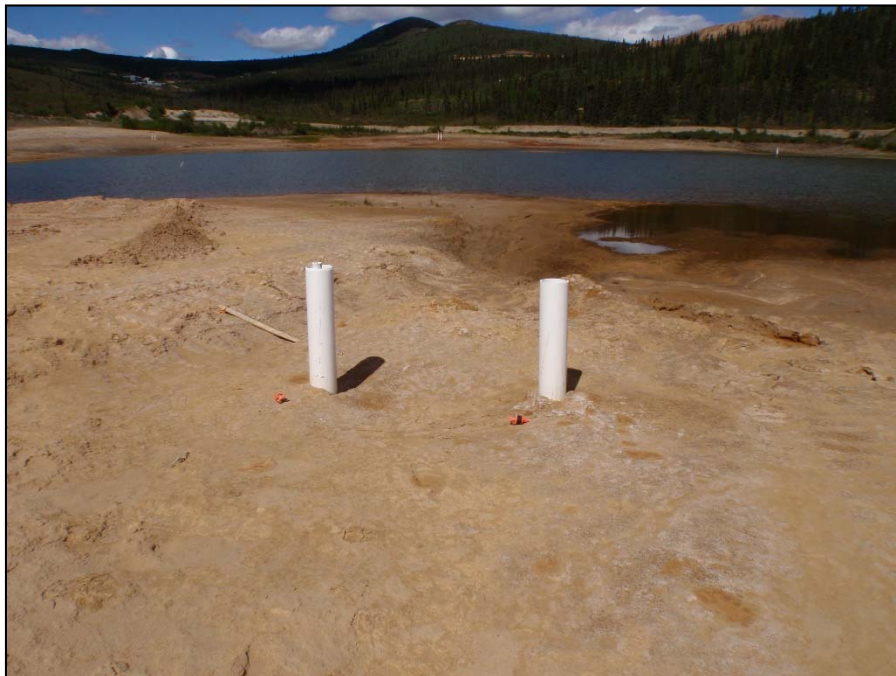
Photo 50: View of wells MW09-01 and MW09-02. Photo taken on June 27th, 2014.

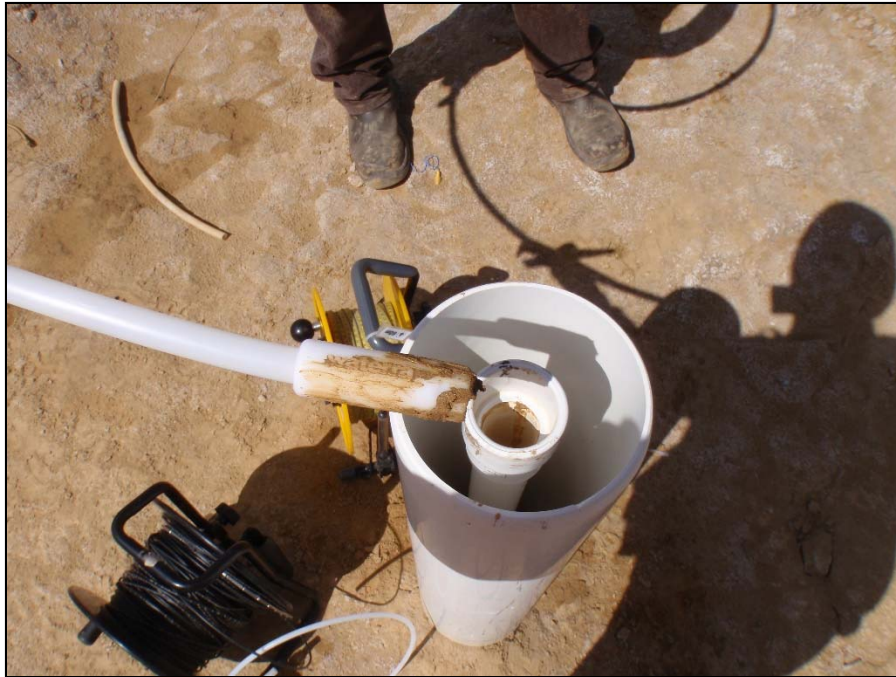
Photo 51: View of well MW09-01. Unable to get any more tubing into well due to large amount of soil found on waterra tubing already existing in well. Photo taken on June 27th, 2014.

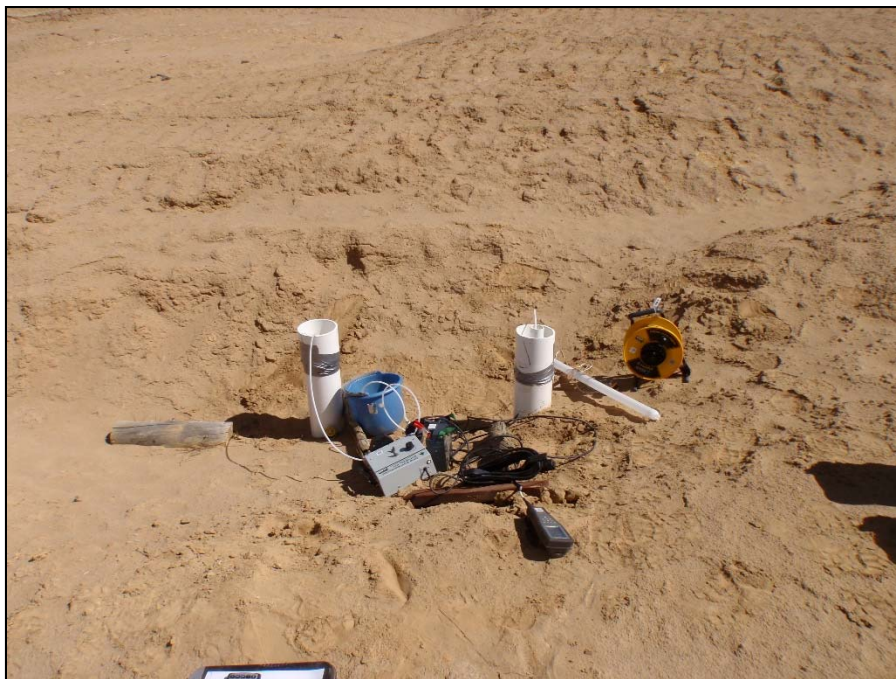
Photo 52: View of wells MW09-03 and MW09-04. Photo taken on June 27th, 2014.

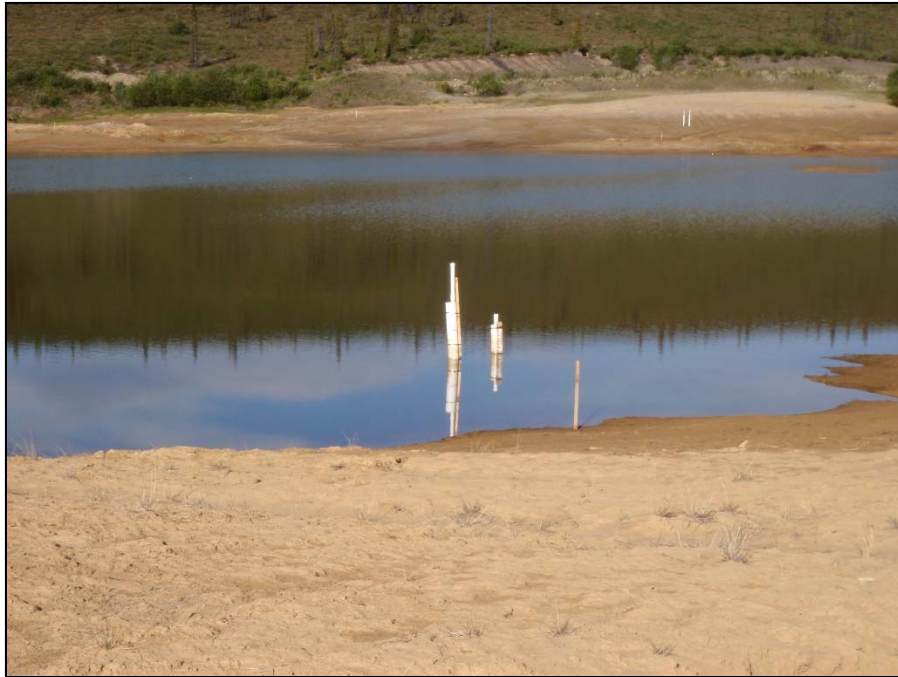
Photo 53: View of well MW09-05. Well located within the water of the tailings pond. Photo taken on June 28th, 2014.

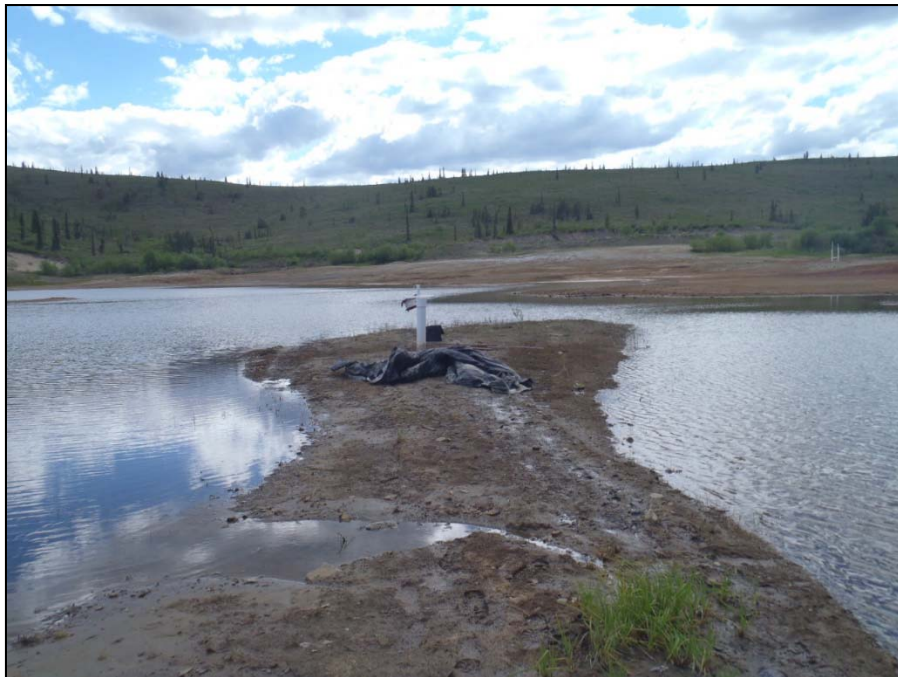
Photo 54: View of well MW09-07. Photo taken on June 28th, 2014.

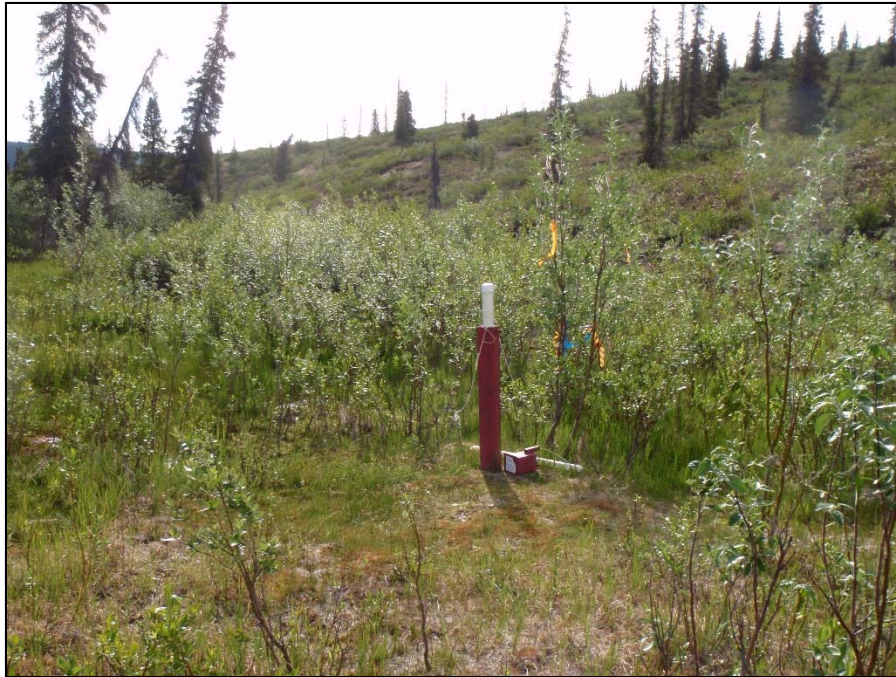
Photo 55: View of well MW09-08. Photo taken on June 28th, 2014.

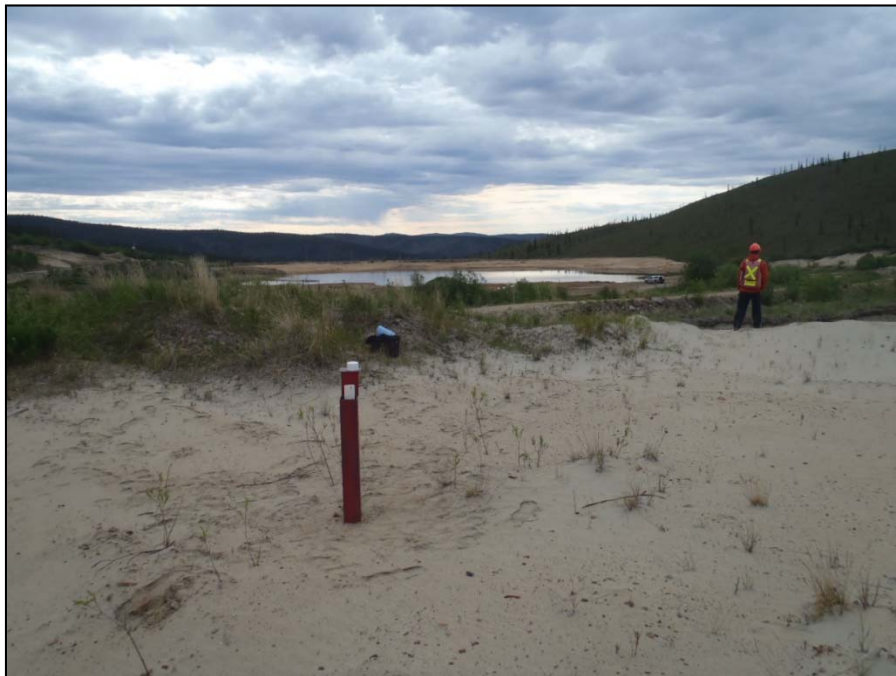
Photo 56: View of well MW09-11. Photo taken on June 29th, 2014.

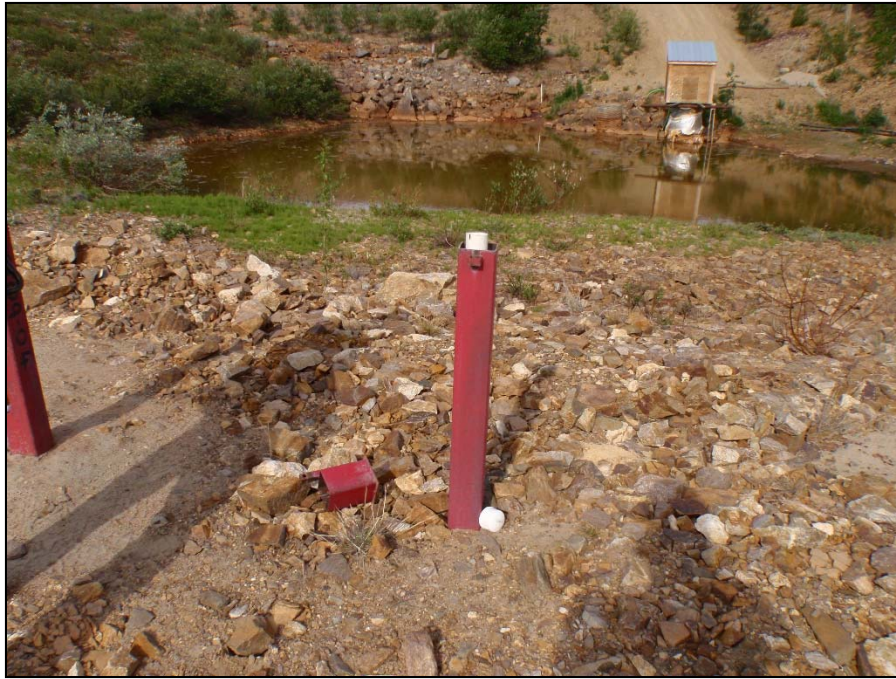
Photo 57: View of well MW09-20. Photo taken on June 28th, 2014.

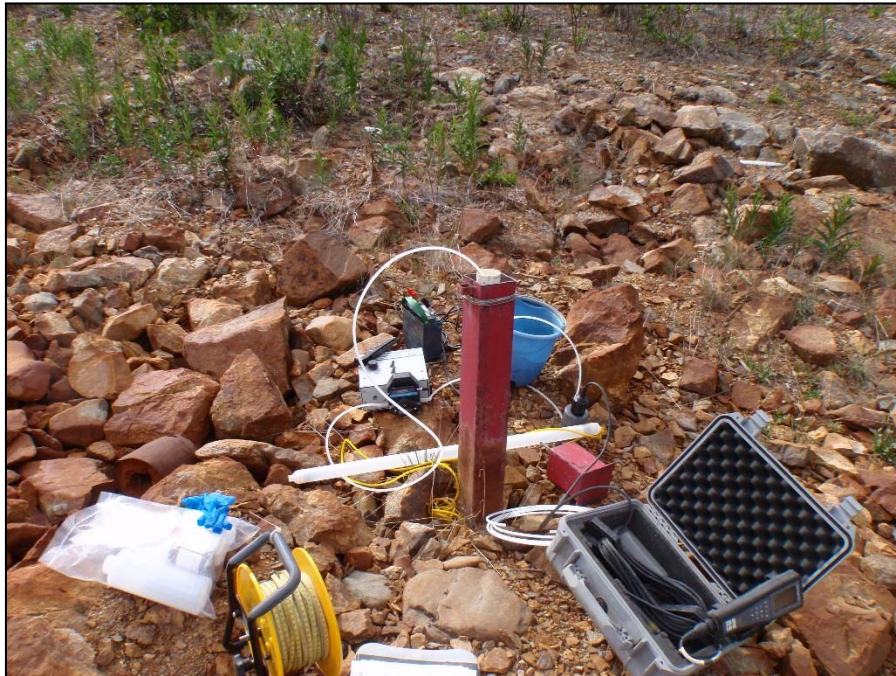
Photo 58: View of well MW09-21. Photo taken on June 28th, 2014.

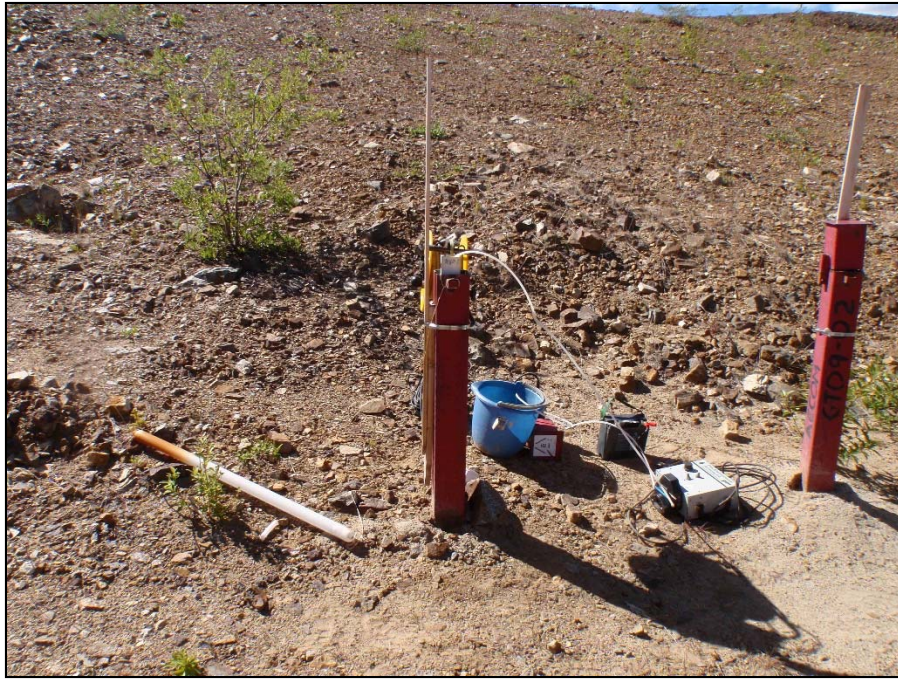
Photo 59: View of well MW09-22. Photo taken on June 27th, 2014.

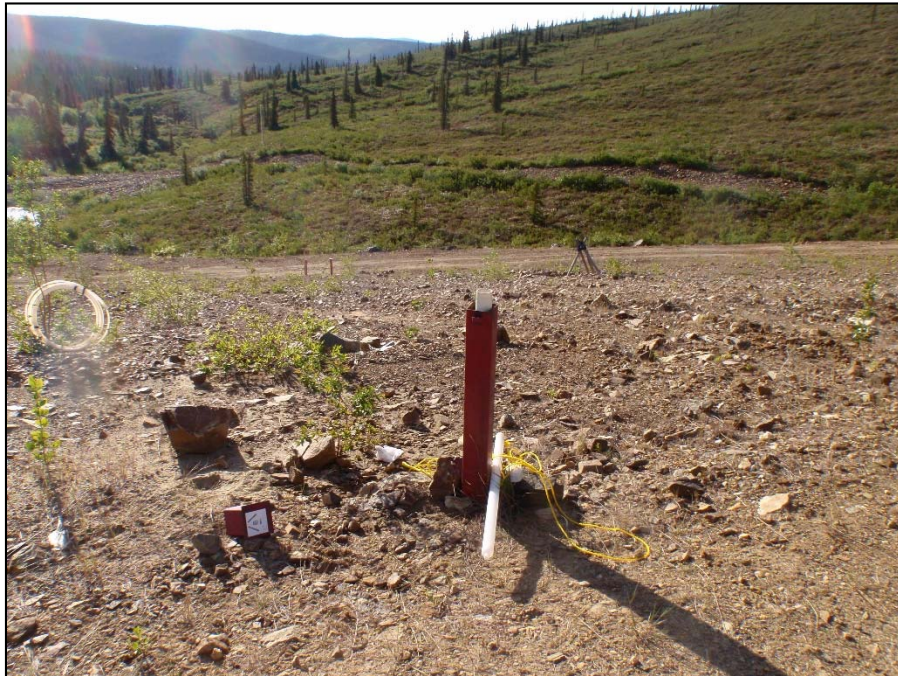
Photo 60: View of well MW09-23. Photo taken on June 27th, 2014.

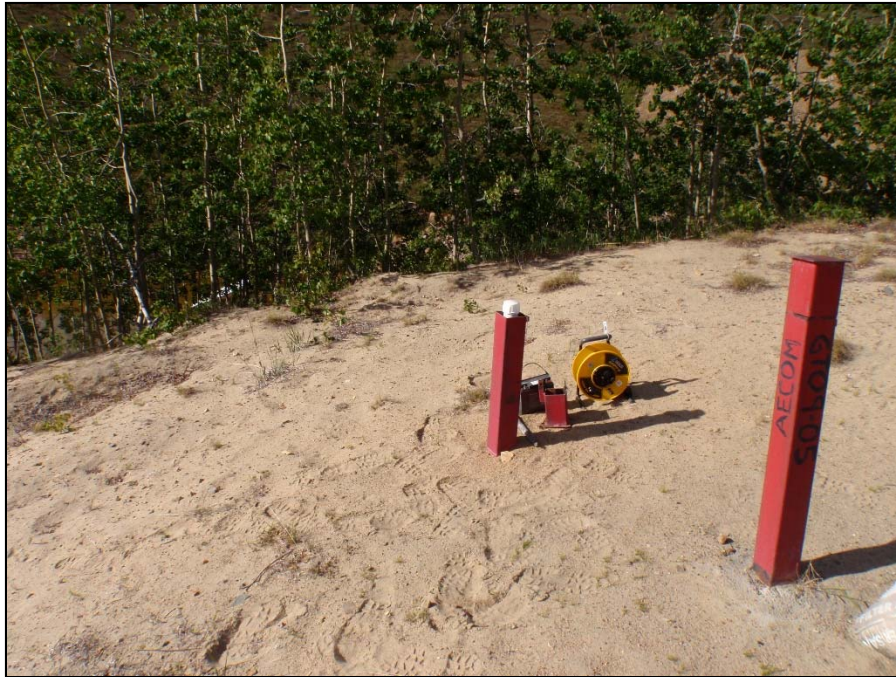
Photo 61: View of well MW09-24. Photo taken on June 28th, 2014.

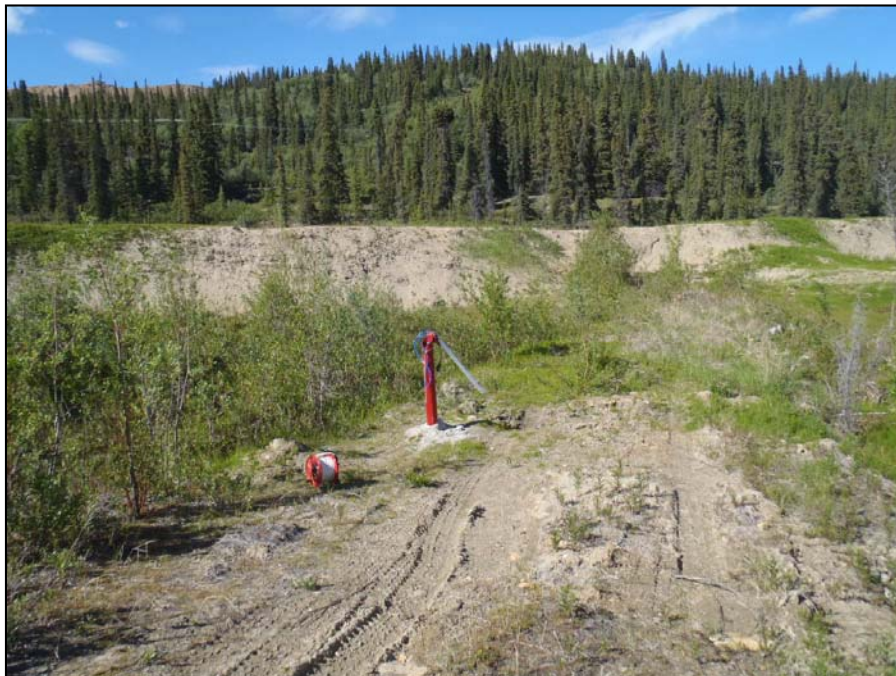
Photo 62: View of well W1403083BH03. Photo taken on June 27th, 2014.
