**MOUNT NANSEN RISK ASSESSMENT,
CONCEPTUAL CLOSURE PLAN AND COST
ESTIMATION**

Prepared for the Government of Yukon

Prepared by EBA Engineering Consultants Ltd.

Project # 1200081

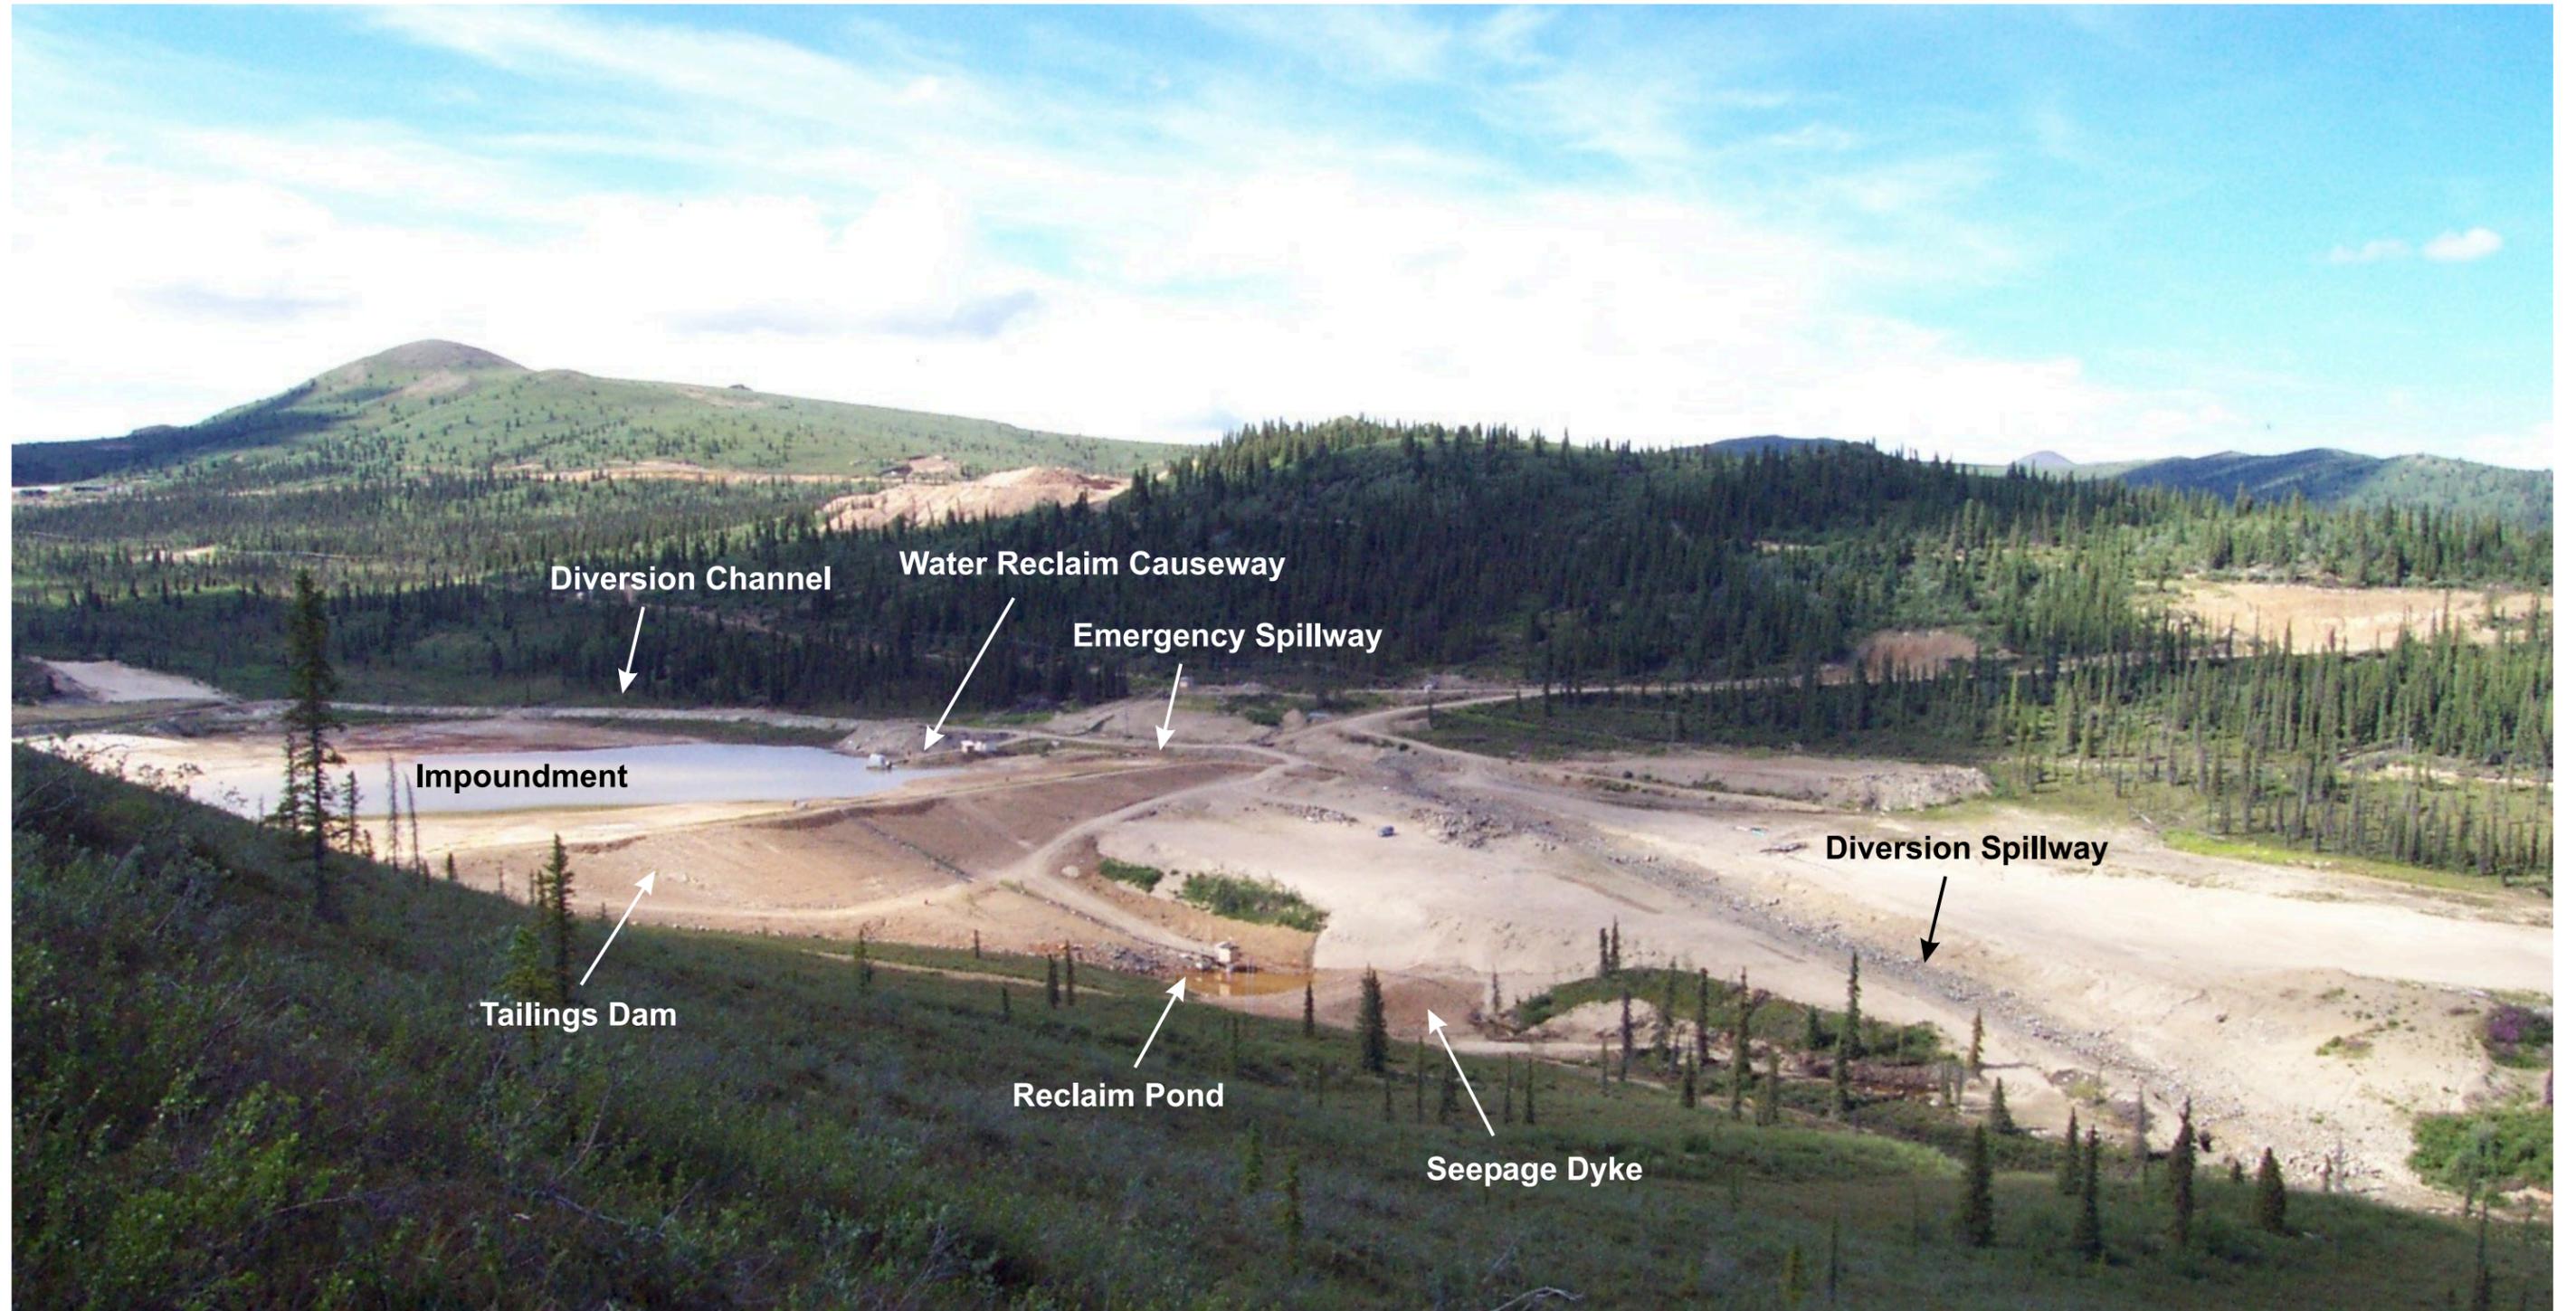
EBA Engineering Consultants Ltd.			PROJECT: MOUNT NANSEN DAM SAFETY ASSESSMENT		
CLIENT: GOVERNMENT OF YUKON ENERGY, MINES & RESOURCES			TITLE: TAILINGS IMPOUNDMENT FACILITY		
DATE: May, 2004	DWN: JSB	CHKD: CRH	FILE NO.: 1200081	DWNG: FIGURE 1	REVISION:

As shown in Figure 1, the Mount Nansen tailings facility currently consists of a tailings impoundment with a water reclaim/pump causeway, a tailings dam, diversion channels, a reclaim pond formed by a cross valley seepage control dyke located below the main dam, and an emergency spillway. The impoundment area is roughly 7 ha in area with rough dimensions of 250 m (north-south) by 280 m (east-west). The volume of tailings within the impoundment is estimated to be in the order of 283 500 m³ including both

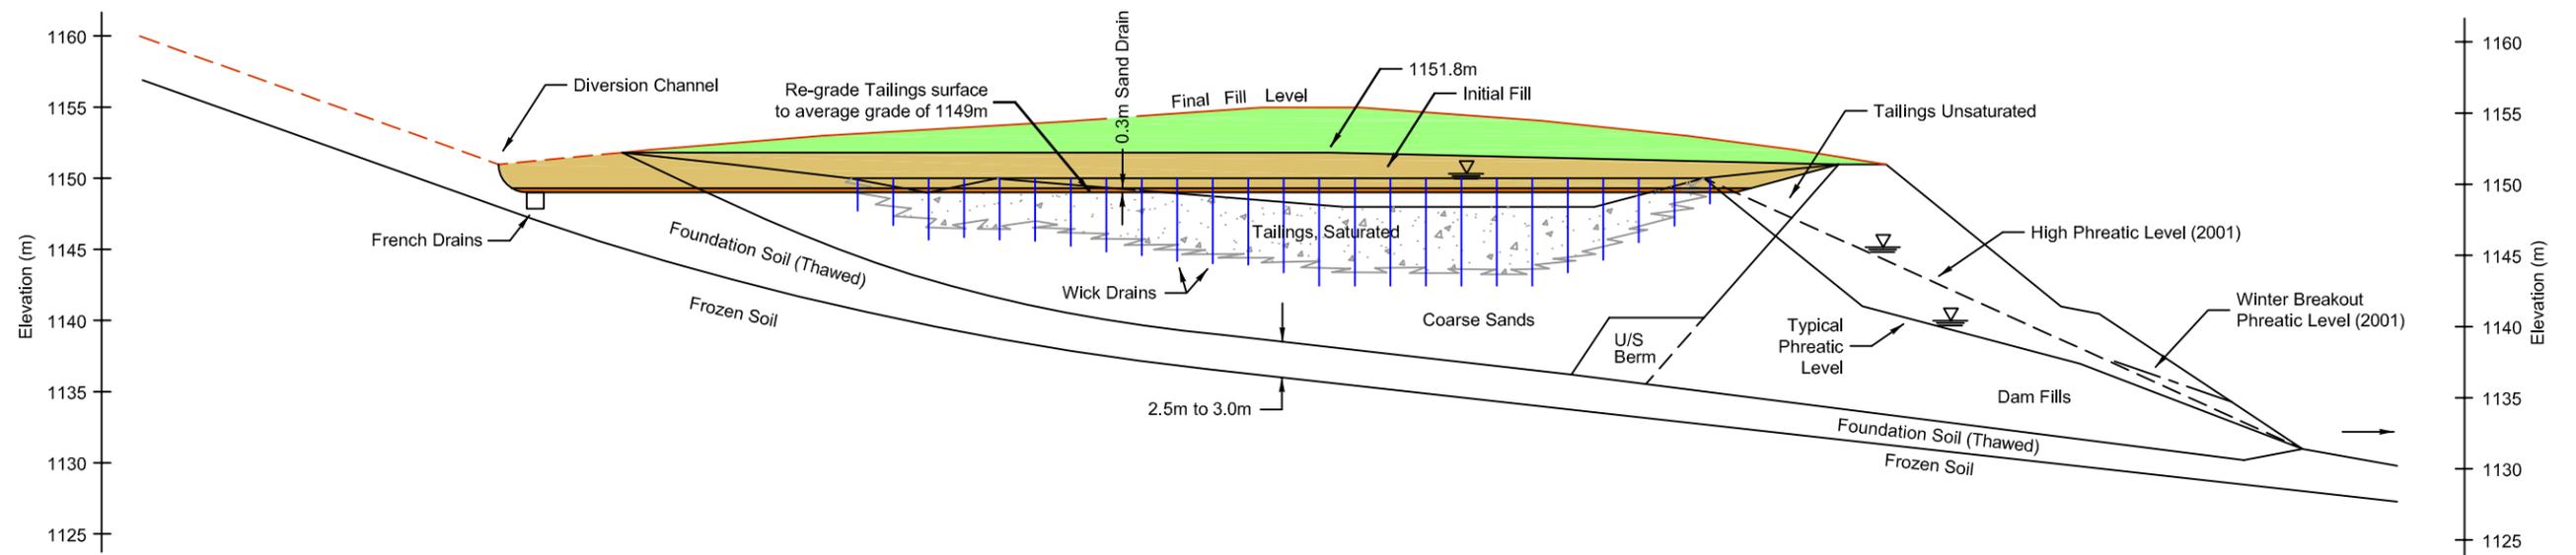
PROJECT MT. NANSEN TAILING IMPOUND ASSESSMENT	
CLIENT GOVERNMENT OF YUKON ENERGY, MINES & RESOURCES		TITLE RESULTS OF SLOPE STABILITY ANALYSIS (CURRENT FACILITY) WITH PROPOSED CAPPING	
DATE 2004/04/04	DWN. JAB	CHKD. EF	FILE NO. 0201-1200081
			FIGURE 3

- The factor of safety of the critical dam section varies from 1.52 to 1.61 under current observed level of phreatic surface (groundwater level within the dam). This range of factor of safety is considered adequate under static conditions for dam stability.

- The factor of safety under the high level of phreatic surface could decrease to 1.36 and is considered adequate for dam stability under permanent condition. The groundwater level at the toe berm is critical to the dam stability.

- The perspective of dam stability for the 5-year window (to 2008) can be viewed as similar or the same as for the current condition. Moreover, the worse case “extreme event” phreatic level scenario (slope breakout at Elev. 1135 m) was considered for the 2008 condition and was found to decrease the factor of safety from 1.34 to 1.23.

- Under the design seismic condition (MDE event), the risk of dam failure for the current configuration along a liquefied foundation soil is considered to be high. The post liquefaction static factor of safety was calculated to be about 0.70 indicating generally unstable slope conditions. By lowering the

phreatic surface and resultant pore water pressures within the dam and foundation, the factor of safety can be increased to greater than 1.0 at closure.
