EDI Job Number: 13-Y-0167

Re: Mount Nansen Surface Water Quality Field Memo: November 12-14, 2013

Trip Dates:	November 12-14, 2013
EDI Field Staff:	Dawn Hansen, Danny Skookum, Joel MacFabe
Tasks:	Hydrology and Water Quality

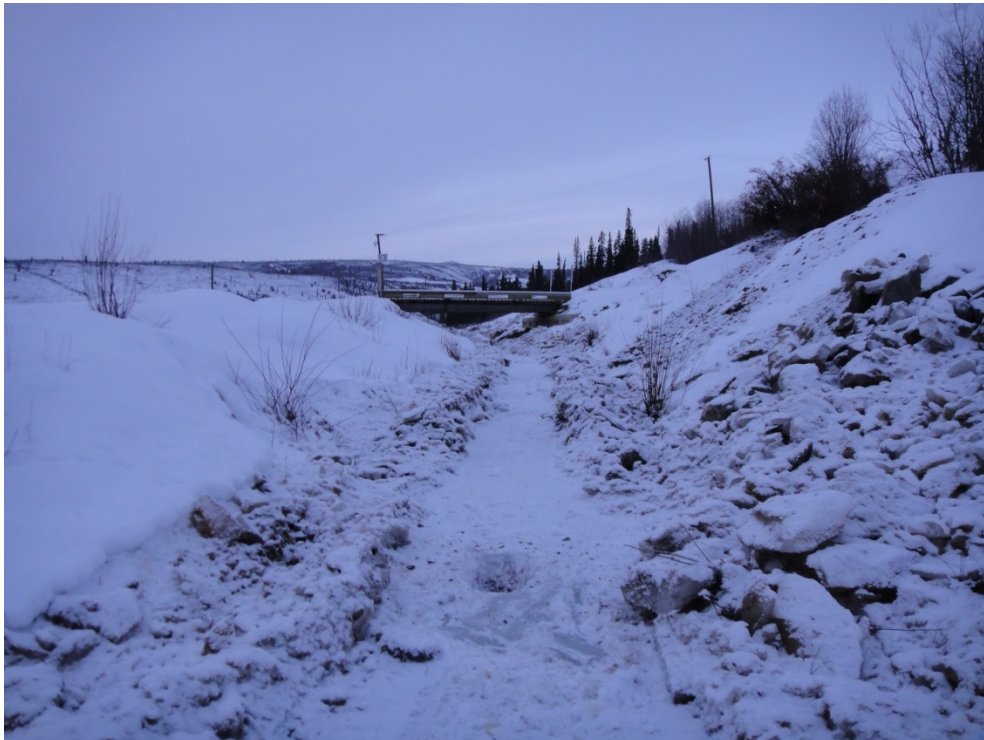
H-DC-B	None	Channel frozen through and dry beneath. Channel covered in ice and snow. Crew noted signs of recent re-trenching in diversion (Photo 1).
H-DC-M	Salt Slug	Water level low, channel snow and ice (1-4cm thick) covered. Salt tracer used to estimate stream discharge. Logger downloaded.

Photo 1. H-DC-B Snow and ice covered as well as signs of recent re-trenching November 12, 2013.

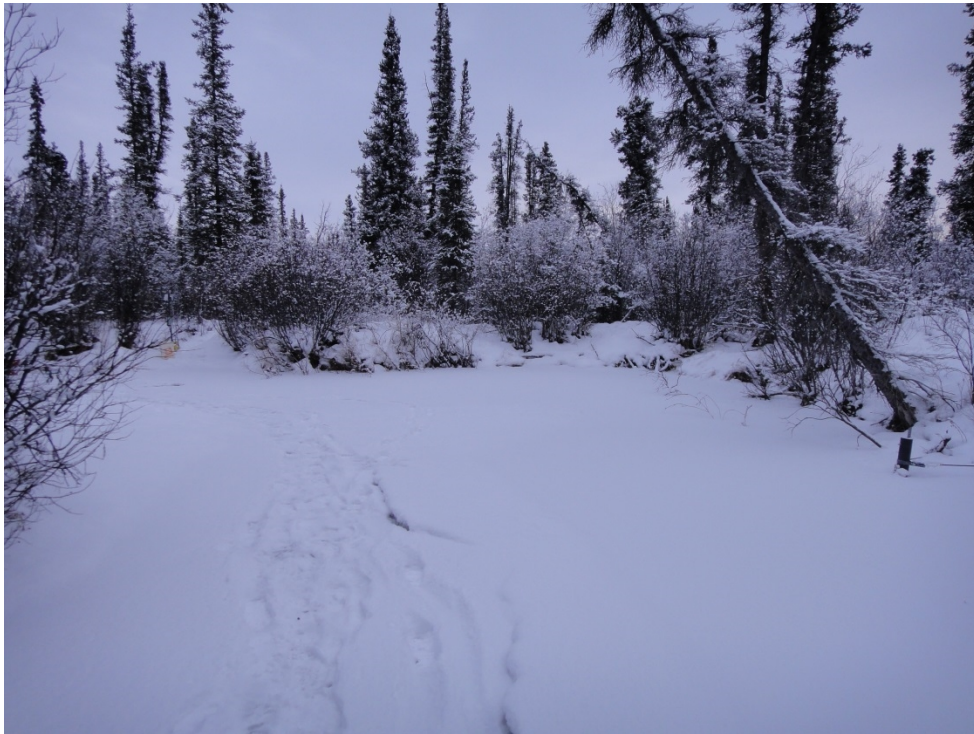
Photo 2. H/WQ-VC-REF - snow and ice covered November 13, 2013, looking downstream.

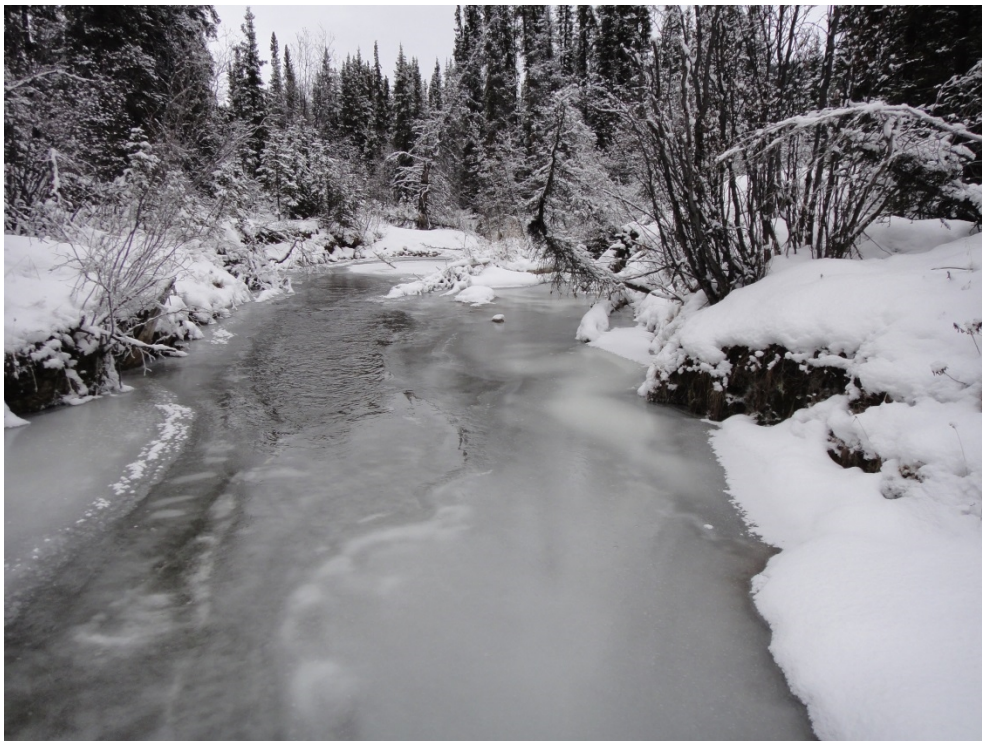
Photo 3. H-VC-U - ice covered with open sections November 13, 2013, looking downstream.

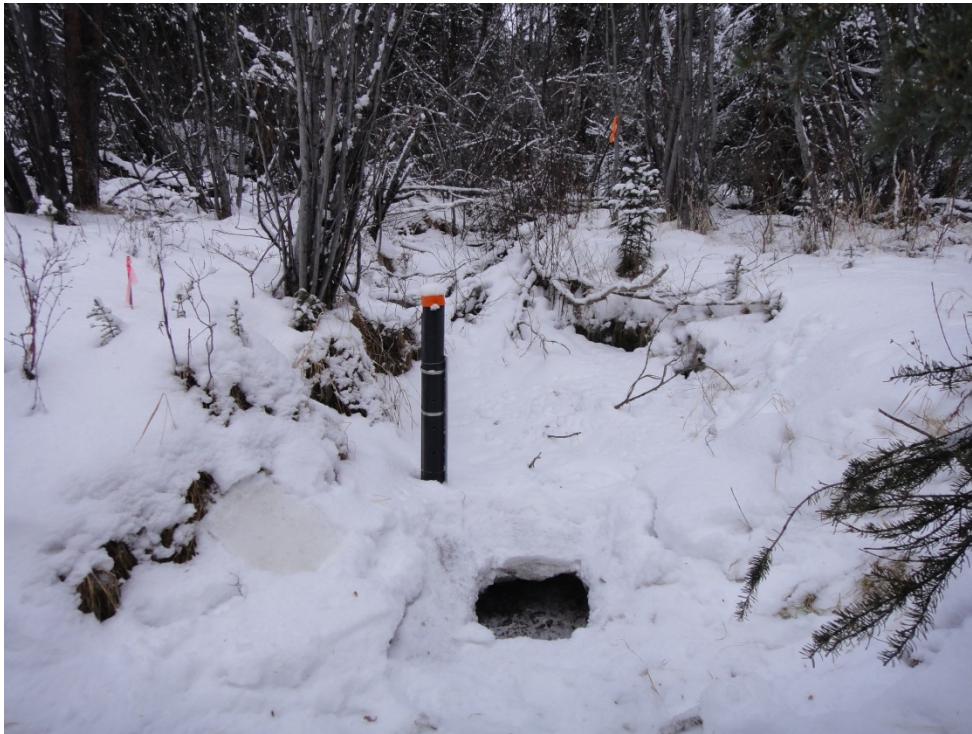
Photo 4. H/WQ-BC Snow and ice covered channel with dry streambed below November 12, 2013.

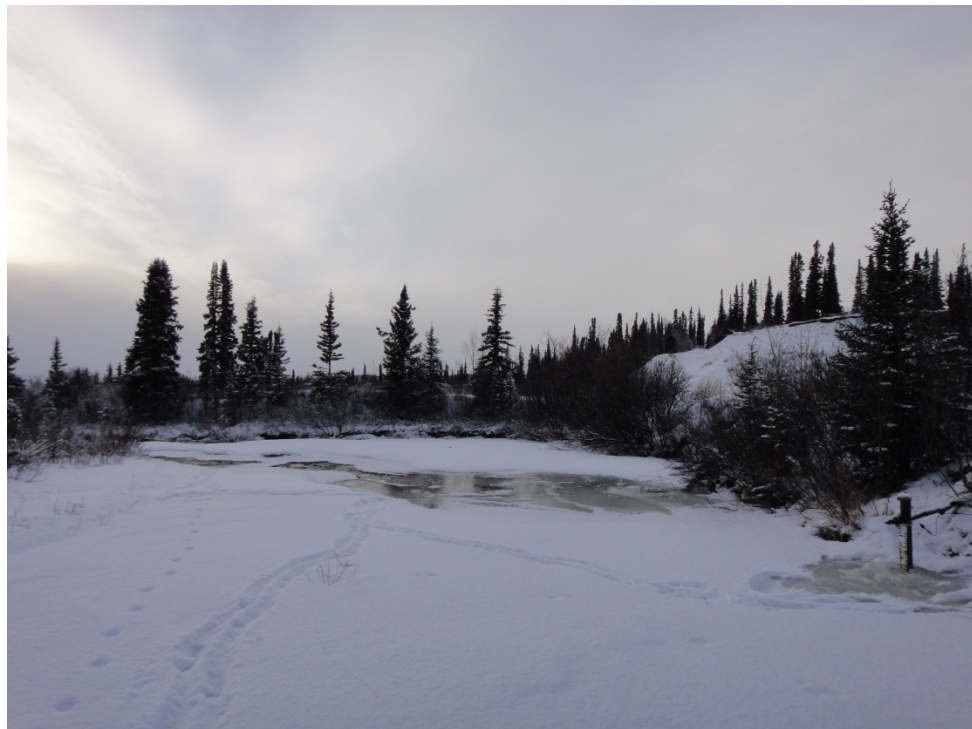
Photo 5. H-VC-R (looking downstream) station showing ice across stream with open water at thalweg.

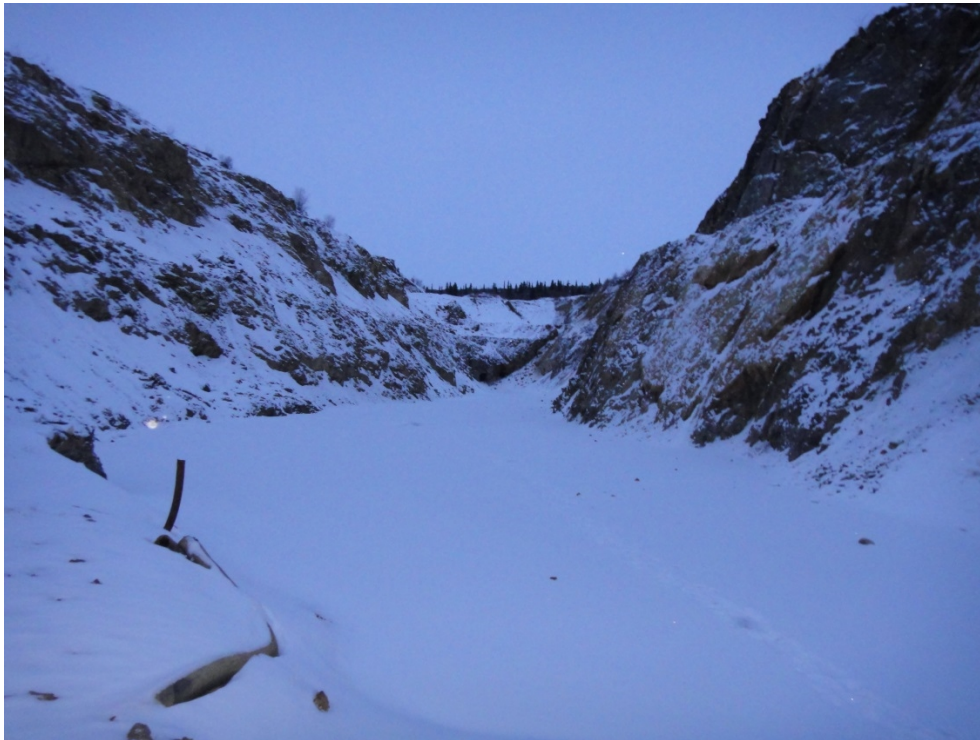
Site	Sampled? (Yes/No)	Notes / Explanations
WQ-PIT1	Yes	Samples taken from surface. Water level was lower than usual with total depth of 6.5 meters (Photo 6). Dissolved oxygen (DO) 9.84 mg/L.
WQ-PIT2	Yes	Samples taken from 3 m depth (Photo 6). DO 9.09 mg/L.
WQ-PIT3	Yes	Samples taken from 6 m depth (Photo 6). DO 5.49 mg/L.
WQ-SEEP	Yes	Conditions normal for this time of year. Ice build-up around pipe and barrel at the site.
WQ-TP	Yes	Ice thickness 12 cm.
WQ-DC-DX	Yes	Water levels were very low and turbidity was high (59.8 NTU).
WQ-DC-DX+105	Yes	Water levels were moderate.
WQ-DC-D1b	Yes	Water levels were low and overflow ice was 12 cm thick with water flowing through. Excavator activity upstream with the removal of the building on the upstream pond. Suspect disturbed bed when cutting hole in ice, water did not clear up over time.
WQ-DC-U1	Yes	Water quality sample collected slightly upstream of regular site, due to more suitable sampling conditions. Overflow ice developing.

Photo 6. WQ-PIT ice and snow covered.
