Security Classification - Classification de sécurité UNCLASSIFIED
Our file - Notre référence MT. NANSEN : 05-HPAC-PA5-00206
Your File - Votre référence
Date Sept 26 2008

Subject
Objet **MT. NANSEN MINE- VICTORIA CREEK GABION DETERIORATION**

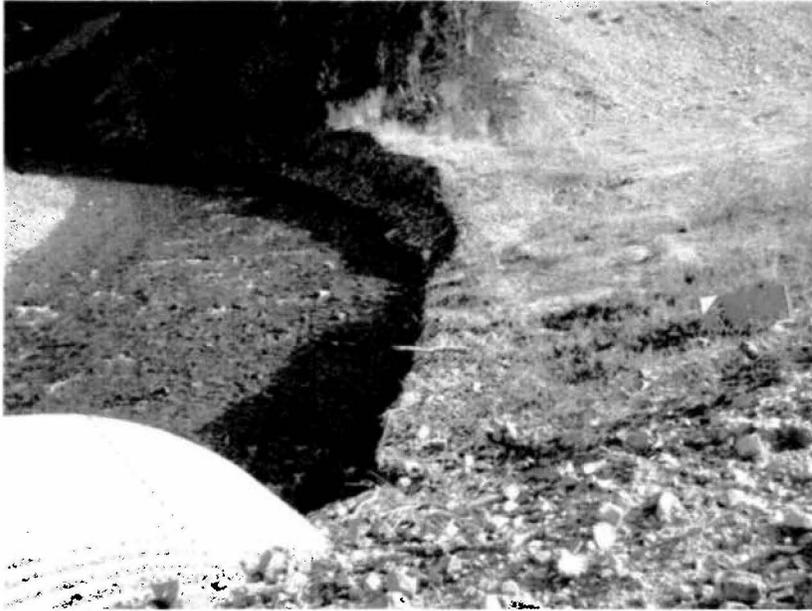
Several gabion structures/baskets were visible in the general vicinity of the culvert when I visited the site on September 25, 2008. Baskets are located both upstream and downstream of the culvert. The upstream baskets are apparent on the left hand margin of culvert (Figure 1); their function appears to have been for bank stabilization/erosion protection. Erosion of the left hand bank upstream of the gabion baskets is apparent. On the right hand margin of the culvert, baskets are clearly apparent from underneath the road surface material to the mid-point of the depth of the culvert (Figure 2). The upstream gabions appear to be relatively intact and appear to be functioning as intended. There is, however, considerable damage to the downstream baskets which were positioned within the bed of the creek.

Figure 1. Gabion baskets were installed on the left-hand side of the stream (river-left) presumably as an erosion protection device. Baskets installed at this location appear to have been effective in preventing bank erosion adjacent to the culvert. Erosion of the left bank upstream of the baskets is occurring.

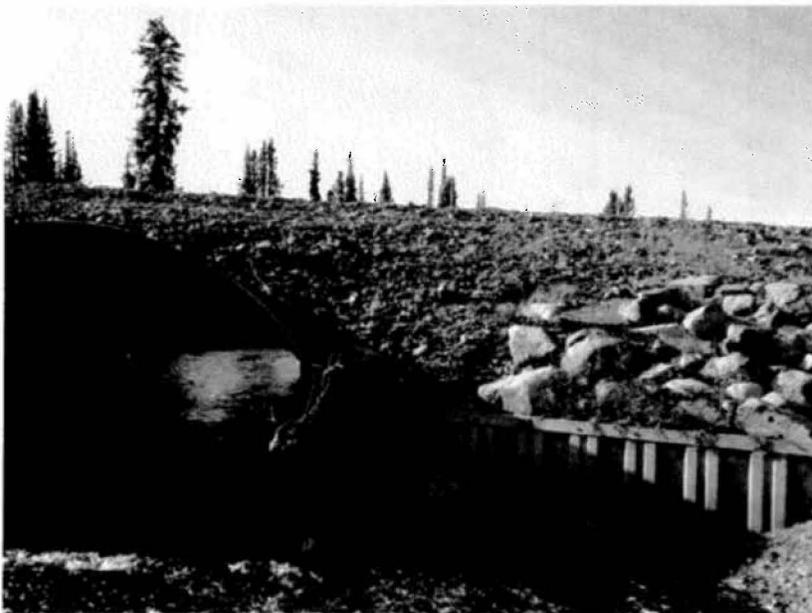
Figure 2. Gabion baskets were also installed on the right hand side of the culvert under the road bed material. Note the large tree stuck in the culvert in the foreground.

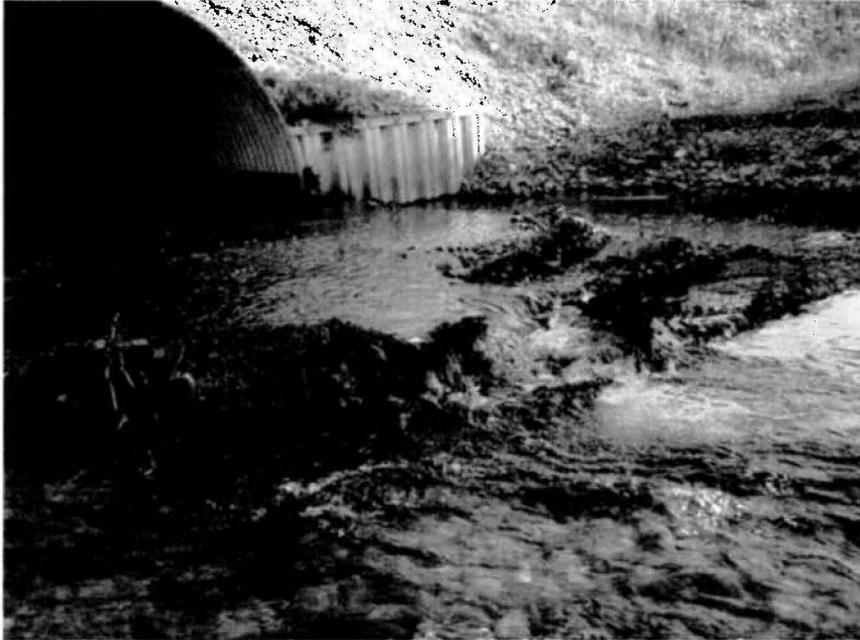
Closer examination of these downstream gabions showed that the baskets have likely shifted from their original placement and currently contain considerable debris (e.g., sticks, leaves, etc...) (Figure 3). They appear to be devoid of much of the rock material that would have originally been placed within them. The wire mesh used for basket construction was fairly large diameter. Since little material remains within many of the baskets, it is likely that rocks used to fill the gabion baskets originally was either too small relative to the size of the mesh used, or has since broken down and has been washed out of the baskets (Figure 4). In several places the gabion baskets have pulled apart and have left the pointed wire ends of the mesh exposed (Figure 5). Although the orientation of the pointed ends of the mesh did not appear to be such that it could cause significant damage to passing fish (i.e., impaling them), further erosion of bed materials could lead to such an outcome. Either the construction of the baskets or their placement was not adequate to withstand water velocities in this reach of stream. Gabions, at least in the currently form, do not appear to be the best solution for stabilization downstream of the culvert, and appear to require more (or at least some) maintenance.

Figure 3. Gabion baskets appear to have shifted from the location at which they were originally placed. Baskets have been pushed up and out of the water in several spots. Baskets have also become filled with debris.

Since reclamation of the mine and monitoring of the site will occur for many years, the access road to the site needs to remain passable and the culvert will likely remain in place. I would suggest that, should there be a desire to leave these gabion structures in place, there will be the need for some maintenance and monitoring of these structures, particularly downstream of the culvert. At any rate, it is likely that the downstream gabions will need to be replaced with something more resilient in time to ensure successful fish passage of the culvert.

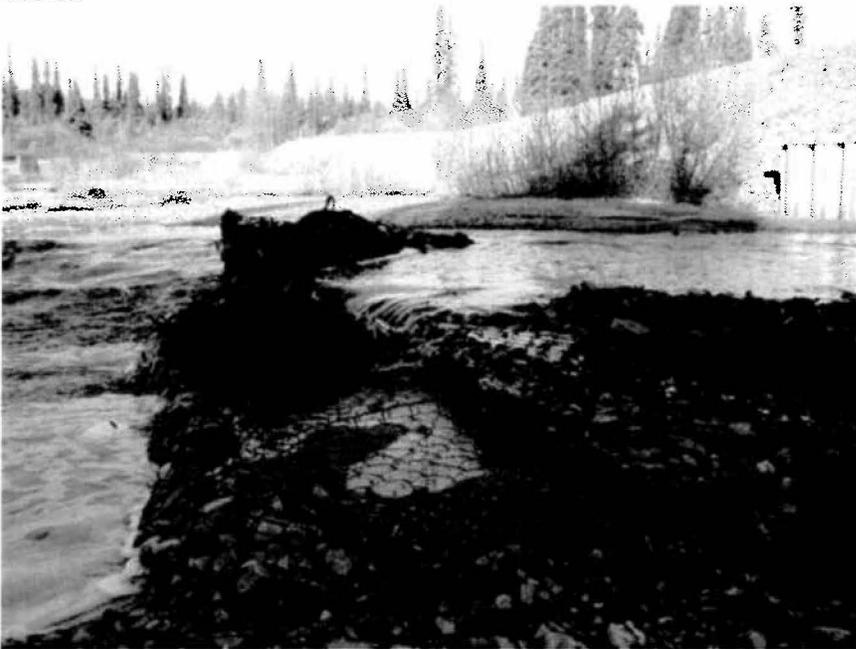
Figure 4. Much of the rock material appears to have been washed out of the gabion baskets since their construction.

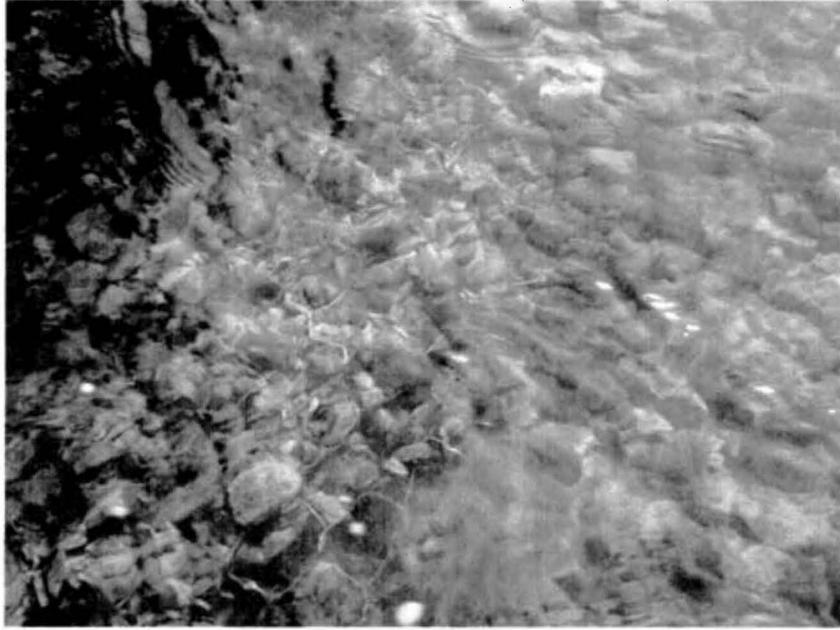
Figure 5. In several places, gabion baskets have pulled apart and have left pointed wire ends of the mesh exposed.
