TO: Jon Bronson, Kaori Torigai, File
DATE: 8 January 2010
FROM: Jay Cherian
SUBJECT: Preliminary X3, X10 Review

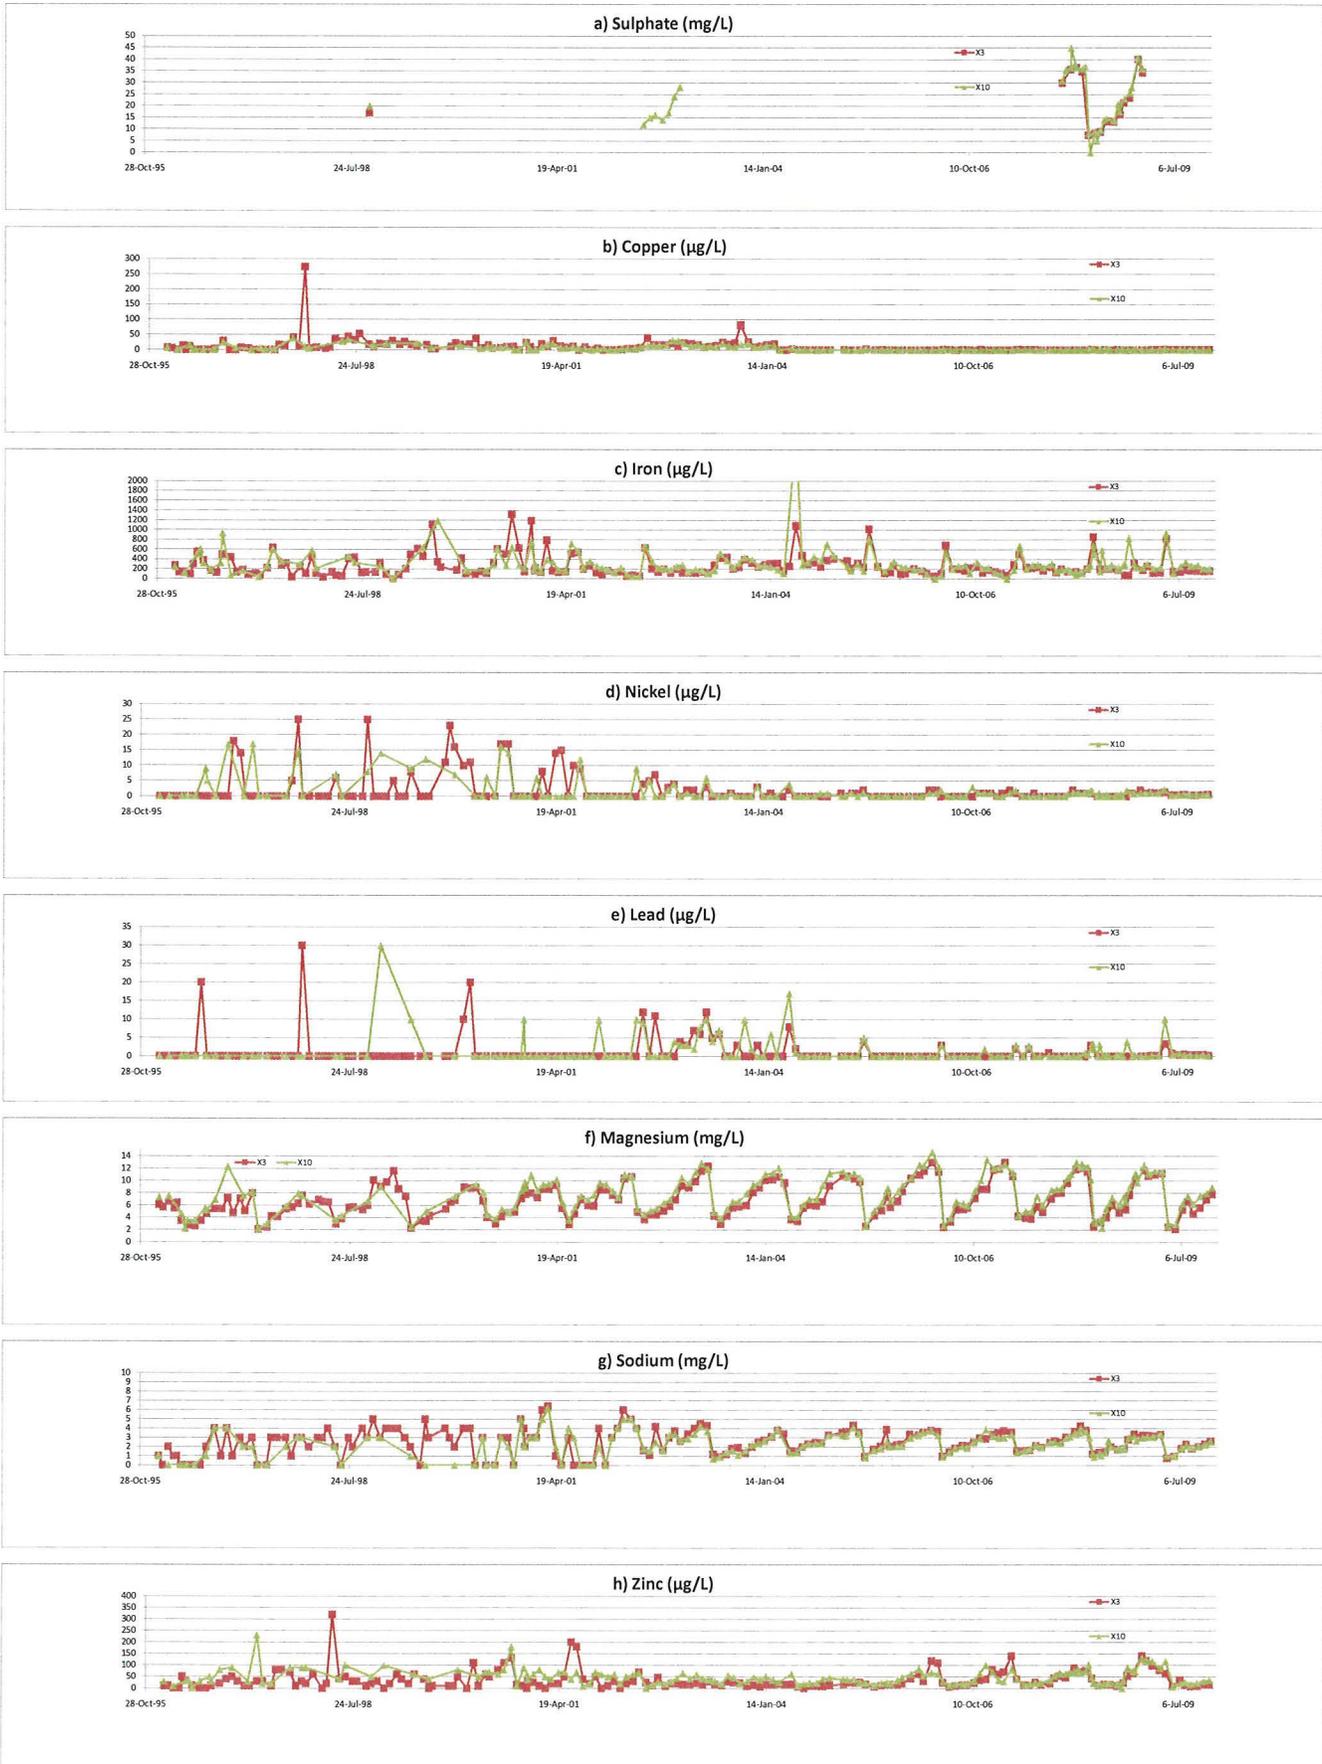
Figure 1a - h: Comparison of X3 and X10 for Select Water Quality Parameters

Figure 1 shows that for all the parameters selected (iron, sulphate, copper, nickel, lead, magnesium, sodium, zinc), with the possible exception of magnesium, iron and zinc, the concentrations of X3 and X10 are comparable. Statistical analysis would be required to determine whether or not the differences are significant between for magnesium, iron and zinc. In addition, the results for all parameters, including zinc show generally that trends at X3 parallel trends at

X10, indicating that no increasing trend in concentrations at X10 with respect to X3 is observable.

While detailed statistical analysis of the iron, magnesium and zinc may show that there is some loading to the RCDC within the reach from X3 to X10, it can be concluded from the preliminary review that the loading rate is not increasing with respect to historic rates.

Overall, water quality at X3 and X10 is comparable with historic water quality and it is possible that statistical analysis shows improved water quality generally, likely due to the capture of groundwater prior to recharge to the North Fork of Rose Creek, downstream from the Rock Drain, in the S-Wells area.

It is recommended that water quality at X3 and X10 be compared again after January monitoring events (the first working week of January), to include results after the staining was observed. From the comparison assessment further recommendations will be made.

Preliminary assessment, which excludes post staining data, does not show an immediate Care and Maintenance issue with respect to the possibility of slow degradation of the tailings containment compoundment and RCDC. Therefore, no immediate Care and Maintenance response, other than continued monitoring and additional follow-up assessment, is recommended.
