SECOND REPORT TO  
CASSIAR ASBESTOS CORPORATION LTD.  
ON  
STABILIZATION MEASURES  
FOR MINE CLOSURE

CLINTON MINE

YUKON TERRITORY

Originally submitted in draft: February 1977  
Final submission, with minor revisions: April 1977

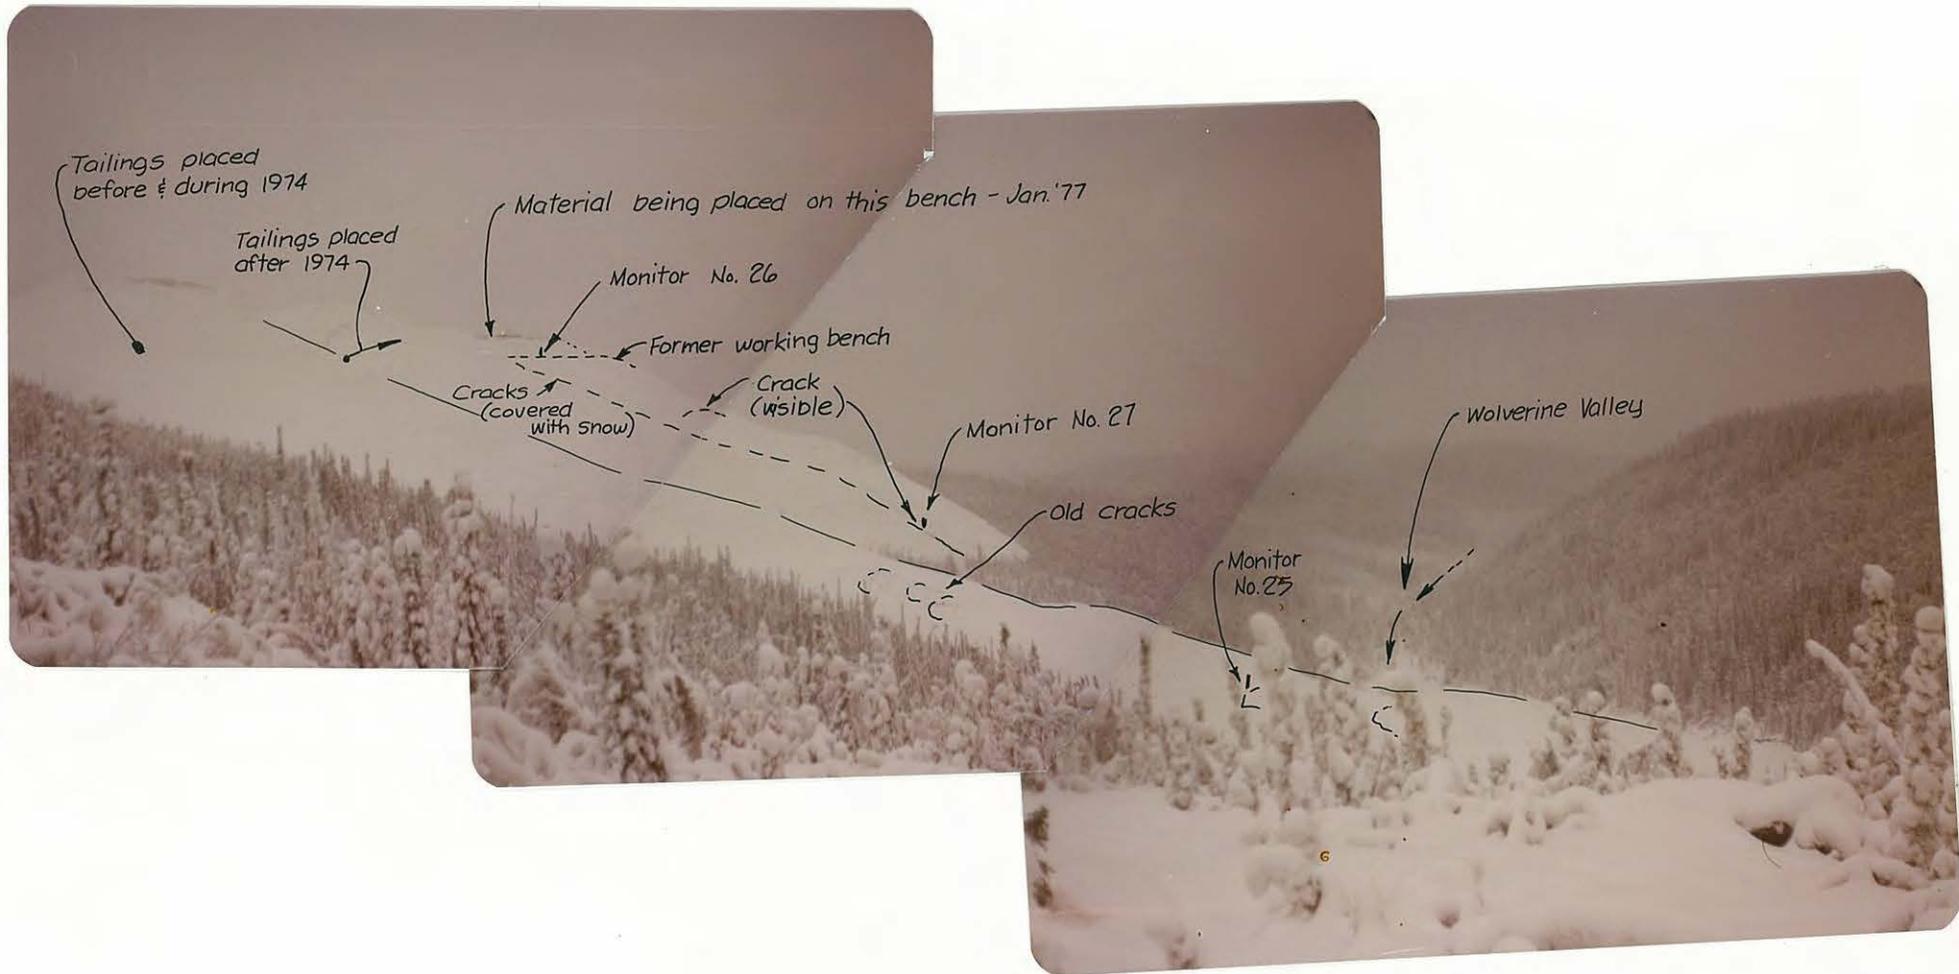
Photo 1 shows the east slope of the tailings pile, viewed from the instrument station used for sighting the pile monitors. This station is on a locally high point of land on the same side of the valley as the tailings pile, some 1/2 to 1 mile south of the pile.

The part of the pile that underwent creep movement and blocked Wolverine Creek in 1974, is shown nearest the camera in photo 1. Two monitors are installed in this part of the pile: No. 24 near the top, and No. 25 near the base. Monitor No. 26 is installed in an upper part of the pile where the tails were more recently deposited. This is where large settlements were known to be occurring. Initial measurements were taken on monitors Nos. 24, 25 and 26 in December, 1976. After 28 days, when large displacements had been recorded on monitor No. 26, a further monitor (No. 27) was installed near the base of the pile below No. 26.

The northeast part of the tailings pile (i.e. that portion to the north of the crack shown on photo 1) is slumping at the top, and moving downslope at the base. The movement is gradual, and no sudden failures are expected, except in localized areas where the surface slope is steeper than average. The exposed native soil at the base of the pile slope suggests that the seat of the movement is in unfrozen soil near the original ground surface.

1 Looking North, across east face of tailings pile. View from instrument station. Photographs taken Jan 26/1977

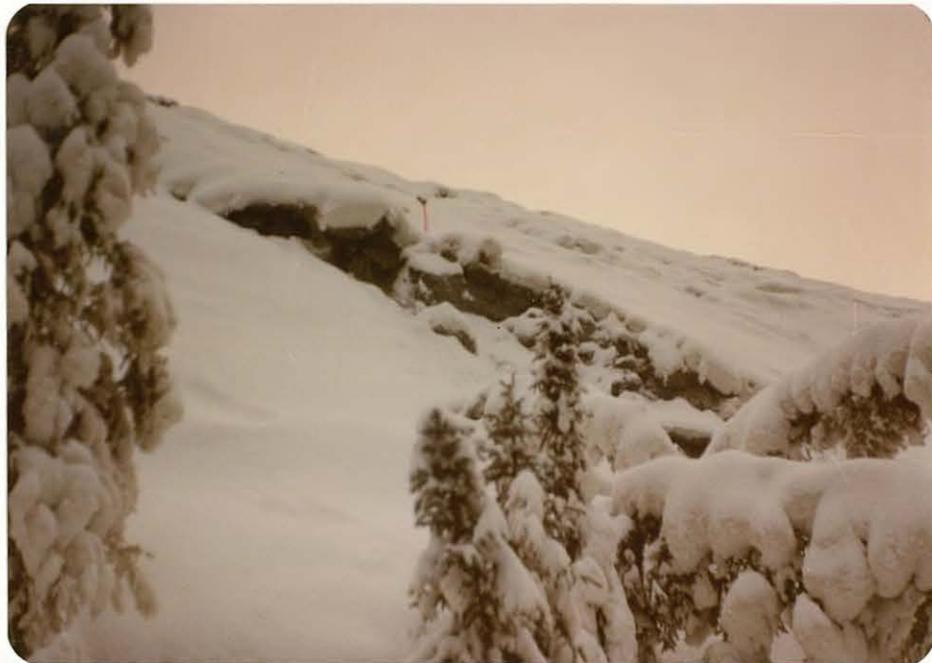
Surface cracking is visible near the toe of the northeast part of the pile. Some cracks are aligned roughly parallel to the toe of the pile, and are associated with local slumping. There is also a major crack aligned upslope passing just to the south of monitor No. 27. The writer was informed that the crack extends for the full height of the tailings pile (and is probably continuous with the system of cracks on the upper working bench), but the full extent of the crack could not be seen by the writer, due to the blanket of snow. Photo 2 shows this crack. The surface of the pile on the north side of the crack has heaved, relative to that on the south side, by about 5 ft. It is on the north side of the crack that most of the movement has taken place.

2 Looking northwest from toe of tailings pile. Monitor No. 27 indicated by red flagging. Five-foot high face of crack aligned up-slope, in foreground.

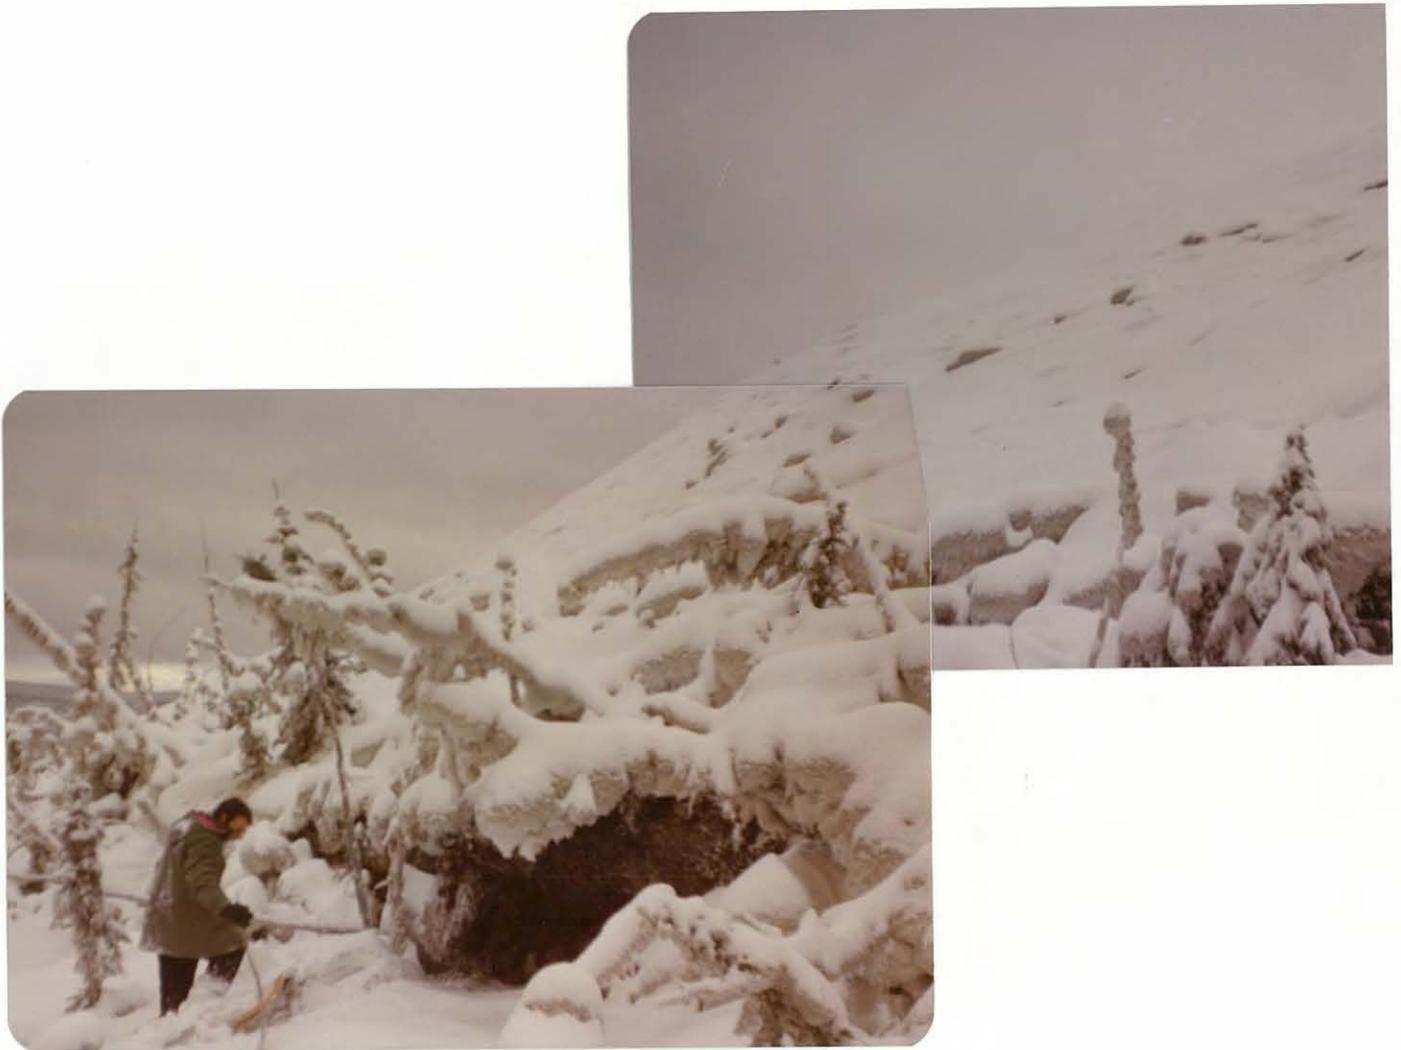
There is considerable evidence of downslope advancement of the toe of the northeast part of the tailings pile. As the toe has advanced, it has "bulldozed" native soil ahead of it, and this soil was exposed in several locations in the form of a 6 ft. high "bank" at the toe. In some areas, the exposed soil was not frozen (however, the weather for the previous few days had been

Photo 3 shows the "bulldozing" effect of the base of the pile.

3 Toe of tailings pile on north side of monitor No. 27. Exposed material at base of slope is native soil, unfrozen. Slope of tailings pile near toe varies between  $32^{\circ}$  and  $37^{\circ}$ .
