Site Visit to UKHM Sept 19-20, 2007

Glenn Ford

Oct 26, 2007

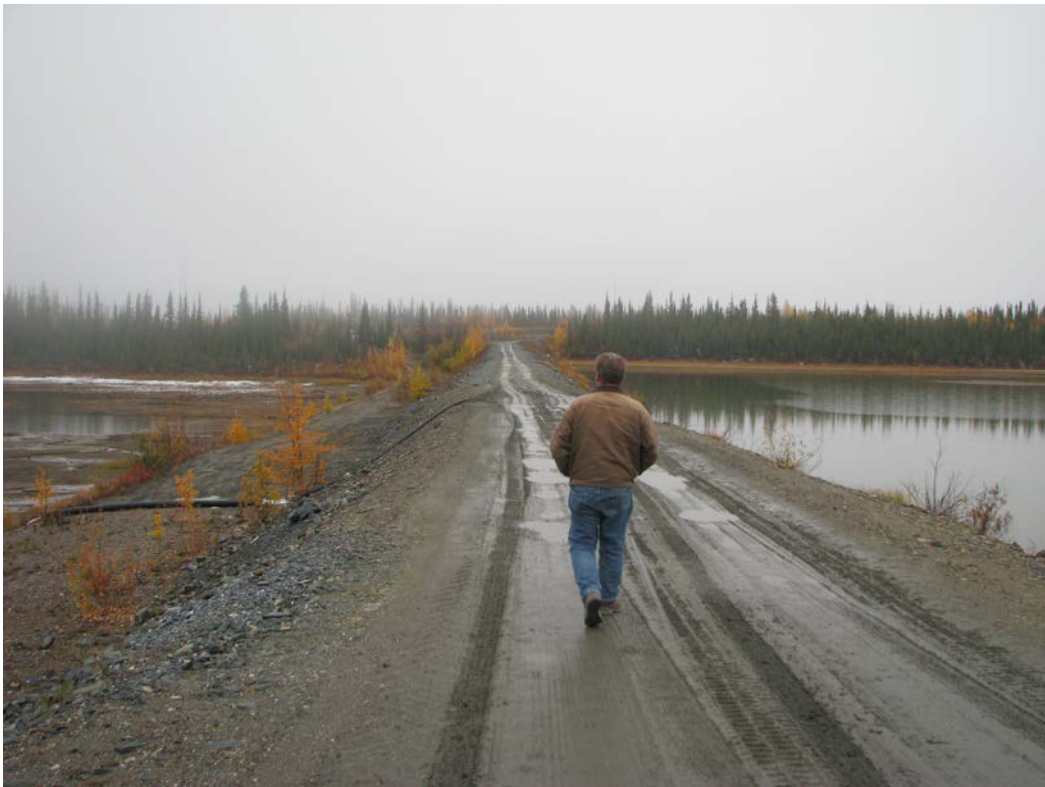
Crest of dam 1. Note low area of crest ahead of Frank Patch. Siphon hose can be seen

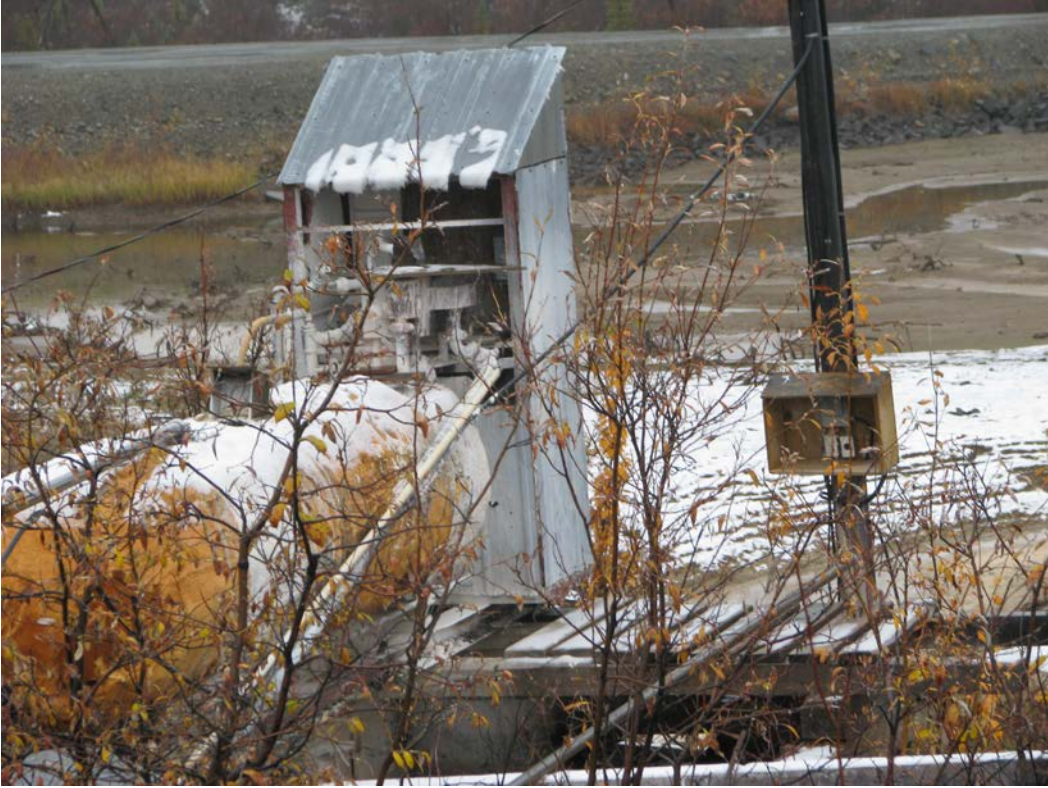
Treatment system from dam 1. Not in use

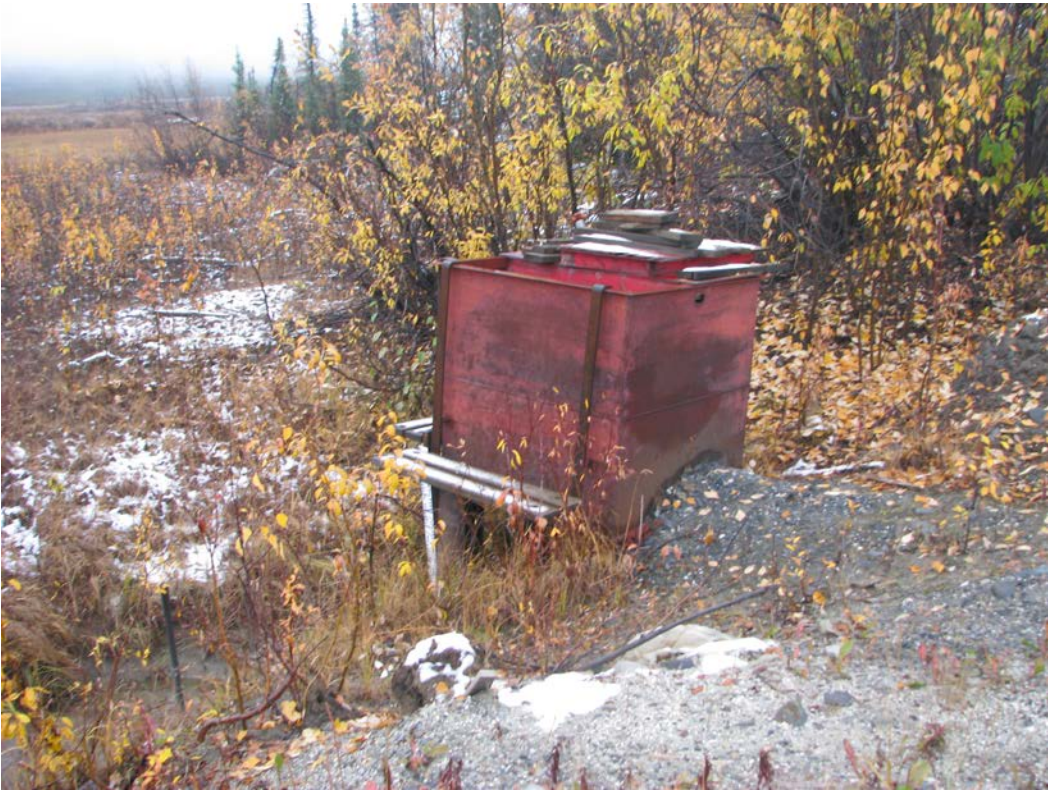
Decant system from dam 1. Water level well below decant invert.

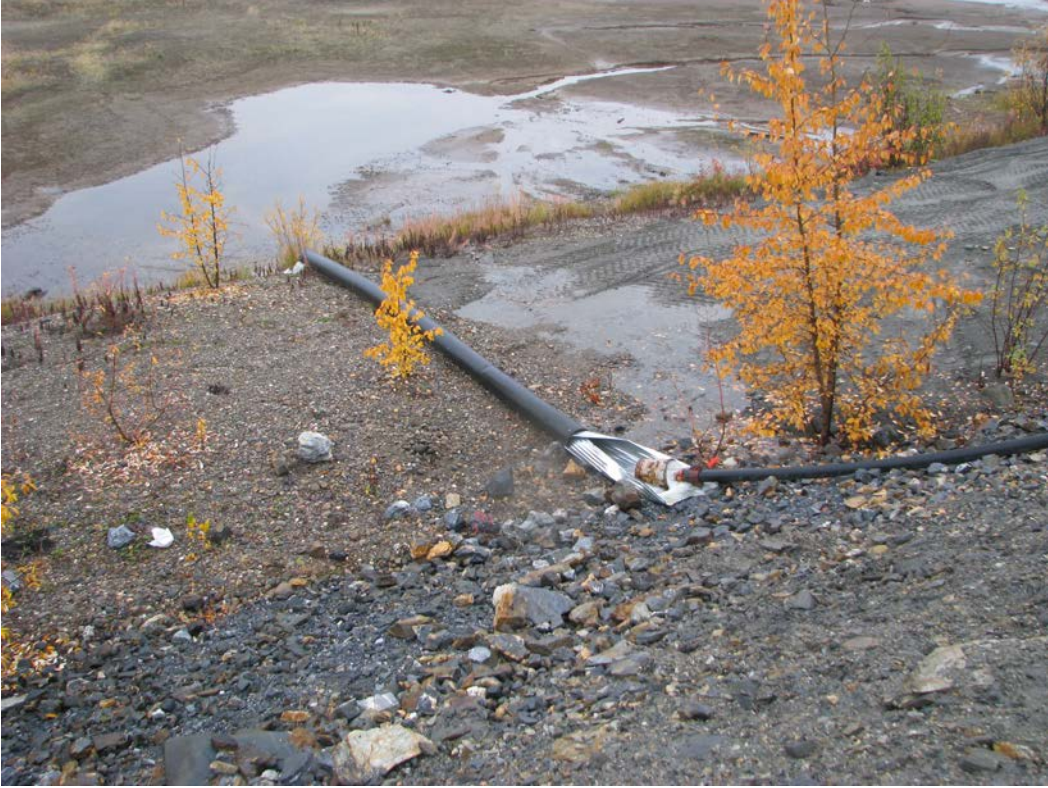
Siphon hose on dam 1 discharging into pond two

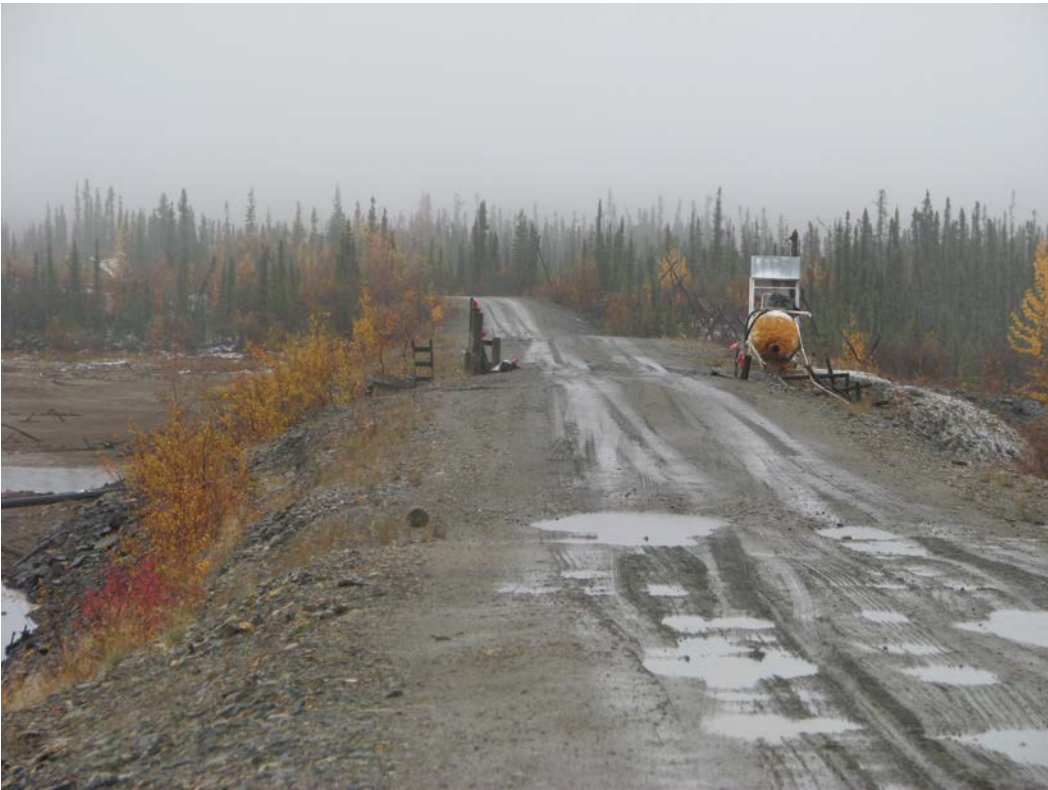
Water treatment system on dam 2 at location of low level structure

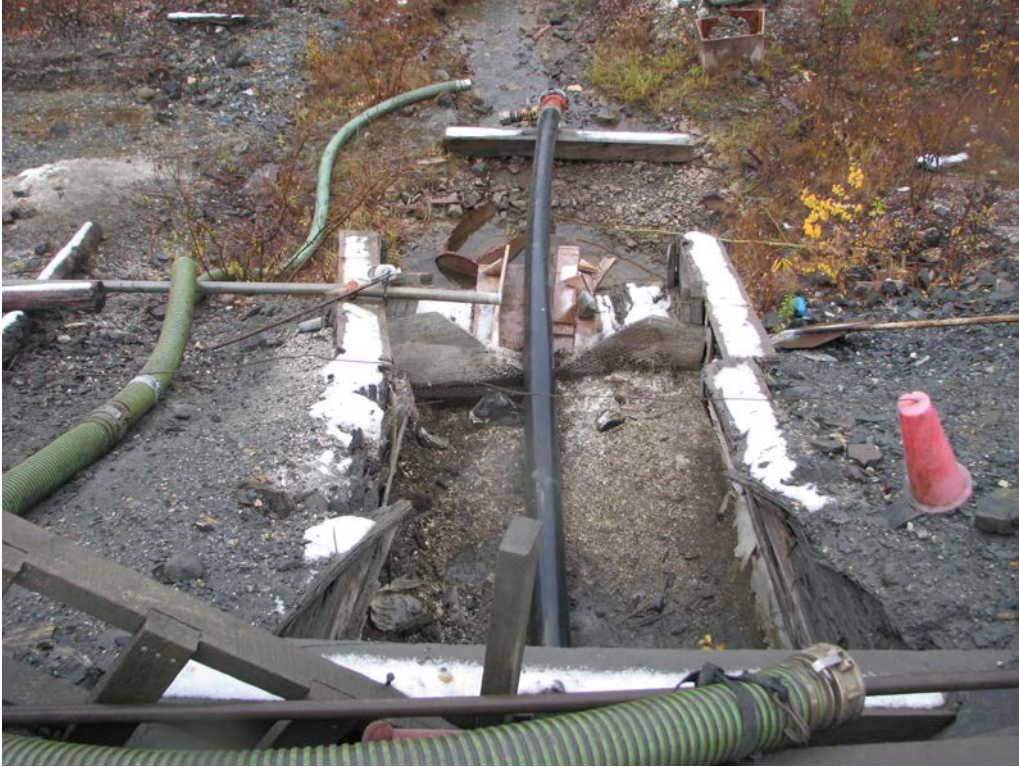
Downstream side of dam 2 outlet structure. Note poor condition. Siphon hose in place

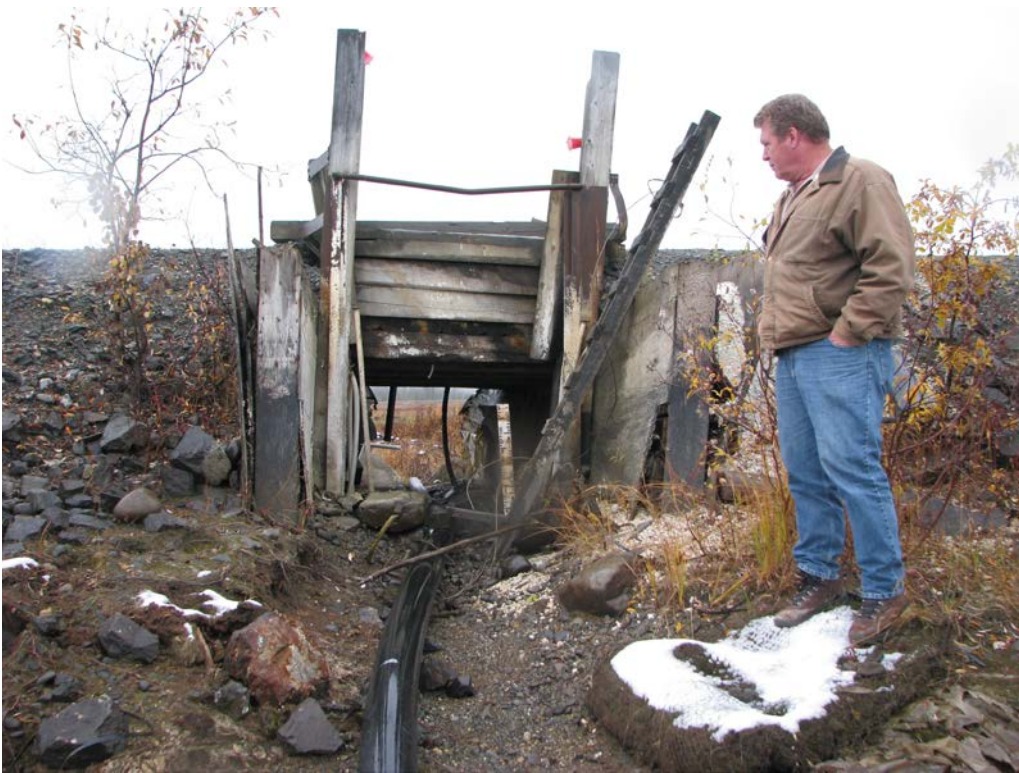
Frank Patch at D/S side of outlet structure Dam 2

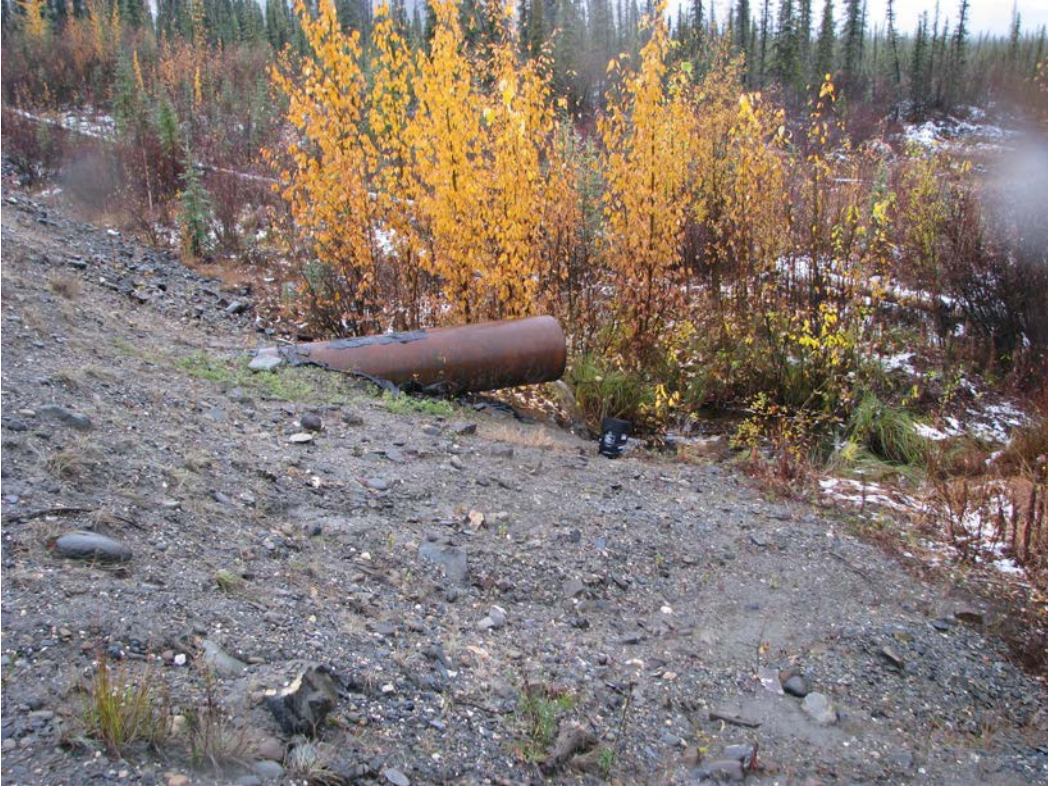
Outlet pipe on dam three. Some flow

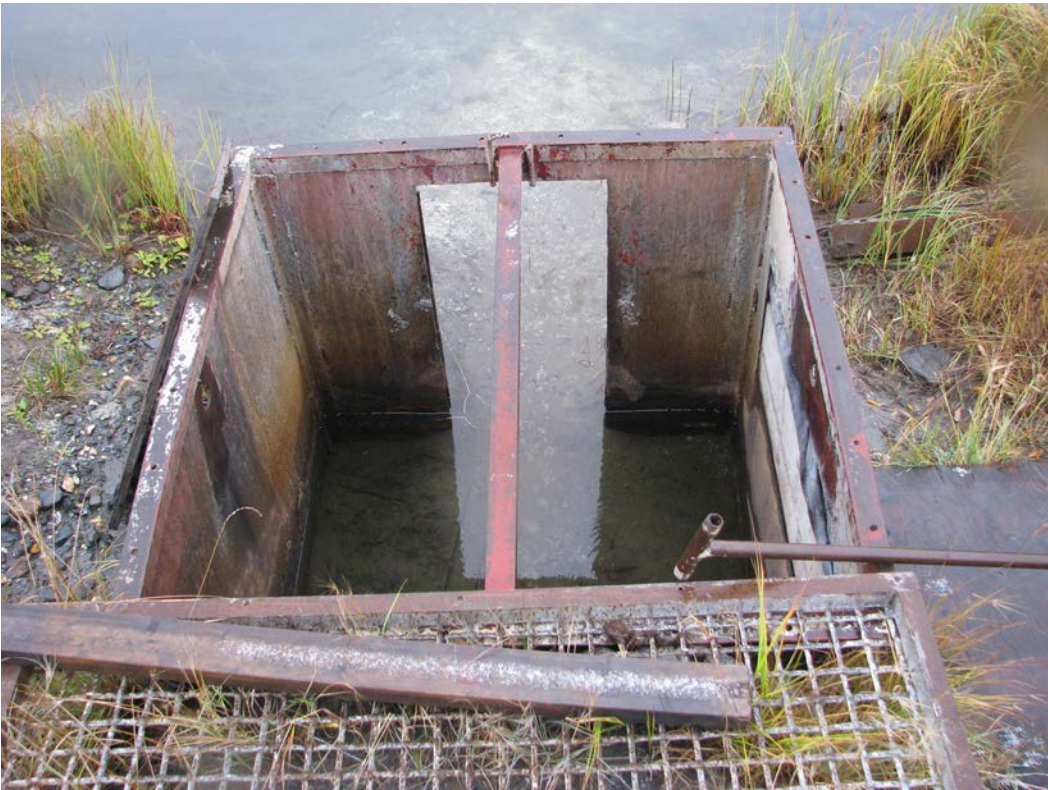
Dam three outlet structure. Upstream side
