12 Oct 2016

To: Faro Mine Site - Yukon Government

Mitigation of Flicker on Meters at IWTP

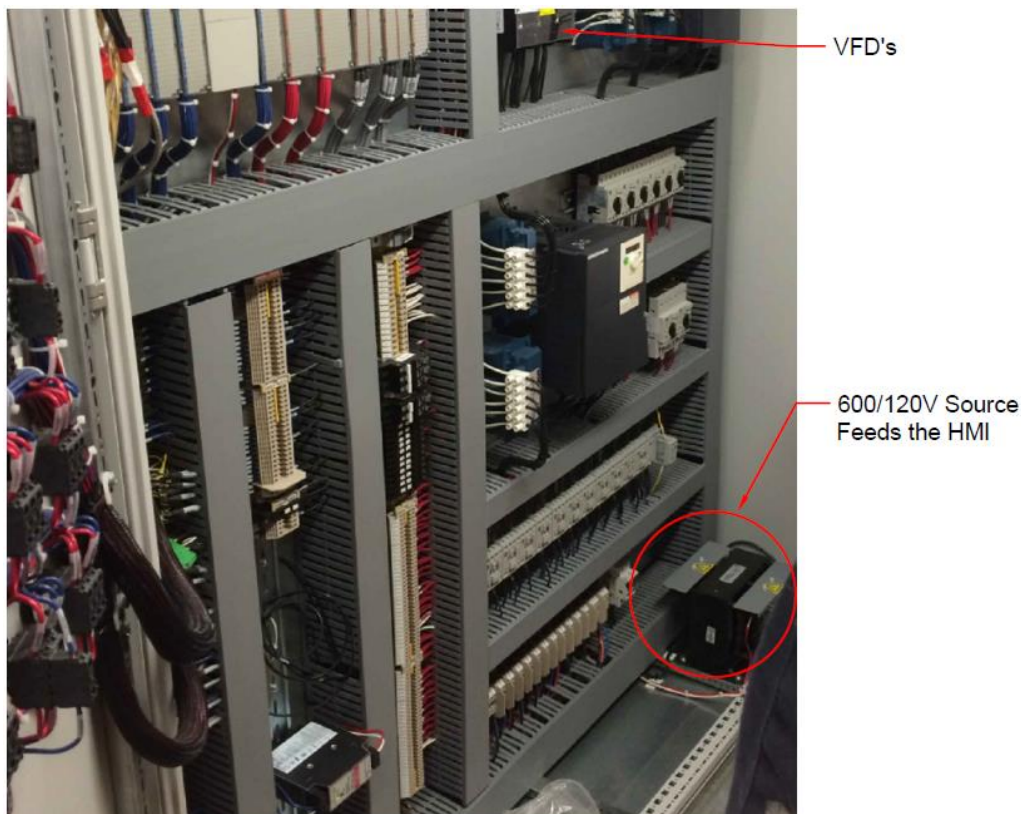
Fig.1

System information displayed on the HMI for the Flow meter, PH and Turbidity readings at the IWTP was observed to flicker continuously. We suspected the cause of this flicker was intersystem ground noise. This type of noise is most likely caused by the VFD's located in the same enclosure as the power source that feeds the HMI.

The major path for this intersystem coupling to occur is through the metallic surface of the enclosure that electrically connects the "referenced ground point on the negative terminal of the 120V HMI source" to the "VFD earth ground".

To get an idea of the amount of noise generated by the VFD and possibly other noise generating components in the cabinet, we measured the voltage from the metallic surface of the enclosure to an external ground point and observed 10's of mV in the kHz range. This difference in potential is the major cause of the ground loop between the VFD cabinet and the HMI cabinet.

The long term solution is to bring in a reference point to the -120V terminal that is away from the noise generated by the VFD. To do this we recommend following the steps outlined below:

- a) De-energize the cabinet shown in figure 1.
- b) Using the same gauge of wire coming out of the 120V terminals in the cabinet, run a wire from a grounding point outside the building to the cabinet. (There are many points to do this near the 2MVA - 25kV/600V transformer).

- c) Connect an insulated terminal block inside the cabinet where the HMI 120V source resides.
- d) Connect the grounded wire from the exterior of the building to this terminal block.
- e) Remove all wires connected to the -120V terminal and reconnect just the white “-120V” wire that feeds the 120V circuit to the insulated terminal block from part “c”.
- f) Connect a single wire from the -120V terminal to the insulated terminal block.
- g) Ensure all terminals on the insulated terminal block are shorted together and isolated from the housing.
- h) Re-energize the cabinet and observe the flicker on the PH meters.
- i) If the problem persists, try different grounding points outside the building.
