Supplement to the Preliminary Breach Design Fresh Water Supply Dam, Faro Mine

Project Reference Number:
SRK 1CD003.22

March 2003

**SUPPLEMENT TO THE PRELIMINARY BREACH DESIGN REPORT
FRESH WATER SUPPLY DAM, FARO MINE**

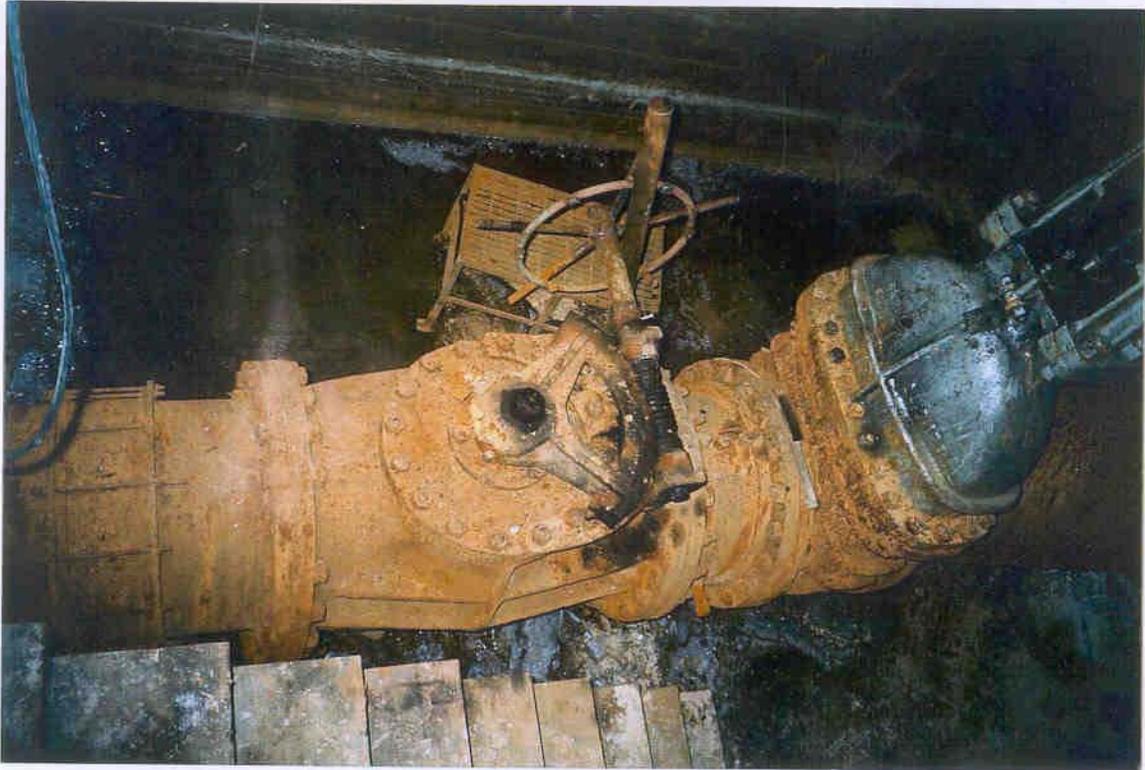
The components of the pipe work within the low-level outlet structure valve chamber differ from the details shown on the "as-built" drawings. The principal difference is the presence of a 24-in-diameter spool piece 14.5 in long between the gate valve and the plug valve (Photos. 1 and 2). The spool piece previously housed a flow meter. Mr. Bryson reported that the tappings in the left and right wall of the pipe that housed the meter sensor leaked badly. The sensor was removed and the tappings were replaced and capped. The type of meter has not been established, but was probably either a vortex or positive displacement type, although it is not known how power was supplied to provide the 4 mA signal current required by the Moore Industries Inc. Linear Integrator mounted in a box on the wall of the chamber entrance vestibule. In addition to the two sensor tappings, there are two small shutoff cocks and a plugged tapping in the top of the spool piece.

Photo. 1 Outlet structure valve chamber pipe work, flow is from right to left. Note spool piece between gate valve (at right) and plug valve.

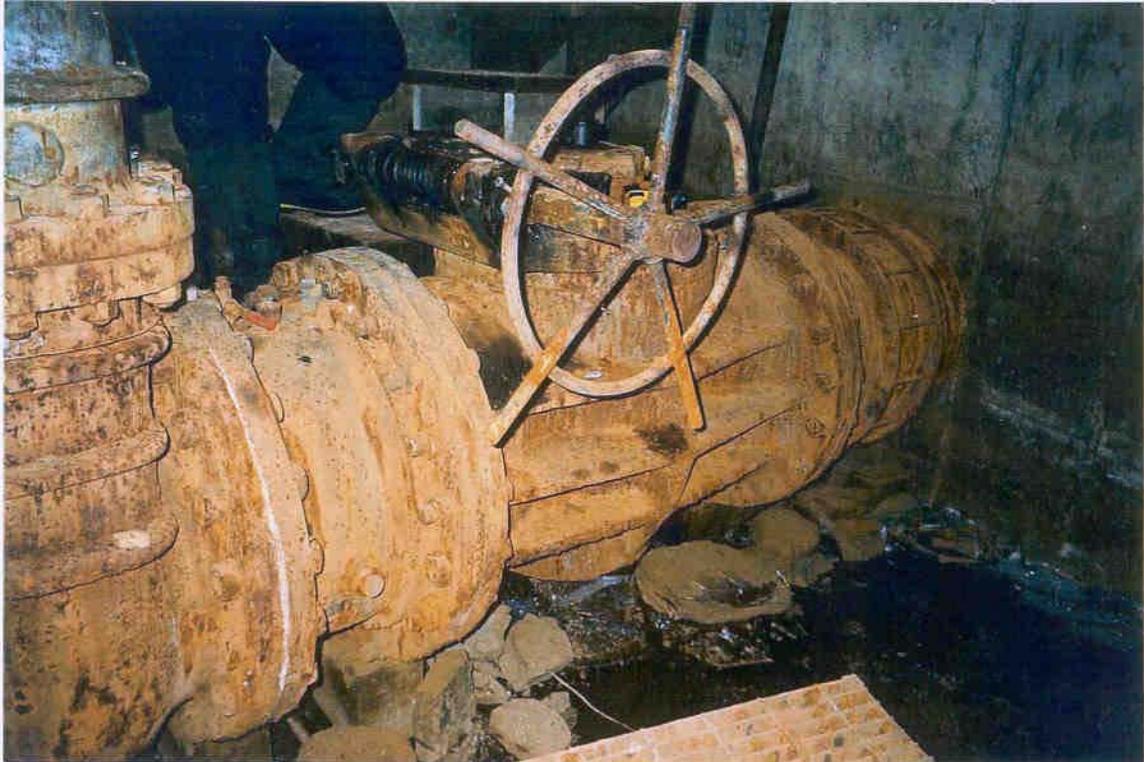
Photo. 2 Side view of spool piece and plug valve. Note small concrete plinths beneath flanges of spool piece, but not beneath d/s plug valve flange.

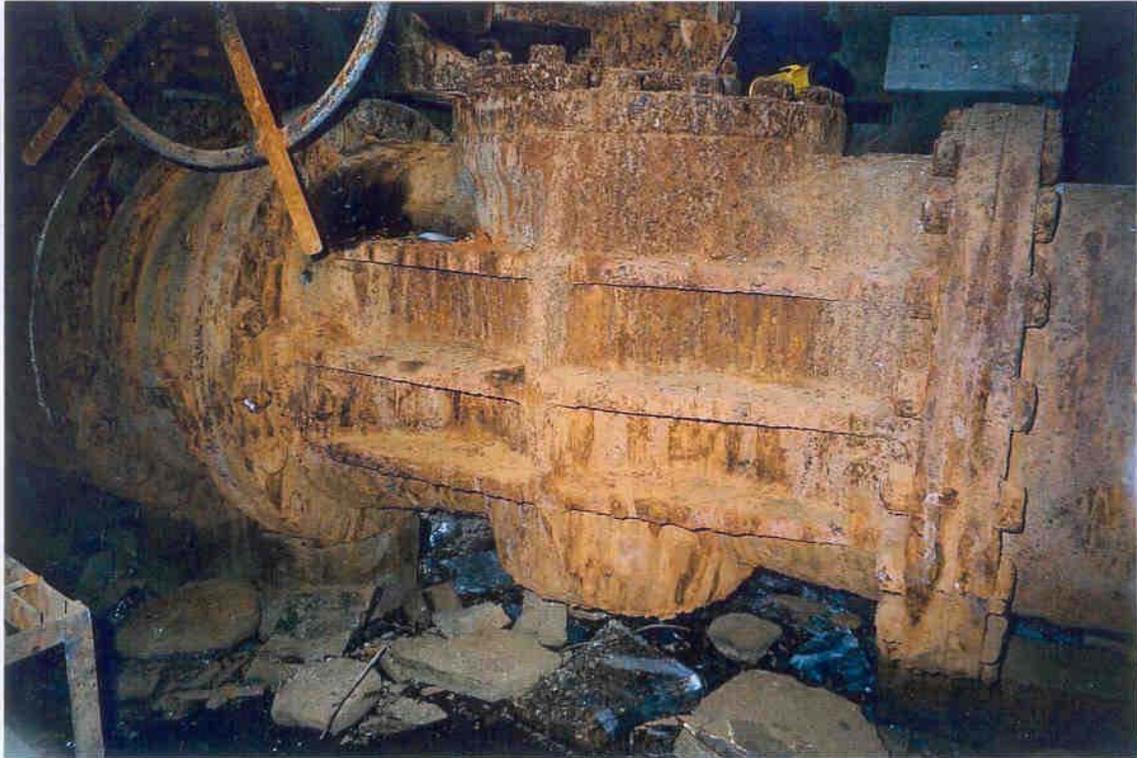
Photo. 3 Close up of plug valve. Downstream end unsupported except for what appeared to be a piece of timber

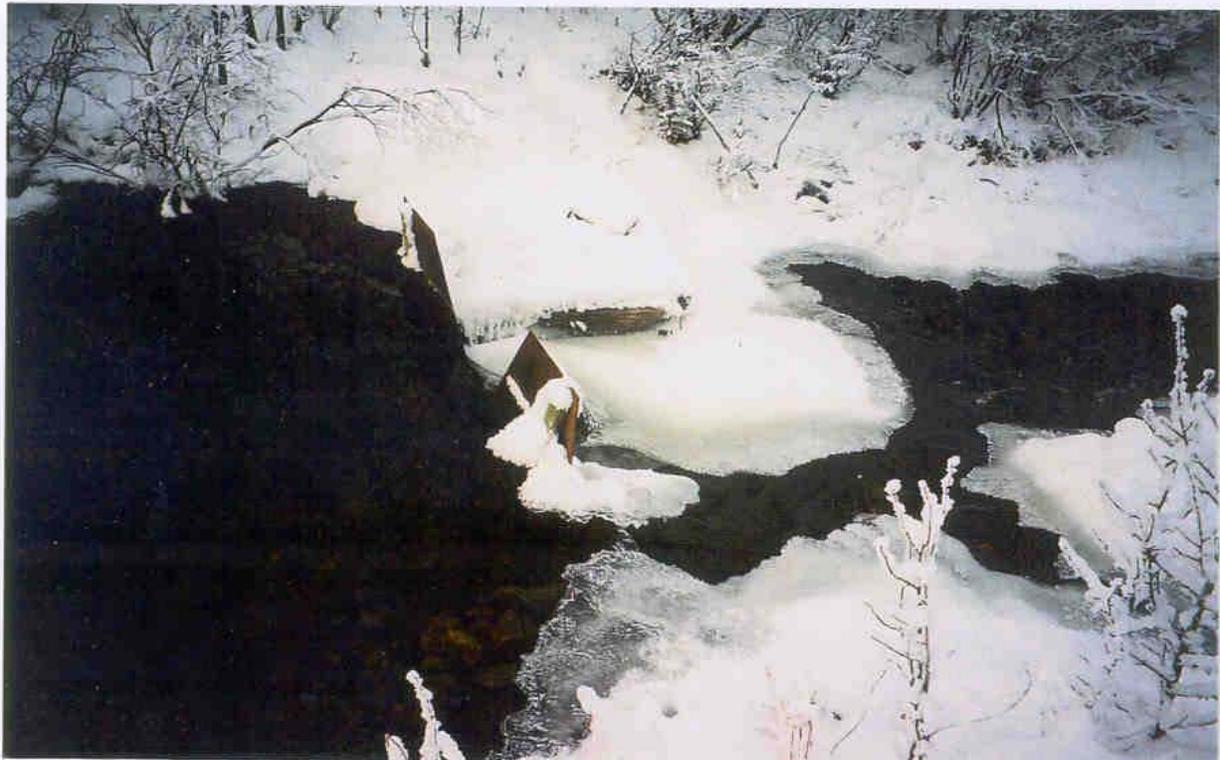
Photo. 6 V-notch weir plate in discharge channel. Note flow bypassing plate on right hand side.

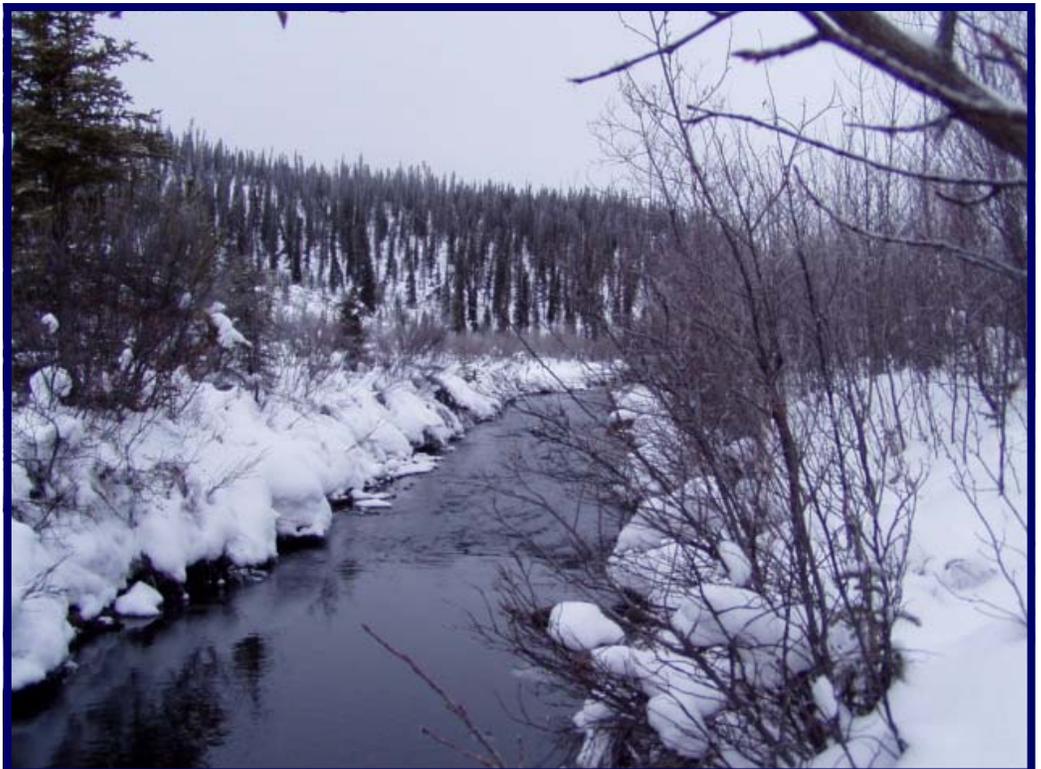
**Photograph 14**

View of the fresh water channel, looking downstream. Note: bank heights on the LHS of the photo.

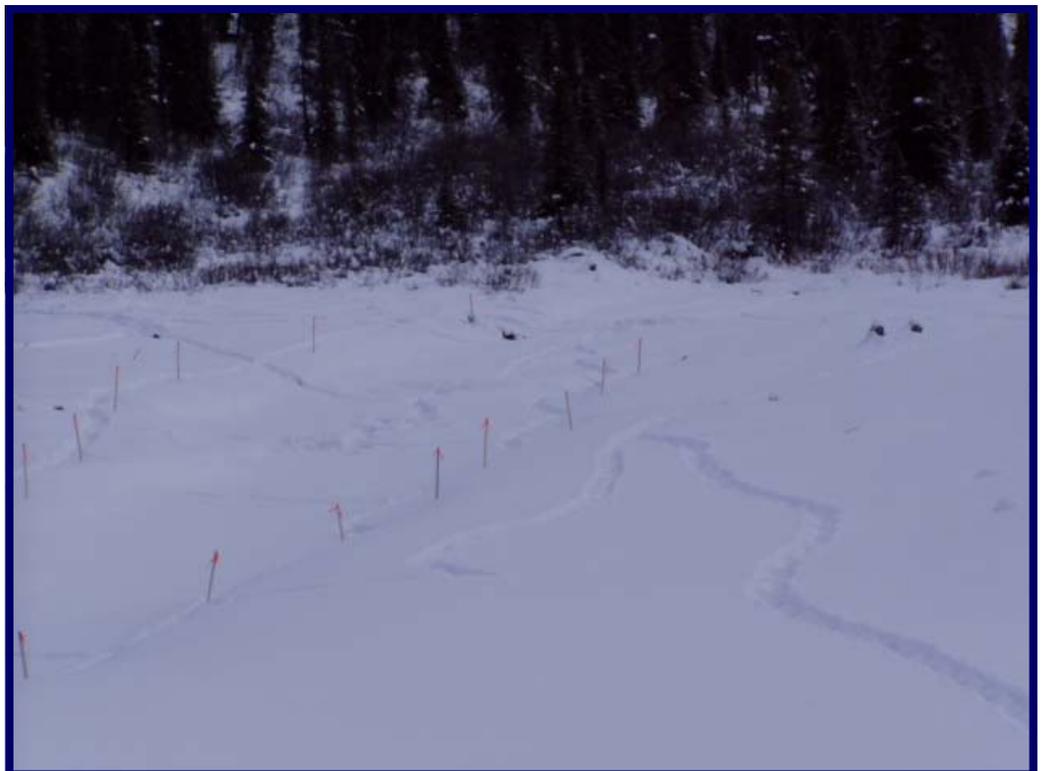
**Photograph 16**

South Fork of Rose Creek. Note the stakes marking the position of the channel. This portion of the channel would normally be within the reservoir outline.

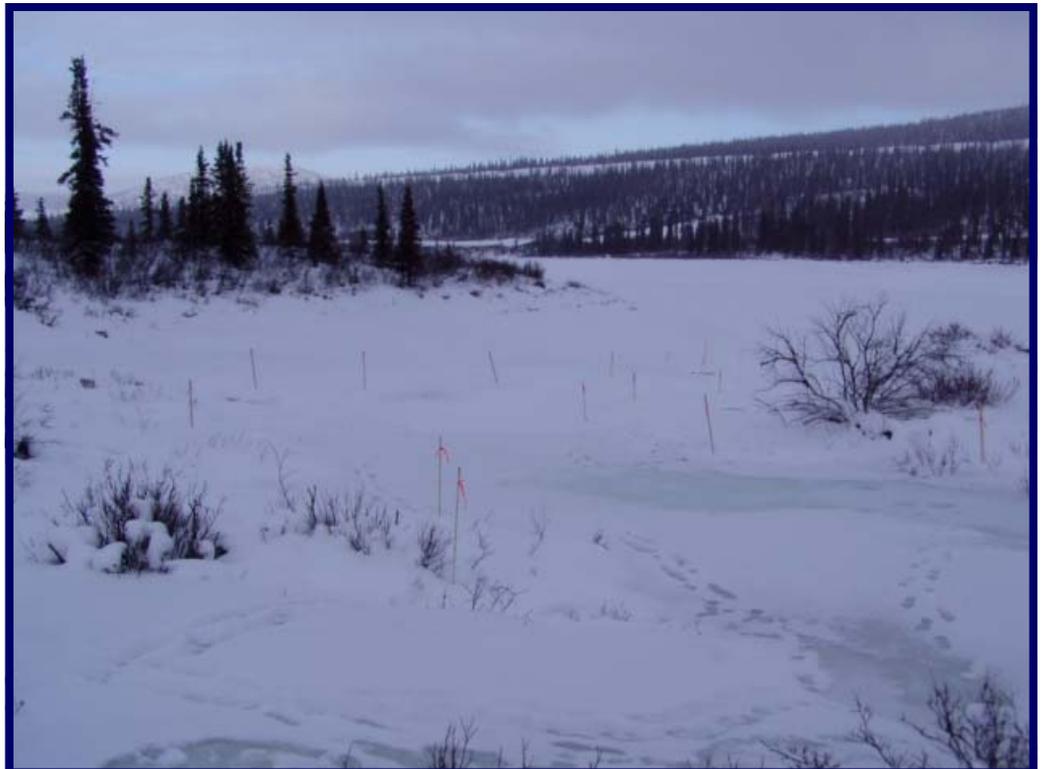
Photograph 18
Southeast tributary as it enters the reservoir. Note the stakes marking the position of the channel.
