**Government of Yukon
Water Resources Branch
United Keno Hill Mine, YT
2007 Geotechnical Inspections**

Prepared by:
UMA Engineering Ltd.
1479 Buffalo Place
Winnipeg, Manitoba, R3T 1L7

UMA Project No.: 6029 010 00 (4.10.4)

February 2008

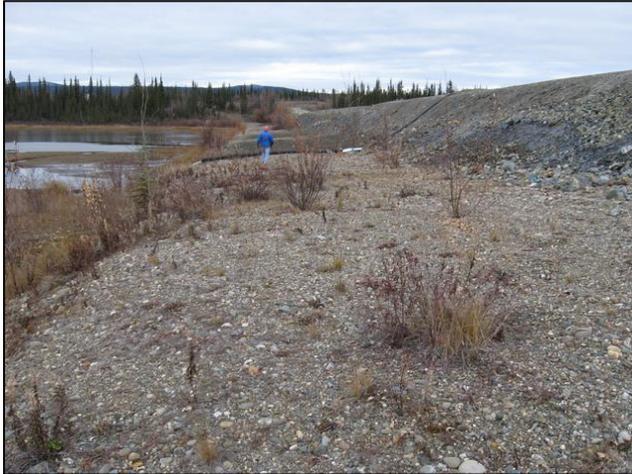
Dam 1 is rock fill structure about 5 m in height and about 800 m long. The freeboard at the time of our inspection was estimated to be 2 m. Two culverts originally installed through the base of Dam 1 have since been abandoned although the discharge end of the most northerly culvert is still visible. Downstream side slopes are estimated to range from 1.5 horizontal to 1 vertical (1.5H:1V) to 2H:1V. The crest elevation is uneven and it appears that fill has recently been added along the top of the dam at several locations to restore the design crest elevation. An 8 m wide toe berm, about 1.5 m high has been added on the downstream side of the dam (Figure 04). Sections of the toe berm that have apparently settled have been filled with darker coloured granular material. Iron staining visible on the downstream slope above the top of the toe berm is indicative of a seepage flow path exiting above the toe berm, although no seepage was noted during the inspection (Figure 05).

Figure 04 Downstream Toe Berm

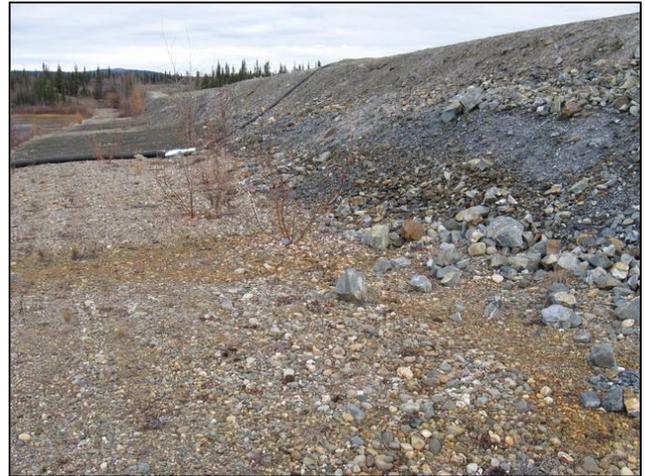
Figure 05 Iron Staining

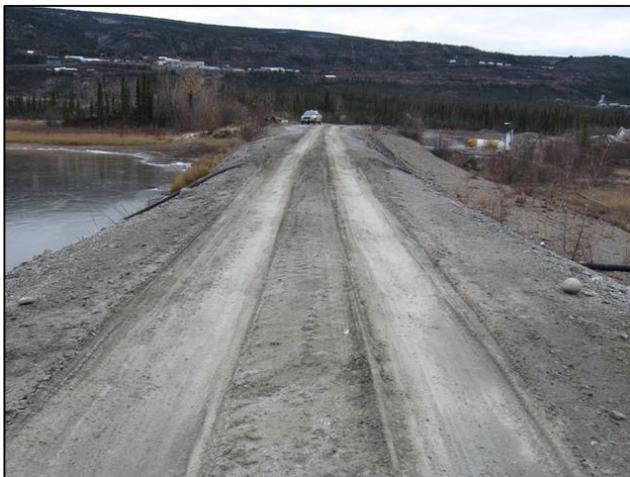
Water from Pond 1 was being siphoned over Dam 1 at the time of our inspection through a 150 mm diameter pipe (Figure 06). A larger pipe on the toe berm conveyed water into Pond 2 (Figure 07). A decant weir consisting of a steel box with stop-log gates located near the south abutment is in good condition although not in use at the time of our inspection (Figure 08). There are three openings in the structure fitted with stop log guides. A 900 mm diameter corrugated metal pipe (CMP) discharges water from the decant weir through the dyke to a lime addition plant on the downstream side (Figure 09). Two steel pipes inside of the CMP are likely for heating. The water level in Pond 1 was well below the base of the decant weir although corrosion on the lower half of the structure provides an indication of previous pond elevations.

Figure 06 Siphon Over Dam 1

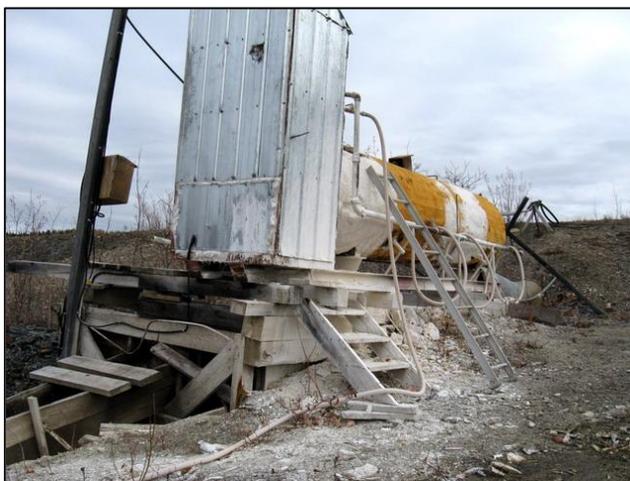
A 900 mm diameter corrugated metal pipe connects the decant weir to a lime addition plant consisting of an insulated slurry tank, mixer and discharge chute (Figure 10). The plant is in some disrepair and it appears that the inlet culvert through the dyke has settled relative to the inlet to the lime plant (Figure 11). Armouring on the upstream side of the dam is sparse for the first 30 m north of the south abutment and was limited to coarser dyke fill material up to 250 mm diameter exposed from wave action (Figure 12). Between the siphon and middle of the dam, the armouring consists of riprap with an estimated maximum size of 250 mm and a D_{50} of 150 mm. The armouring along this stretch is in good condition (Figure 13) with the high water mark (evidenced by iron staining) visible about 1 m below the crest. The upstream slopes in this stretch are in the order of 1.5H:1V to 2H:1V. A staff gauge in Pond 1 read 0.81 m.

Figure 10 Lime Addition Plant

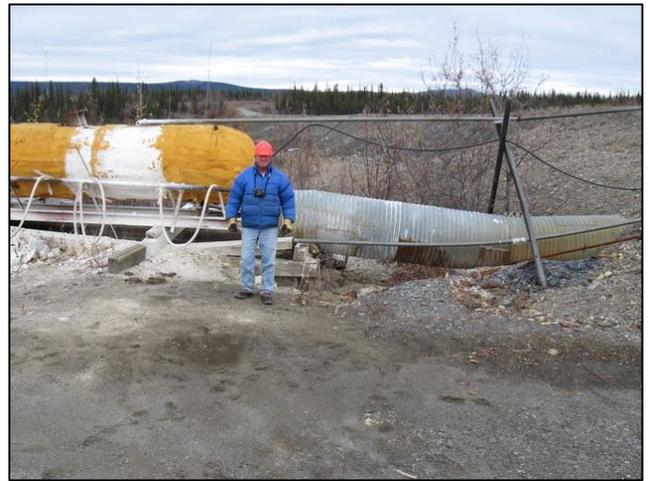
Figure 11 Settlement of Lime Plant Inlet Pipe

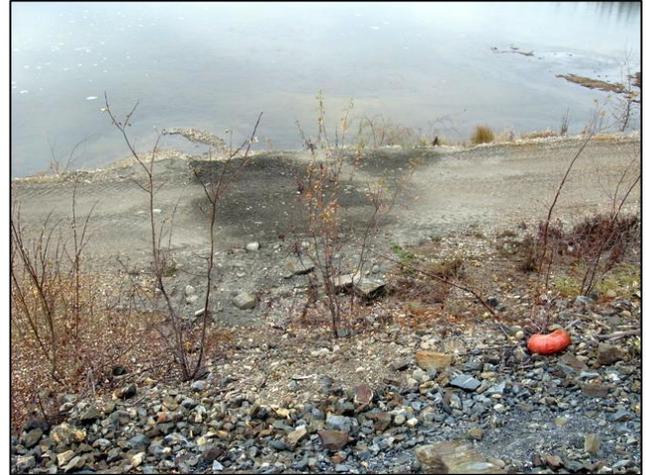
appears that the crest has been raised by about 0.75 m and the downstream slope at the toe berm area has been recently filled (Figure 17 & 18). Iron staining on the downstream slope surface is also visible. There is also minor longitudinal cracking (about 7 m long) along the downstream edge of the crest at this location (Figure 19).

Figure 17 Toe Repair Area

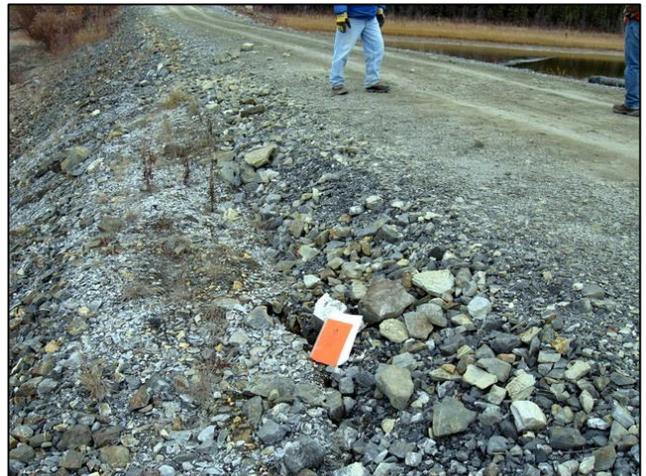
Figure 19 Longitudinal Cracking

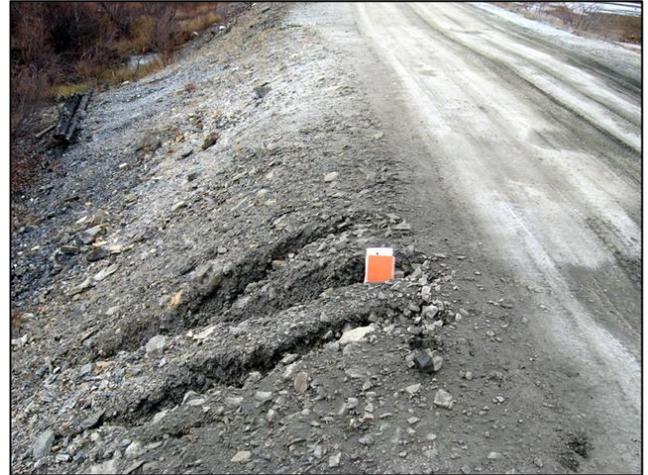
Figure 21 Rilling on D/S Edge of Crest

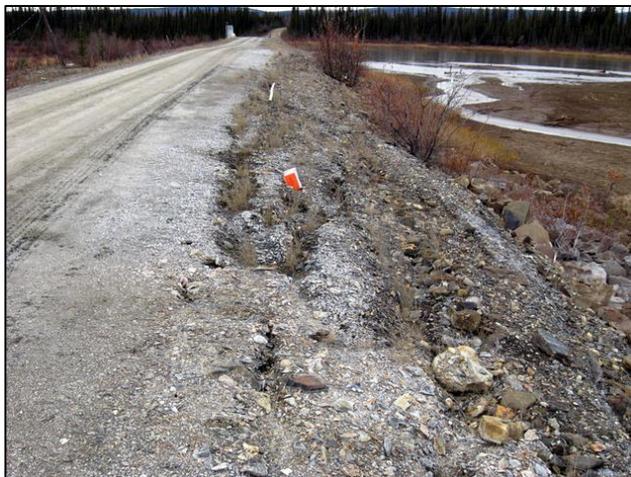
Lateral spreading along the upstream edge of the crest and upstream slope begins about 165 m south of the decant outlet. At the south end of this area, the tension cracks appear old and are up to 75 mm wide (Figure 22). More recent (active) cracking is apparent in a northerly direction along the dam towards the decant outlet where they have extended to within 2 m of the centerline of the dam (Figure 23). Vertical slumping in this area is estimated to be up to 300 mm. Riprap along the upstream toe may be associated with previous repair measures.

Figure 22 Tension Cracks and Slumping

The stability of the dam, in particular where significant deformations are occurring is considered marginal. A failure of Dam 2 could have a significant environmental consequence if Pond 3 cannot safely store the volume of water released from Pond 2.

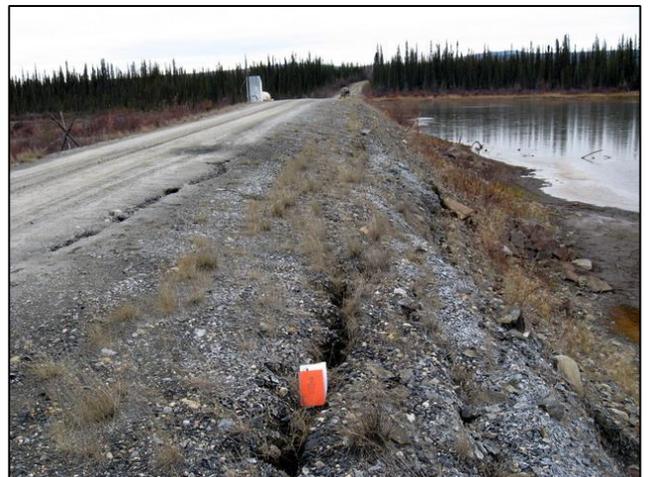
Figure 23 Tension Cracks Extending to CL

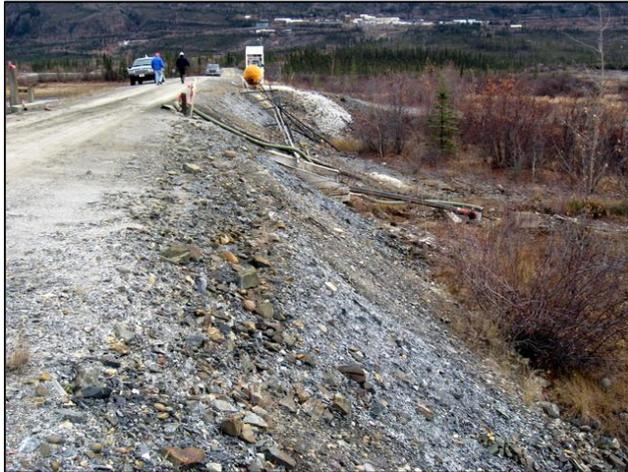
A decant outlet (weir) and lime addition system are located near the middle of the dam (Figure 24). The timber decant outlet is in very poor condition and on the verge of collapse (Figure 25). A 150 mm diameter polyethylene line siphons water from pond 2 into Pond 3 at this location, although it was not in

Figure 24 View S at Decant Weir and Lime Mixer

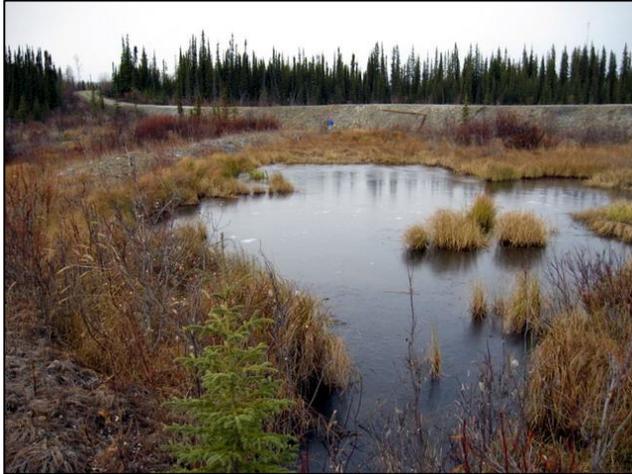
A secondary containment dyke is visible on the downstream side of Dam 2 at the weir (Figure 28). It is believed that it was an emergency dyke built sometime before the construction of Dam 3 (SRK, 2005). The dyke is about 1 m high with a 900 mm diameter culvert installed near the north end (Figure 29). The toe of Dam 2 was noticeably soft and wet at the junction of the secondary containment dyke.

Figure 28 Water Behind Secondary Dyke

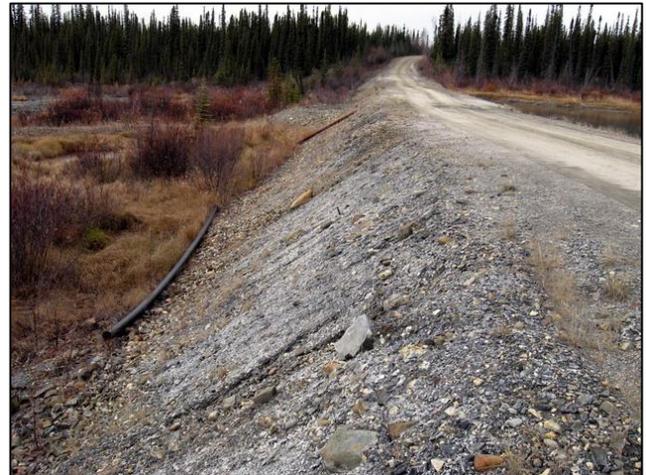
The armouring along the upstream edge extends for about 15 m north of the weir beyond which, there is no upstream erosion protection until about 15 m from the north abutment (Figure 30). Erosion of the unprotected dam slope in this stretch is minor. The maximum rock size visible is in the order of 100 mm. Downstream slopes are steep at about 1H:1V (Figure 31).

Figure 31 D/S Side N of Weir (view N)

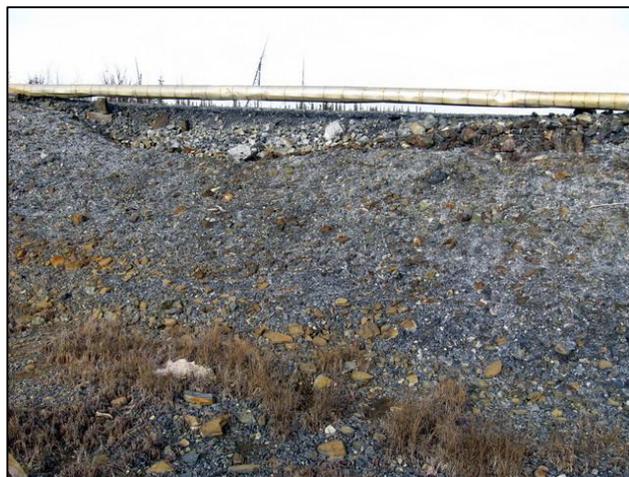
Dam 3 consists of two segments separated by naturally high ground. The total length including the high ground is in the order of 425 m. An abandoned culvert crosses the south segment of Dam 3 where the dam has also been considerably widened (Figure 32). The upstream end of the culvert has collapsed and the downstream side is not visible (Figure 33). Significant settlement of the crest over a 40 m stretch

is evident just north of the culvert crossing where up to 1.2 m of fill has been added (Figure 34). A granular pad has been placed on the downstream side of the dam at this location although the function of the pad is unclear (Figure 35). Iron staining on the granular pad indicates active seepage at this location. The upstream shoreline is grassy with little to no active erosion.

Figure 34 Crest Fill on DAM 3

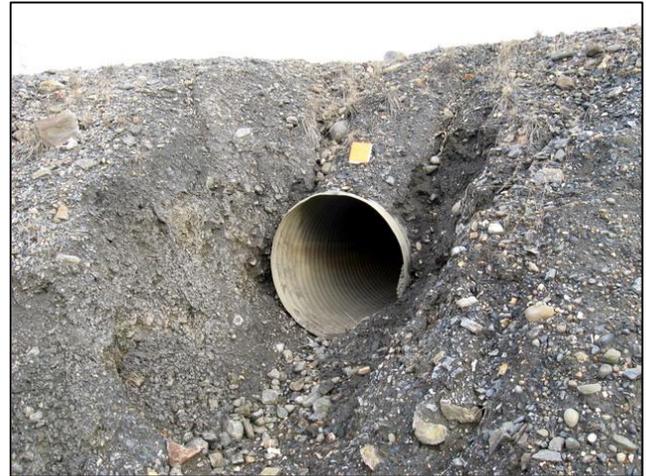
A 900 CMP culvert is located near the south end of the north segment of Dam 3 (Figure 36). The culvert looks relatively new with no deformation or deflections visible throughout its length. The bottom of the inlet is partially blocked with timbers, likely to regulate upstream water levels. A non-woven geotextile cover has been cut open. The purpose of the geotextile is unclear but it may be for sediment control. Erosion of the downstream slope has occurred where the end of the culvert is recessed (Figure 37). The culvert is believed to be an emergency spillway for Dam 3 (SRK, 2005).

Figure 37 Erosion at Culvert Outlet

- Evaluate the hydraulic capacity of the emergency spillway on Dam 3, in particular with respect to failure of upstream dam(s) or the Porcupine Creek Diversion.
- Evaluate the need for Dam 2.
- Evaluate the stability of all of the dams and structures and identify appropriate improvements.
- Evaluate condition and extent of armouring on upstream dam slopes and add material where necessary.
- Cut saplings on upstream and downstream dam slopes.
- Survey dam crests to identify low areas (below design crest elevation) and fill as required.
- Armour the gravel dyke at the headwater for the Porcupine Creek Diversion Channel.
- Repair scouring of dam slope and toe at downstream ends of culverts through Dam 3. Extend 900 mm emergency spillway culvert and construct spill pads to dissipate energy at culvert ends.

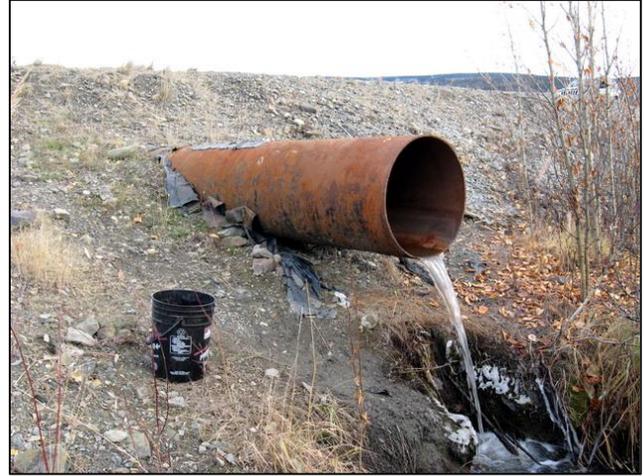
The main control structure for Dam 3 is located at about mid-point along the north dam segment where the upstream slope has been widened to about 18 m (Figure 38). The structure consists of a steel decant box with stop-log guides on the inlet end (Figure 39). The wooden gate (not in use at the time of our inspection) fits into the stop-log guides. A 750 mm diameter steel pipe fastened to the box runs through the dam exiting about 1.5 m above the toe (Figure 40). A flow rate of 0.2 litres per second was measured using a 5 gallon pail. A scour hole has developed at the unprotected toe of the dam (Figure 41).

Figure 41 Decant Structure Outlet Pipe

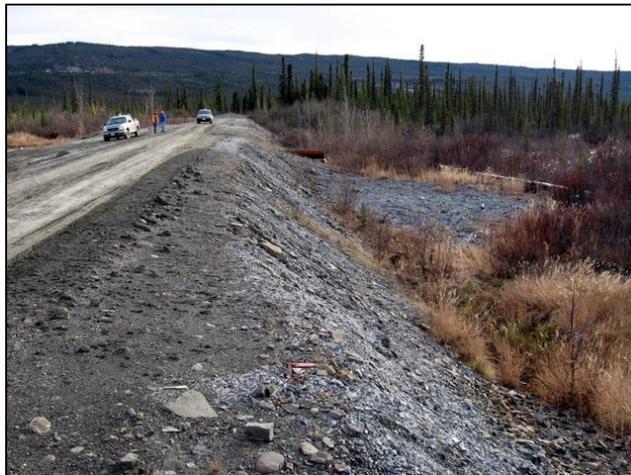
A gravel pad has been placed on the downstream side of the dam for about 25 m north of the decant structure, possibly in an area of seepage (Figure 42). Iron staining on the downstream slope just above the toe in this vicinity suggests that seepage through the dam occurs but probably only visibly during higher water levels in Pond 3. The upstream shoreline is grassy and stable (Figure 43).

Figure 42 Gravel Pad N of Decant Weir

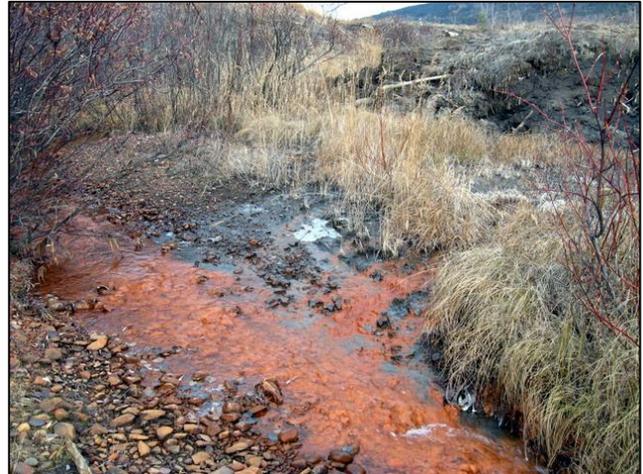
The Porcupine Creek Diversion diverts water around the TMA. The headwater for the diversion is along the natural creek channel between the mill and tailings impoundment referred to as Brefalt Creek on the Plant Site Drawing. A gravel berm or dyke diverts water into the diversion channel, preventing it from entering Pond 3. The author did not inspect the diversion channel itself but observations provided by Mr. Glenn Ford indicated it was flowing with no visible channel blockages. Previous inspections indicated that the channel is cut through natural ground, comprised of stratified silts and sands covered with muskeg. These deposits are apparently ice-rich and thawing continues resulting in sloughing of the bank (Geo-Engineering, 1996). The channel upstream of the diversion is cut through what appears to be natural material. Water first appears in the channel as ice (Figure 44) where the diversion channel banks are about 2 m high (Figure 45). From this point, the creek channel runs westerly until joining the diversion at the gravel dyke (Figures 46-48). Iron staining is visible at numerous locations along the diversion (Figure 49).

Figure 49 Iron Staining in Creek Channel Bed
