KENO HILL PROPERTY
VALLEY TAILINGS REVEGETATION ASSESSMENT
2008

DRAFT
JANUARY 2008

Valley Tailings Revegetation Assessment - Elsa Silver Mine

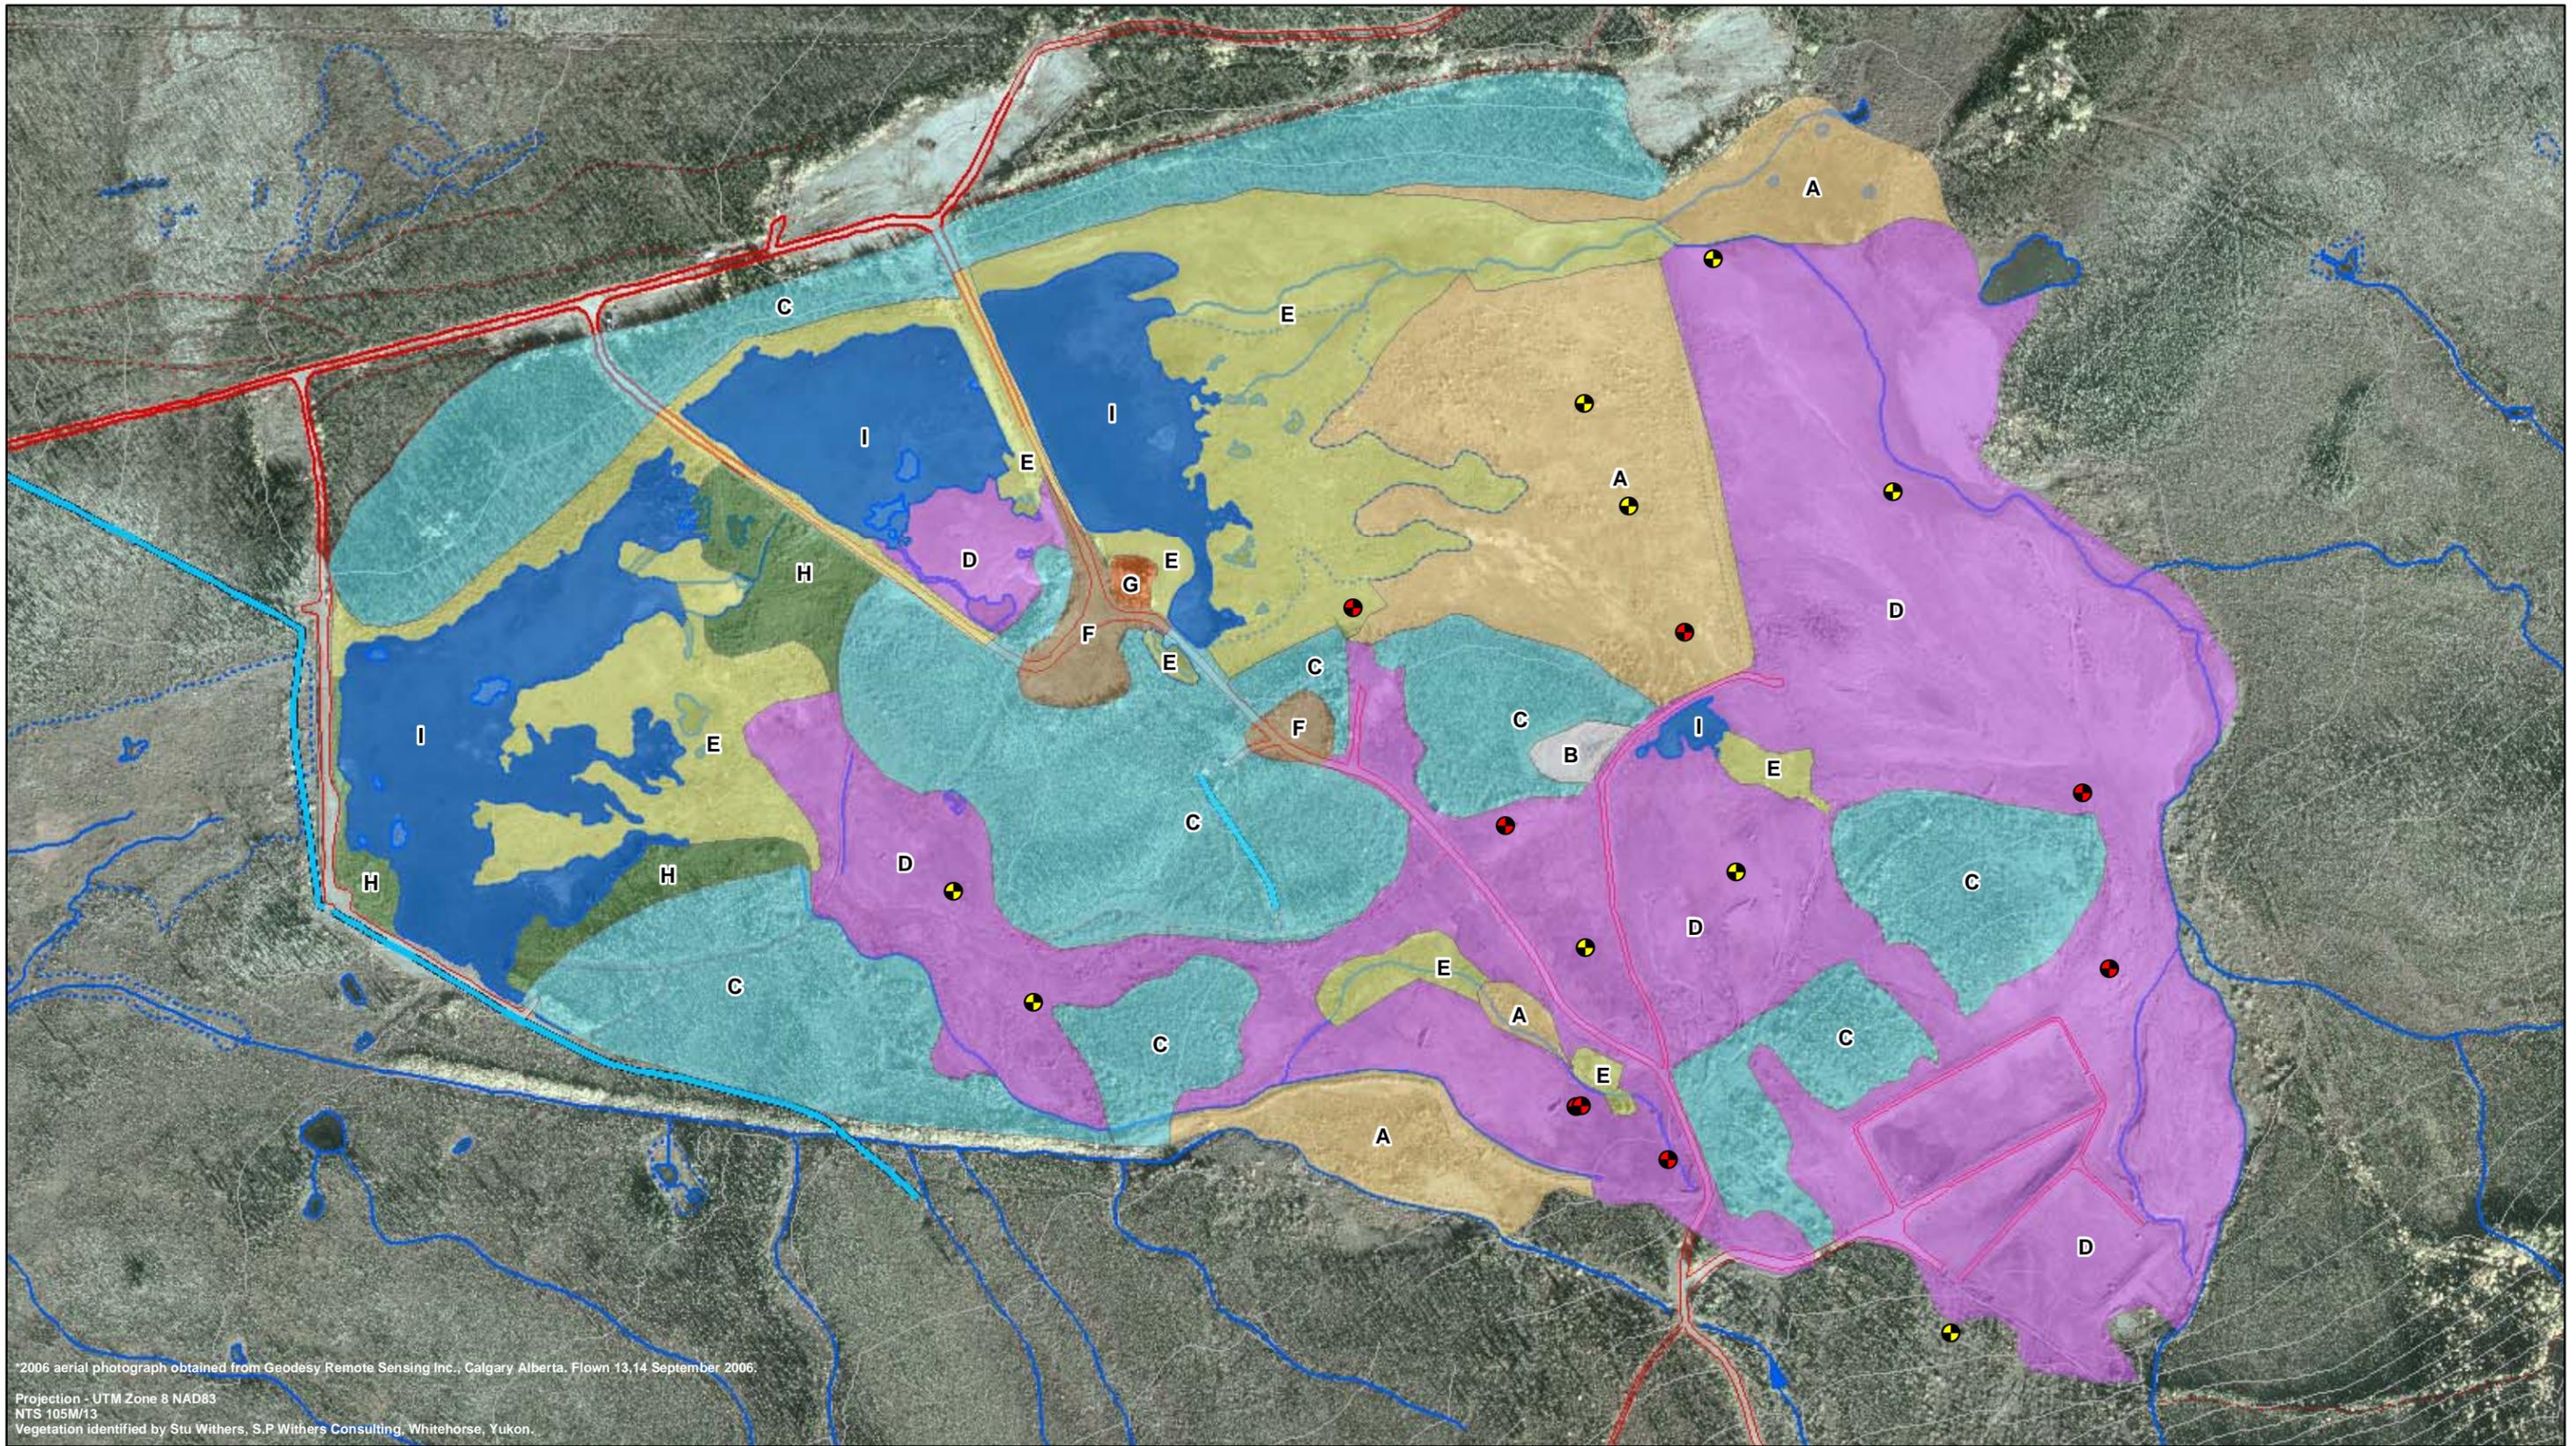
VALLEY TAILINGS VEGETATION TYPES

The following vegetation types were observed on the valley tailings during the 2007 assessment (the approximate extent of each vegetation type is delineated on the accompanying aerial photograph):

D) Barren

These barren areas are void of vegetation. Some of these areas are higher dry ground while other areas are seasonally flooded.

Of the ha of current tailings impoundment, approximately ha remain almost void of vegetation (see areas delineated as Barren on attached air photo). These barren zones include sections of both the east and west tailings areas. In order to resume efforts to revegetate these areas, while benefiting from the insight gained from the earlier field trials, the following steps are recommended:

The results of these analyses should help characterize the current state of the impounded tailings. The results may also shed some light on why there is no vegetative growth on the barren areas of the tailings, Vegetation Type D (Barren) on the air photo, compared to the areas where natural revegetation is occurring, particularly Vegetation Type A (Willow Regeneration).

- A field survey of the unvegetated area of the tailings should include (at a minimum) a series of transects with in-situ measurements of soil pH and moisture content at rooting depths (2-10 cm) and an examination of the current surface penetrability.

- If the character of the unvegetated tailings has not altered significantly since the field trials of the early 1980's, experimentation with soil caps should commence. This could include the establishment of test plots with differing thicknesses granular material and soil, followed by applications fertilizers and seed mixes.
