GOVERNMENT OF YUKON - ASSESSMENT & ABANDONED MINES BRANCH

WATER SAMPLING FIELD COMPLETION REPORT MOUNT NANSEN, YUKON

NOVEMBER 2012
ISSUED FOR USE
EBA FILE: W23101586

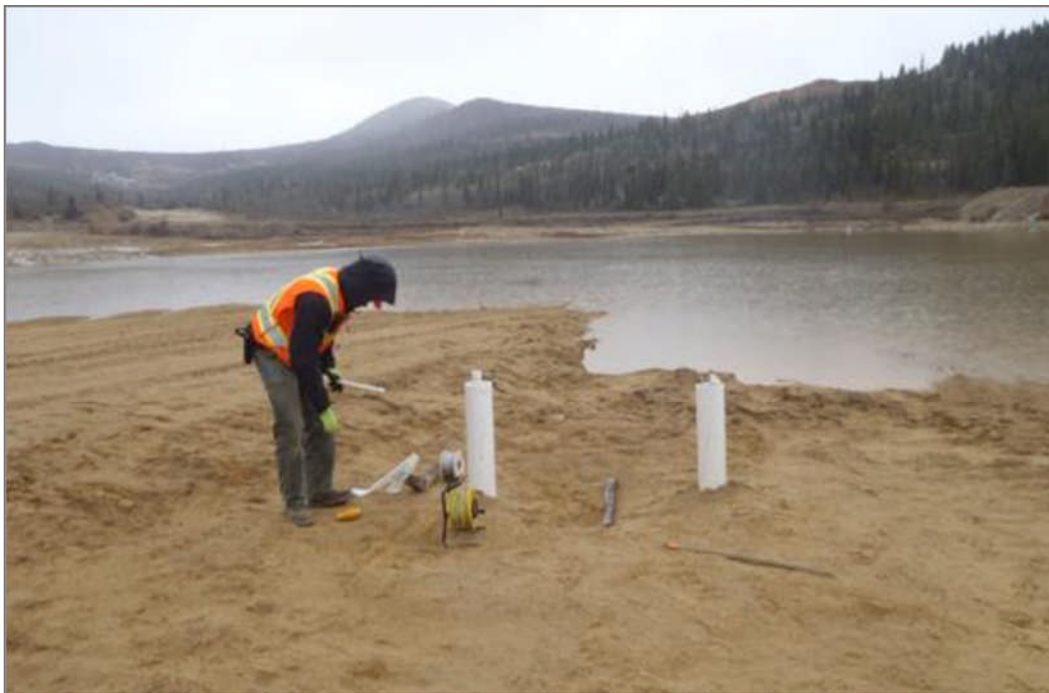
Photo 1: MW09-01 and MW09-02 in the Southeast Tailings. Also shown in this photograph are the Heron Instruments water level sounder and cable for the Solinst Levelogger used during the sampling event. June 2, 2012

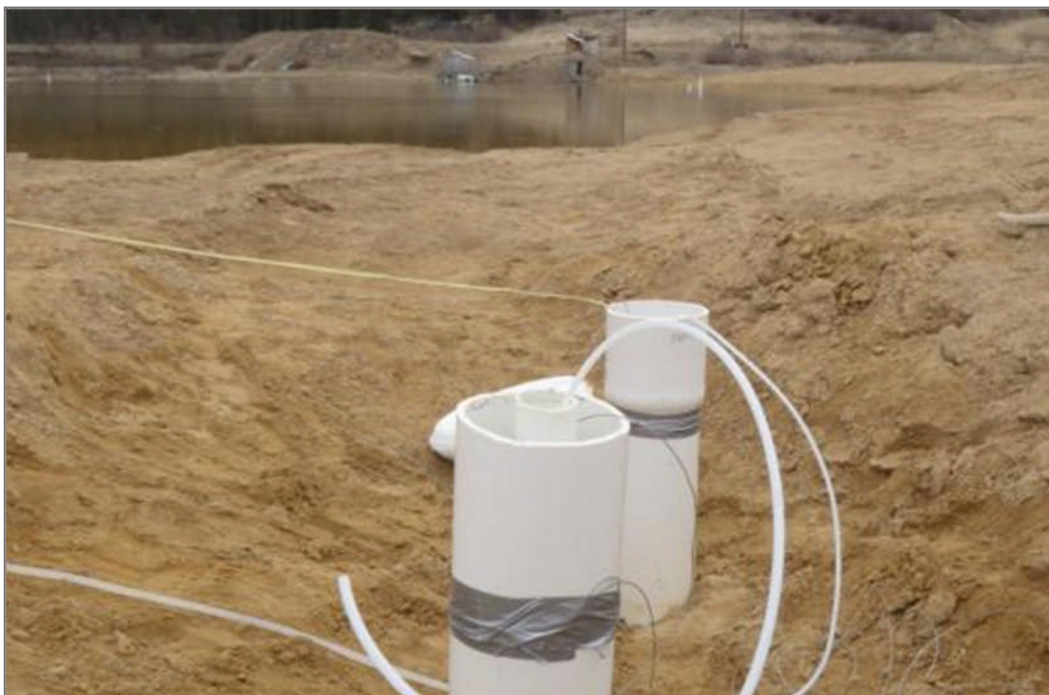
Photo 2: MW09-03 and MW09-04 in the Southeast Tailings. Note the cable in each well used to suspend Solinst Leveloggers. June 2, 2012

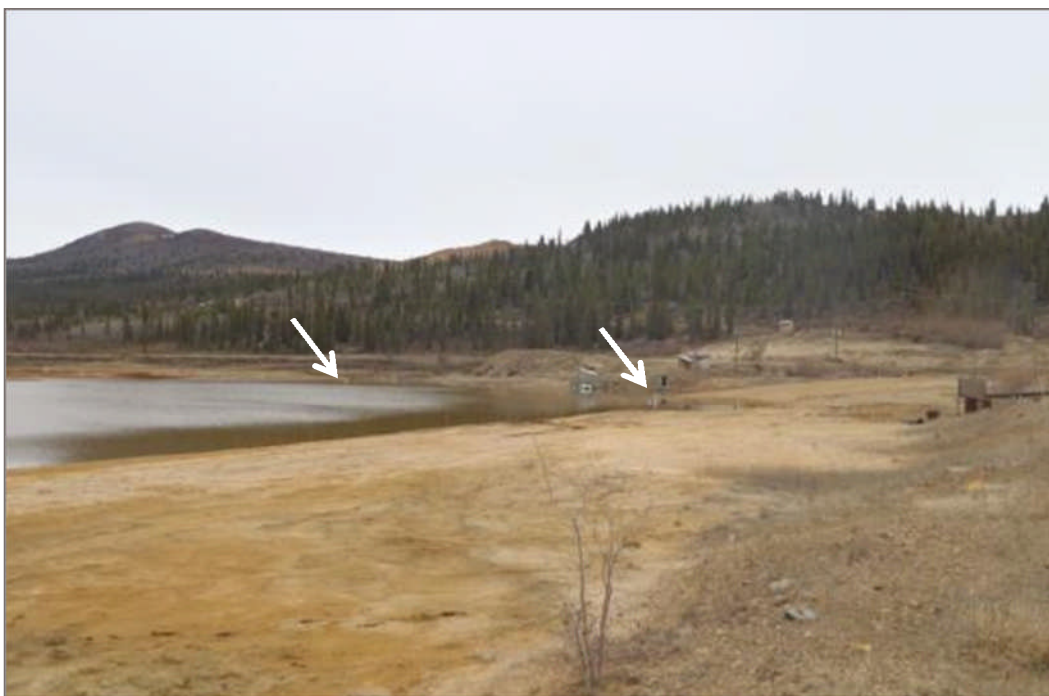
- MW09-05, MW09-06, and MW09-07 were partially submerged by standing water in the tailings pond preventing safe access at the time of the site visit (see Photo 3);
- MW09-08, MW09-11, MW09-13, MW09-14, MW09-15, MW09-16, MW09-19, MW09-21, MP09-09, MP09-10, MP09-11, MP09-12, MP09-14, GLL07-01 and GLL07-03 were frozen at the time of the site visit;
- MW09-20, MP09-03, and GLL07-02 were dry at the time of the site visit;
- MP09-06 and MP09-13 were found to be destroyed. (See Photo 22 and 27);
- MP09-07 and TH09-01 were not found. MP09-07 is assumed destroyed as the location of the well (in Dome Creek) was found, and the well was not there. (See Photo 23). The exact location, description and history of TH09-01 was not provided. EBA personnel investigated the area that the well was indicated to be, but were not able to find it.

Photo 3: MW09-05, MW09-06 (right arrow) and MW09-07 (left arrow). Note that all three wells are partially submerged. June 2, 2012

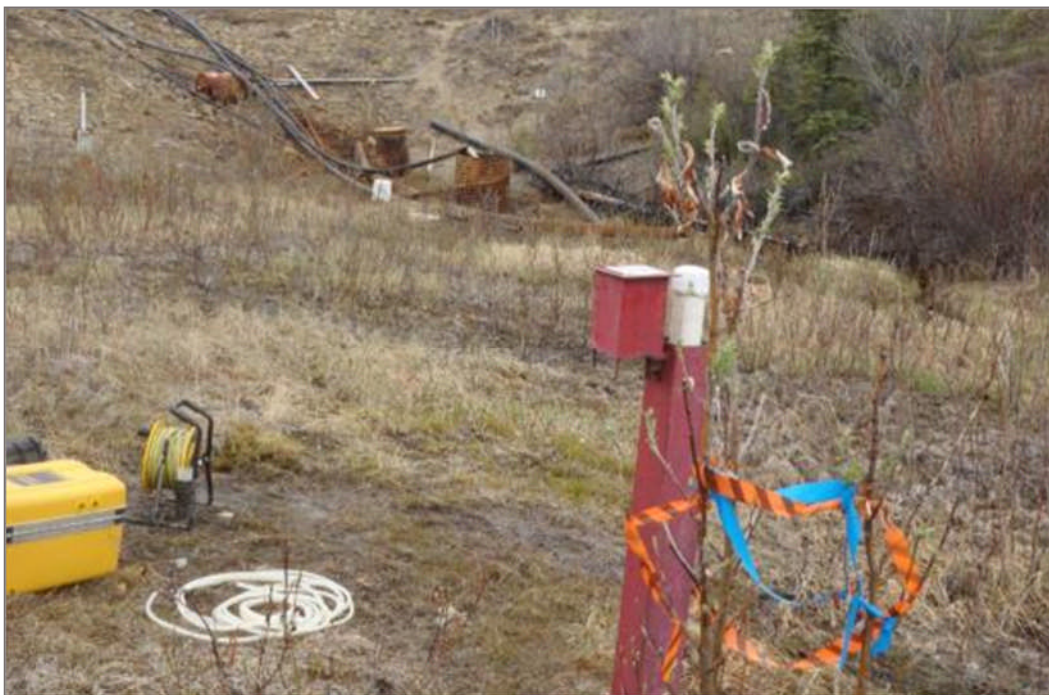
Photo 4: MW09-08 East of Seepage pond. Note seepage discharge point in the background. June 3, 2012

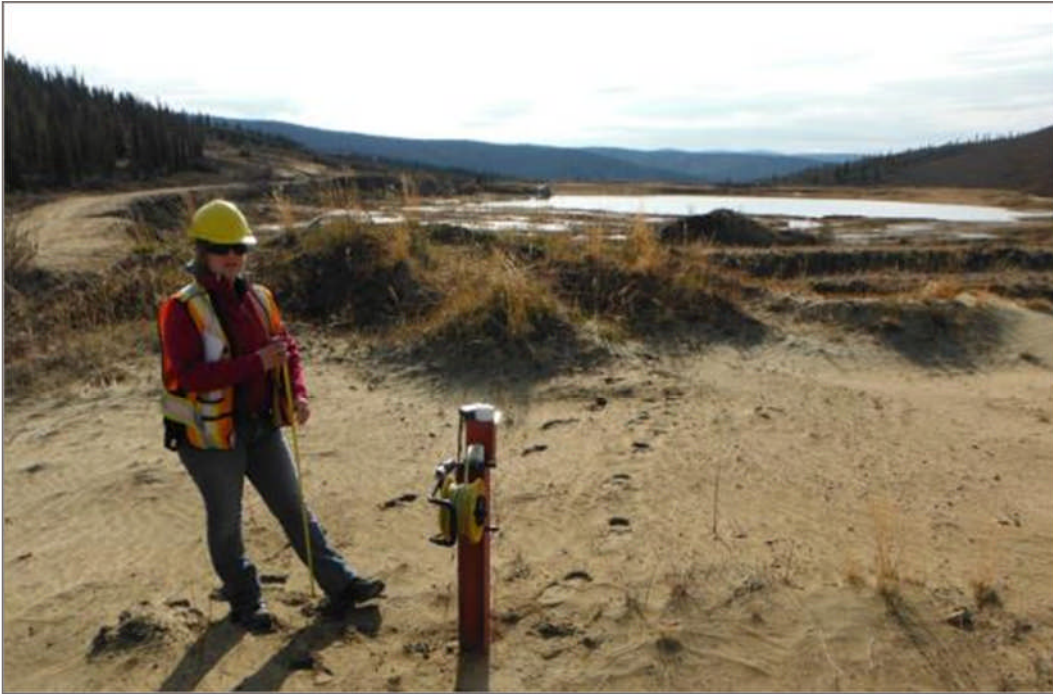
Photo 5: MW09-11 in the Sands West of the Tailings Pond. June 4, 2012

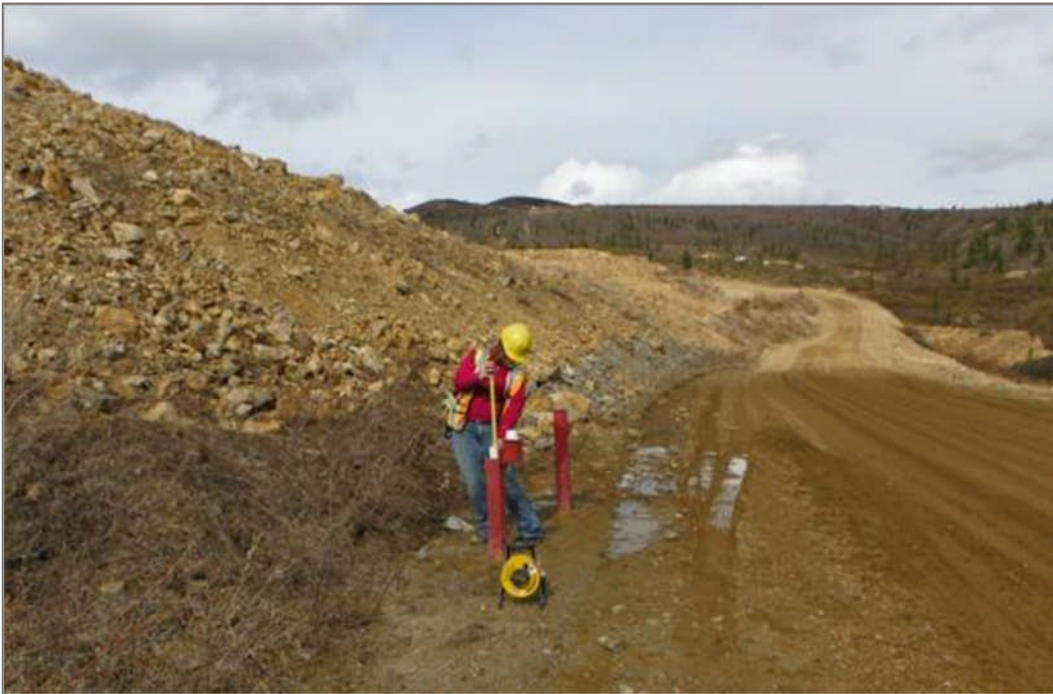
Photo 6: MW09-13 and MW09-14 along the Main Mount Nansen Access Road East of the Open Pit. June 4, 2012

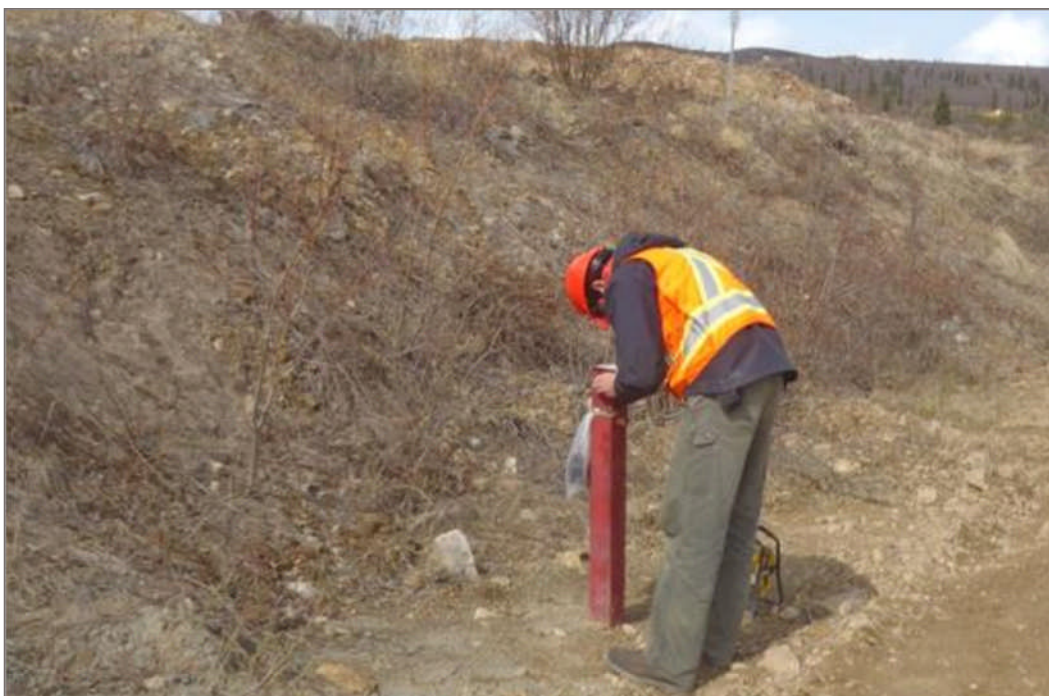
Photo 7: MW09-15 Located along the Main Mount Nansen Access Road East of the Open Pit. June 4, 2012

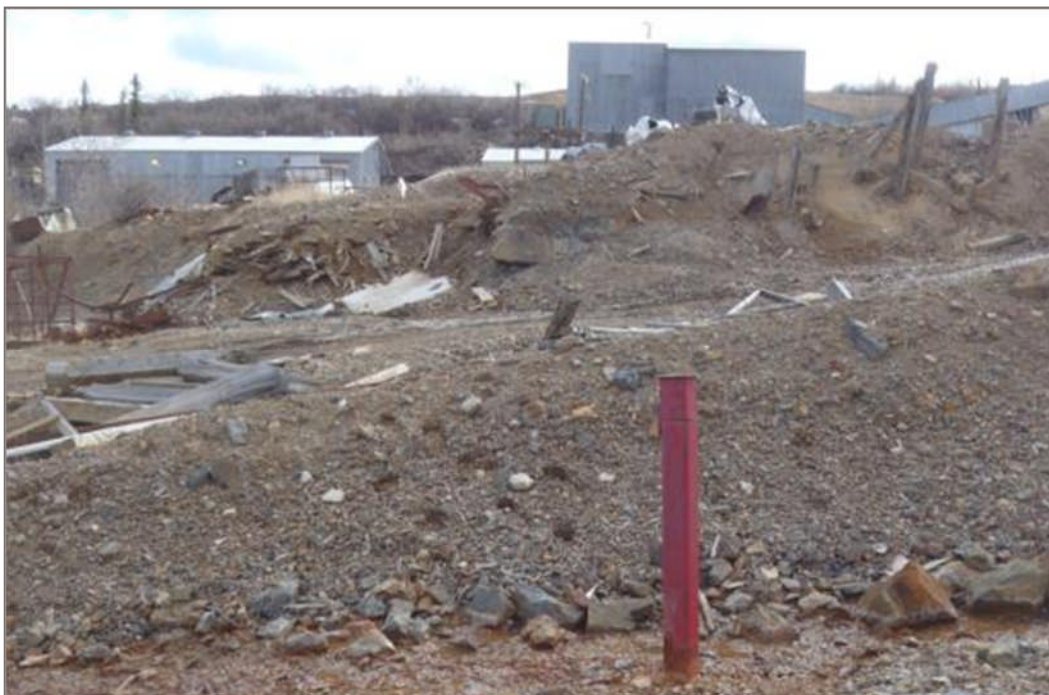
Photo 8: MW09-16 Northeast and Downgradient of the Mill Complex. Note the main mill building in the background. June 1, 2012

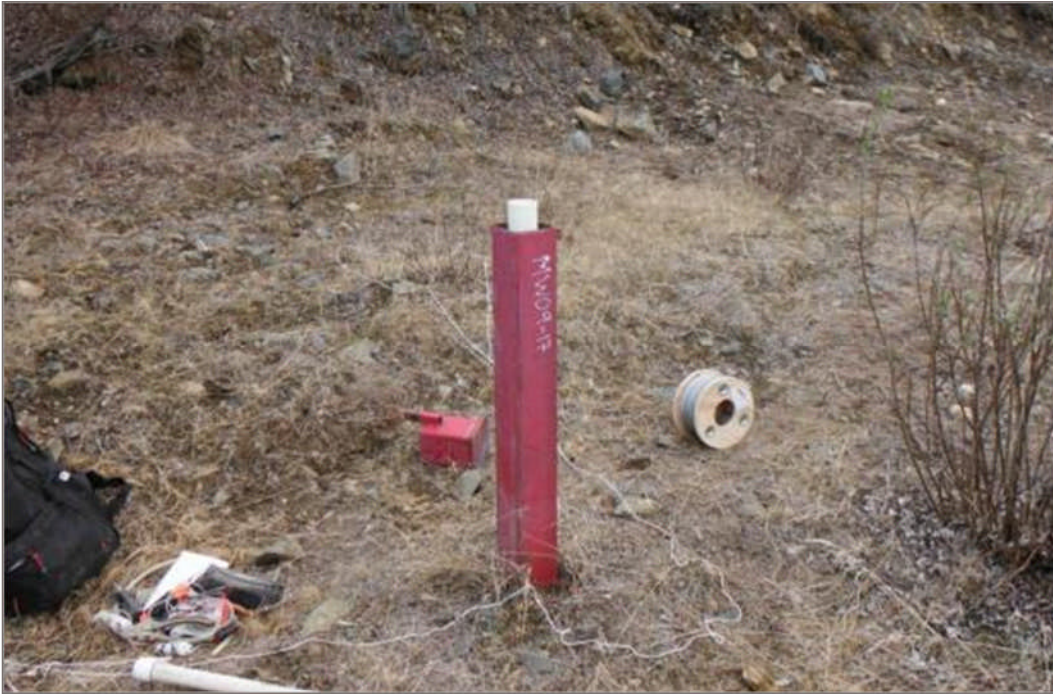
Photo 9: MW09-17, East and Downgradient of Mill Complex. June 1, 2012

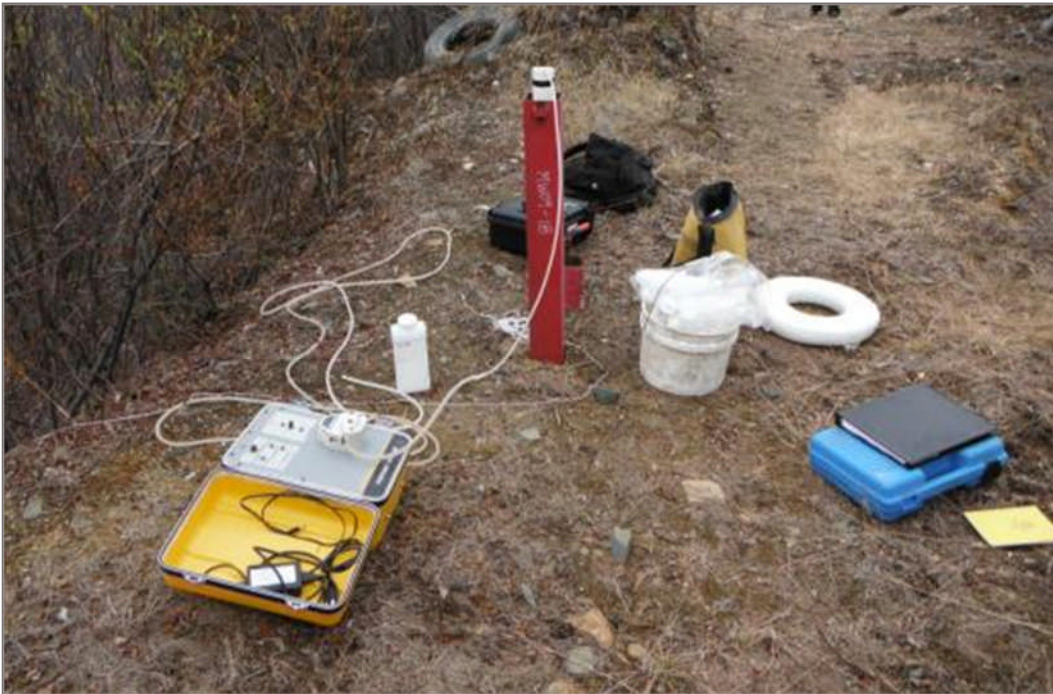
Photo 10: MW09-18, East and Downgradient of the Mill Complex. Note peristaltic pump set-up. June 1, 2012

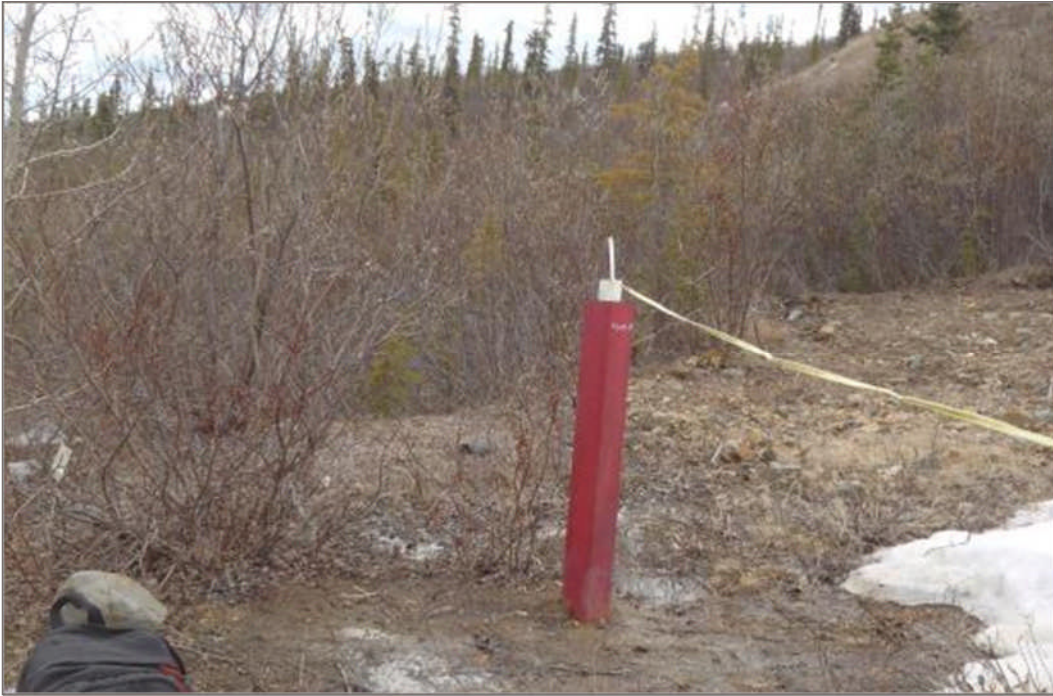
Photo 11: MW09-19 Located East of Mill Complex. June 2, 2012

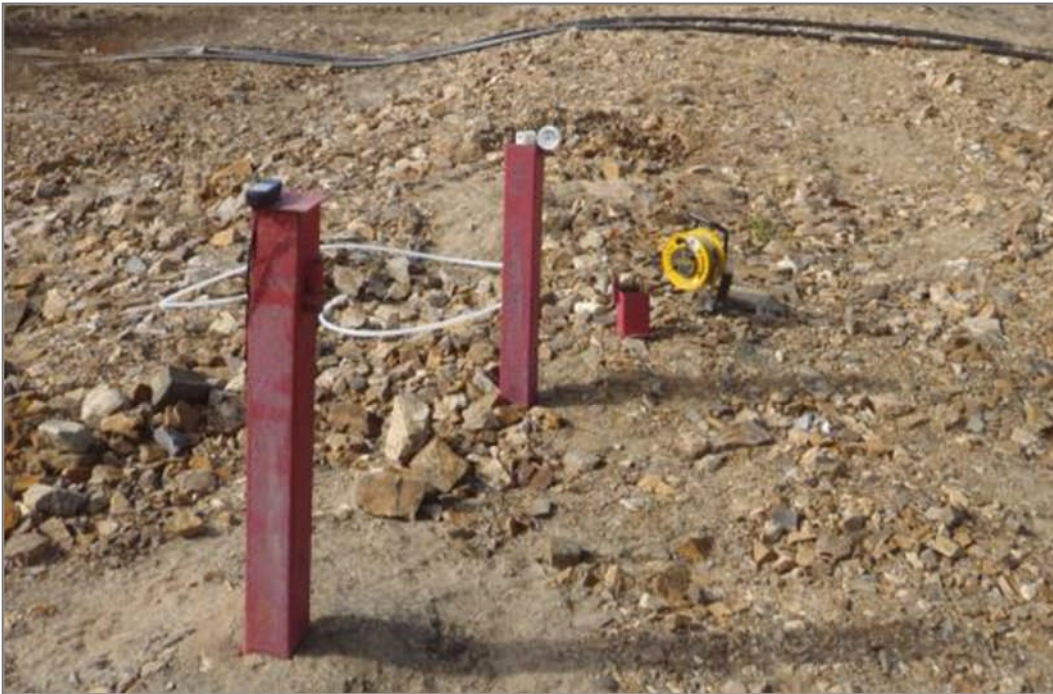
Photo 12: MW09-20, Seepage Pond Crest. Note the thermistor casing in the foreground. June 2, 2012

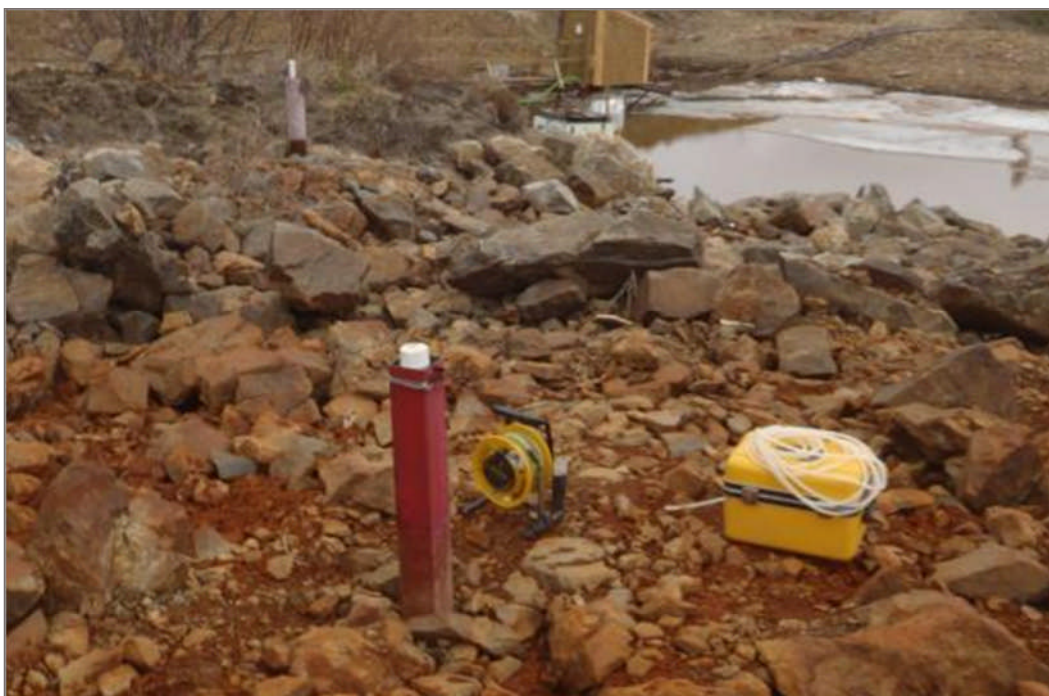
Photo 13: MW09-21, West and Upgradient of Seepage Pond. Note seepage pond and pumphouse in background and levellogger cable wrapped around the top of the protective casing. June 3, 2012

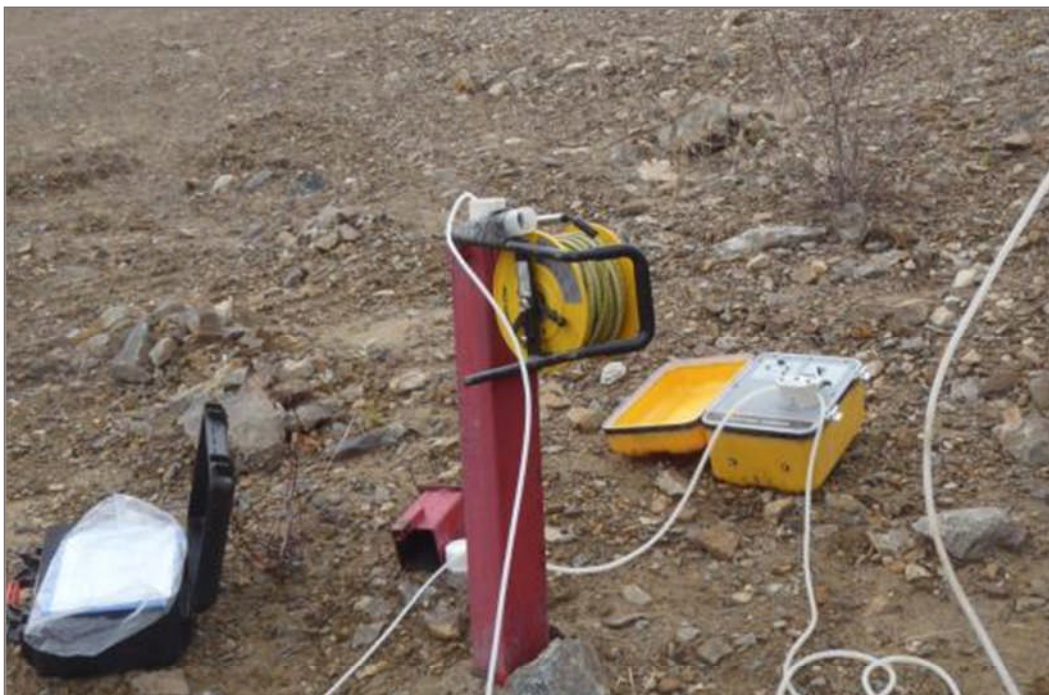
Photo 14: MW09-22 at the Front of the Tailings Dam. June 3, 2012

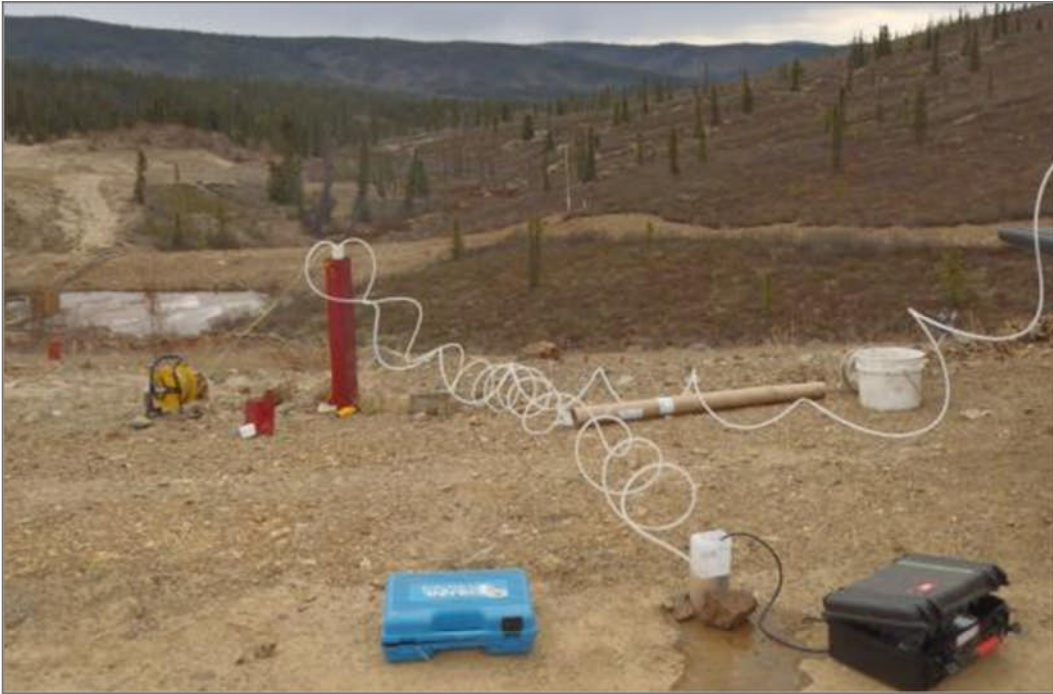
Photo 15: MW09-23 on the Tailings Dam Crest. Note the two hose bladder pump set-up and the flow through cell for monitoring field parameters. June 2, 2012

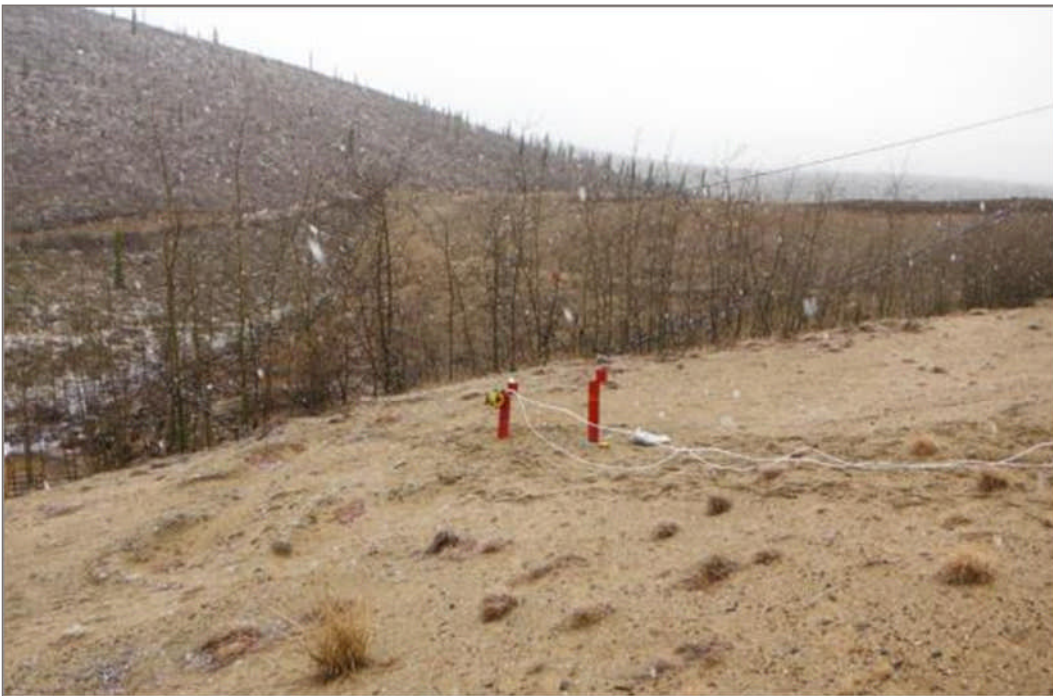
Photo 16: MW09-24 in Sand North of Seepage Pond. June 3, 2012

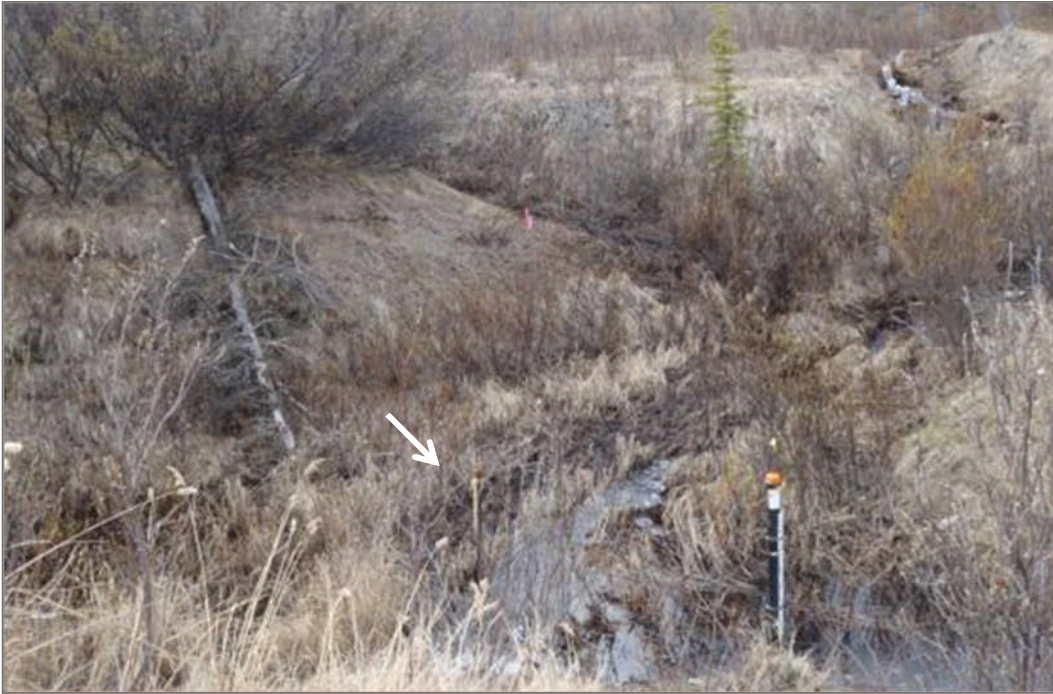
Photo 17: MP09-01, Drive-Point Well (indicated by arrow). Note the Pony Creek weir in the background. June 5, 2012

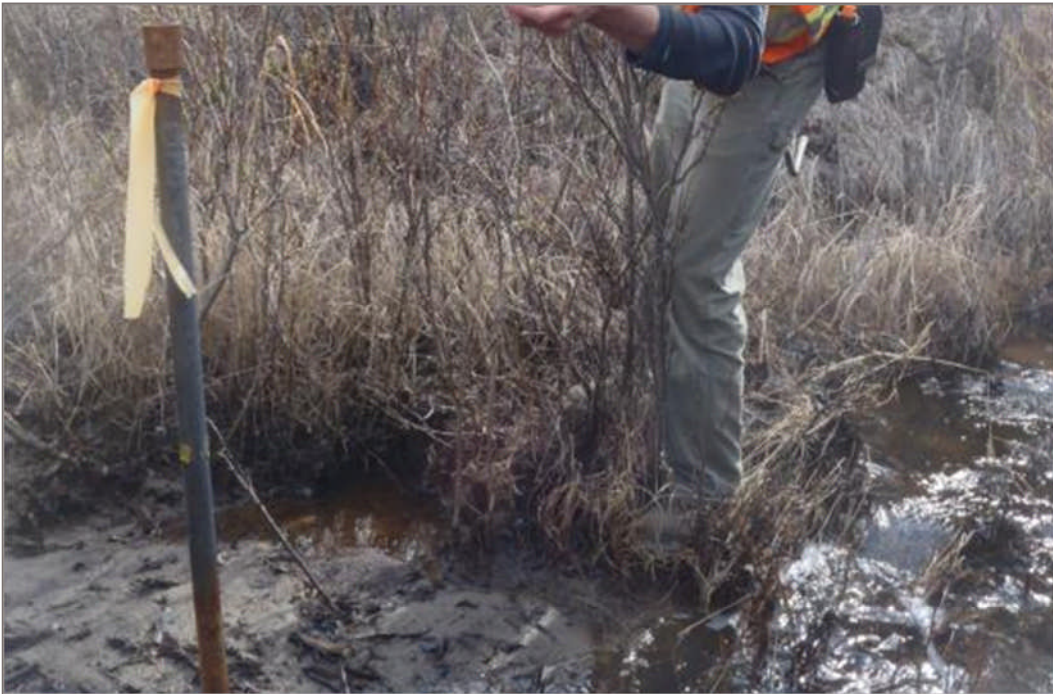
Photo 18: MP09-02 Drive-Point Well in Pony Creek. June 4, 2012

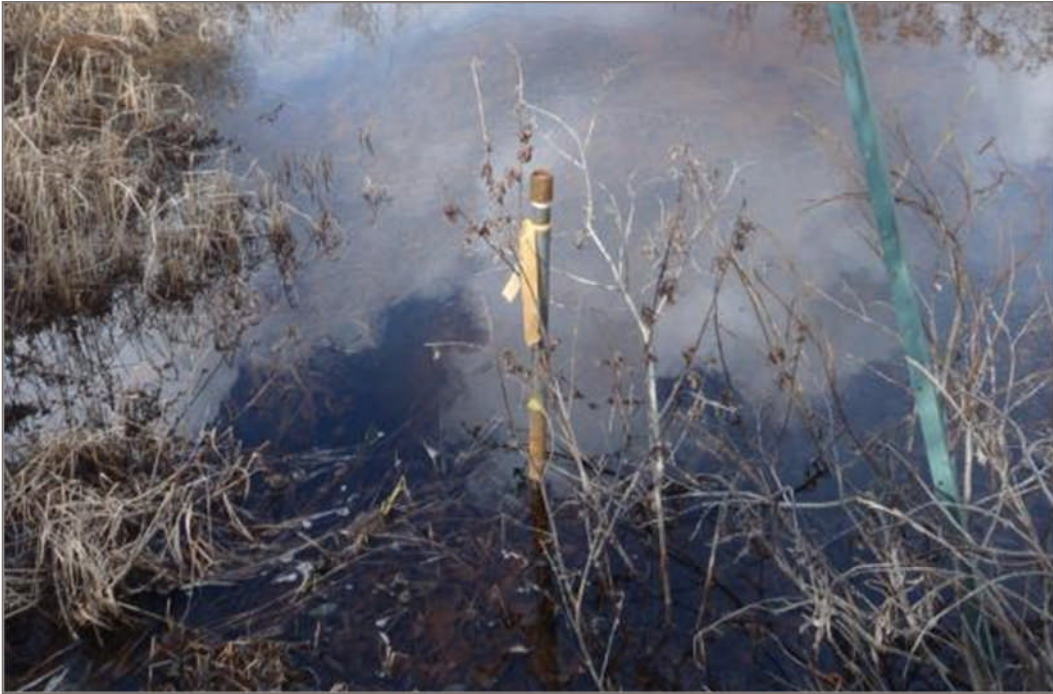
Photo 19: MP09-03 in Pony Creek. Note that this Drive-point well is at the upstream Pony Creek surface water sampling point. June 4, 2012

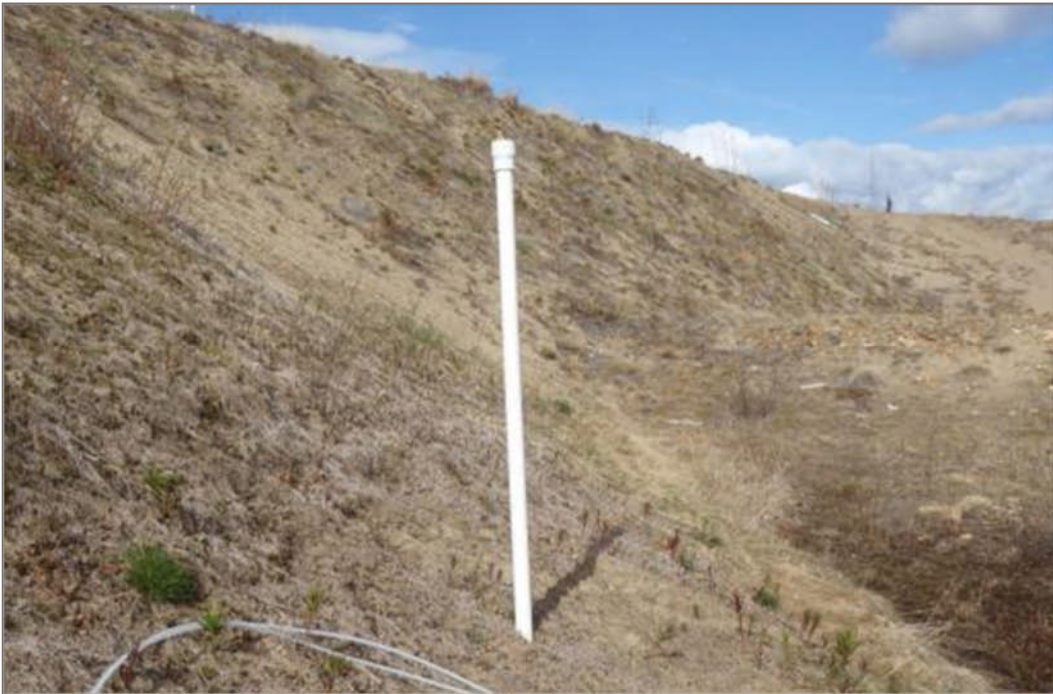
Photo 20: MP09-04 Located North of the Seepage Pond. June 3, 2012

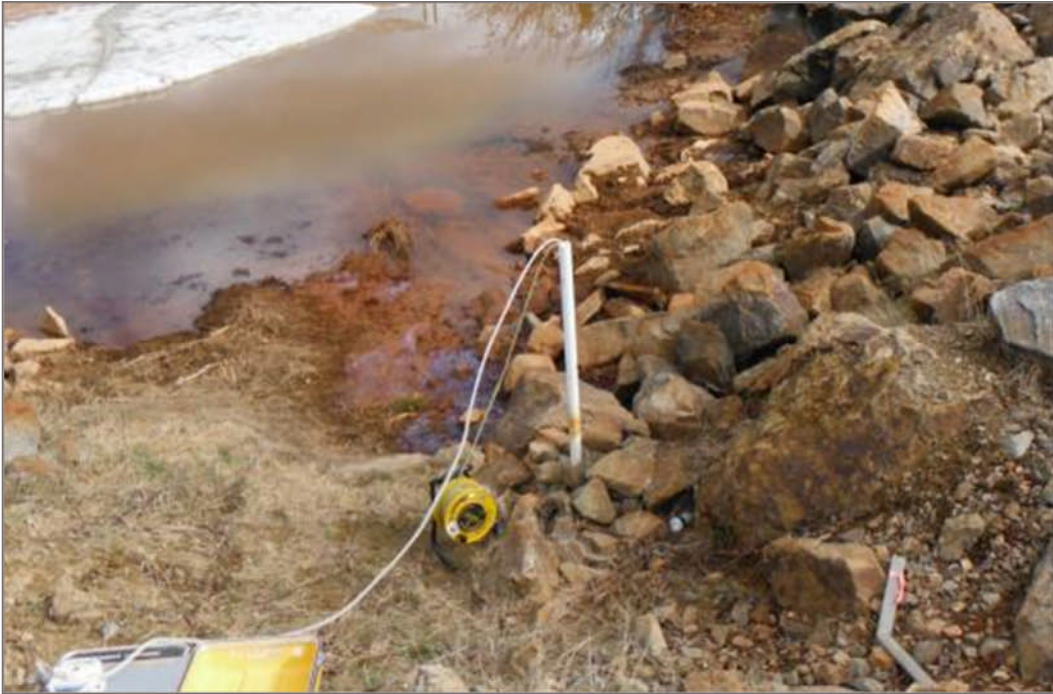
Photo 21: MP09-05 Located at the West Edge of the Seepage Pond. June 3, 2012

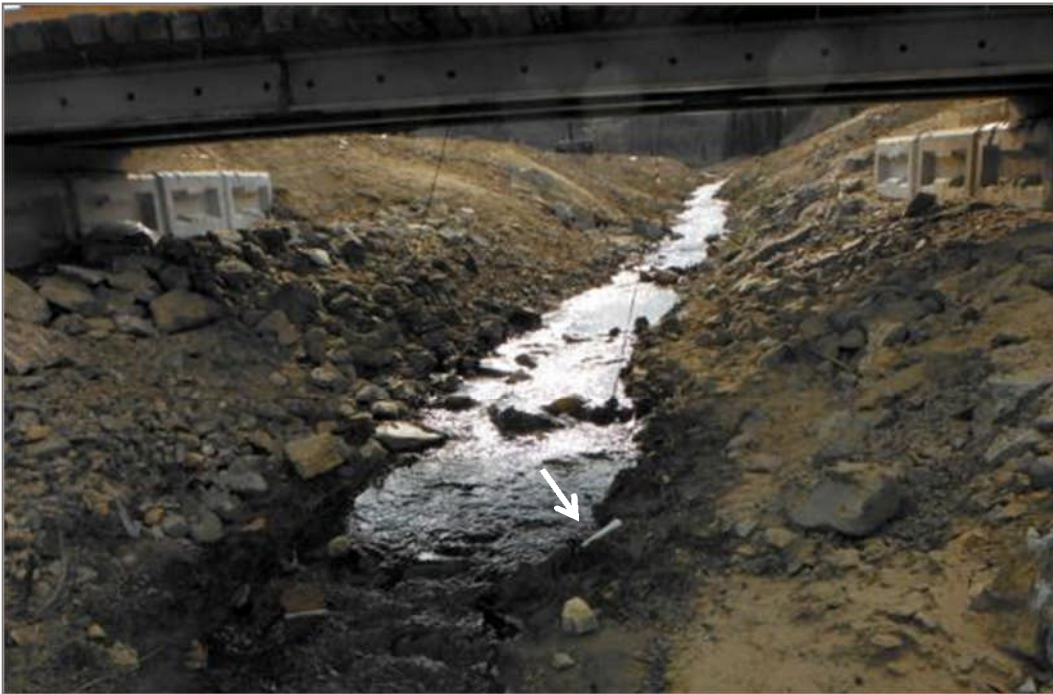
Photo 22: MP09-06 Located under the Dome Creek Diversion Ditch Bridge (indicated by arrow). Note that the mini-piezometer is destroyed. June 4, 2012

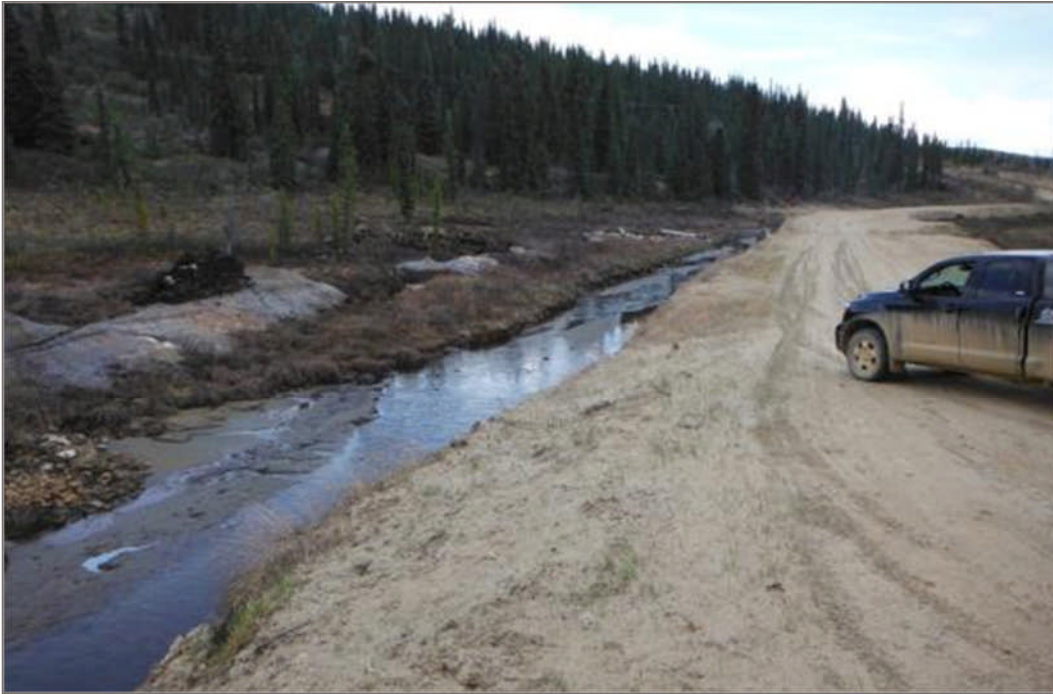
Photo 23: MP09-07 Should be Located in this Section of Dome Creek. It is not there, and EBA assumes it was destroyed during ditch cleaning efforts the previous winter. June 4, 2012

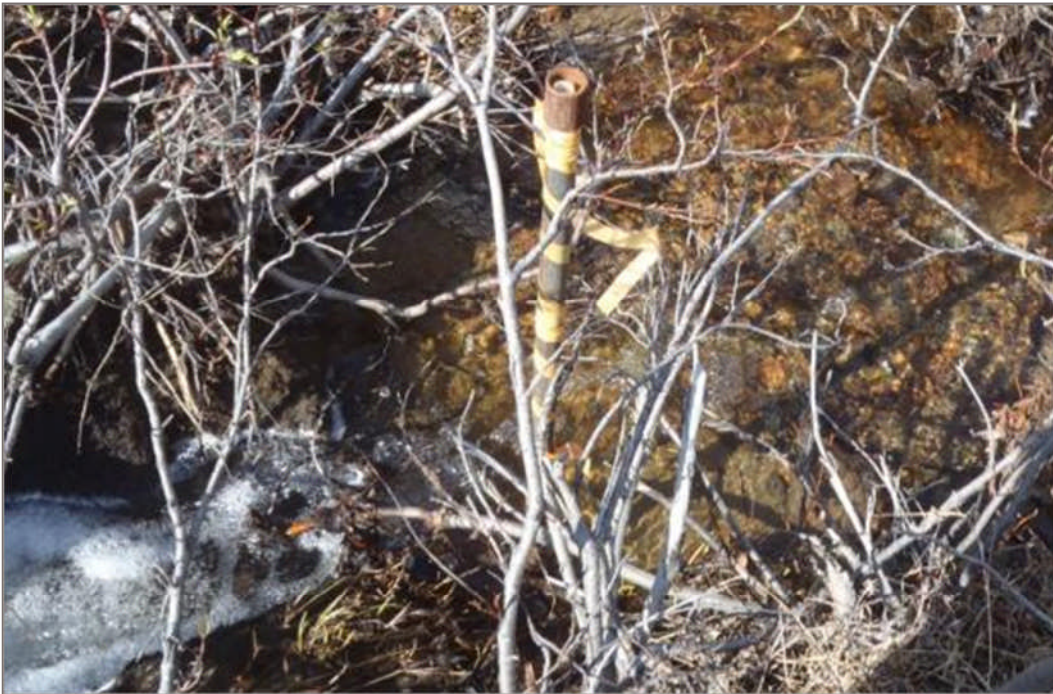
Photo 24: MP09-08 Drive-Point Well Located about 50 M Downstream of the Downstream Surface Water Sampling Site on Pony Creek. June 4, 2012

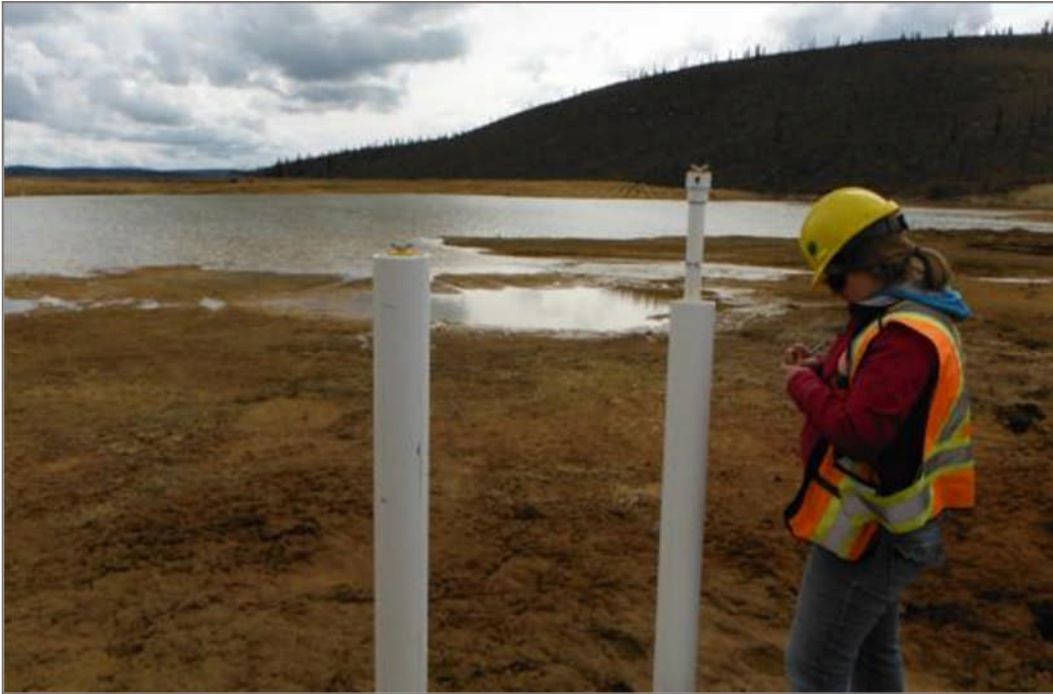
Photo 25: MP09-09 and MP09-10 Mini-Piezometers Located in the West End of the Tailings Pond. June 4, 2012

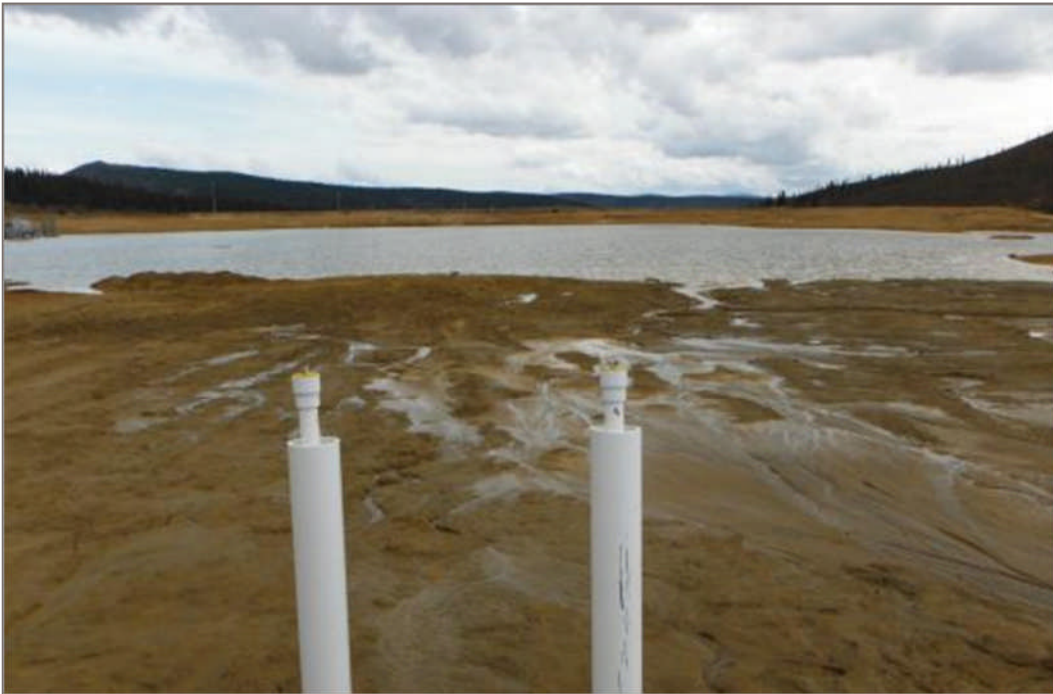
Photo 26: MP09-11 and MP09-12 Located in the West End of the Tailings Pond. June 4, 2012

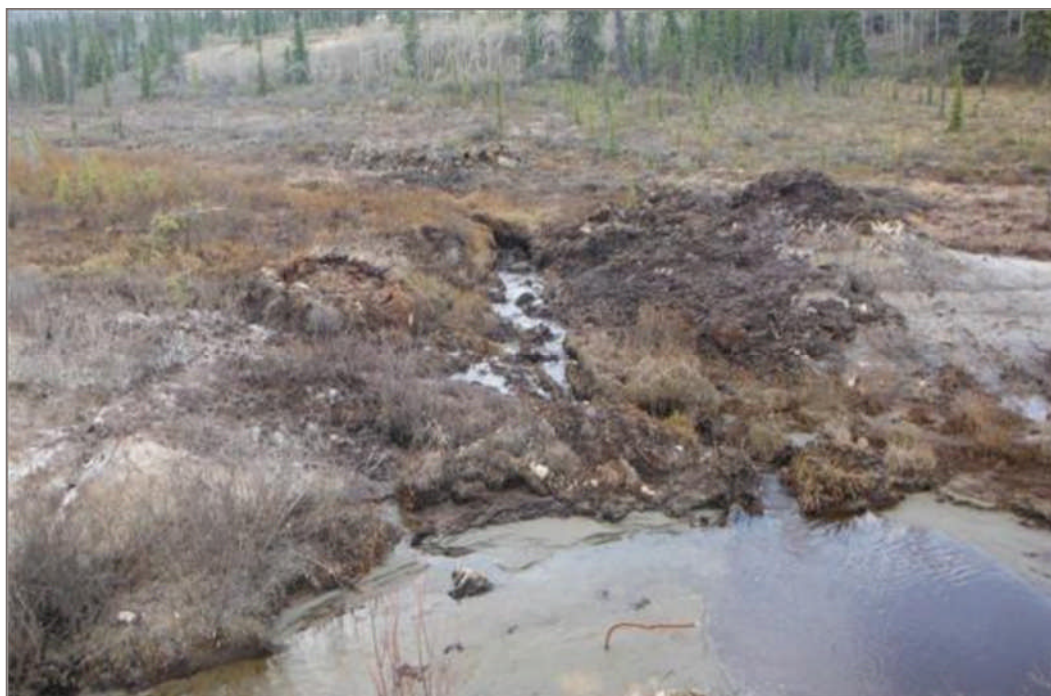
Photo 27: MP09-13 Located in the Dome Creek Diversion at the Intersection of Dome Creek. Note that this Drive-point well is destroyed. June 4, 2012

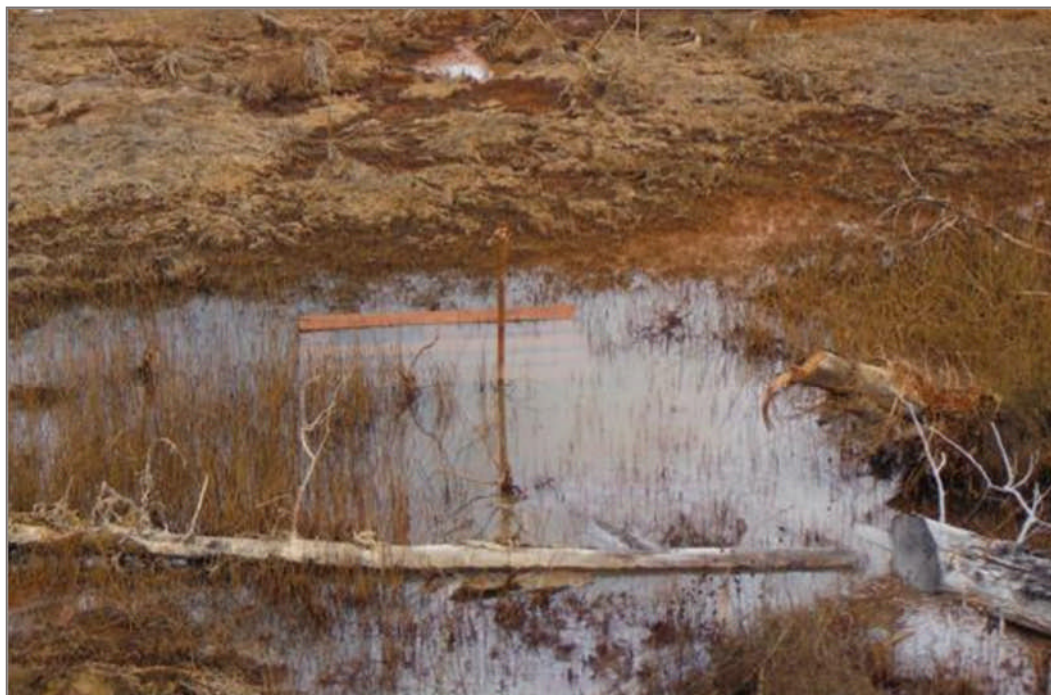
Photo 28: MP09-14 Located in the Northwest Corner of the Tailings Pond. June 4, 2012

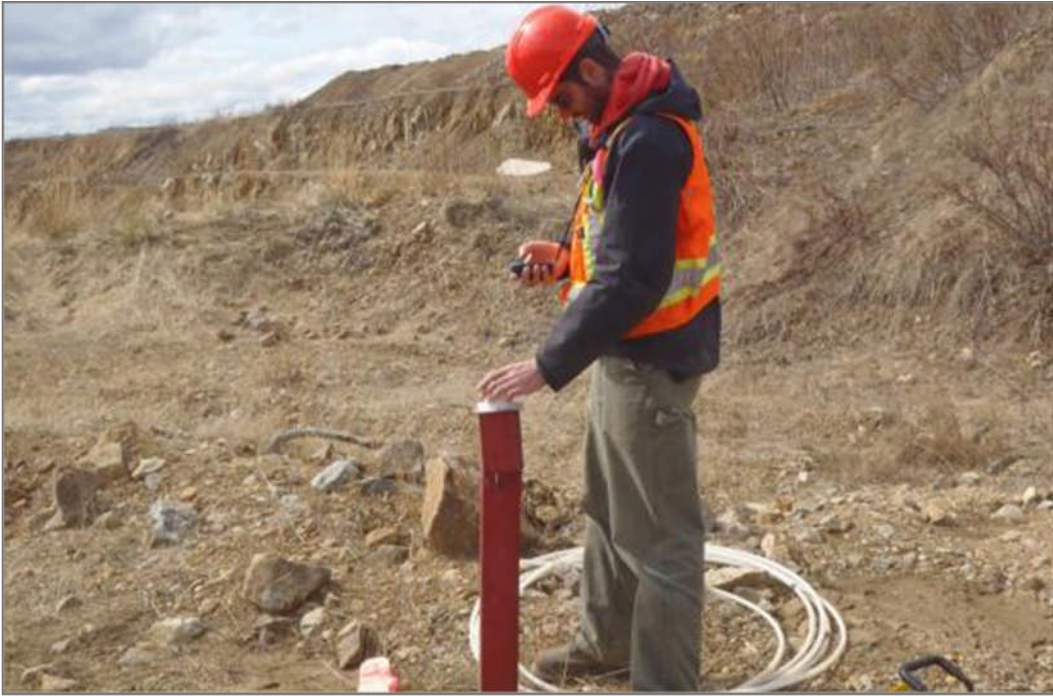
Photo 29: GLL07-01 Located East of the Open Pit. June 4, 2012

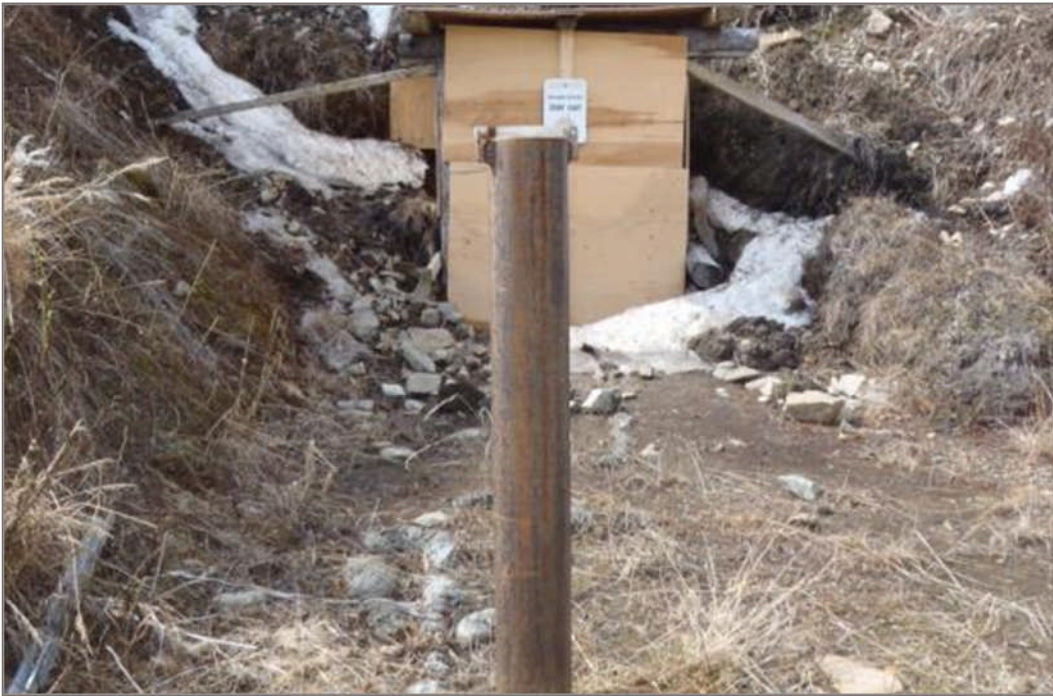
Photo 30: GLL07-02 Located in Front of the Pony Creek Adit. June 4, 2012
