GOVERNMENT OF YUKON - ASSESSMENT & ABANDONED MINES BRANCH

WATER SAMPLING FIELD COMPLETION REPORT MOUNT NANSEN, YUKON

NOVEMBER 2012
ISSUED FOR USE
EBA FILE: W23101586

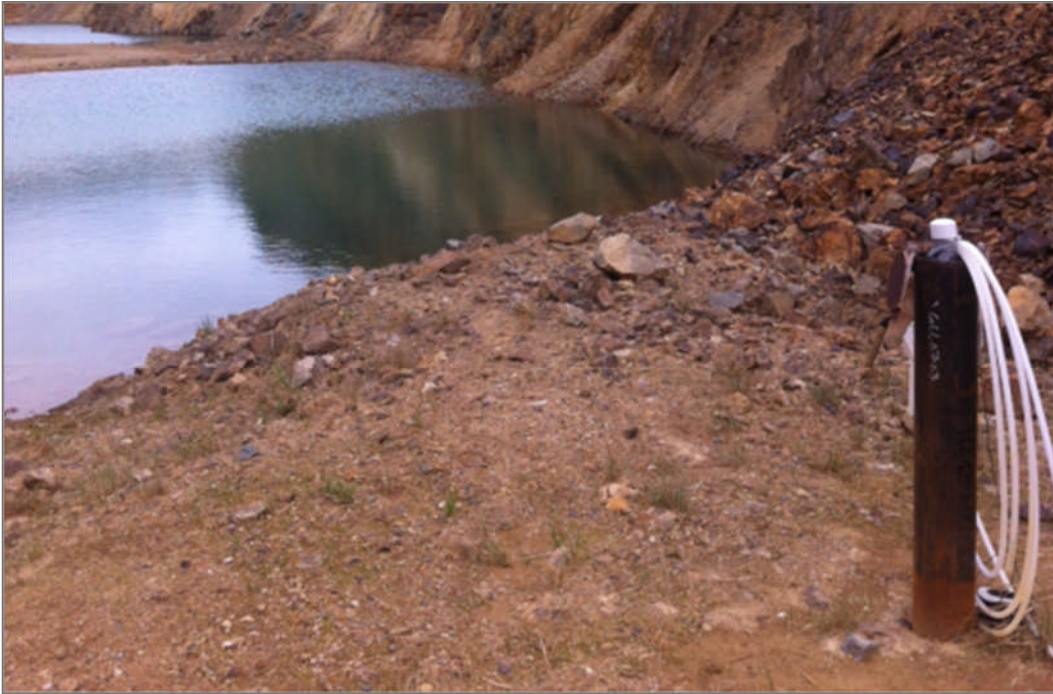
Photo 31: GLL07-03 Located in the Open Pit. Note the barologger attached to the casing lid.
June 27, 2012

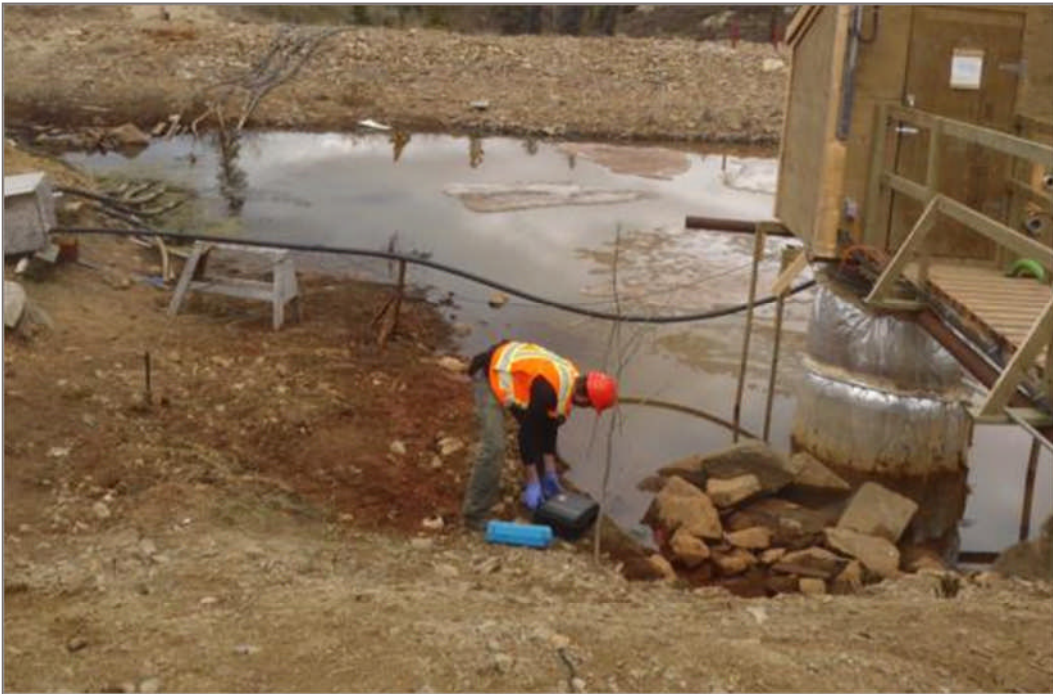
Photo 32: Seepage Pond Sampling Location. June 3, 2012

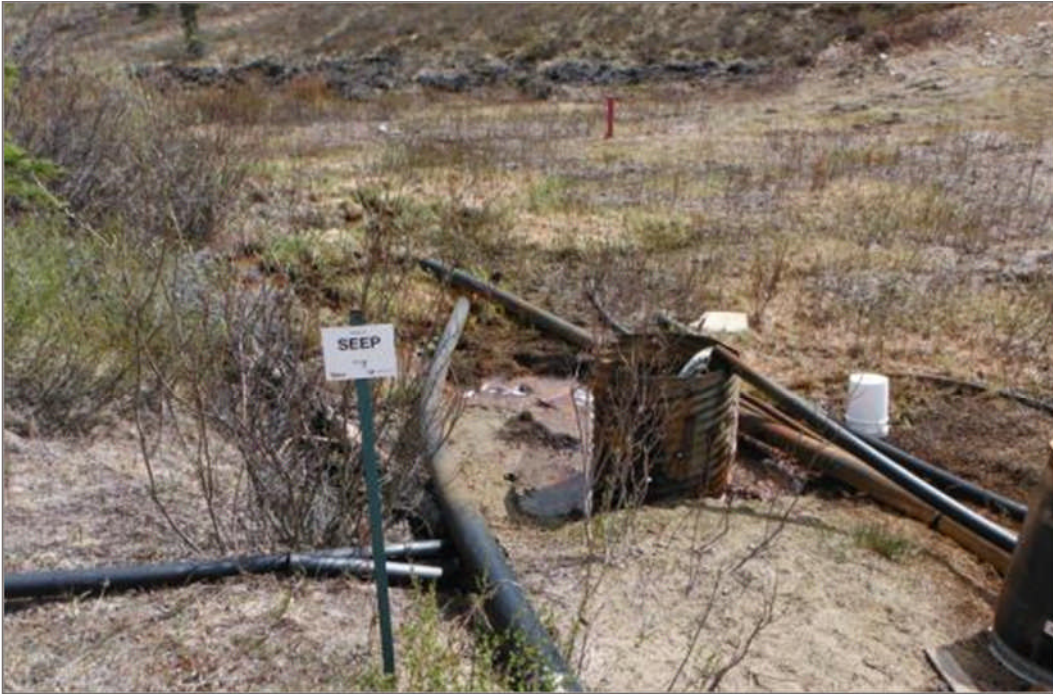
Photo 33: Seepage Discharge Point. Note MW09-08 in background. June 3, 2012

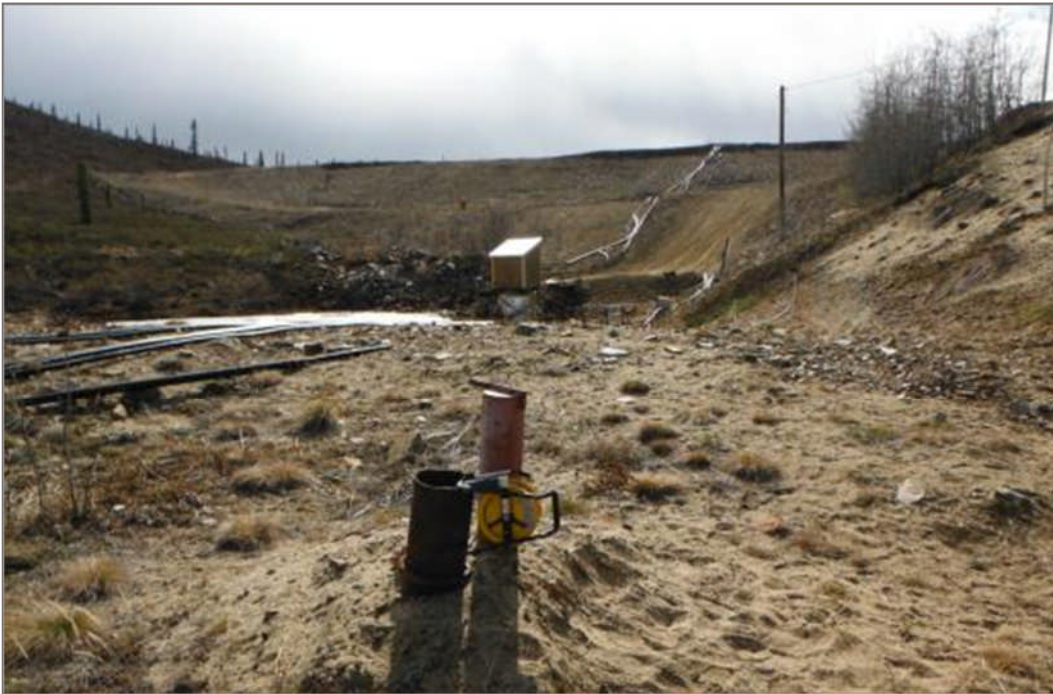
Photo 34: Unknown 1 – Located East and Cross-Gradient of Seepage Pond. June 4, 2012

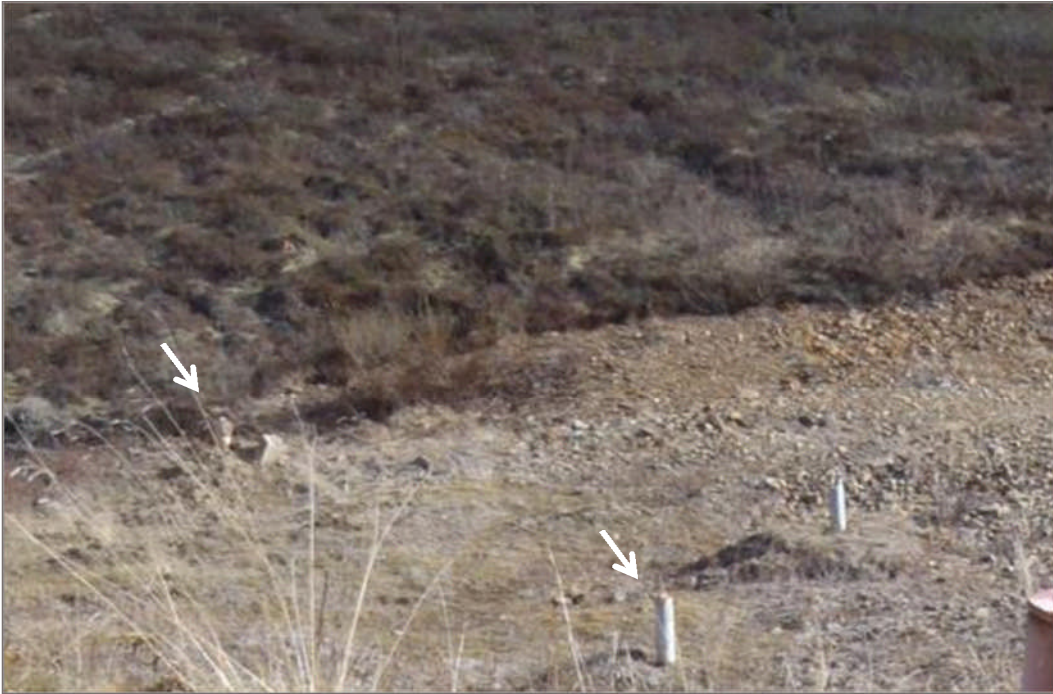
Photo 35: Unknown 2 (right arrow) and Unknown 3 (left arrow) located east of Seepage Pond.
June 4, 2012
