**GEOHAZARD RISK STUDY
WHITEHORSE ESCARPMENT**

Whitehorse, Yukon
October, 2002

EBA File: 0201-1200002

prepared by:
EBA Engineering Consultants Ltd.
Whitehorse, Yukon

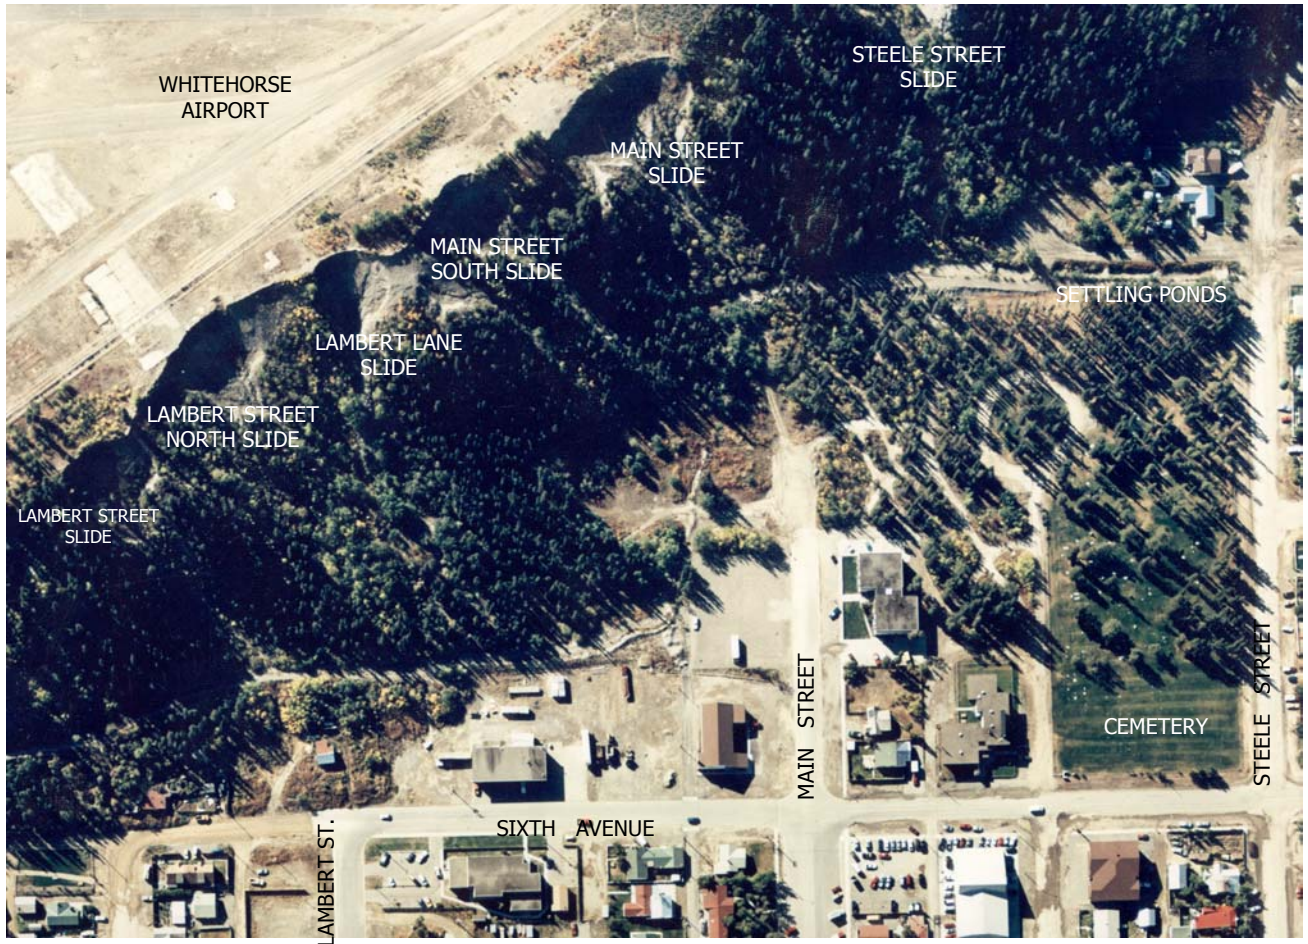
Photograph 1. August 1990. Aerial view of escarpment between Lambert Street and Steele Street.

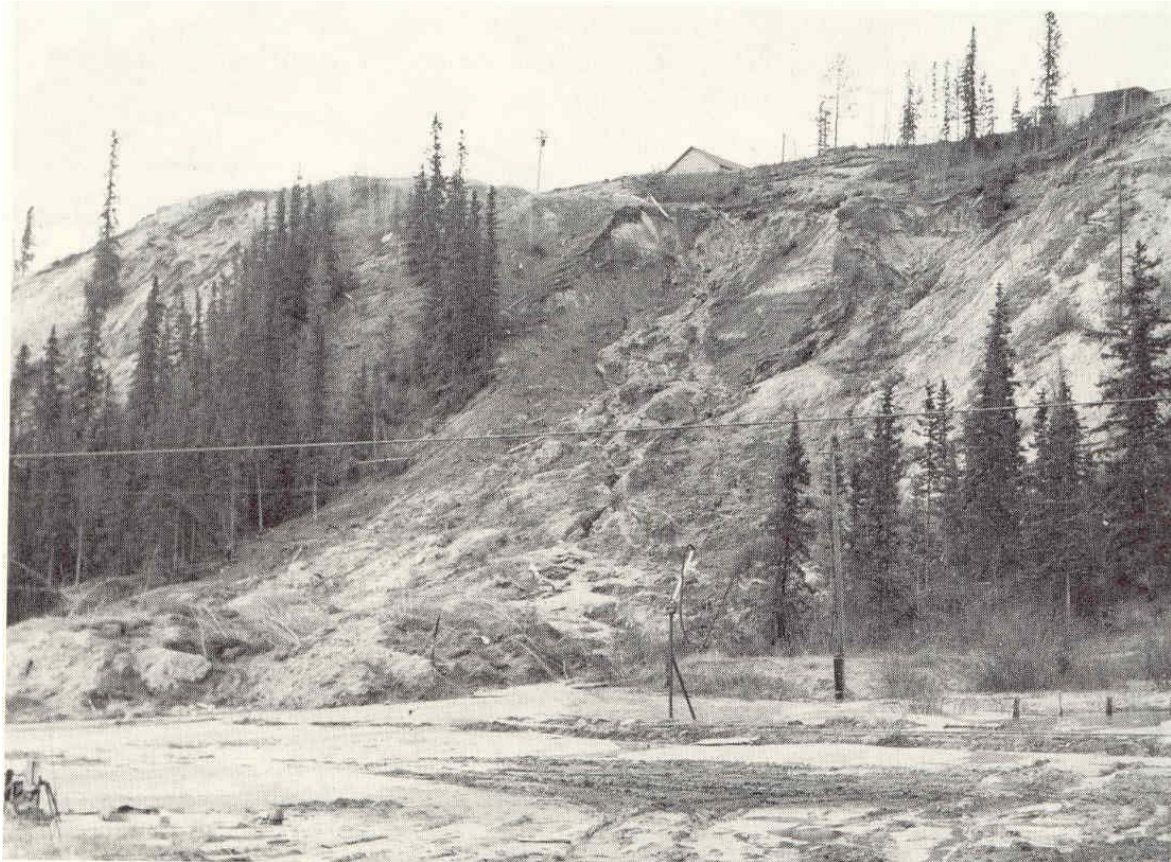
Photograph 2. [June] 1953. Landslide near Hoge Street (R.F. Legget).

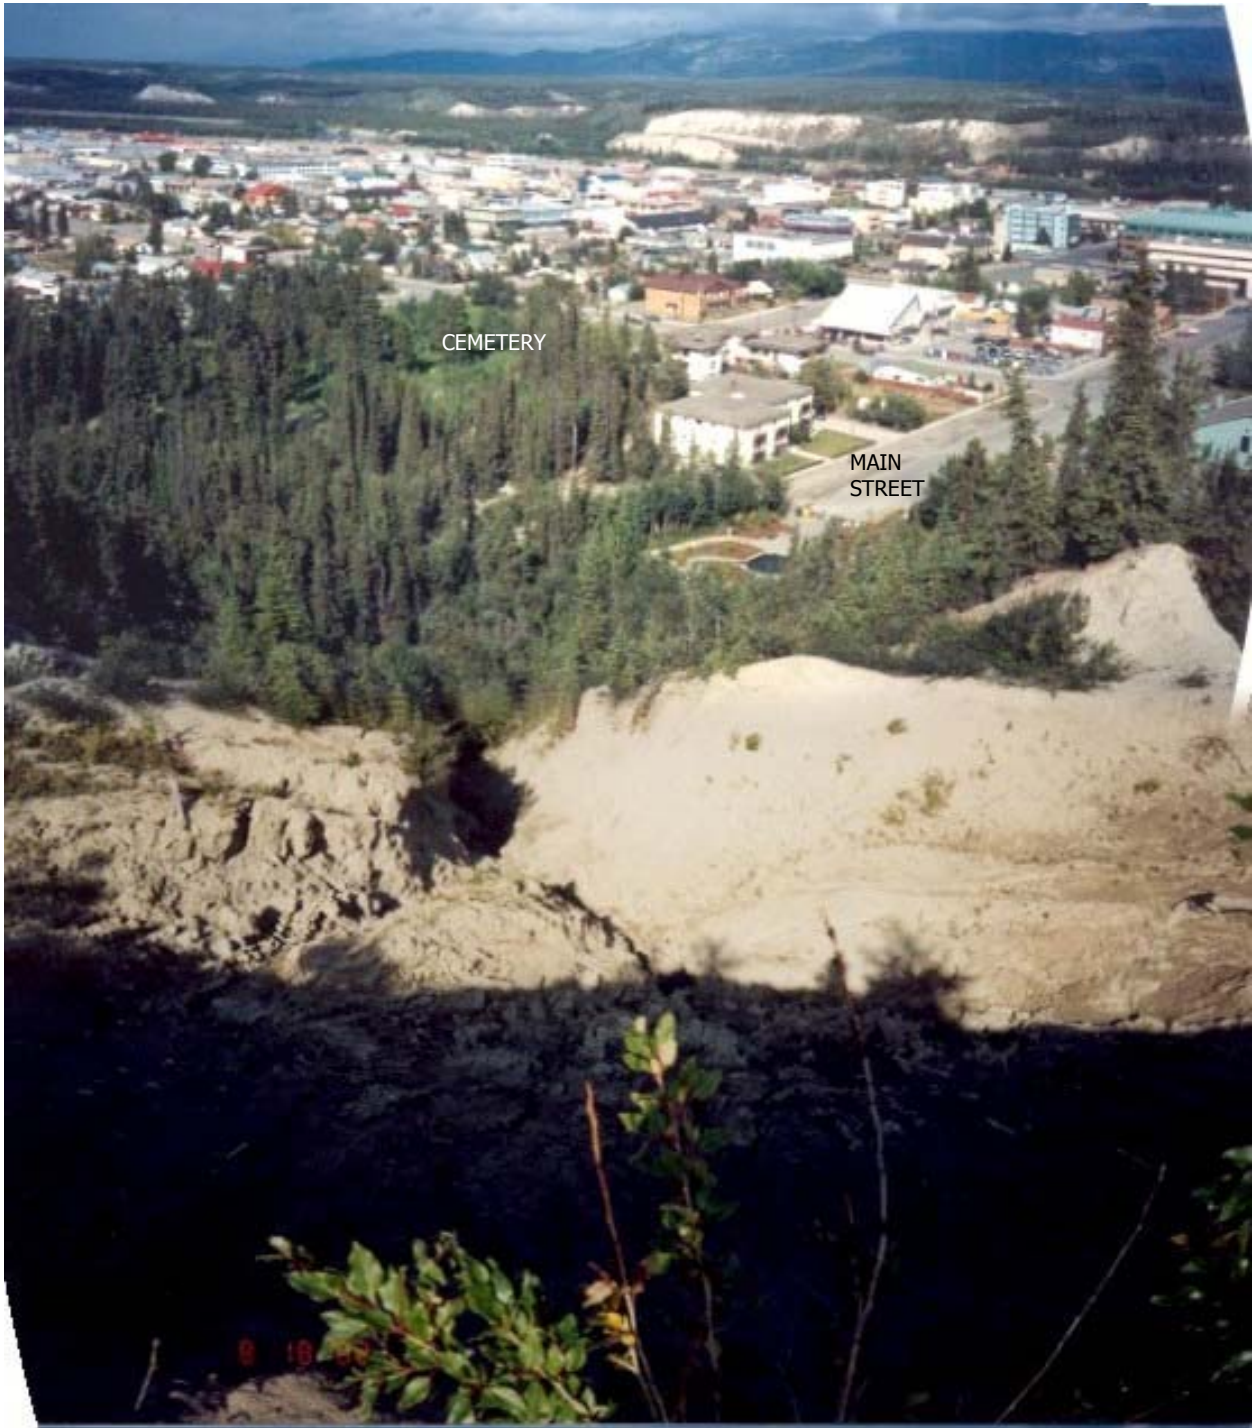
Photograph 3. May 2002. Headscarp of Main Street Slide.

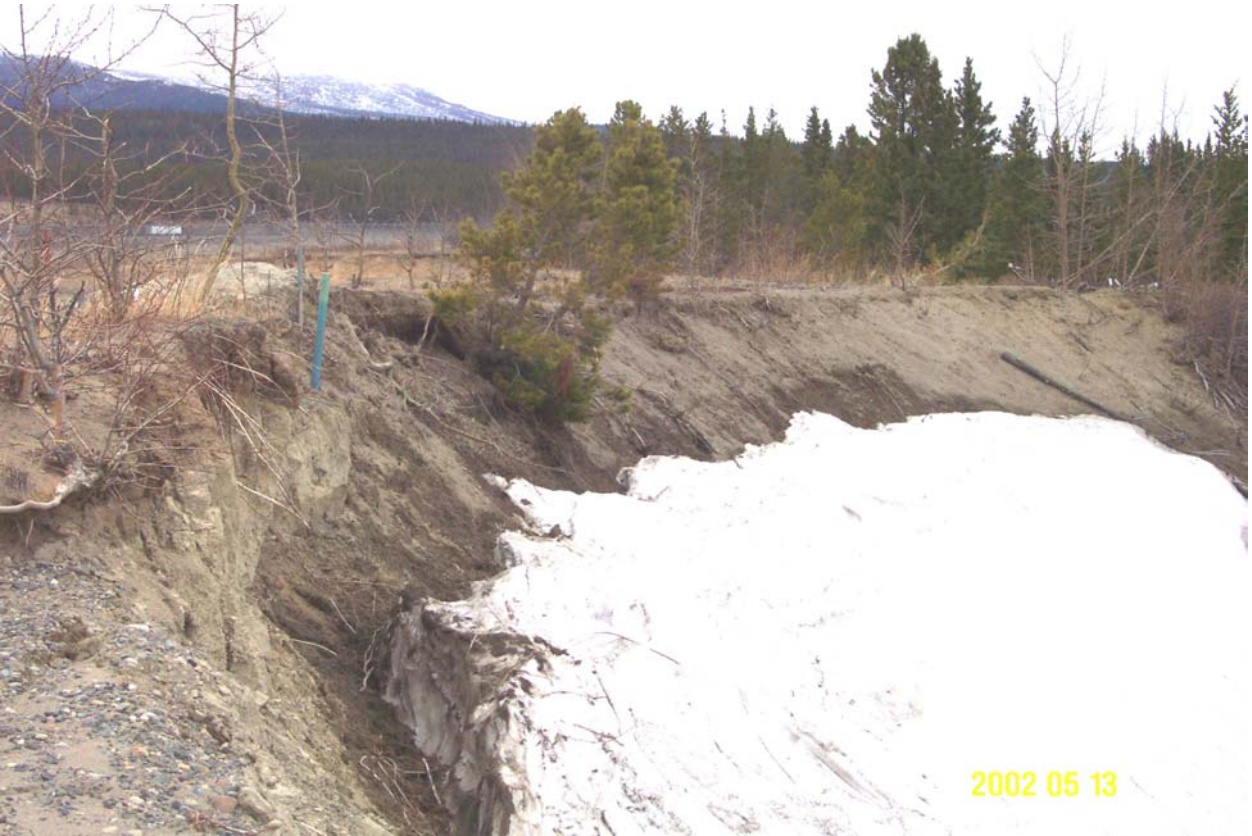
Photograph 4: May 2002. Main Street Slide. Melting snow in the headscarp contributes to the erosion process. The blue pipe stem to the left of centre is the slope stability indicator casing installed in 1970 and used for this study.

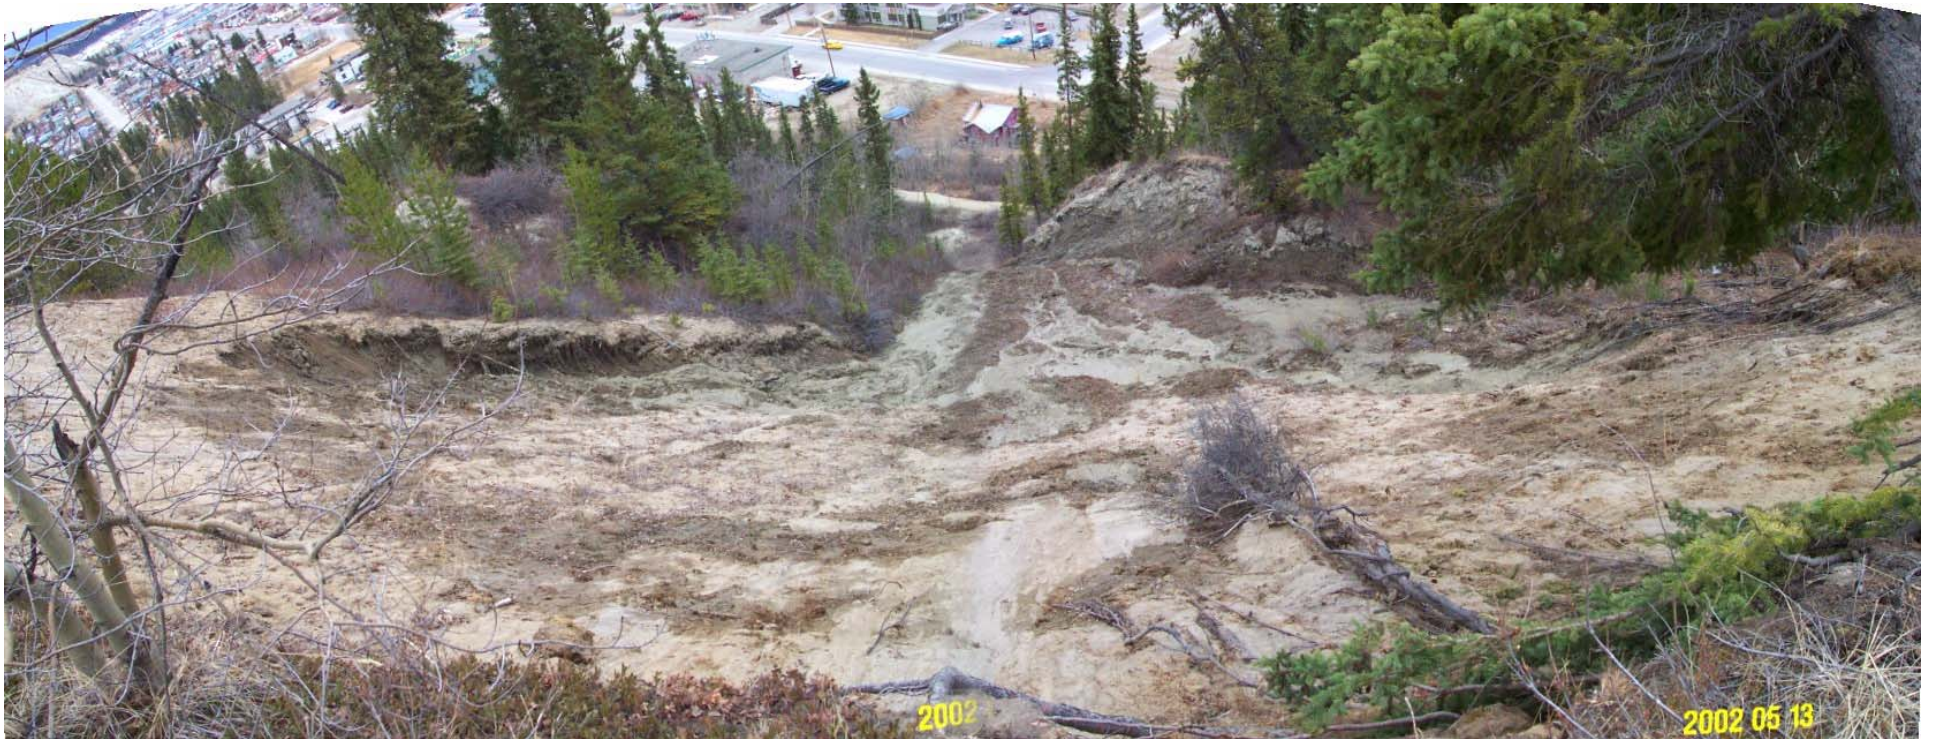
Photograph 5: May 2002. View from the crest of the active headscarp of the Lambert Street Slide.

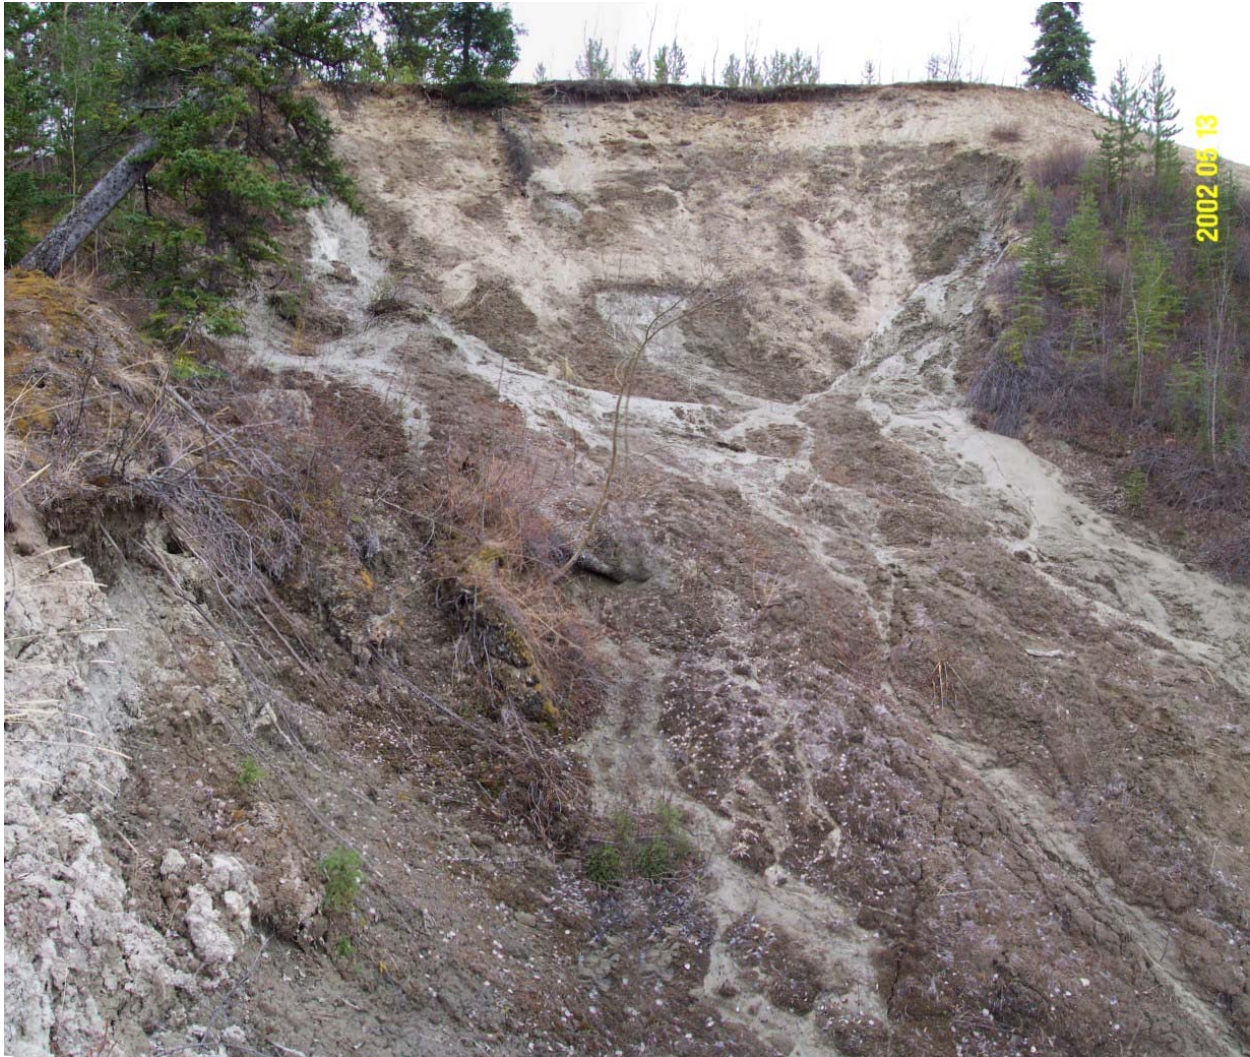
Photograph 6: May 2002. Headscarp of an active area of thawing saturated silt below the eolian sand on the Lambert Street Slide. Detail of the specific active areas is shown on Photographs 7 and 8.

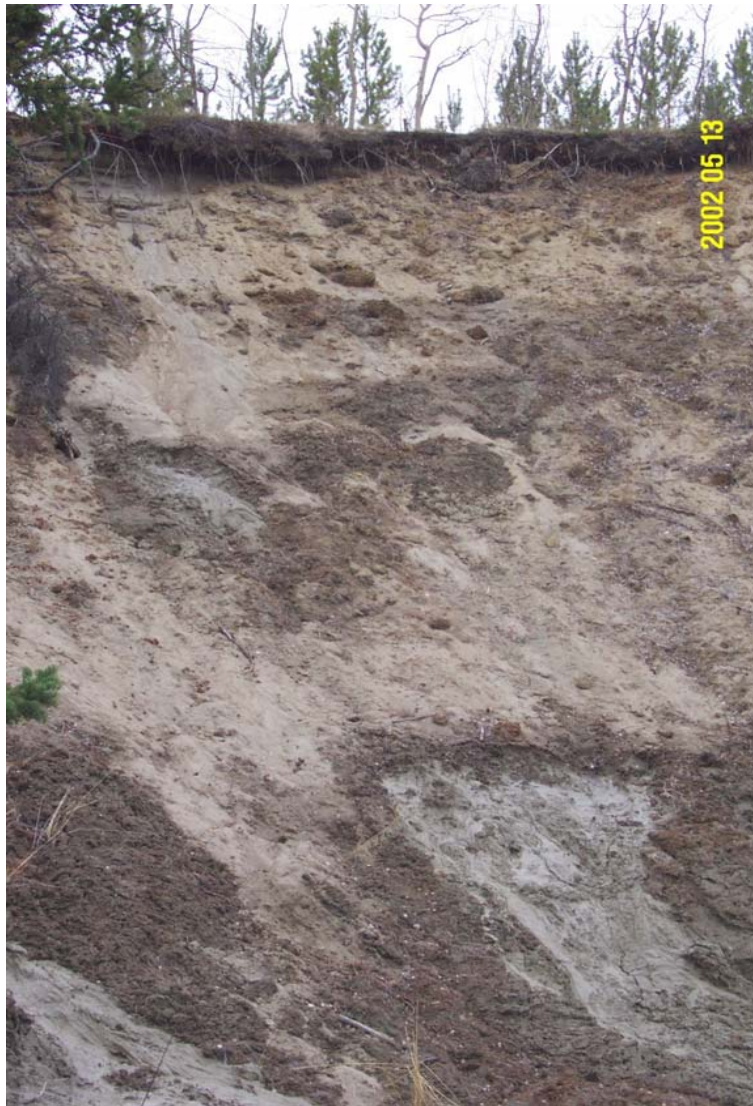
Photograph 7: May 2002. Details of thaw/flow zones within the active headscarp of the Lambert Street Slide.

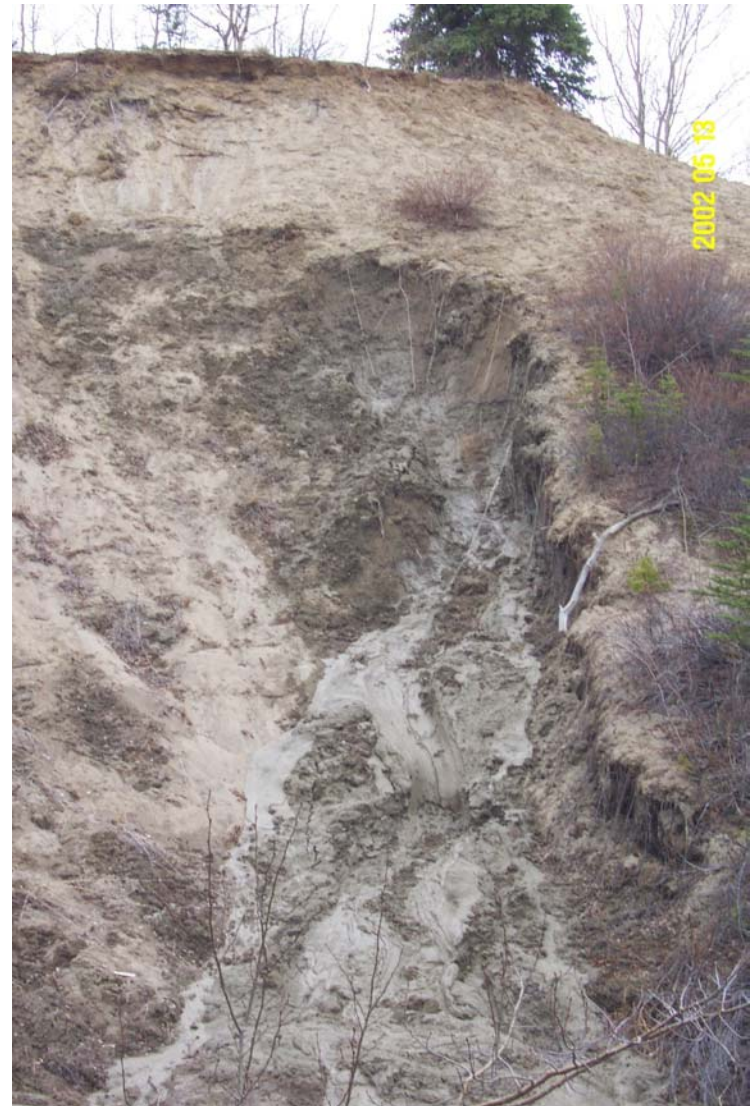
Photograph 8: May 2002. Details of thaw/flow zones within the active headscarp of the Lambert Street Slide.

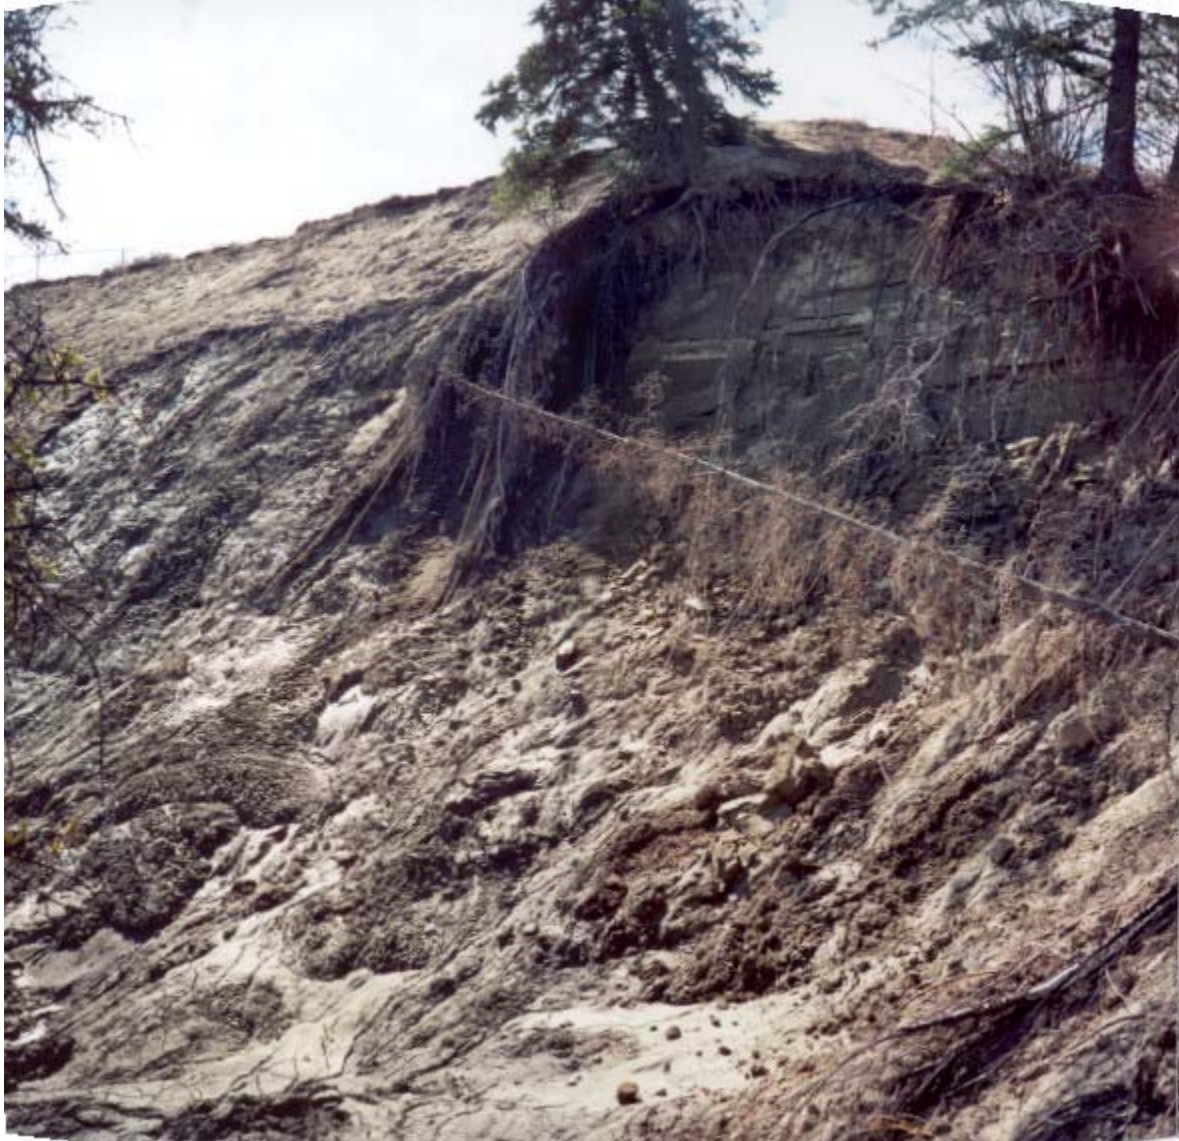
Photograph 9. May 2002. Active sloughing at thawing silt at contact with capping eolian sand within the Steele Street Slide headscarp.

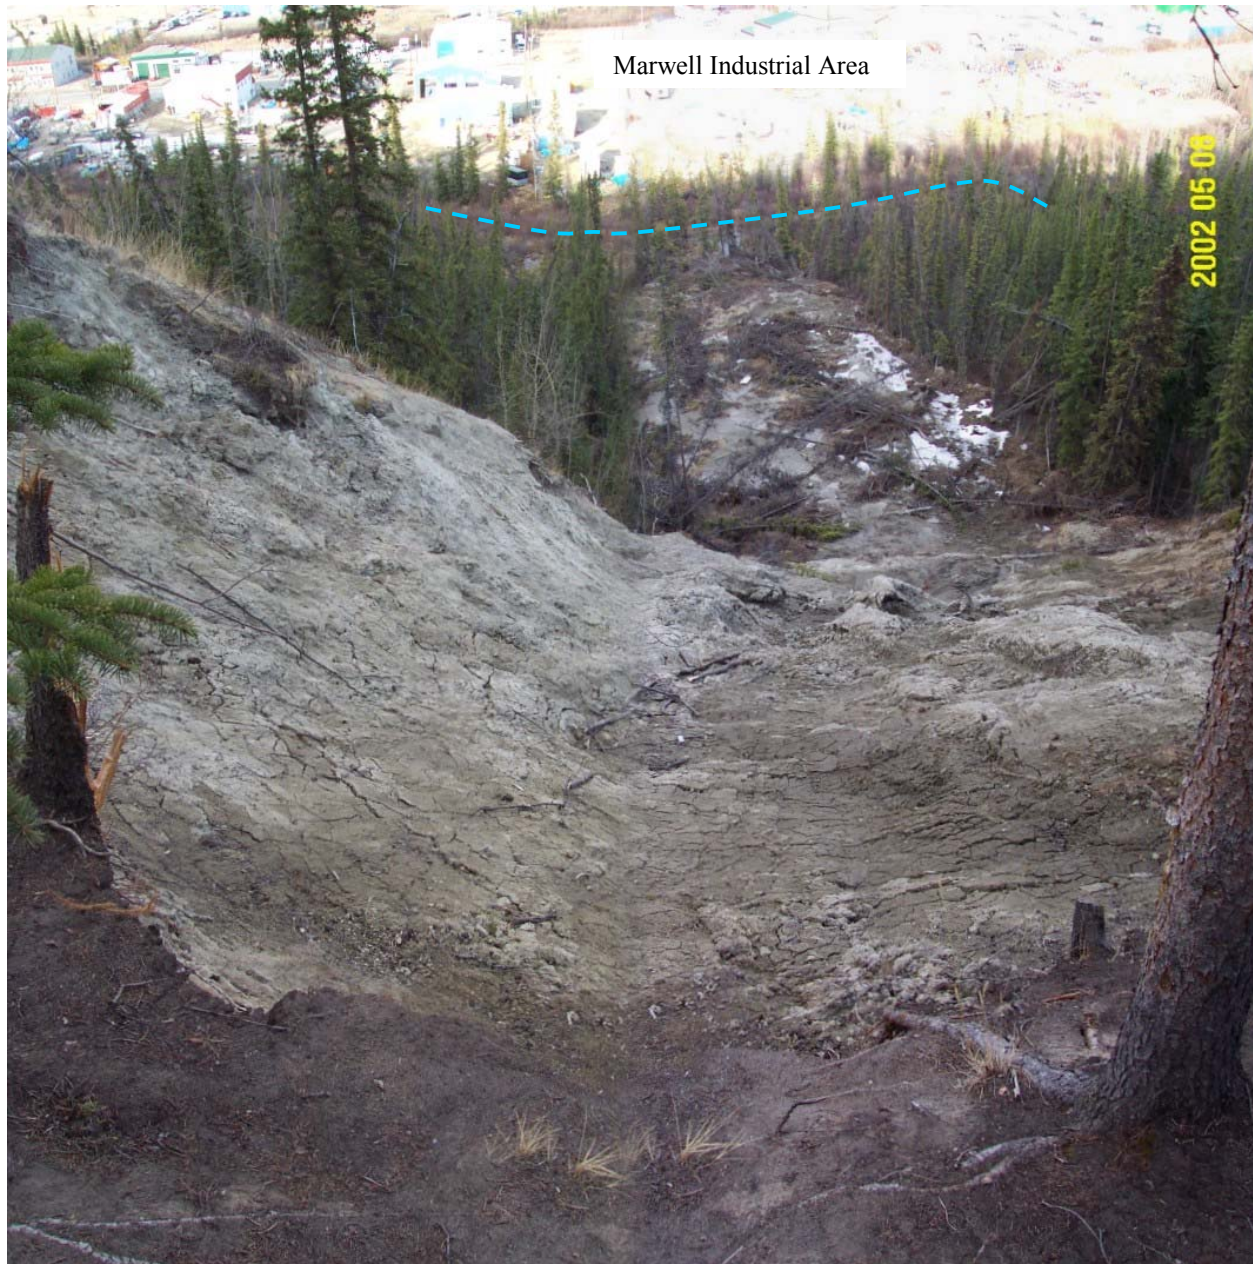
The Whitehorse escarpment has had a history of surface sloughing and mud flows generally associated with the spring thaw season and groundwater runoff; however, no reference to a deep-seated or large scale failure of the slope has been noted in the available information even following earthquakes experienced in the Whitehorse area. The Takini East debris slide involved the mobilization of an estimated 3000 m³; however, it is still considered a shallow landslide (Photographs 10-12).

Photograph 10: May 2002. The Takhini debris slide, which occurred in July 2000, is located on the escarpment that separates the Takhini subdivision from the Marwell Industrial Area. It occurred behind the Northern Windows assembly plant on Copper Road. The toe of the deposition zone is close to a stream channel / drainage ditch (blue) and is within 50 m of private property.

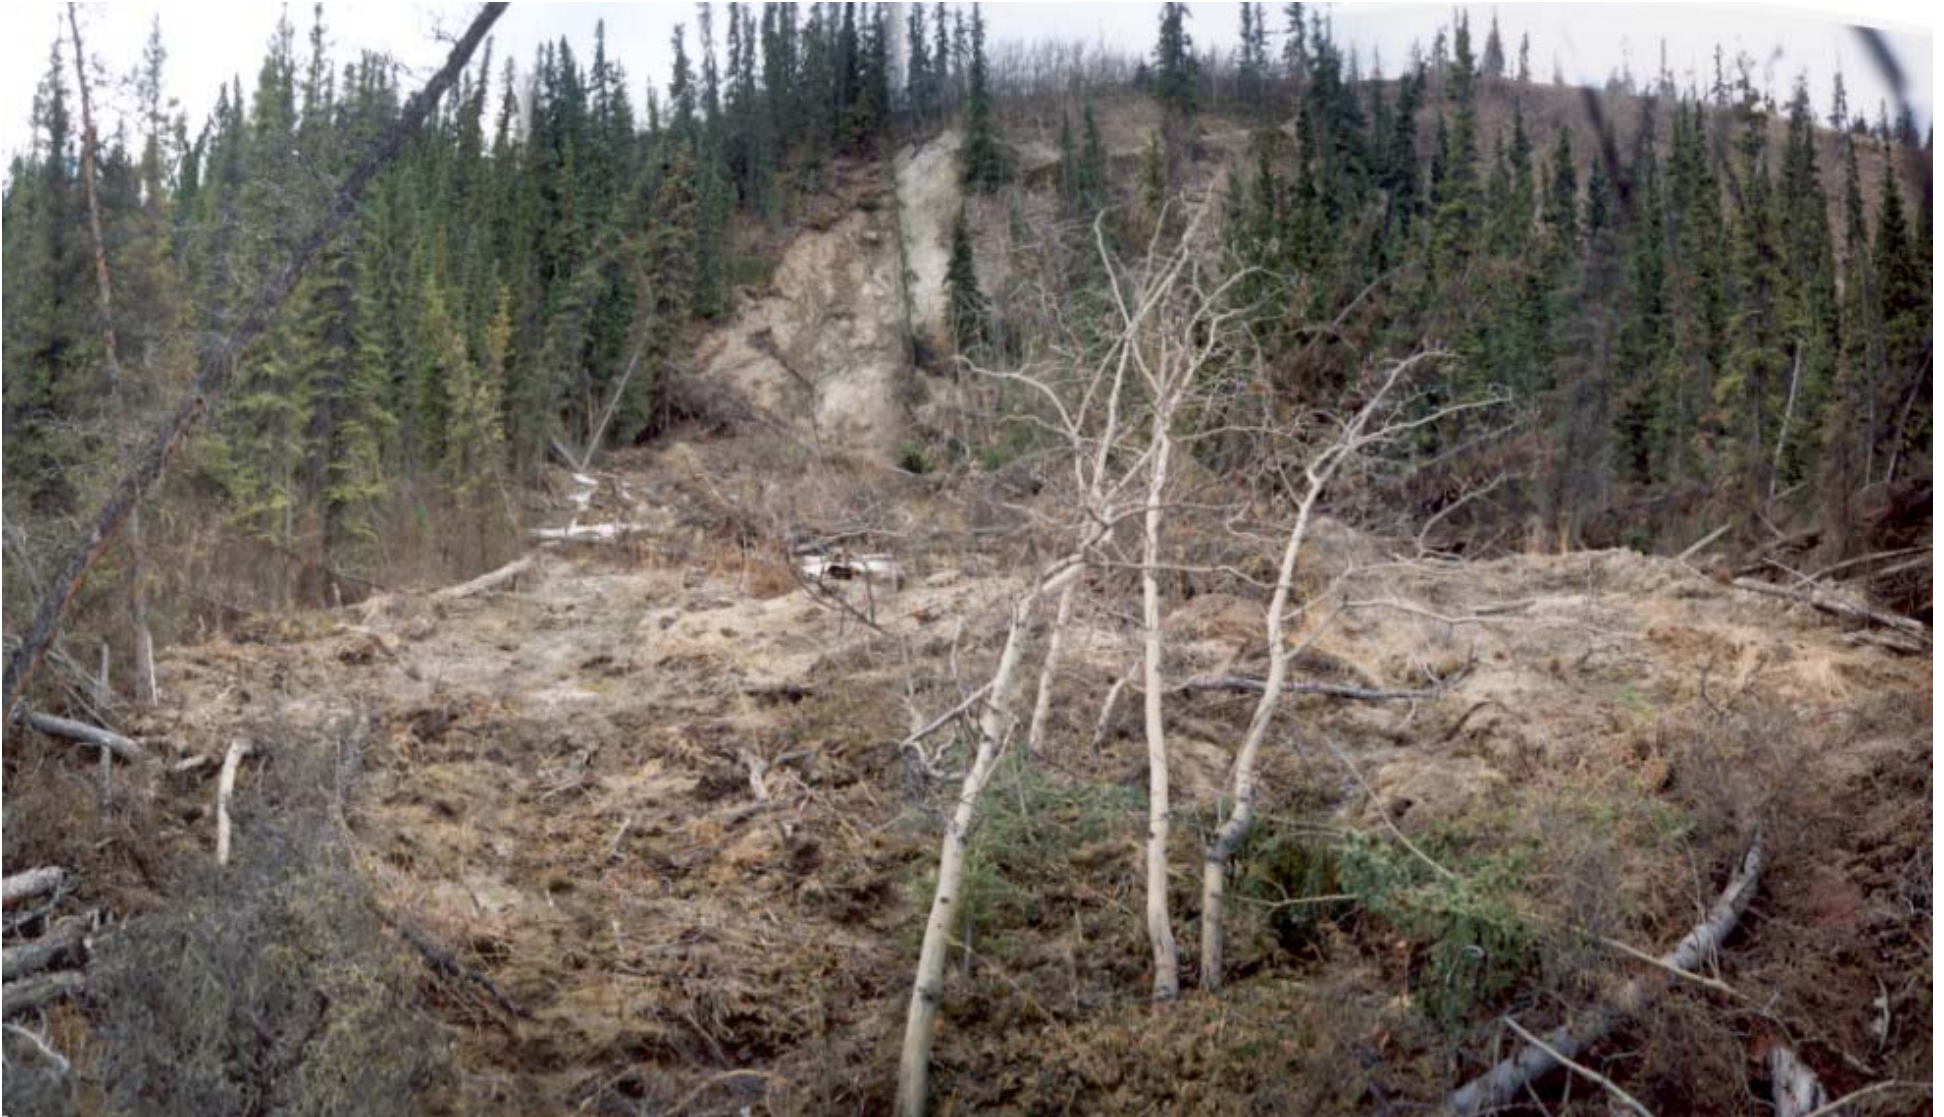
Photograph 11: May 2002. View of the Takhini debris flow from the toe of the deposition zone.

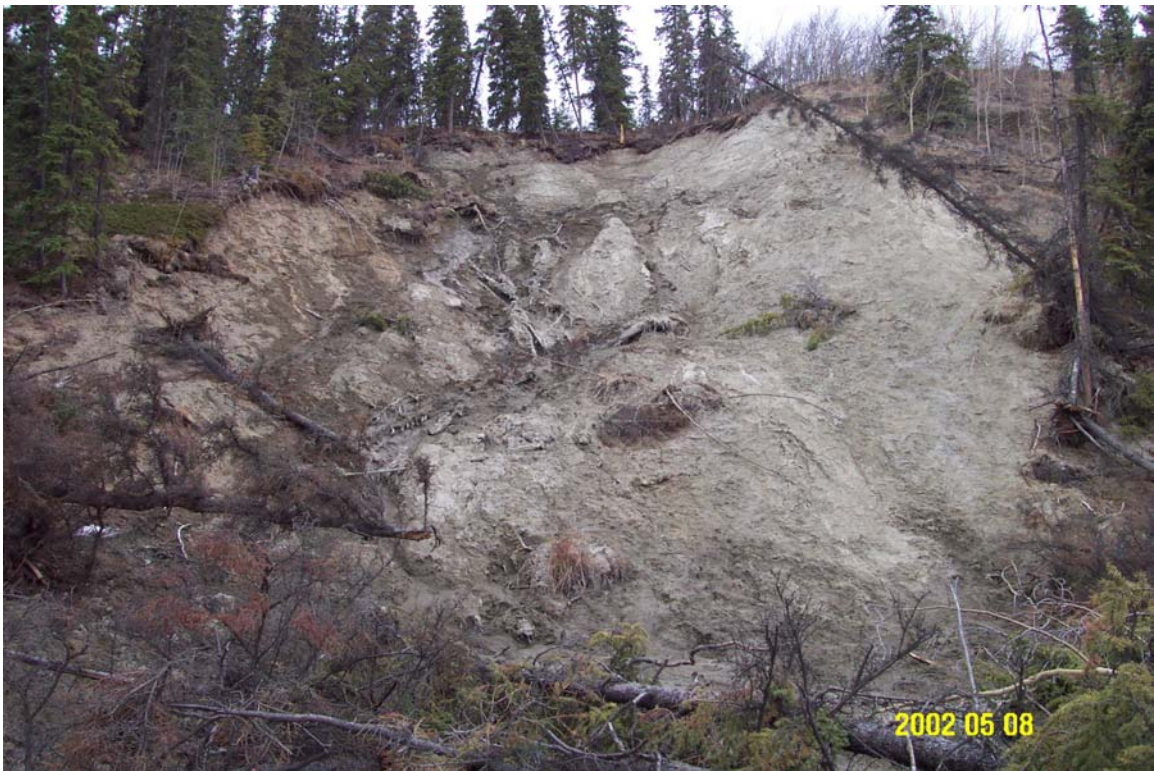
Photograph 12: May 2002. Headscarp of the Takhini debris flow.

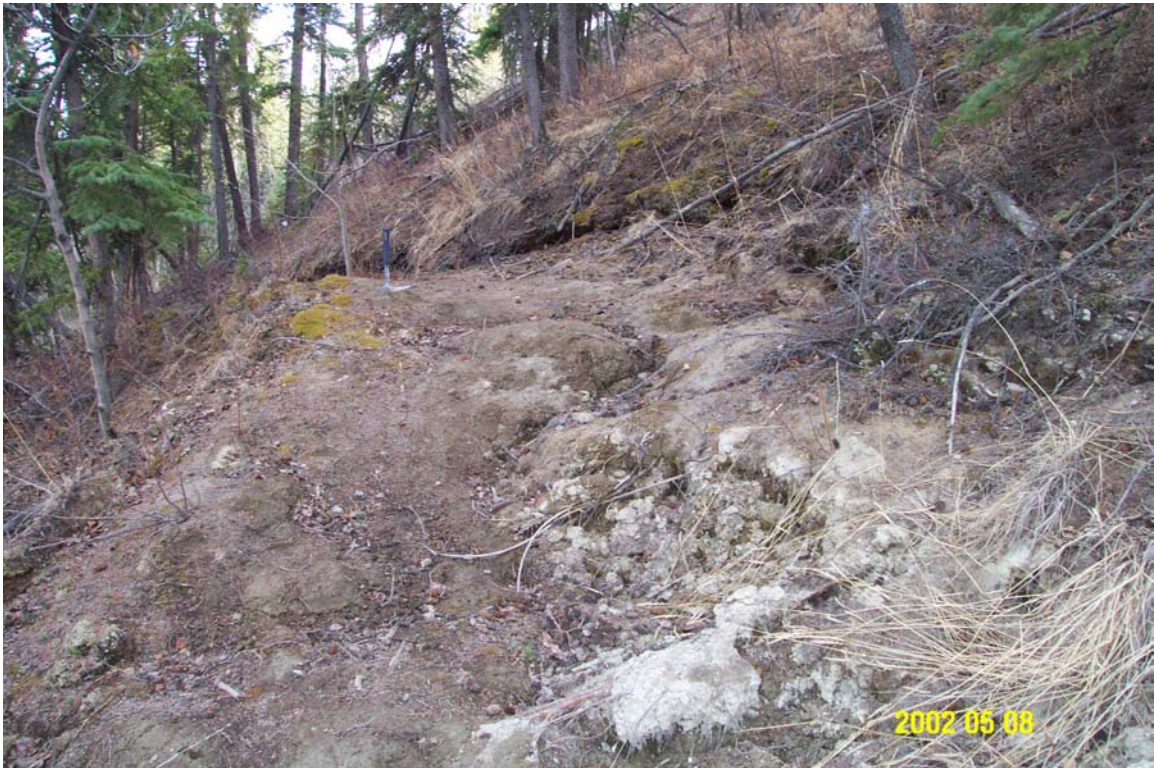
Photograph 13: May 2002. Tension crack formed upslope of the headscarp of the Takhini debris slide.

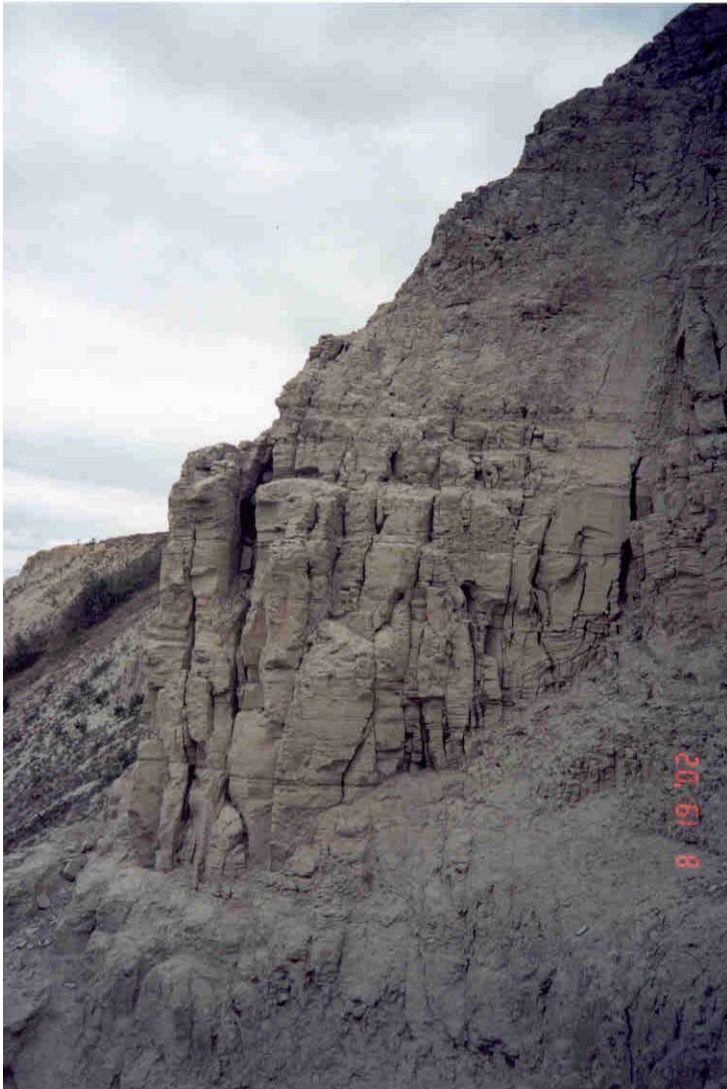
Photograph 14. August 2002. Sub-vertical silt bluffs on upper escarpment slope above Baxter Street.

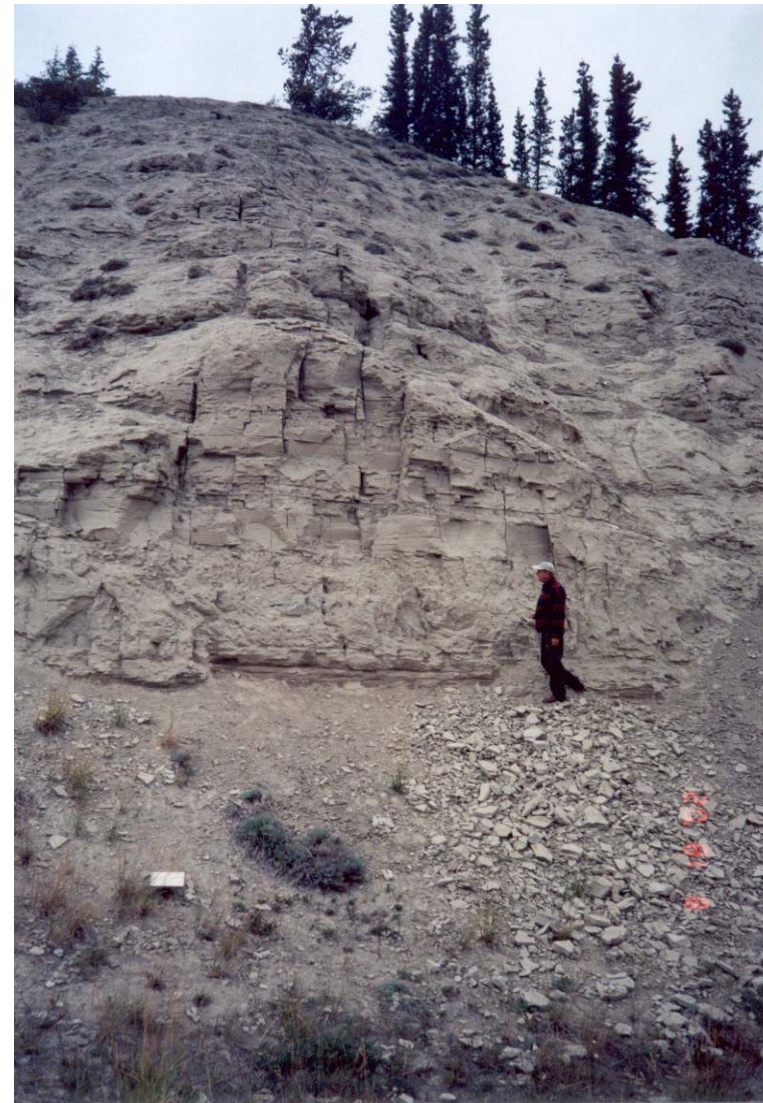
Photograph 15. August 2002. Sub-vertical silt bluffs with toppling debris at viewpoint on historic east airport road near Hawkins Street.

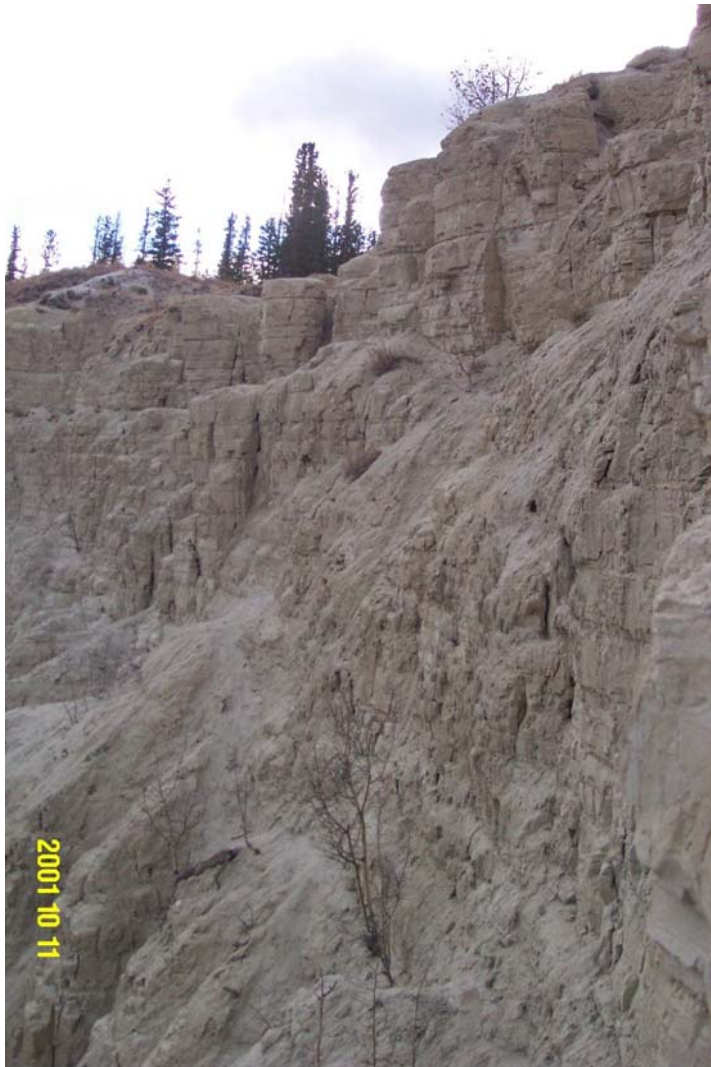
Photograph 16: May 2002. Sub-vertical bluffs of compact silt on the upper escarpment slopes above the end of Baxter Street

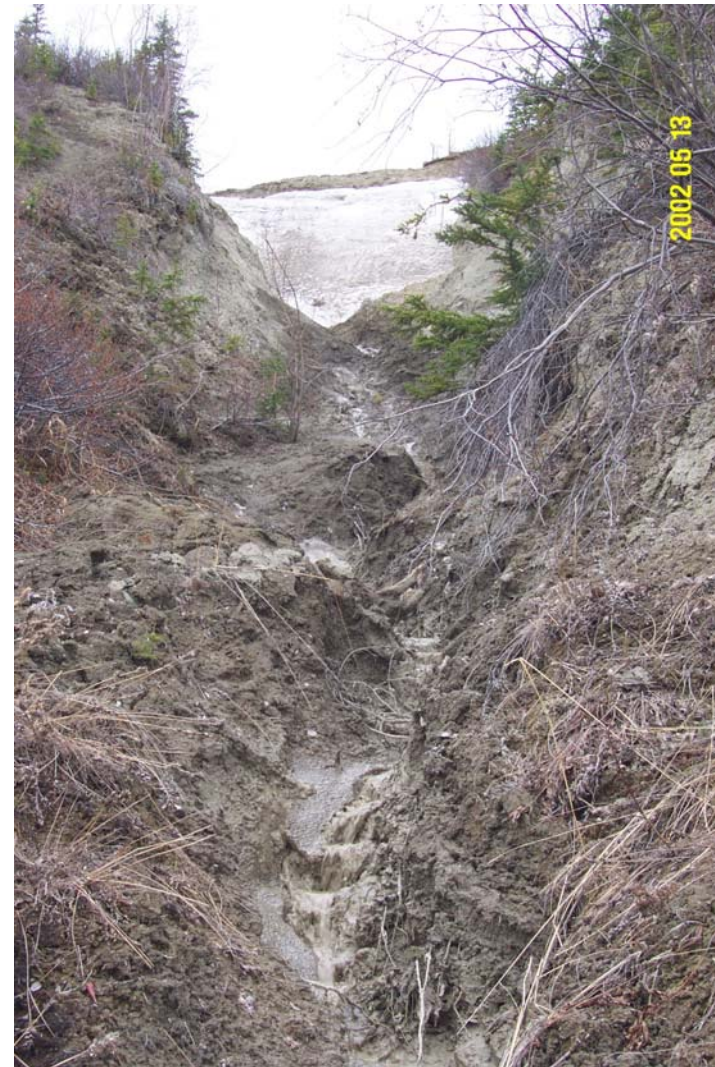
Photograph 17: May 2002. View up gully towards an active headscarp on the escarpment above the end of Main Street.

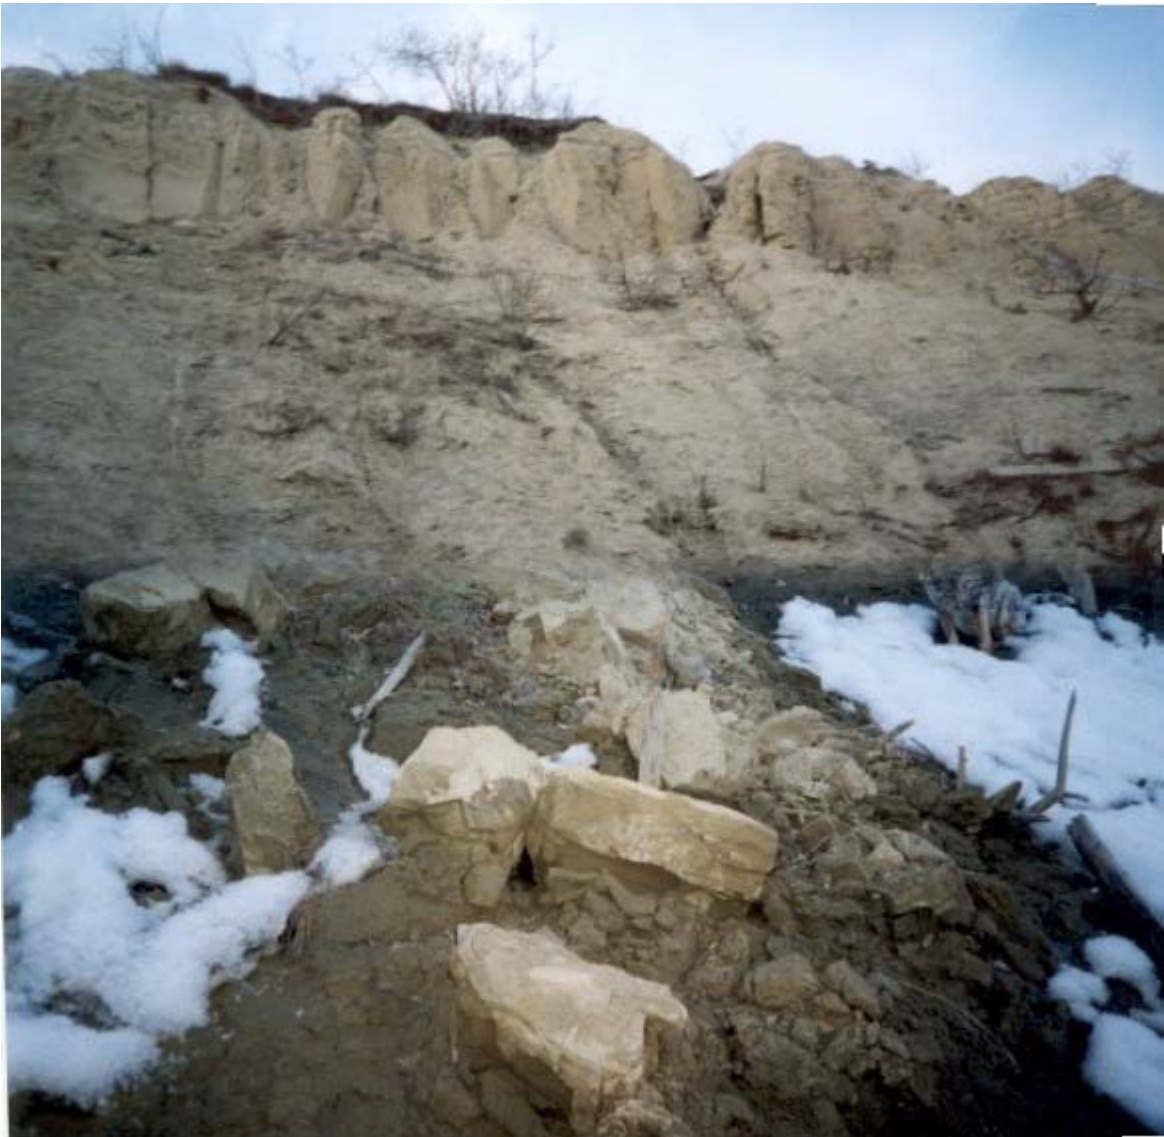
Photograph 18: April 2002. Toppled blocks of silt from sub-vertical bluffs within Baxter Gulch.

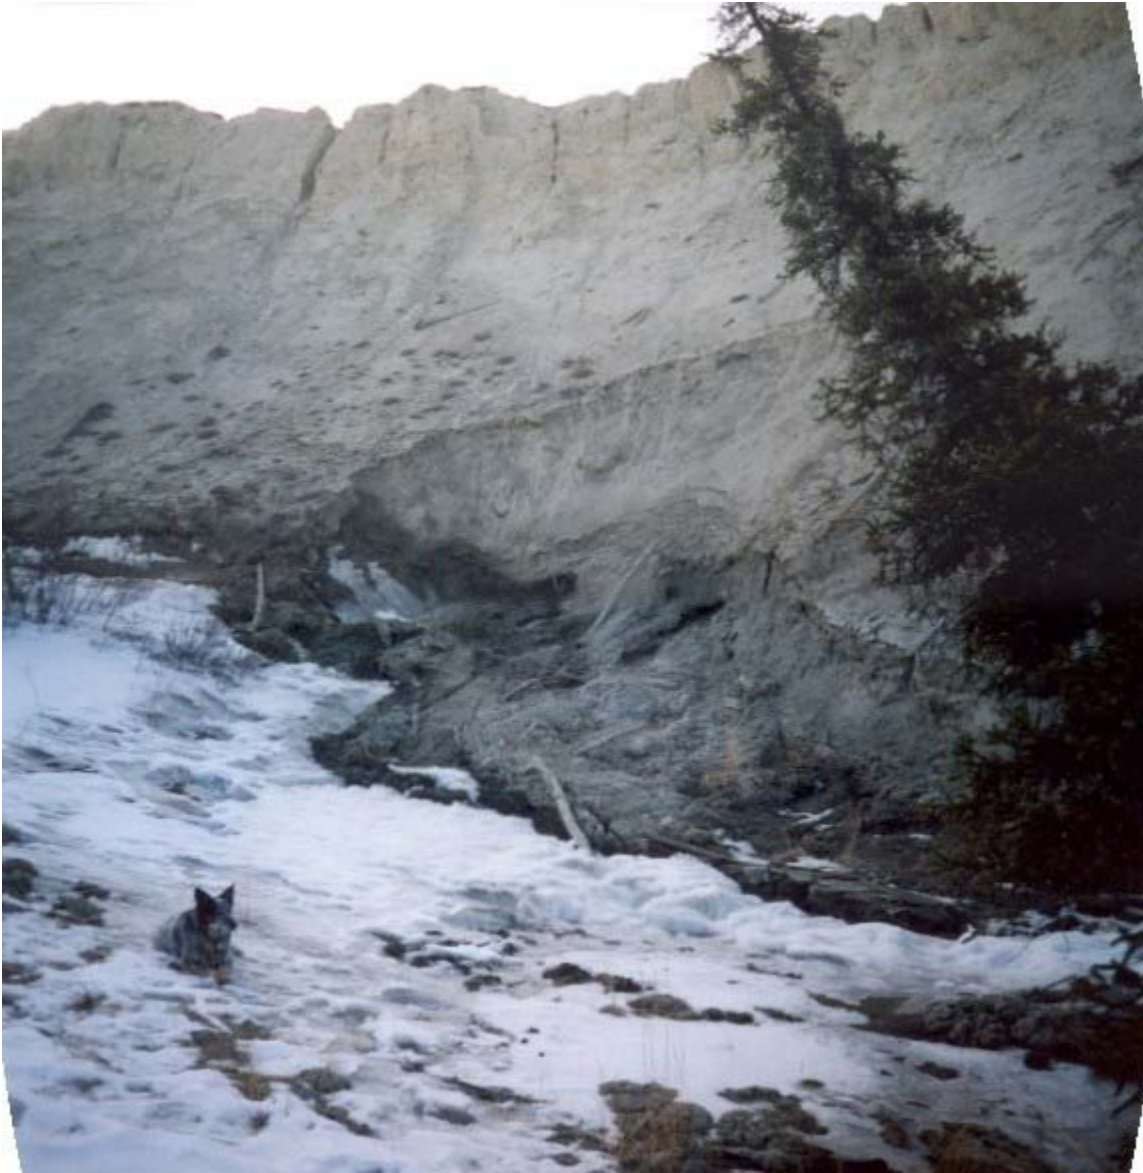
Photograph 19: April 2002. Slump and earthflow located at upper Baxters Gulch.
