**GEOHAZARD RISK STUDY
WHITEHORSE ESCARPMENT**

Whitehorse, Yukon
October, 2002

EBA File: 0201-1200002

prepared by:
EBA Engineering Consultants Ltd.
Whitehorse, Yukon

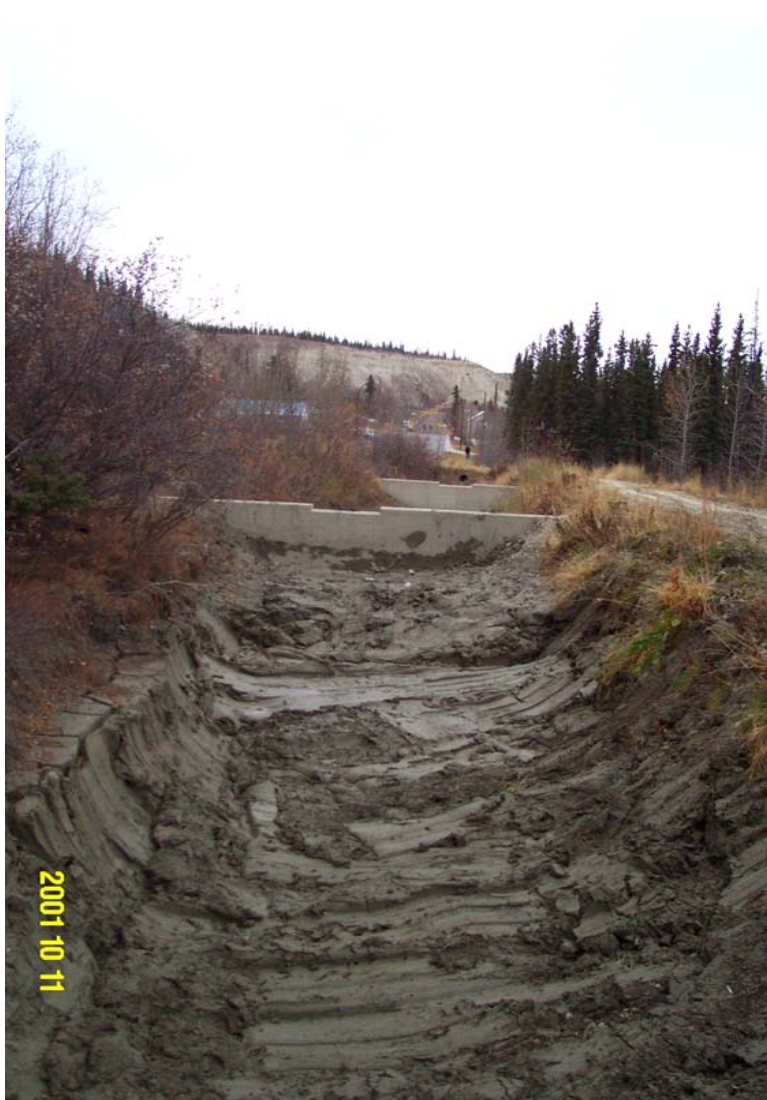
Photograph 20: September 2001. Baffled settling ponds located near the toe of the escarpment at the end of Steele Street. Silt has recently been removed.

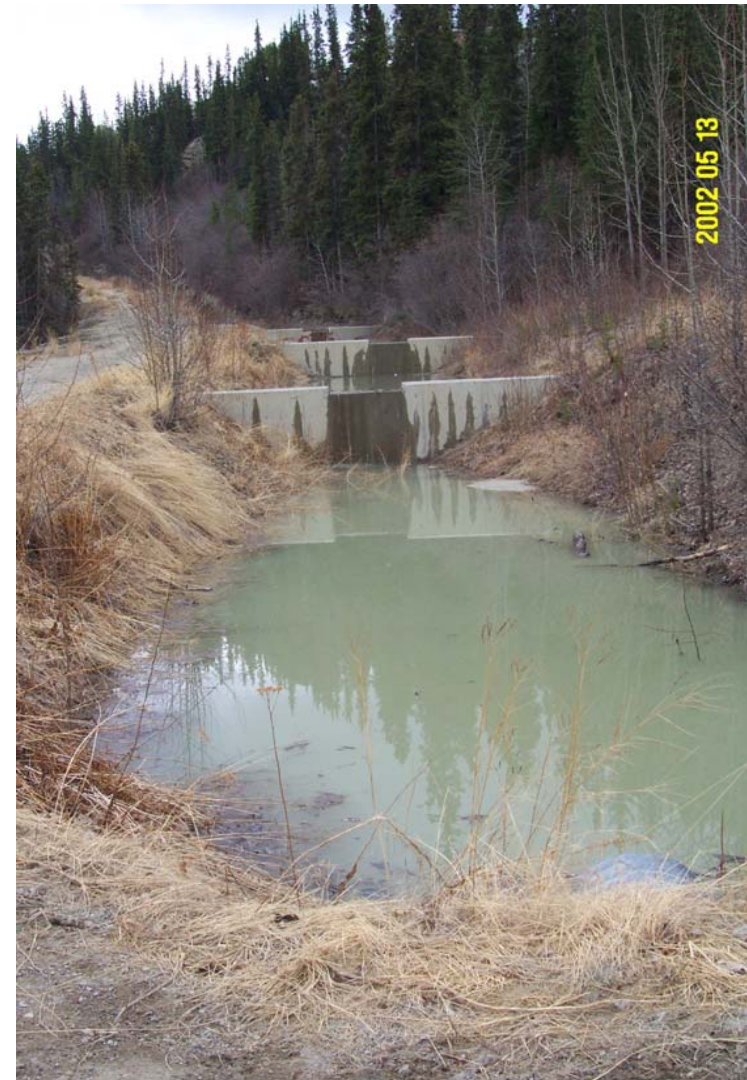
Photograph 21. May 2002. Baffled settling ponds located near the toe of the escarpment at the end of Steele Street.
